Inspection Photos

Location Name: TEP ROCKY MOUNTAIN LLC FEDERAL RMV 133-19 Pad

Location ID: 335369

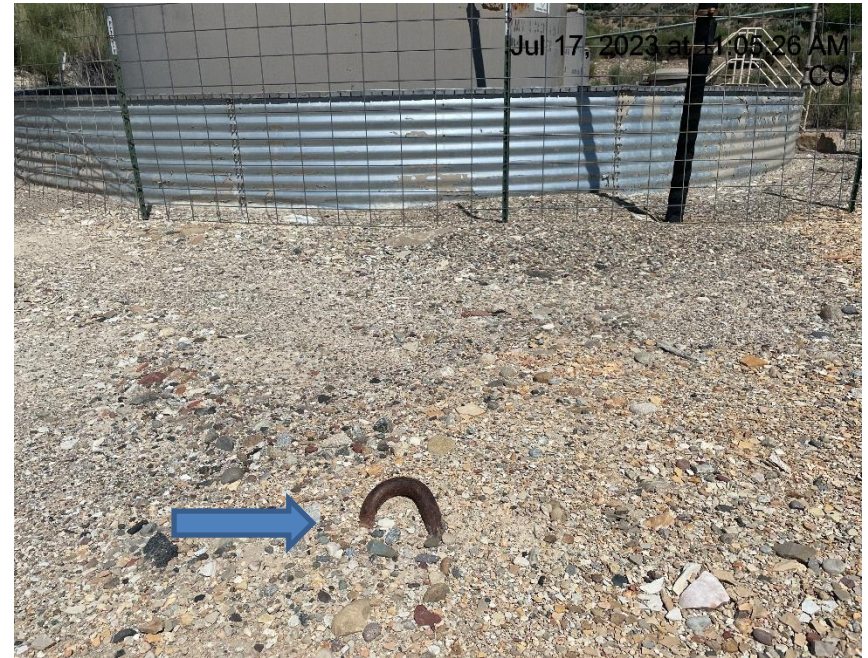
Photo # 3313 Unmarked deadman

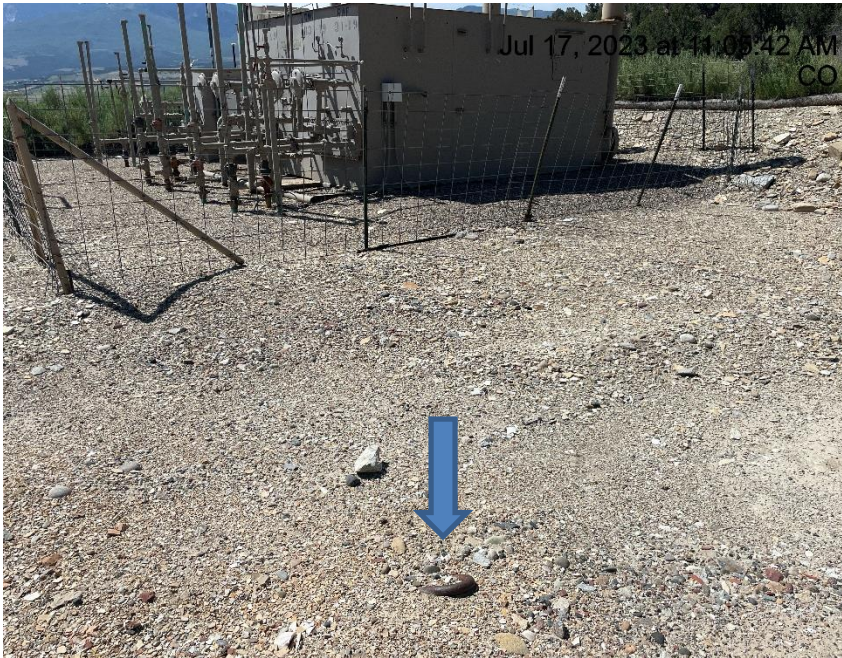
Photo # 3315 Same unmarked deadman from a different view

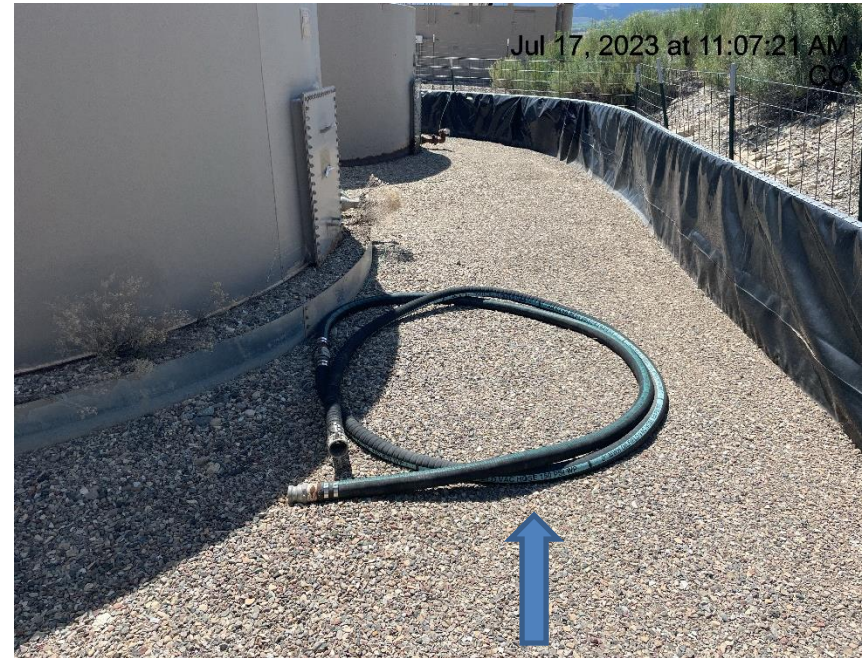
Photo # 3321 Unused equipment

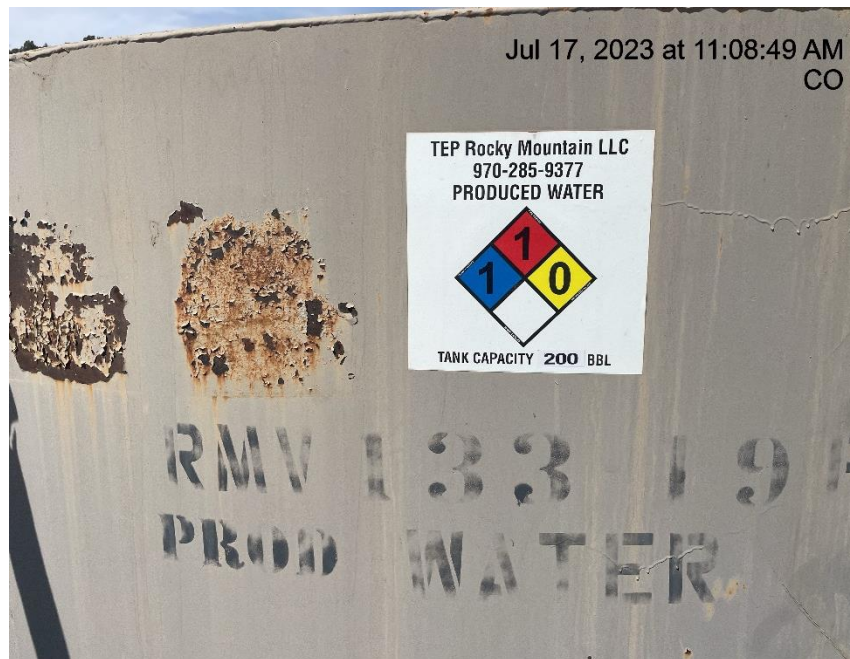
Photo # 3325 Tank label has incorrect capacity

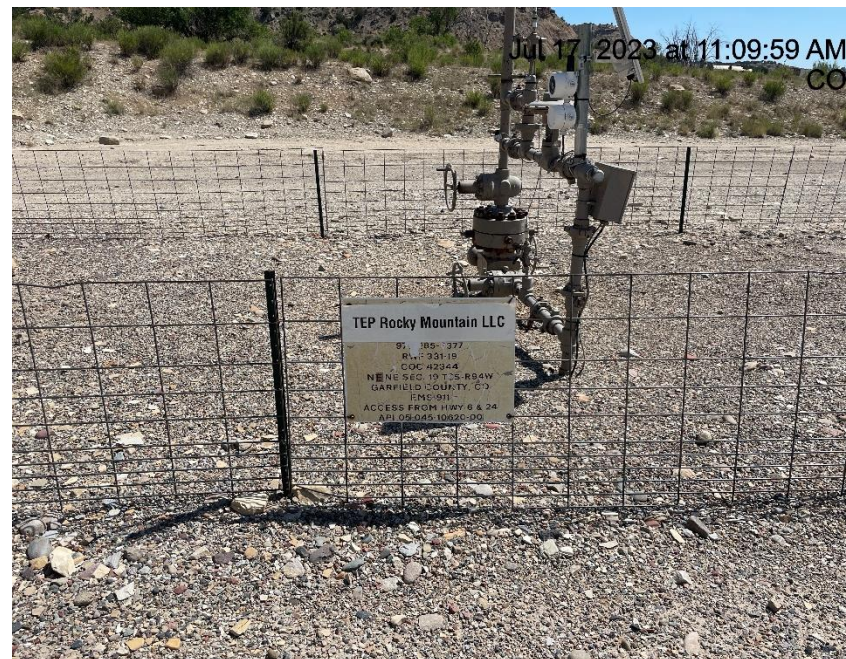
Photo # 3326 Operator contact # partially illegible on RWF 331-19 wellhead sign
