Storm Water Management and Erosion control

Location Name: TEP ROCKY MOUNTAIN LLC FEDERAL RMV 63-19 Pad

Location #: 335176

Location Overview: Location is within High Priority/Density Habitat areas. Location is approximately 27 yards from a drainage that contributes to the Colorado River.

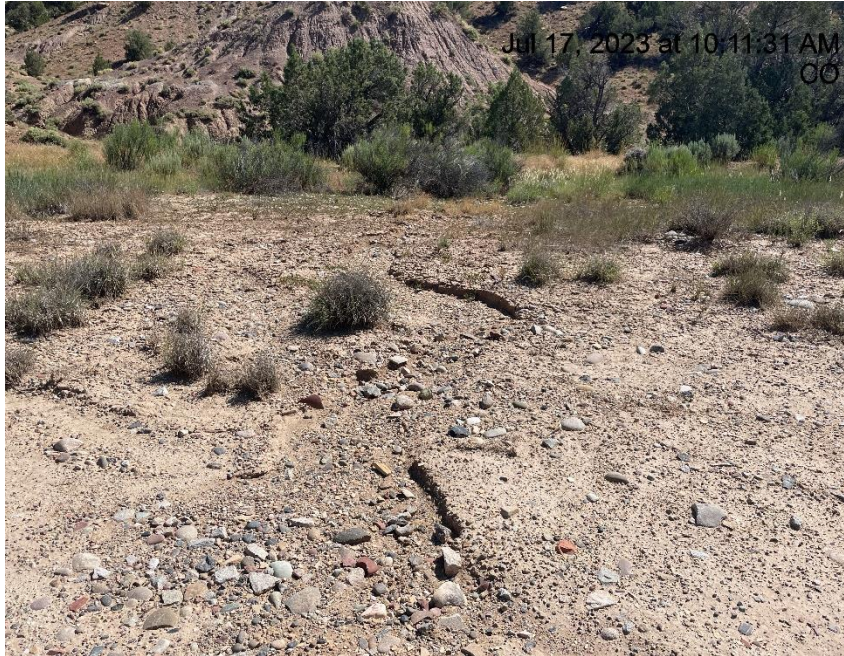
Photo # 3168 Erosion & transport of sediment off location

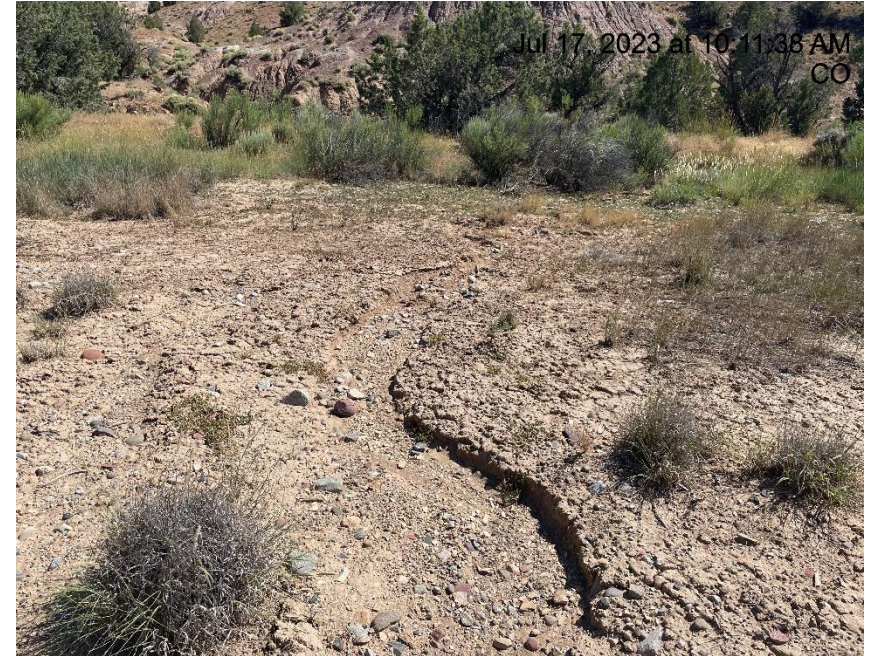
Photo # 3169 Erosion & transport of sediment off location

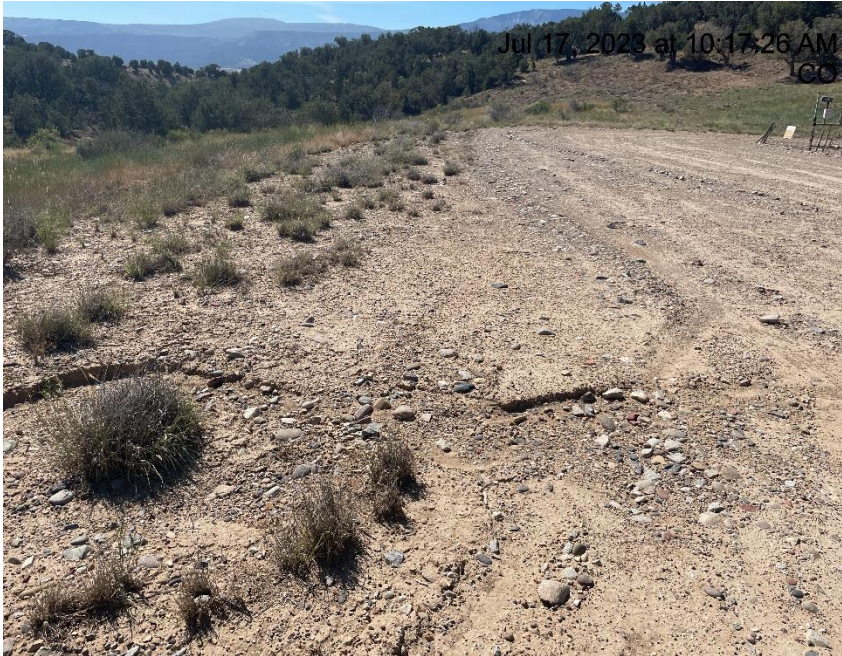
Photo # 3194 Erosion & transport of sediment off location

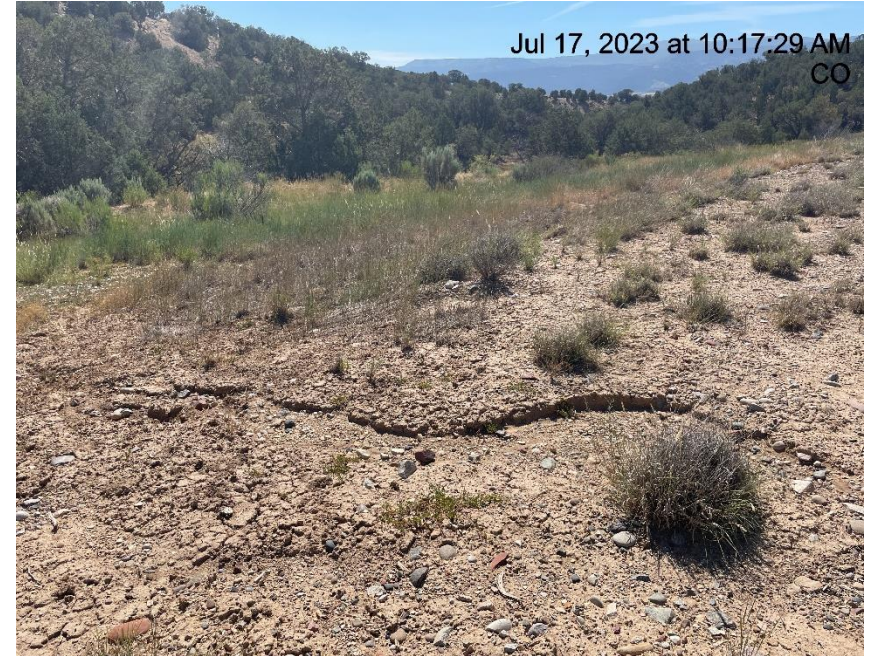
Photo # 3195 Erosion & transport of sediment off location

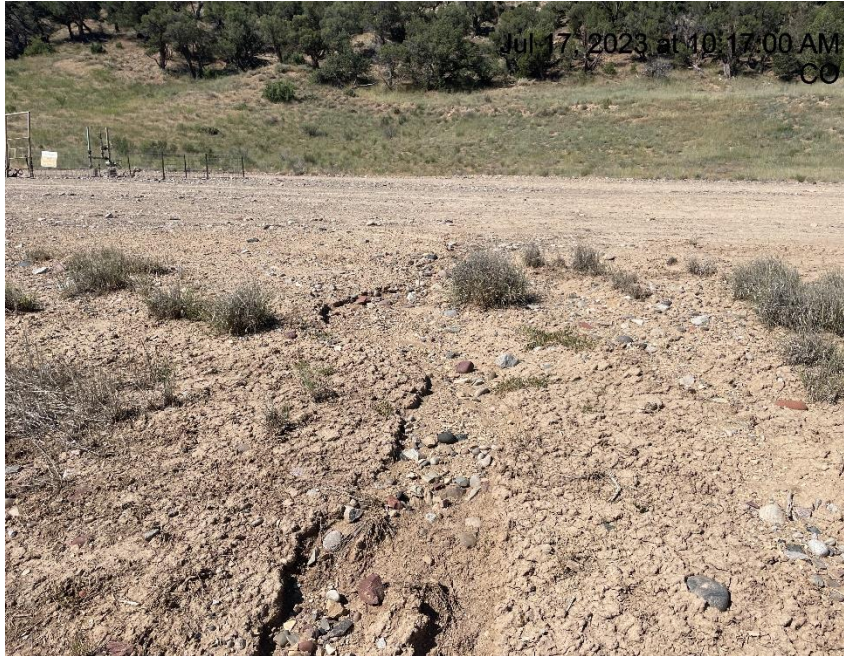
Photo # 3191 Erosion & transport of sediment off location

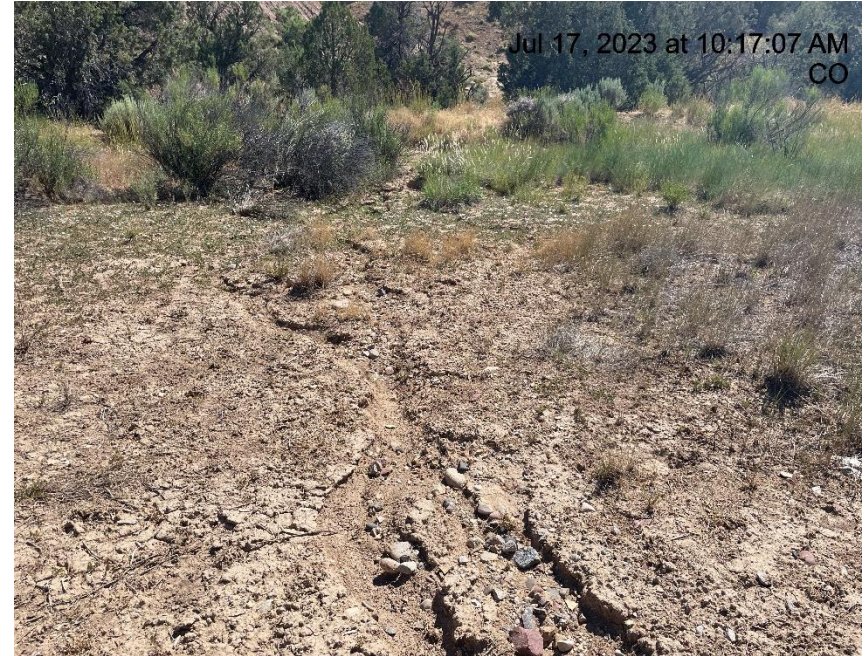
Photo # 3192 Erosion & transport of sediment off location

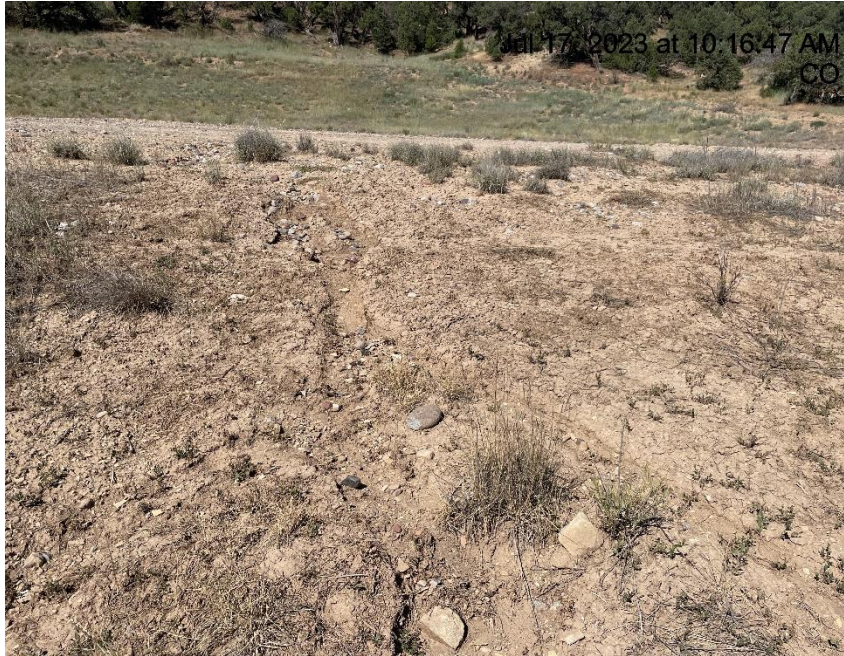
Photo # 3188 Erosion & transport of sediment off location

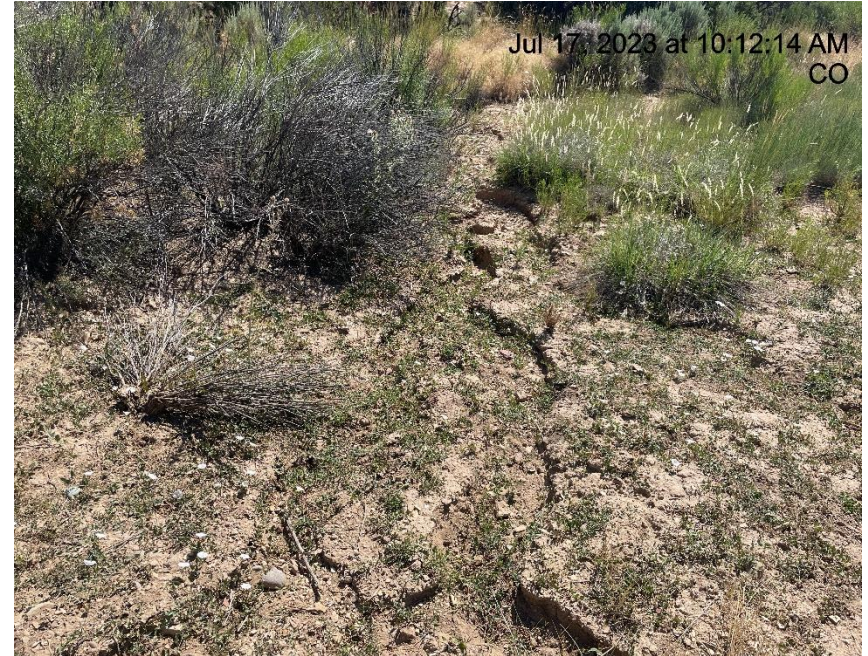
Photo # 3172 Erosion & transport of sediment off location

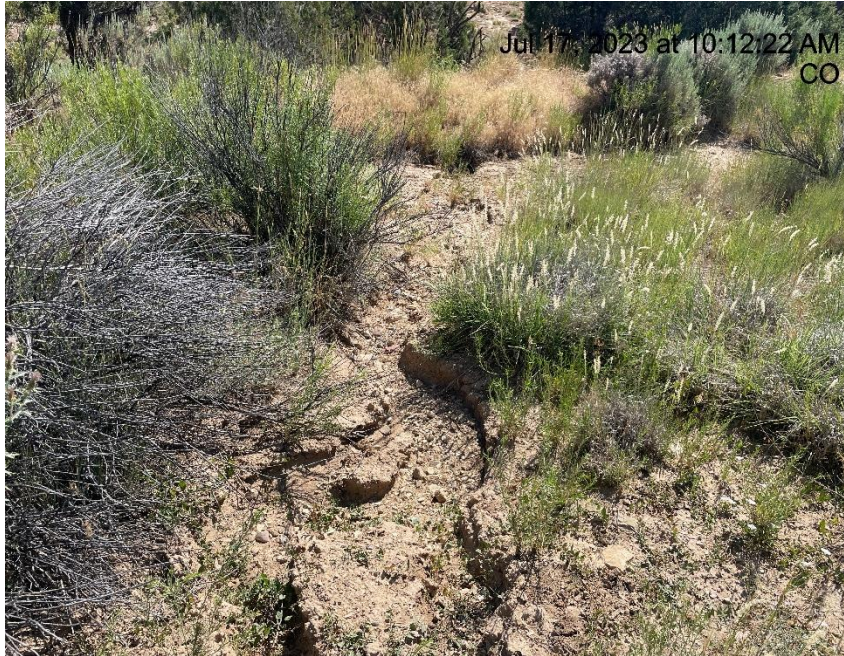
Photo # 3173 Erosion & transport of sediment off location/sediment choking off vegetation (E/NE area of location)

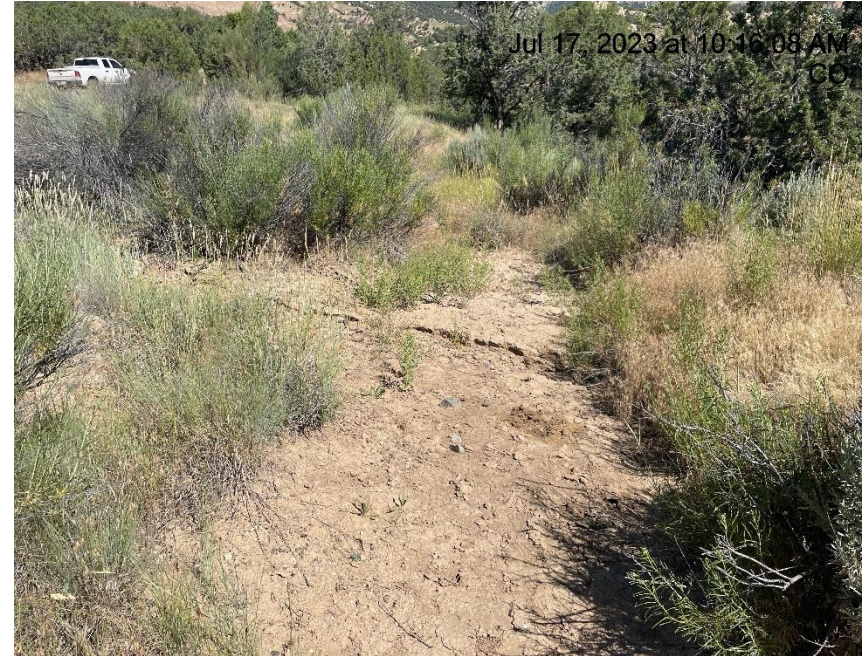
Photo # 3184 Erosion & transport of sediment off location/sediment choking off vegetation (E/NE area of location)

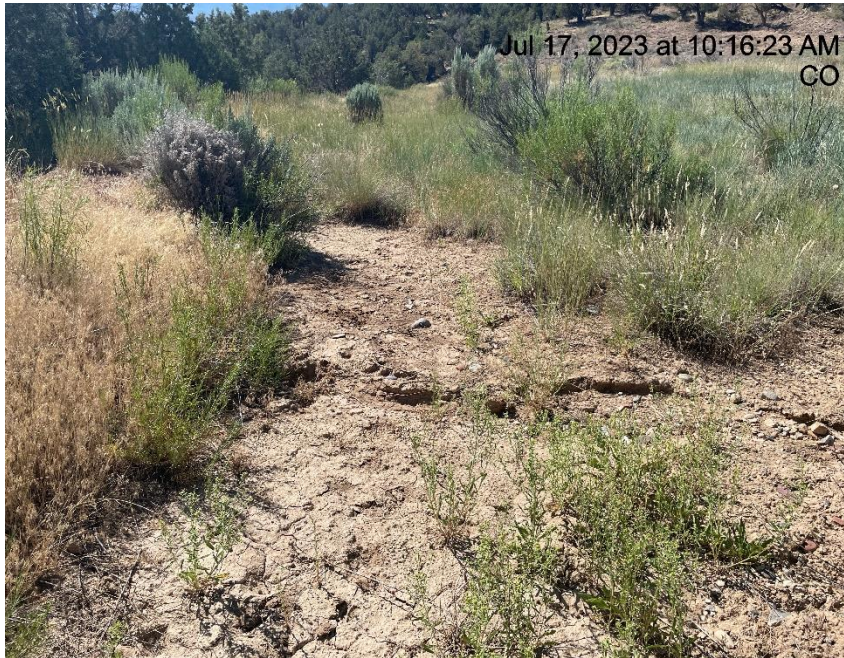
Photo # 3185 Erosion & transport of sediment off location/sediment choking off vegetation (E/NE area of location)

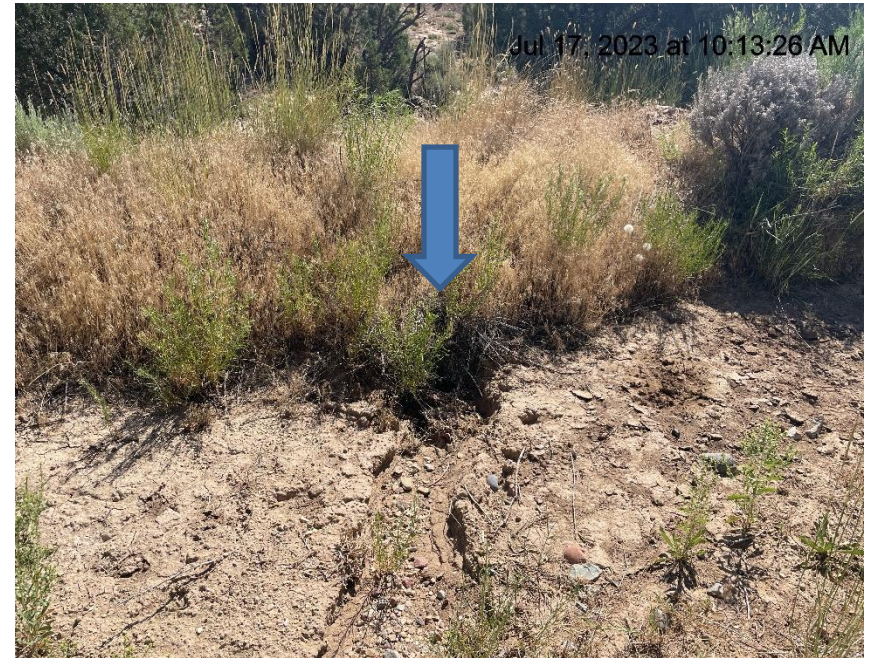
Photo # 3175 Erosion & transport of sediment off location/sediment choking off vegetation/Tunnel erosion going through berm (E/NE area of location)

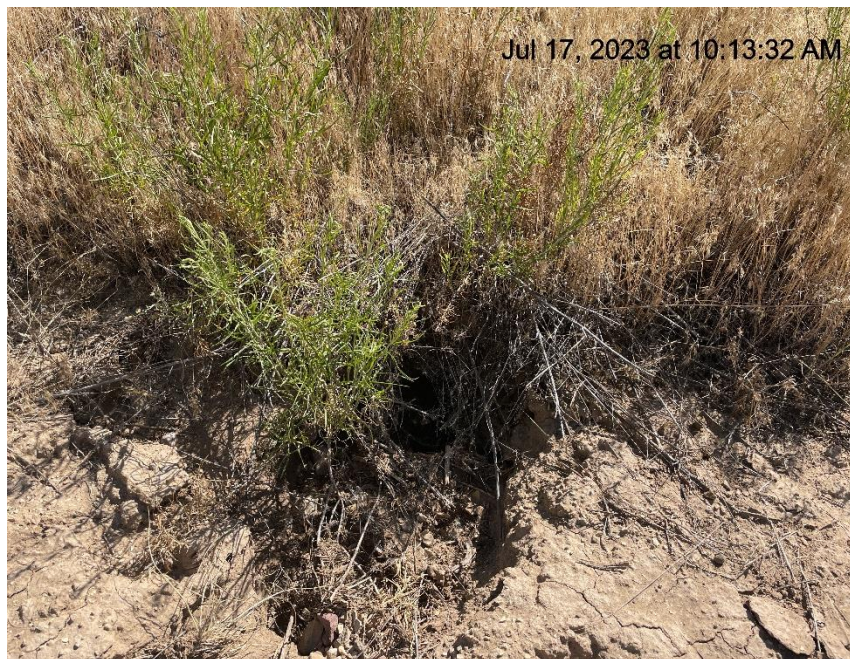
Photo # 3176 Tunnel erosion in berm (E/NE area of location)

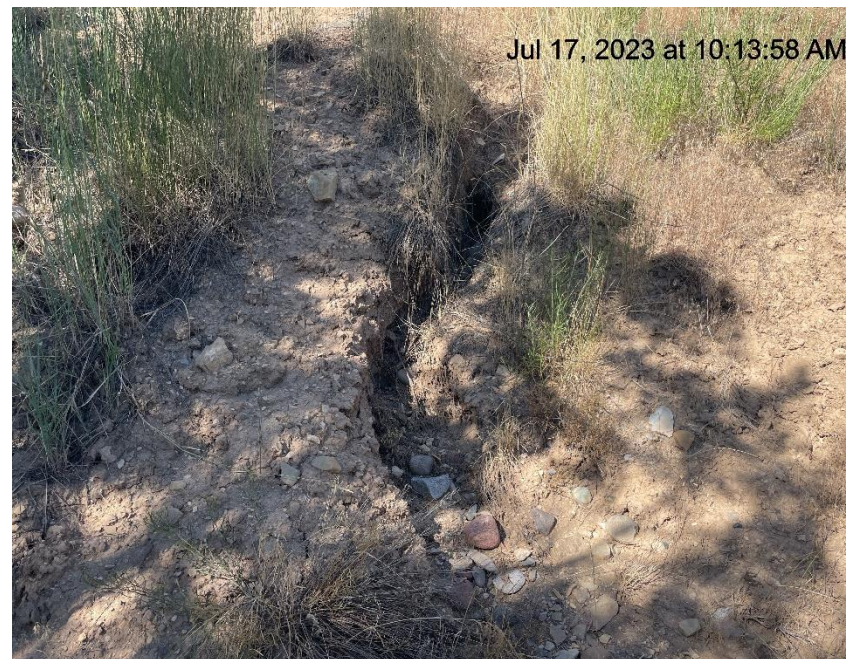
Photo # 3177 Opposite side of berm – tunnel erosion has breached berm & is carrying sediment further offsite & into a drainage (E/NE area of location)

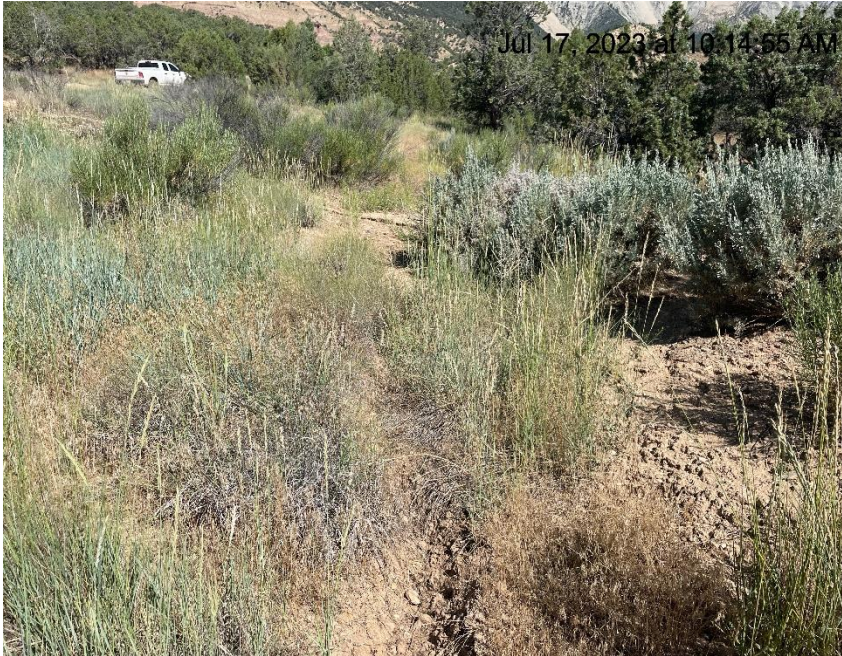
Photo # 3181 Erosion & transport of sediment (E/NE area of location)

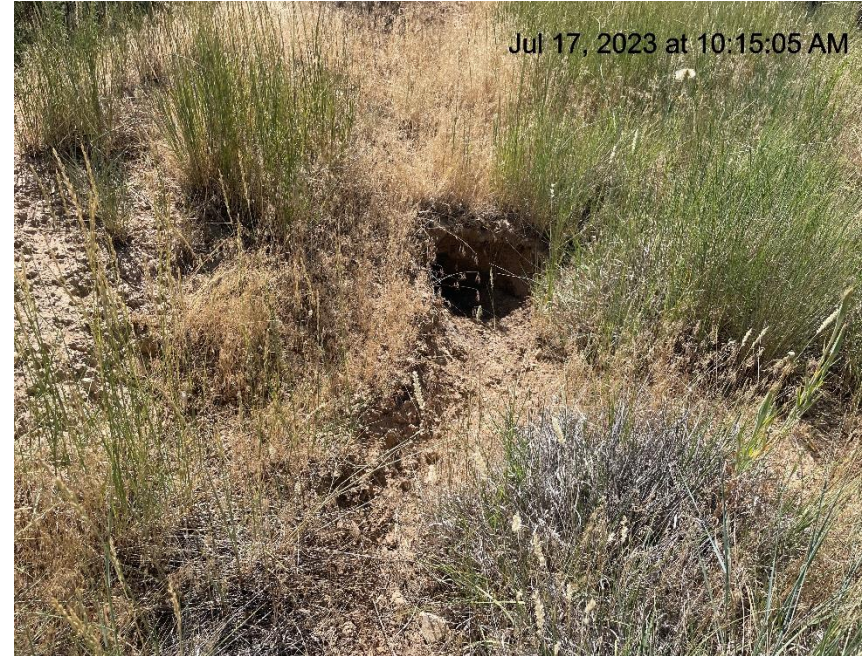
Photo # 3182 Tunnel erosion through another area of the berm (E/NE area of location)

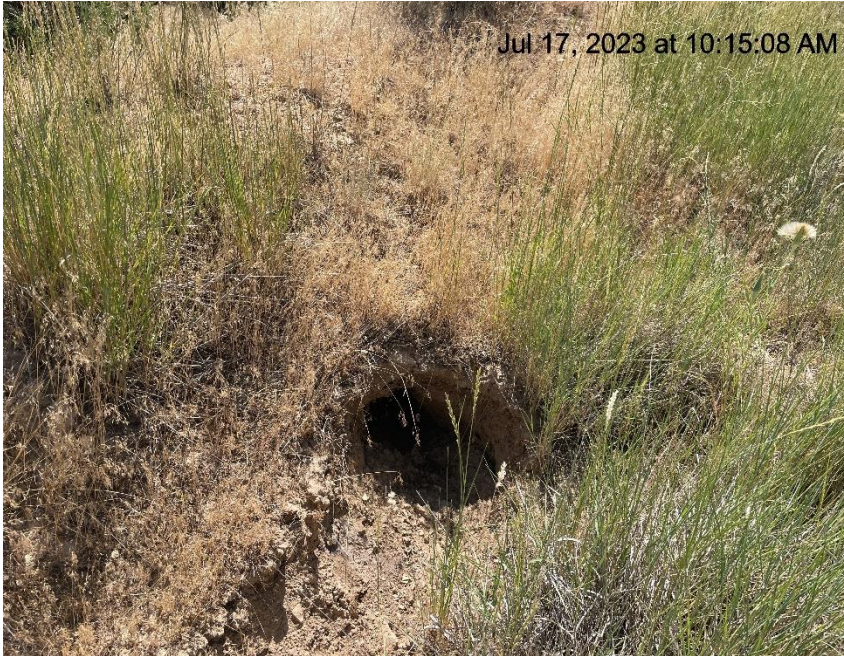
Photo # 3183 Tunnel erosion through berm (E/NE area of location)
