**Storm Water Management and Erosion control**  
**Location Name: TEP ROCKY MOUNTAIN LLC FEDERAL RMV 144-19 Pad**  
**Location #: 335109**

**Location Overview: Location is within High Priority/Density  
Habitat areas & drainages contribute to the Colorado River.**

**Section/Township/Range: 19 6S94W**

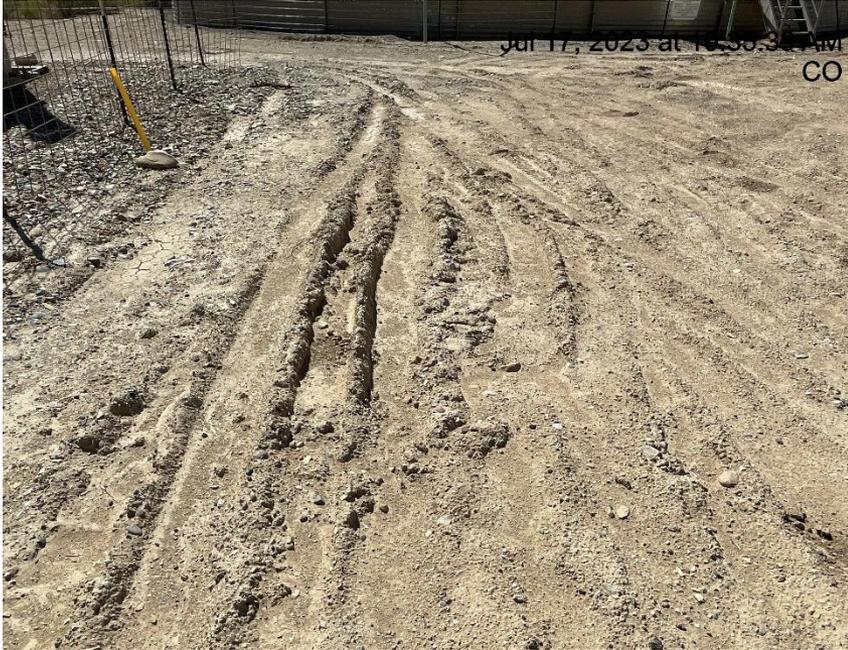
**Photo # 3224 Lack of compaction/Stabilization**

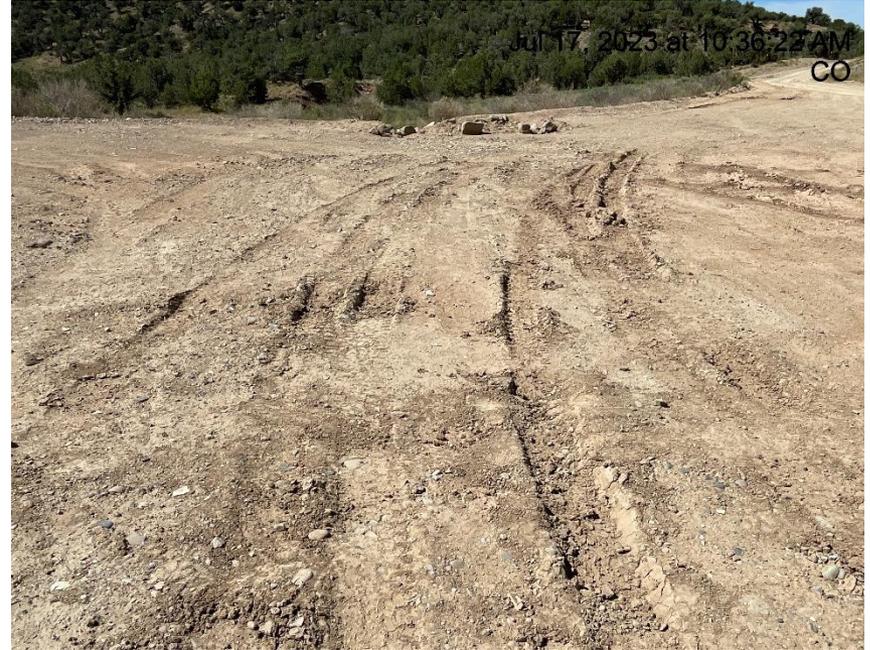
**Photo # 3227 Lack of compaction/Stabilization**

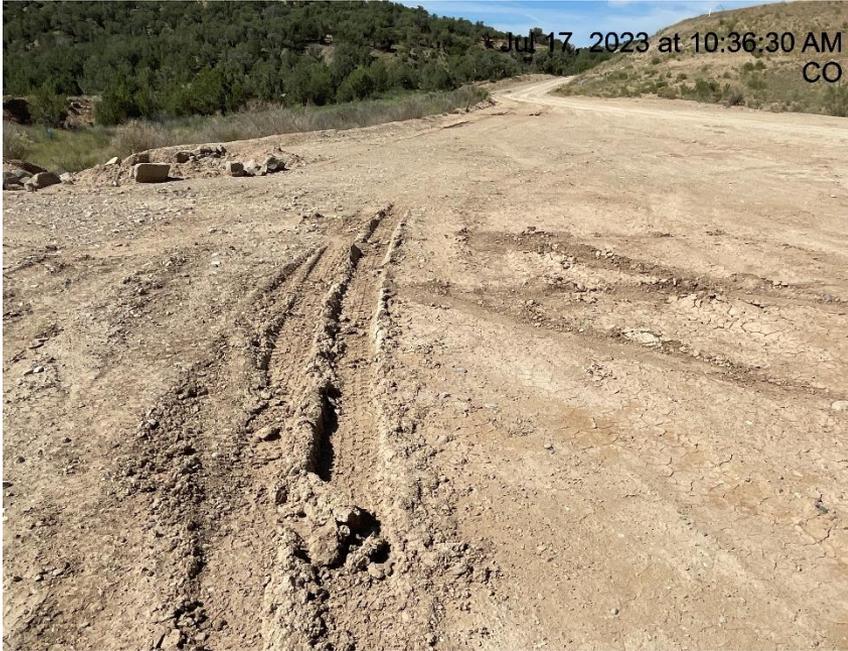
**Photo # 3228 Lack of compaction/Stabilization**

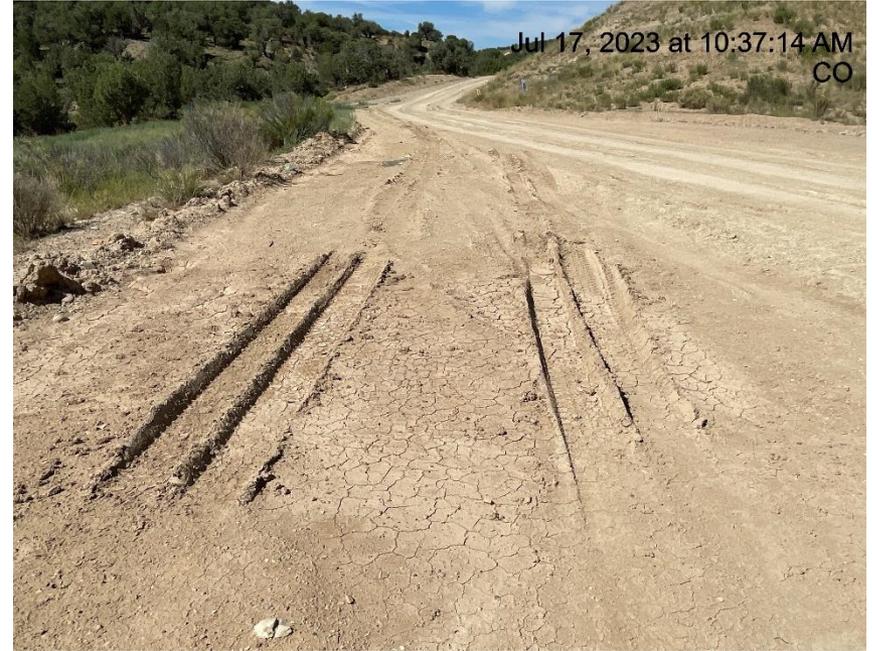
**Photo # 3231 Lack of compaction/Stabilization**

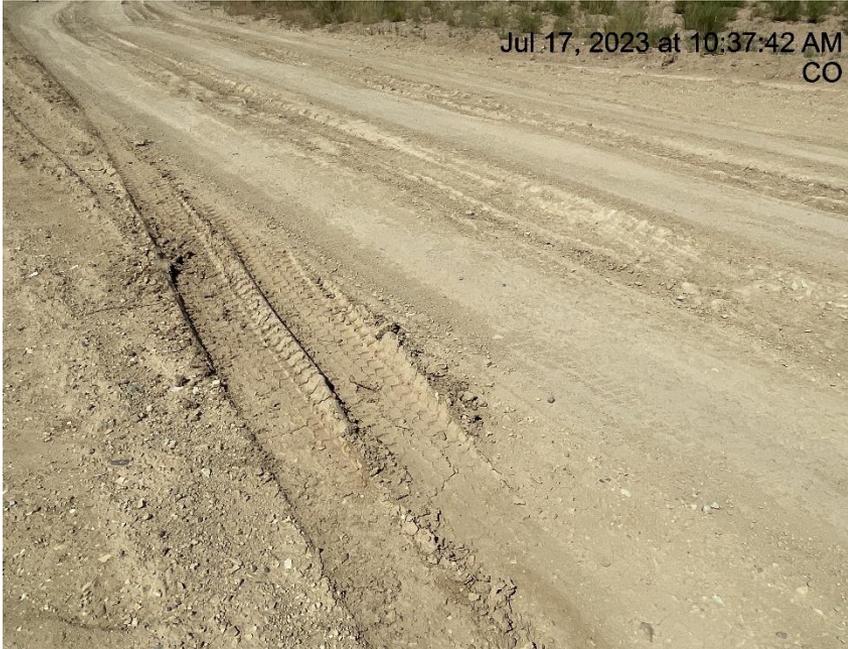
**Photo # 3232 Lack of compaction/Stabilization**

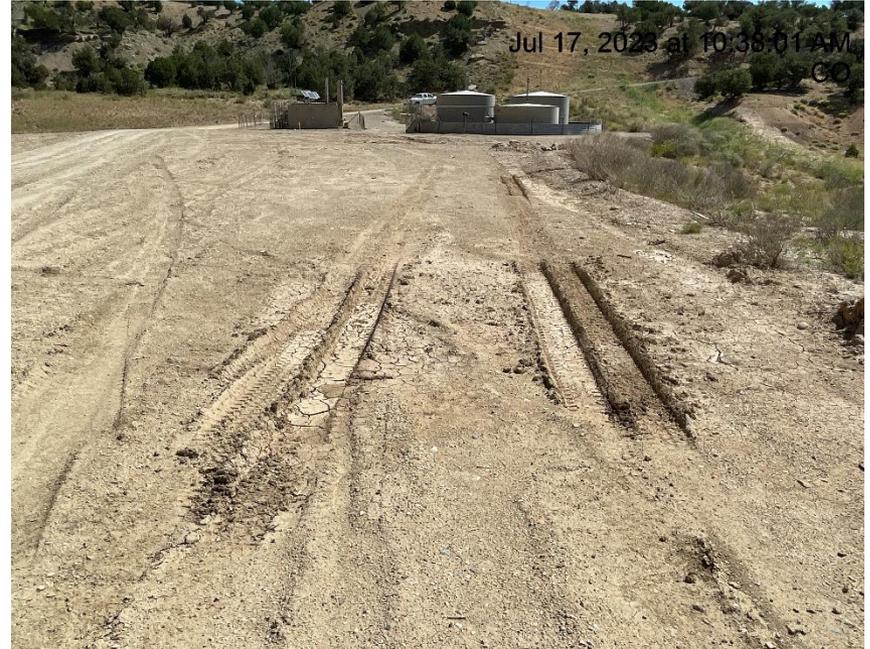
**Photo # 3233 Lack of compaction/Stabilization**

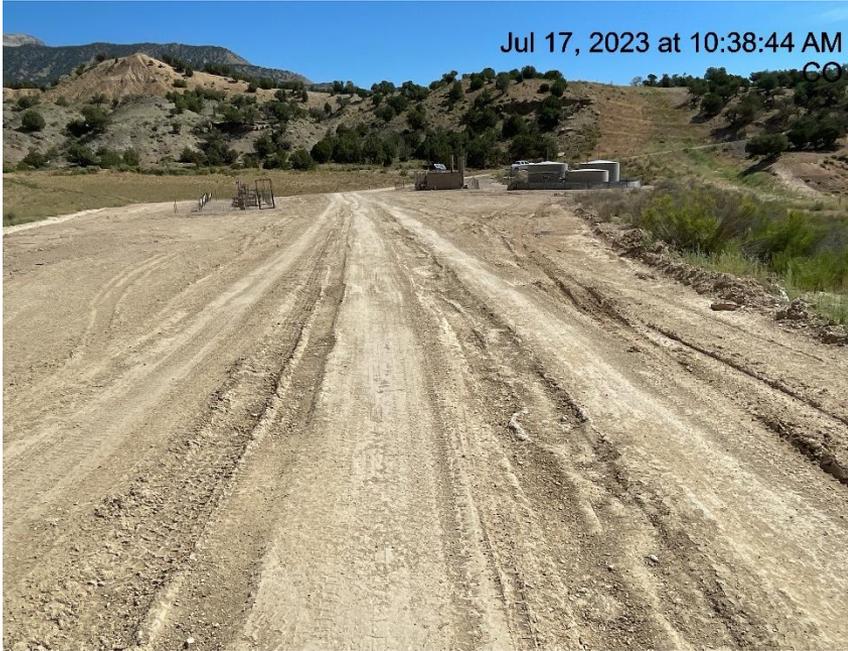
**Photo # 3238 Lack of compaction/Stabilization**

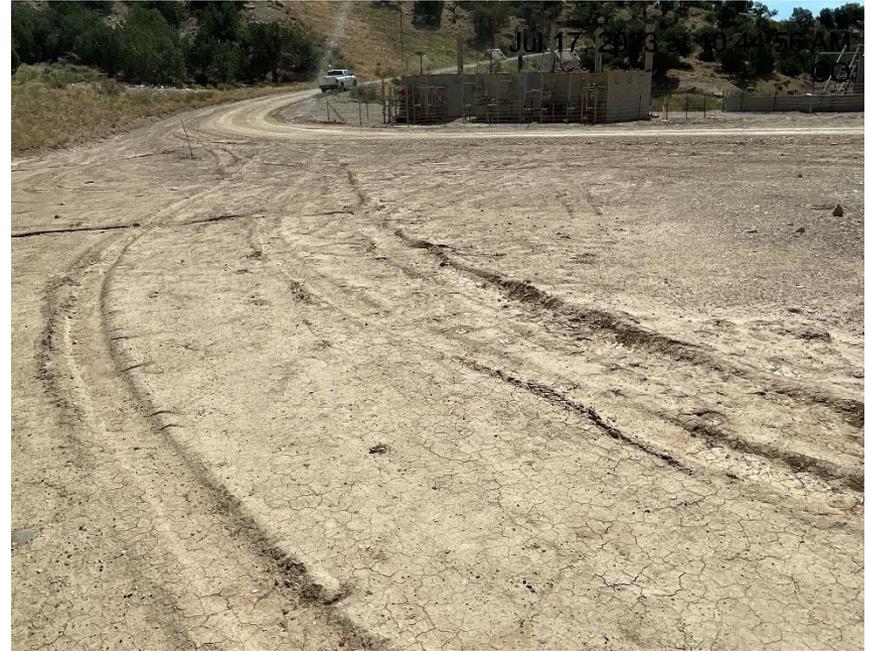
**Photo # 3271 Lack of compaction/Stabilization**

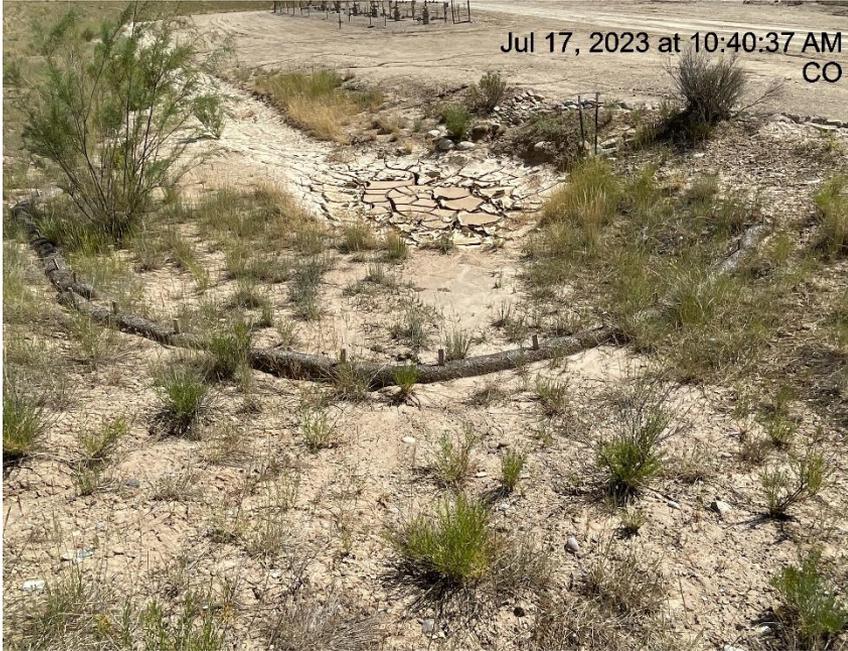
**Photo # 3244 BMP's need maintenance (N/NW area of location)**

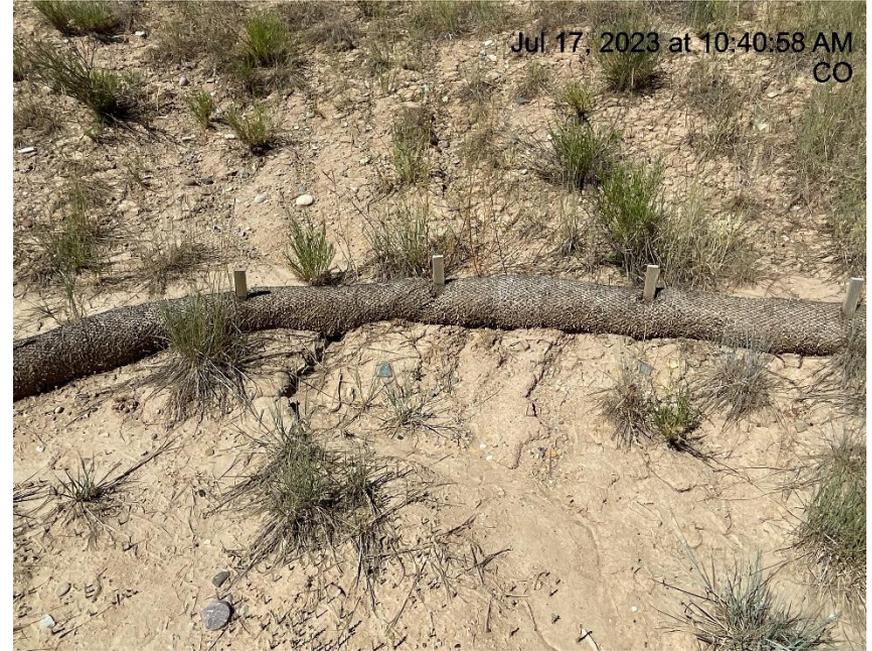
**Photo # 3246 BMP's being undercut by stormwater flow (N/NW area of location)**

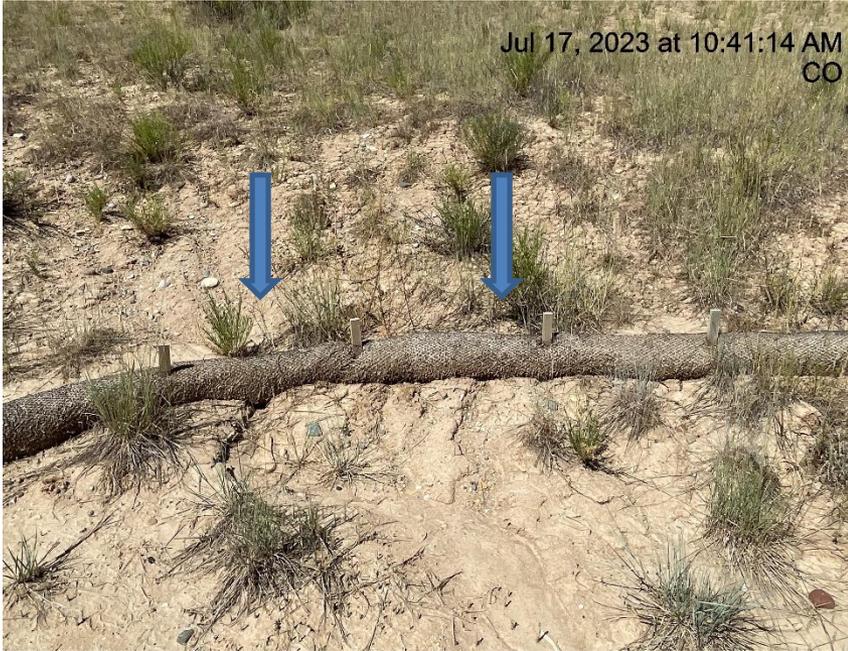
**Photo # 3247 BMP's being undercut by stormwater flow (N/NW area of location)**

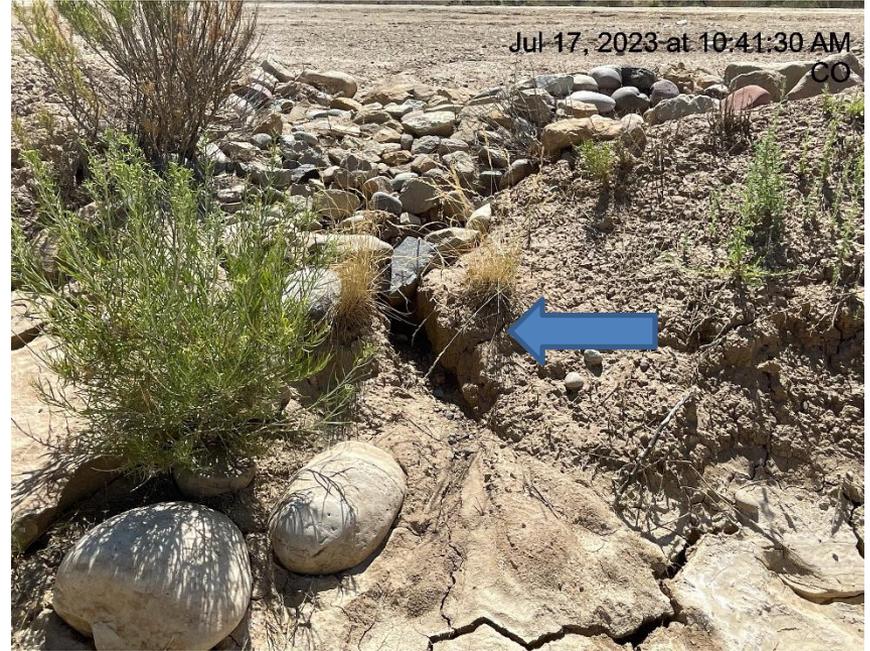
**Photo # 3248 BMP's being undercut by stormwater flow (N/NW area of location)**

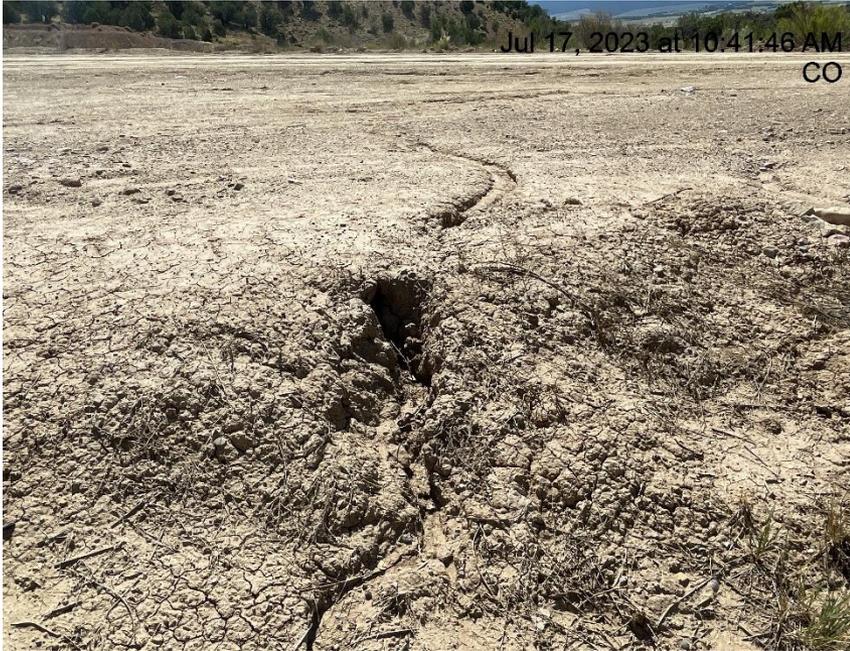
**Photo # 3249 Tunnel erosion (N/NW area of pad)**

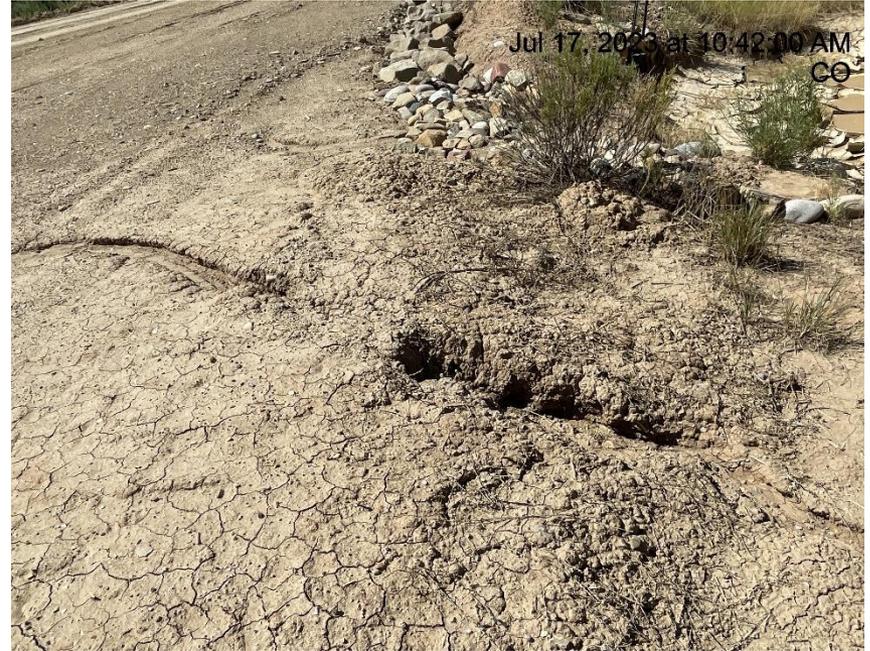
**Photo # 3251 Tunnel erosion (N/NW area of pad)**

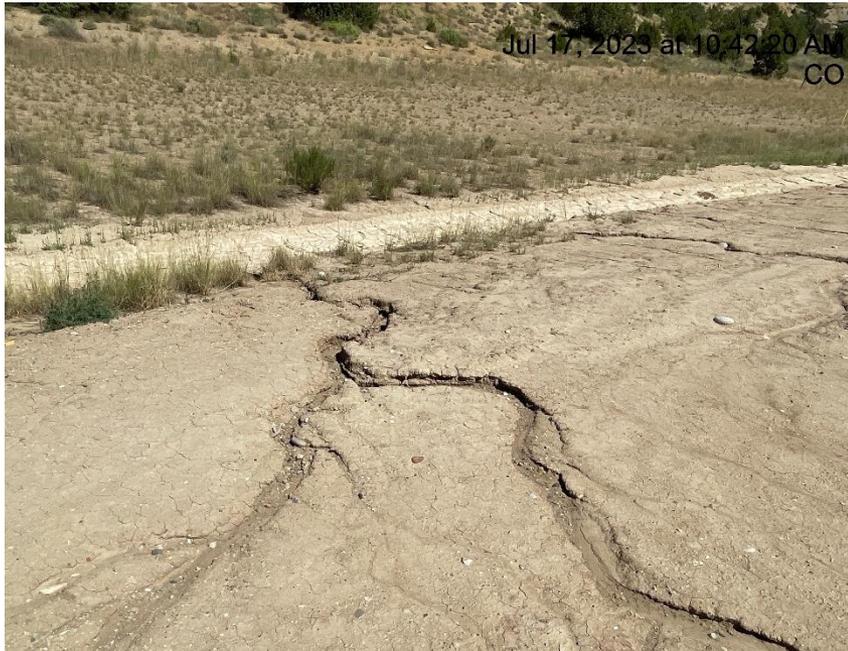
**Photo # 3253 Rill erosion (North side of location)**

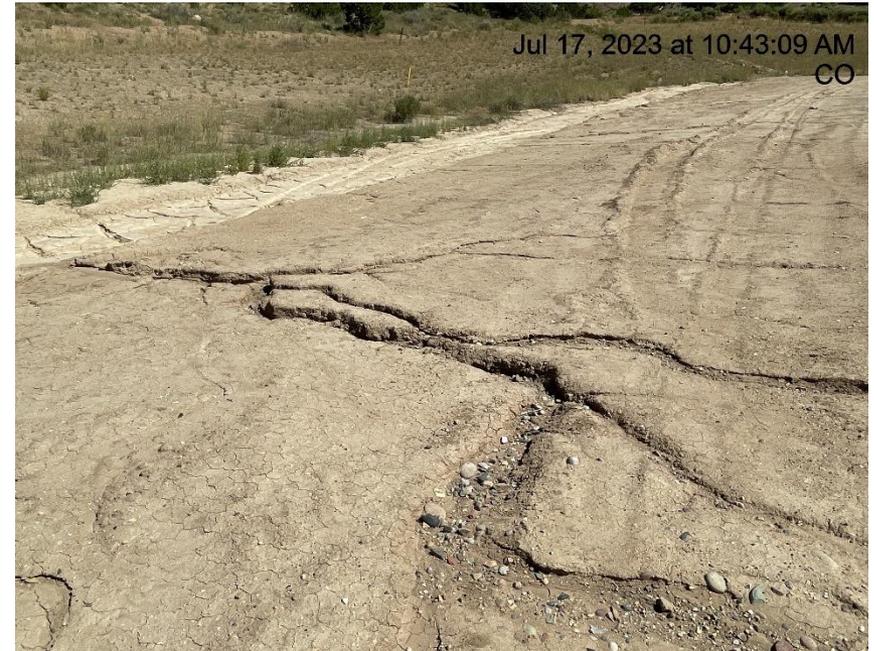
**Photo # 3258 Rill erosion (North side of location)**

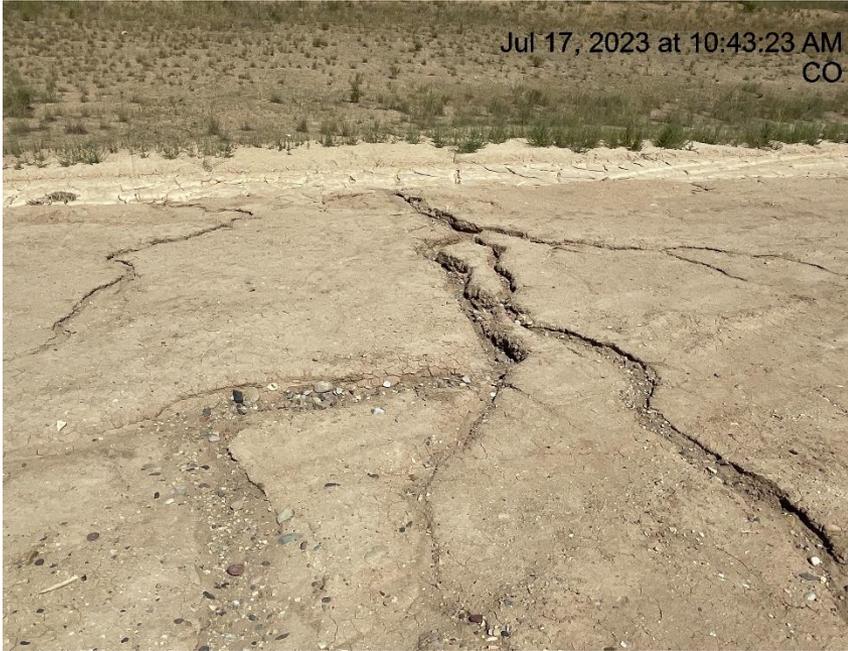
**Photo # 3260 Rill erosion (North side of location)**

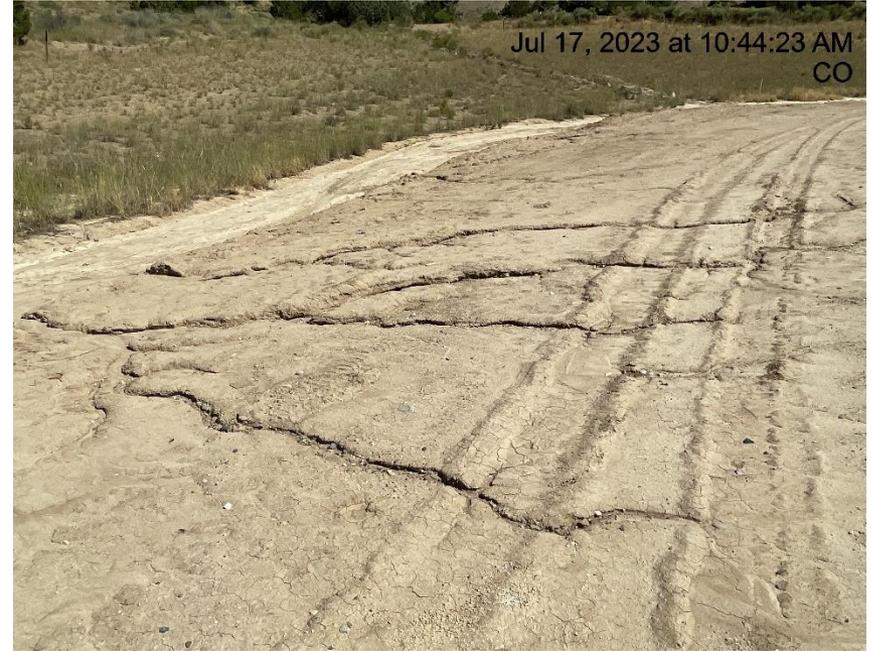
**Photo # 3267 Rill erosion (North side of location)**

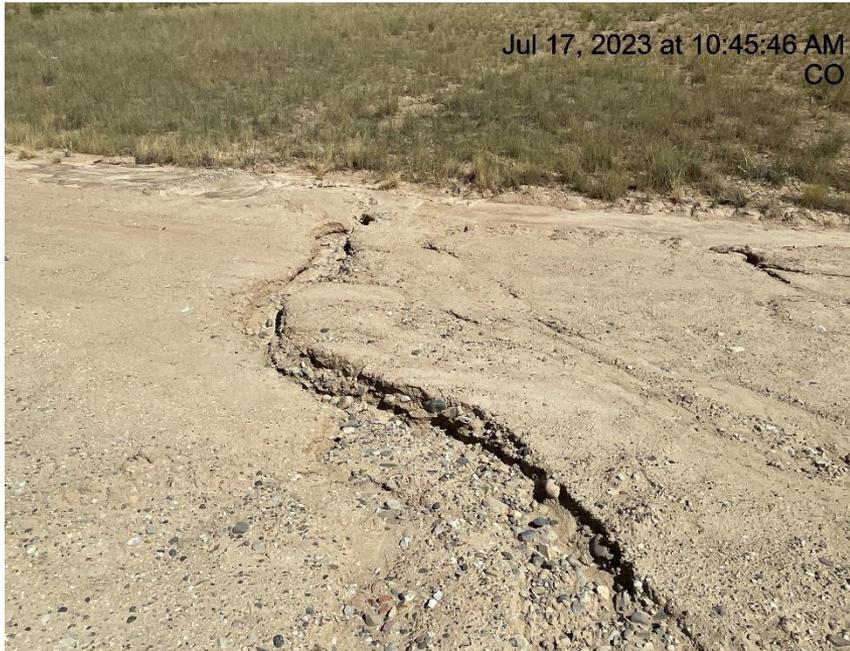
**Photo # 3276 Rill erosion (N/NE area of location)**

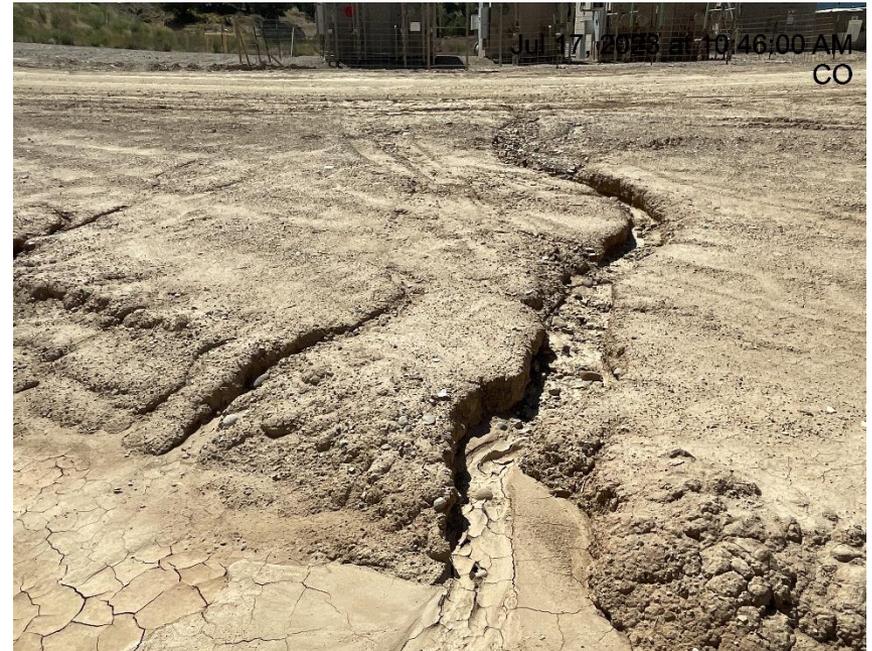
**Photo # 3277 Rill erosion (N/NE area of location)**

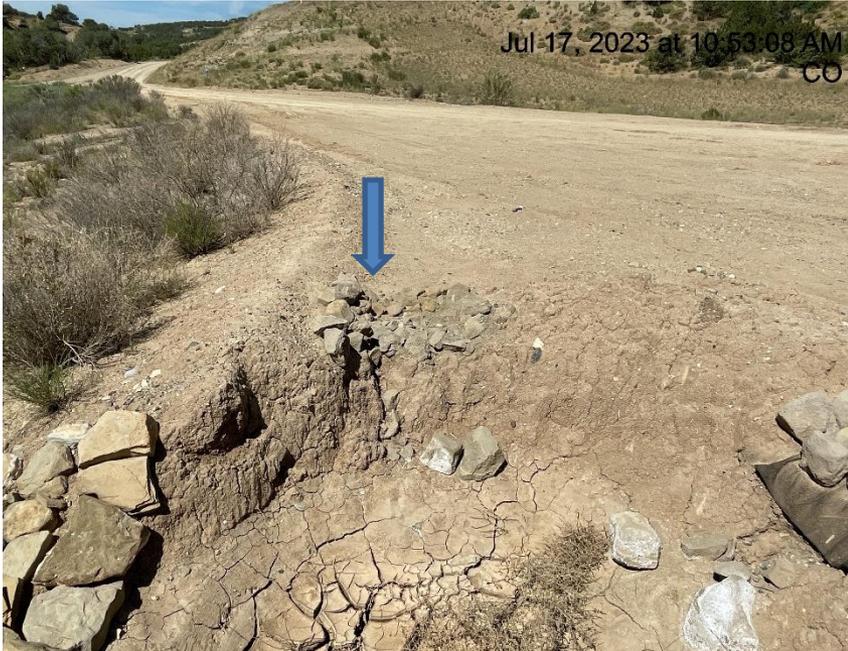
**Photo # 3301 BMP's being undercut by stormwater flow (south side of location)**

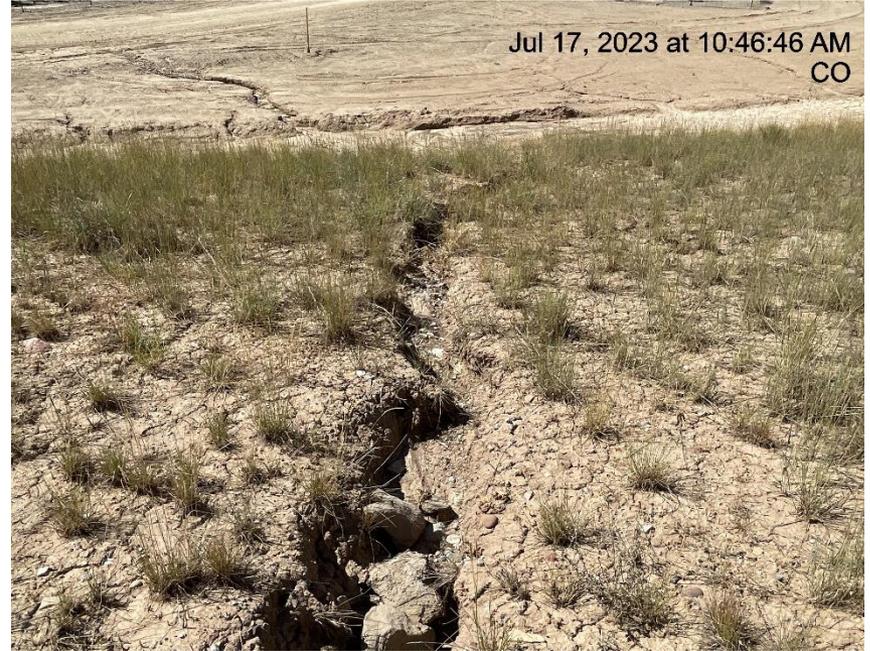
**Photo # 3281 Gulley erosion/insufficient BMP's (N/NE area of location)**

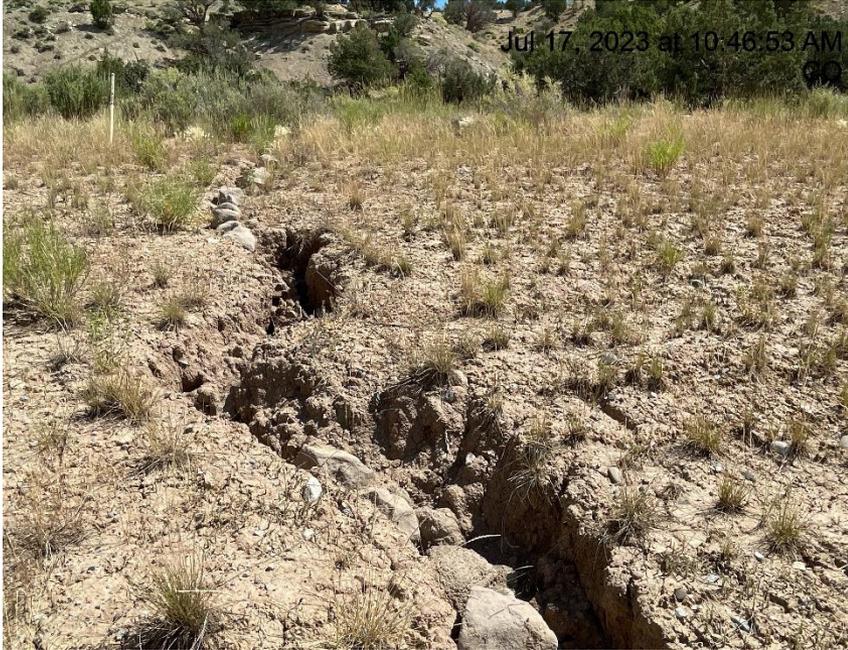
**Photo # 3282 Gully erosion/insufficient BMP's (N/NE area of location)**

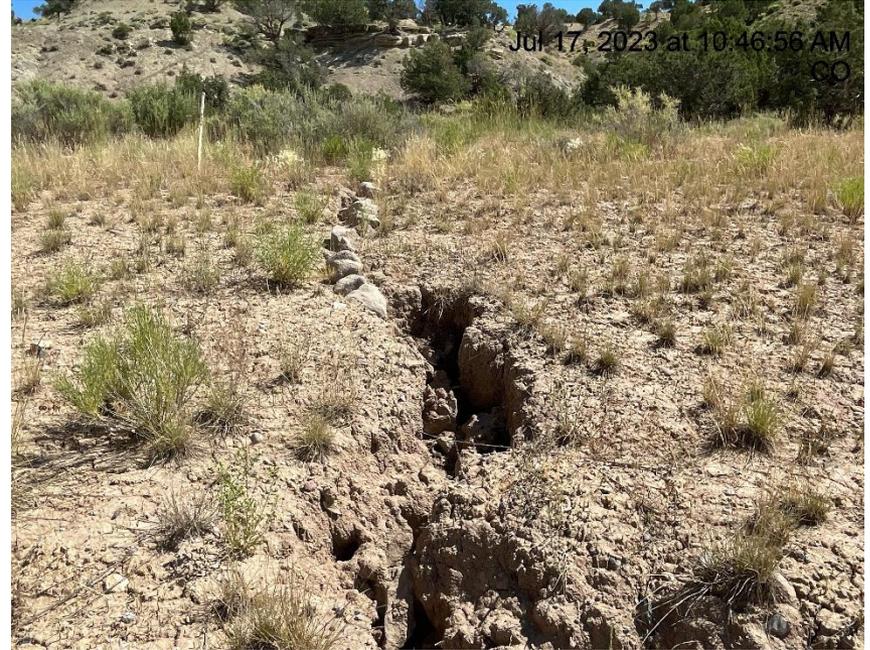
**Photo # 3283 Gully erosion/insufficient BMP's (N/NE area of location)**

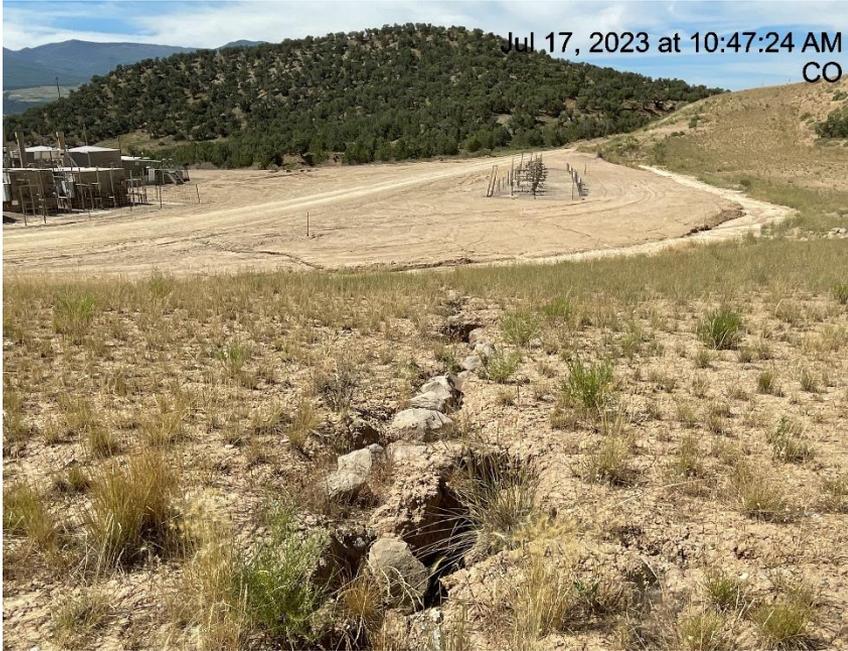
**Photo # 3286 Gully erosion/insufficient BMP's (N/NE area of location)**

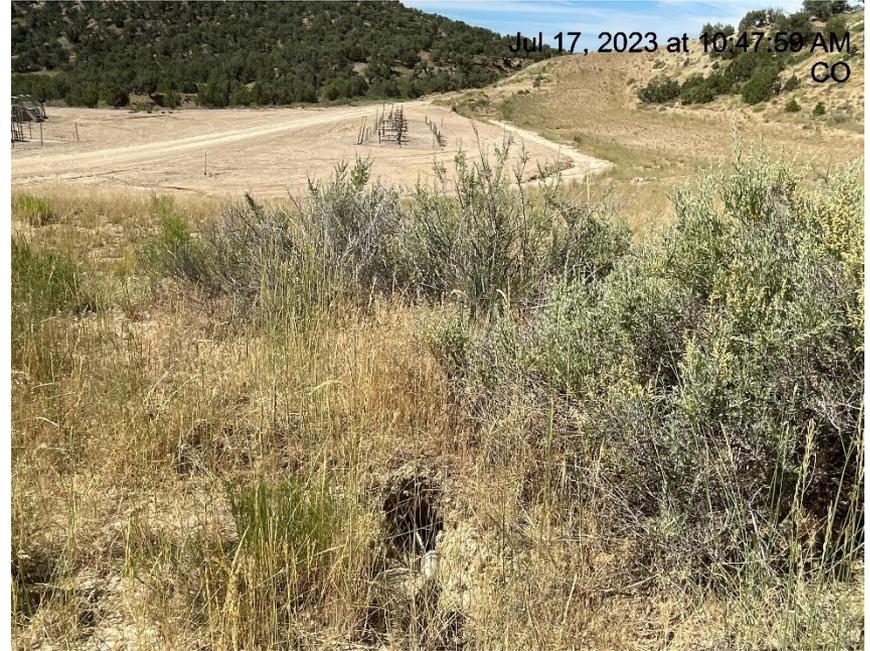
**Photo # 3287 Tunnel erosion through berm allowing stormwater through leading to the gully erosion in previous 4 photos**

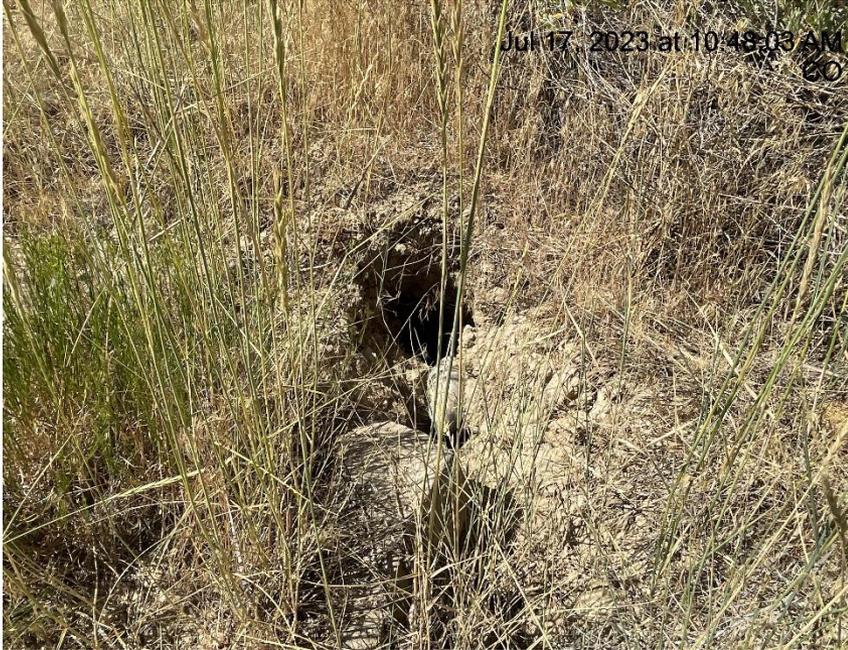
**Photo # 3288 Tunnel erosion through berm (N/NE area of location)**

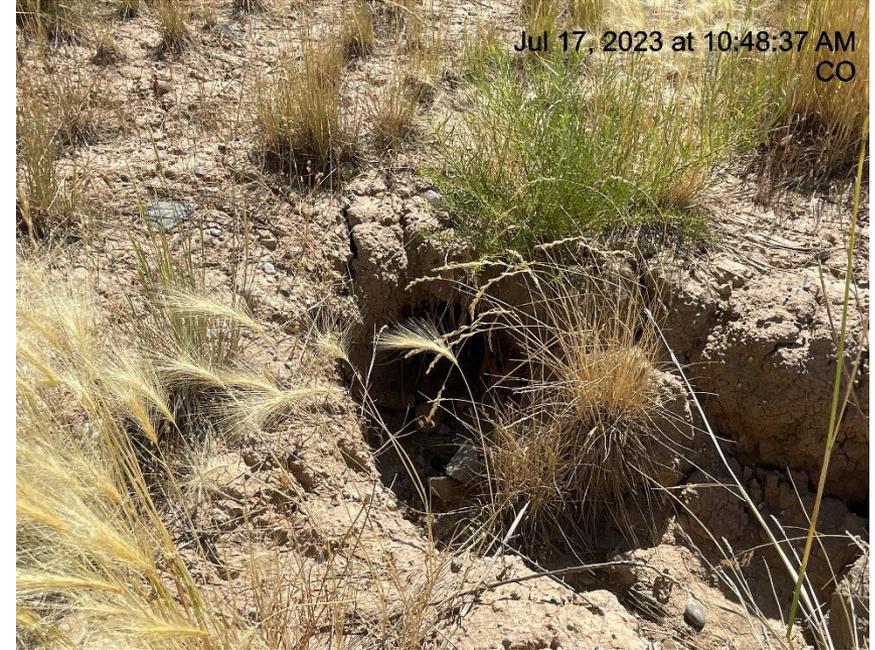
**Photo # 3290 Tunnel erosion through berm (N/NE area of location)**

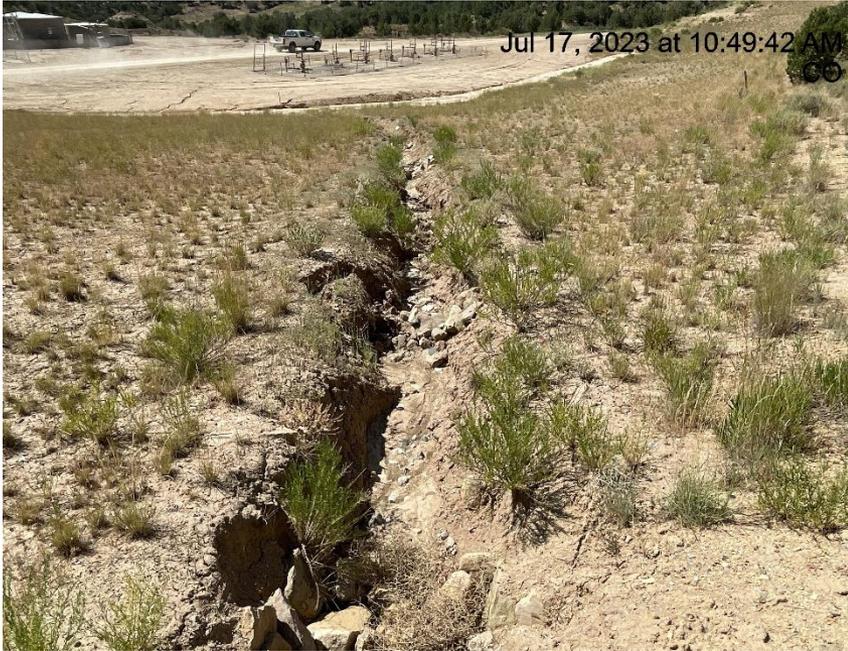
**Photo # 3292 BMP's need maintenance/insufficient run on controls**

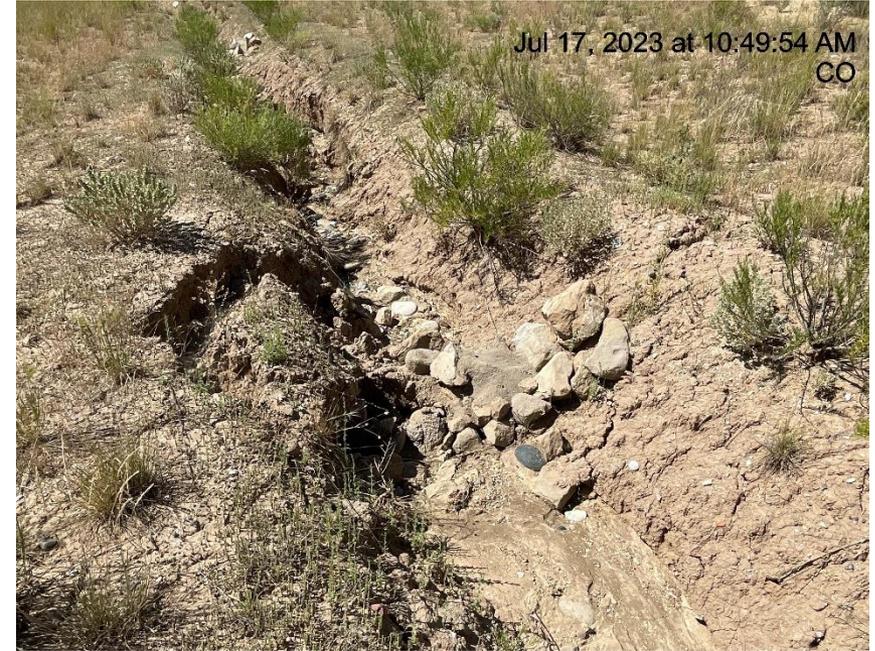
**Photo # 3293 BMP's need maintenance/insufficient run on controls**

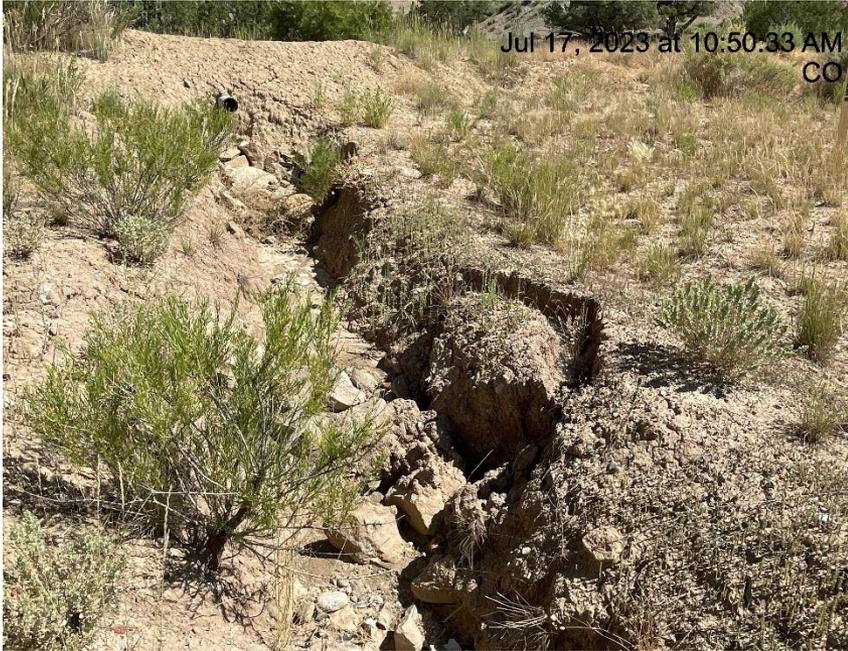
**Photo # 3294 BMP's need maintenance/insufficient run on controls**

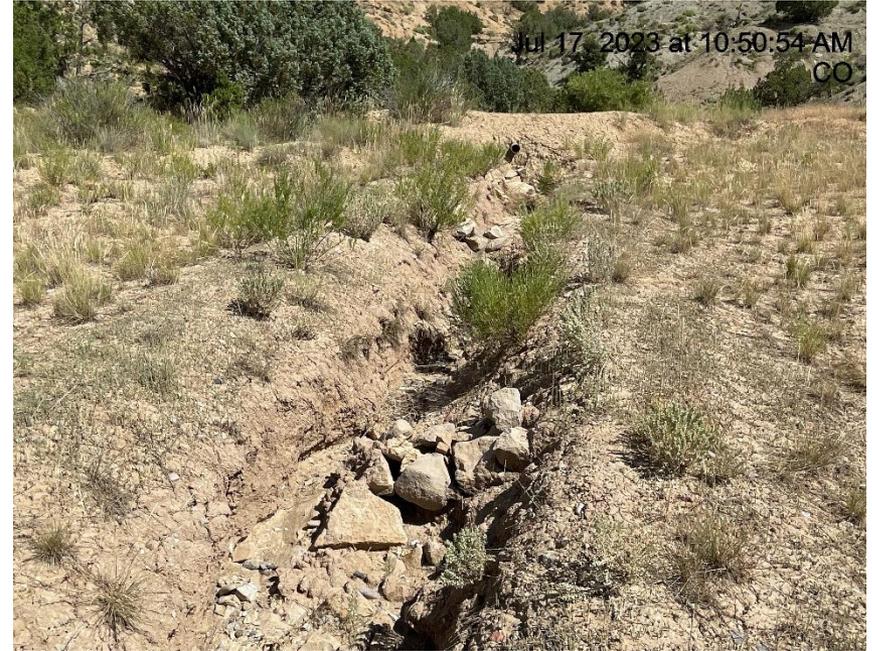
**Photo # 3295 BMP's need maintenance/insufficient run on controls**

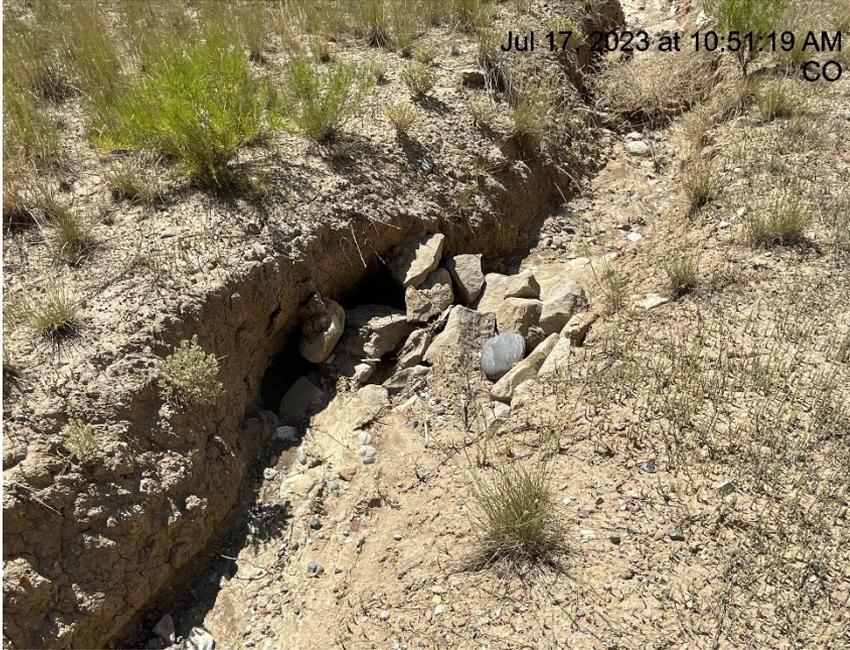
**Photo # 3297 BMP's need maintenance**

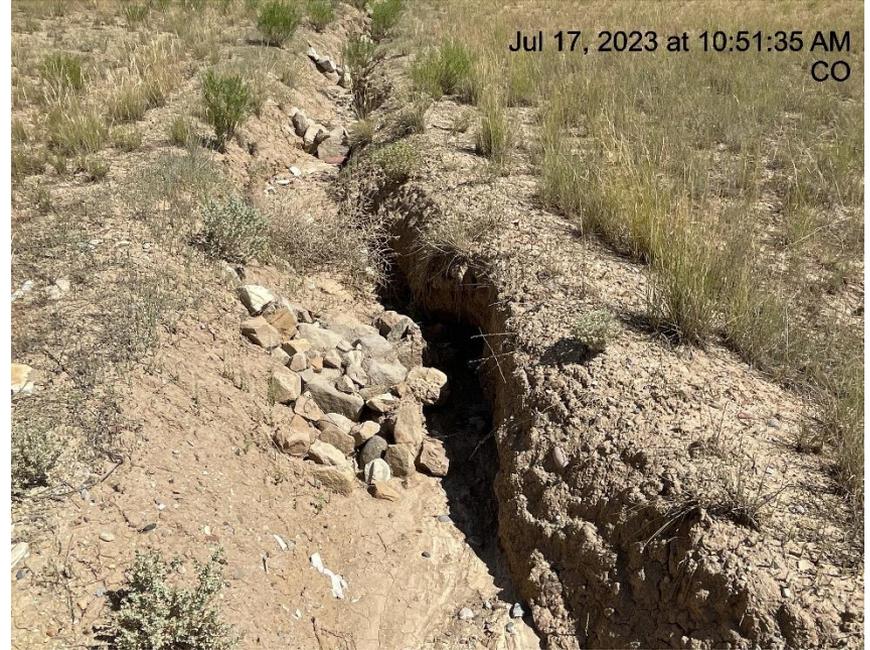
**Photo # 3298 BMP's need maintenance**

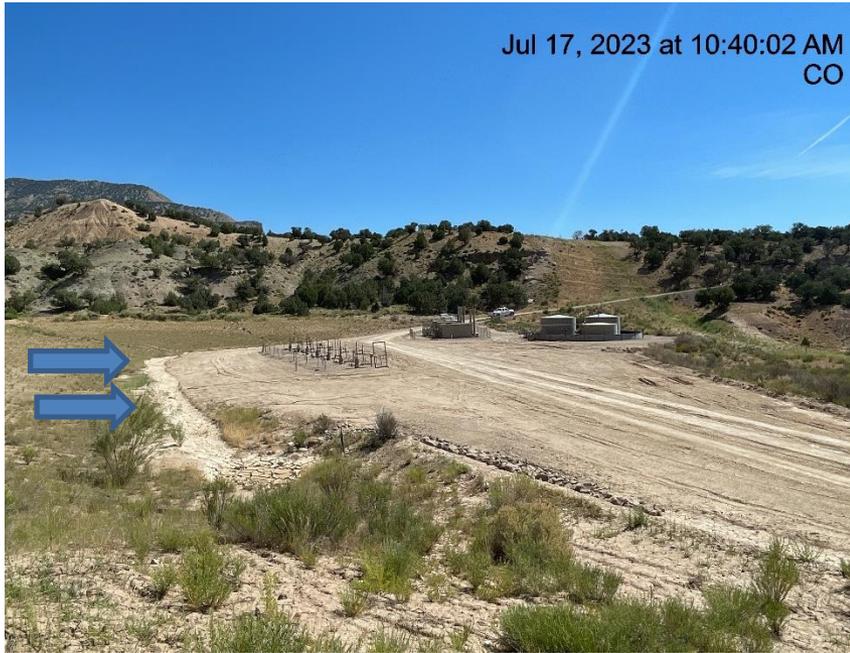
**Photo # 3242 Ditch needs maintenance**

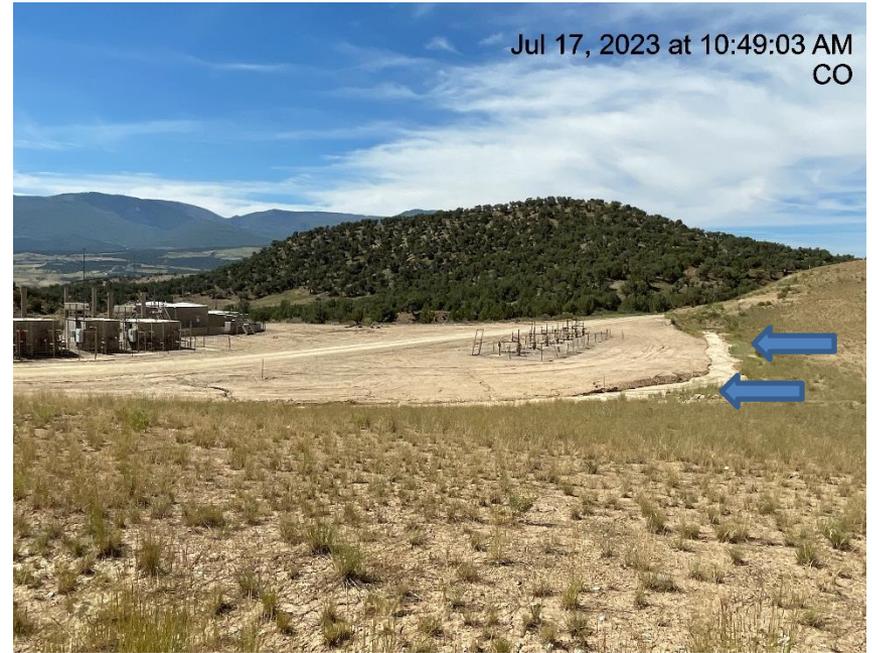
**Photo # 3291 Ditch needs maintenance**
