Final Reclamation Inspection

Operator: PDC ENERGY INC - 69175

Location ID: 310546

Inspection Photos
Location Name: Butterball B4-19
Location ID: 310546

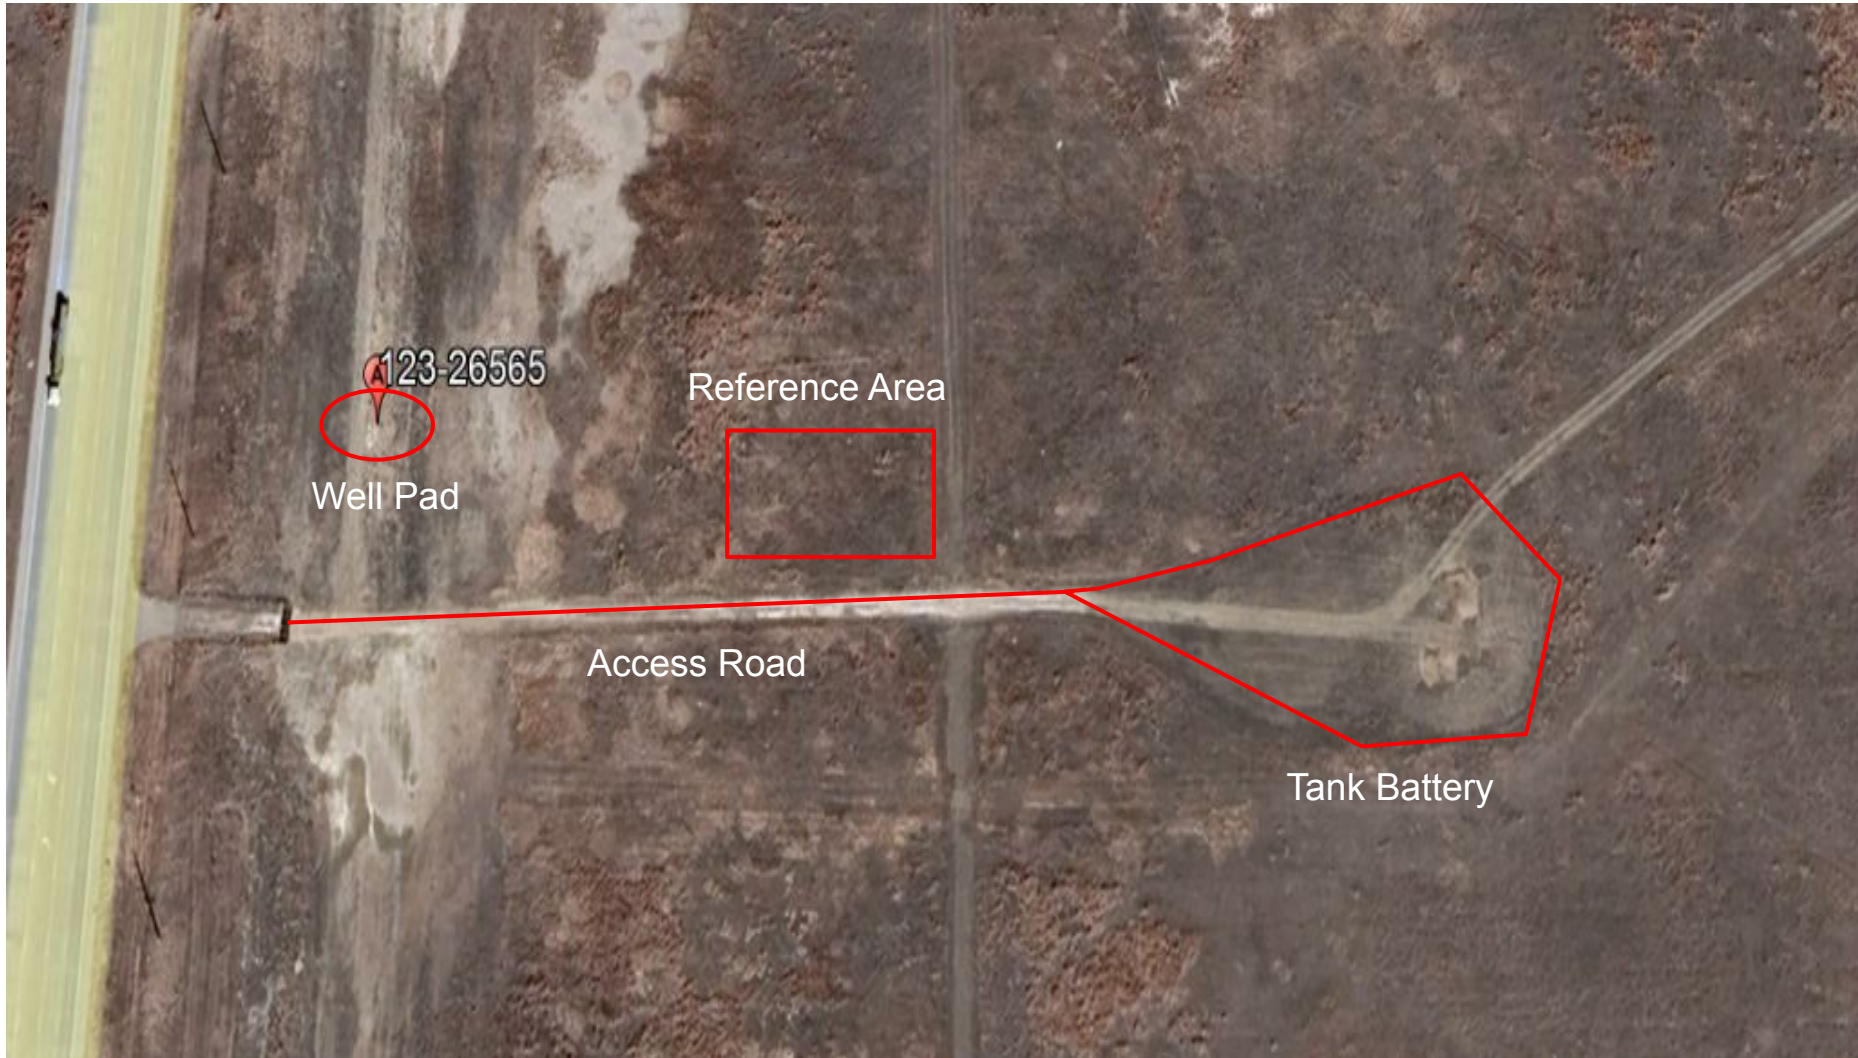
Photo 1. 2022 aerial imagery of the well pad, access road, tank battery and reference area (north is up).

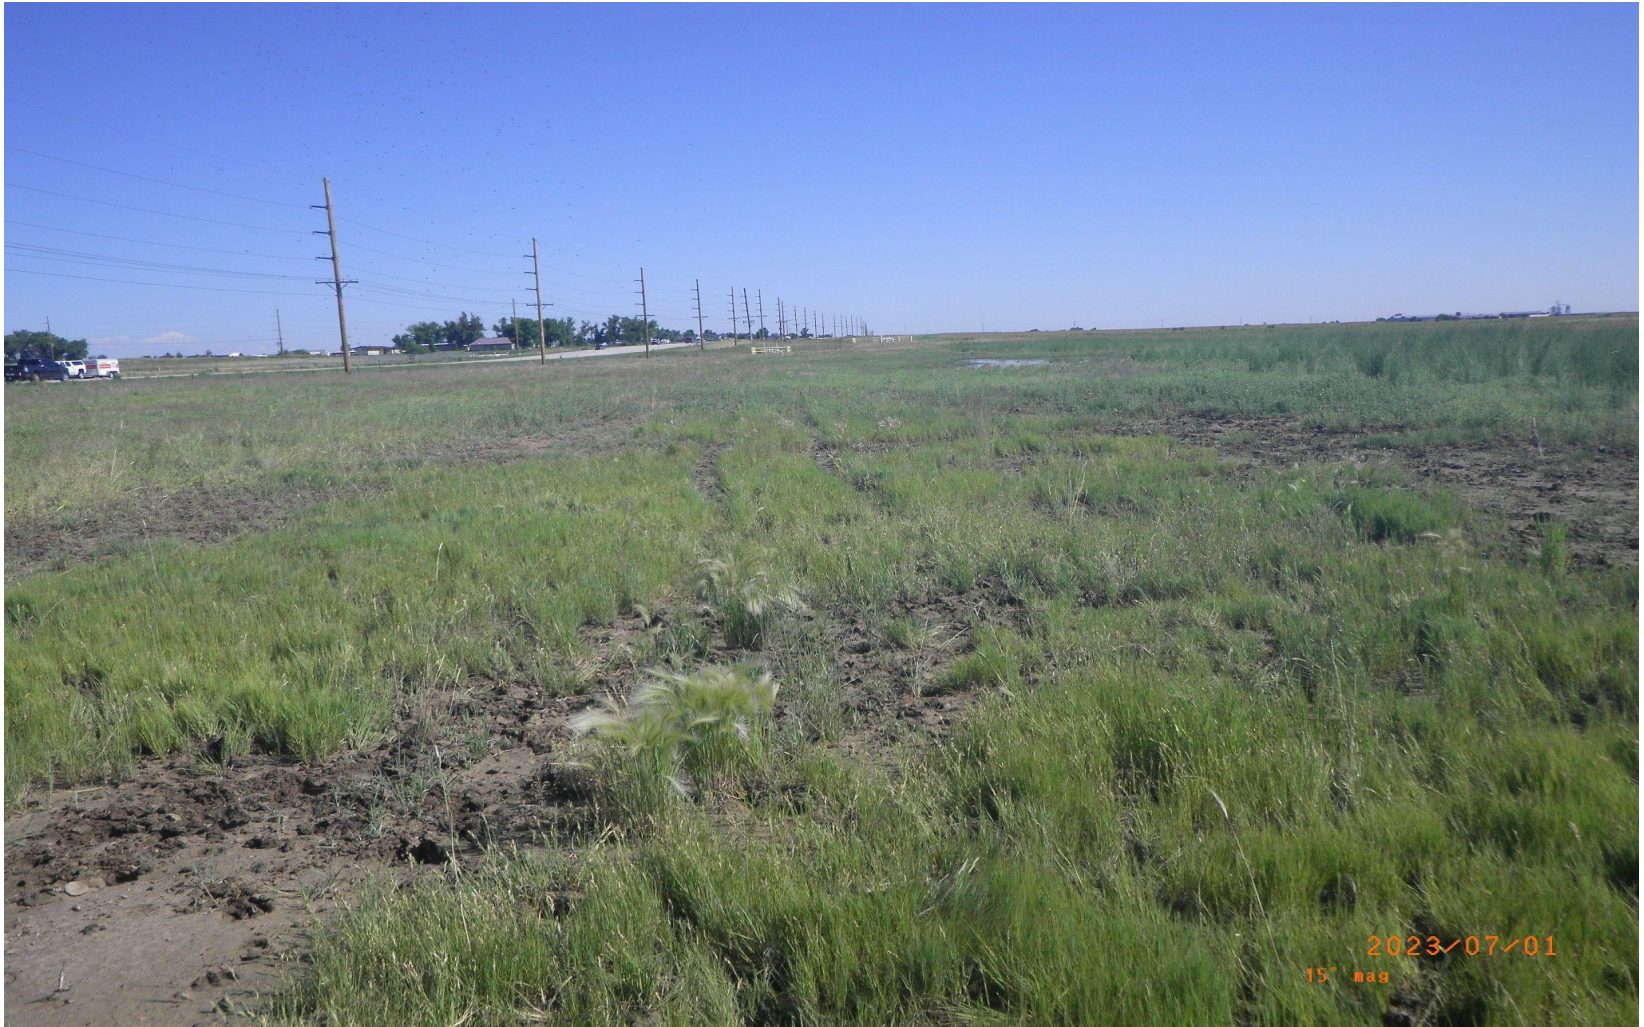
Photo 2. Overview photo of the well pad taken at ground level from the southern edge facing north.

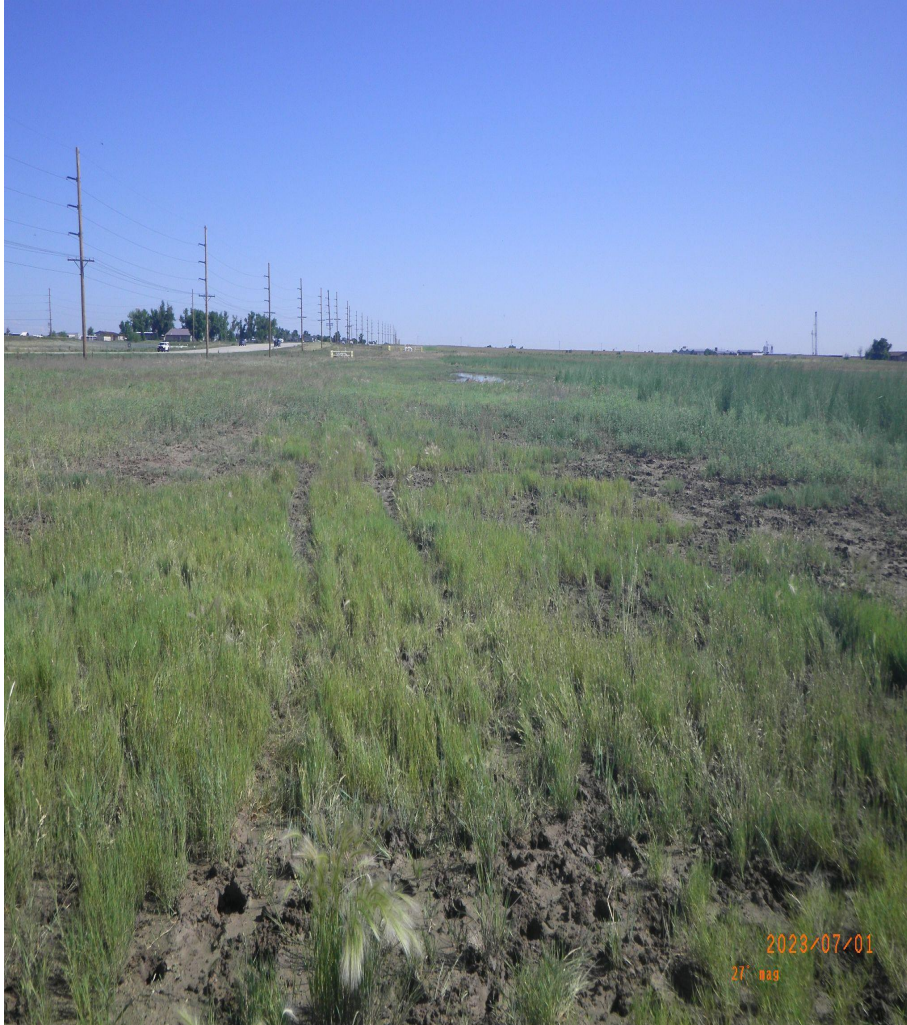
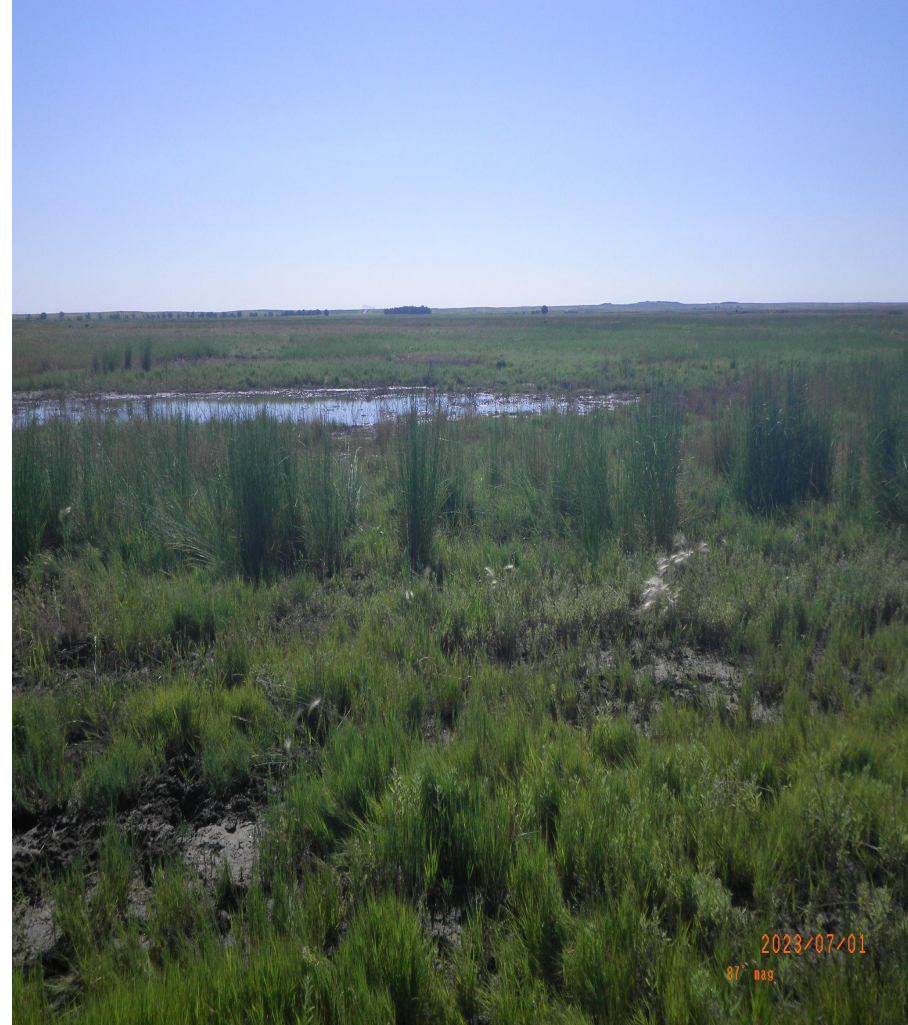
Photo 3. Cardinal photos taken from the middle of the well pad. Left photo facing north, right photo facing east.

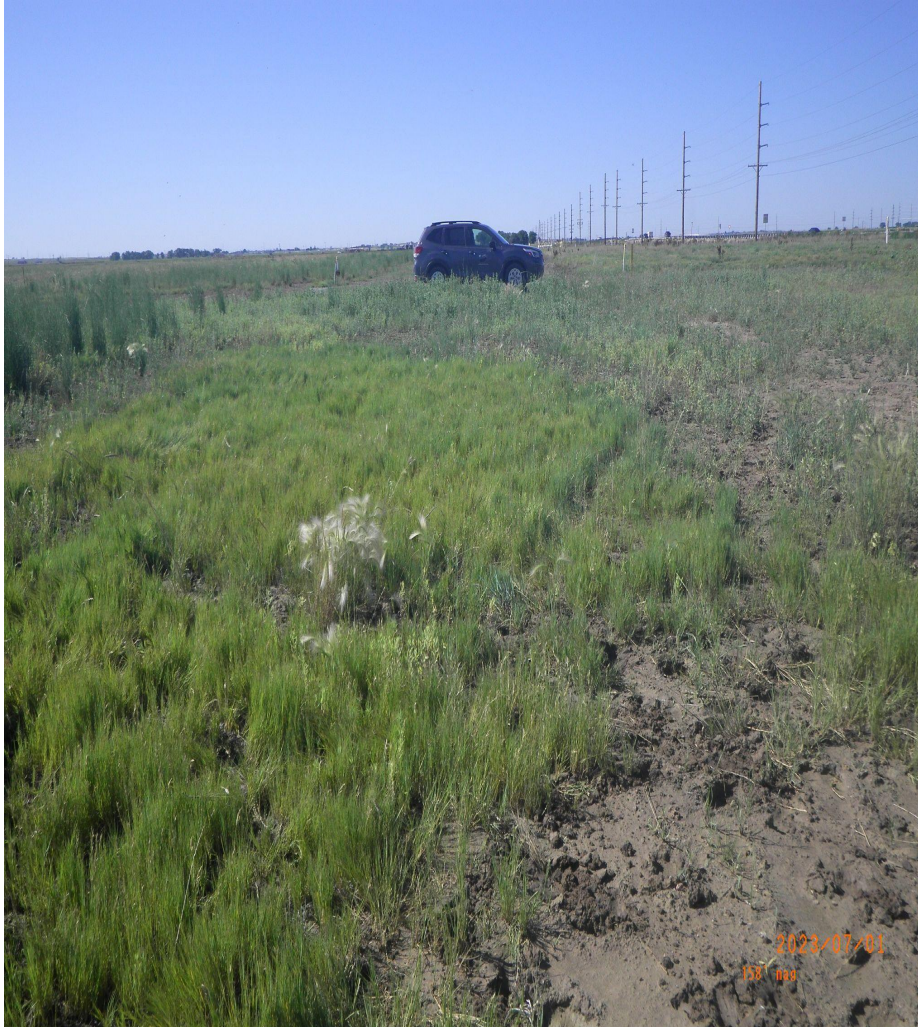
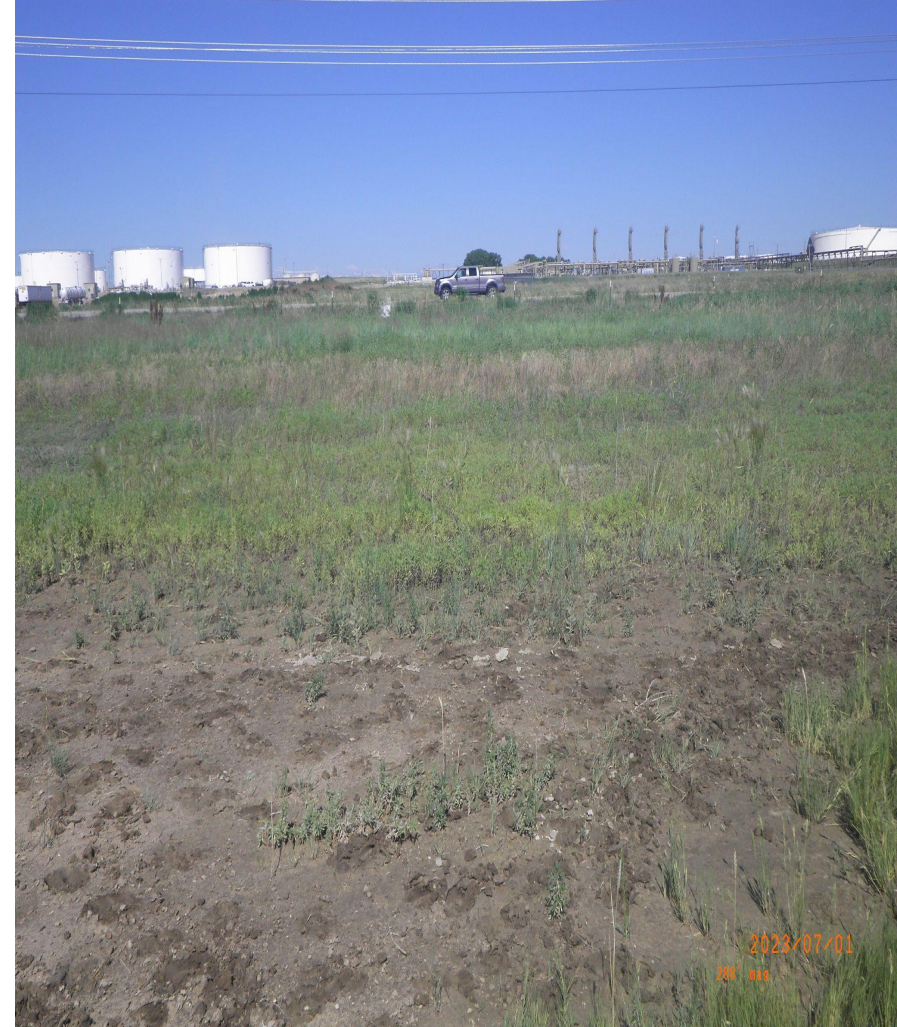
Photo 4. Cardinal photos taken from the middle of the well pad. Left photo facing south, right photo facing east. Note: bare ground in foreground of photos were caused by cattle grazing in the area and are not associated with oil and gas operations. Plant species in well pad disturbance appear consistent with reference area (see photo #5).

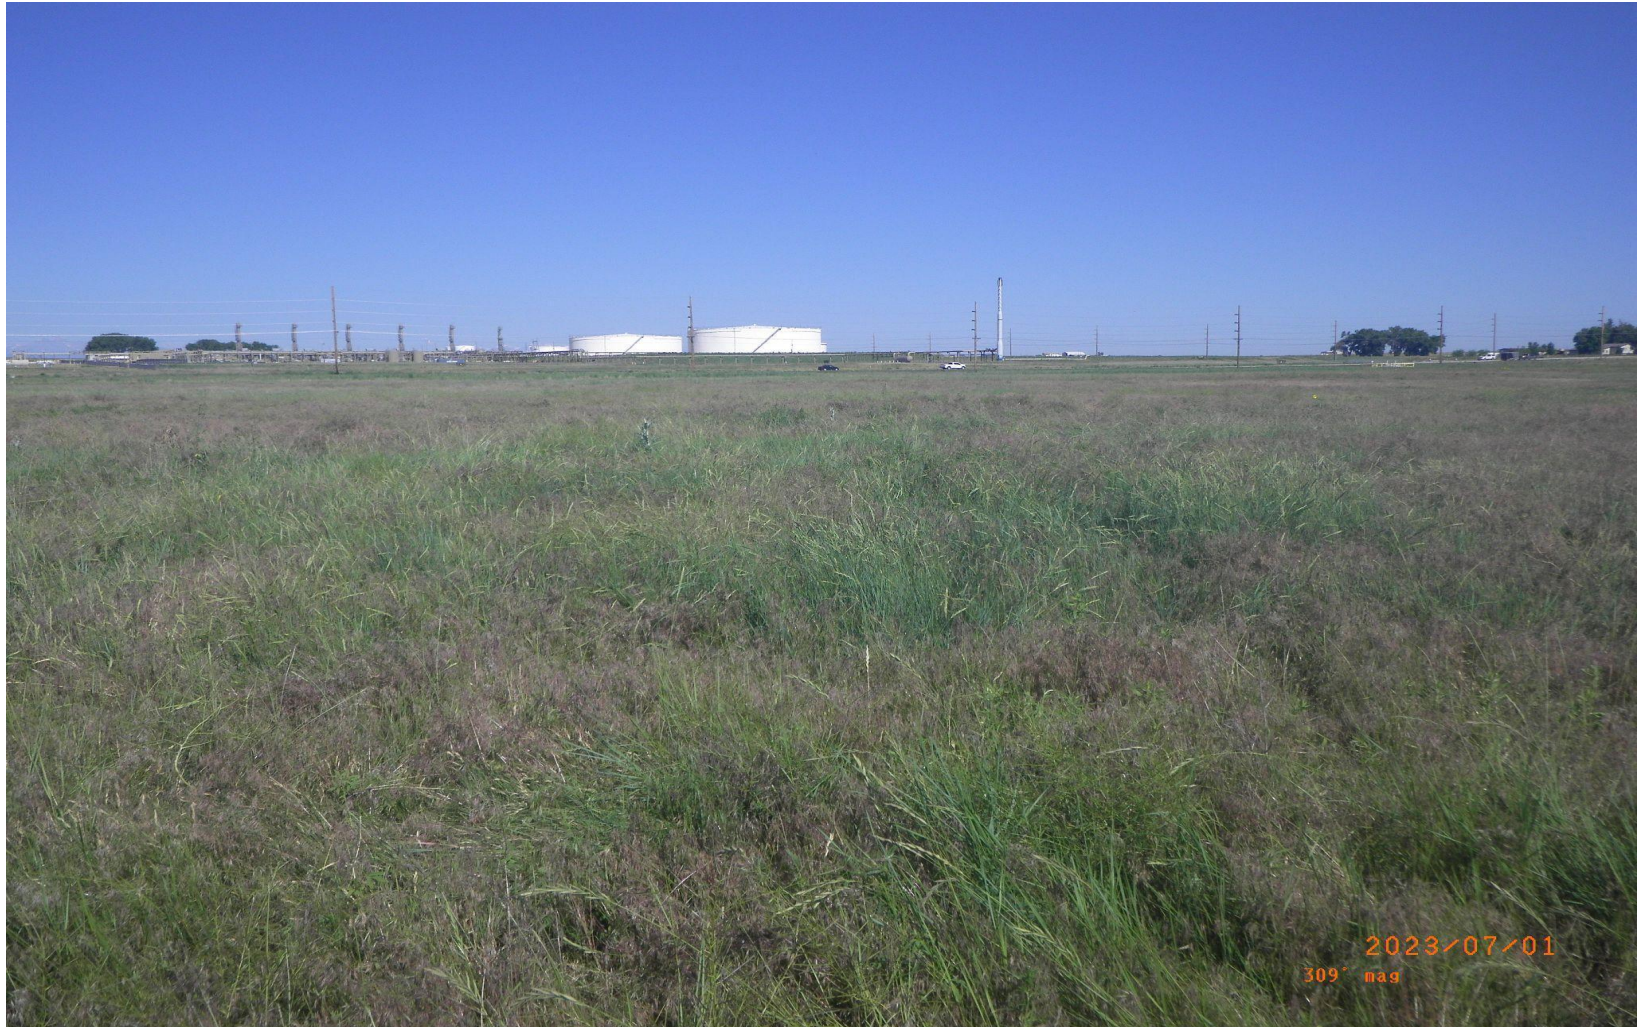
Photo 5. Reference area.

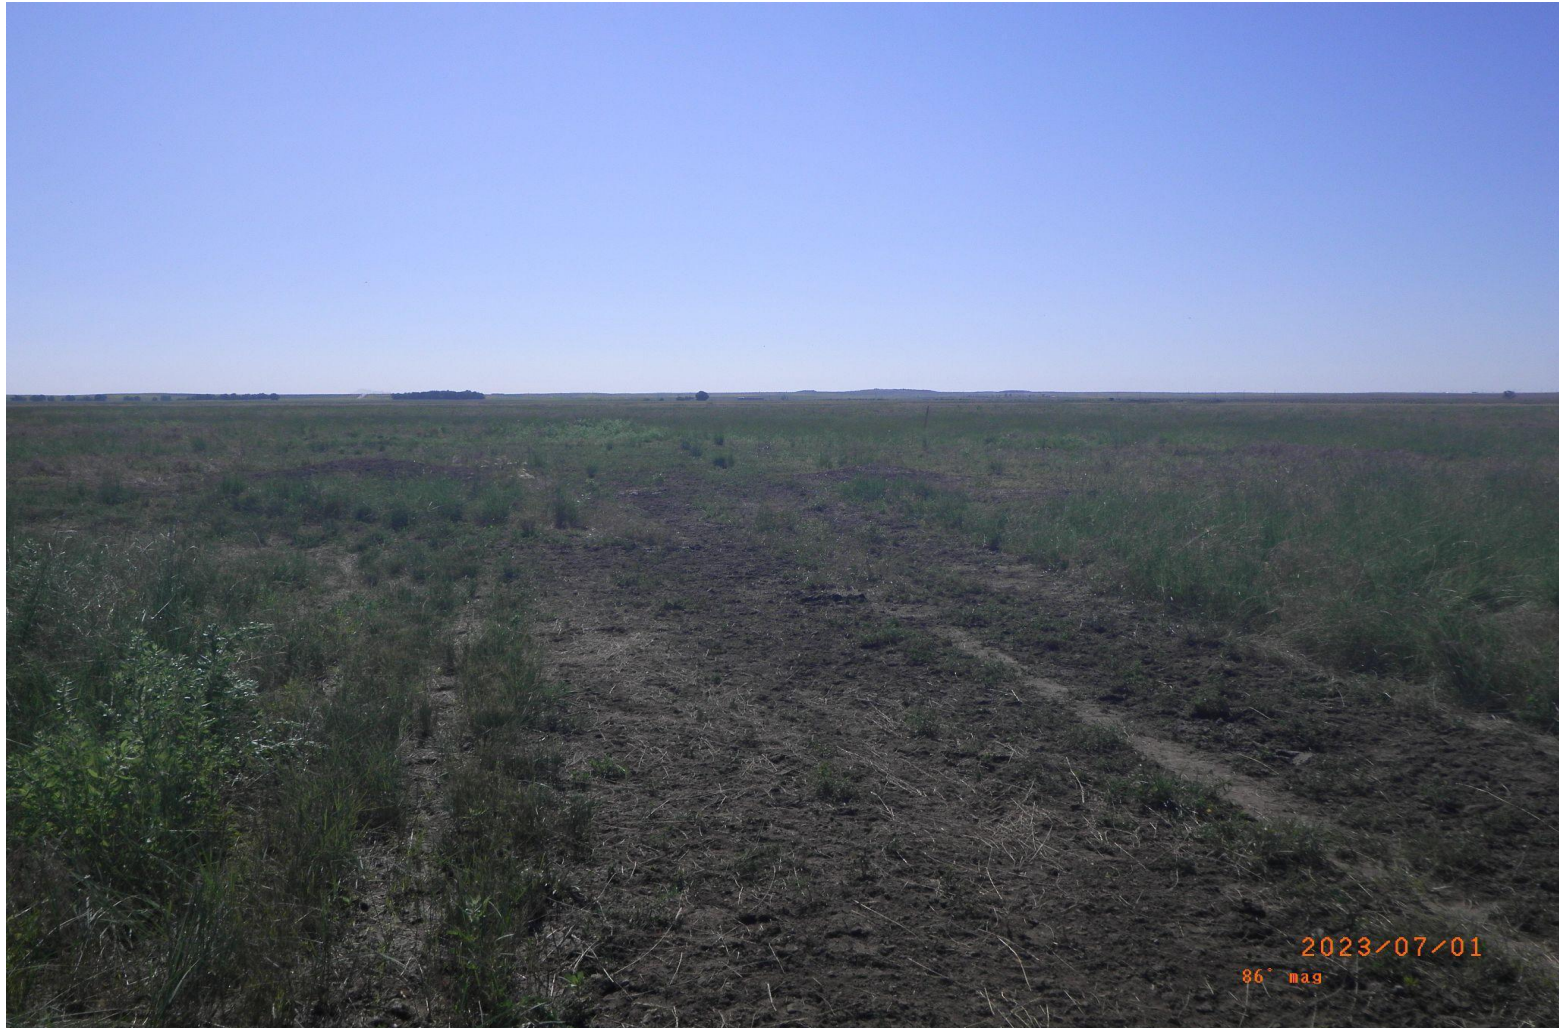
Photo 6. Overview photo of the tank battery taken at ground level from the western edge facing east.

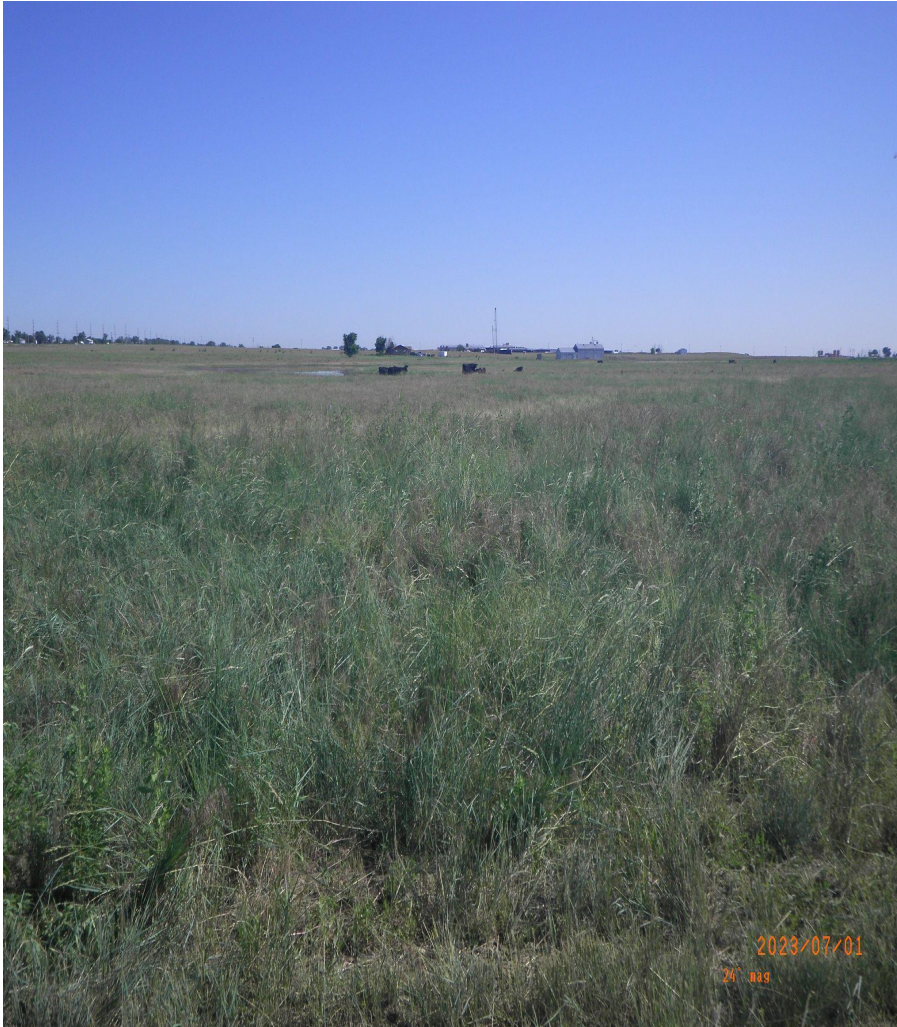
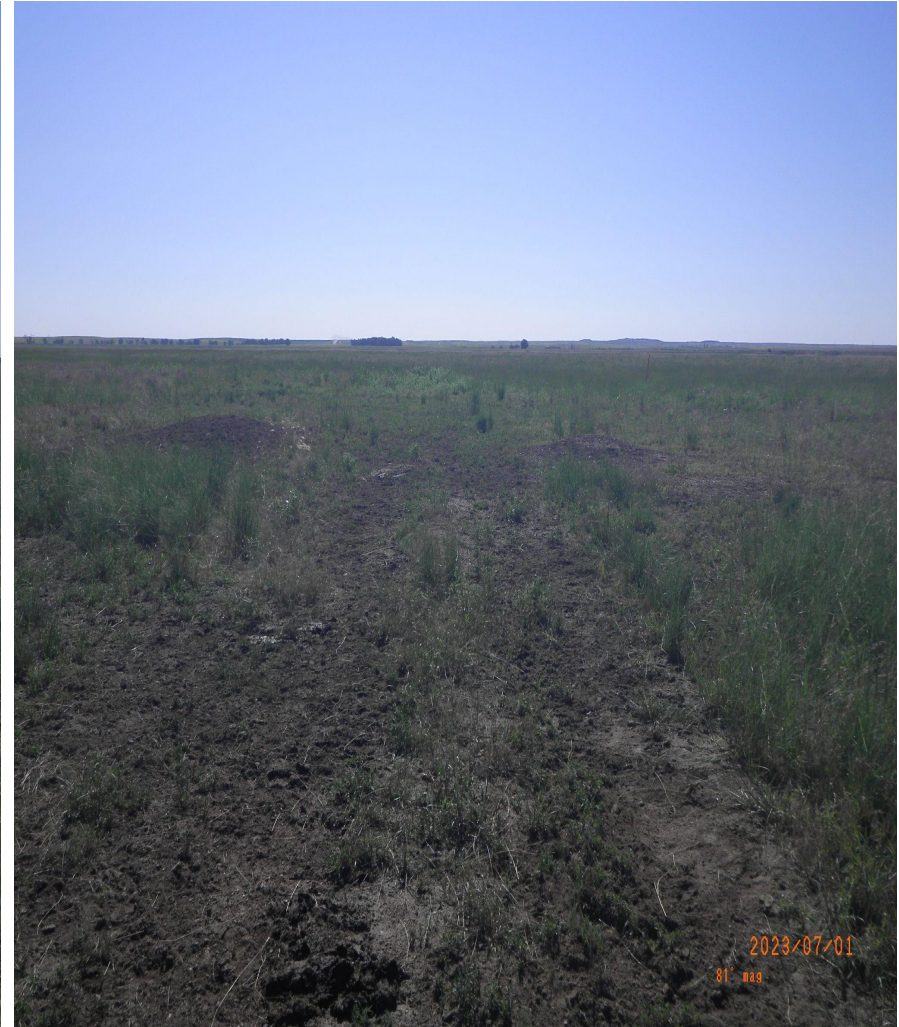
Photo 7. Cardinal photos taken from the middle of the tank battery.
Left photo facing north, right photo facing east.

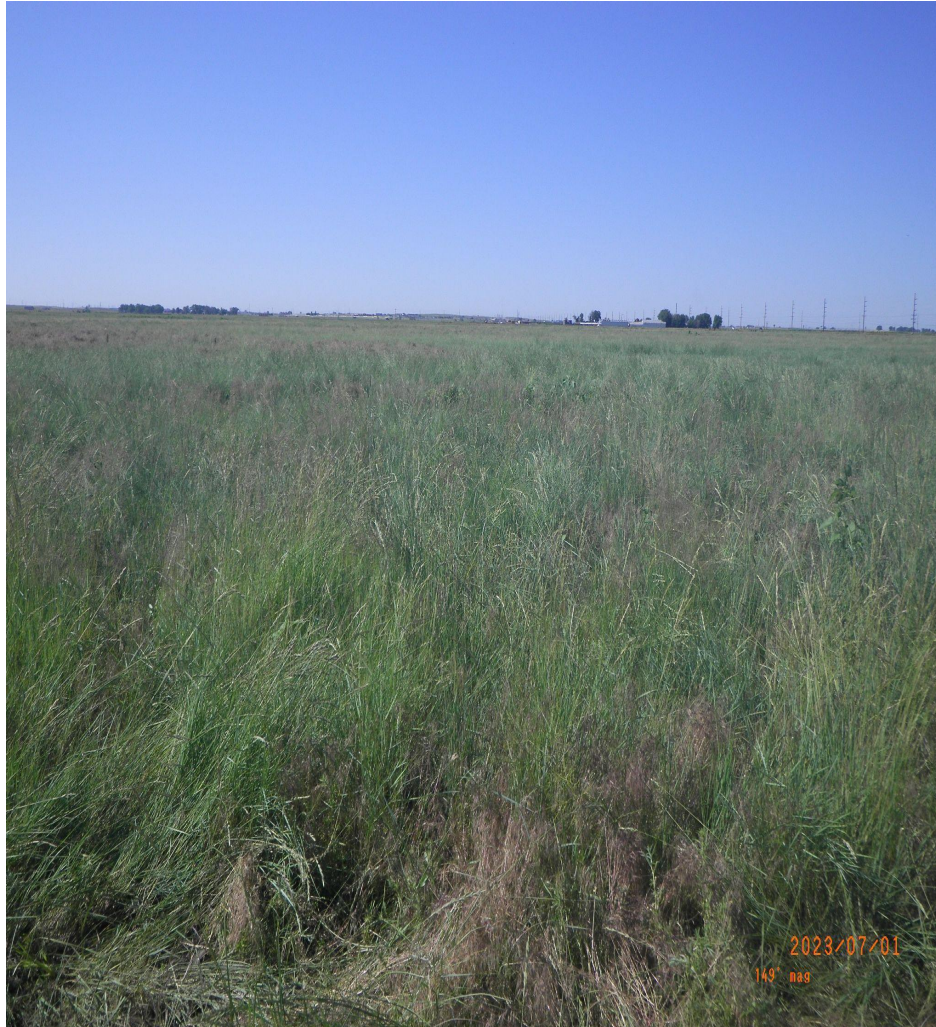
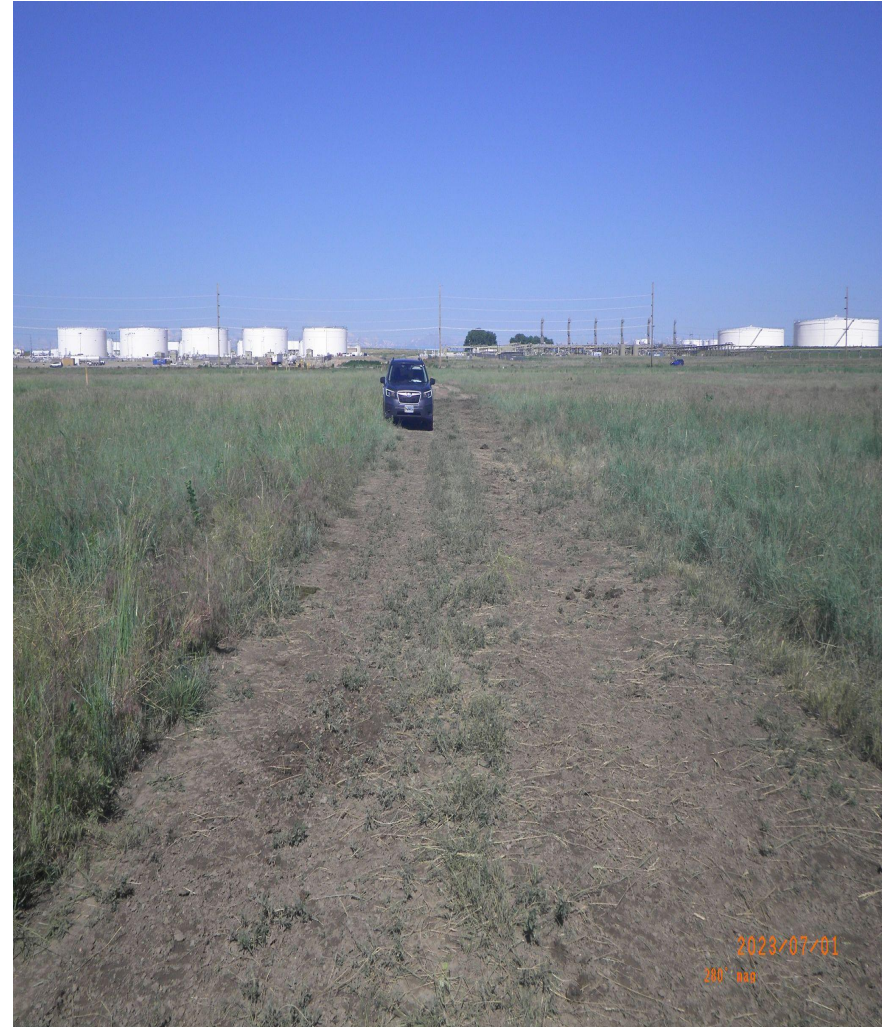
Photo 8. Cardinal photos taken from the middle of the tank battery. Left photo facing south, right photo facing west. Note: lack of vegetation in background of east facing photo is caused by cattle grazing/disturbance and does not appear to be associated with oil and gas operations.

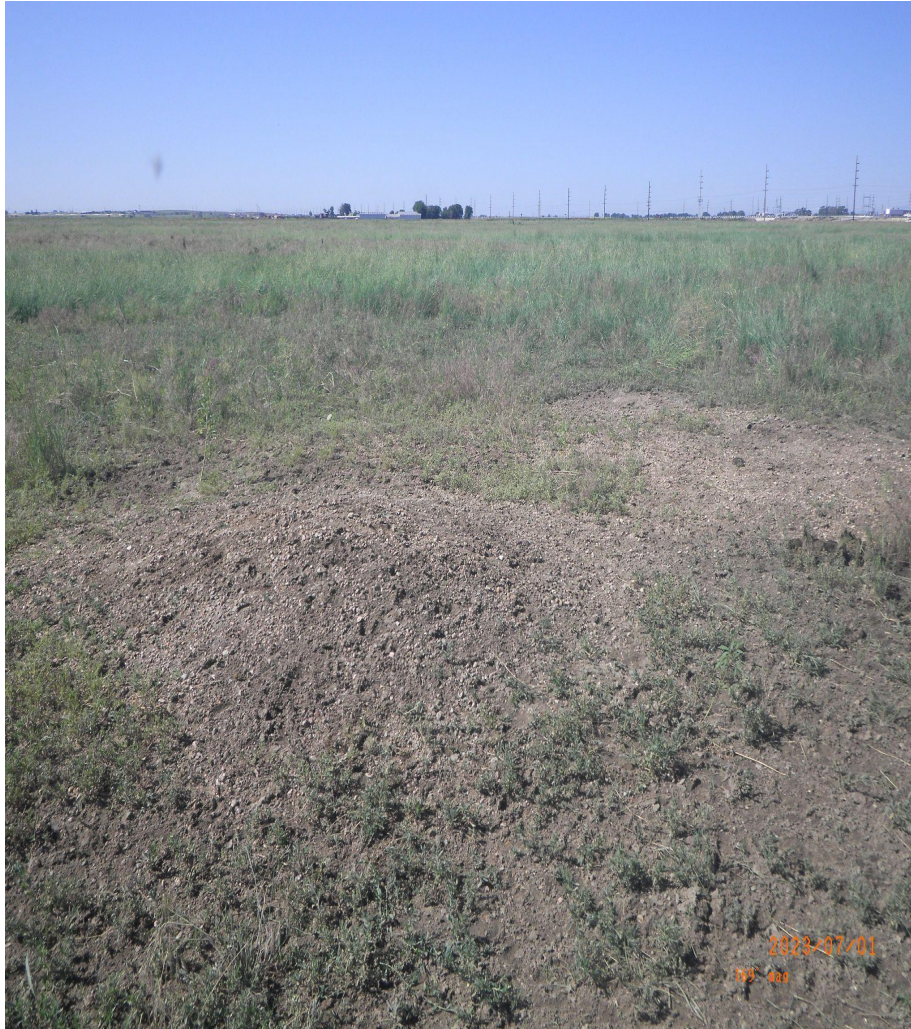
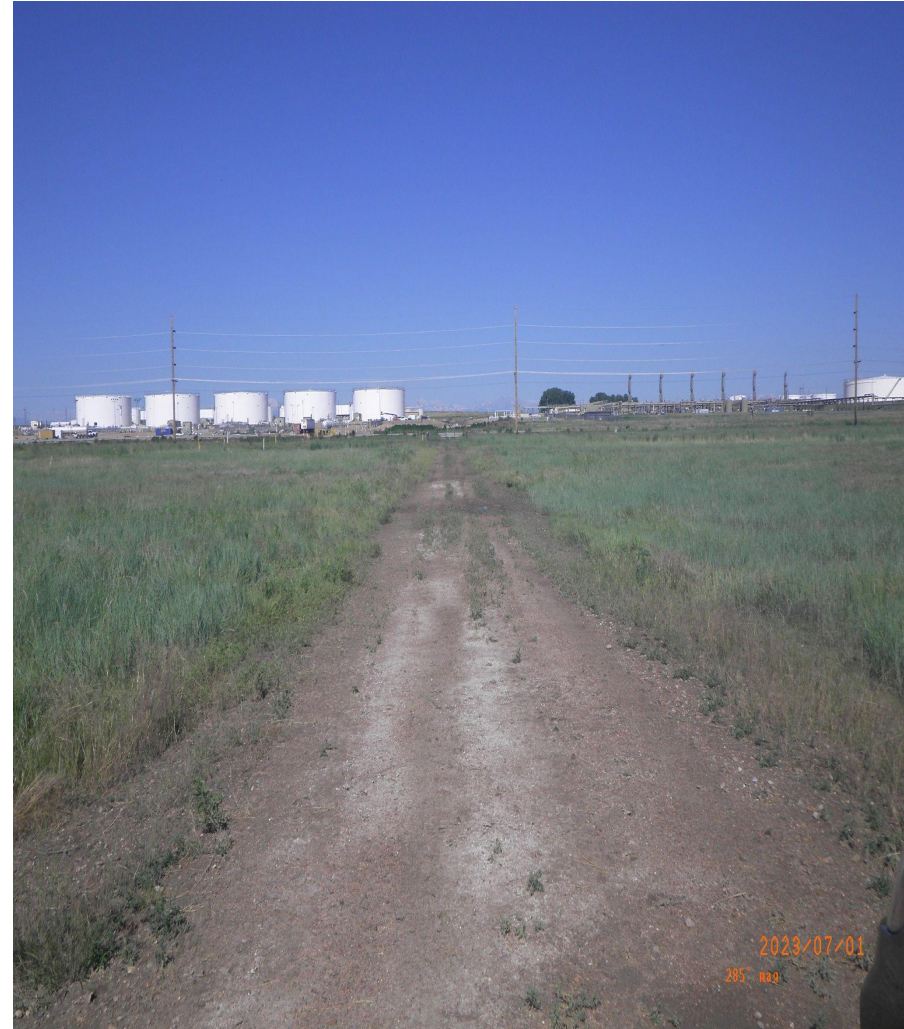
Photo 9. Left photo shows a pile of gravel in the eastern portion of the tank battery. Right photo shows tank battery access road that remains unreclaimed.
