Final Reclamation Inspection

Operator: PDC ENERGY INC - 69175

Location ID: 330004

Inspection Document #: 701900949

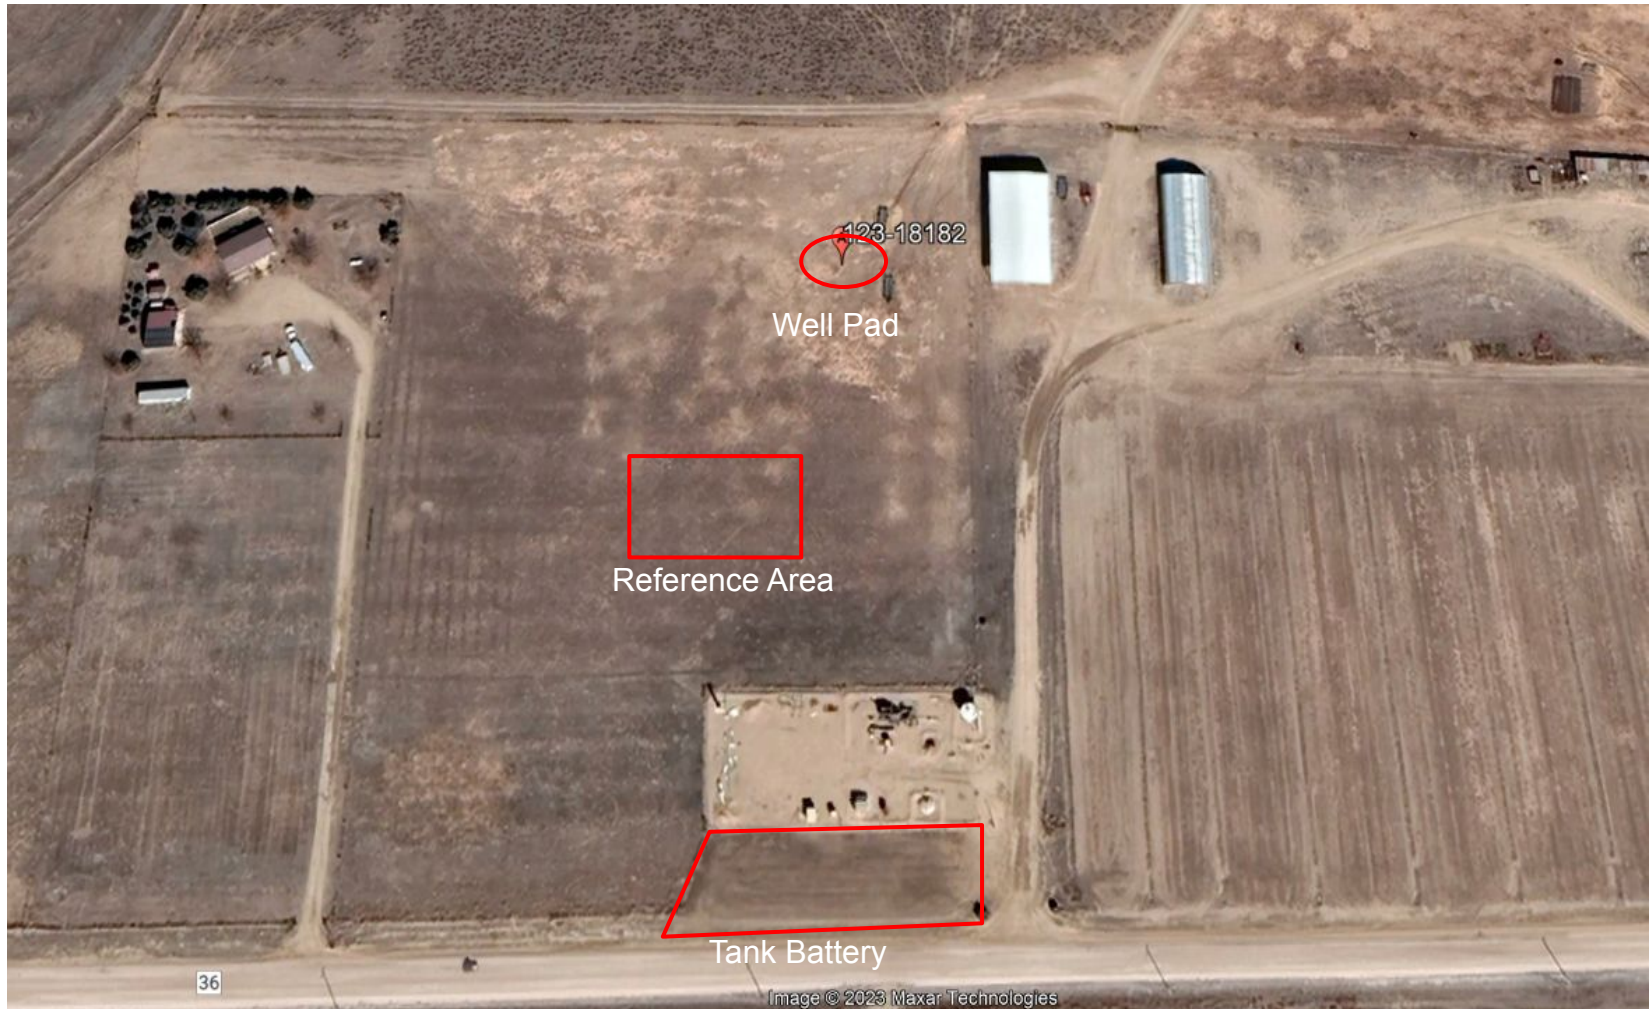
Photo 1. 2022 aerial imagery of the well pad and associated tank battery (north is up).

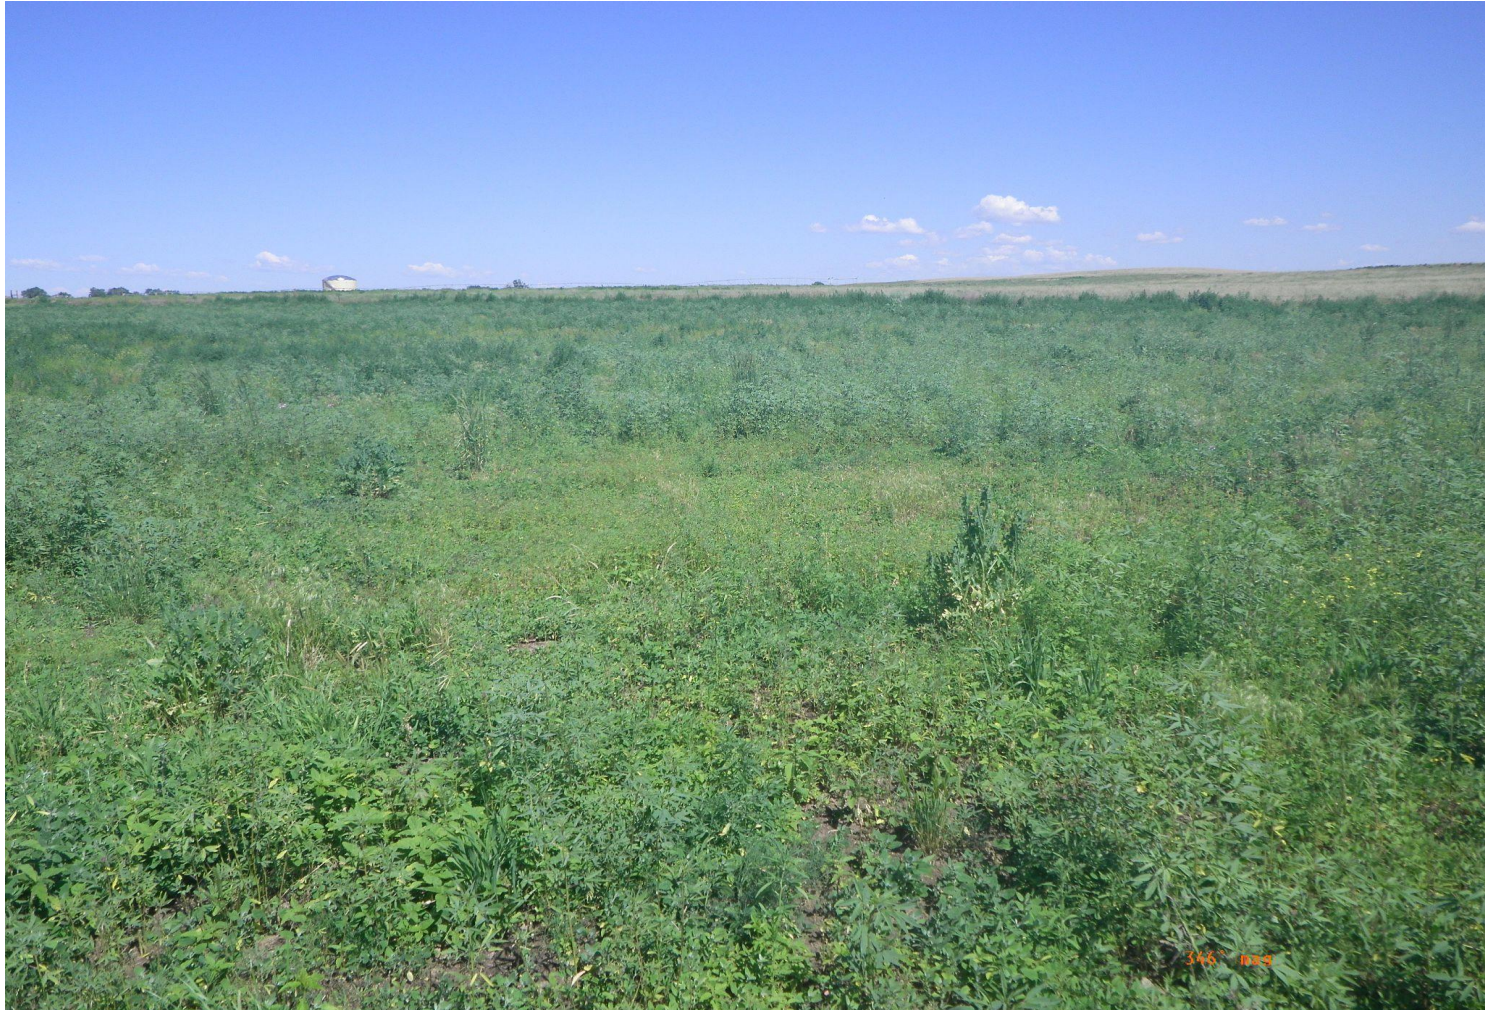
Photo 2. Overview photo of the well pad taken at ground level from the eastern edge facing west.

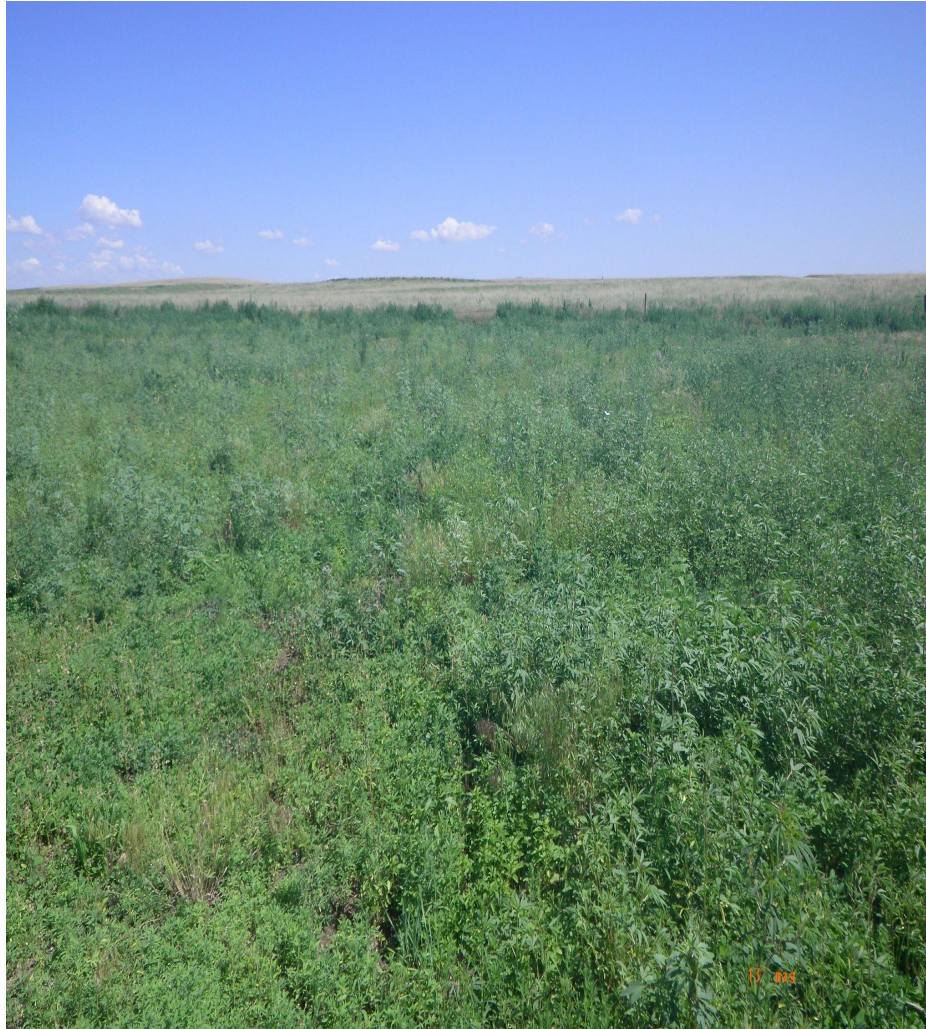
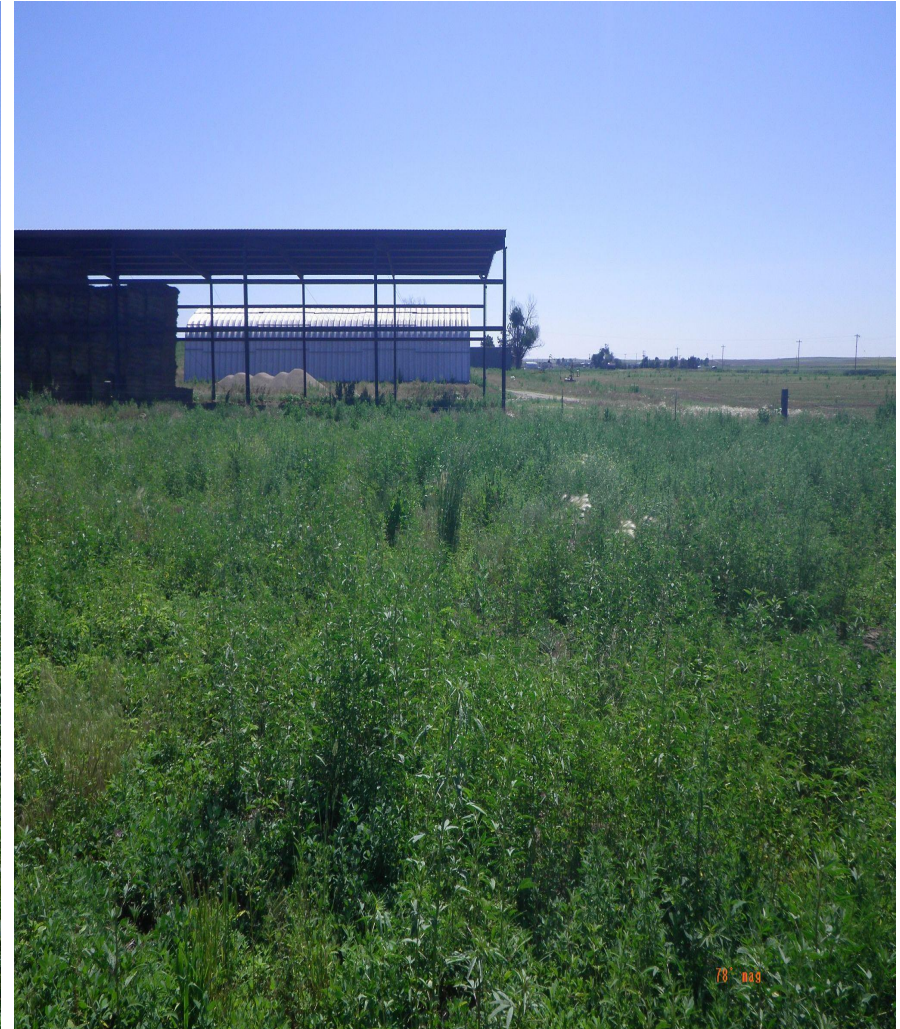
Photo 3. Cardinal photos taken from the middle of the well pad. Left photo facing north, right photo facing east.

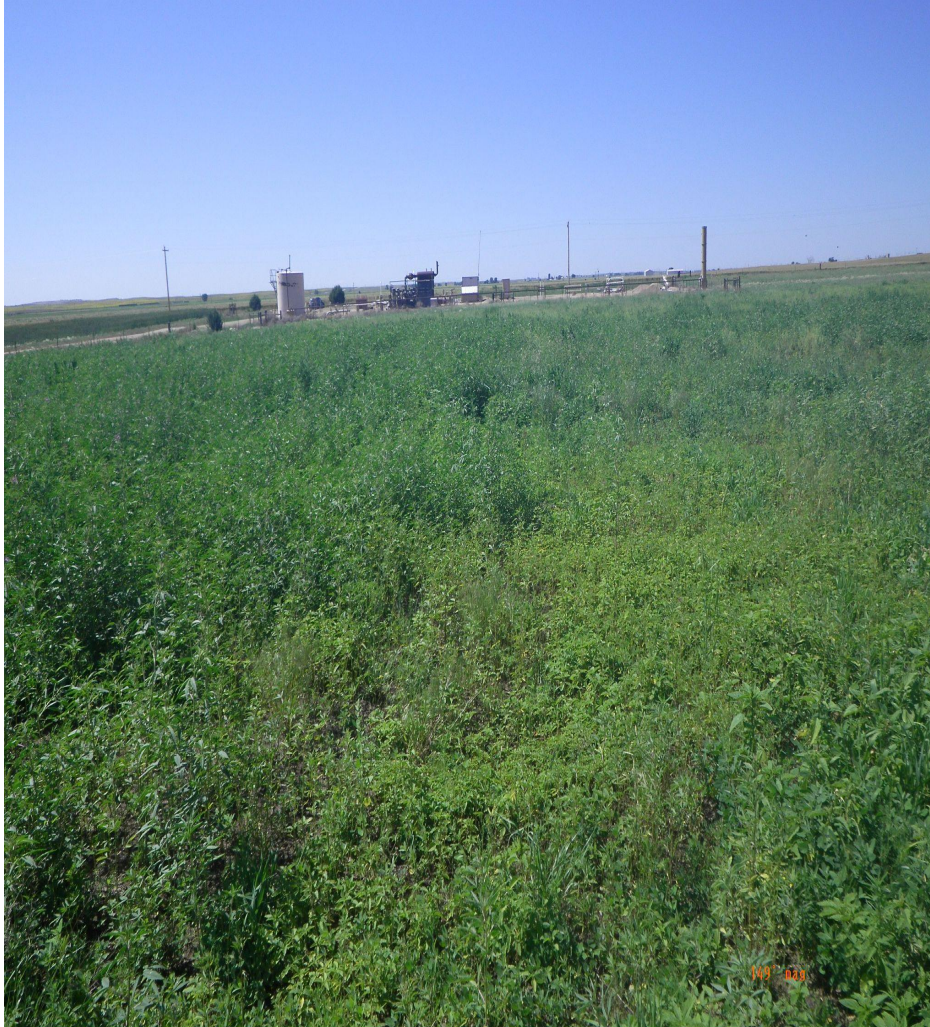
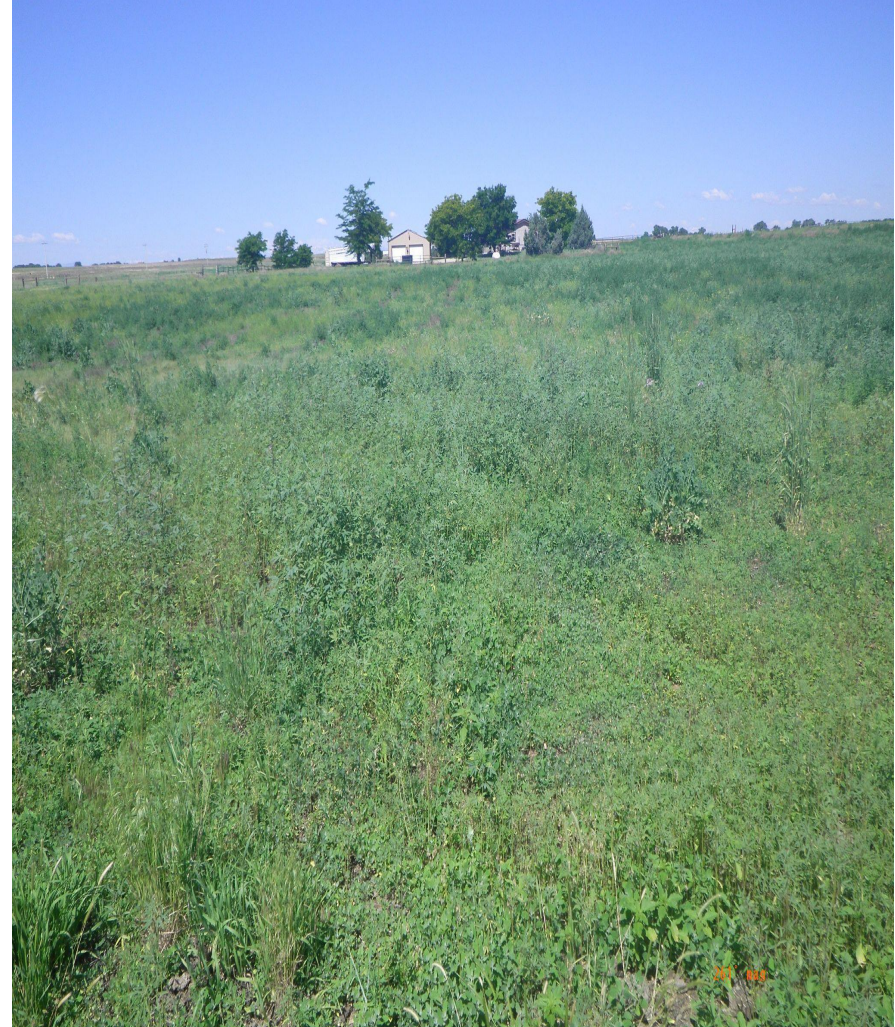
Photo 3. Cardinal photos taken from the middle of the well pad. Left photo facing south, right photo facing west. Note: well pad appears consistent with reference area (see photo #4).

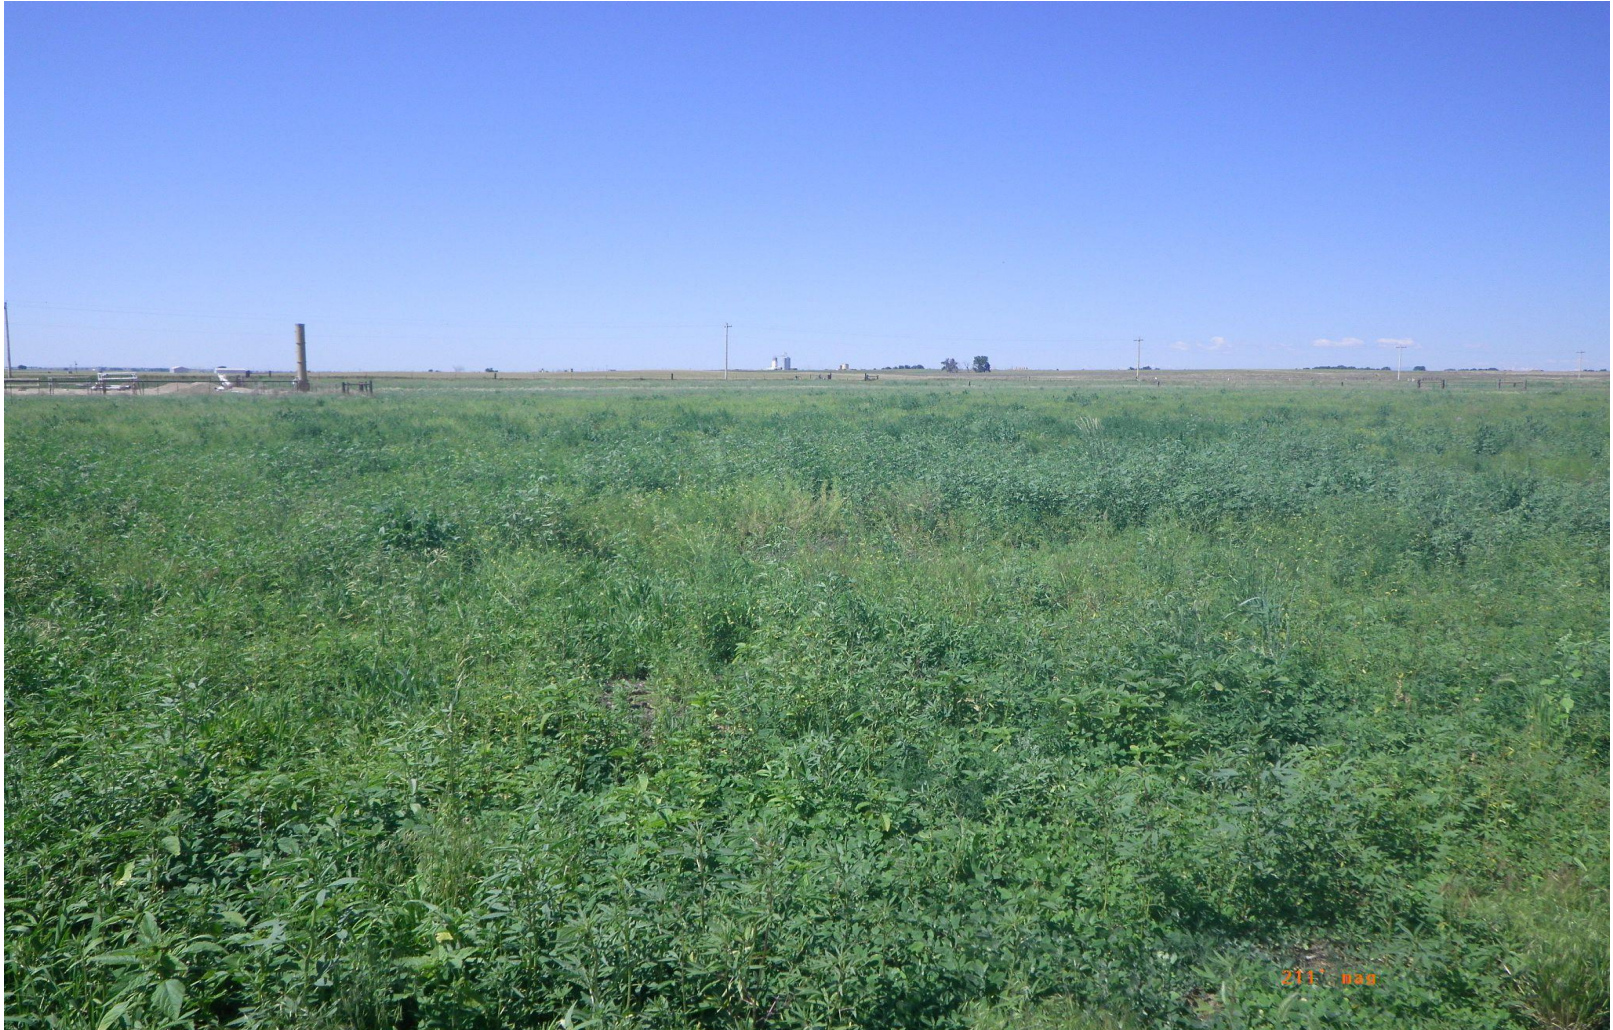
Photo 4. Well pad reference area.

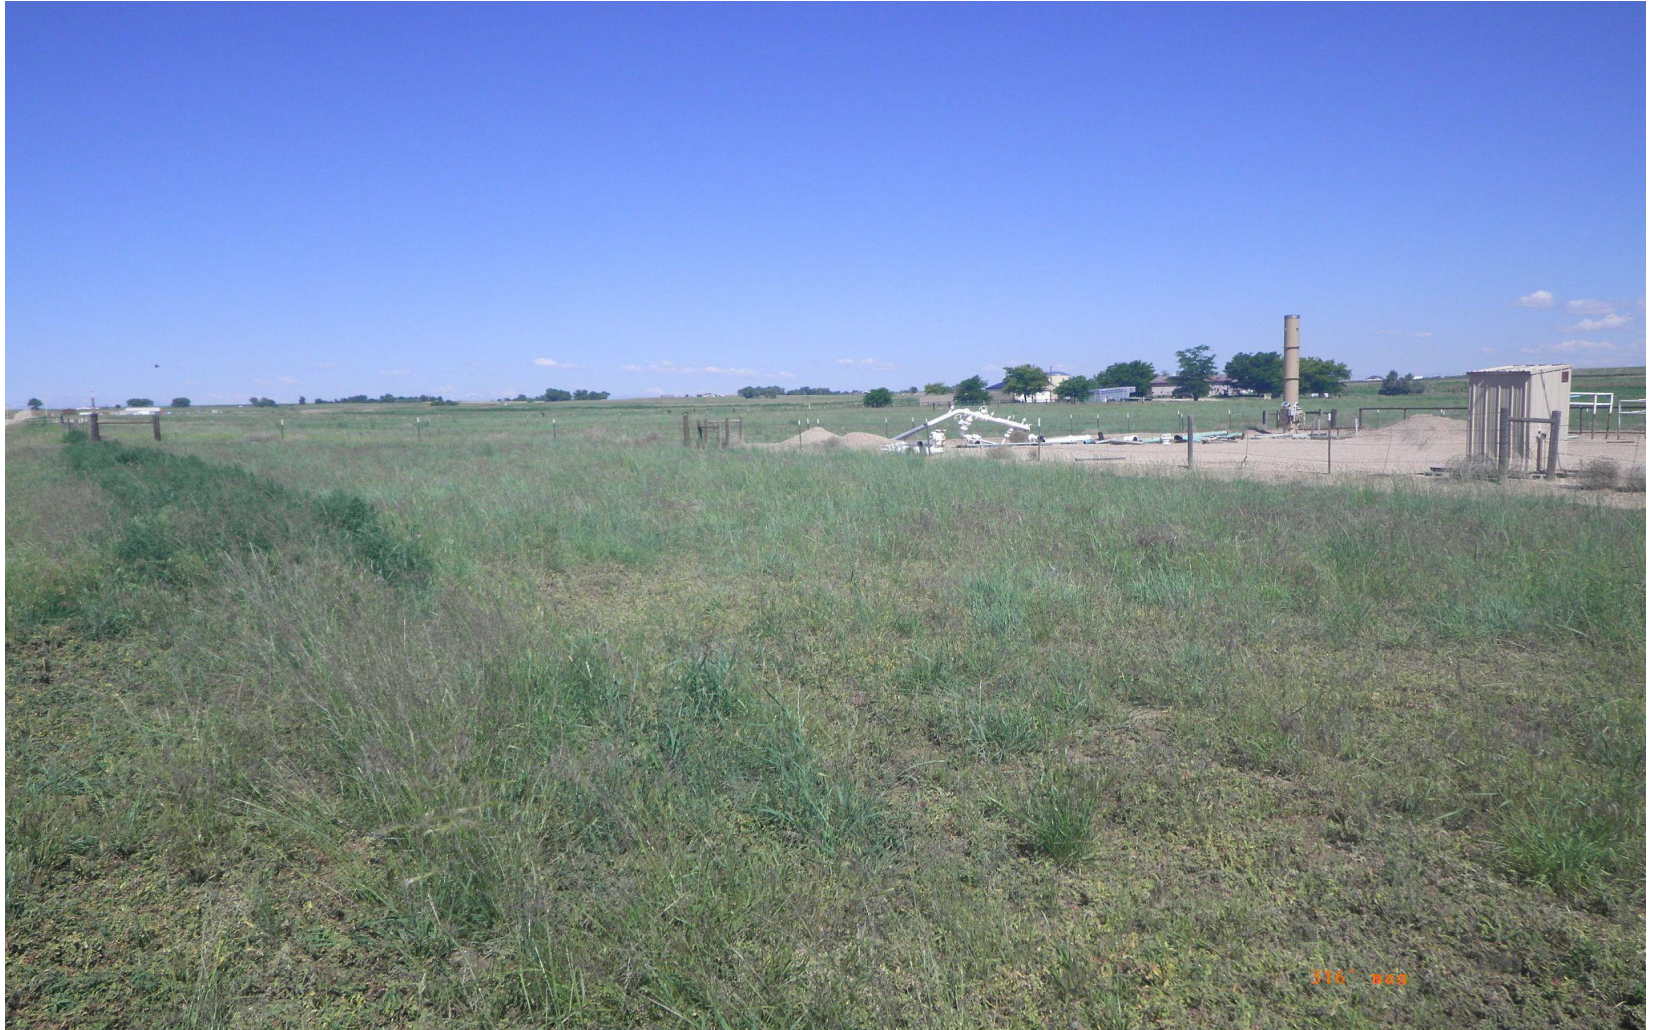
Photo 5. Overview photo of the tank battery taken at ground level from the eastern edge facing west.

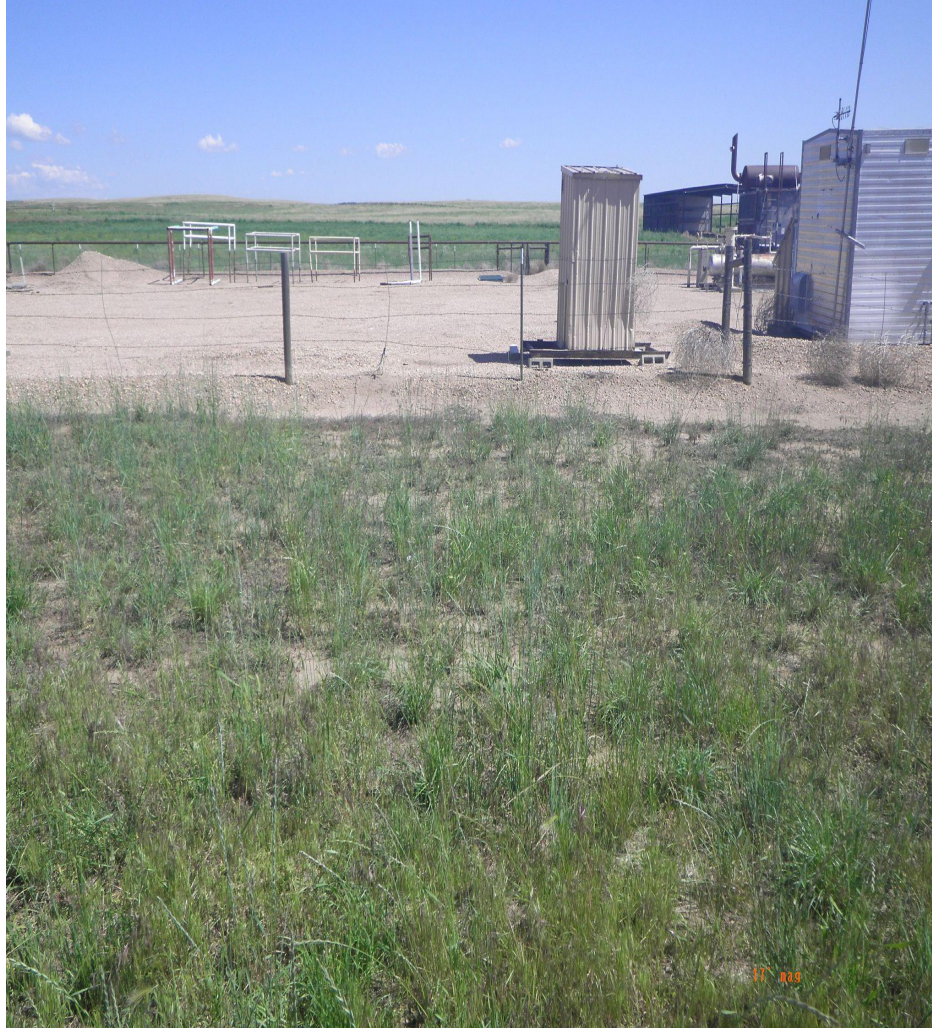
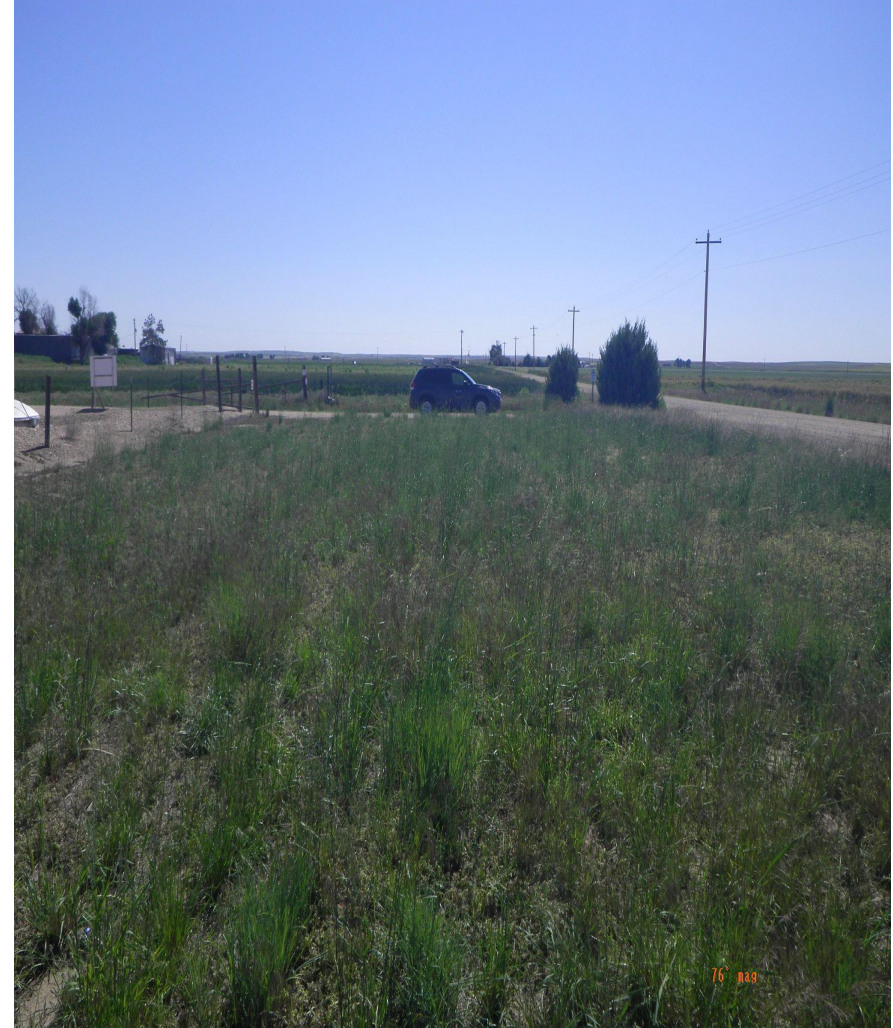
Photo 6. Cardinal photos taken from the middle of the tank battery. Left photo facing north, right photo facing east.

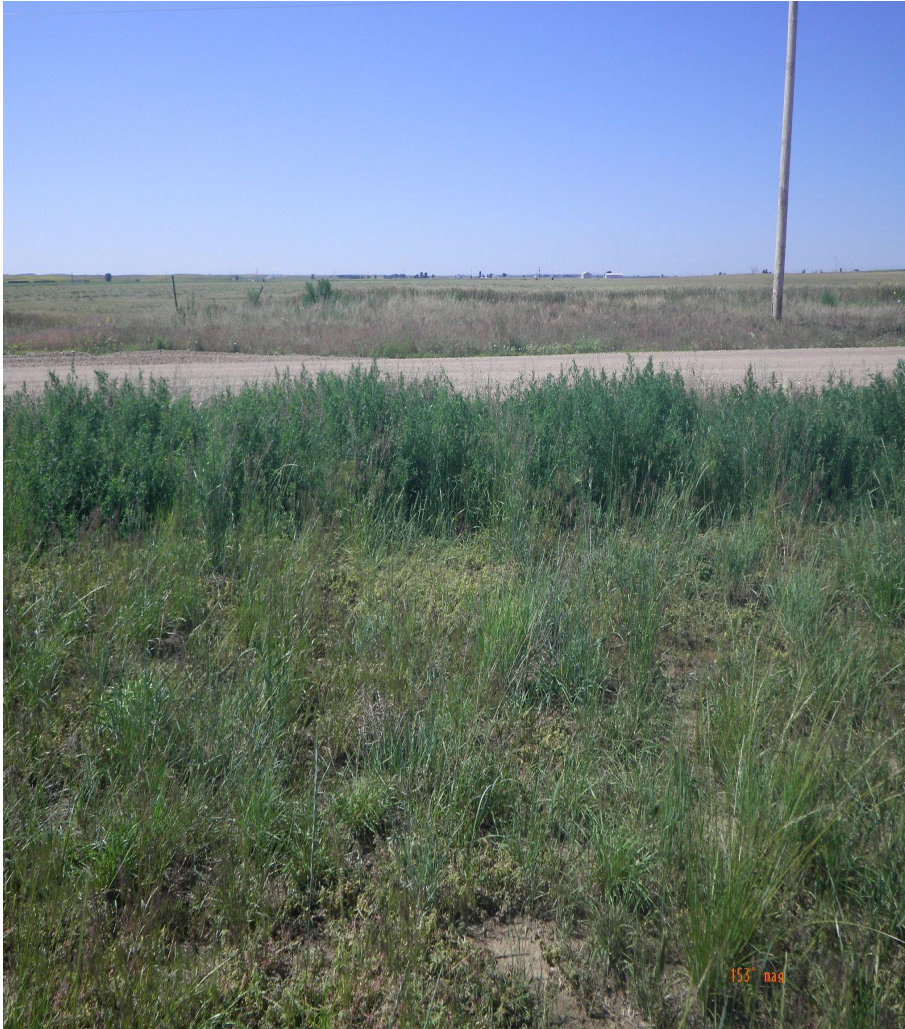
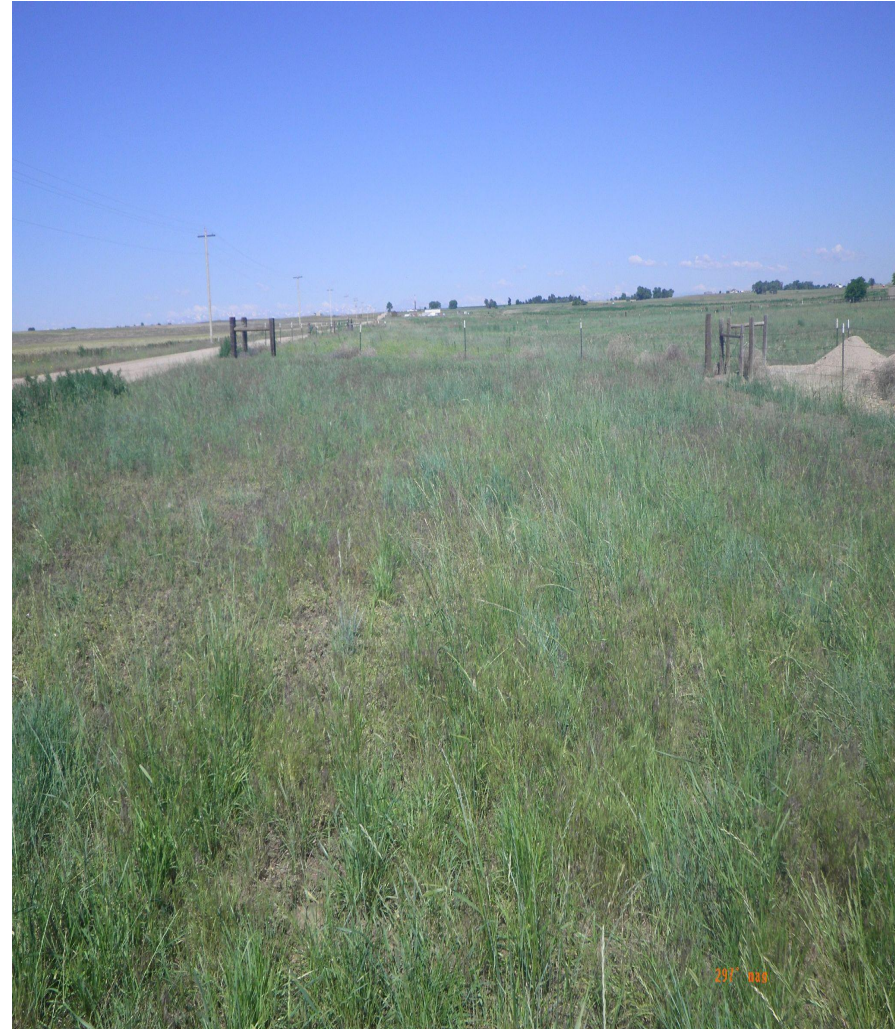
Photo 7. Cardinal photos taken from the middle of the tank battery. Left photo facing south, right photo facing west. Note:
