Final Reclamation Inspection

Operator: PDC ENERGY INC - 69175

Location ID: 322943

Inspection Photos
Location Name: Becker 5-1
Location ID: 322943

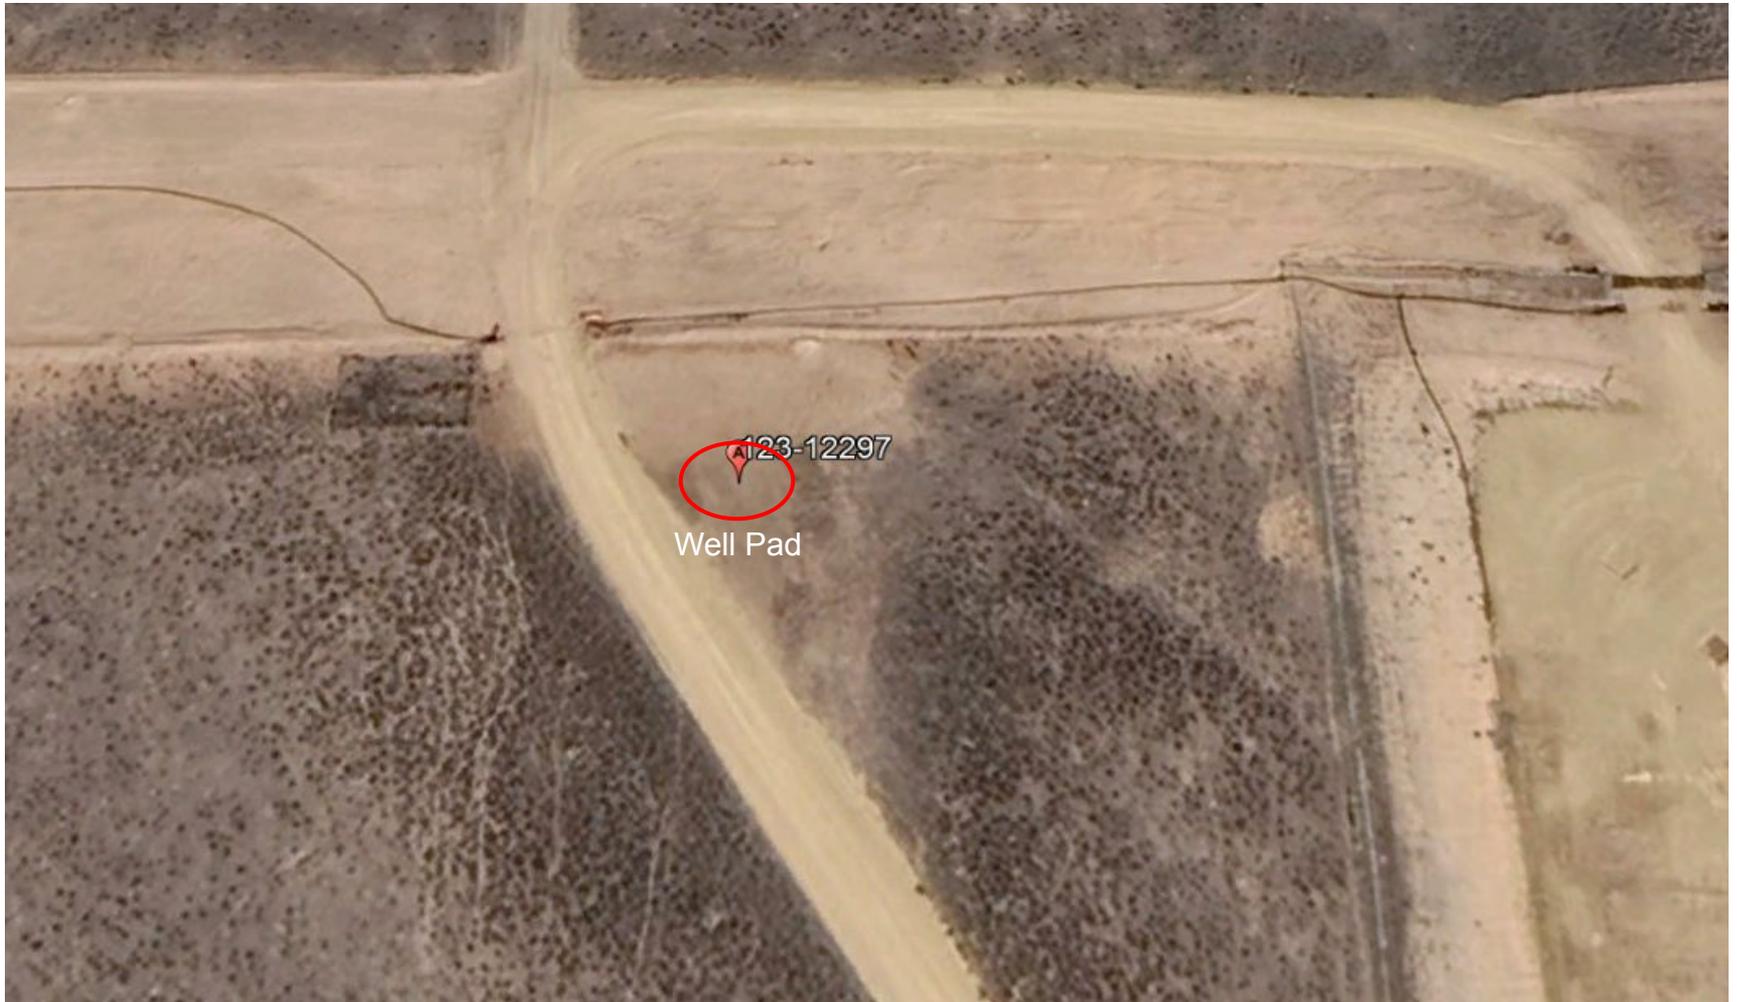
Photo 1. 2022 aerial imagery of the well pad (north is up). Note: tank battery not pictured to the south is associated with the Becker 5-15 well API #123-18182.

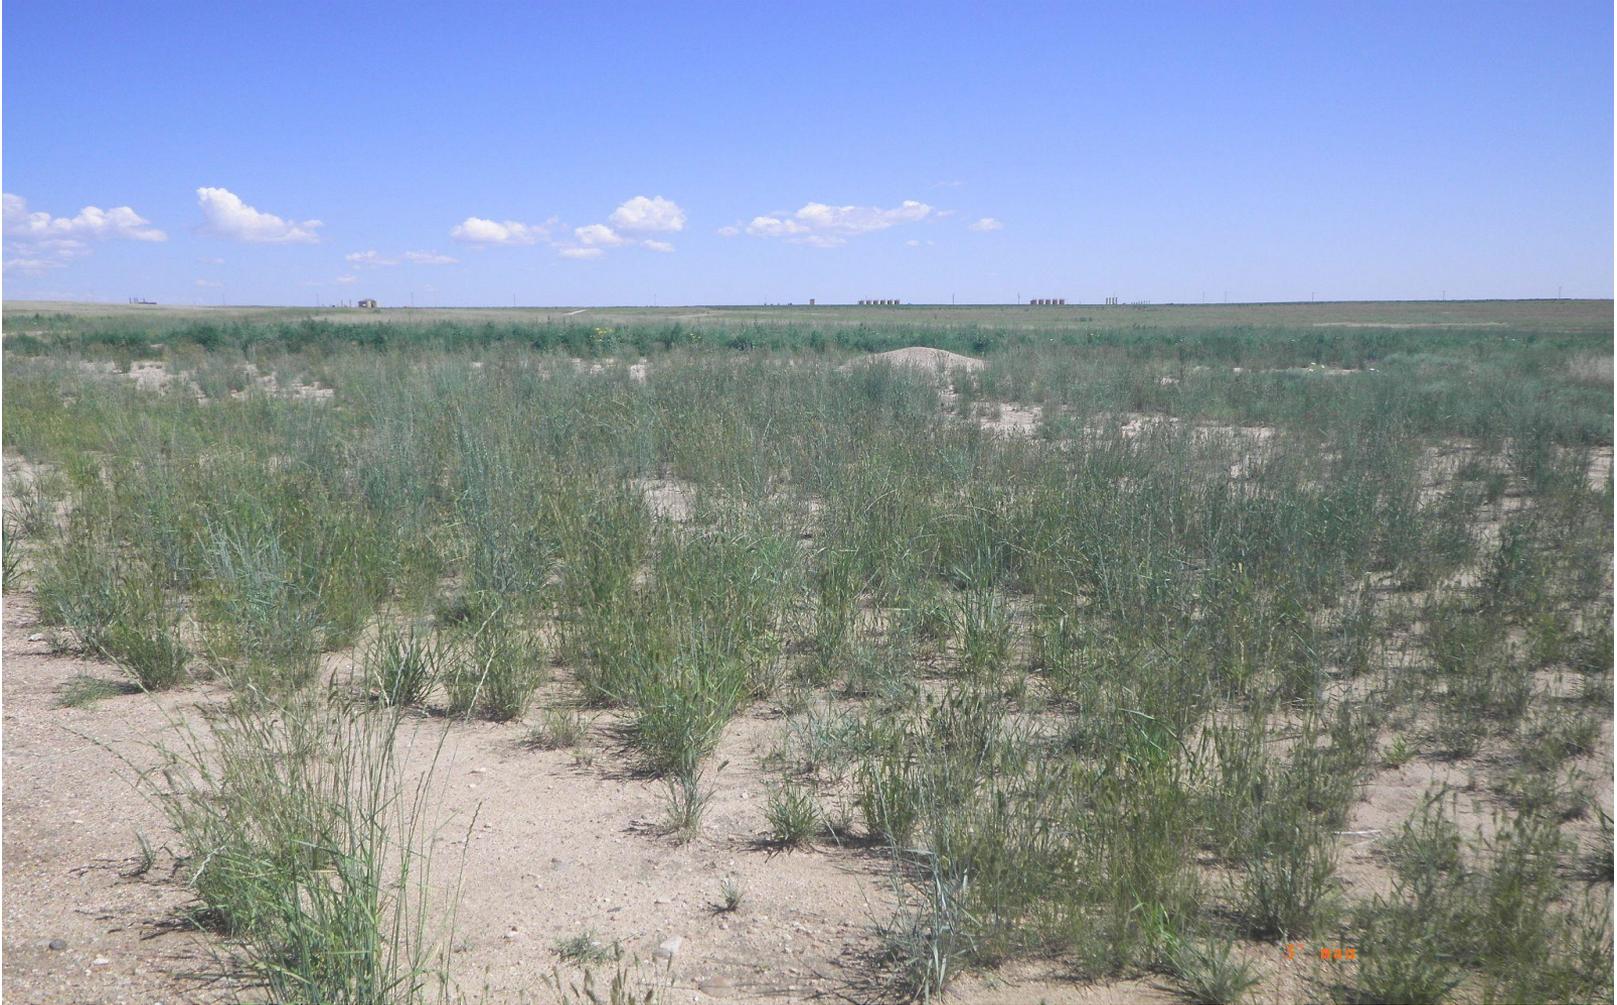
Photo 2. Overview photo of the well pad taken at ground level from the western edge facing northeast.

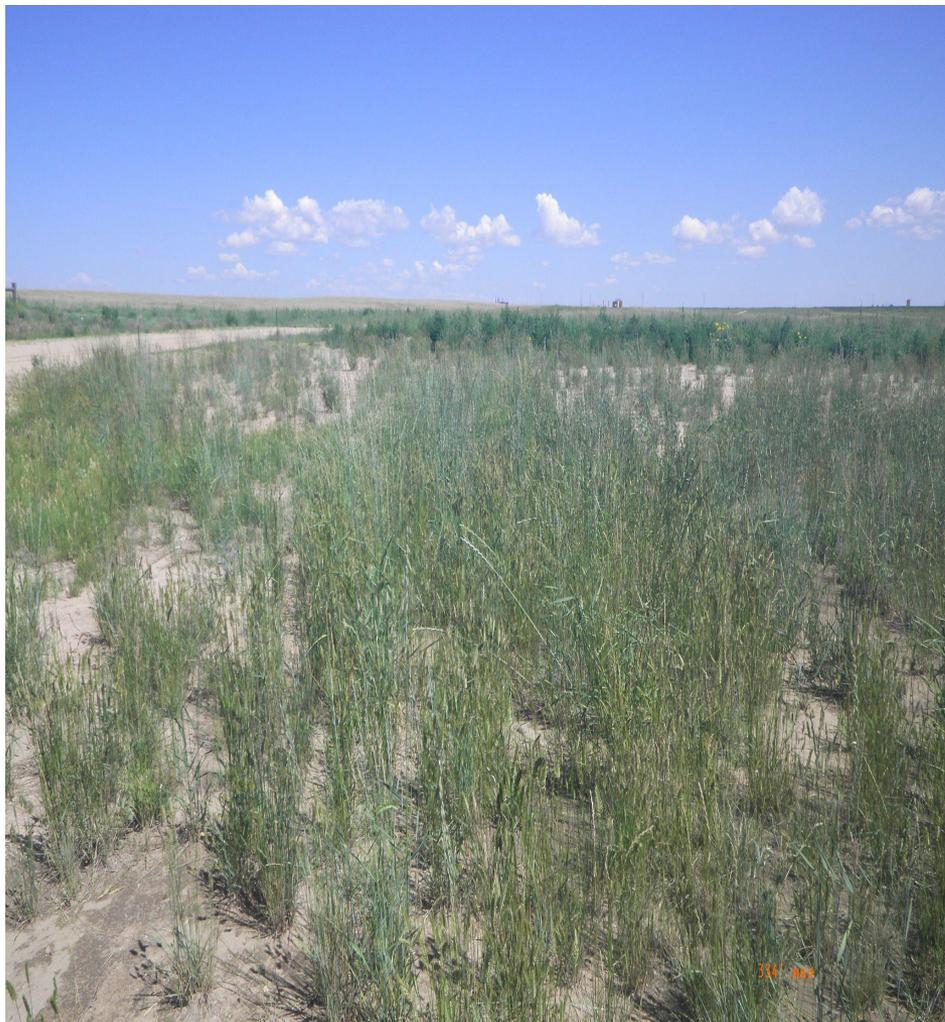
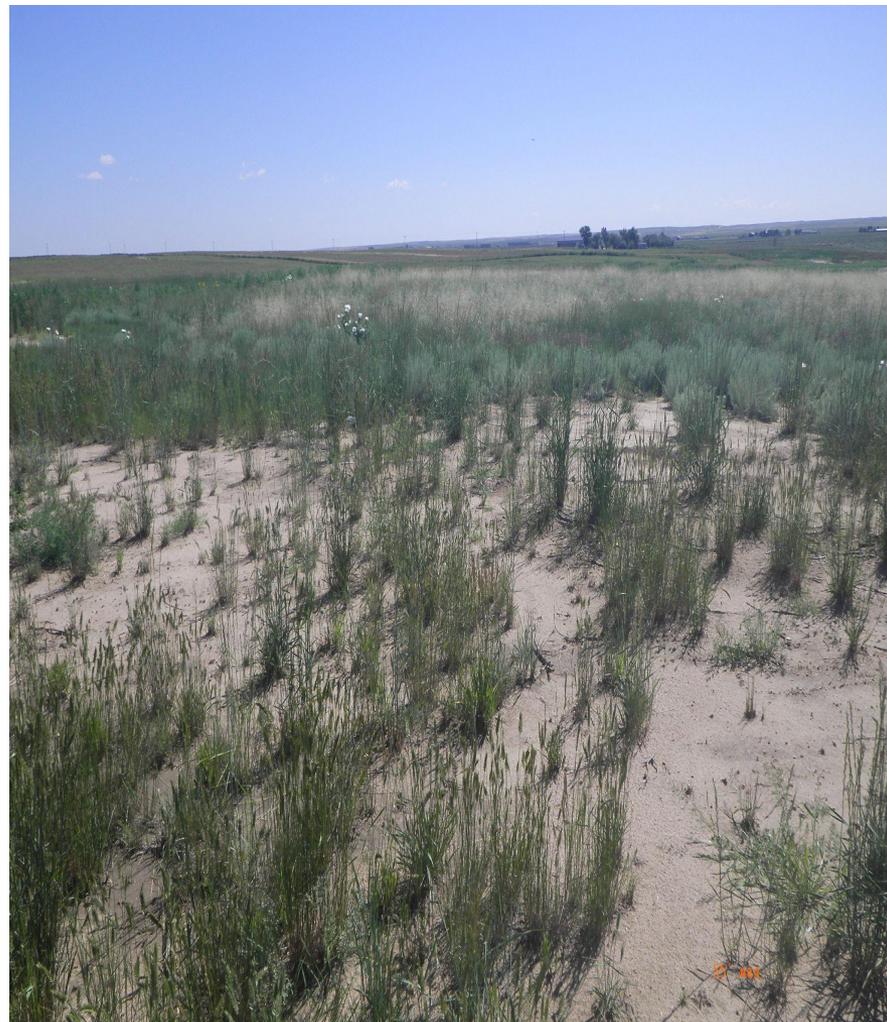
Photo 3. Cardinal photos taken from the middle of the well pad. Left photo facing north, right photo facing east.

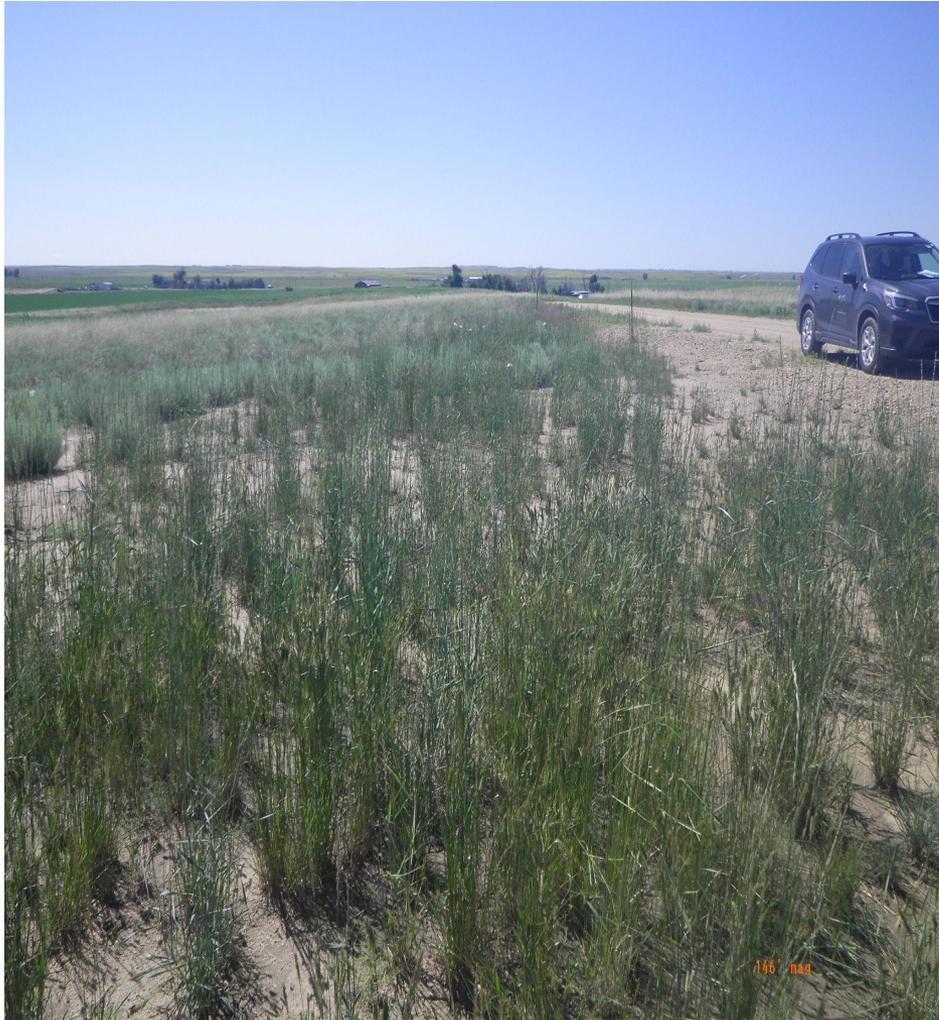
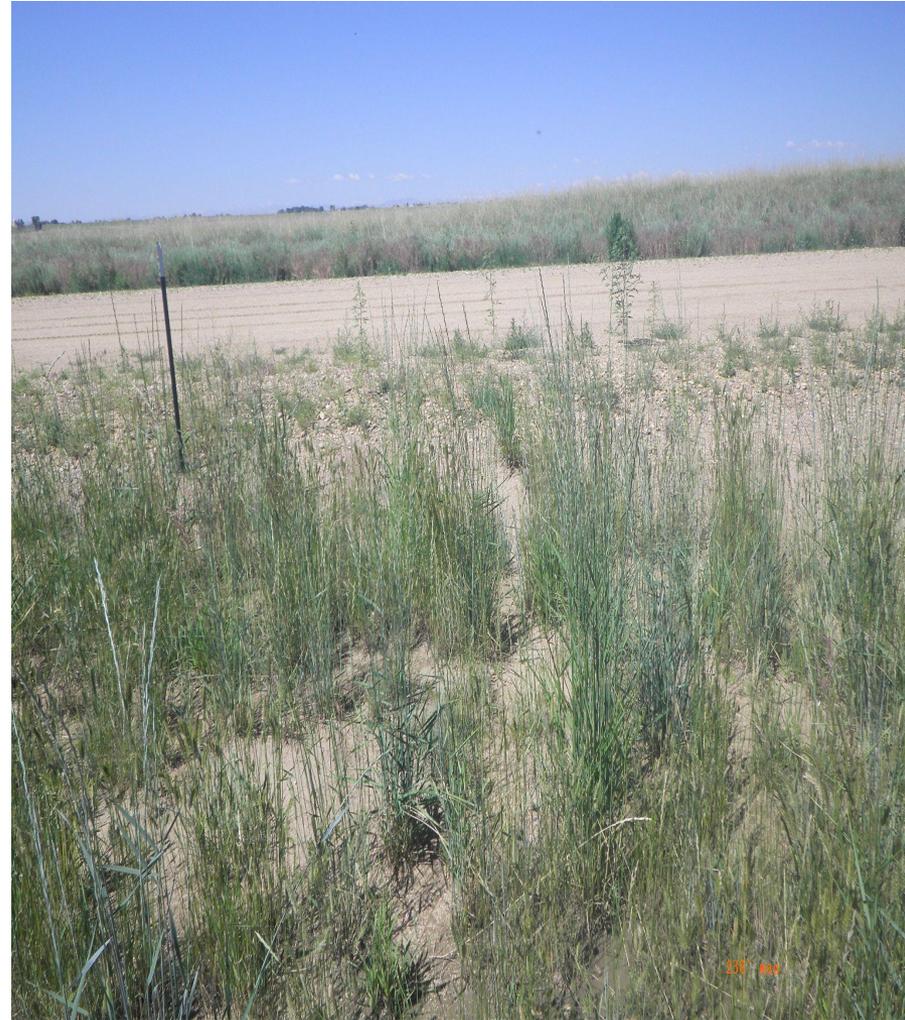
Photo 4. Cardinal photos taken from the middle of the well pad. Left photo facing south, right photo facing west. Note: germination of desirable species observed at location. 80% vegetation cover has not yet been met, site will remain in-process until rule 1004 standards are achieved.

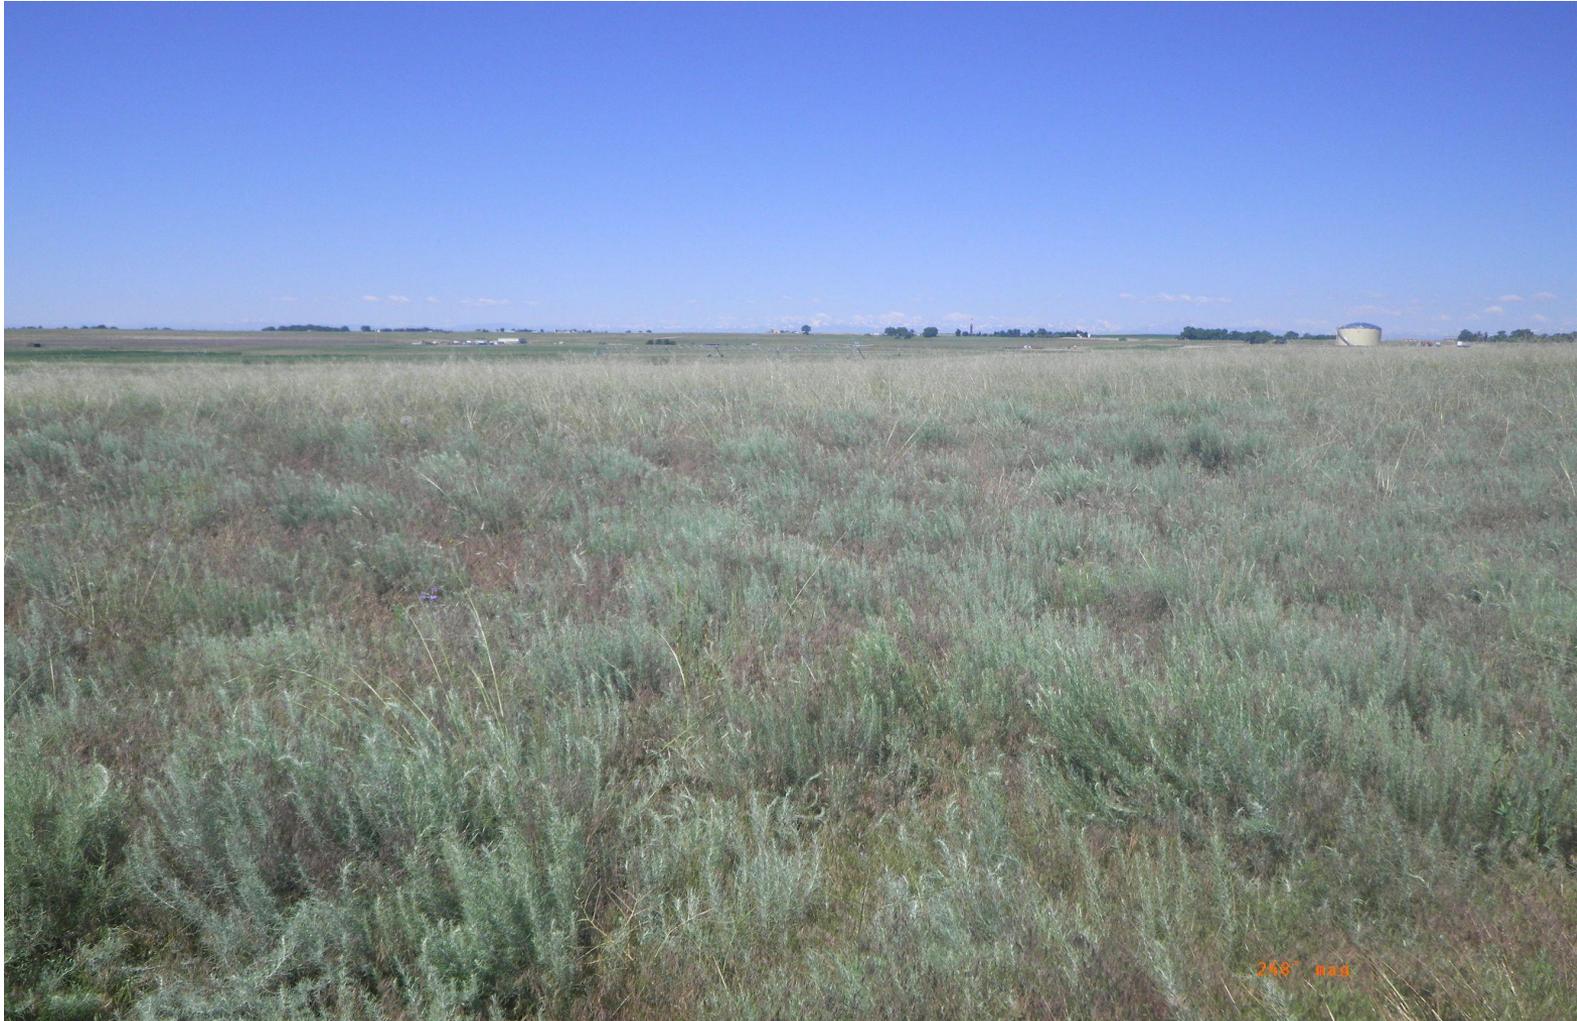
Photo 5. Well pad reference area.
