MEMORANDUM

DATE: July 14, 2023

RE: MGP Enterprise - July 2023 Site Inspection

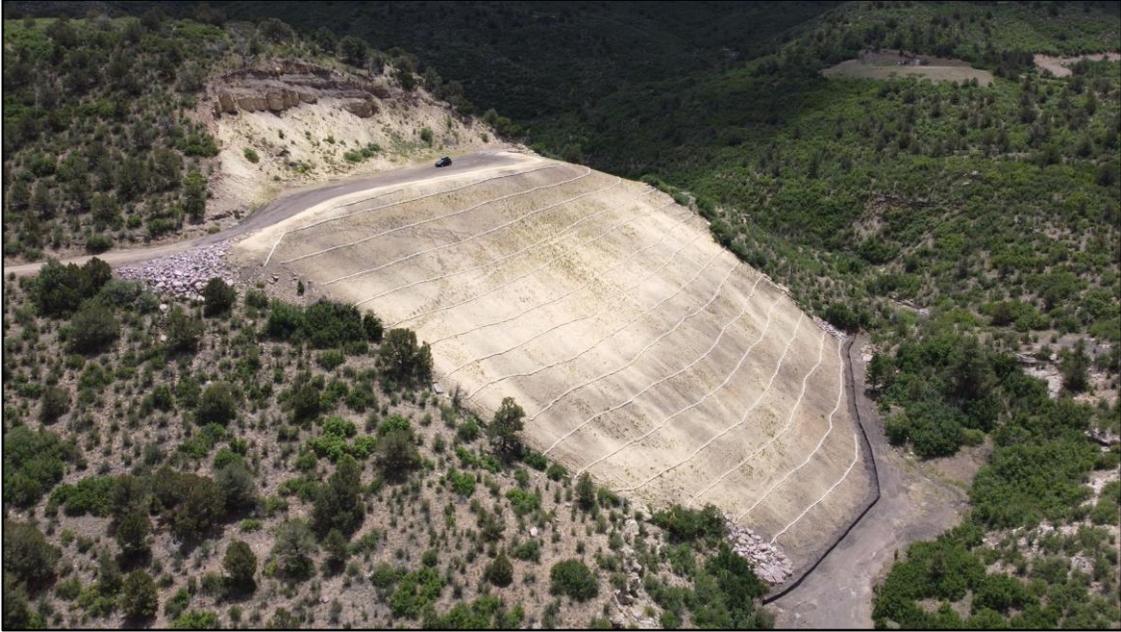
The well pad is generally in good condition with a berm installed along the western and southern edges (see Photos 1 and 2). The pad was regraded to reduce flow to the western slope and redirected to riprap channels on the northwestern and southeastern boundaries (see Photos 1 and 2).

Photo Number: 1	Direction of camera: Southeast	Date: 7/13/2023
Description: Drone photo of western slope

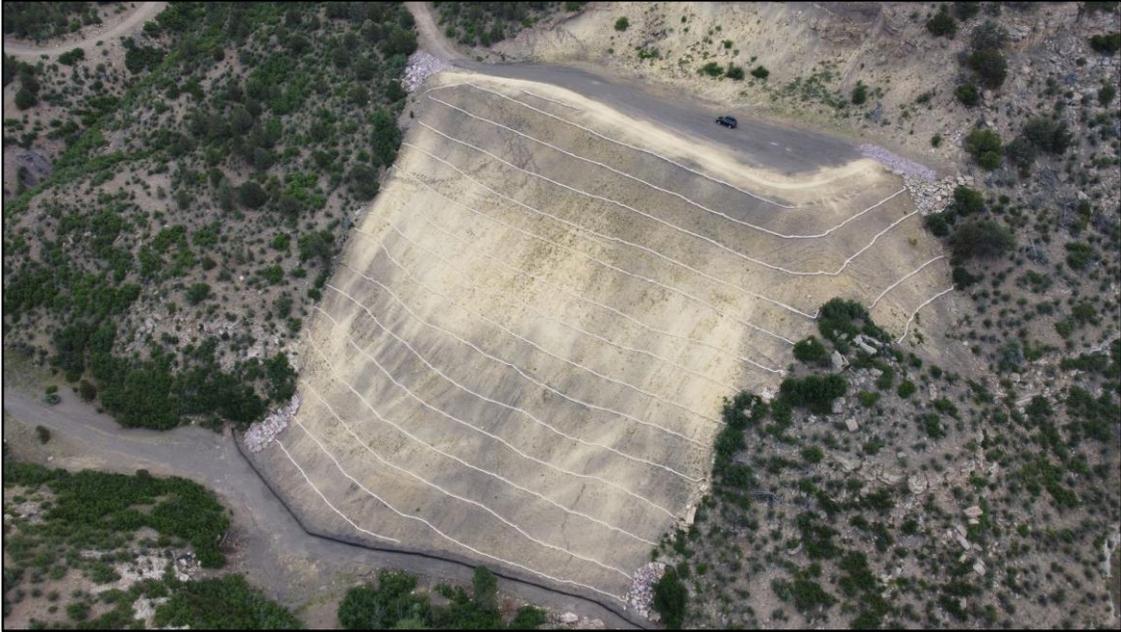
Photo Number: 2	Direction of camera: Northeast	Date: 7/13/2023
Description: Drone photo of western slope

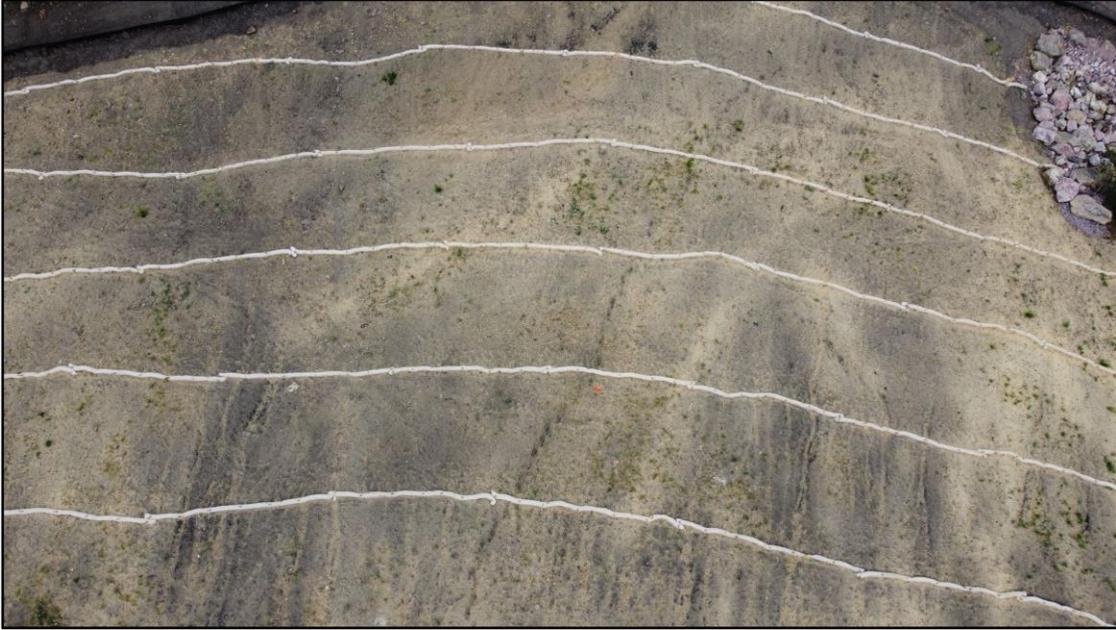
Photo Number: 3	Direction of camera: West	Date: 7/13/2023
Description: Drone photo of western slope

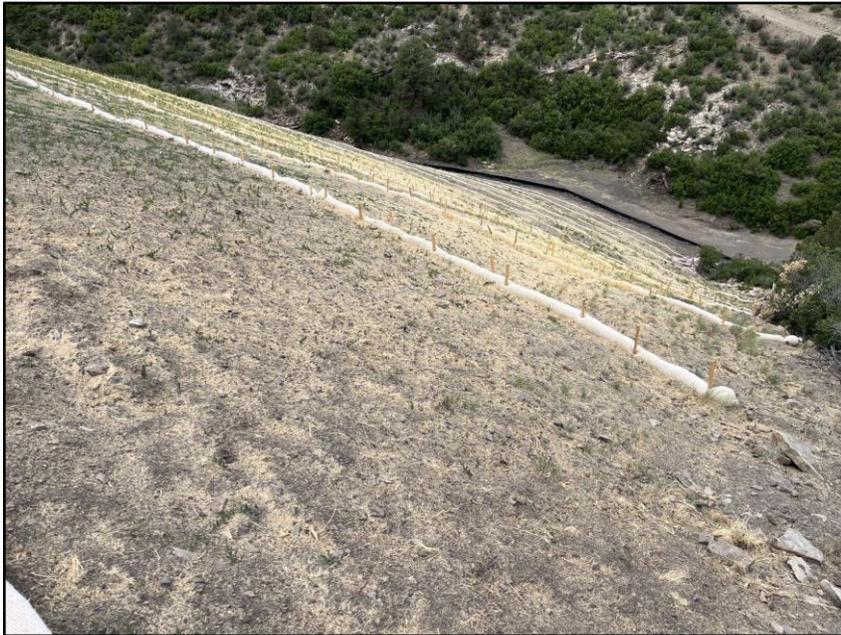
Photo Number: 4	Direction of camera: Southwest	Date: 7/13/2023
Description: Ground photo of western slope

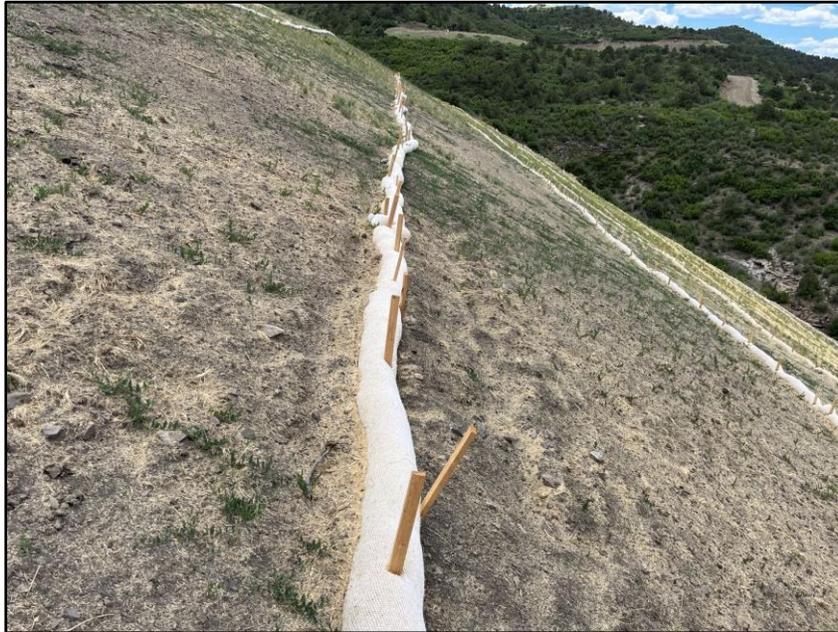
The western slope has new visible growth, mainly of grasses. Growth is limited in various areas where erosion was most severe prior to reclamation construction. Very minor erosion rills were present in select locations where sediment logs overlap and cause points of weakness, but the western slope is generally free of rills (see Photos 3-5). The rills do not appear to have worsened since the construction concluded. In addition, sedimentation at the bottom of the slope (see Photo 7) has not increased since the last inspection. The silt fence is in good condition. The sediment logs were in good condition (see Photos 5 and 6) and do not require any maintenance at this time.

Photo Number: 5	Direction of camera: South	Date: 7/13/2023
Description: Ground photo of western slope

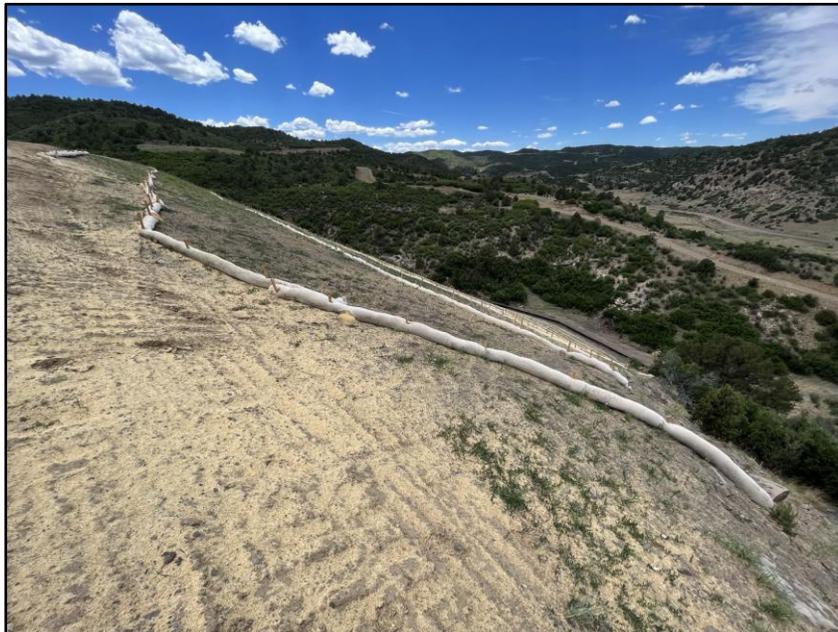
Photo Number: 6	Direction of camera: Southwest	Date: 7/13/2023
Description: Ground photo of straw wattles by top of western slope

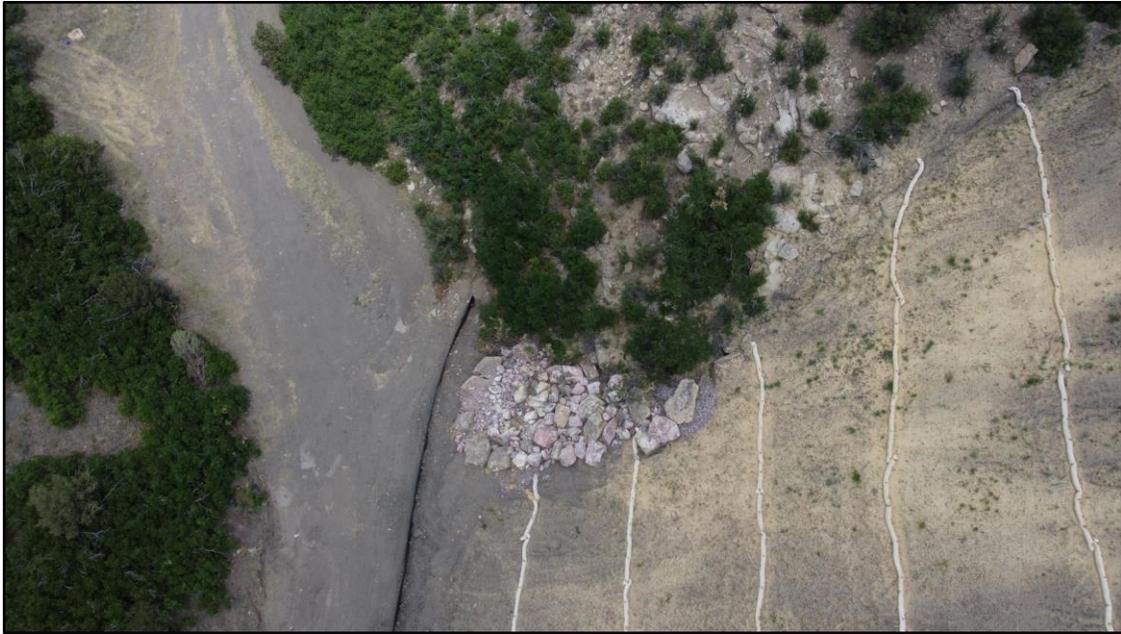
Photo Number: 7	Direction of camera: North	Date: 7/13/2023
Description: Drone photo of bottom of western slope

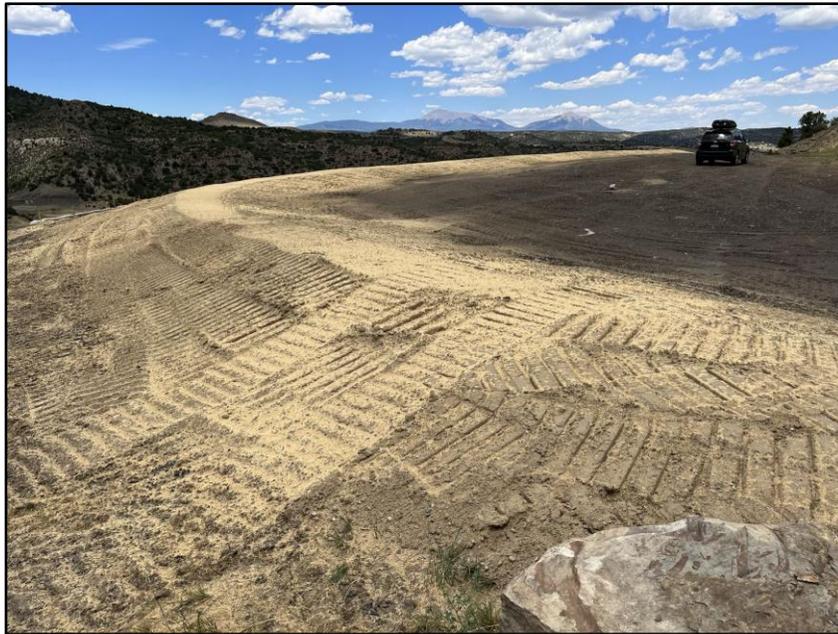
Photo Number: 8	Direction of camera: Northwest	Date: 7/13/2023
Description: Ground photo of well pad

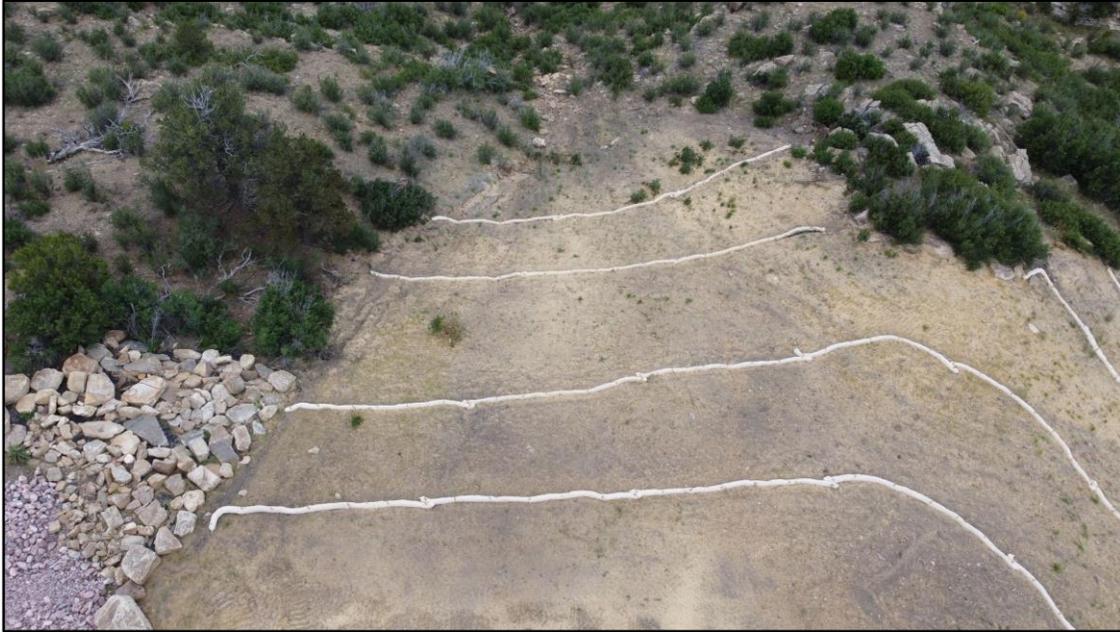
The southern slope presented limited new grass growth. The erosion rills observed during the last inspection were filled in during construction and four rows of sediment logs were installed (see Photos 9 and 10). The sediment logs were in good condition and do not require any maintenance at this time. Additional riprap was placed on the eastern edge of the slope where water is channeled from the southern half of the well pad.

Photo Number: 9	Direction of camera: South	Date: 7/13/2023
Description: Drone photo of southern slope

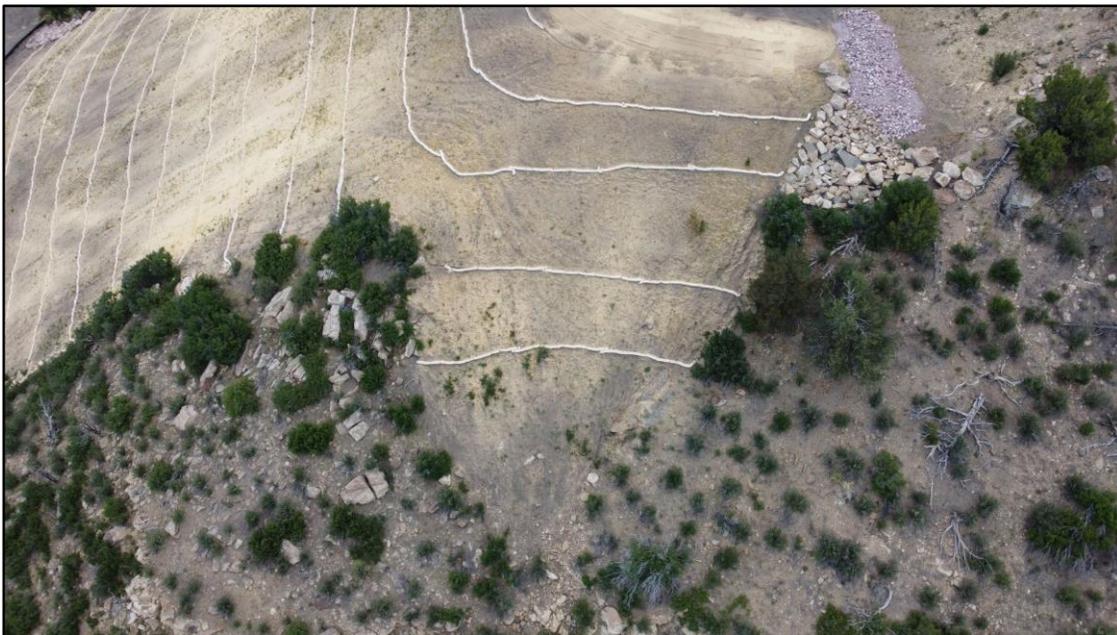
Photo Number: 10	Direction of camera: North	Date: 7/13/2023
Description: Drone photo southern slope

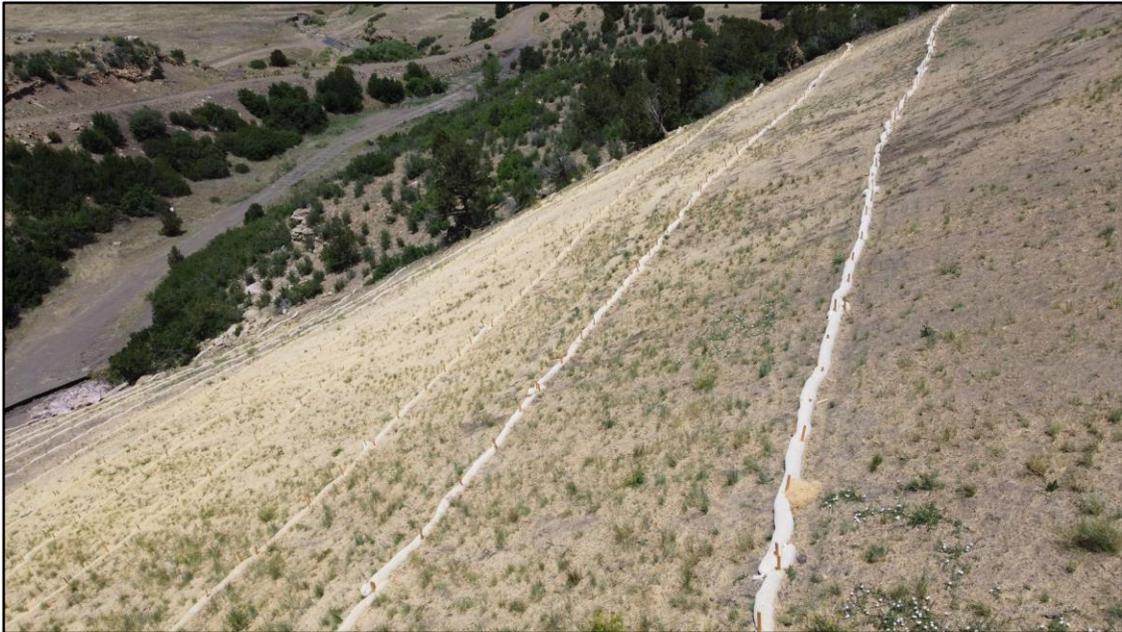
Photo Number: 11	Direction of camera: North	Date: 7/13/2023
Description: Drone photo of western slope

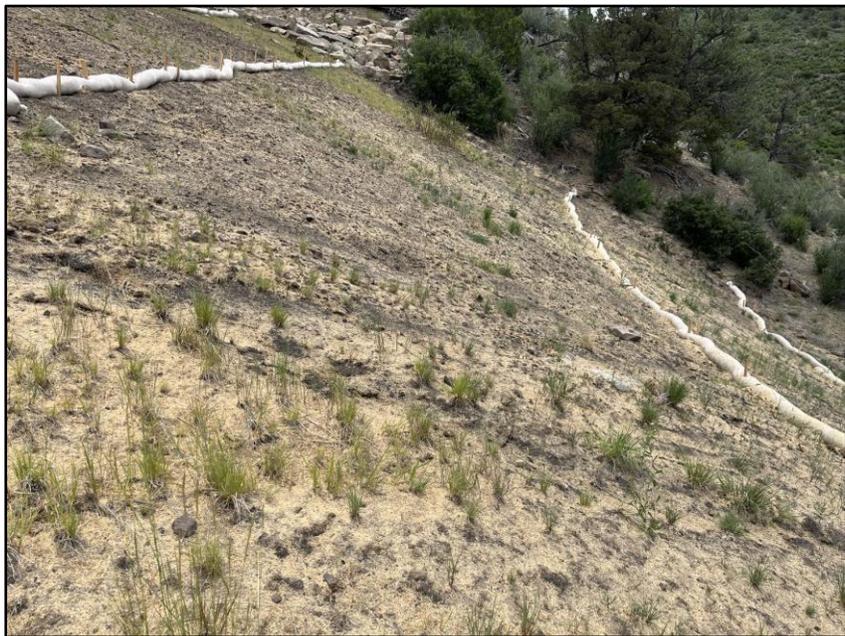
Photo Number: 12	Direction of camera: South	Date: 7/13/2023
Description: Ground photo of western slope

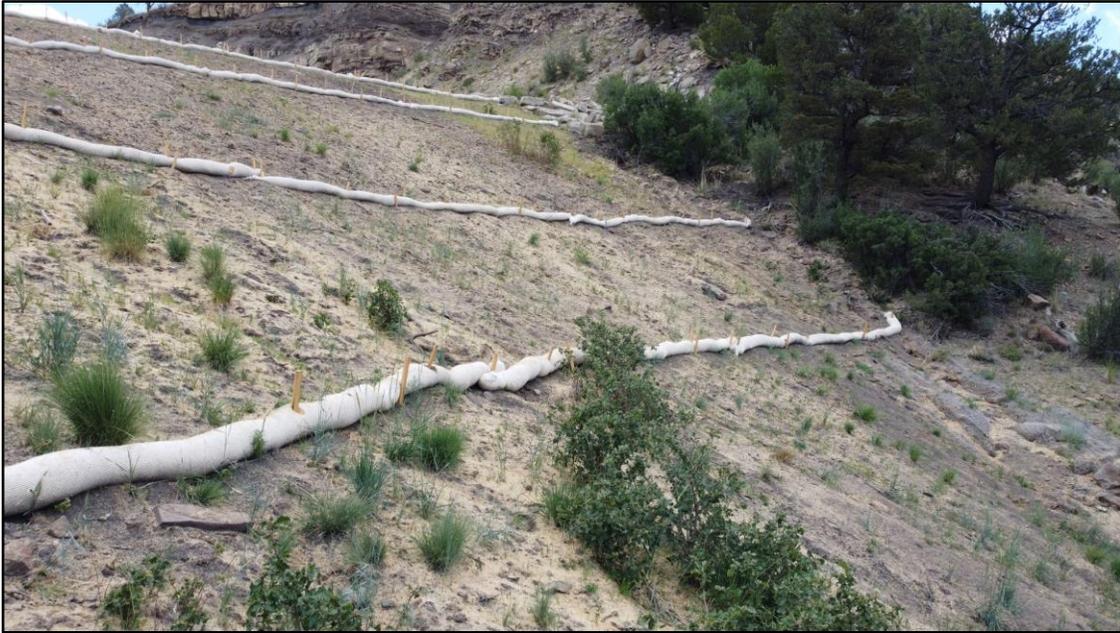
Photo Number: 13	Direction of camera: Northeast	Date: 7/13/2023
Description: Ground photo of southern slope

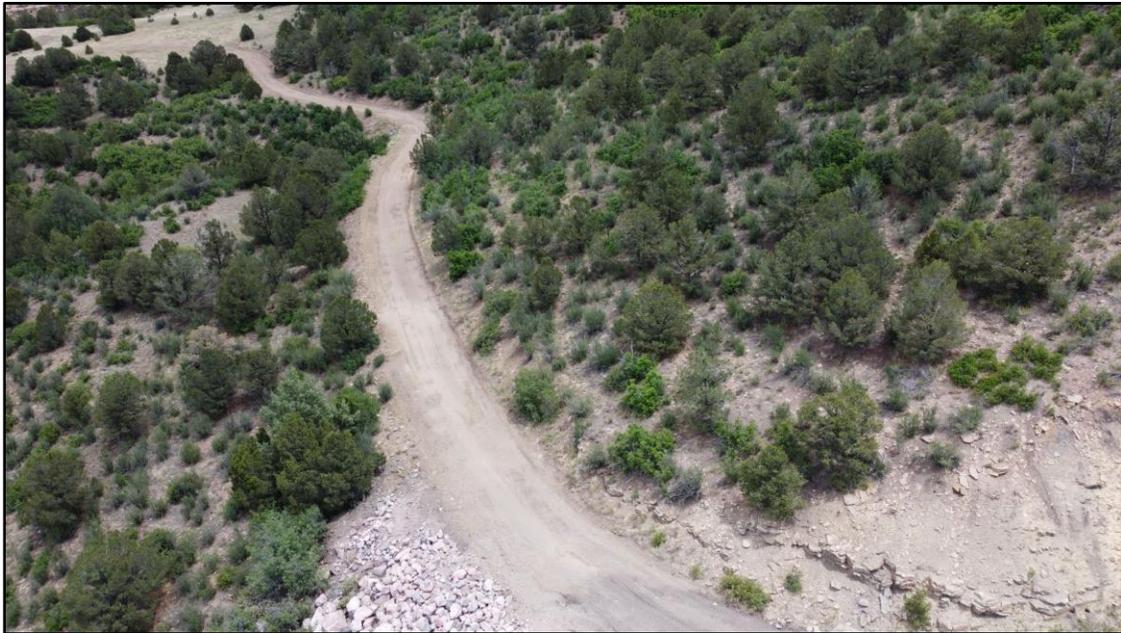
The access road is generally in good condition, with little to no evidence of erosion since it was re-graded (see Photos 14-16).

Photo Number: 14	Direction of camera: Northeast	Date: 7/13/2023
Description: Drone photo of road entrance to well pad

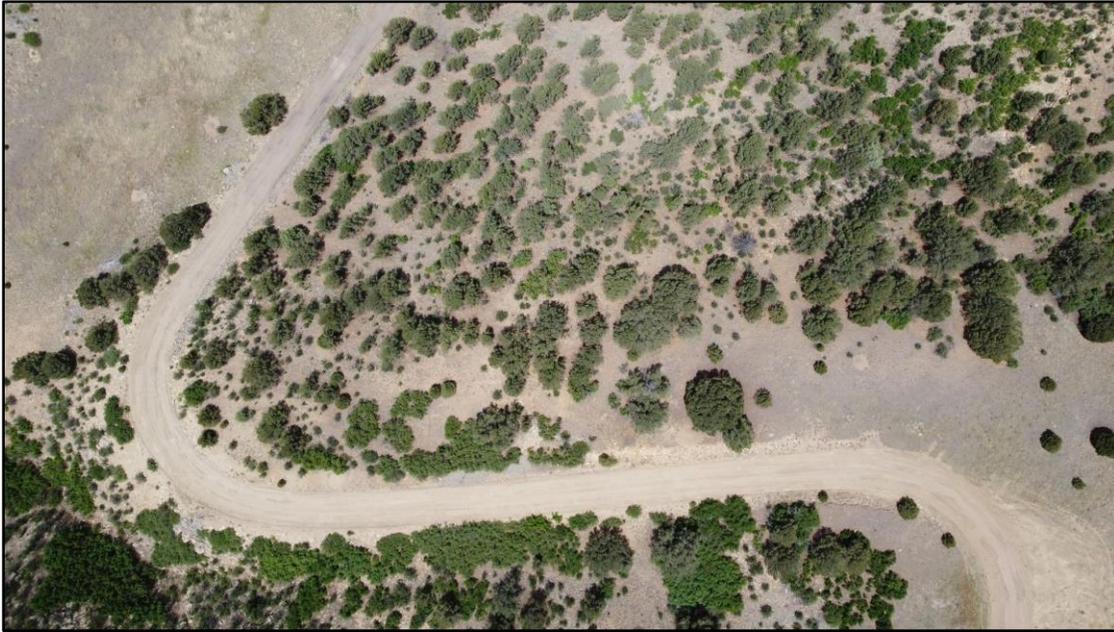
Photo Number: 15	Direction of camera: North	Date: 7/13/2023
Description: Drone photo of access road

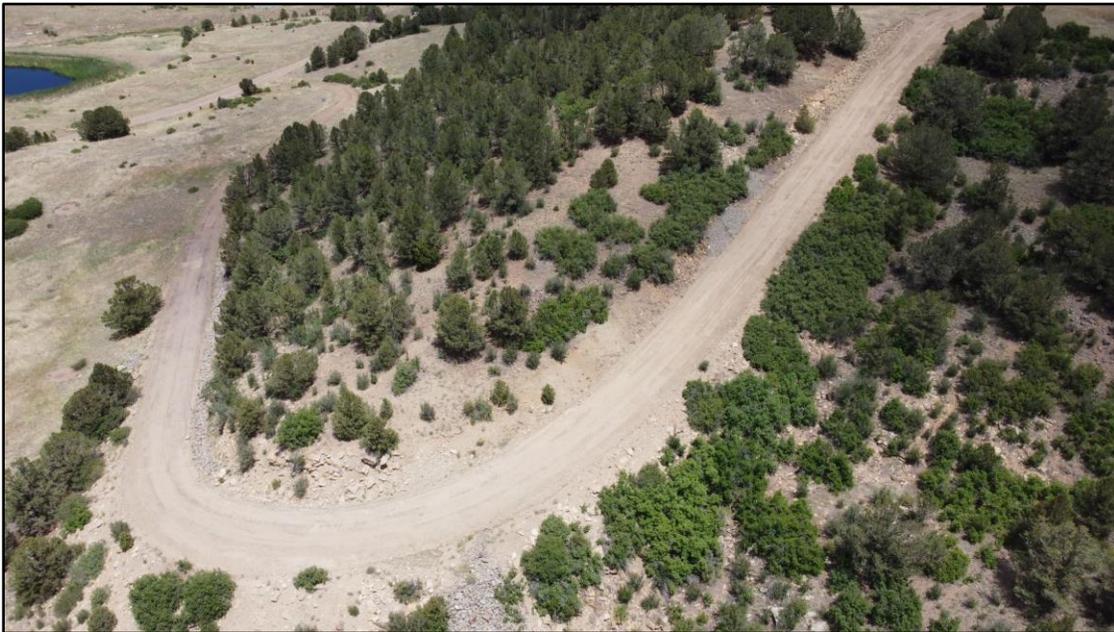
Photo Number: 16	Direction of camera: North	Date: 7/13/2023
Description: Drone photo of access road
