# Construction and Stormwater Inspection

Date: 07/19/2023

Operator: MDS ENERGY DEVELOPMENT LLC - 10814

Inspection Photos  
Location Name: Daffy Pad  
Location ID: 477495

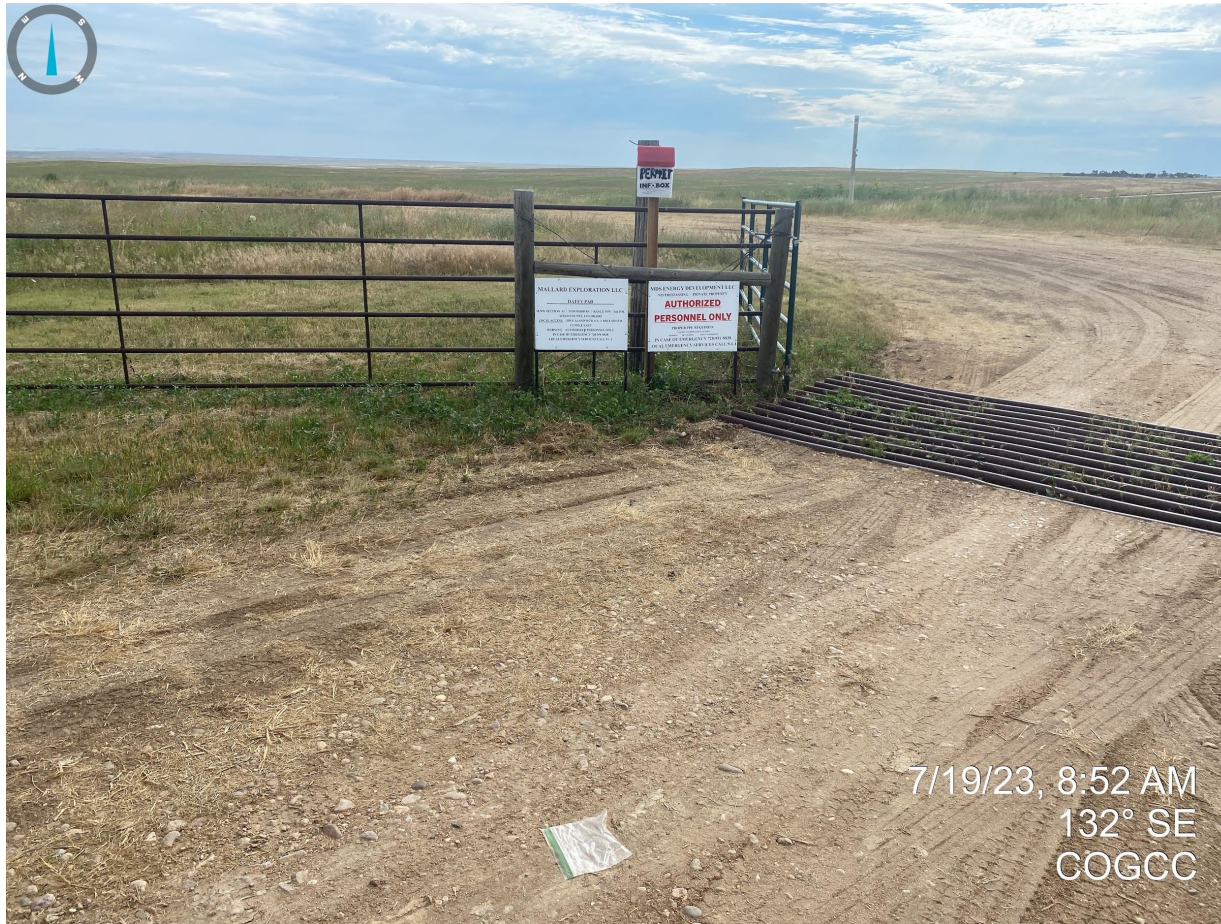
**Photo 1.** Location signage has been posted at an alternate entrance to the location. The entrance pictured here is approximately 1000' south of the location's entrance (see preceding photos for additional info). Signage must be placed at the entrance to the location per Rule 605.a.

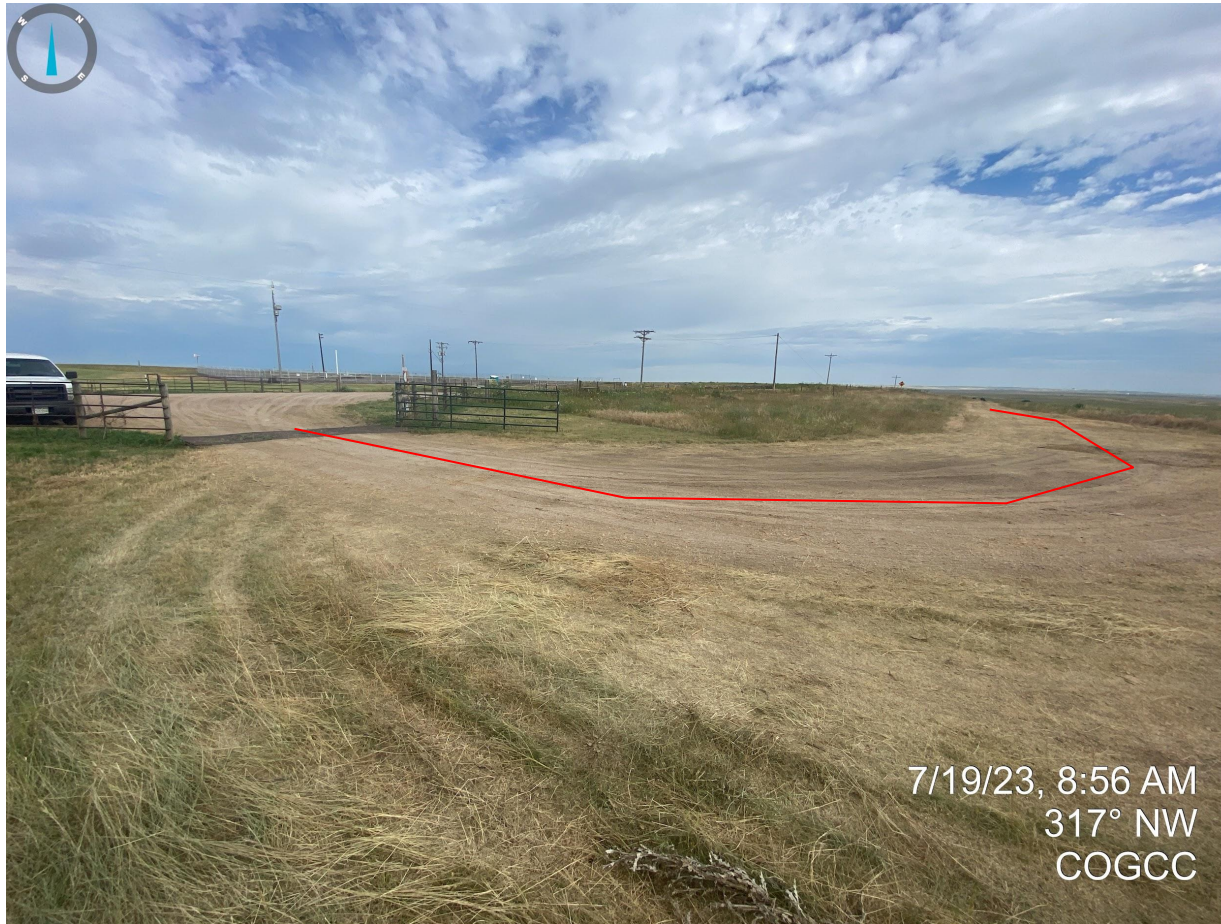
**Photo 2.** Portions of land experiencing vehicle traffic (red line) with no evidence of topsoil salvage having occurred. This entrance is approximately 1000' south of the current location entrance. Topsoil will need to be salvaged from this access point pictured if it's going to be used in future oil and gas operations, or, the disturbed areas will need to be reclaimed in accordance with 1000 series Rules.

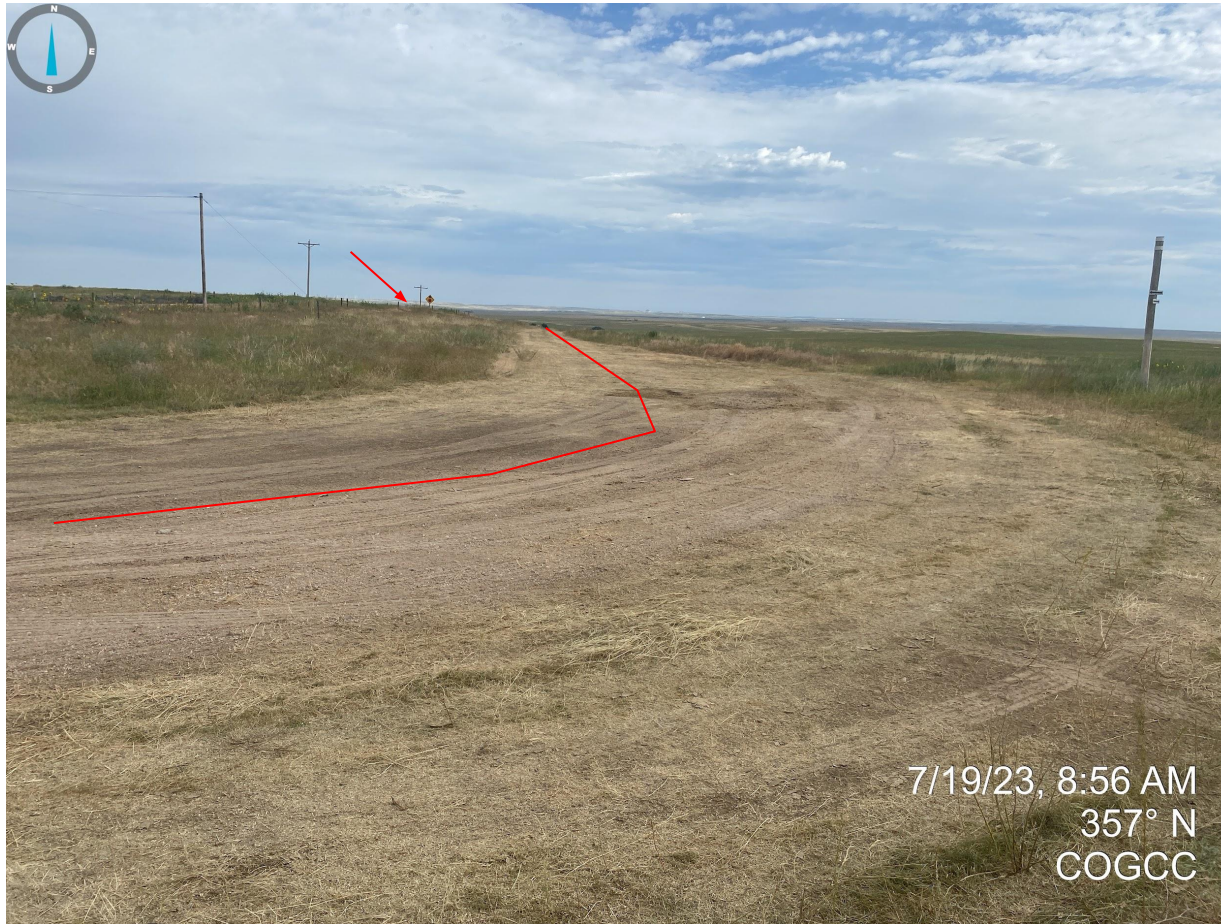
**Photo 3.** See comments in Photo 2. Red arrow indicates current access point for the location (also seen in Photos 4 & 5).

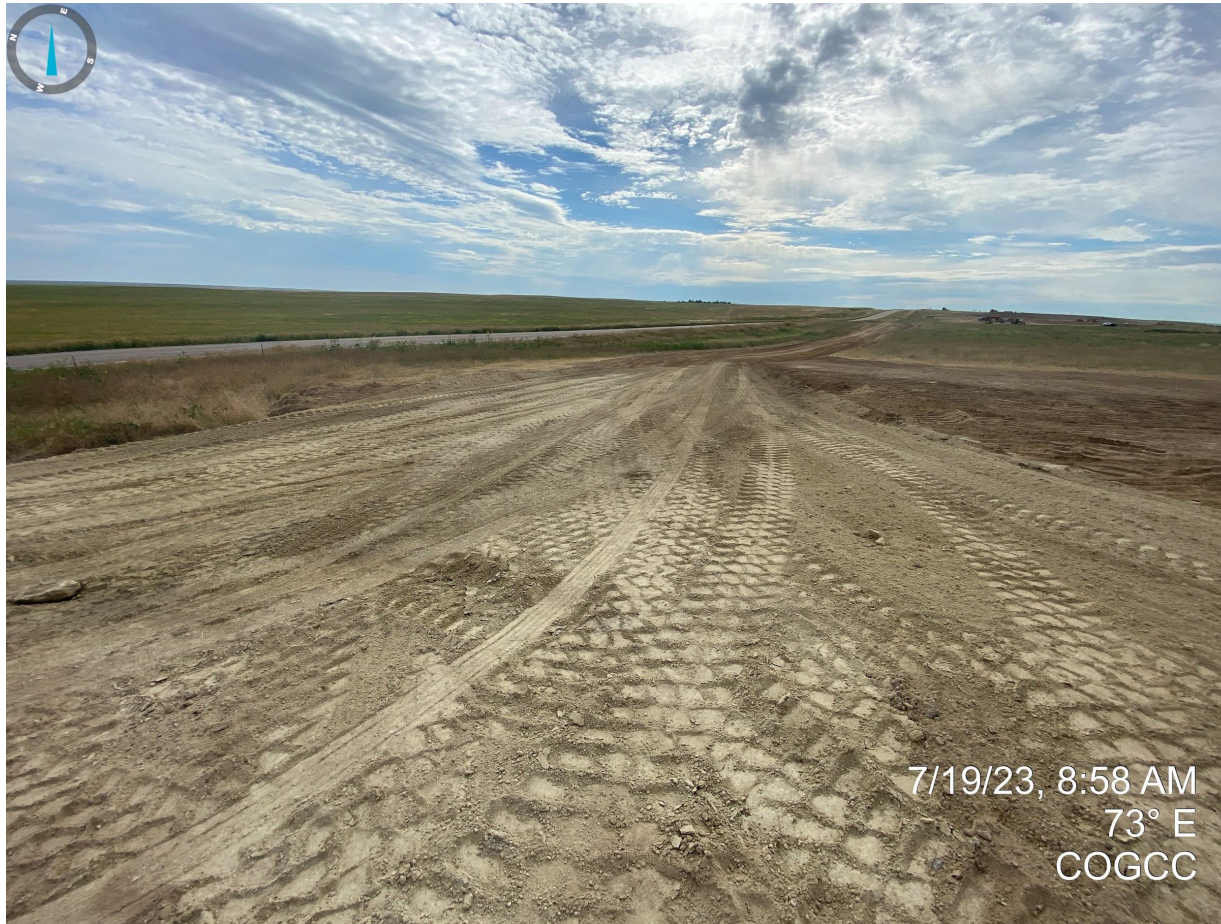
**Photo 4.** Taken from the location's current access road near the intersection of WCR 113 and HWY 14. No BMPs (e.g. vehicle track out pad) were installed at this junction. Proceeding photos illustrate vehicle track out onto HWY 14.

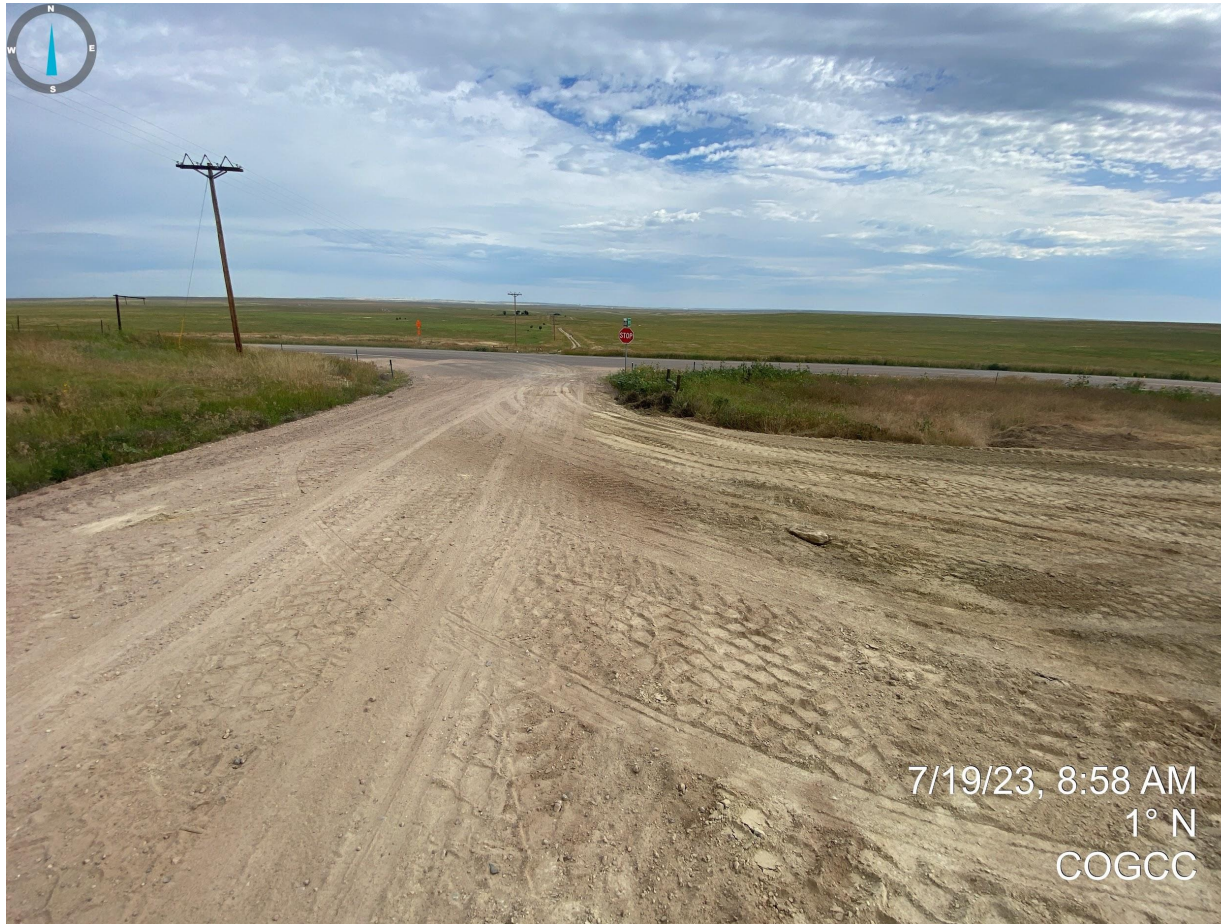
**Photo 5.** Facing north from the location's current access point. No BMPs observed to prevent vehicle track out. The location signage should be installed at the location's access road point and the intersection of an adjacent road.

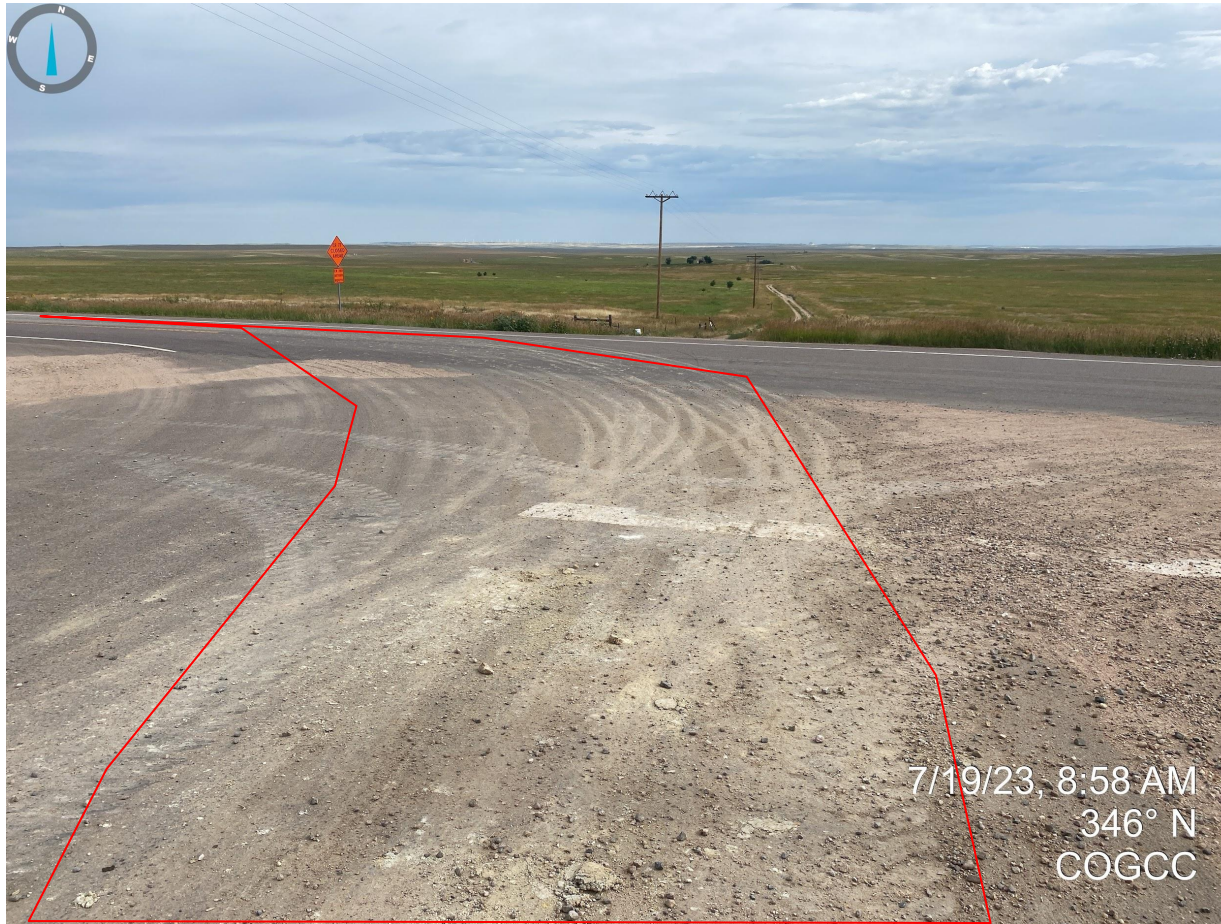
**Photo 6.** Vehicle track out pictured onto HWY 14 westbound.

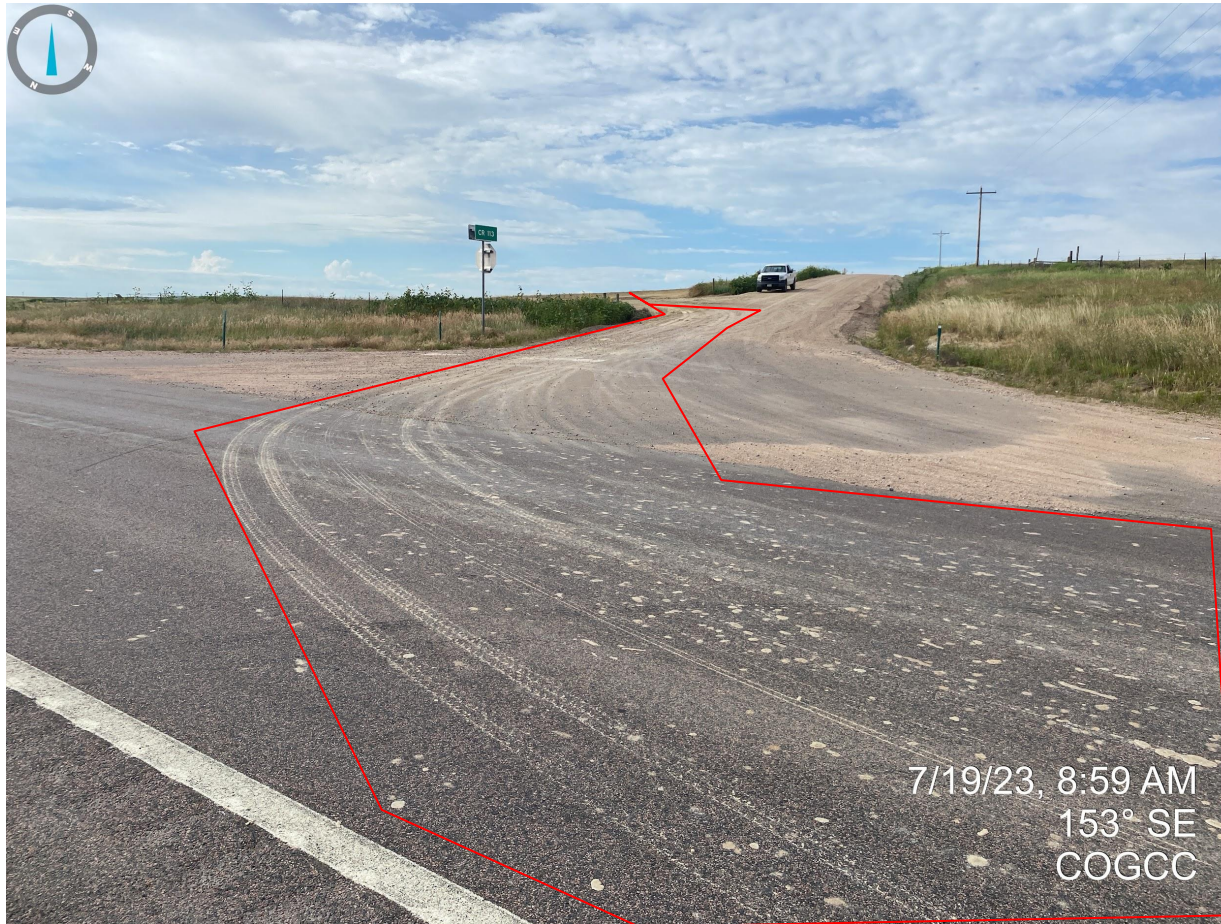
**Photo 7.** Facing southeast, see comments in Photo 6.

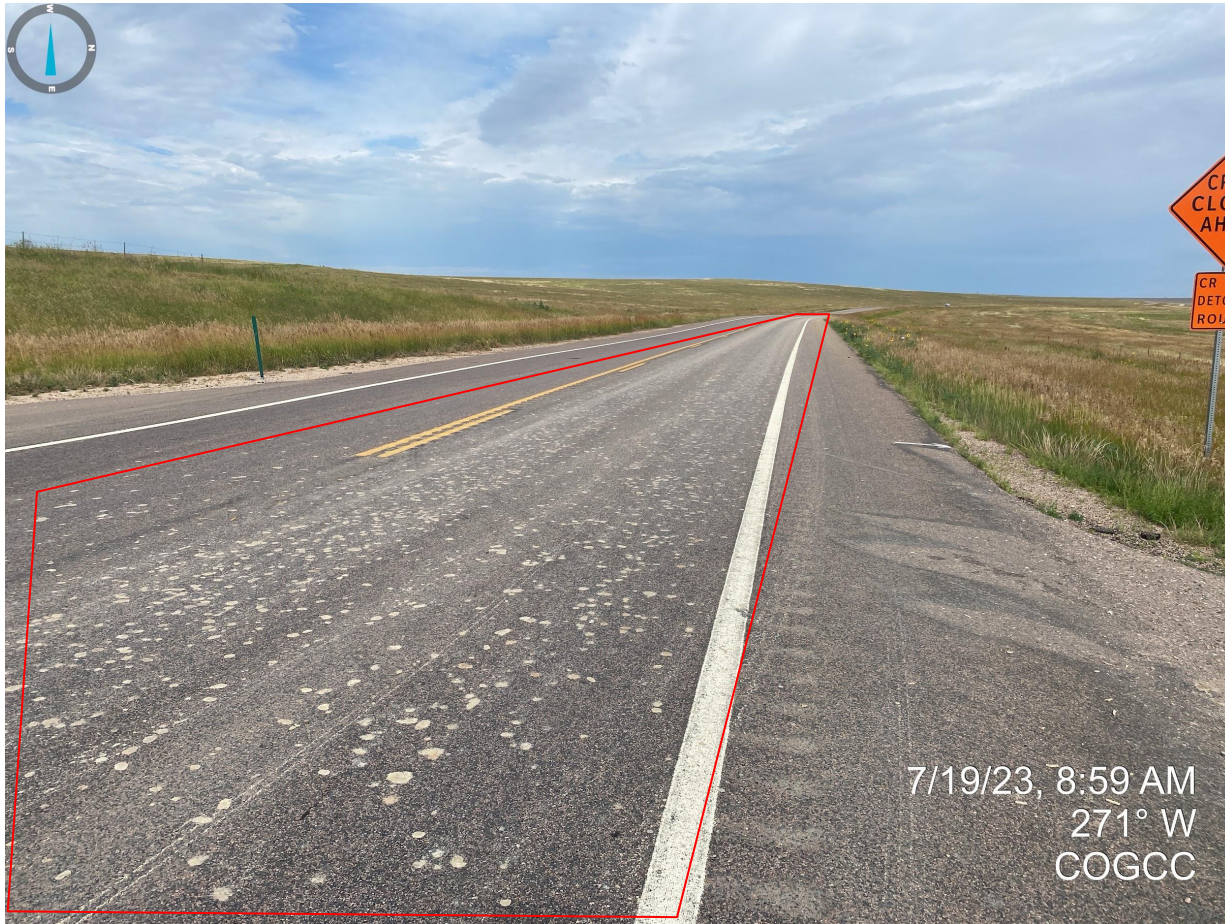
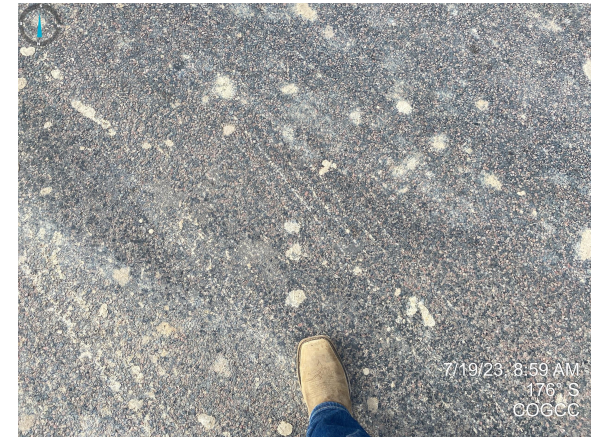
**Photo 8.** Vehicle track out continues on westbound HWY 14. The Operator will need to contact local jurisdictions on how to address and mitigate vehicle track out.

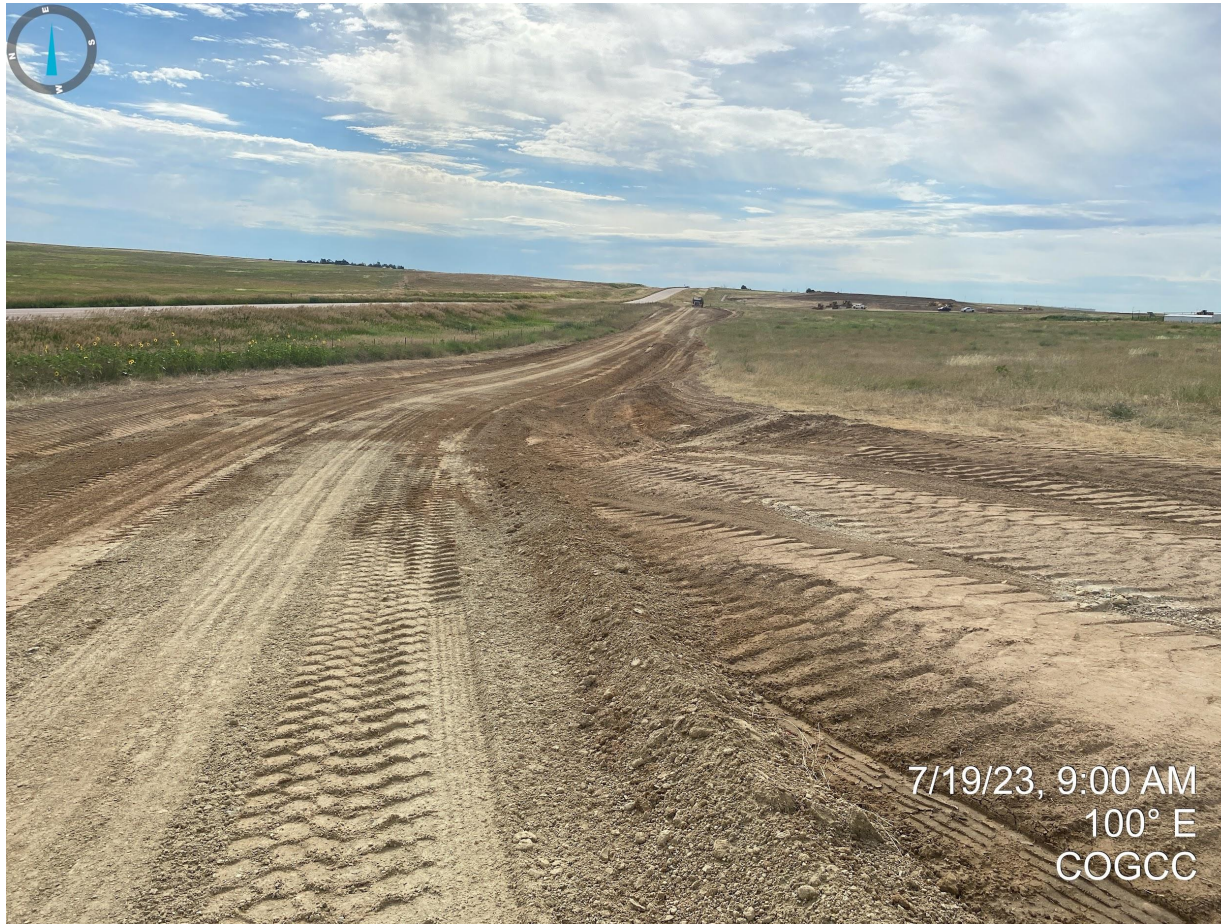
**Photo 9.** Facing east near the location's entrance. It appears topsoil has been salvaged and temporary BMPs (ditch and berm) have been installed alongside of the access road.

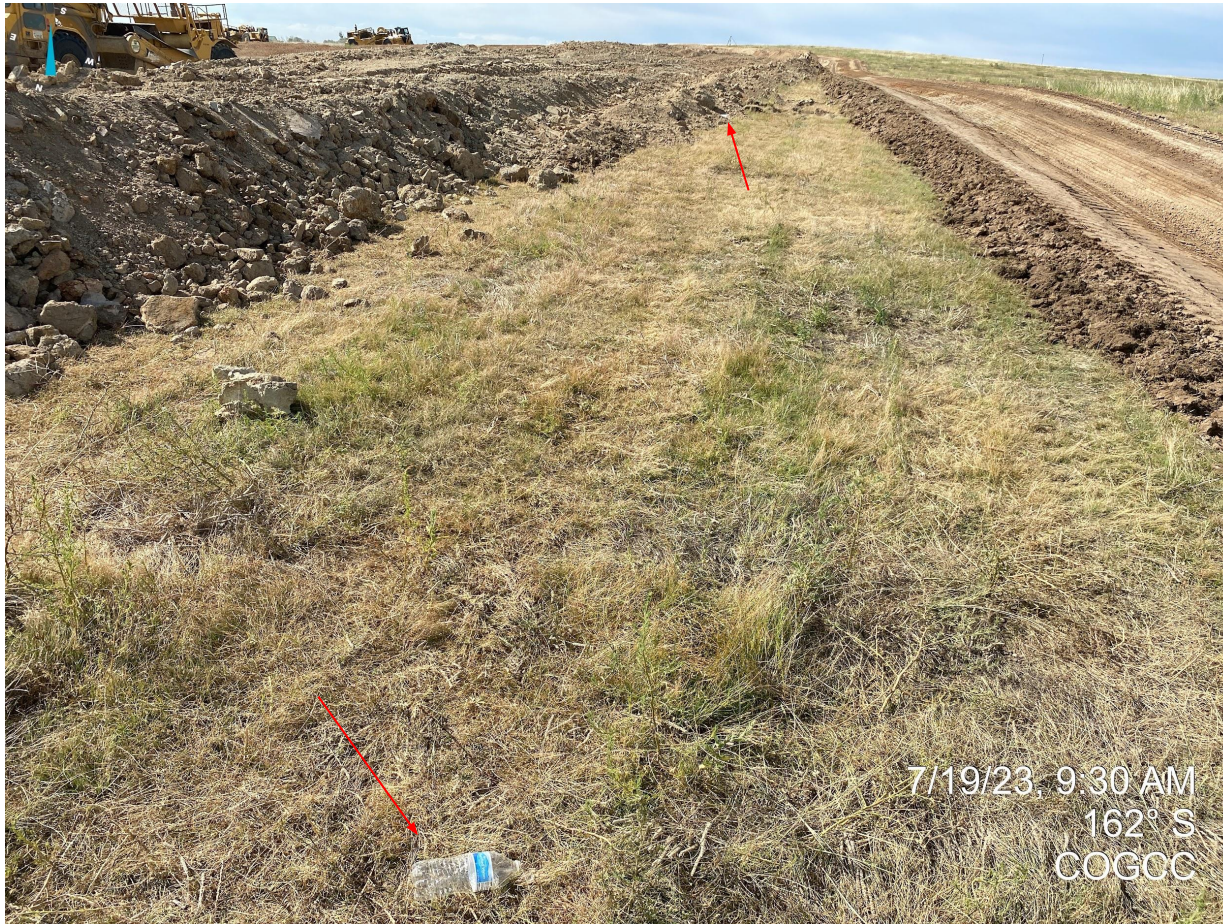
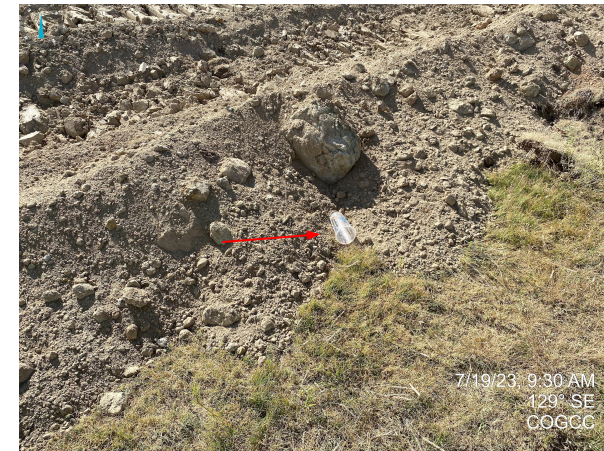
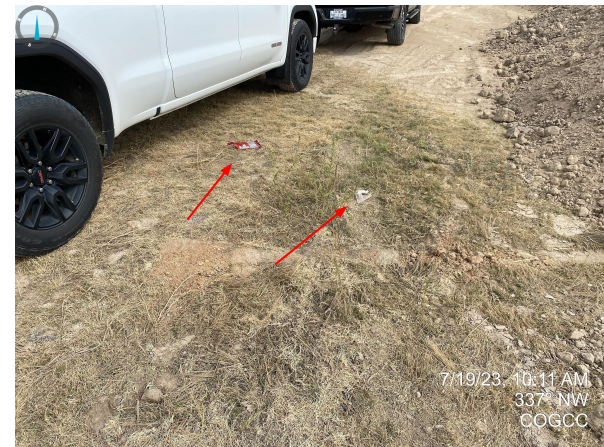
**Photo 10.** Trash and debris observed on the western portion of the location. The operator shall remove all trash per the corrective action and ensure that the location is free of trash and debris to prevent spread onto adjacent lands.

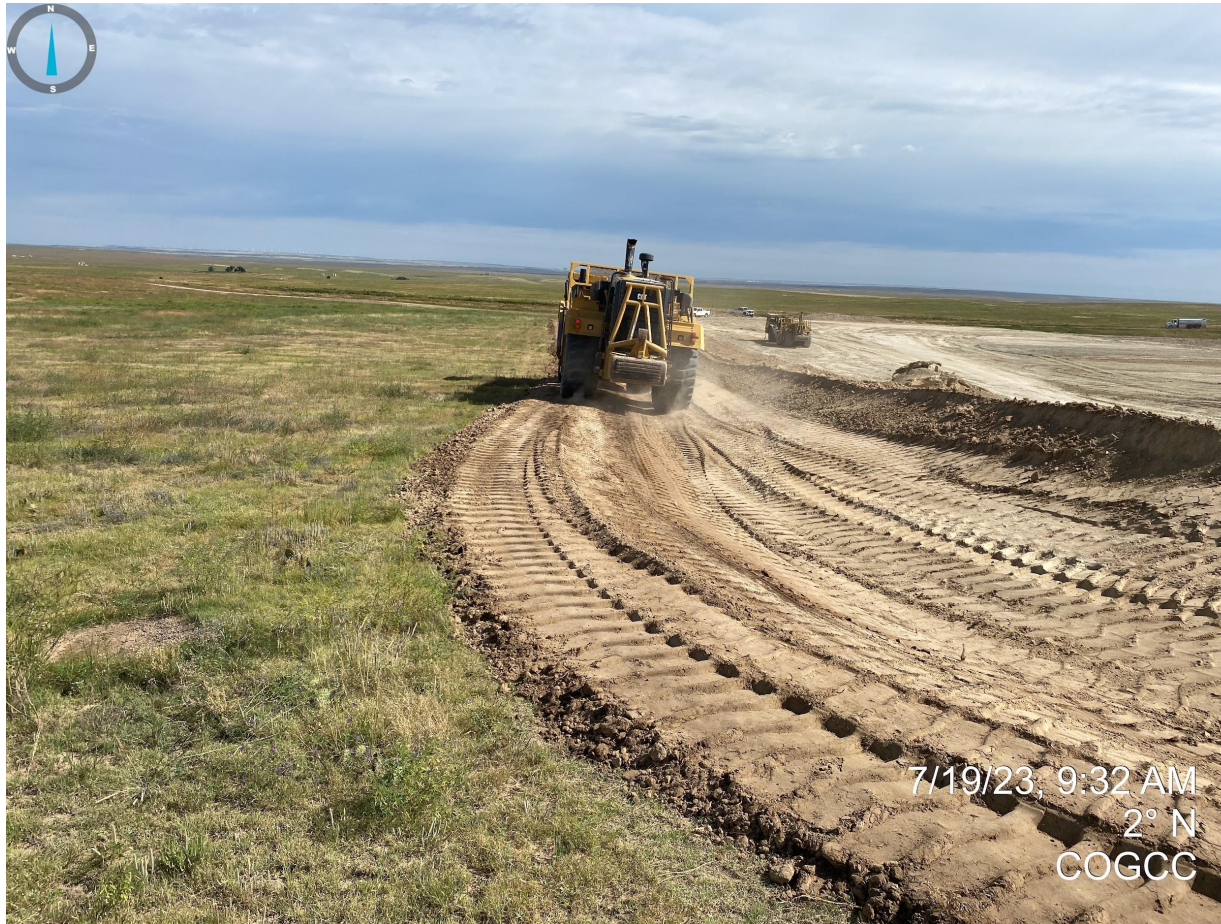
**Photo 11.** Taken from the southwest corner of the location. At the time of this inspection, crews were actively working to improve and/or maintain the perimeter stormwater BMPs. Vehicle wheel packing observed to mitigate unconsolidated material.

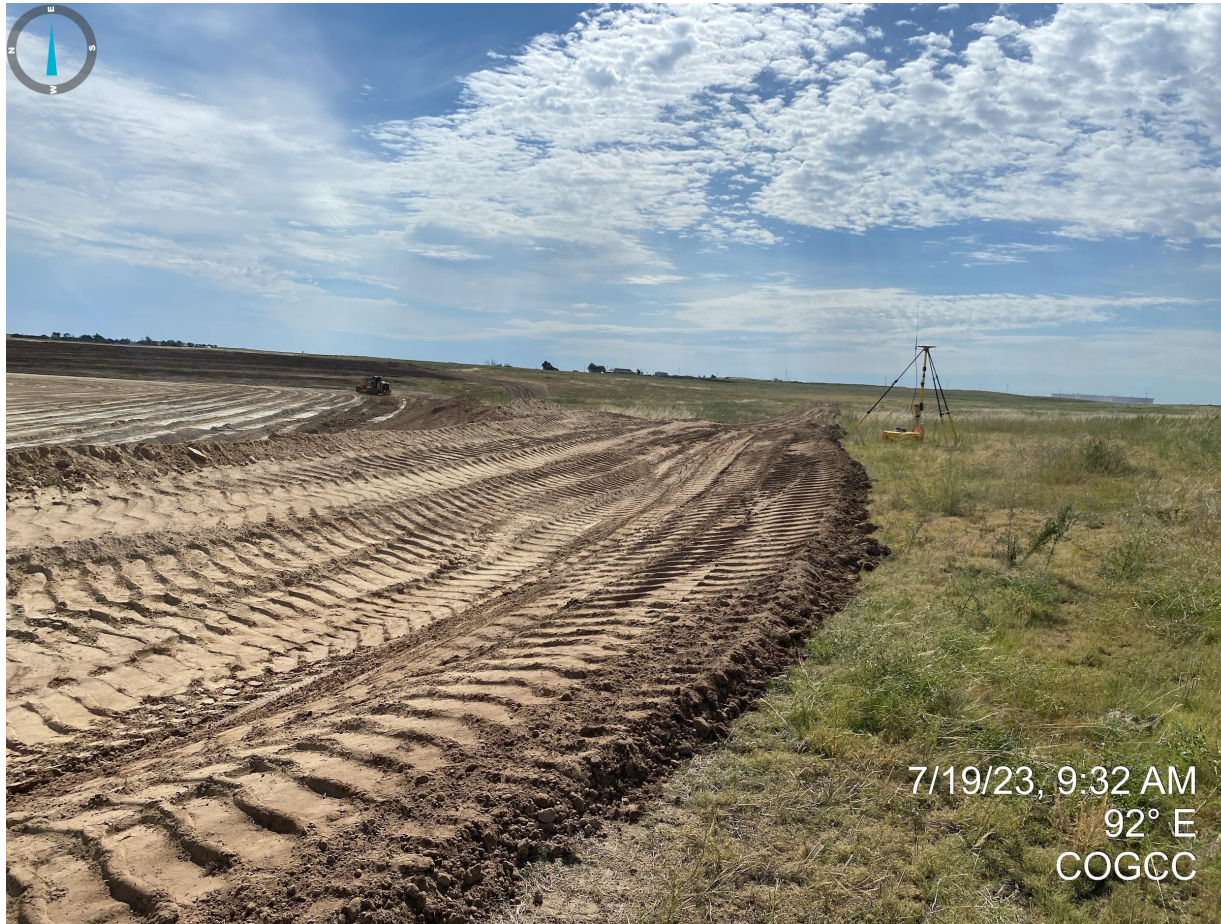
**Photo 12.** Facing east from the southwest corner of the disturbance area; see comments in Photo 11.

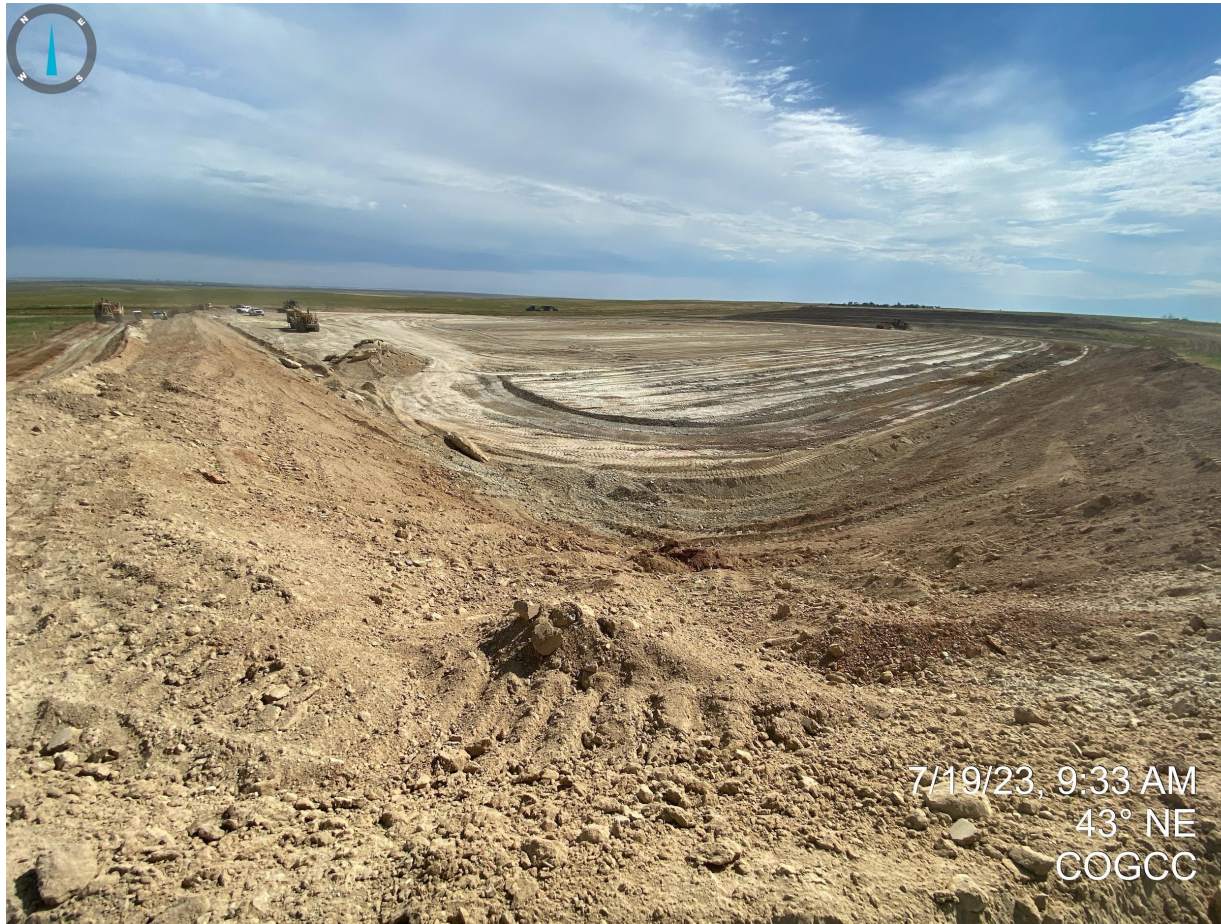
**Photo 13.** Taken from the southeast corner of the newly constructed drilling pad areas. Photo illustrates cut and fill slopes in foreground and production area in the background. Crews were onsite during this inspection and were actively performing dirt work to stabilize cut banks and fill areas.

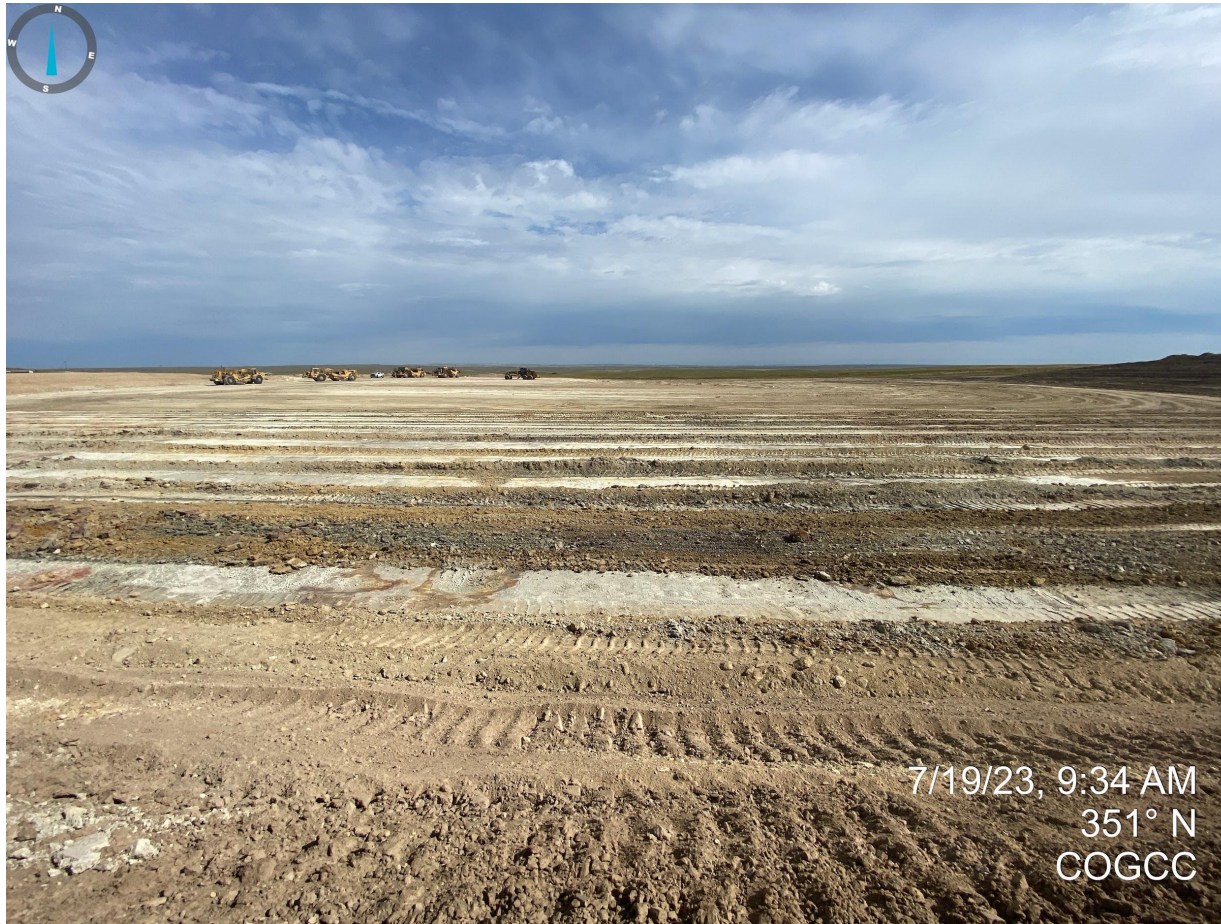
**Photo 14.** Overview of drilling pad area under construction.

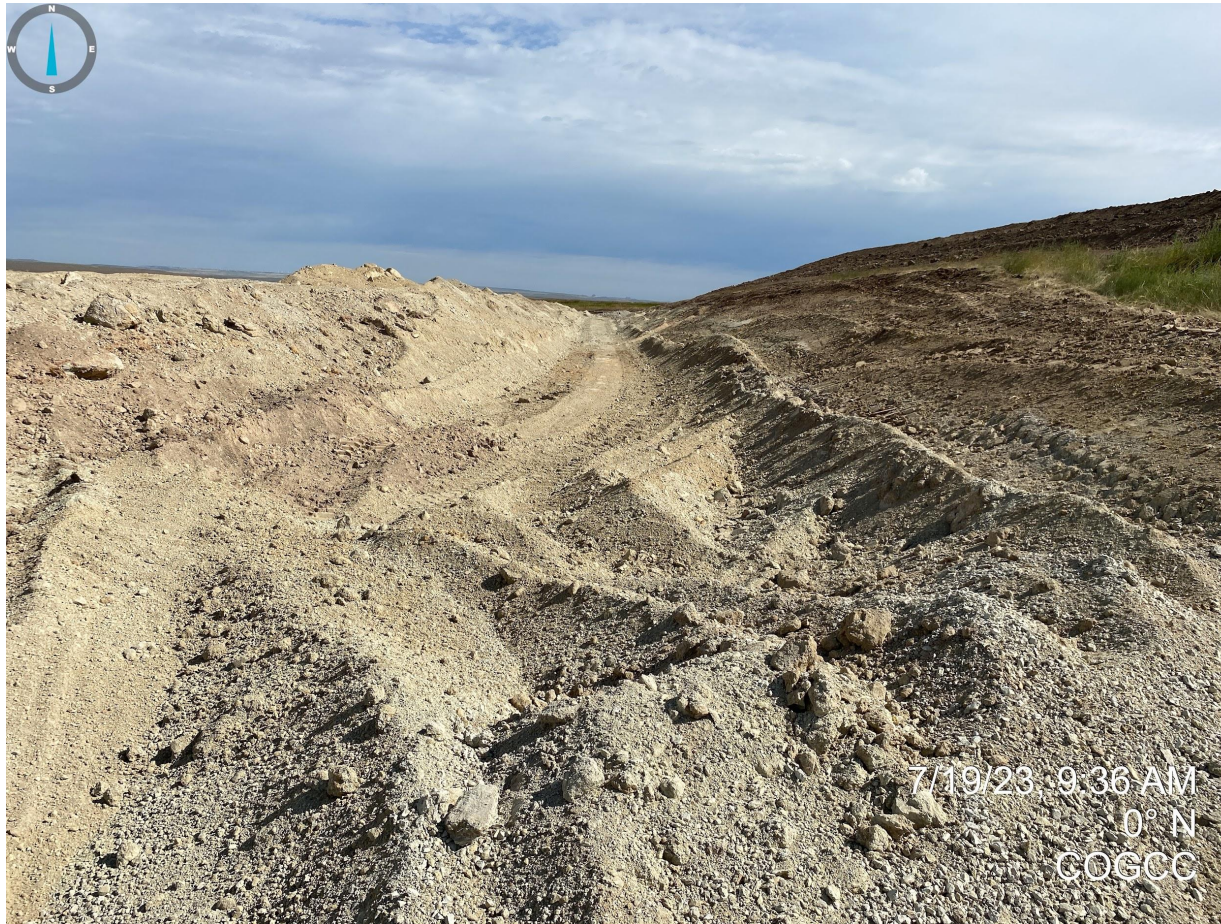
**Photo 15.** Facing north near the topsoil stockpile. Photo illustrates an apparent stormwater retention area still under construction.

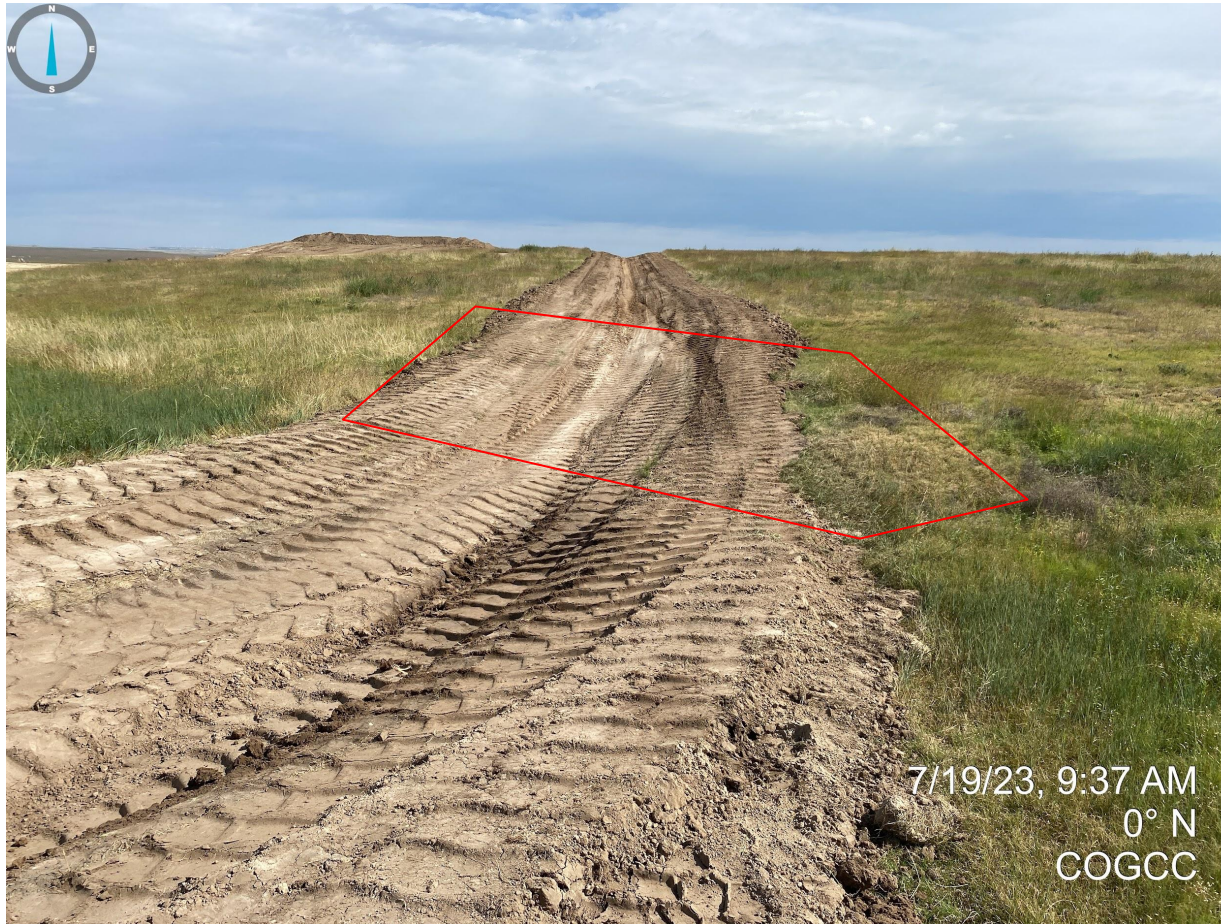
**Photo 16.** This area of the stormwater BMP (red outline) previously documented sediment transport due to unconsolidated materials. It appears the Operator has performed activities to repair/stabilize the unconsolidated soils.

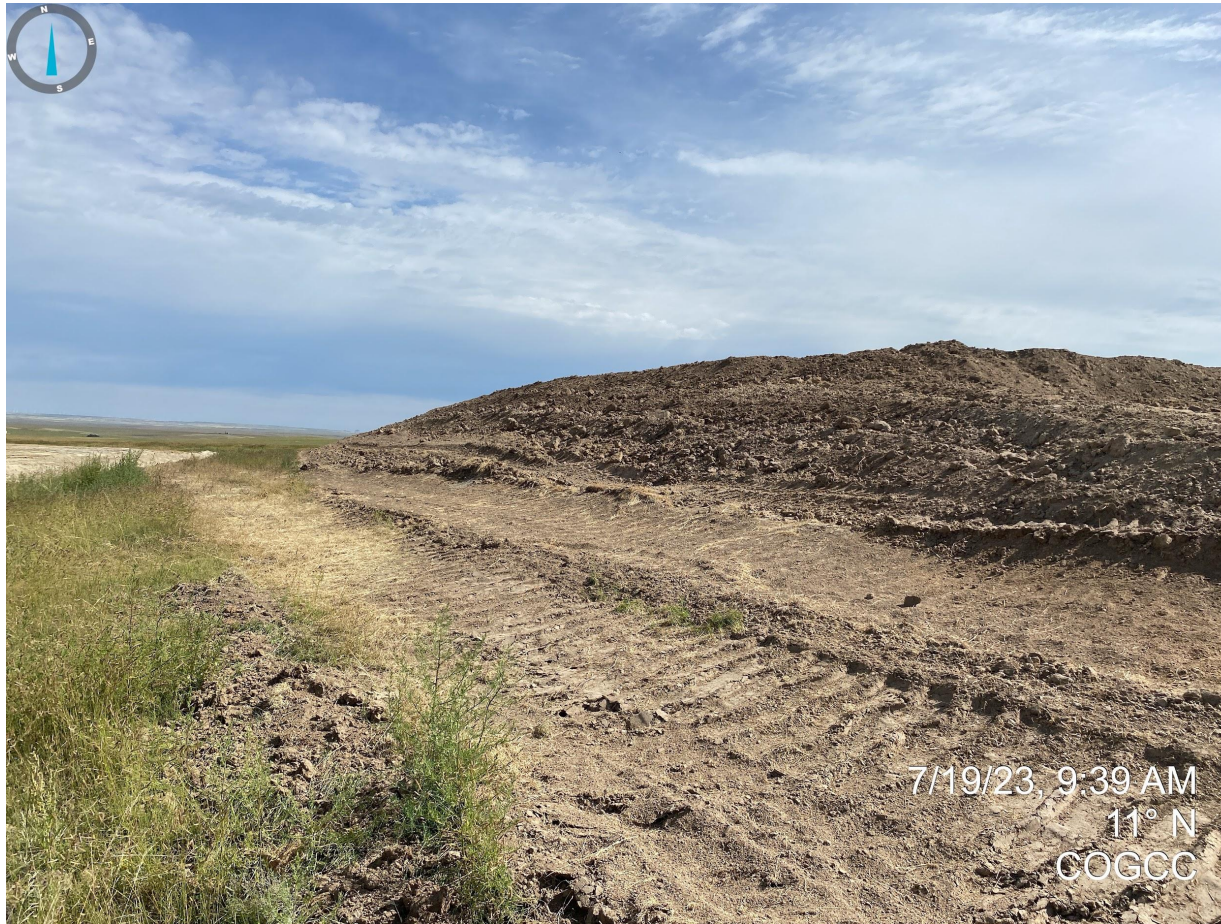
**Photo 17.** Taken from the southwest corner of the topsoil stockpile. It appears that topsoil has been separated and stored east of the disturbance area, in accordance with Rule 1002.b. However, the topsoil stockpile did not have any temporary BMPs (e.g. equipment tracking) to properly stabilize the soils from degradation due to wind and water erosion, etc. Additional BMPs are required to protect the topsoil stockpile on location and come into compliance with Rule 1002.c.

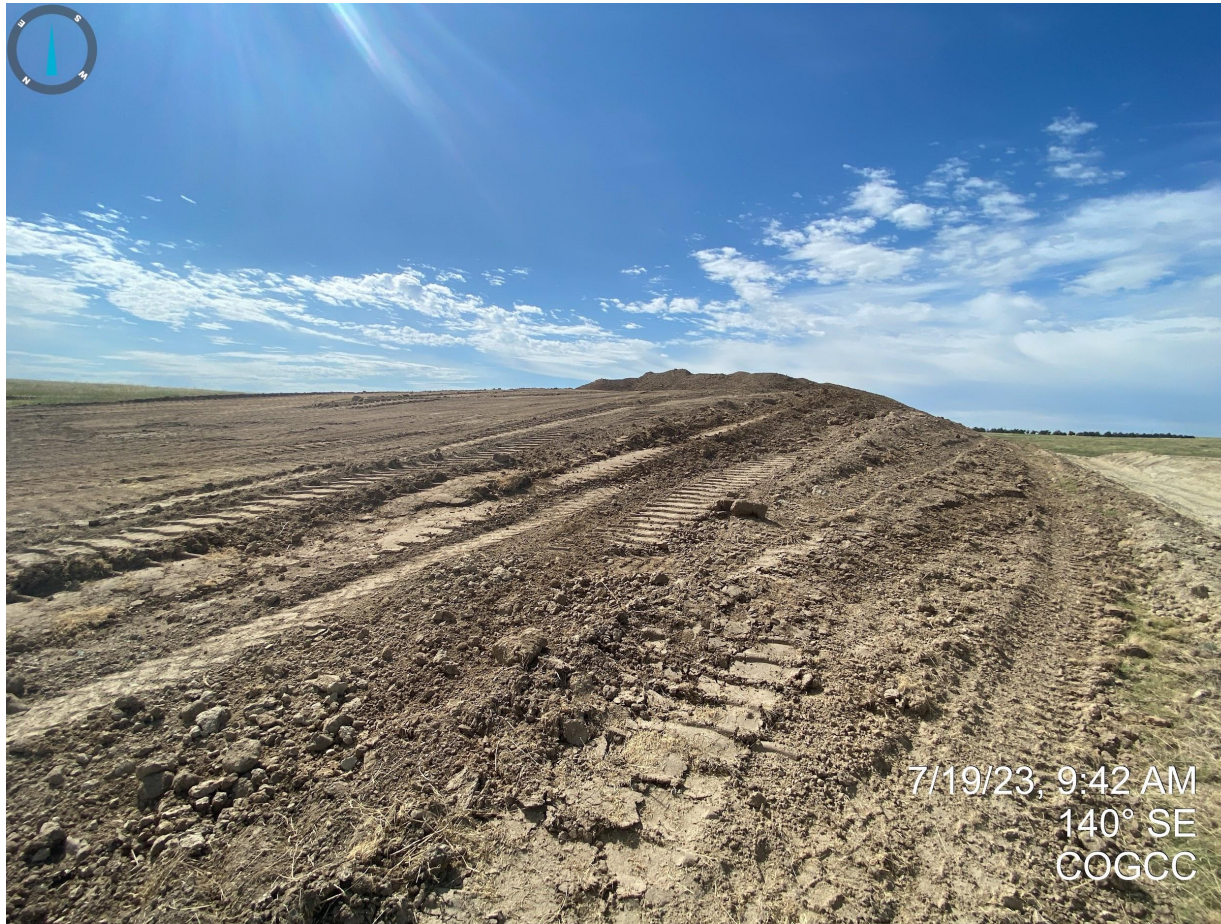
**Photo 18.** Northwest corner of the stockpile area. See comments in Photo 17.

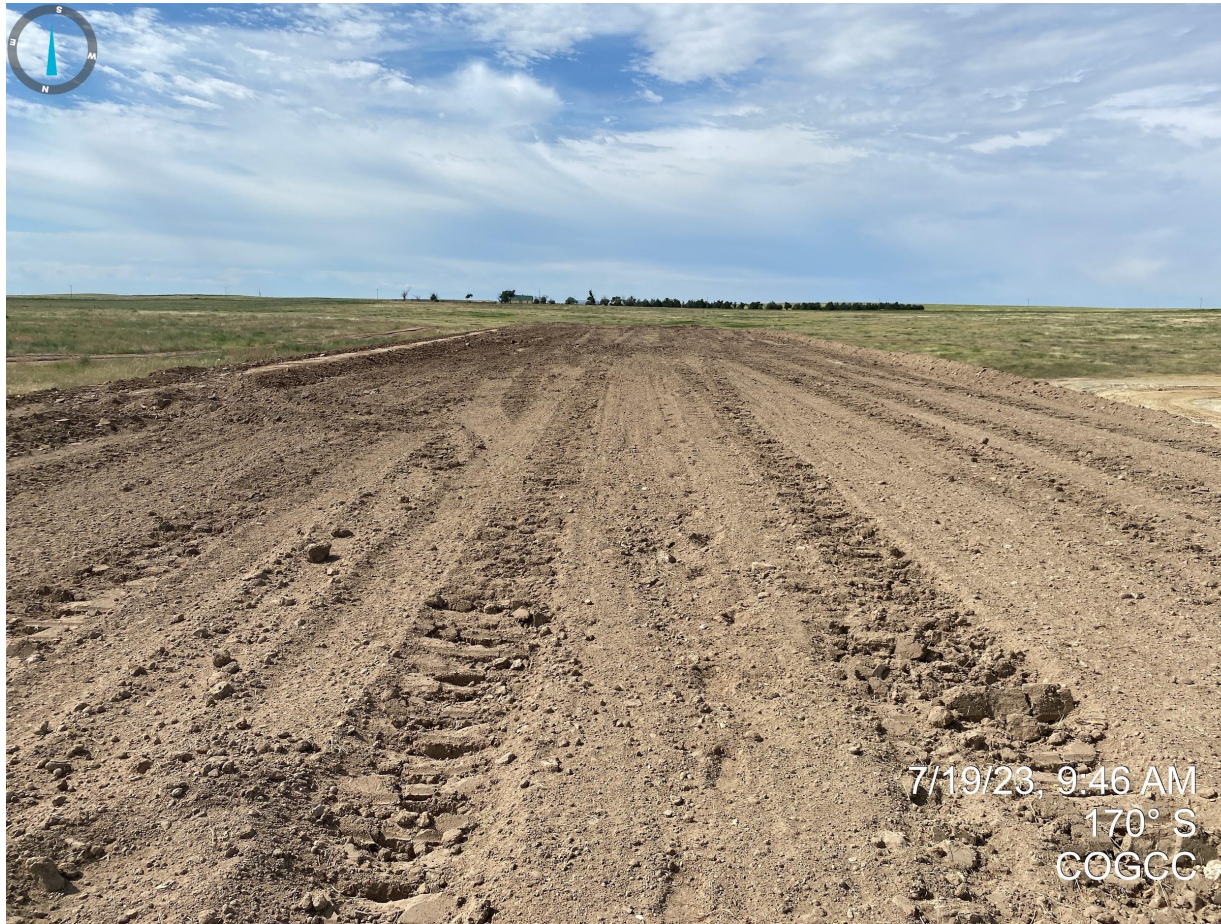
**Photo 19.** Facing south from the top of the topsoil stockpile. See comments in Photo 17.
