# Construction and Stormwater Inspection

Date: 07/19/2023

Operator: MDS ENERGY DEVELOPMENT LLC - 10814

Inspection Photos  
Location Name: Daffy Pad  
Location ID: 477495

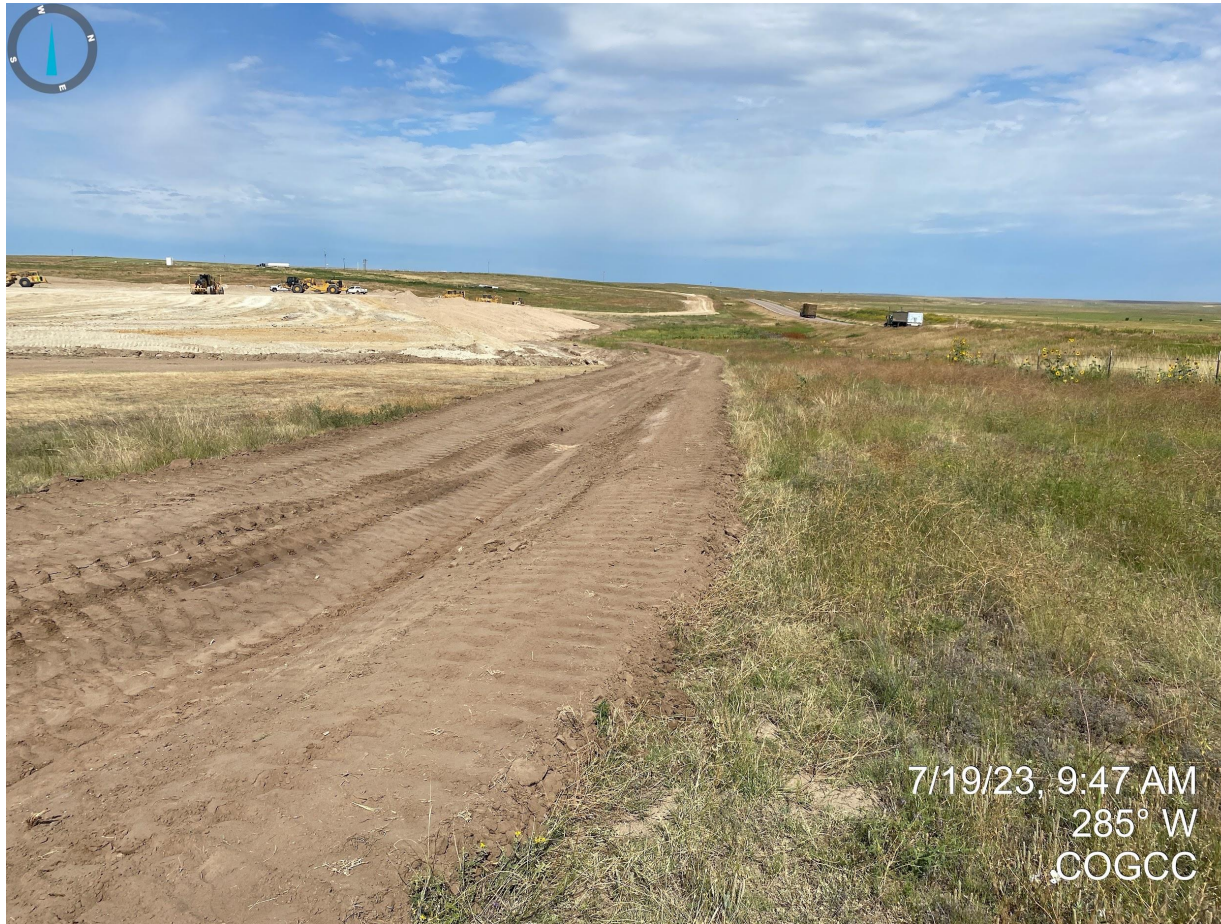
**Photo 20.** Facing west from the northeast corner of the disturbance area. Stormwater BMPs appear to have been improved/repared since the previous inspection.

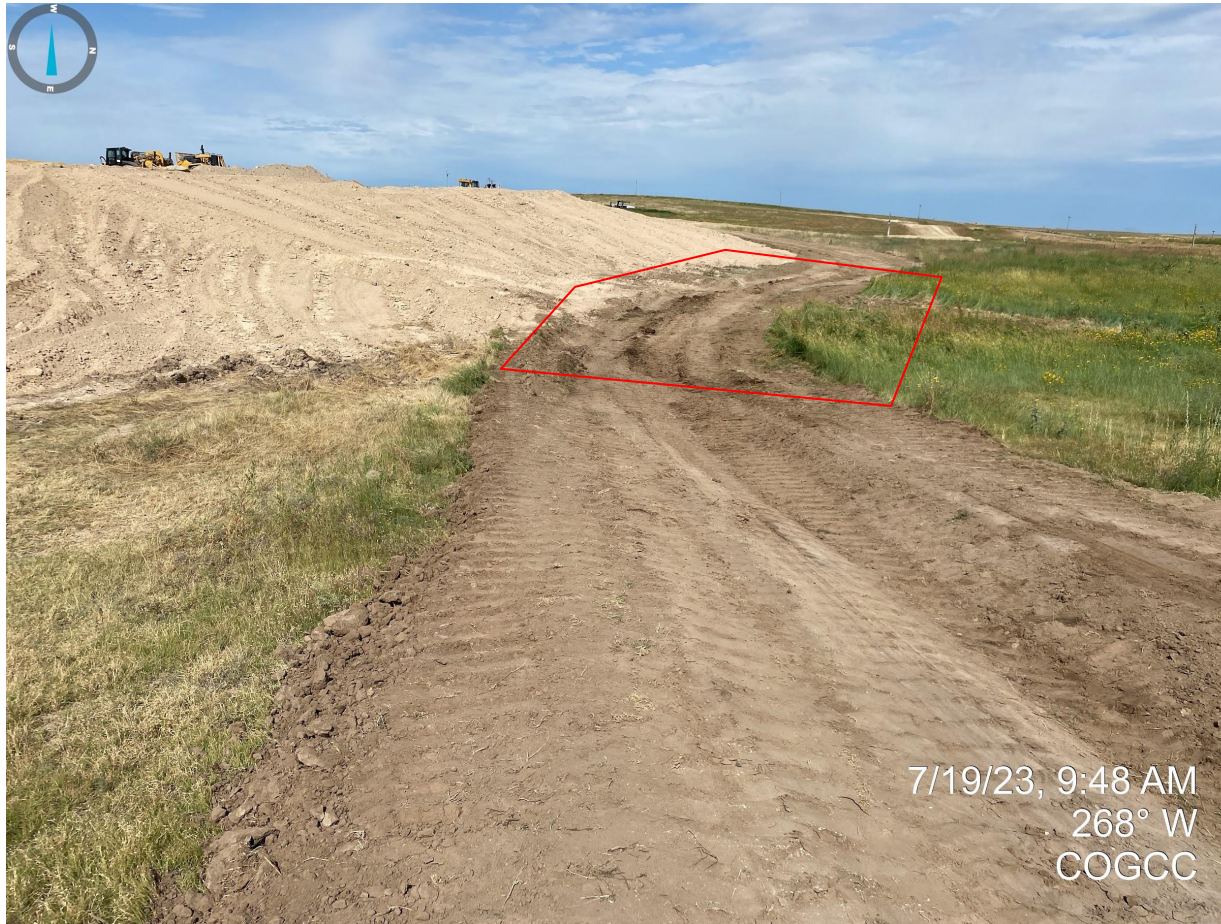
**Photo 21.** This area of the stormwater BMP (red outline) previously documented sediment transport due to unconsolidated materials. It appears the Operator has performed activities to repair/stabilize the unconsolidated soils.

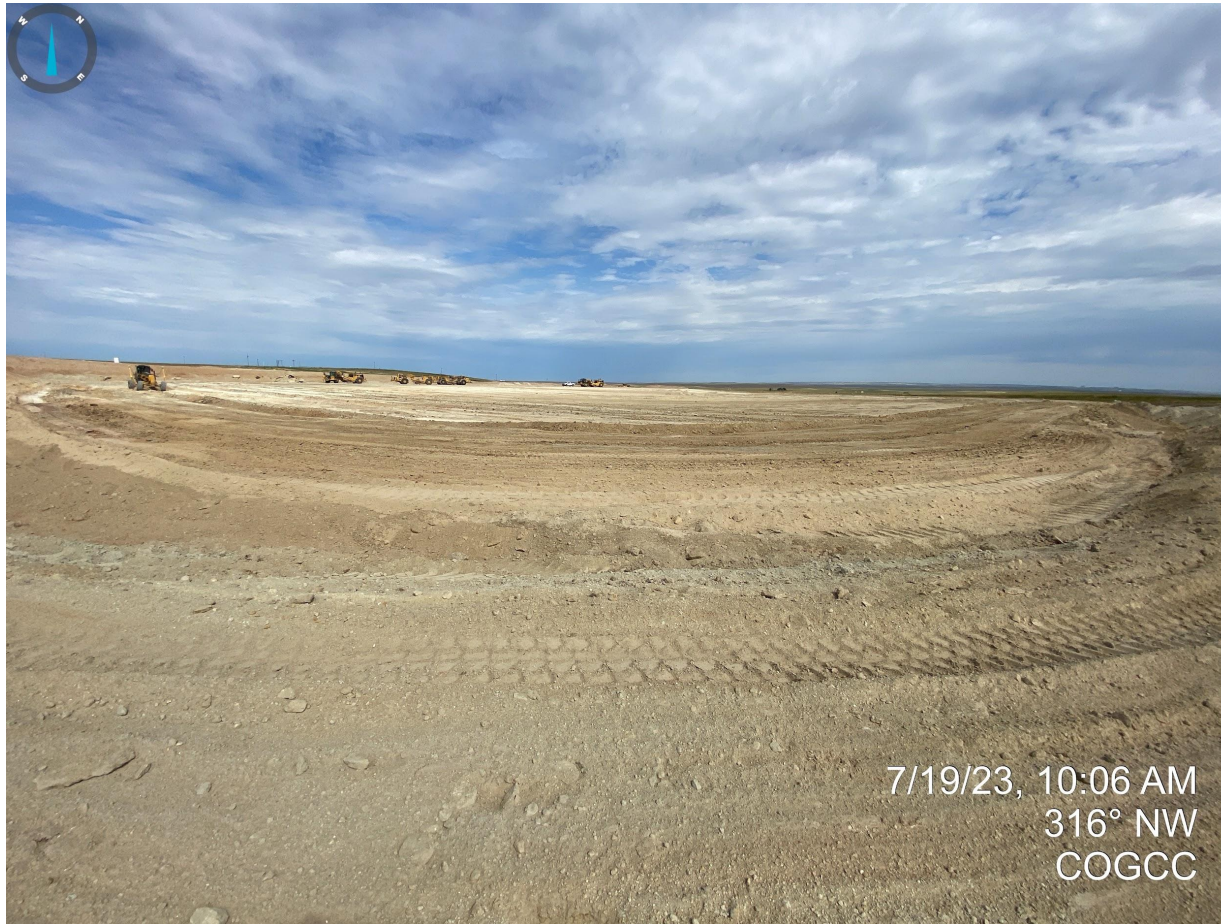
**Photo 22.** Taken from the southeast corner of the drilling pad area, facing northwest. Photo illustrates construction activities being performed. A follow up inspection will be performed at a later date to ensure compliance with ECMC Rules.
