Inspection Photos

Operator: CAERUS PICEANCE LLC #10456

Location Number: 478266

BJU/M23A-496 Pad, #478266

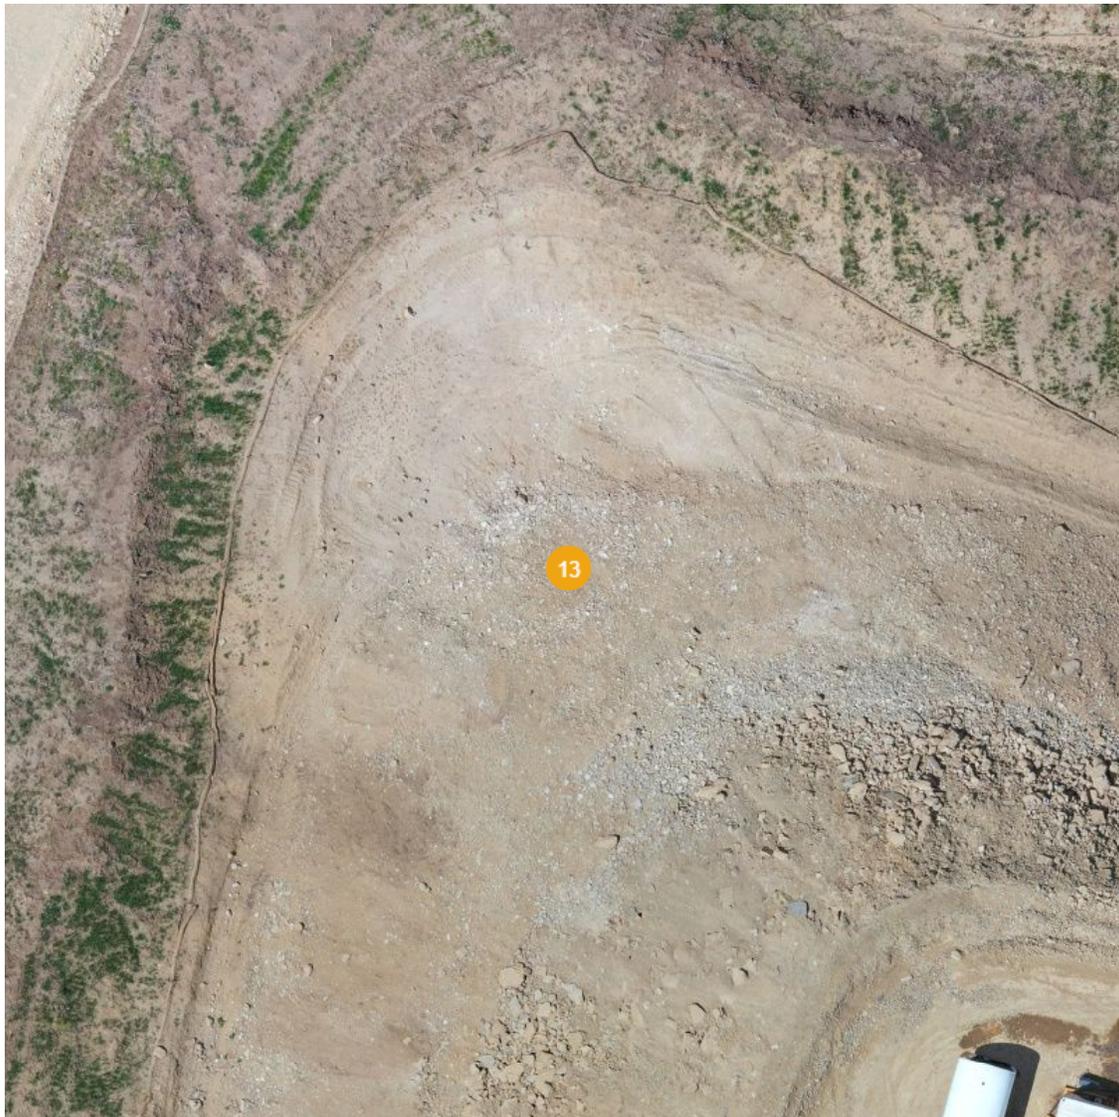
13 - Missing Part

| Summary: | Stormwater and Erosion Control Measures are missing or insufficient at the fill slopes of the Location. |

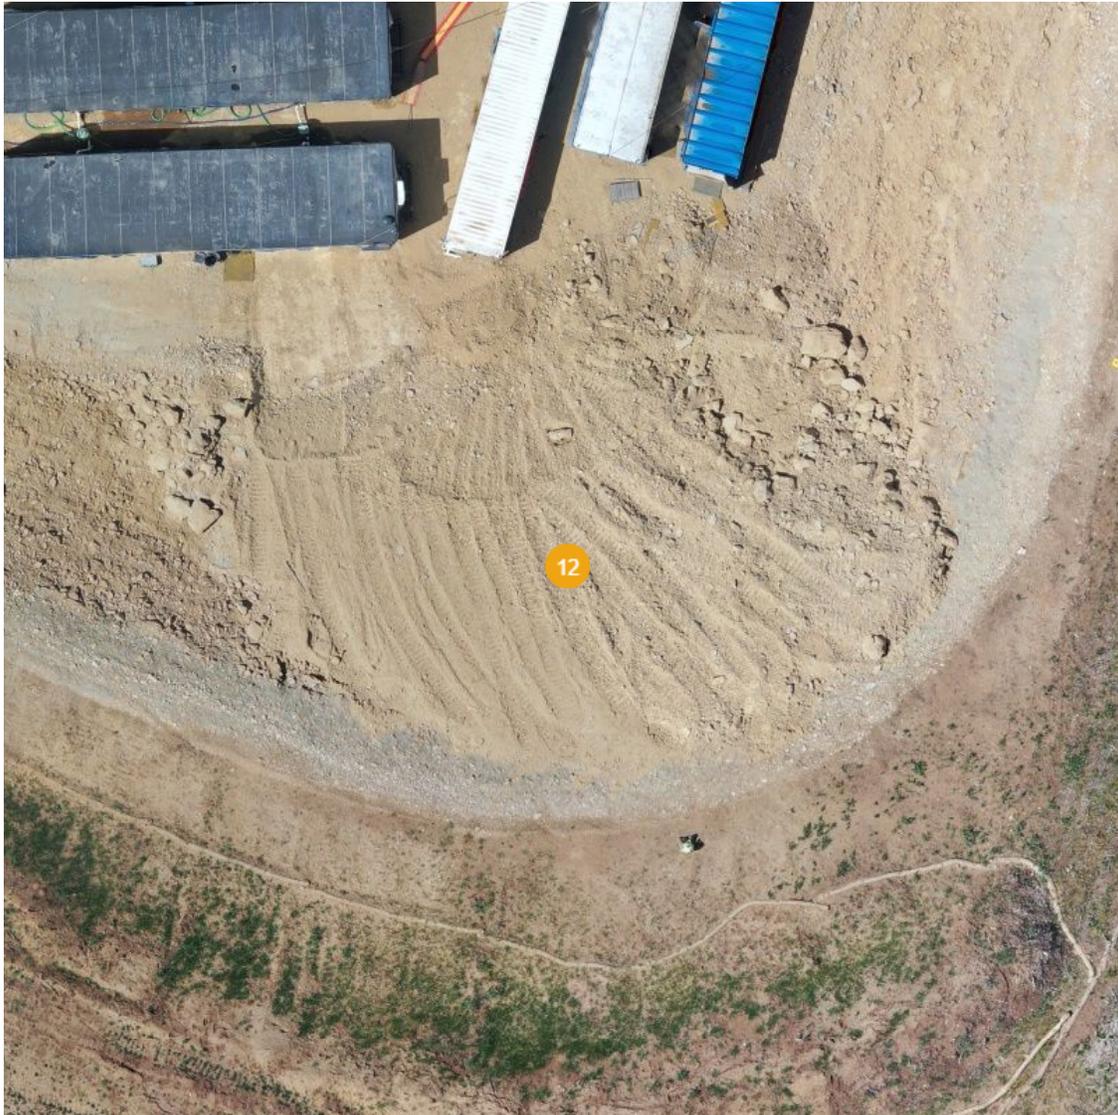
12 - Missing Part

Summary: **Stormwater and Erosion Control Measures to minimize erosion and degradation are missing or insufficient at the cut slopes of the Location.**

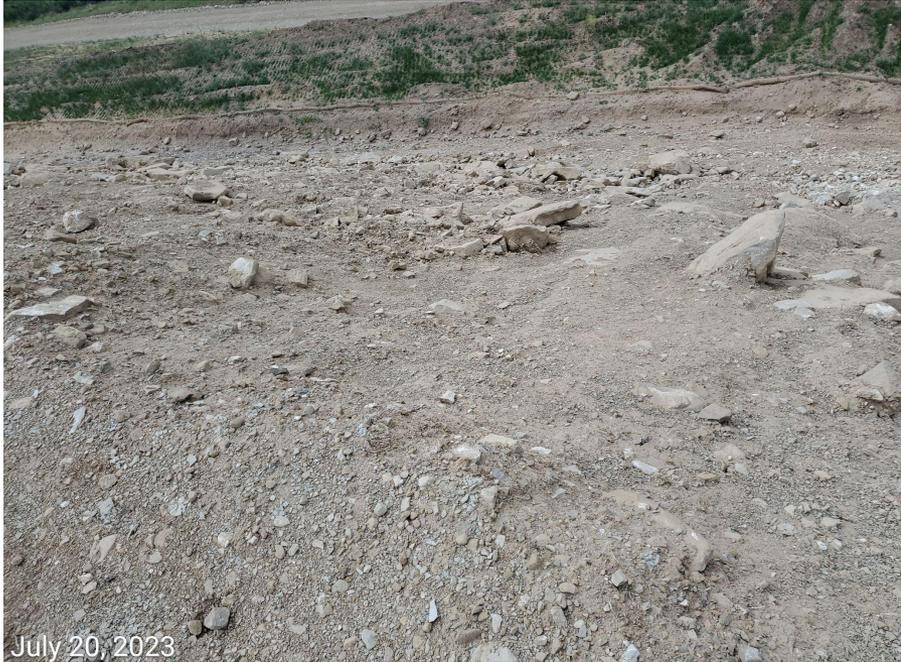
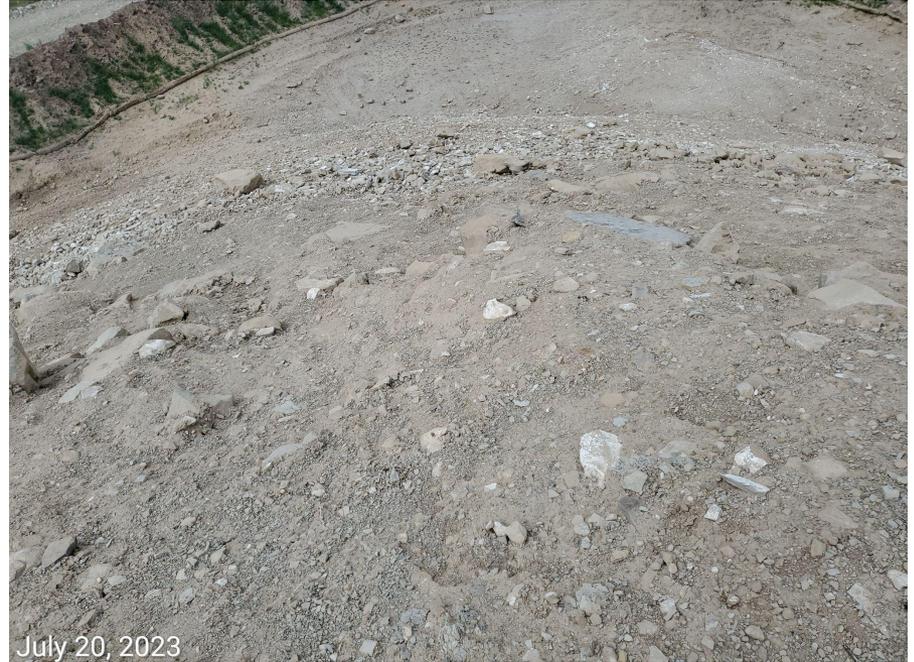
Control measures to minimize erosion and degradation missing or insufficient at fill slopes of the Location.

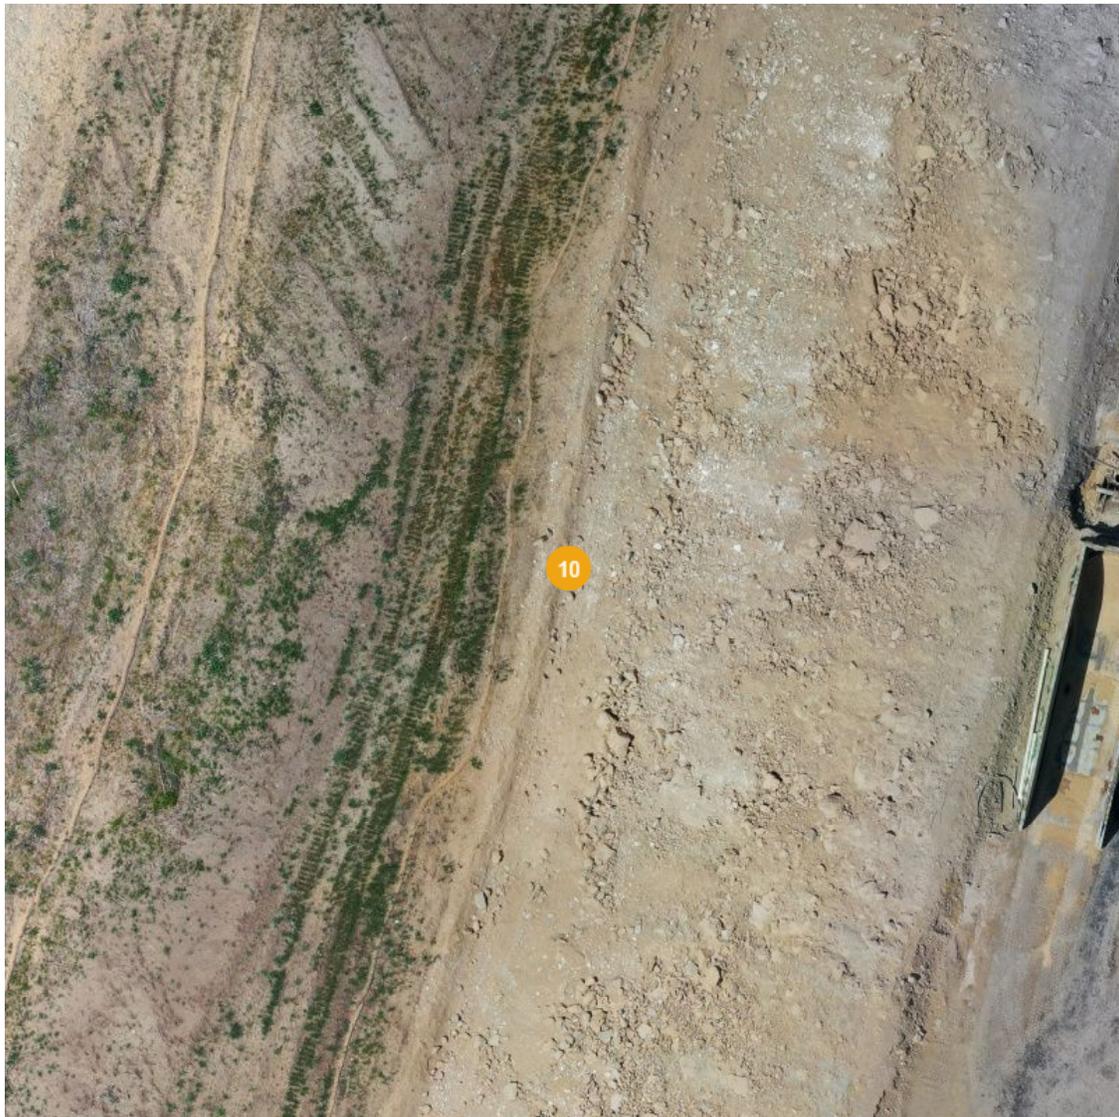
10 - Missing Part

Summary: "Check dams" as identified within the Location drawing figures as part of the Form 2A Location permit not installed.

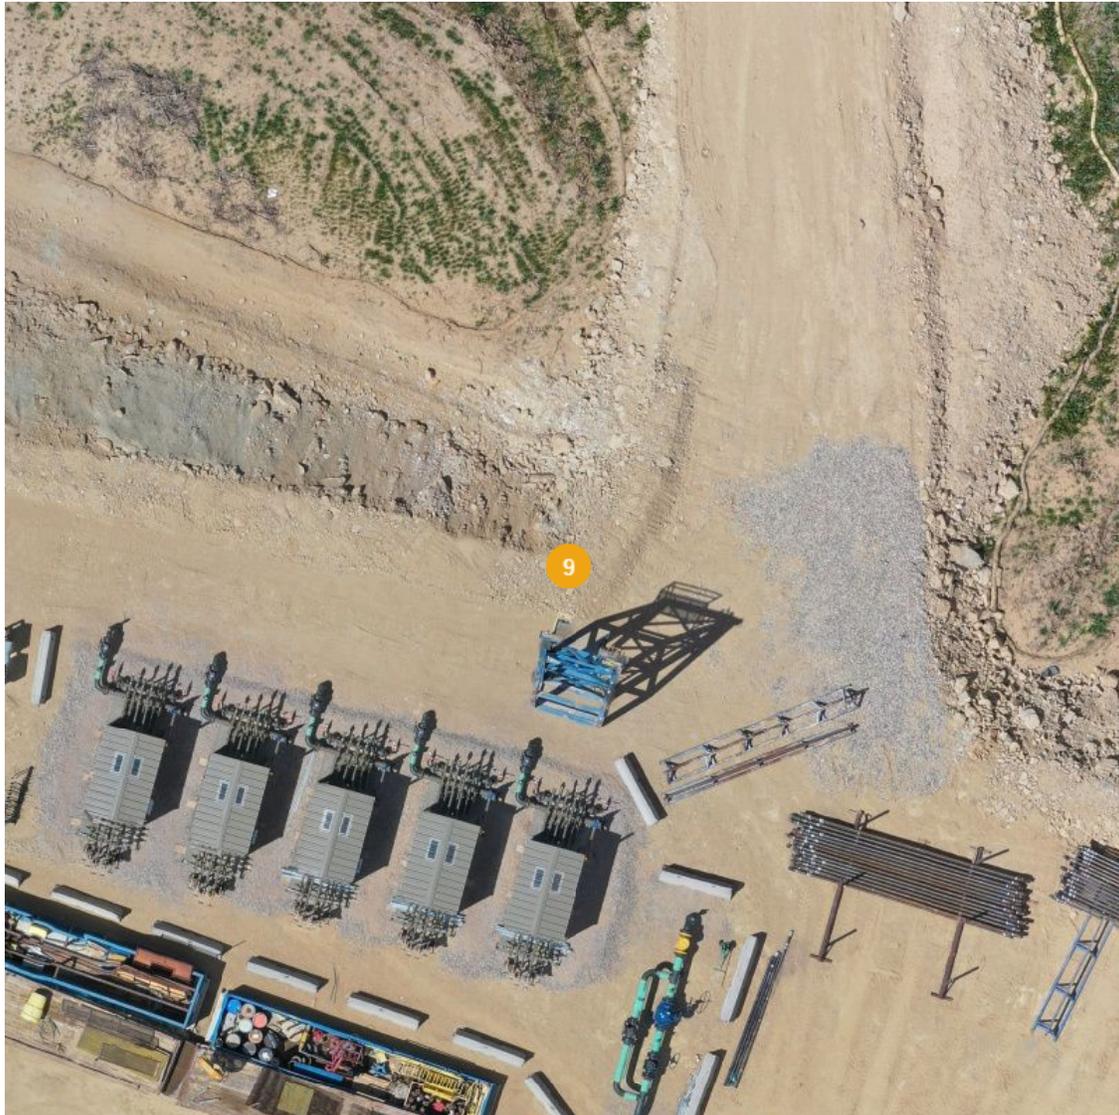
9 - Missing Part

Summary: The installation of (2) 6" Flex Pipes in conjunction with an armored channel, as identified within the Location drawing figures as part of the Form 2A Location permit not installed. No engineered outlet to allow stormwater discharge has been installed.

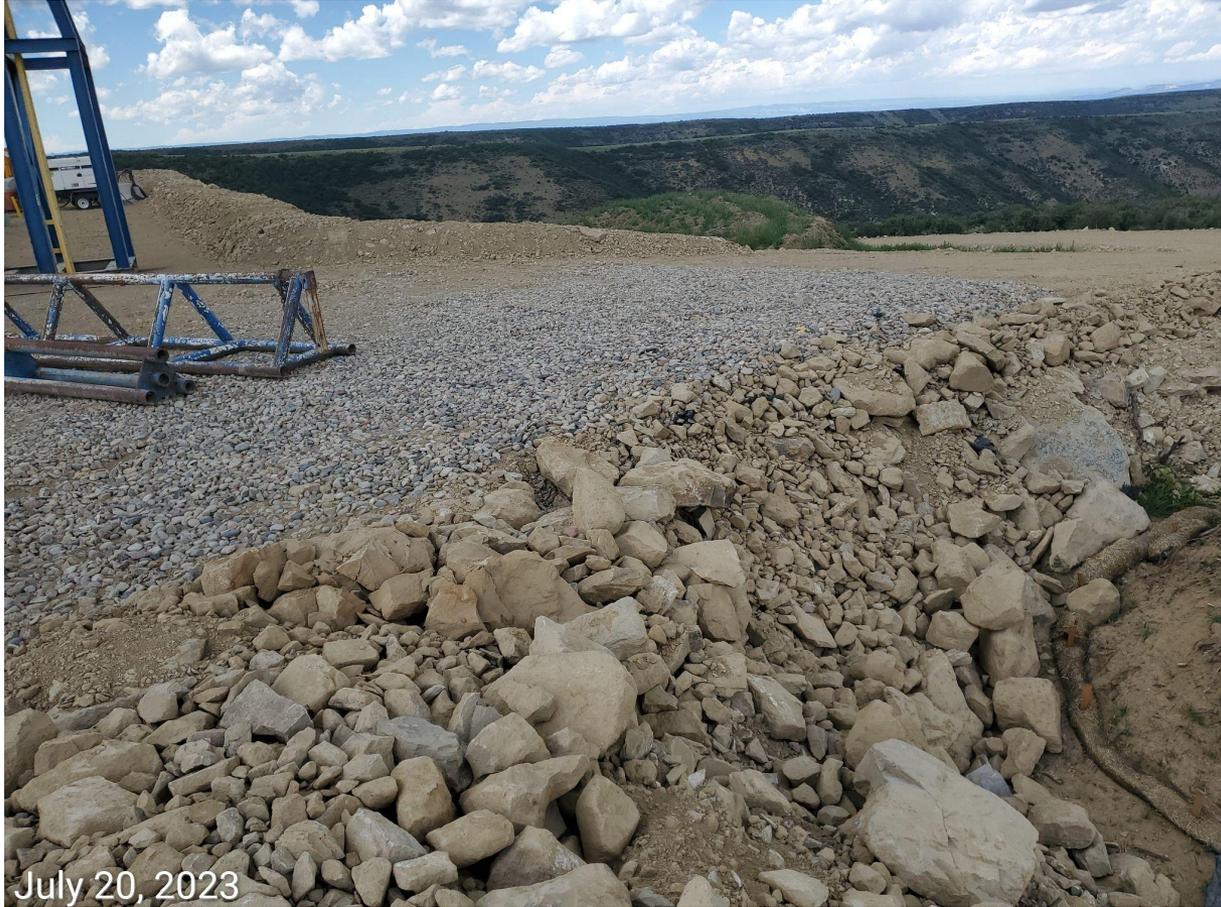
Northern Location entrance. Control measures as identified by the permitted “Construction Layout Drawing” not observed.

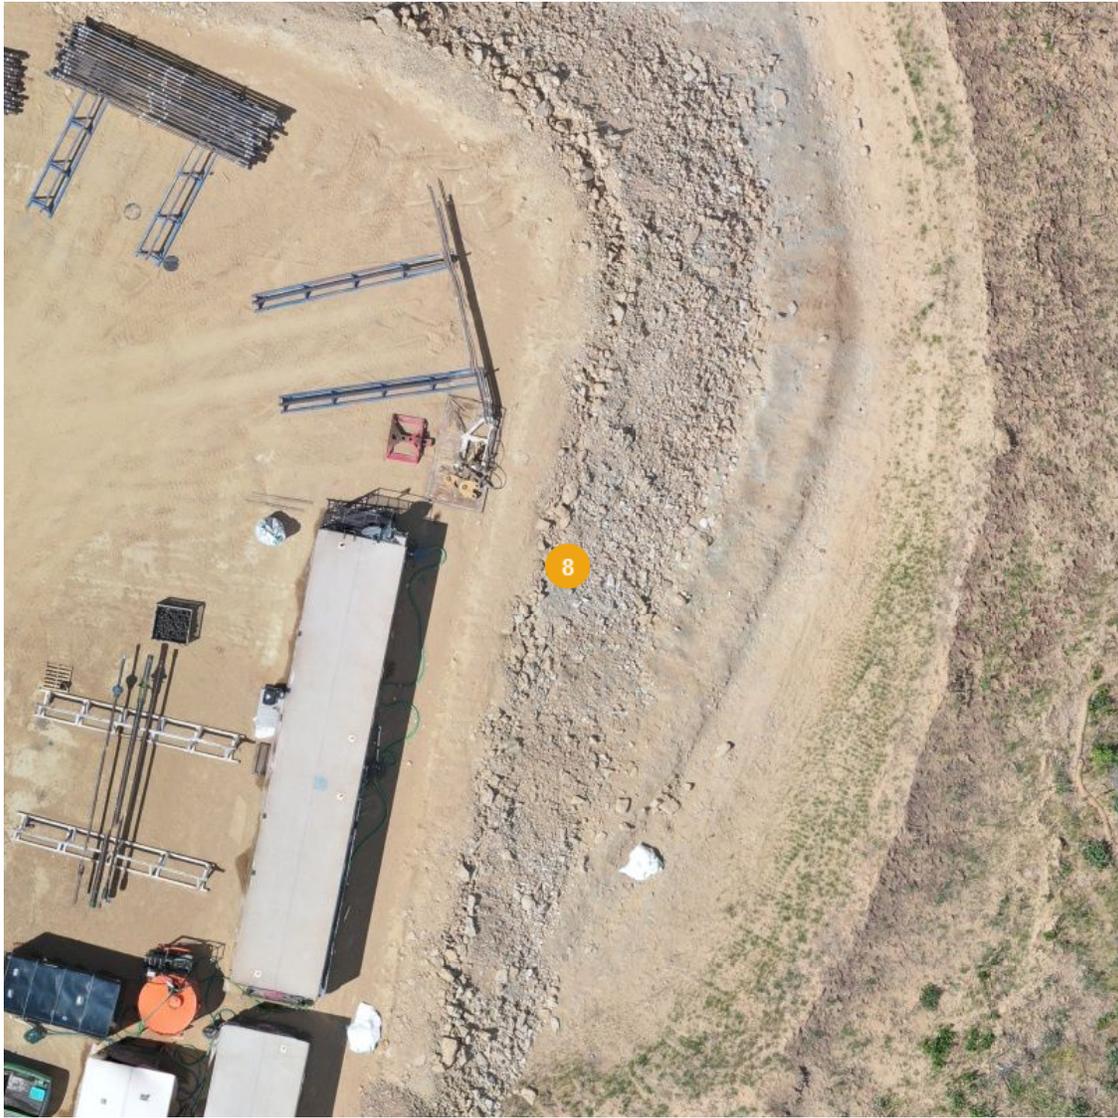
8 - Missing Part

Summary: "Armored Channel" as identified within the Location drawing figures as part of the Form 2A Location permit not installed. No engineered outlet to allow stormwater discharge has been installed.

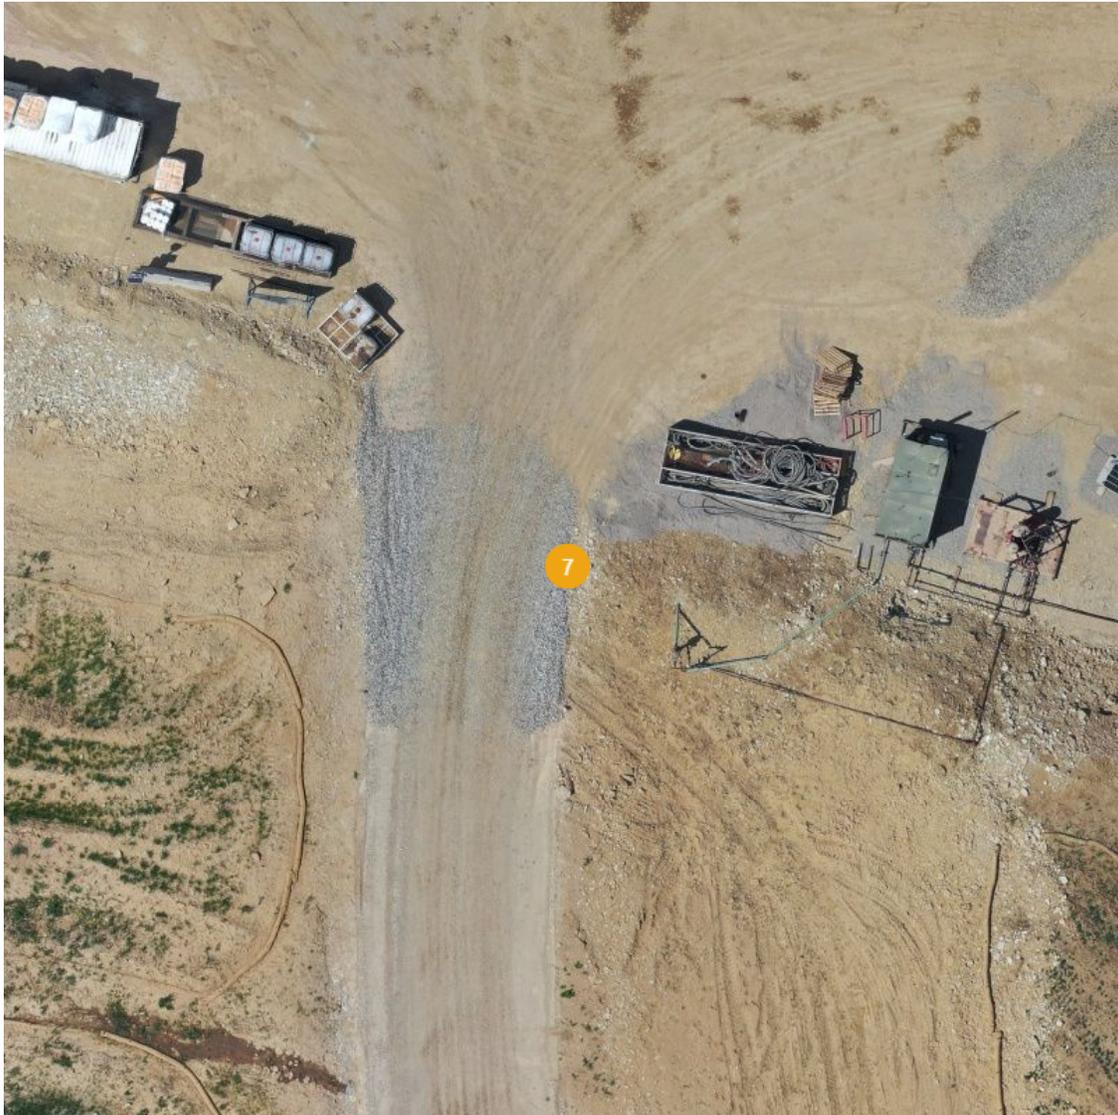
7 - Missing Part

Summary: 24" Culvert as identified within the Location drawing figures as part of the Form 2A Location permit not installed. No engineered outlet to allow stormwater discharge has been installed.

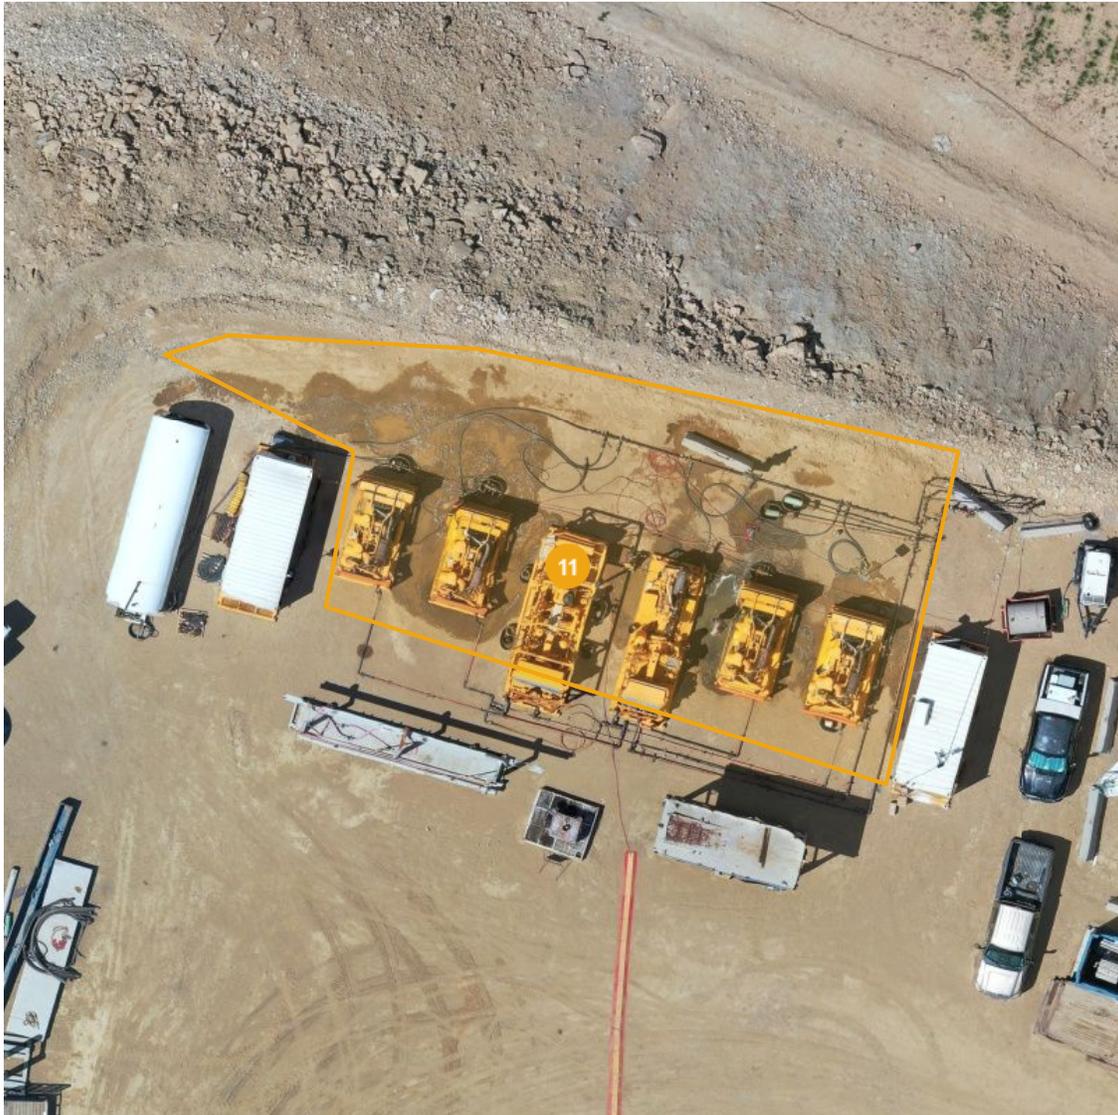
11 - Observation

Stained soils due to operator power washing equipment.

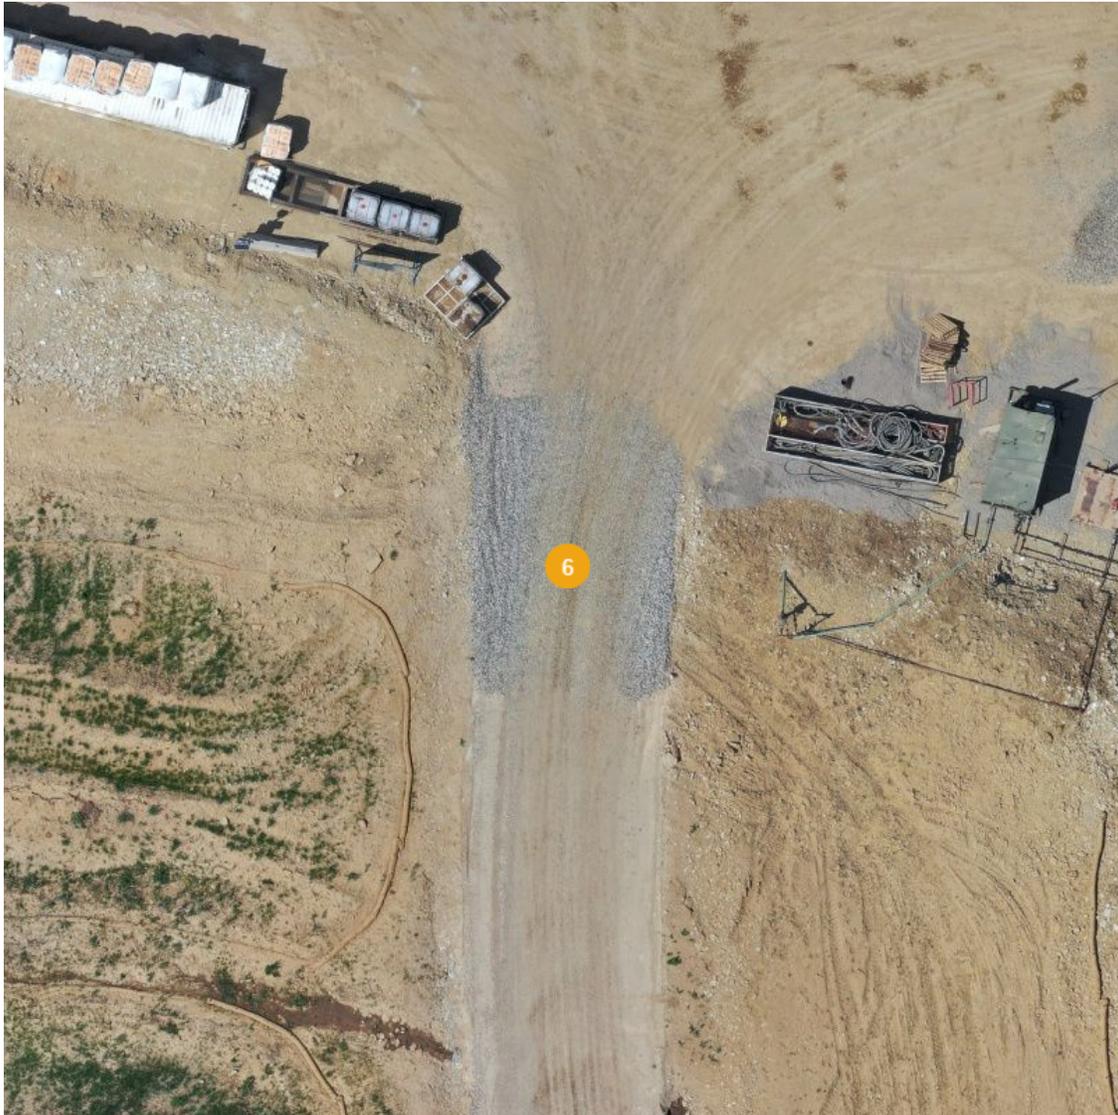
6 - Observation

Tracking pad not in proper functioning. VTC filled w/ sediment; offsite tracking issues apparent.

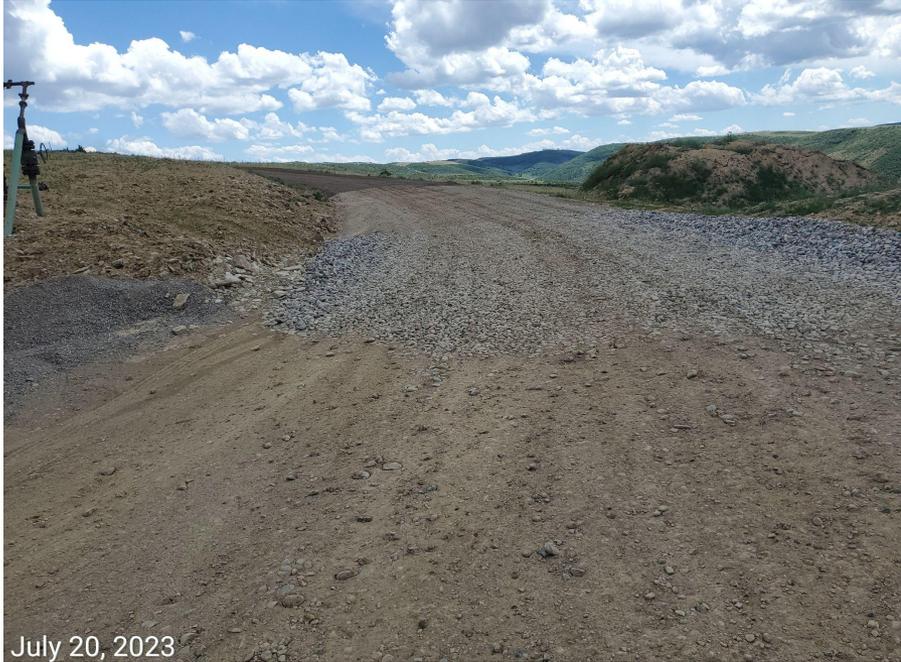
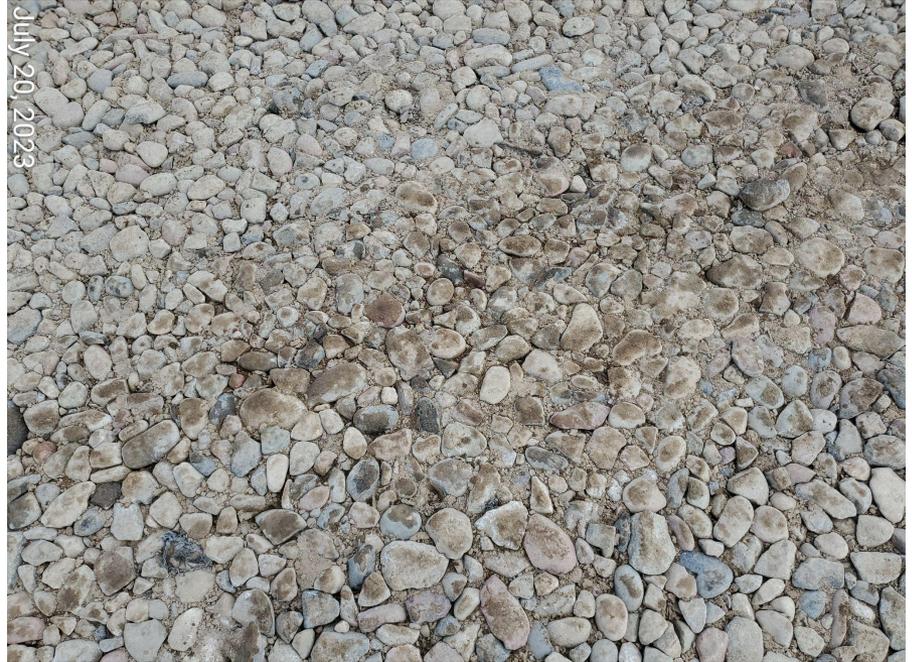
Vehicle tracking pad on the south end of the Location does not appear to have been installed in accordance with good engineering practices, or maintained in proper functioning condition; control measure no longer adequate.

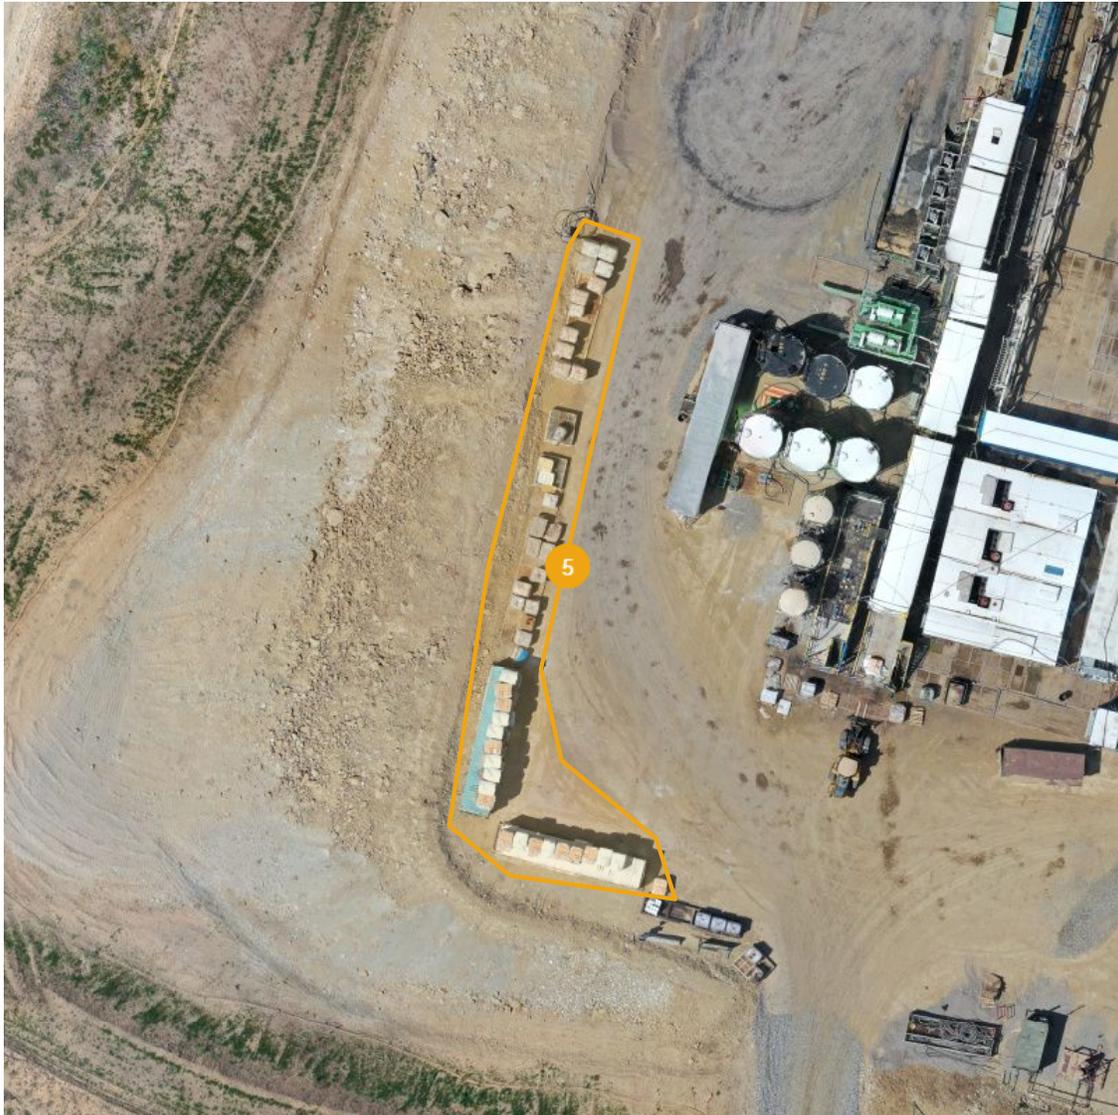
5 - Observation

| Summary: | Materials observed improperly covered. Material spills observed on pad surface. |

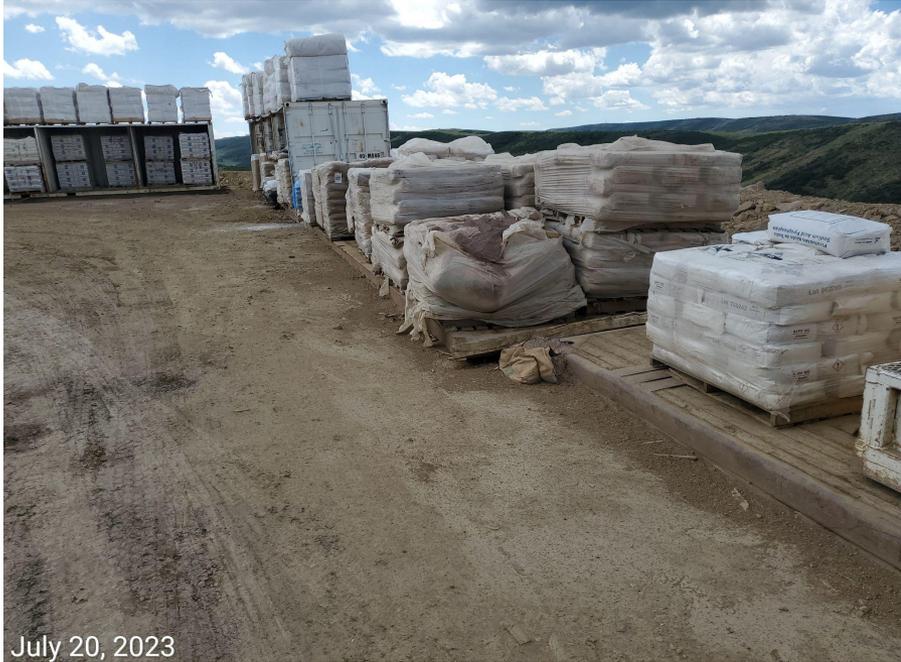
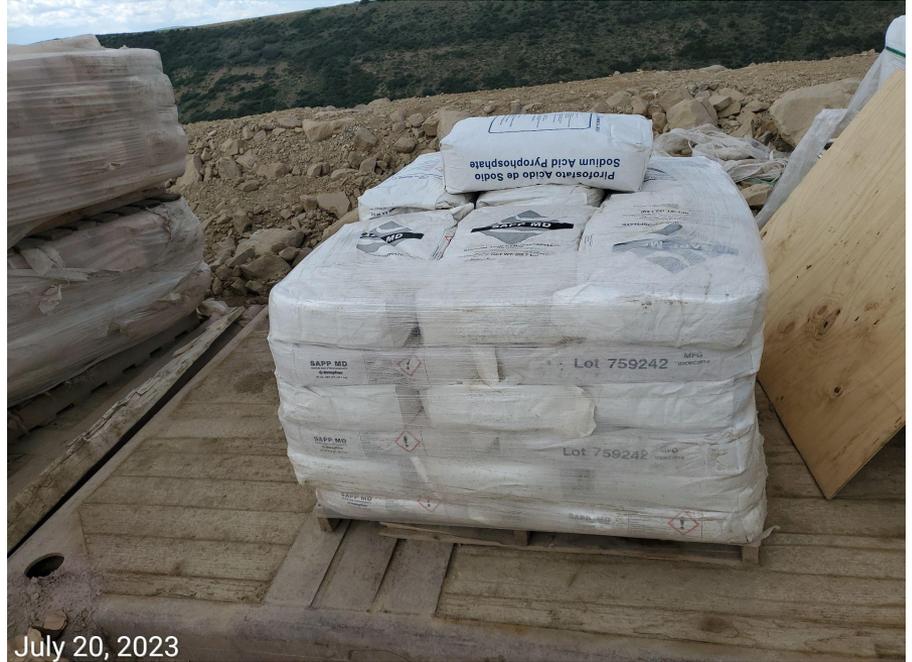
Photos example showing improperly covered materials.

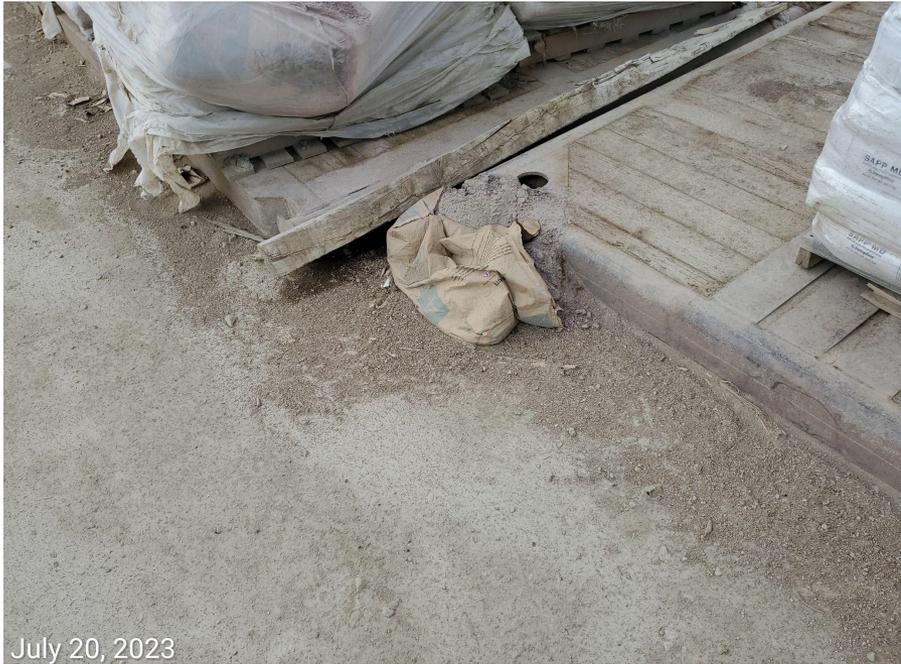
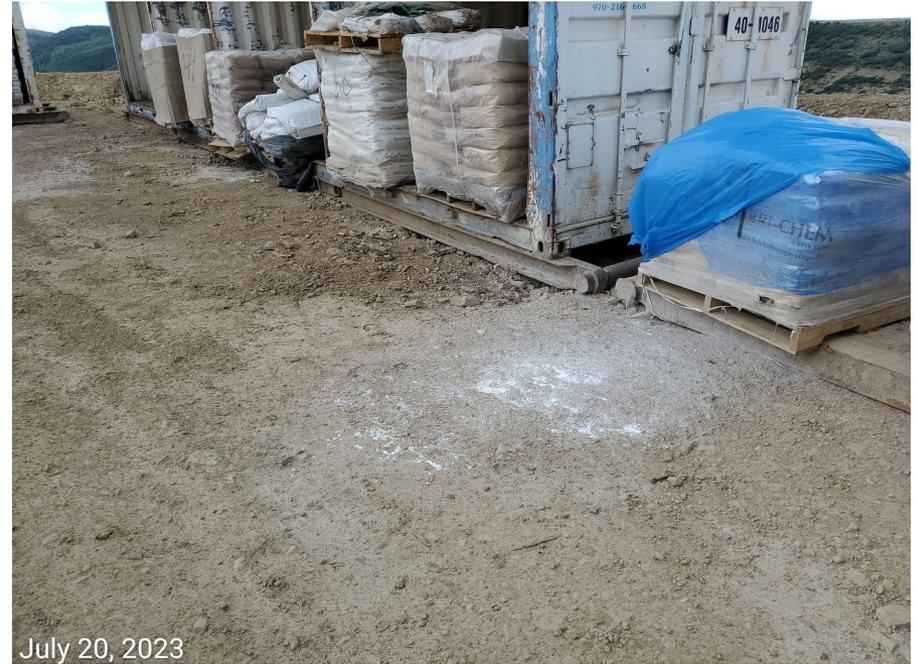
Photos examples showing material spills onto the working pad surface.

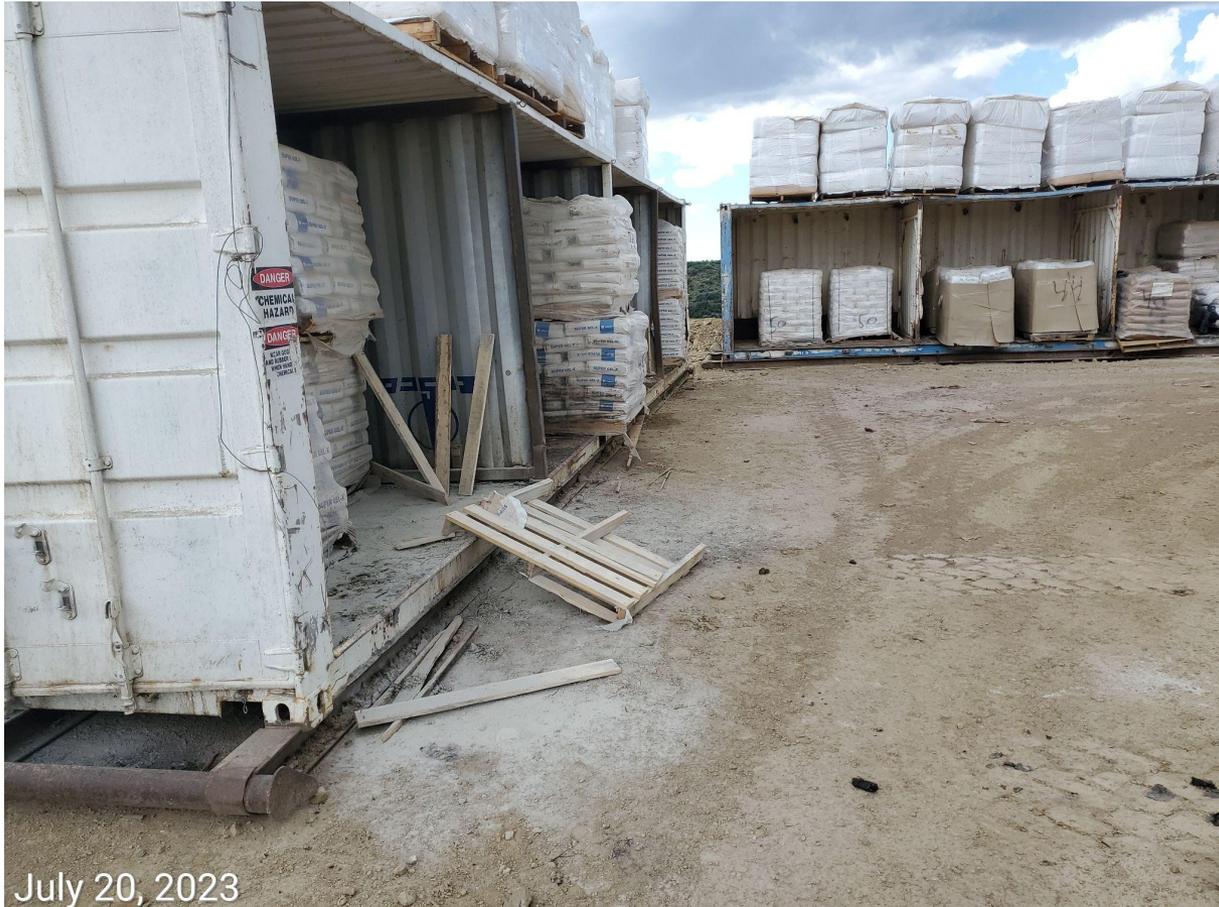
Photo example showing material spills onto the working pad surface.

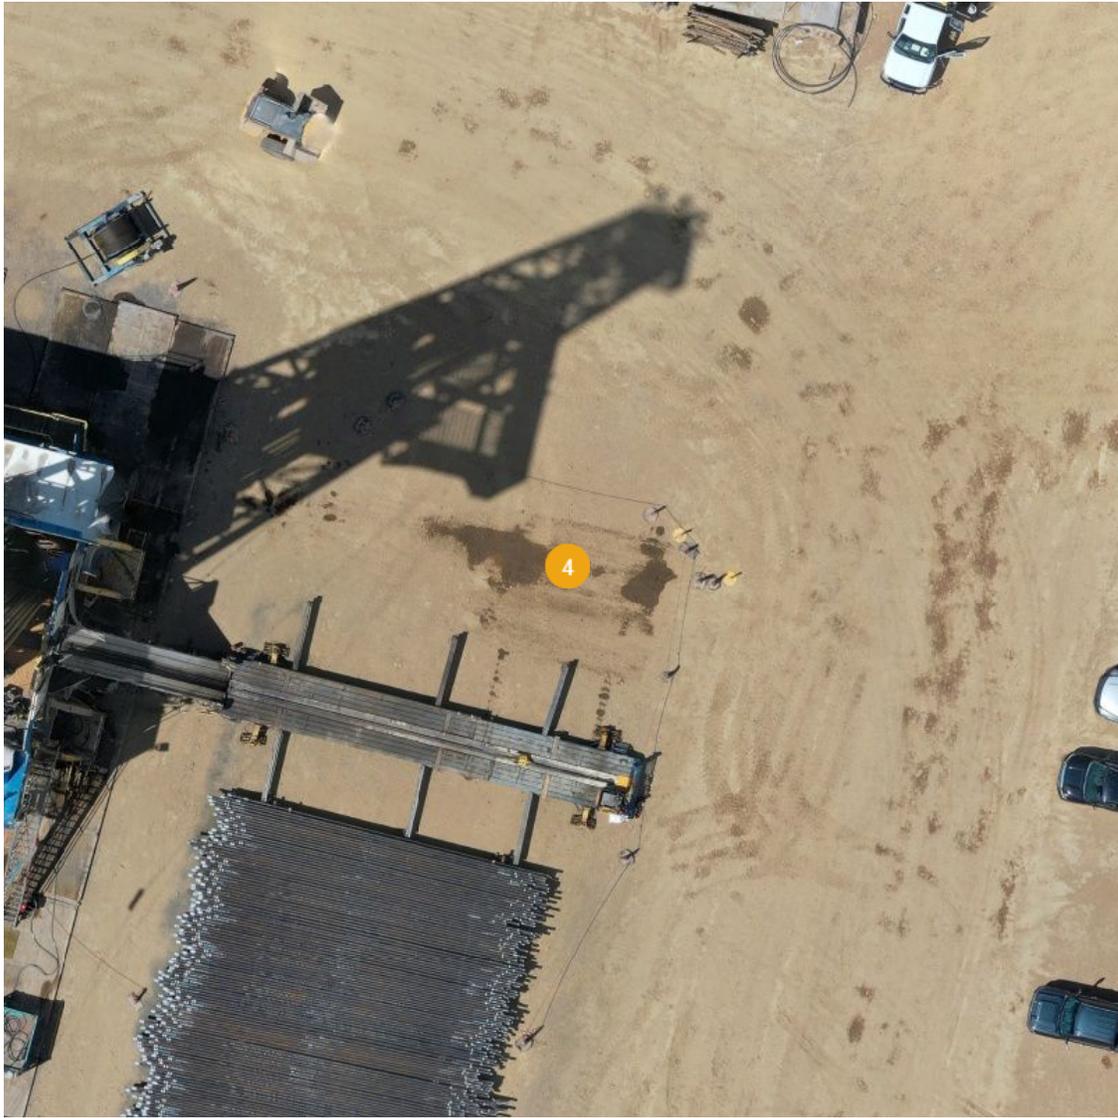
4 - Observation

Example of stained soils around rig/drill equipment.

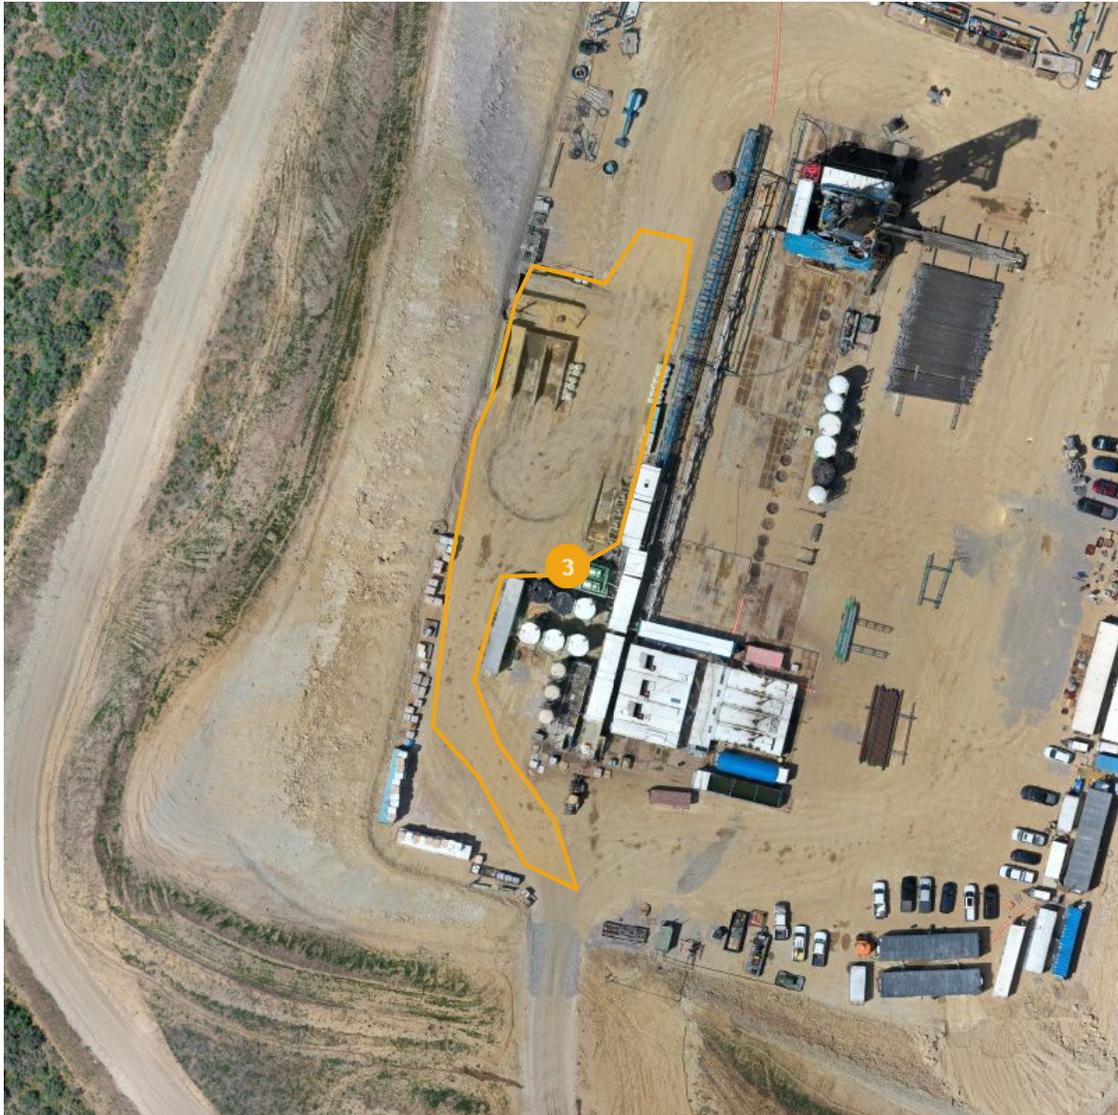
3 - Observation

Summary: **Cuttings material observed spread out over the western/southwestern pad surface. Evidence of cuttings being tracked out via vehicle traffic.**

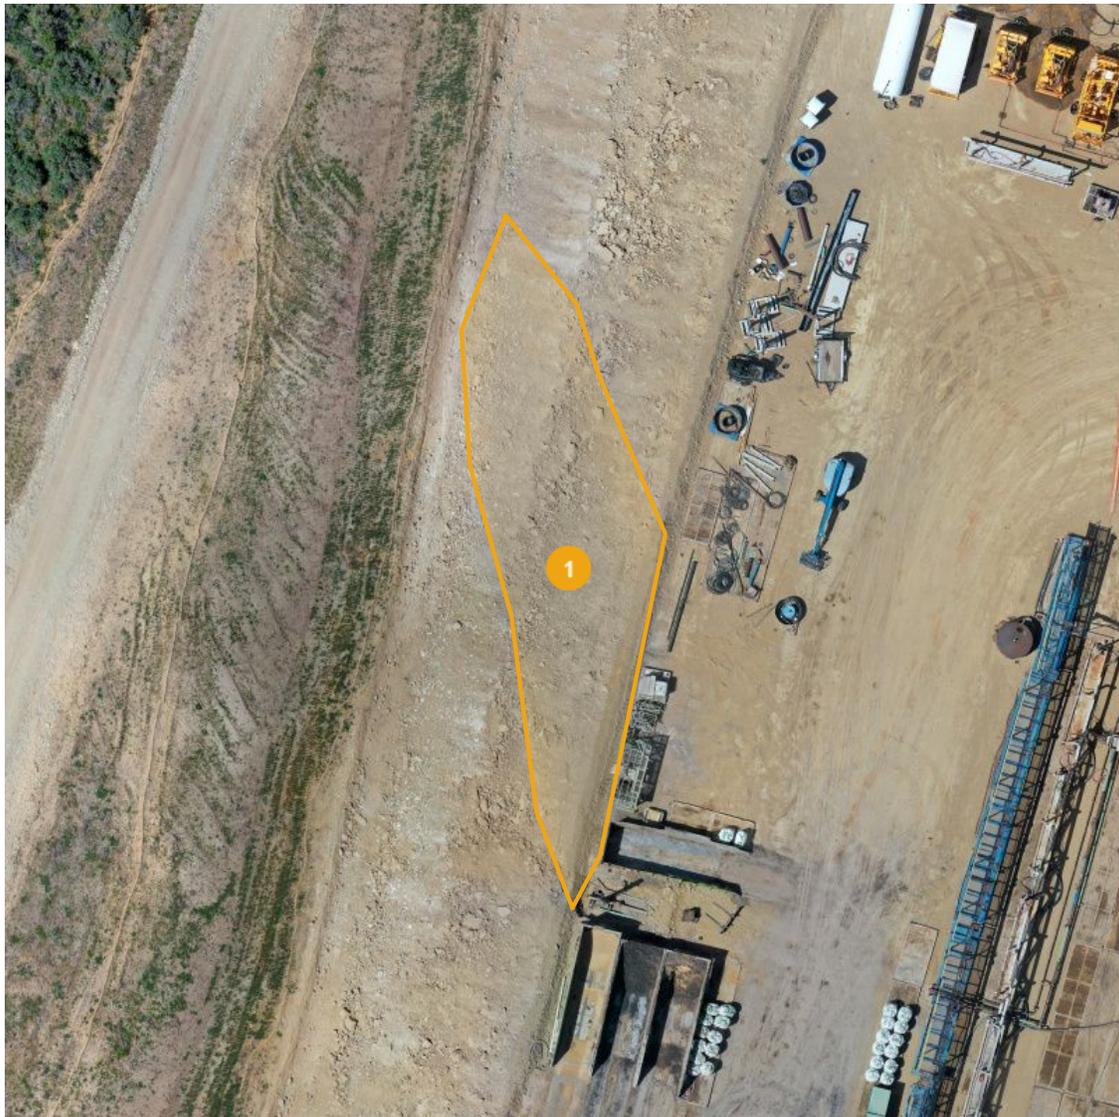
1 - Observation

| Summary: | Unknown material spilled onto fill slope areas on the west end of the Location. |
