Inspection Photos

Operator: CAERUS PICEANCE LLC #10456

Location Number: 478266

BJU/M23A-496 Pad, #478266

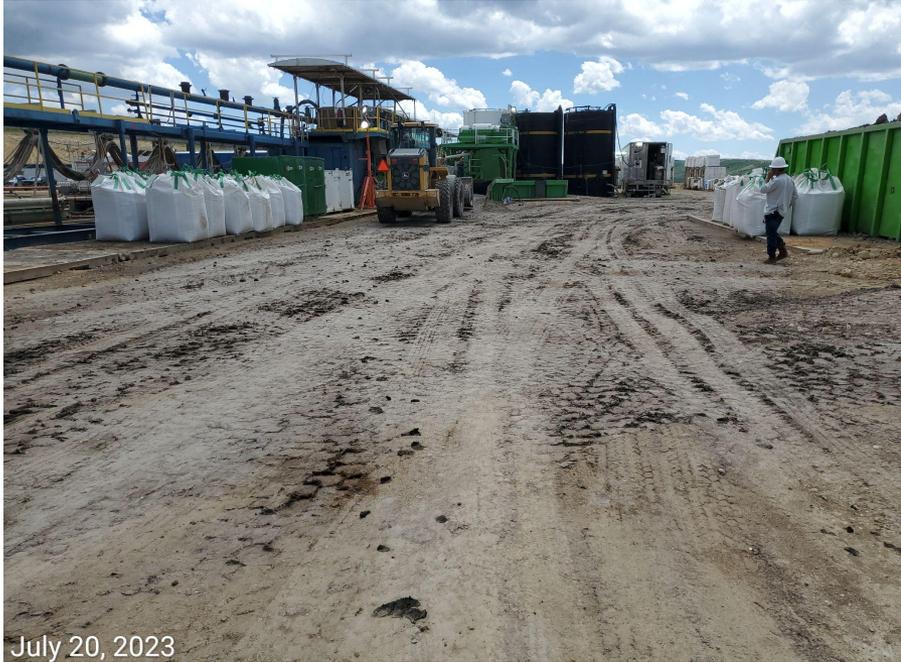
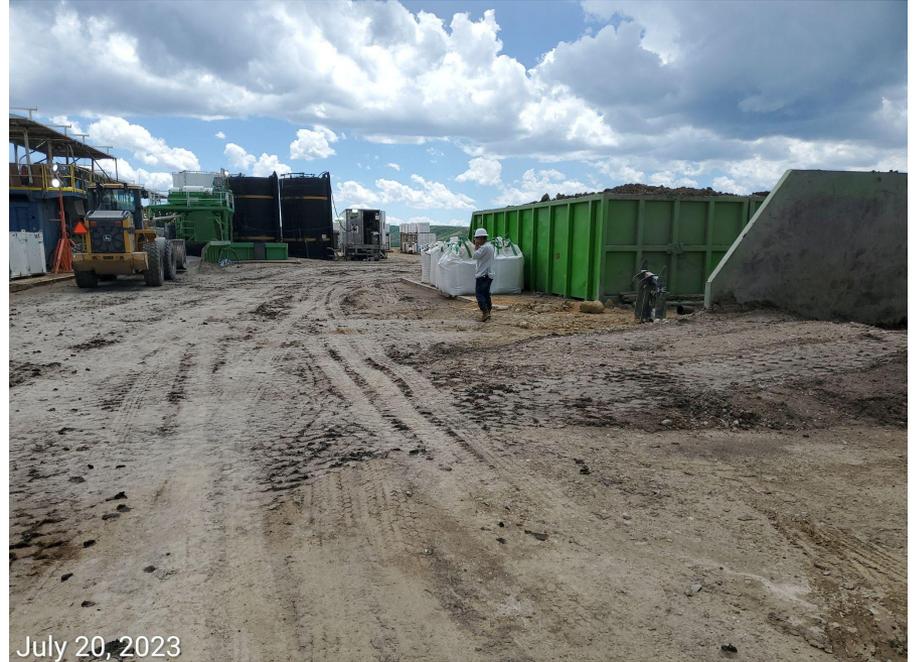
Photos show drill cutting material spilled onto the western working pad surface and tracked.

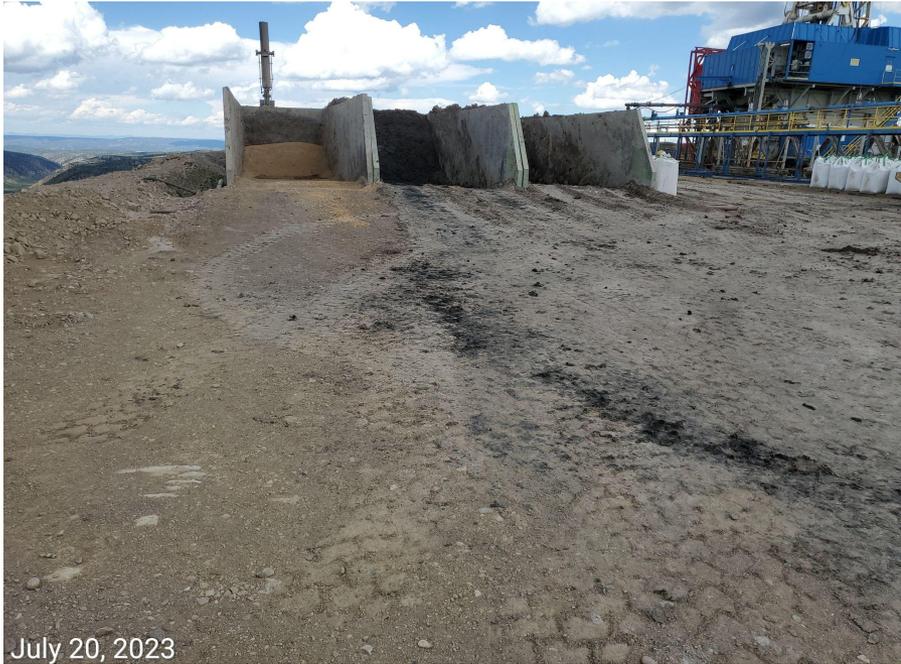
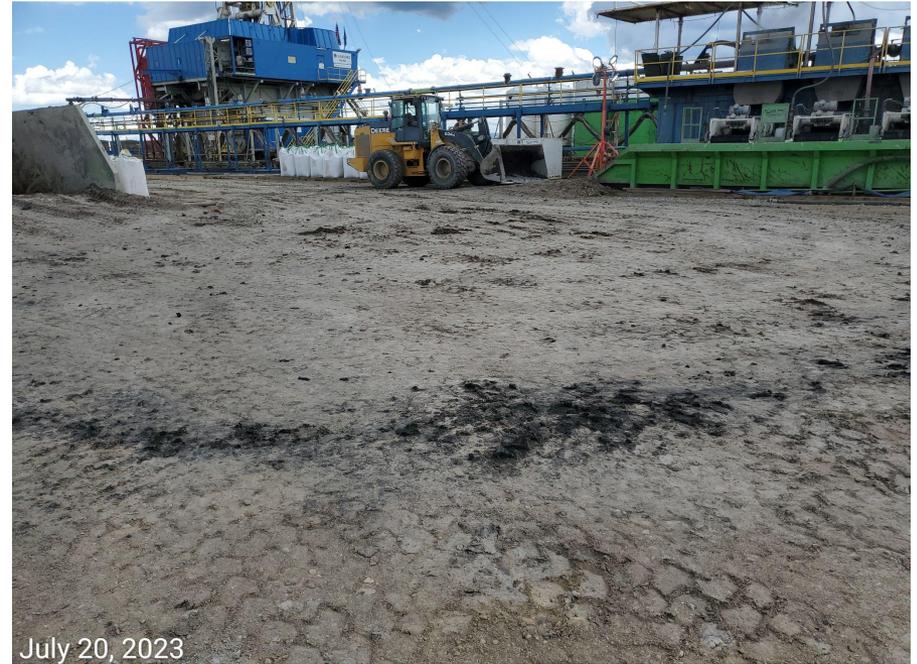
Photos show drill cutting material spilled onto the western working pad surface and tracked.

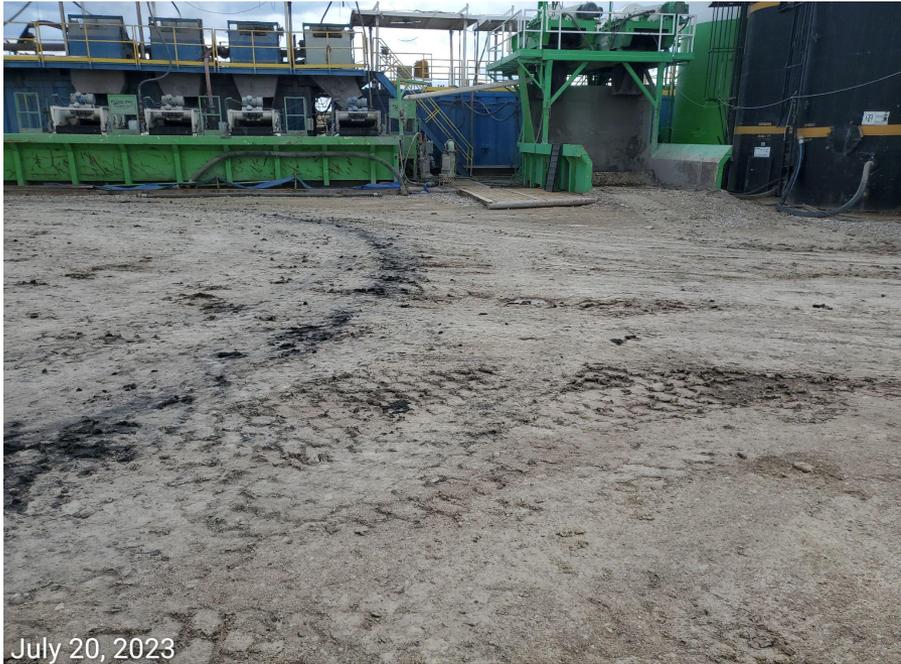
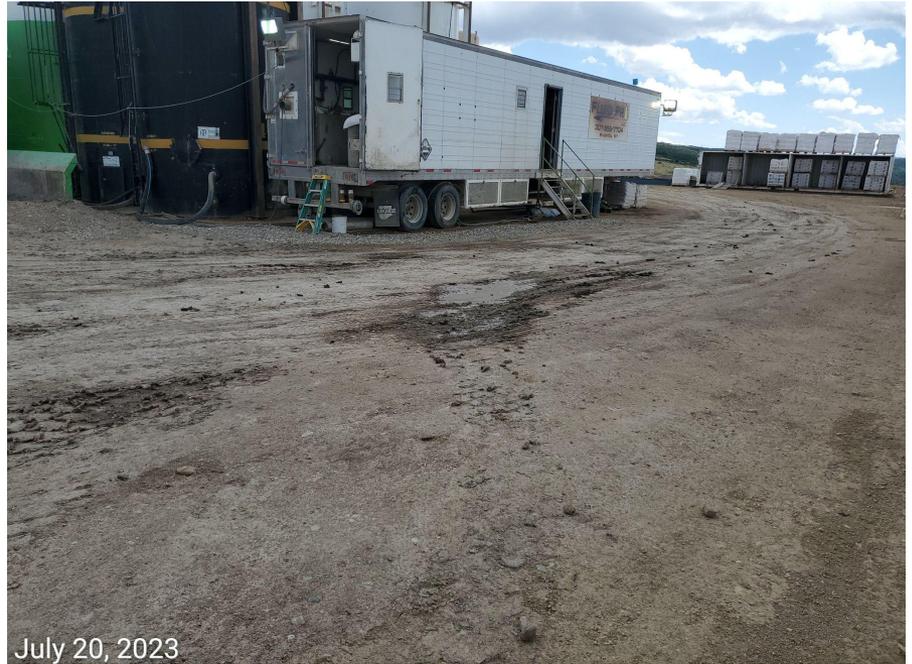
Photos show drill cutting material spilled onto the western working pad surface and tracked.

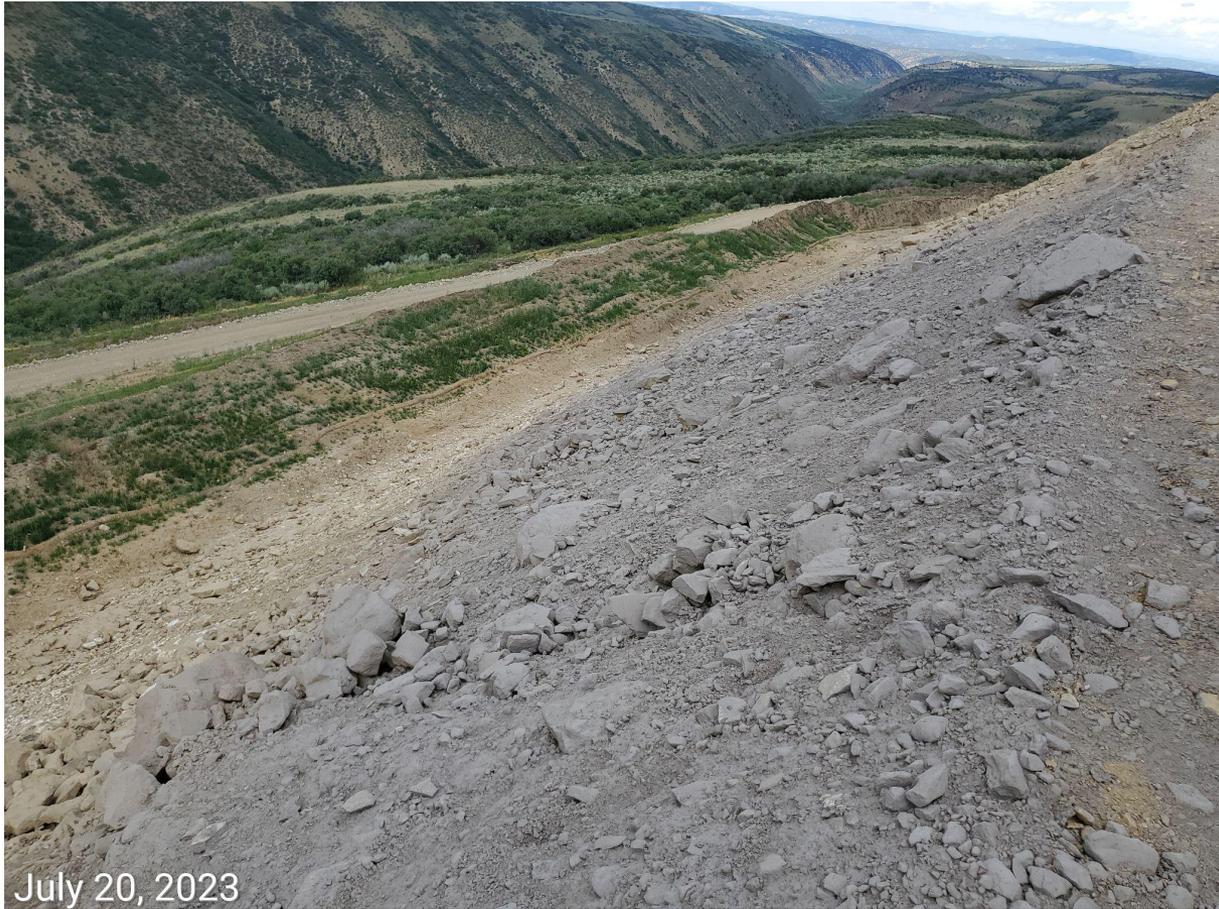
Photo shows Operator has spilled an unknown material onto the western fill slope of the location.

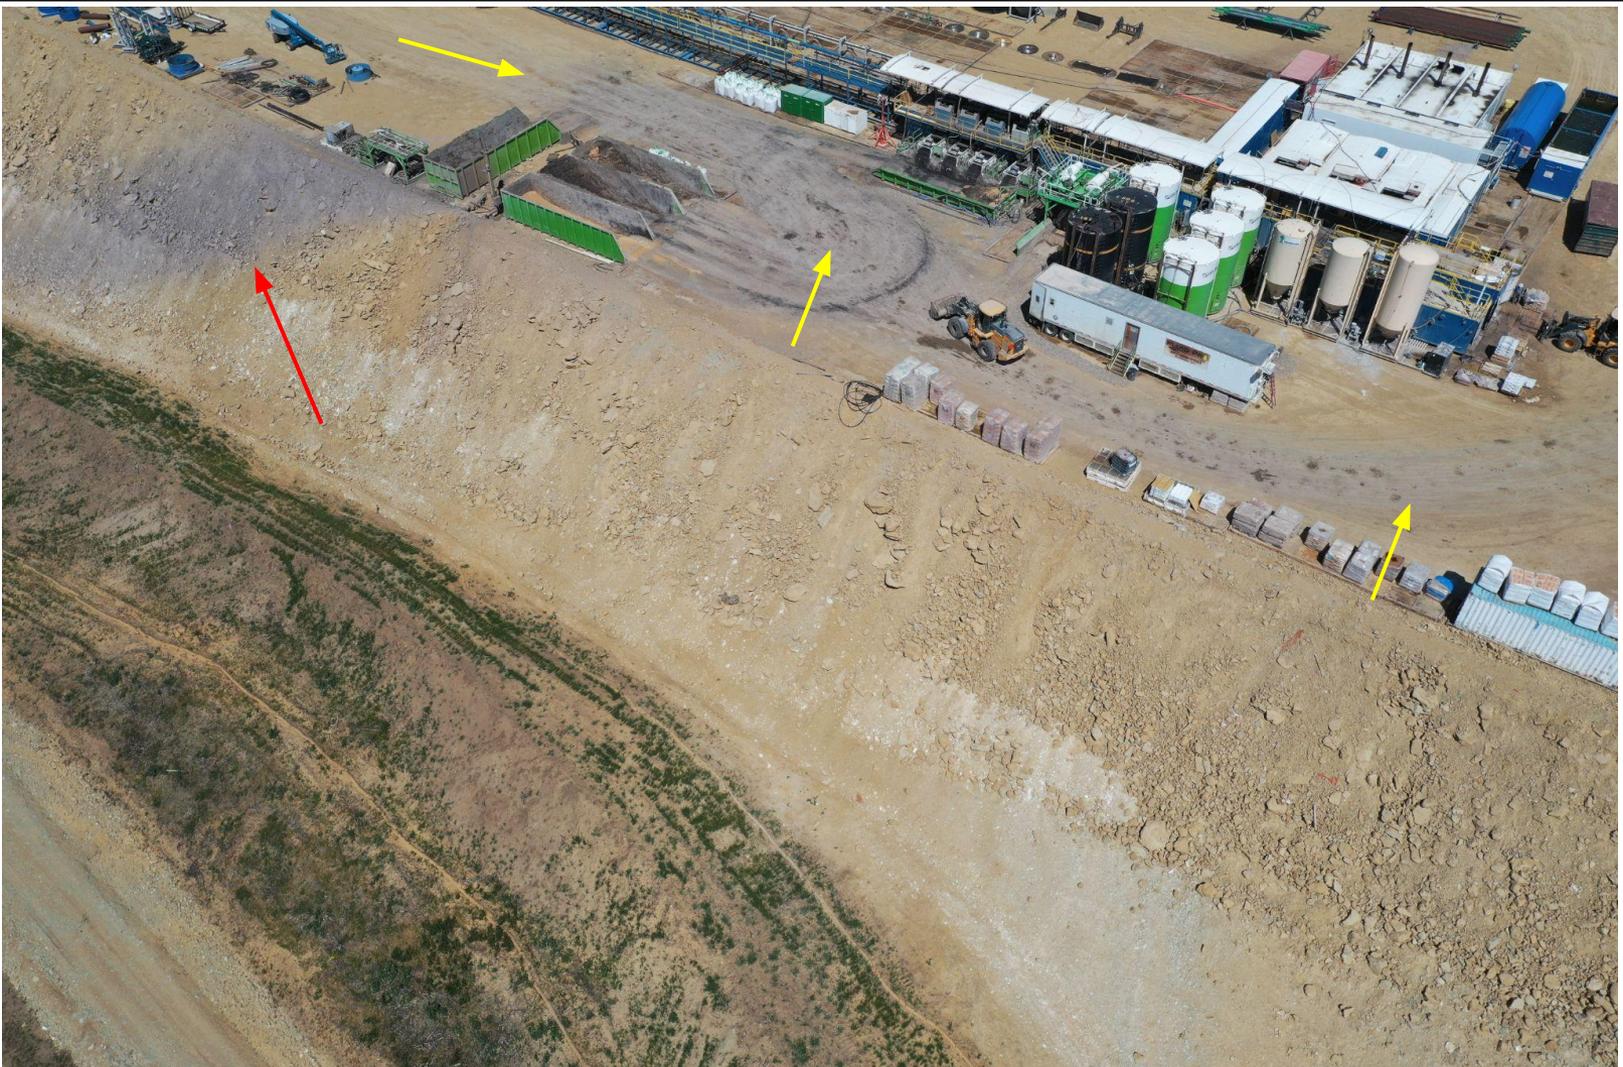
Aerial image showing spill on the fill slope (red arrow), and the drill cuttings spilled onto the working pad surface, and tracked (yellow arrows)

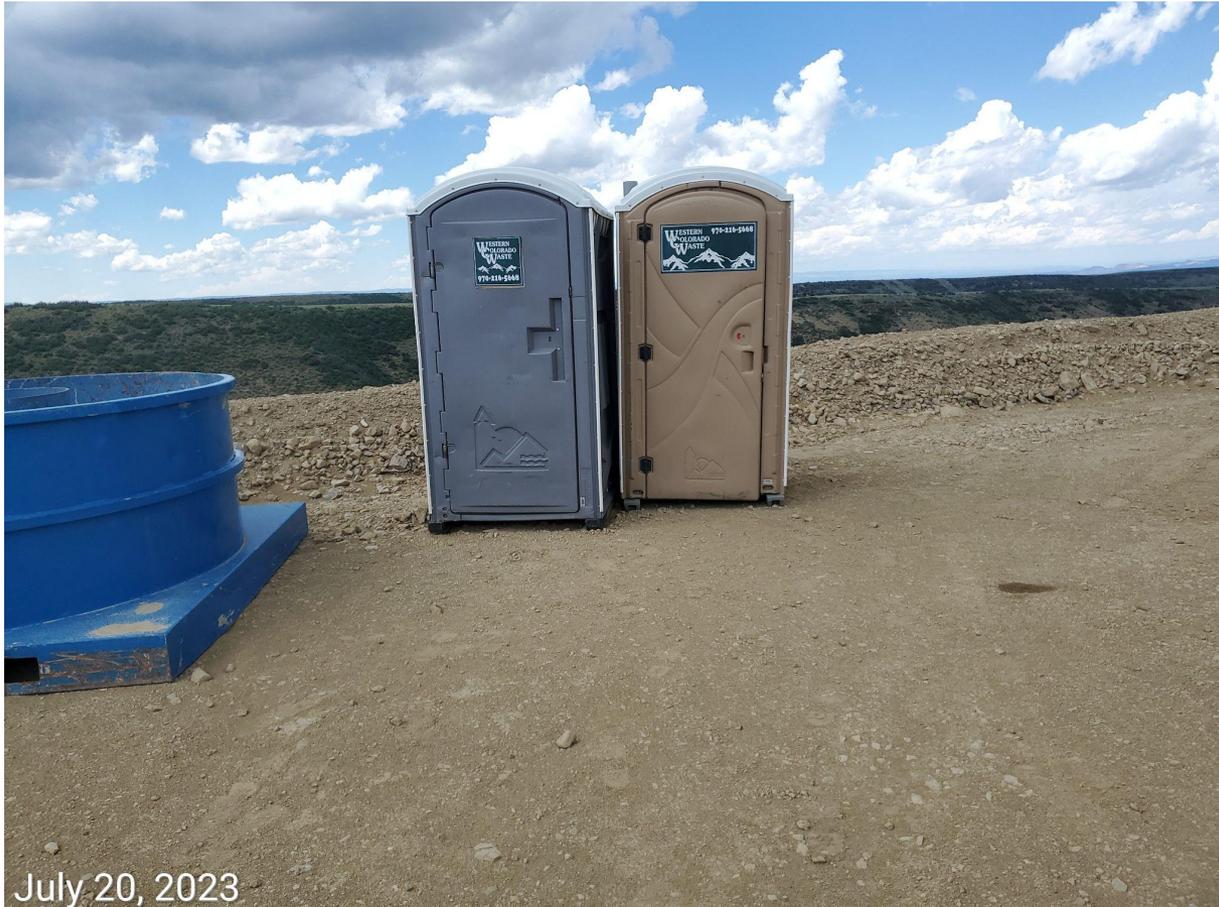
Porta-johns not secured; BMPs to prevent, or contain a spill missing or insufficient at porta-johns.

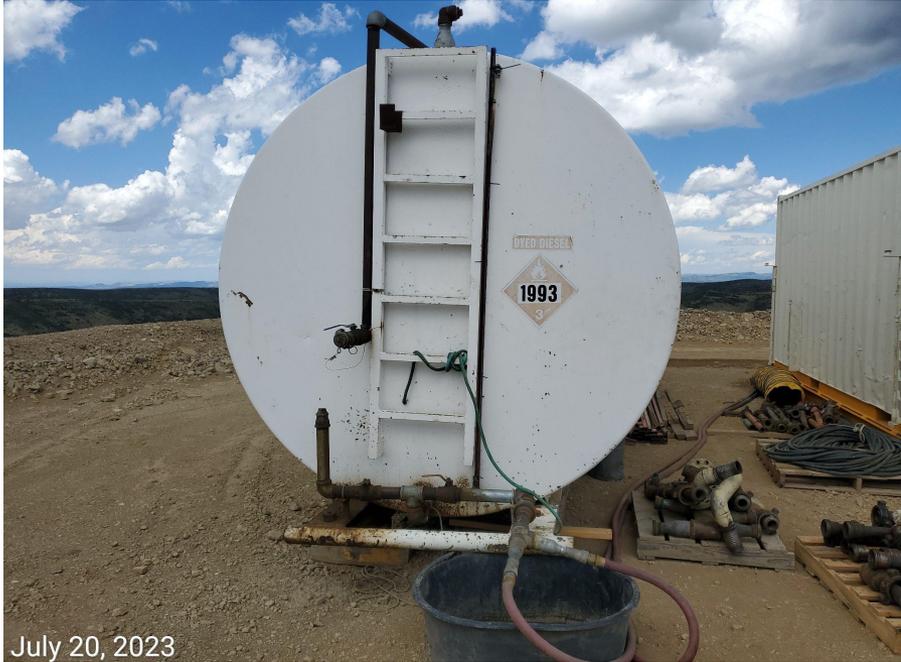
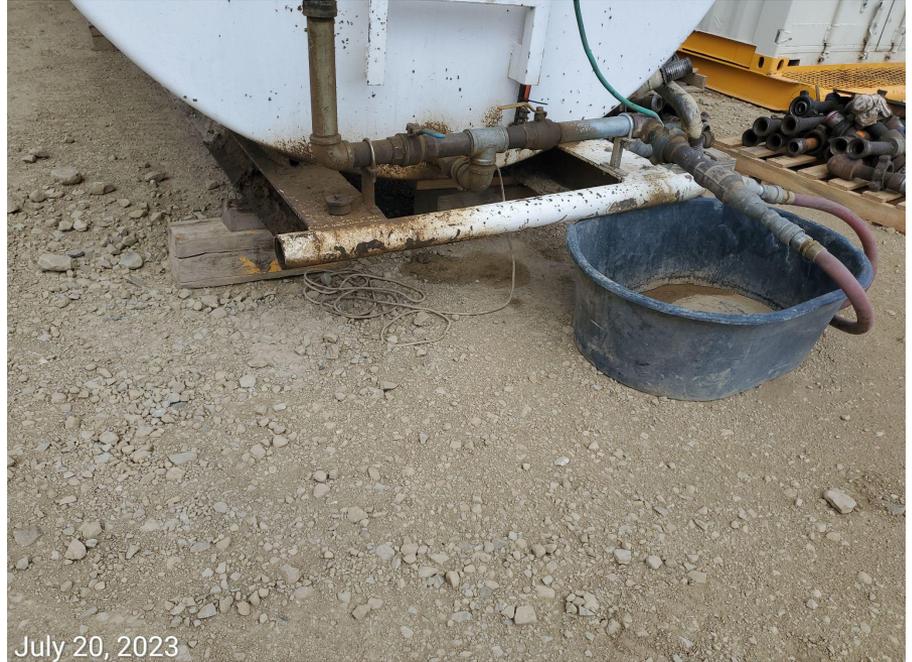
Stained soils at diesel tank.

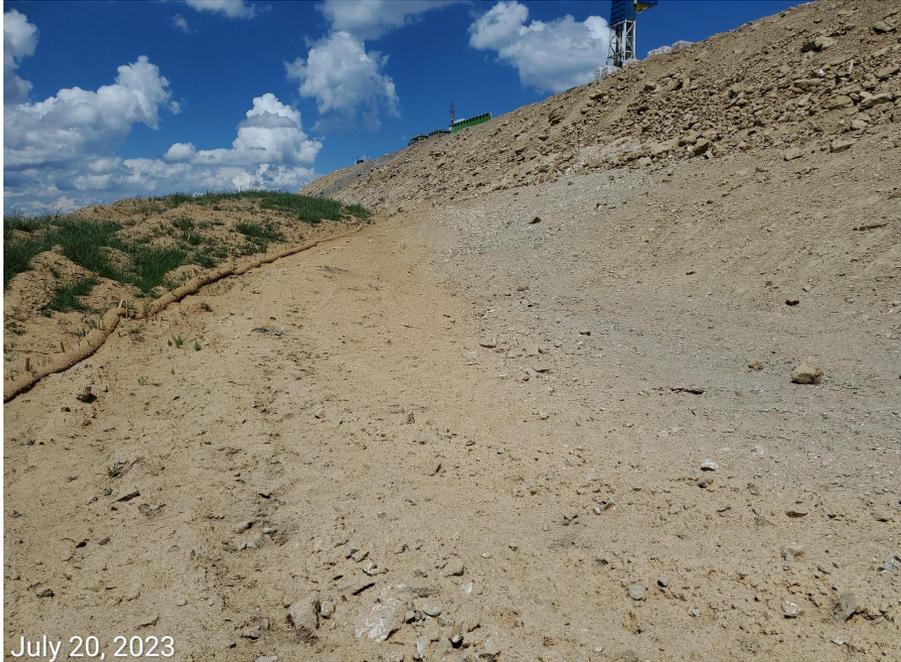
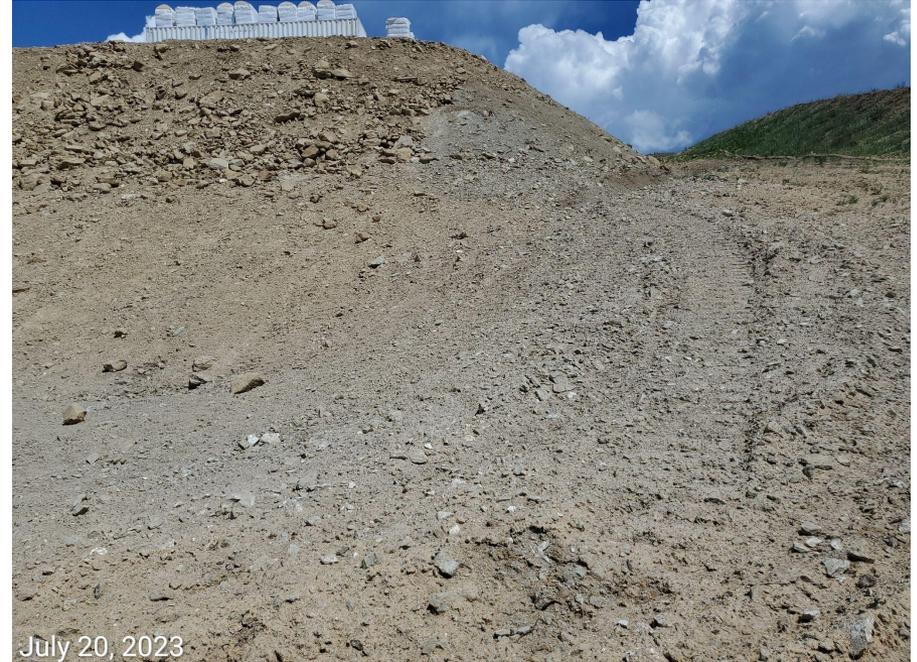
Southwest sediment trap. BMP has not been constructed with an protected/engineered inlet or outlet.

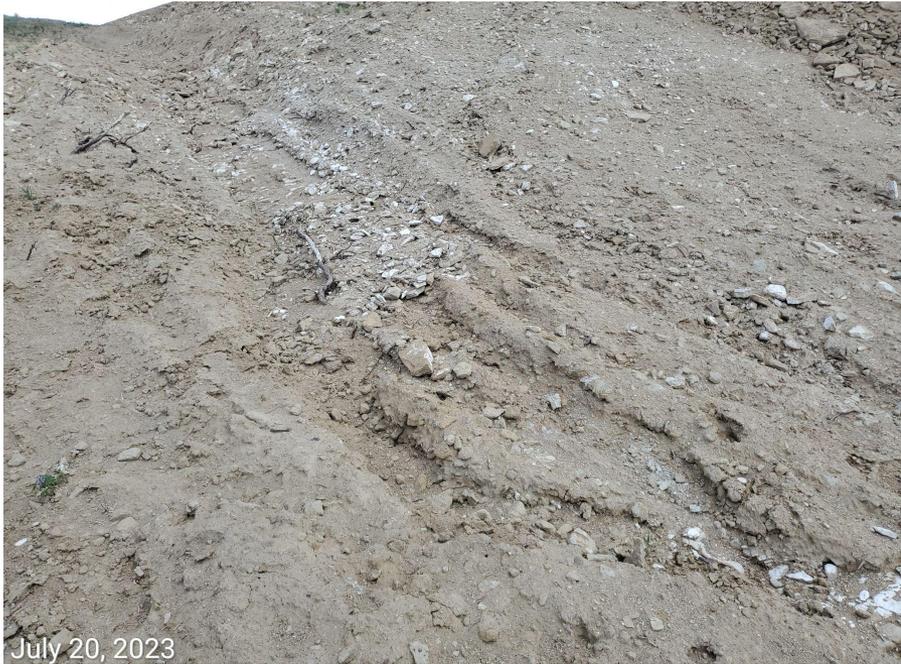
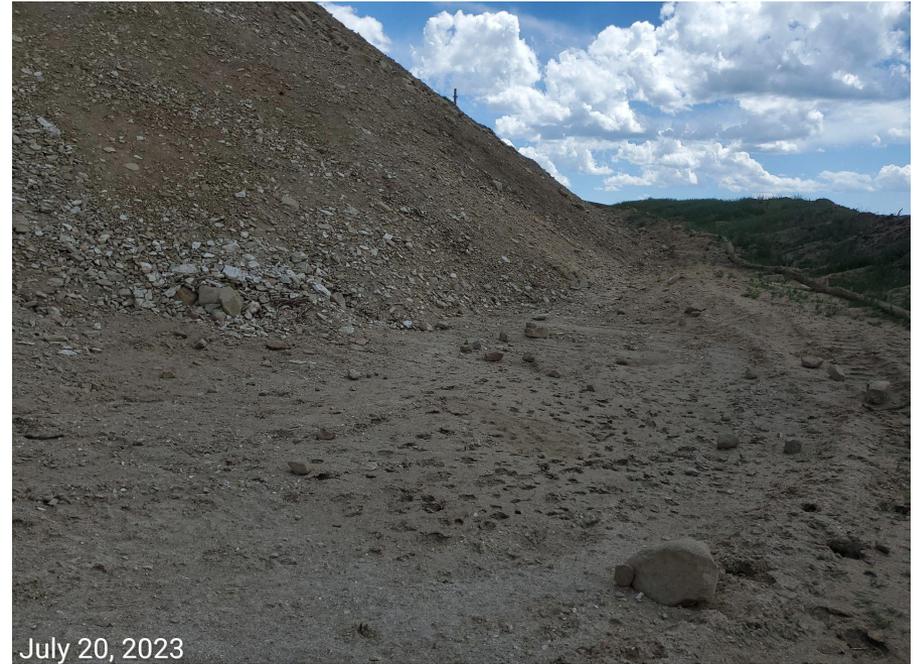
Northwest sediment trap. BMP inadequate in size and has not been constructed with an protected/engineered inlet or outlet.

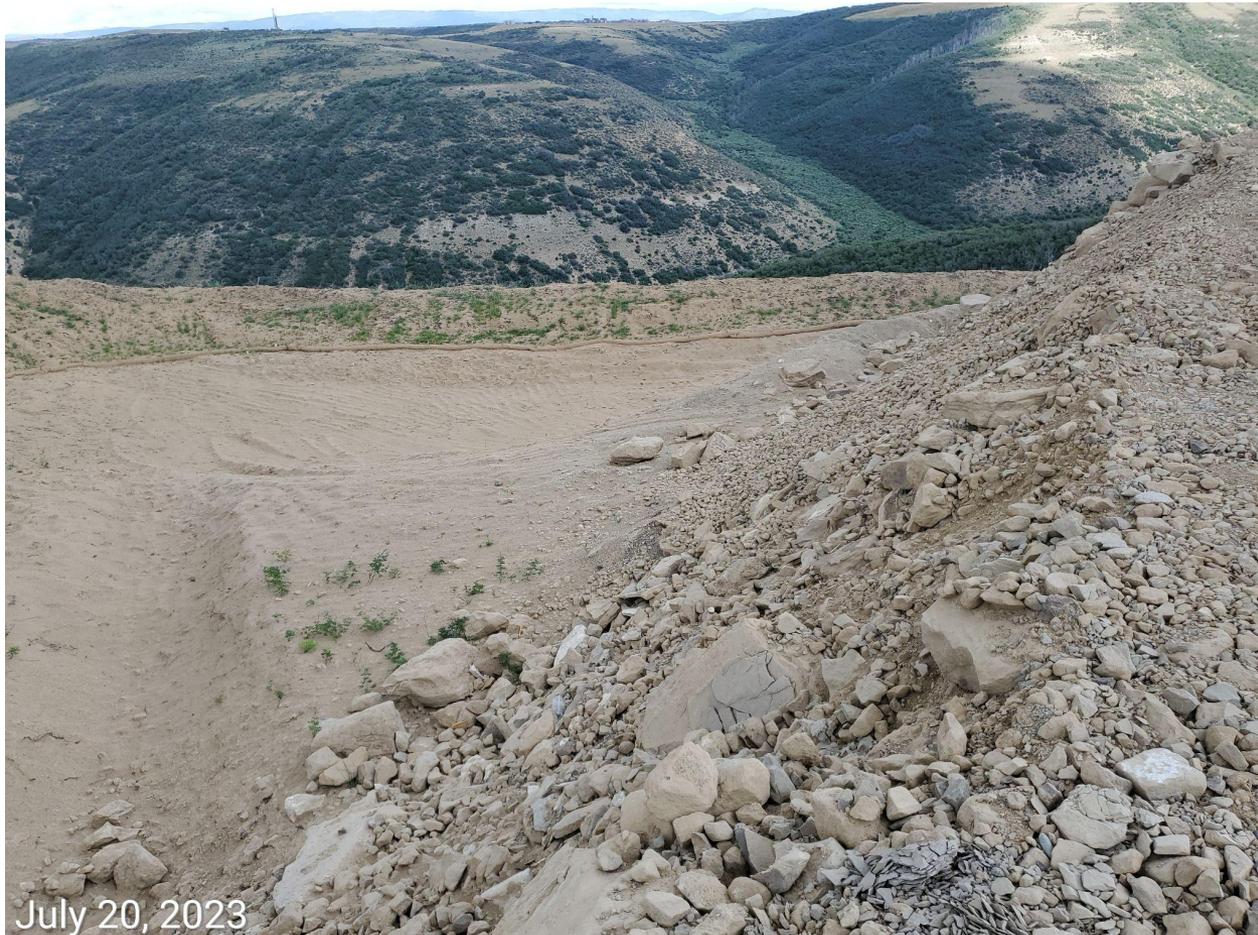
Northeast sediment trap. BMP has not been constructed with an protected/engineered inlet or outlet.
