Inspection Photos

Location Name: TEP ROCKY MOUNTAIN LLC, AMERICAN SODA-67S96W/2SESW

Location ID: 324142

Date: 7/10/2023

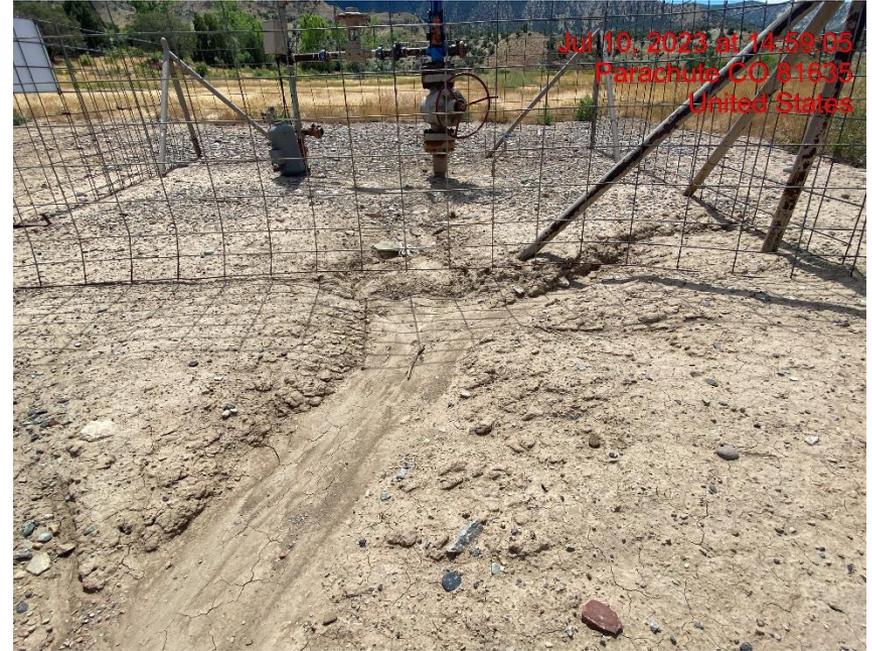
Rill Erosion Causing Run-On to Location – Photo #05113

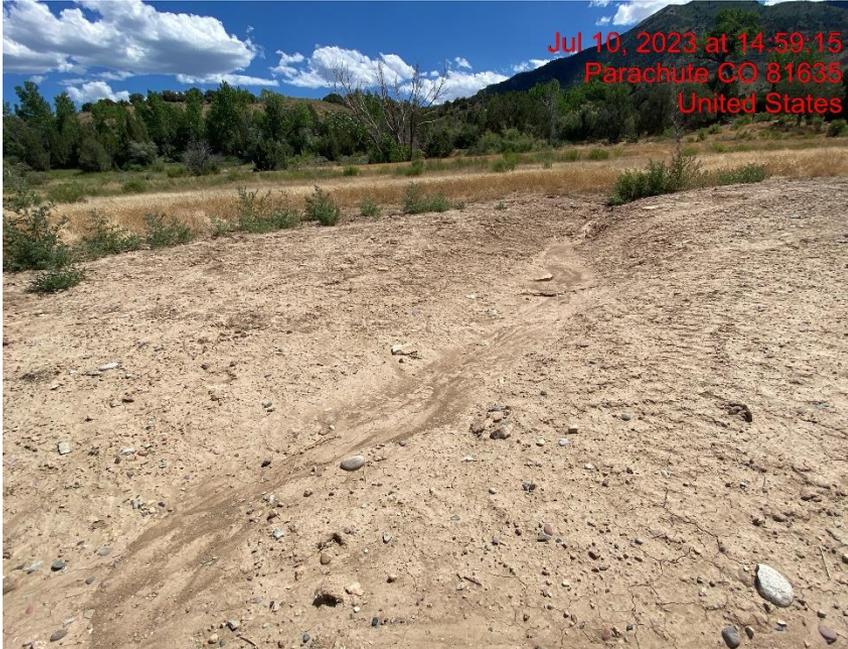
Rill Erosion Causing Run-On to Location – Photo #05114
