Storm Water Management and Erosion control
Location Name: TEP ROCKY MOUNTAIN LLC DOE FED 9-17 MV Pad
Location ID: 335134

Location Overview: Drainage contributes to the Colorado River. Location is within High Priority/Density Habitat areas.
Section/Township/Range: 17 6S94W

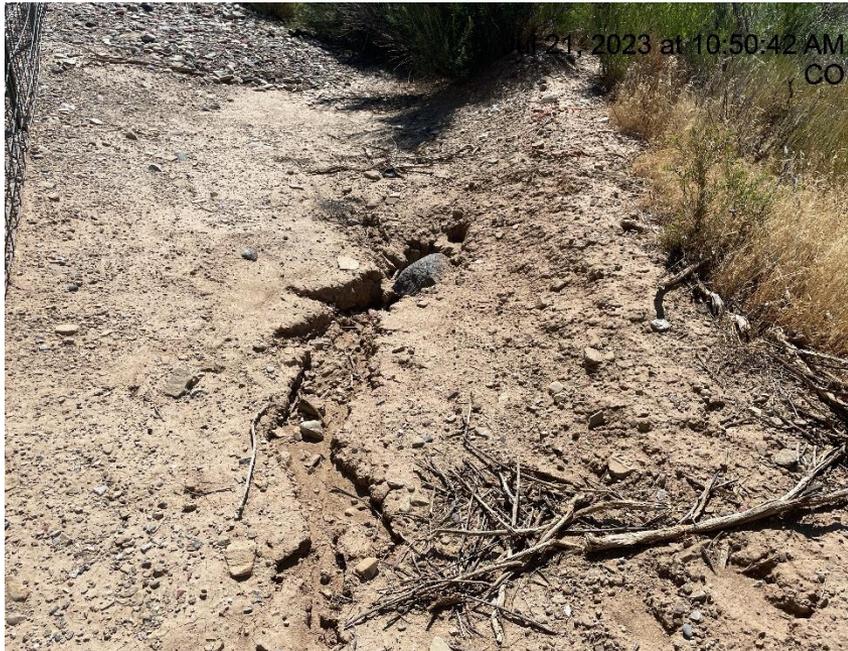
Photo # 3636 Erosion/Tunnel erosion (S/SW corner of location behind production units)

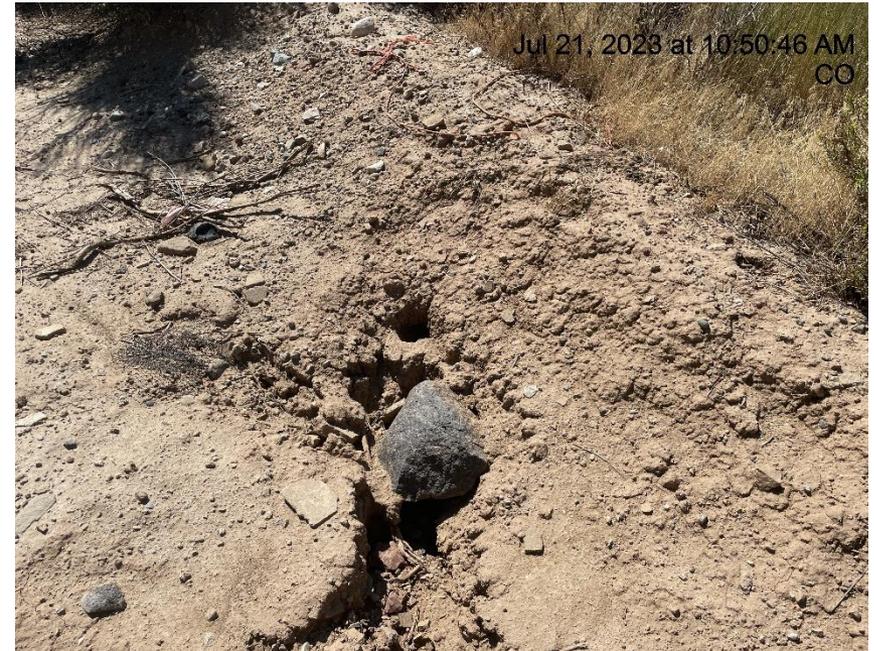
Photo # 3637 Erosion/Tunnel erosion (S/SW corner of location behind production units)

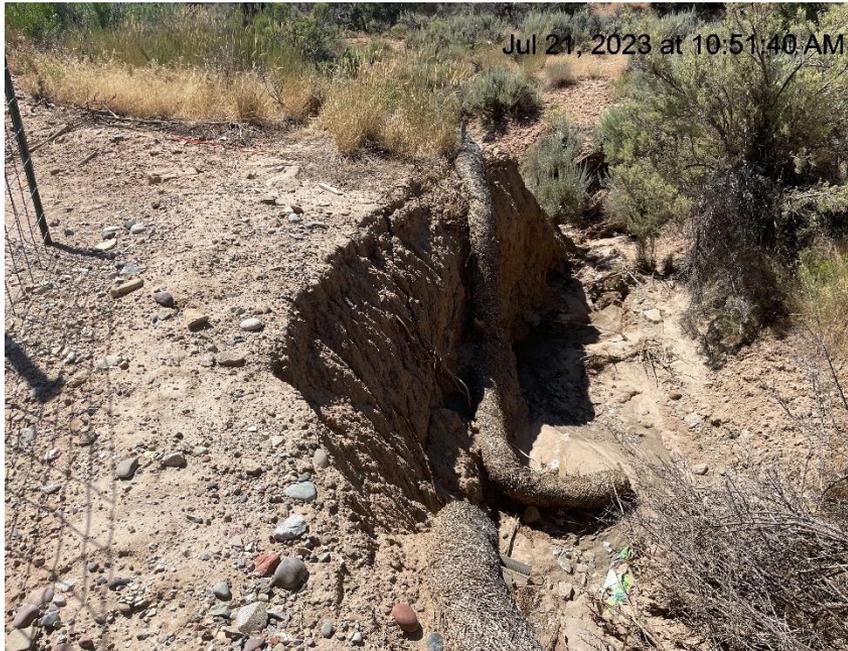
Photo # 3640 Wattles need maintenance - ditch has eroded & wattles have fallen into ditch (SW corner of location behind production units)

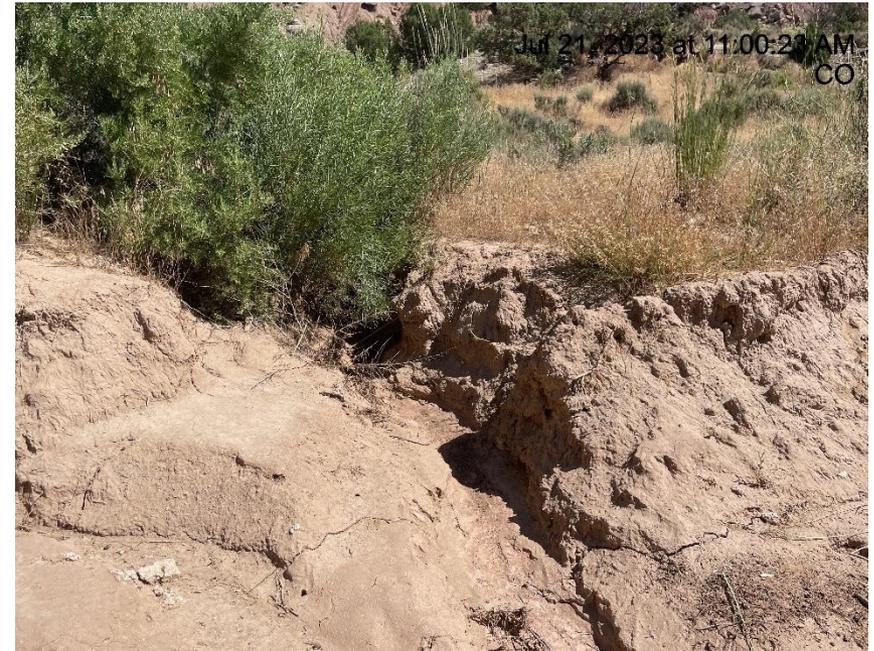
Photo # 3651 Erosion & transport of sediment (S/SE area of location near culvert)

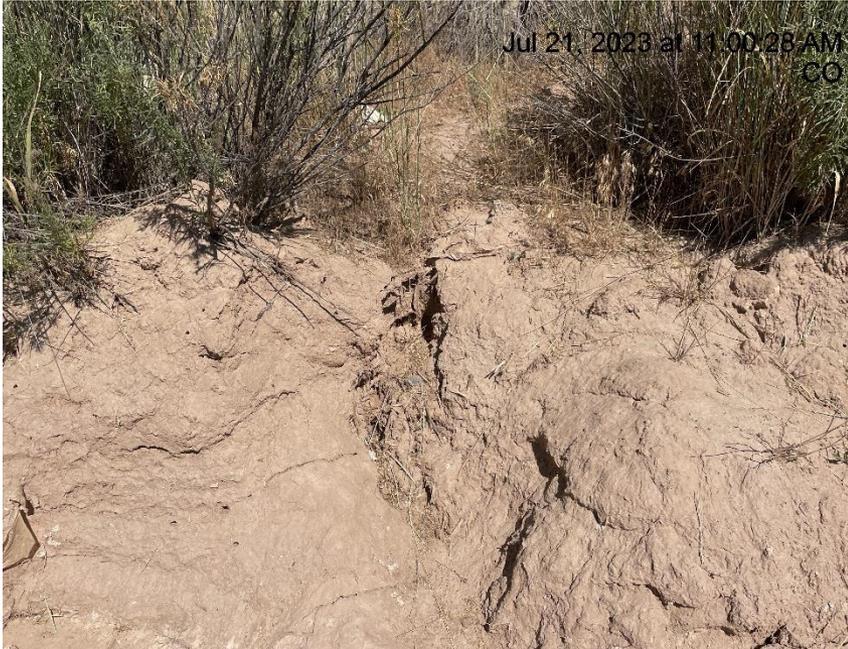
Photo # 3652 Erosion & transport of sediment (S/SE area of location near culvert)

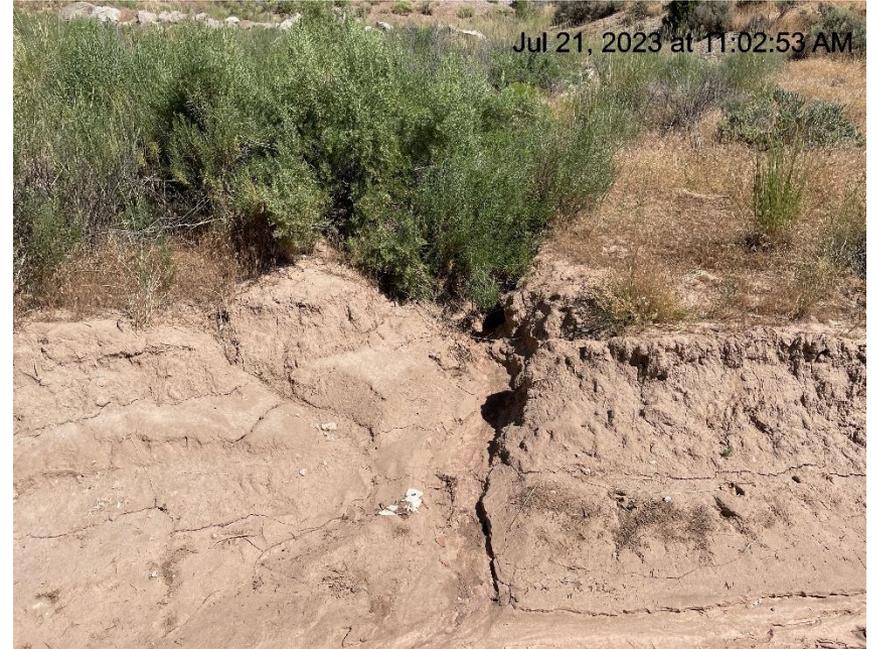
Photo # 3658 Erosion & transport of sediment (S/SE area of location near culvert)

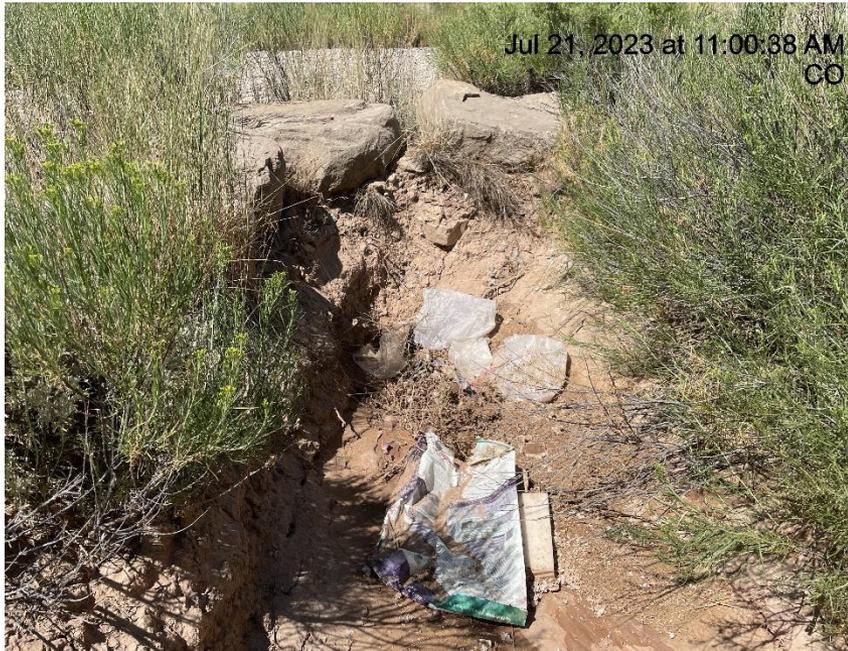
Photo # 3653 Culvert needs maintenance - Culvert appears to have sediment & trash built up on one end which is reducing culvert capacity. (culvert is near entrance to location)

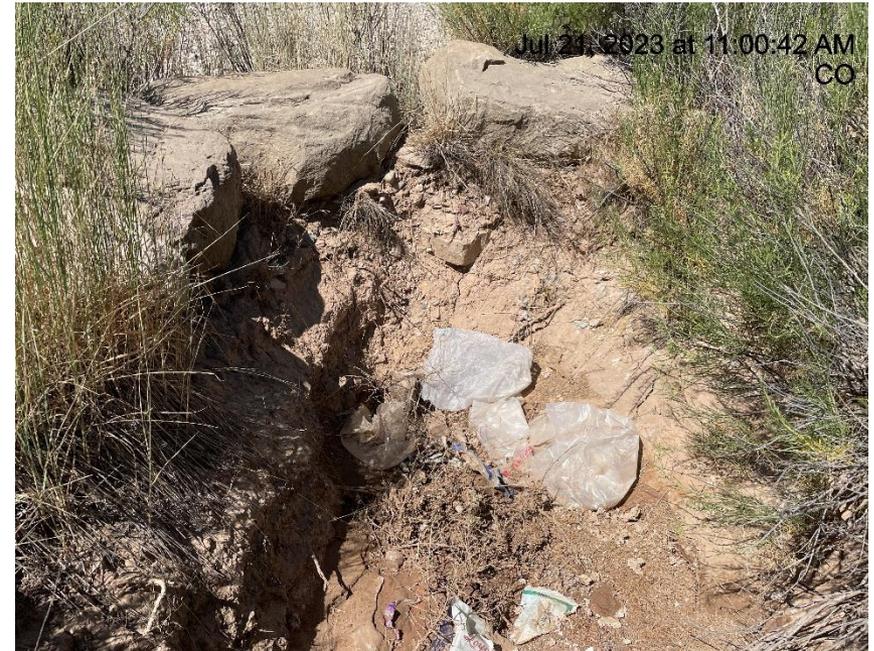
Photo # 3654 Culvert needs maintenance - Culvert appears to have sediment & trash built up on one end which is reducing culvert capacity. (culvert is near entrance to location)
