Inspection Photos
Location Name: Garrett 15-33-6-45
API Number: 095-06120

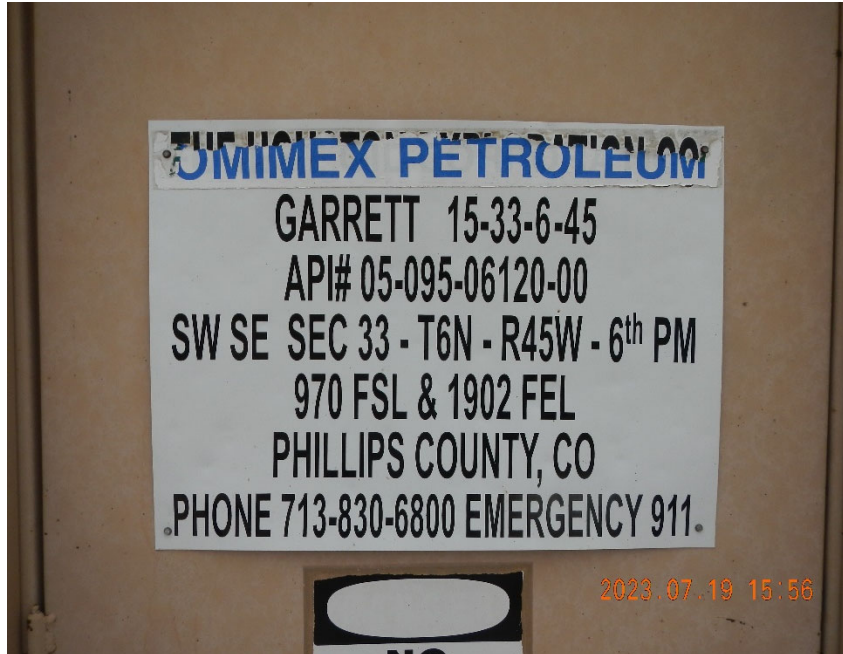
1. Well sign. Emergency contact number is disconnected.

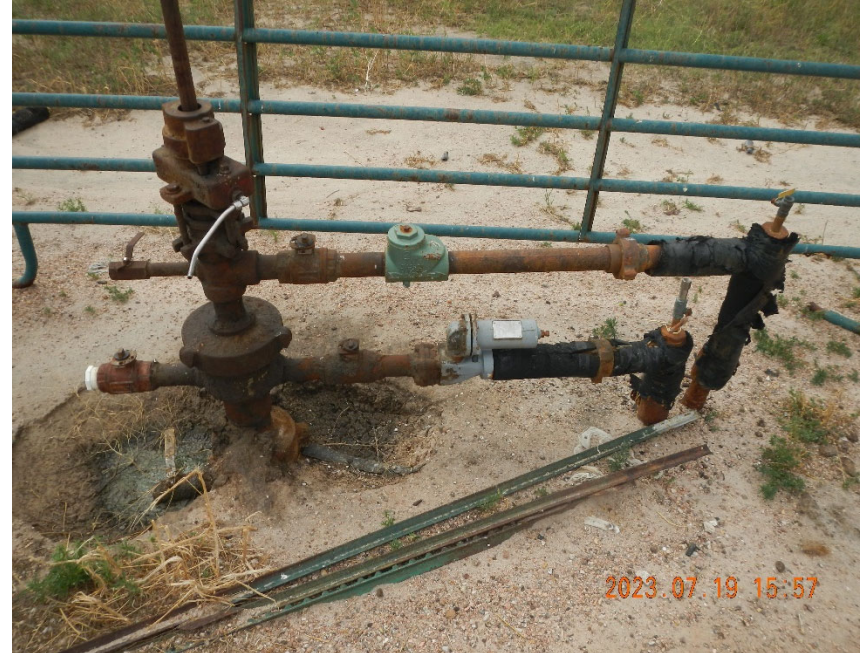
2. View of wellhead. Note soil staining around base of wellhead. Note T Post left at site.

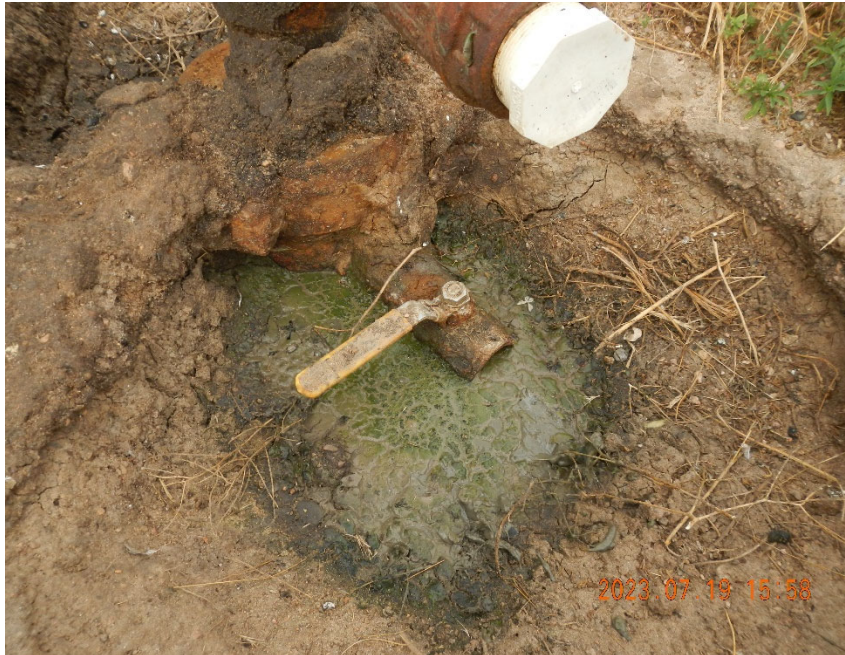
3. Water that has collected around base of wellhead with oily sheen.

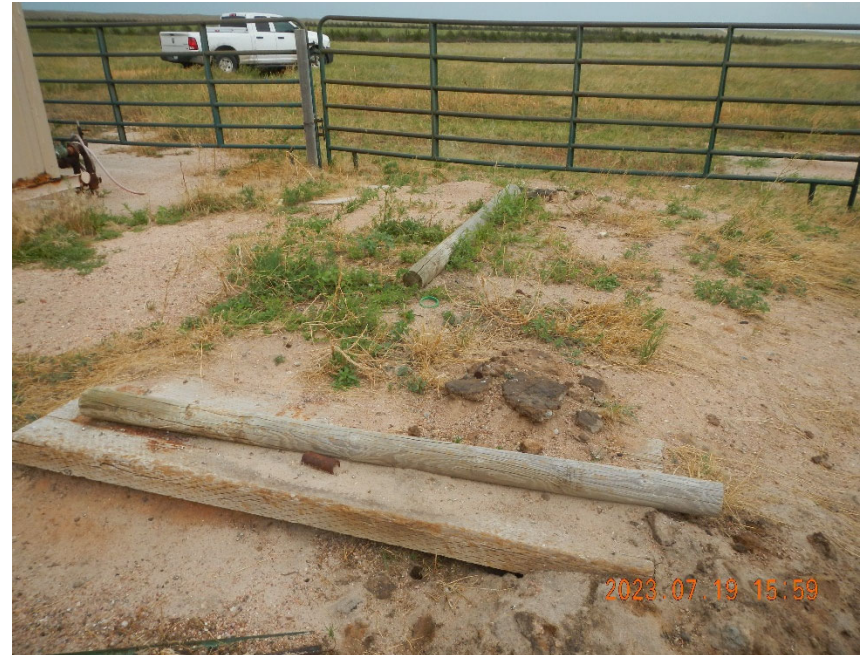
4. Concrete pad with lube oil staining and chunks as identified in pervious inspection still present. Note debris and trash inside fencing.

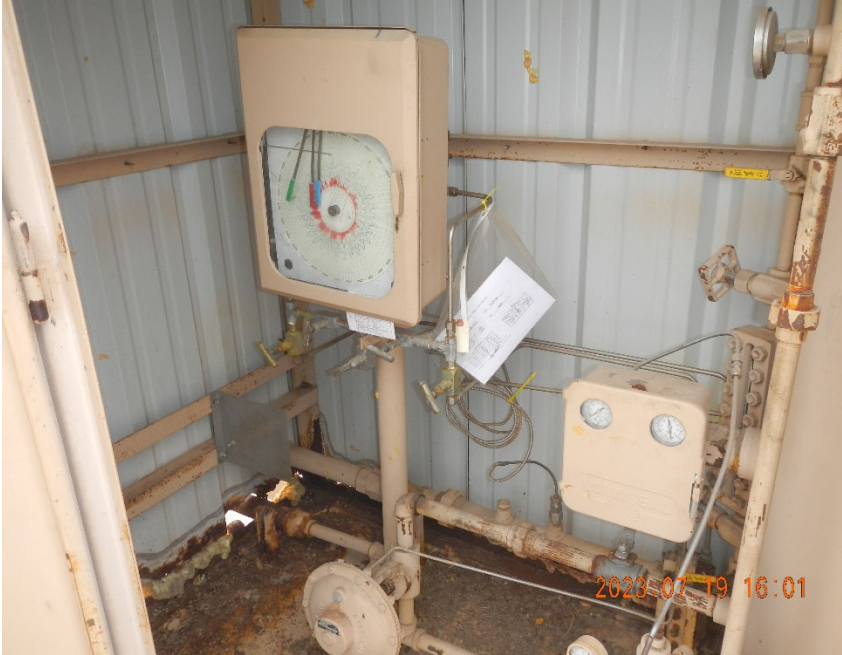
5. View of gas meter run inside meter shed.

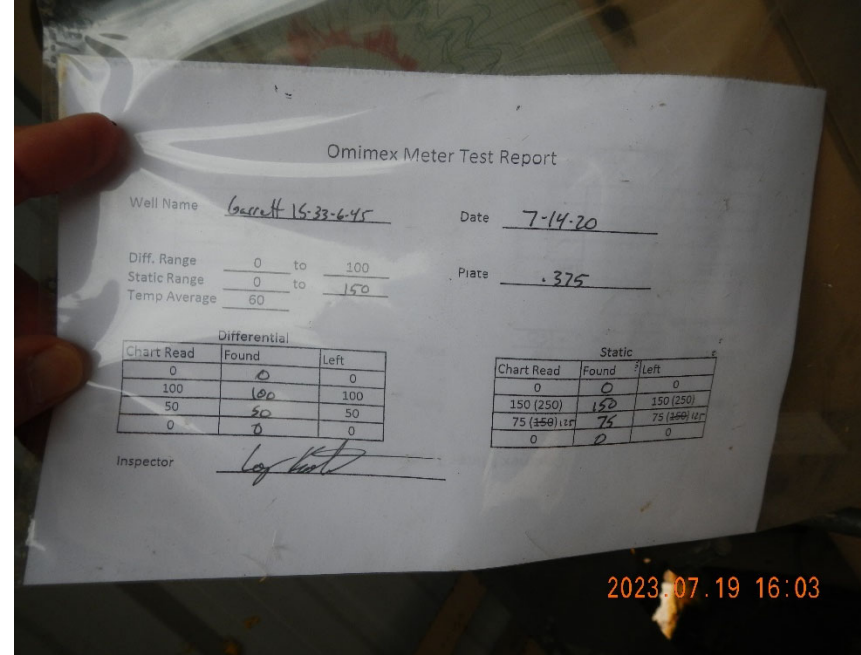
6. Meter calibration test report dated 7-14-20.

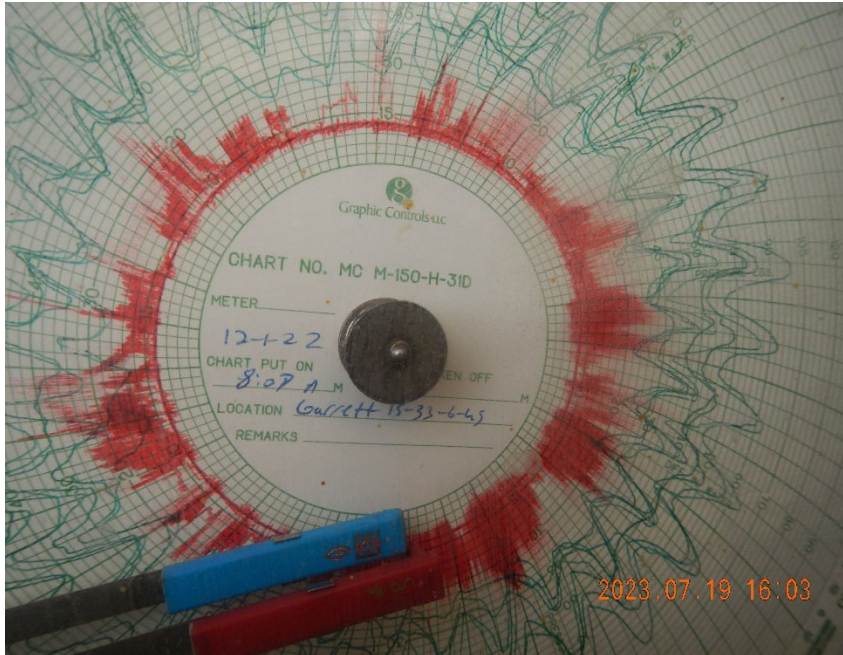
7. Meter chart in meter box at time of inspection dated 12-1-22.

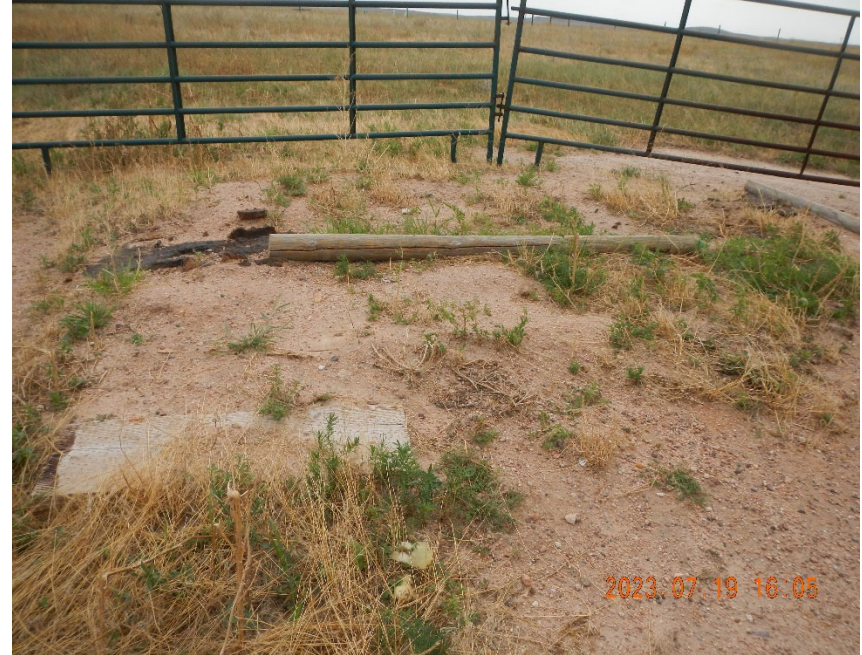
8. Additional view inside well site fencing. Stained soils, production related debris, concrete pad.

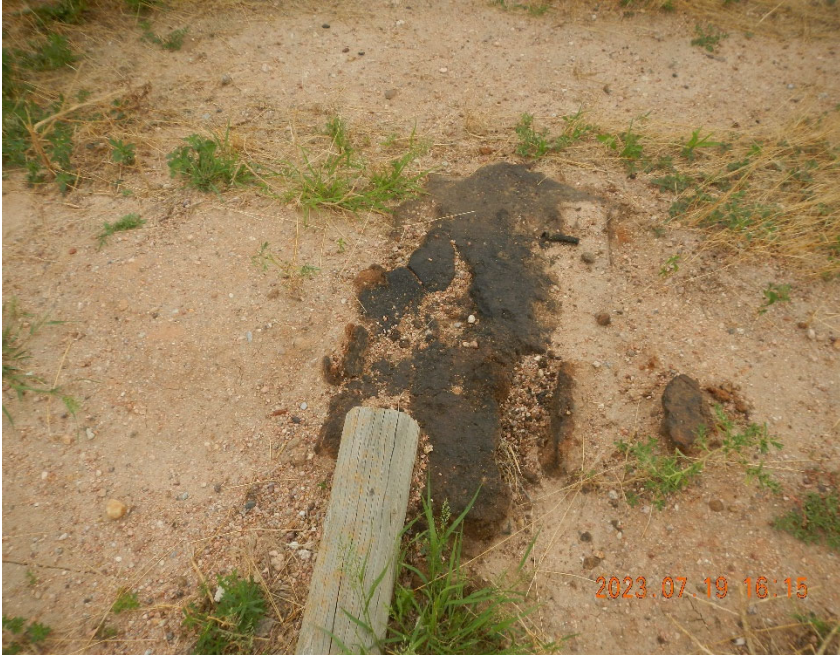
9. Oily staining inside well fencing.

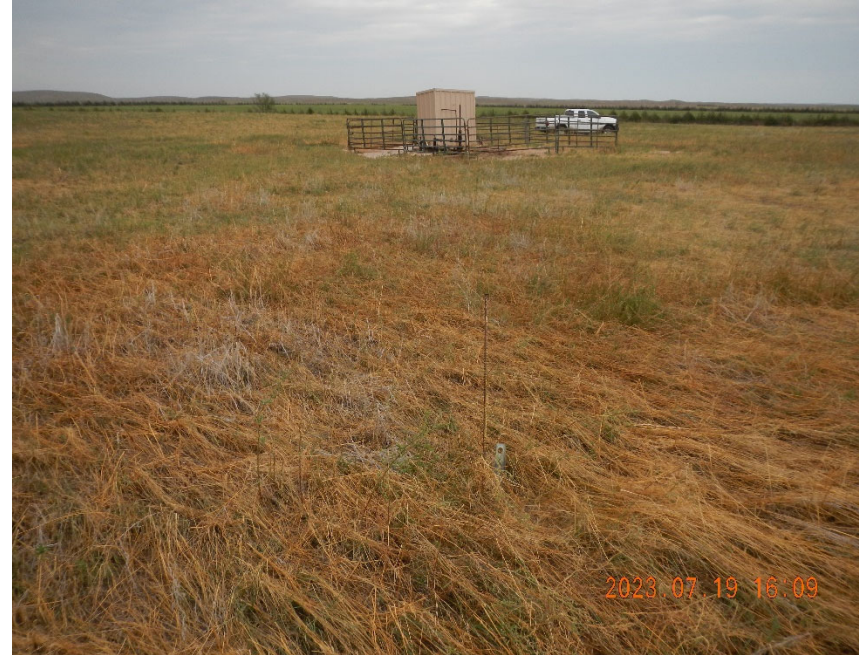
10. One of the four anchors located that require additional marking to comply with rule.
