Inspection Photos

Location Name: TEP ROCKY MOUNTAIN LLC, AMERICAN SODA-67S96W/2SWSW

Location ID: 324088

Date: 7/11/2023

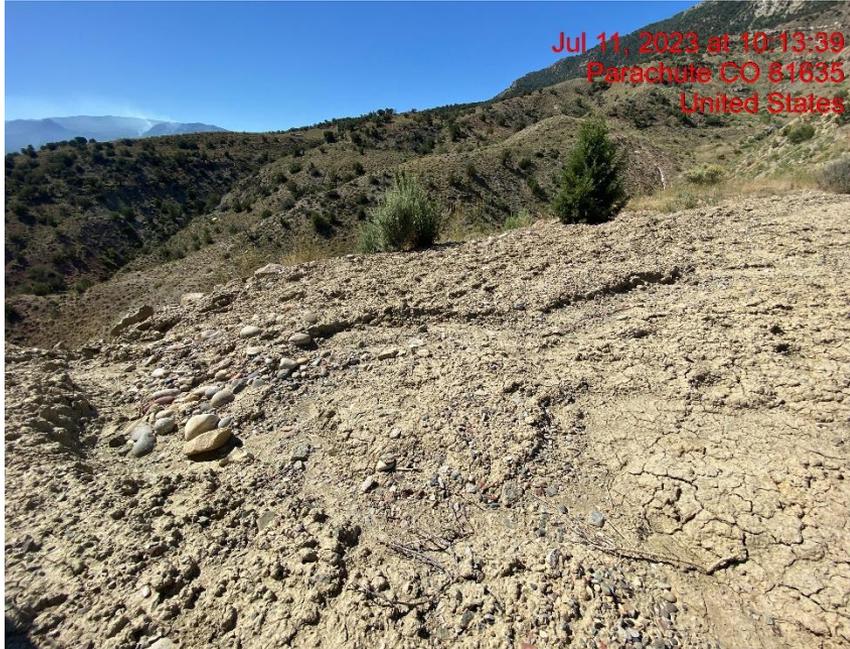
Rill Erosion Transporting Sediment Onto Location – Photo #05149

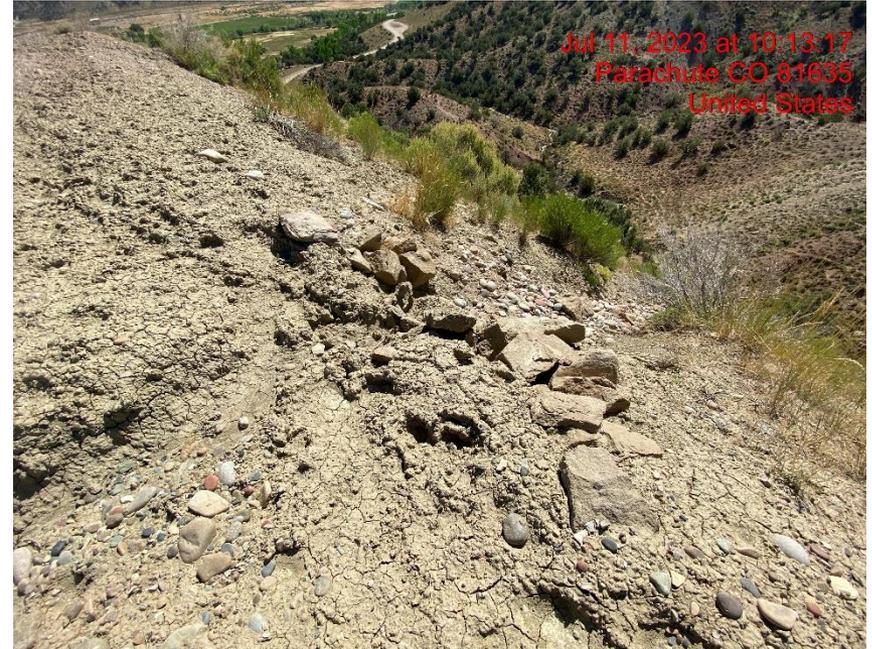
Check Dam Needs Maintenance – Photo #05147

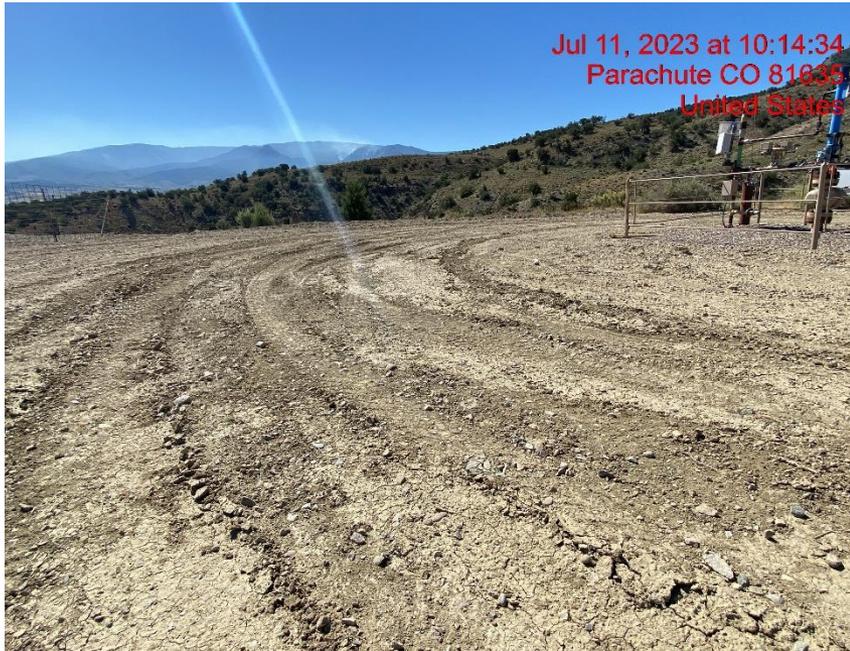
Location Lacks Stabilization – Photo #05153

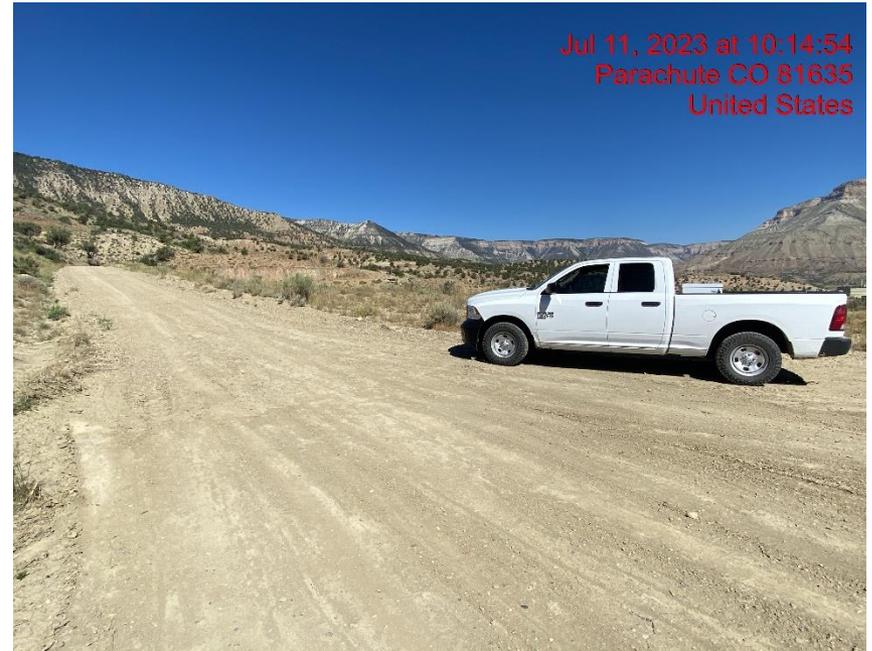
**Insufficient Vehicle Tracking BMPs at Location Entrance/Exit
– Photo #05154**
