Inspection Photos

Location Name: TEP ROCKY MOUNTAIN LLC, GM/42-11 Frac Pad

Location ID: 334956

Date: 7/11/2023

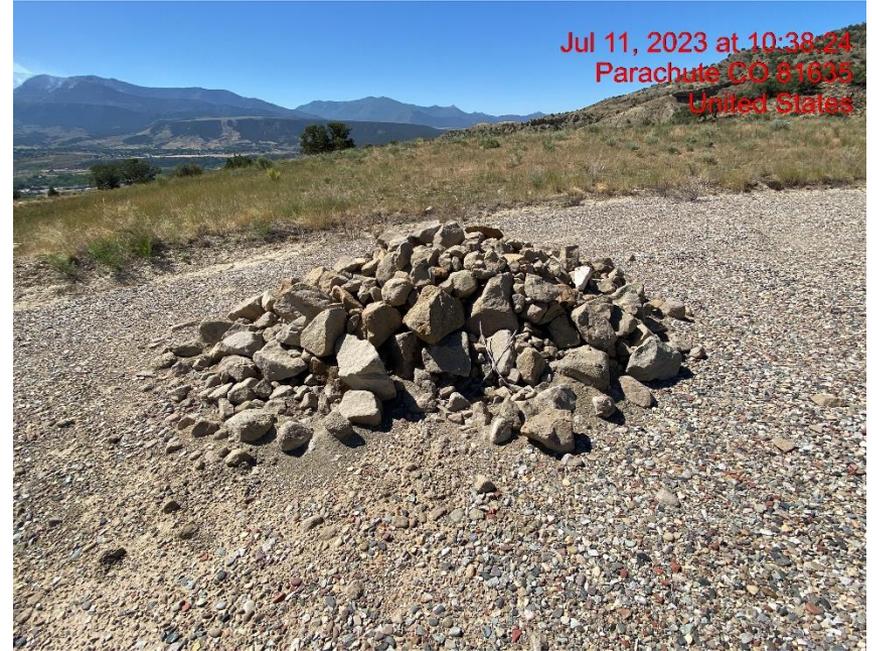
Unprotected Stockpile – Photo #05183

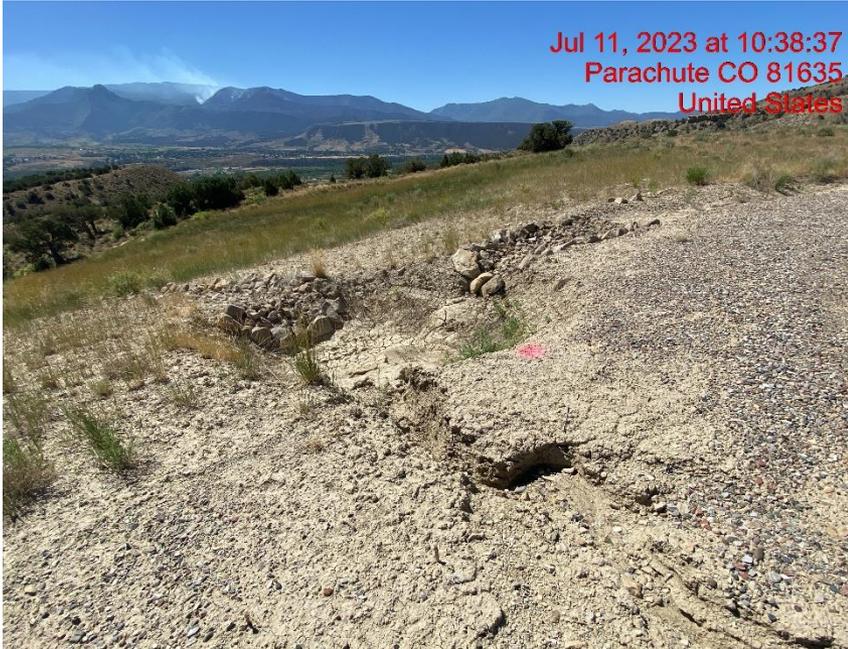
**Inadequate Erosion Control of Location Surface – Photo
#05184**
