**Gadeco LLC**  
**Hiawatha State 2-36**  
**Loc ID: 313297**

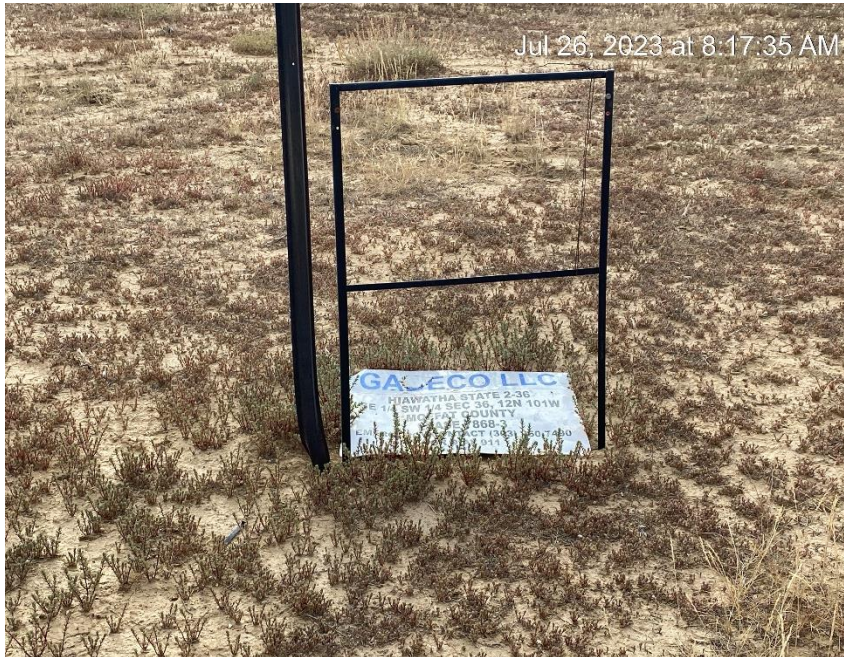
**Sign at intersection of access and lease road**

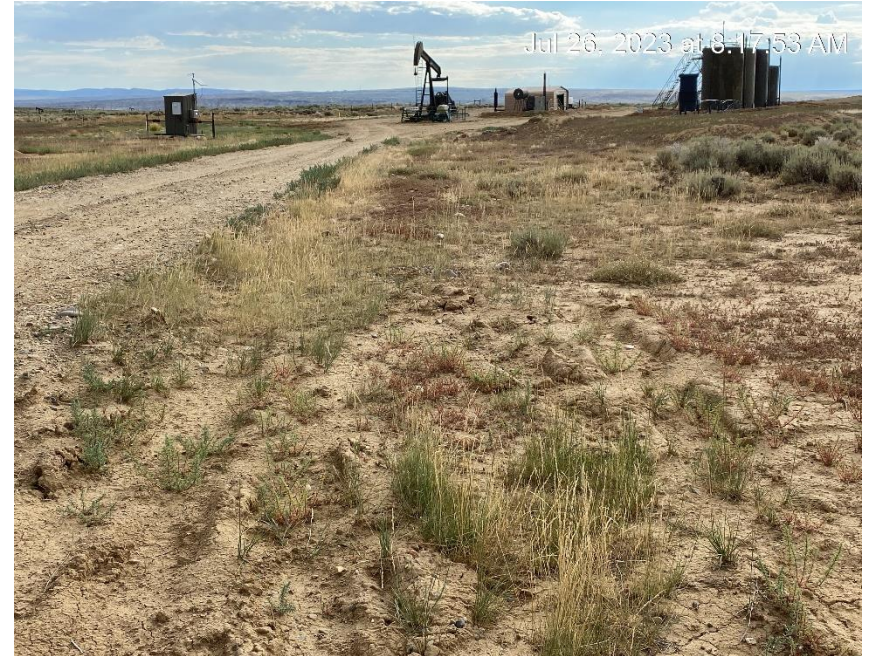
**Access road to location**

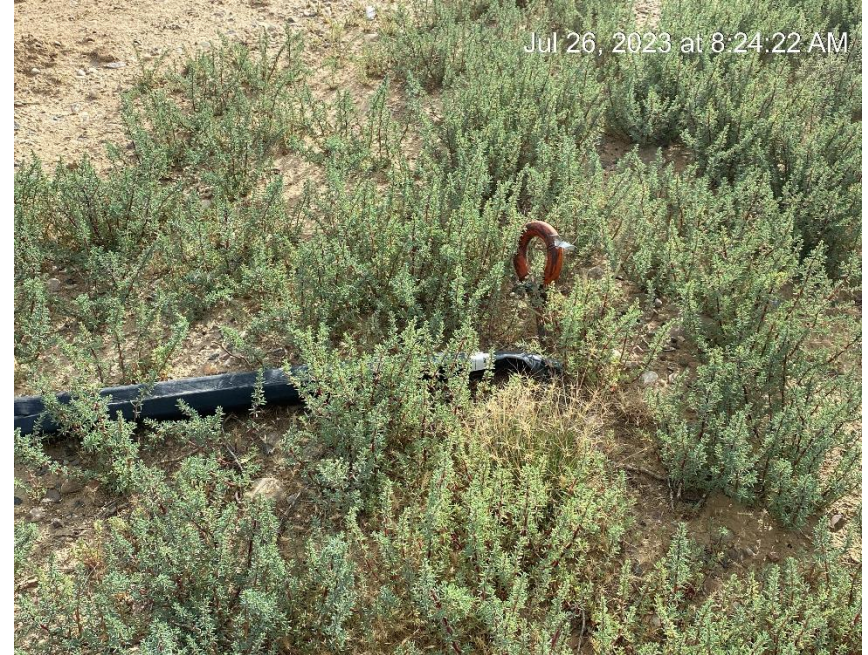
**Unmarked anchor**

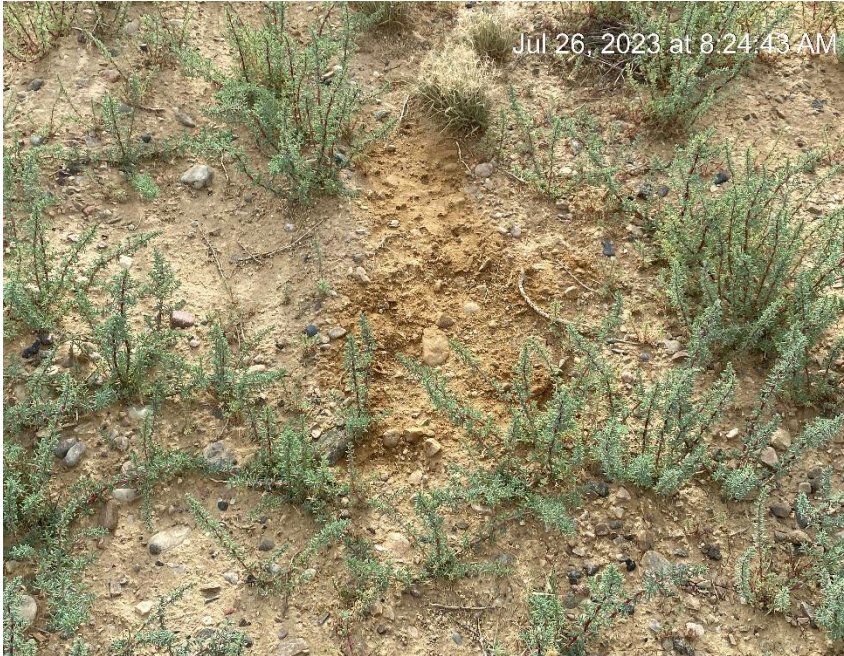
**Stained soil**

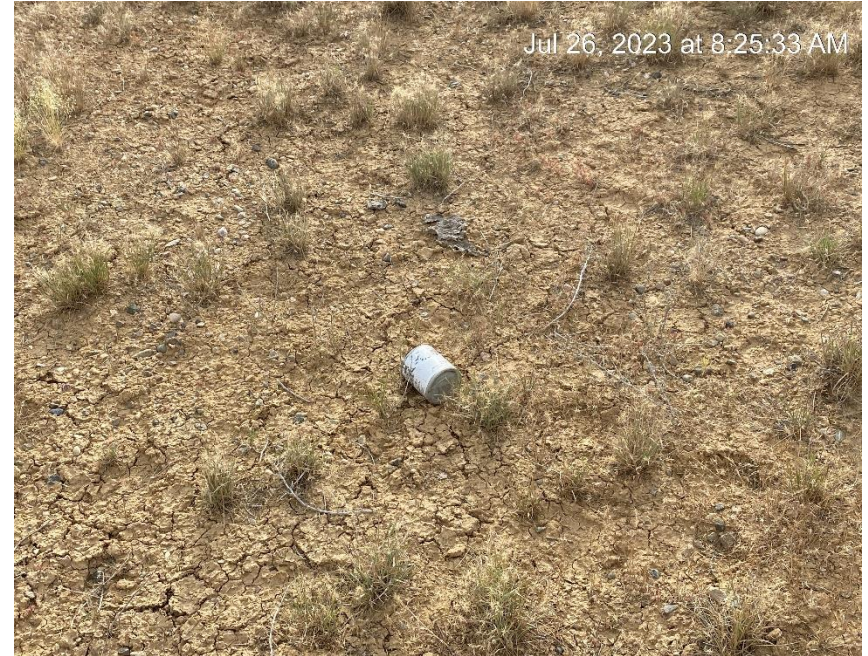
**Debris**

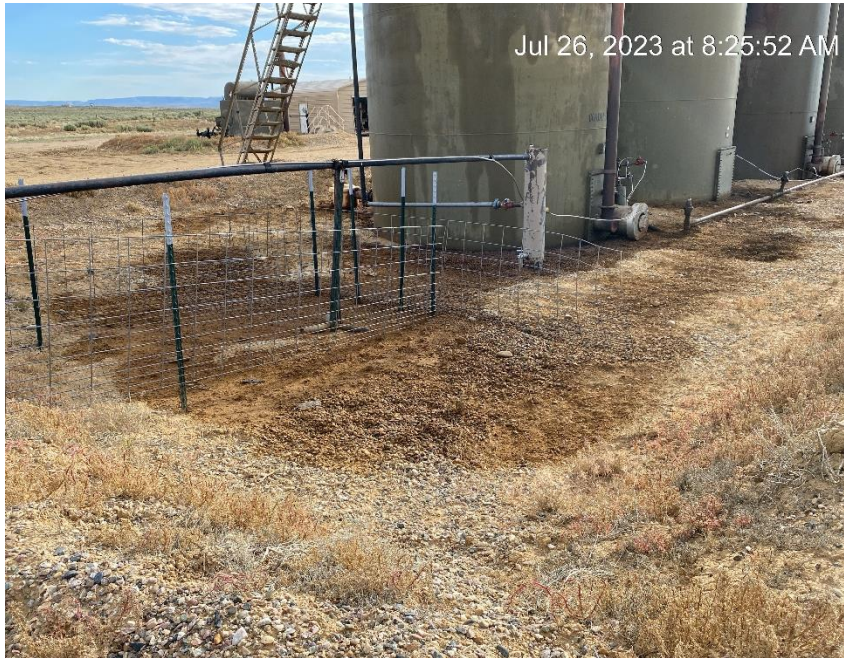
**Stained soils**

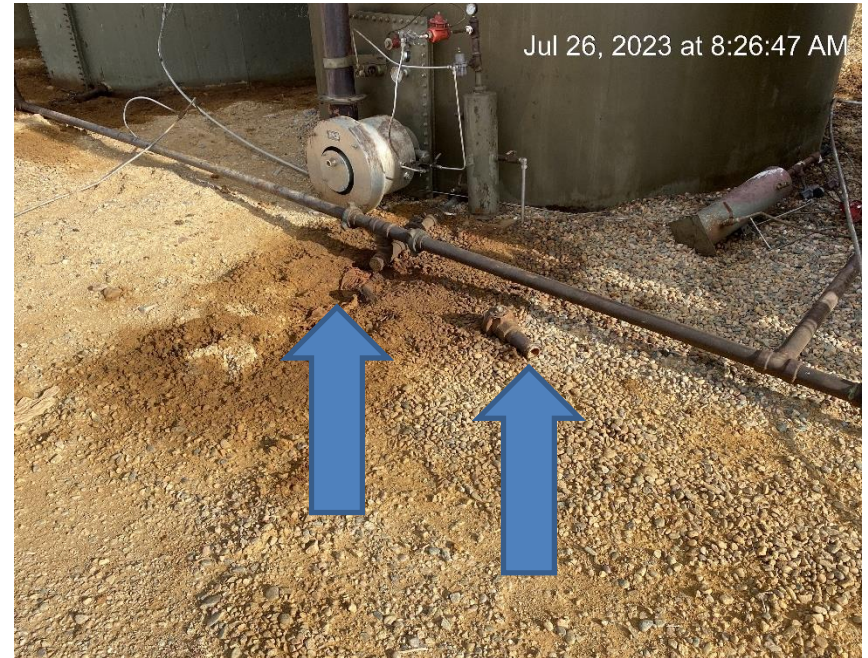
**Debris**

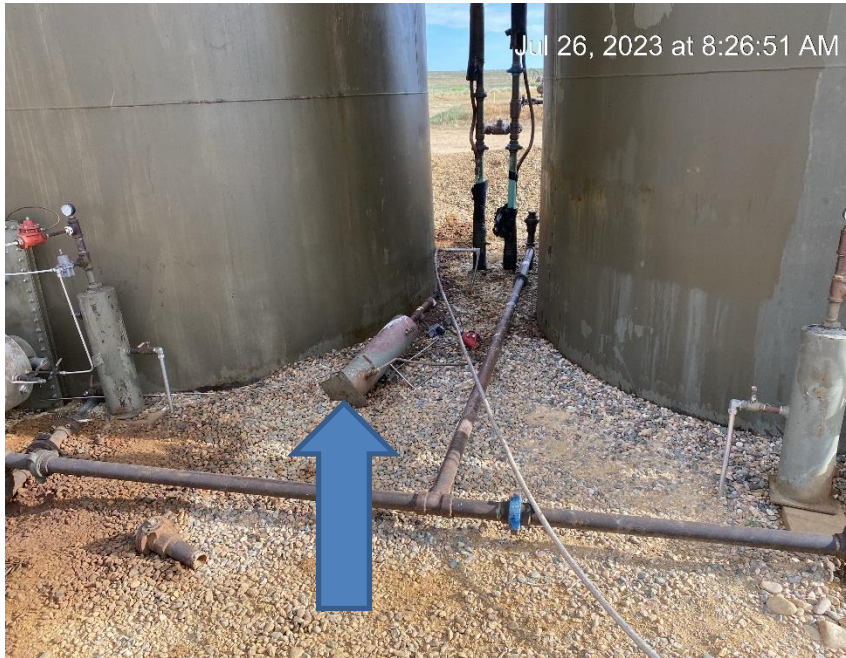
**Unused equipment**

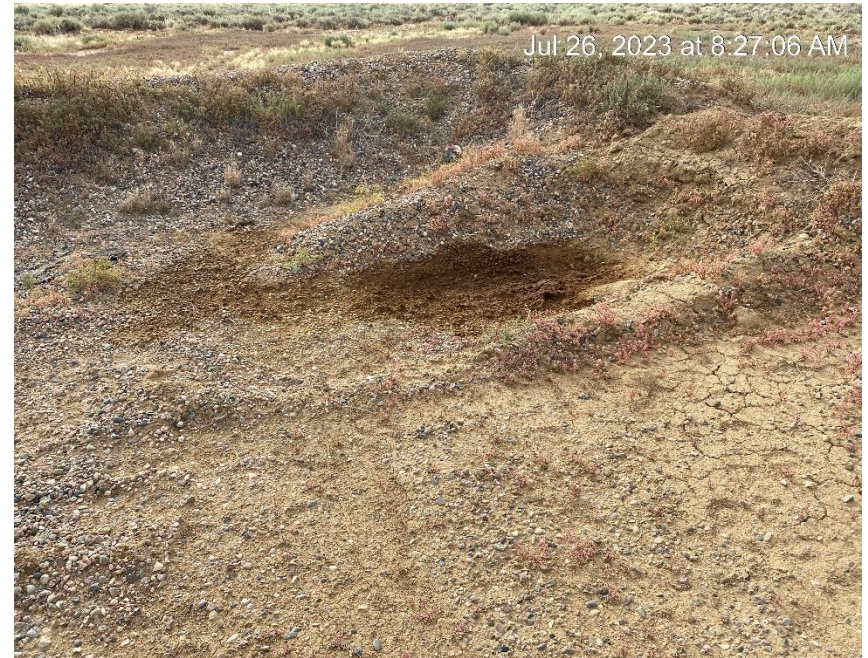
**Stained soil**

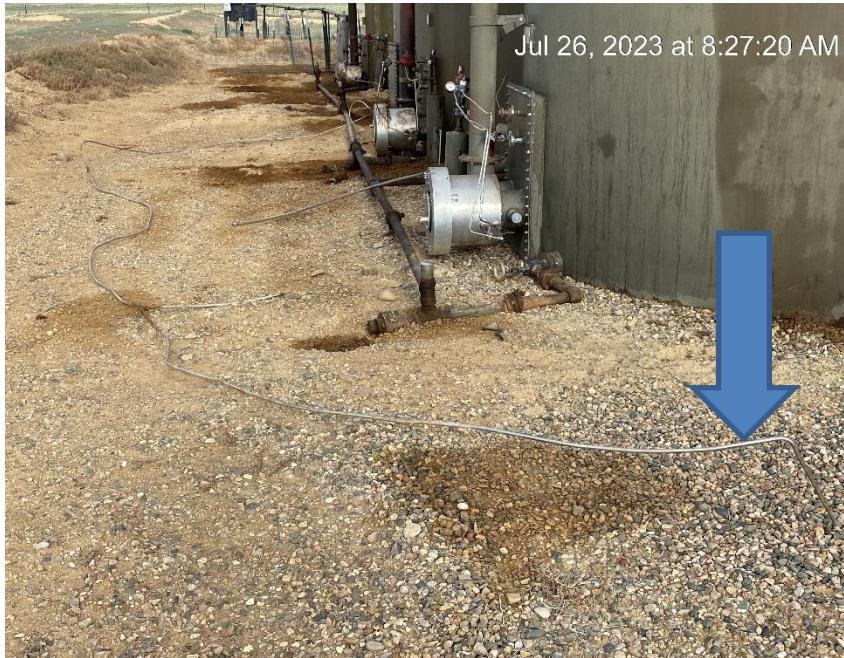
**Debris and stained soil**

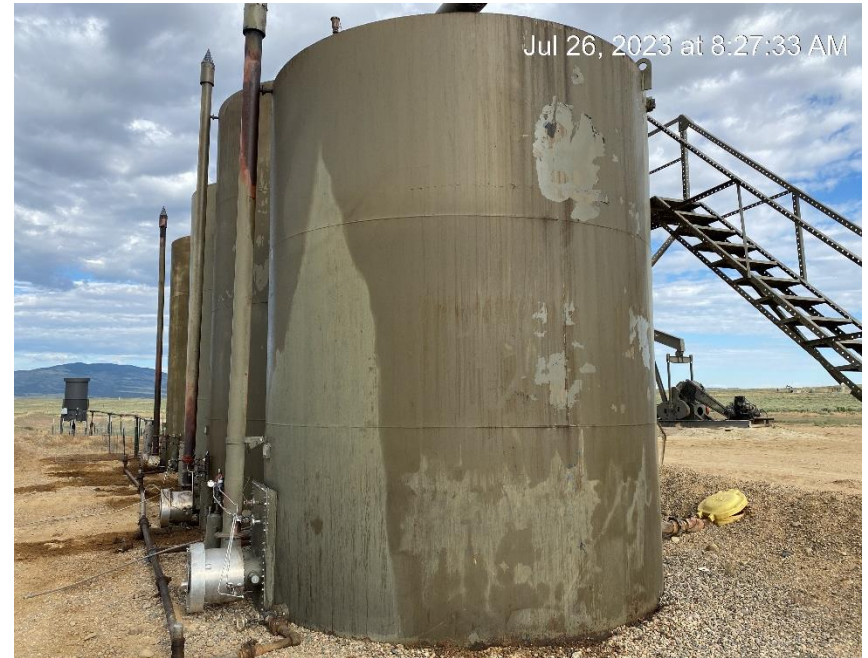
**Oily waste covering tank and on the ground**

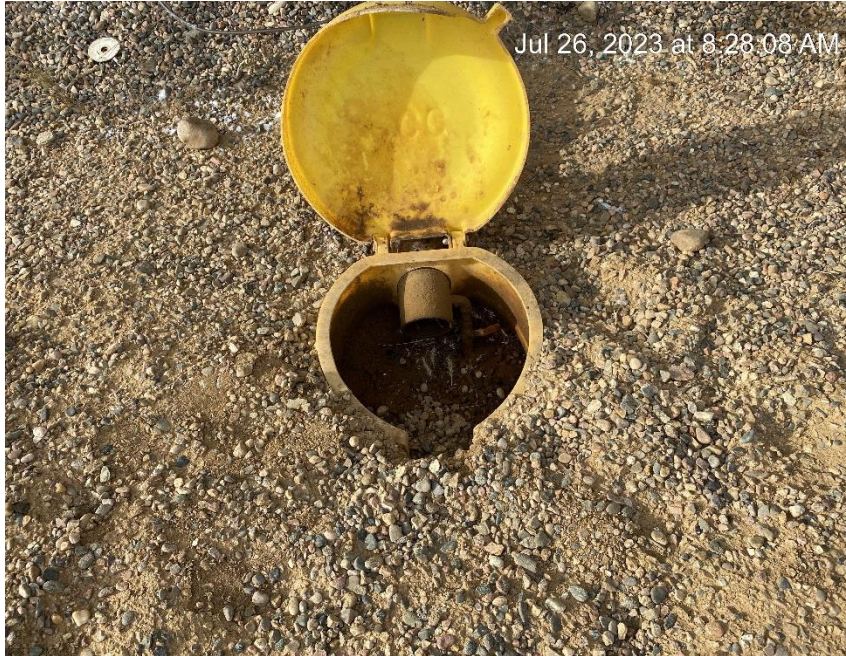
**Open end loadline**

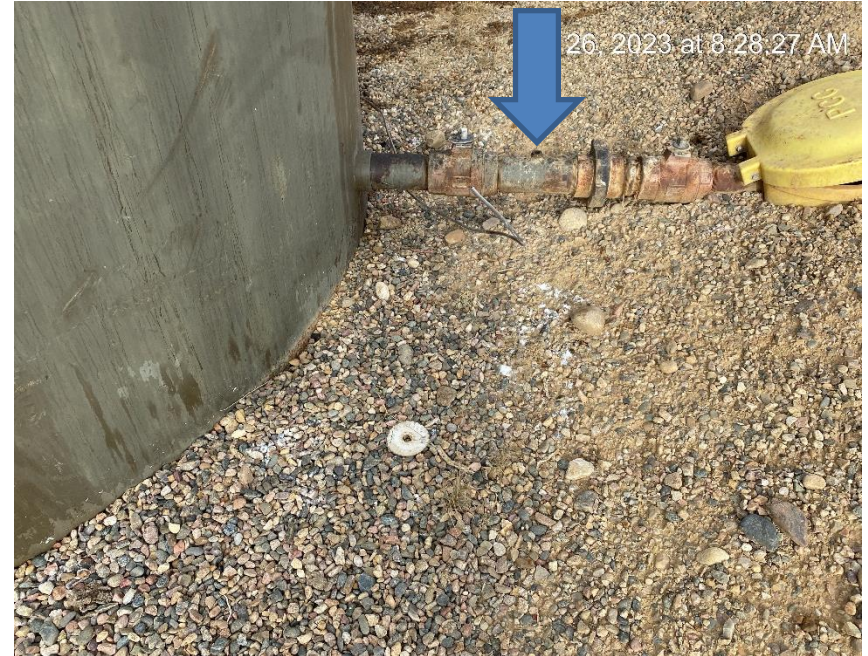
**Open loadline**

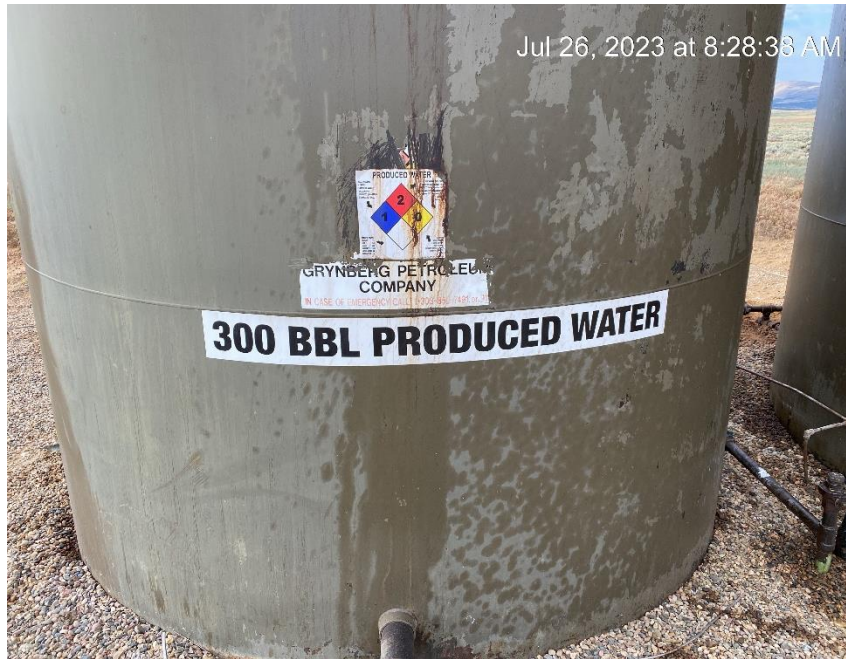
Tank missing required information

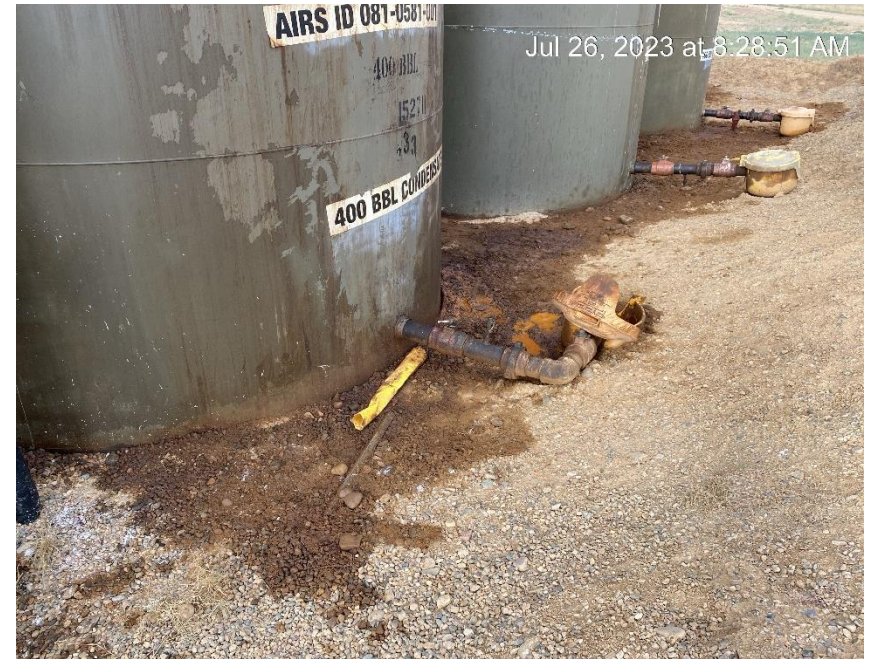
Debris and stained soil

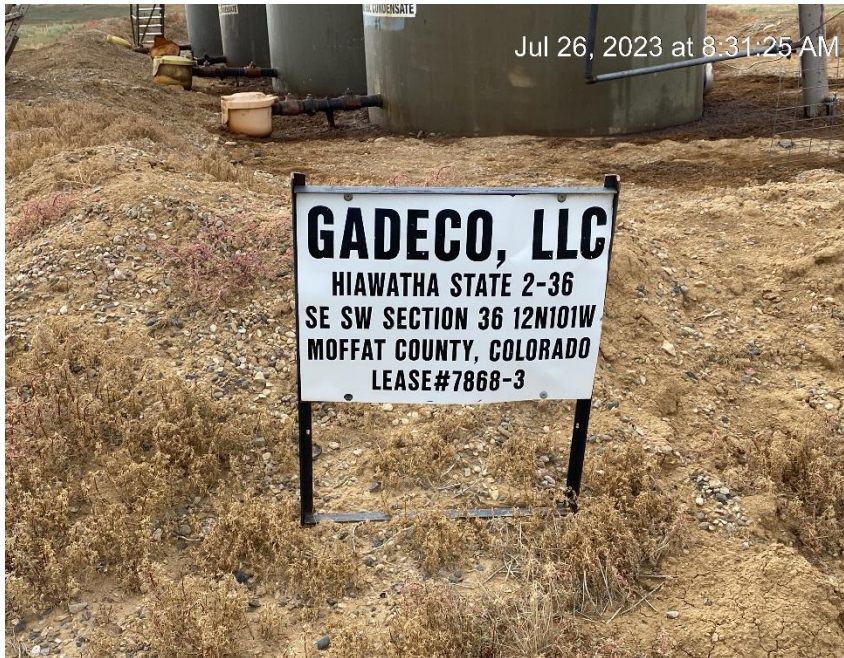
**Tank battery sign missing required information**

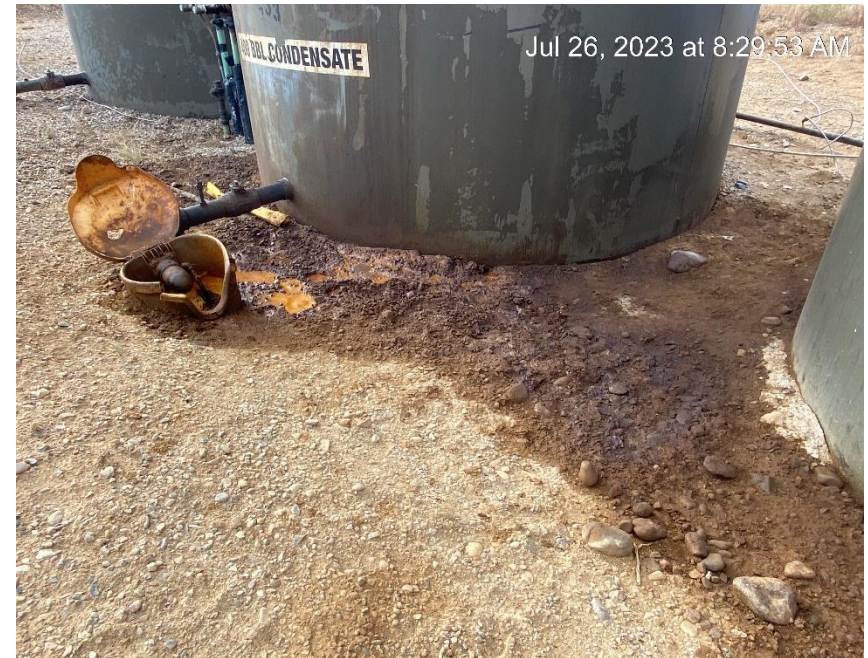
**Debris, oily waste and stained soil**

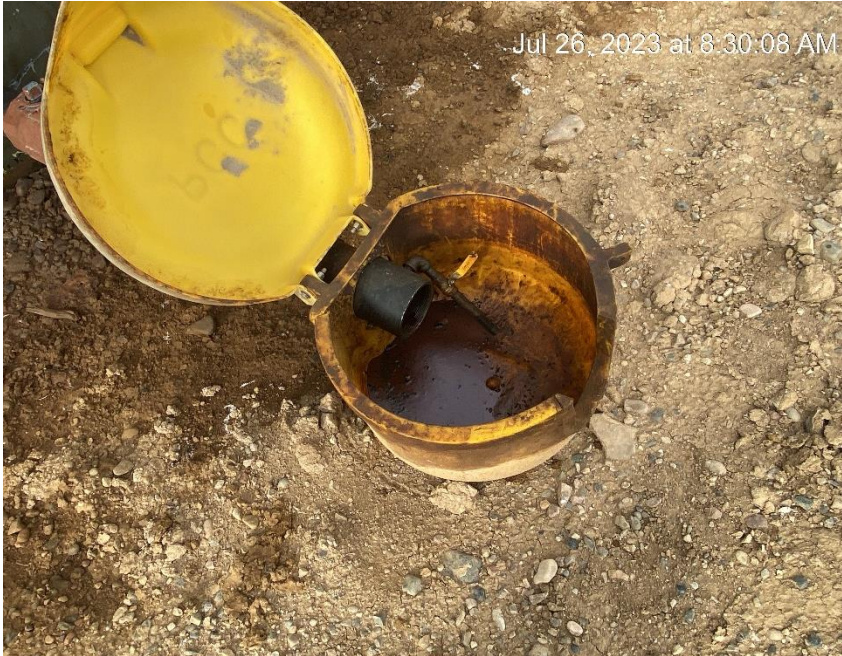
Open end loadline

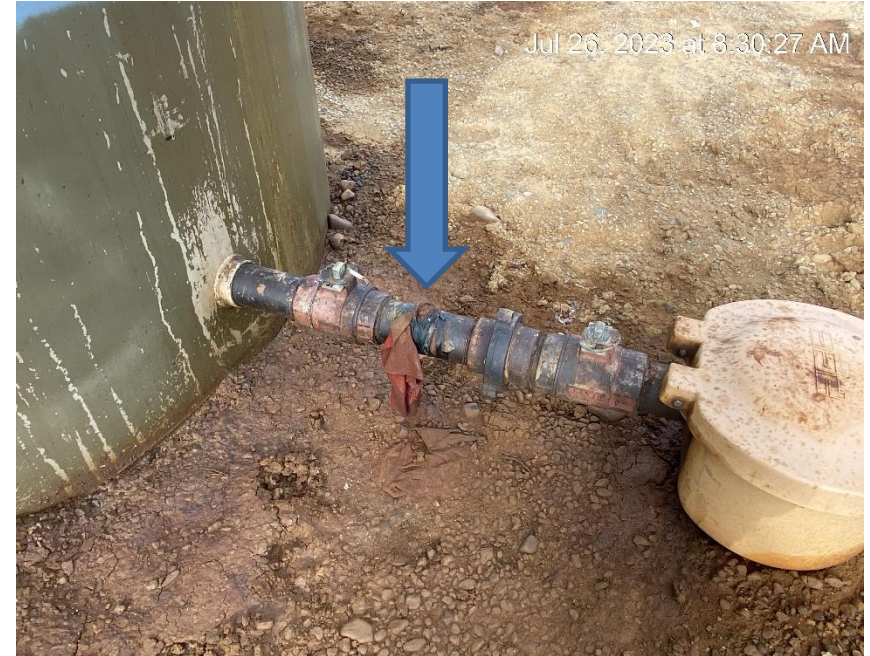
No plug in loadline

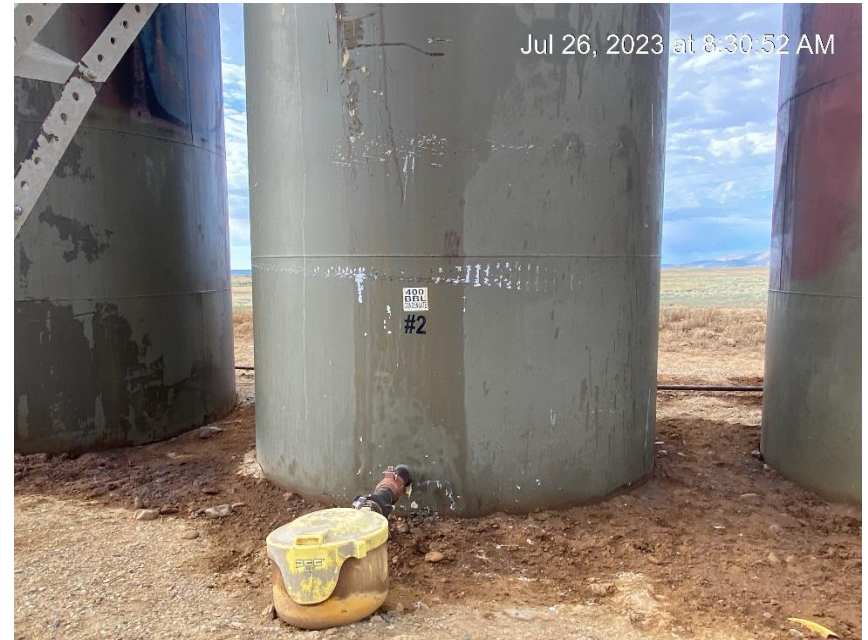
**Tank missing required information**

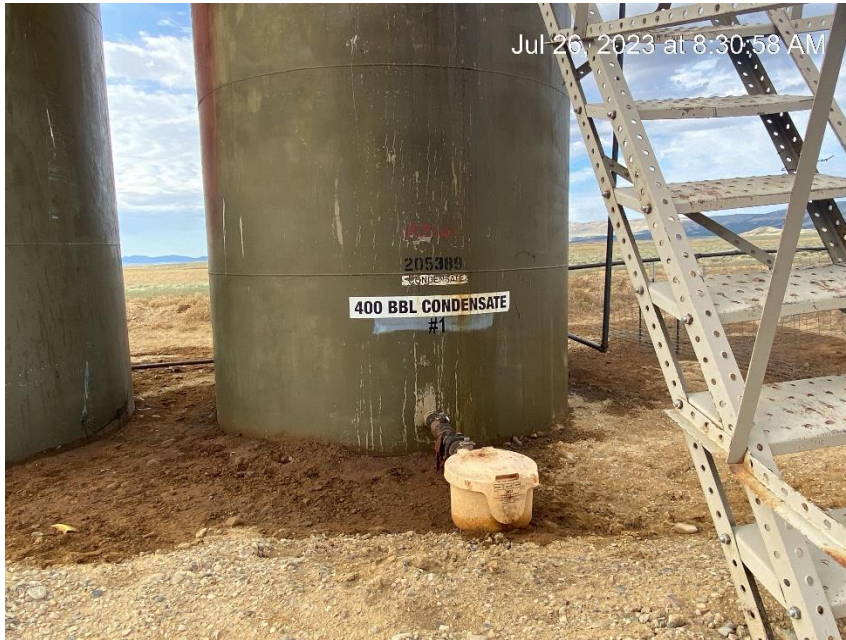
**Tank missing required information**

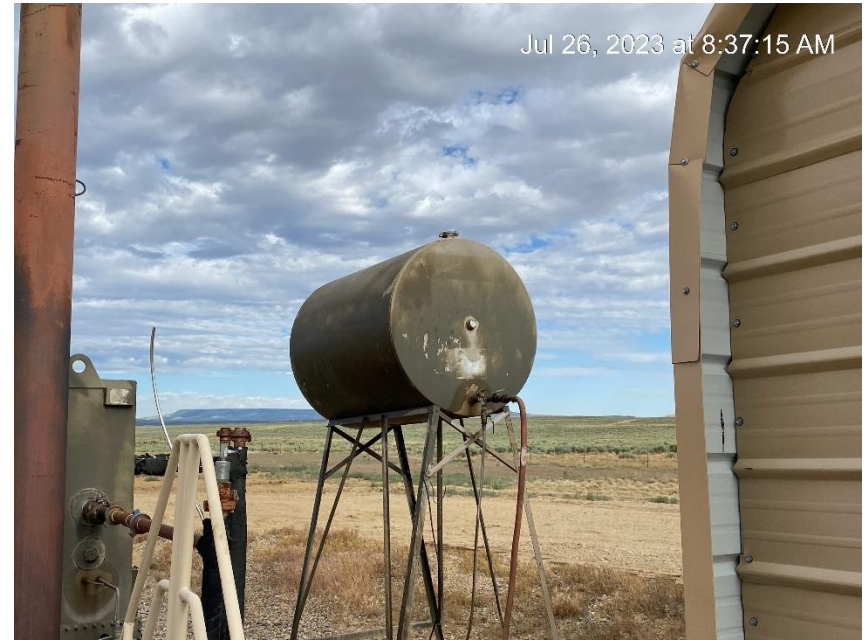
**Tank not labeled**

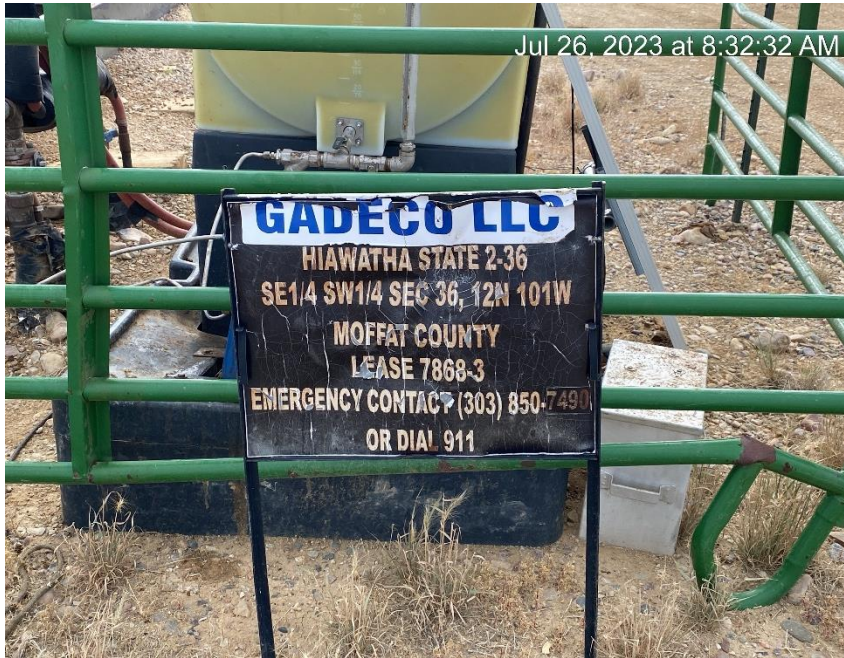
**Sign at wellhead missing required information**

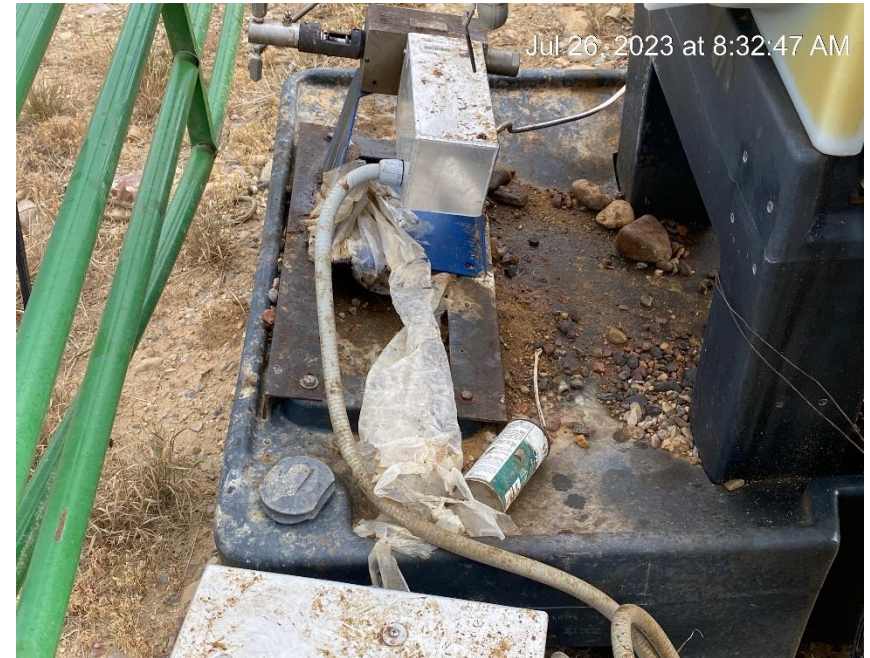
**Debris**

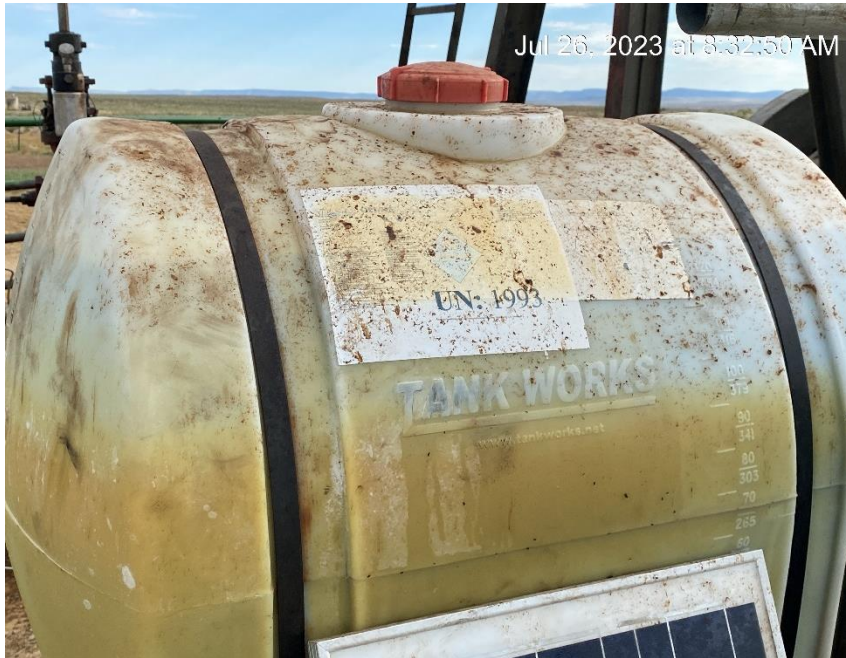
Illegible chemical label

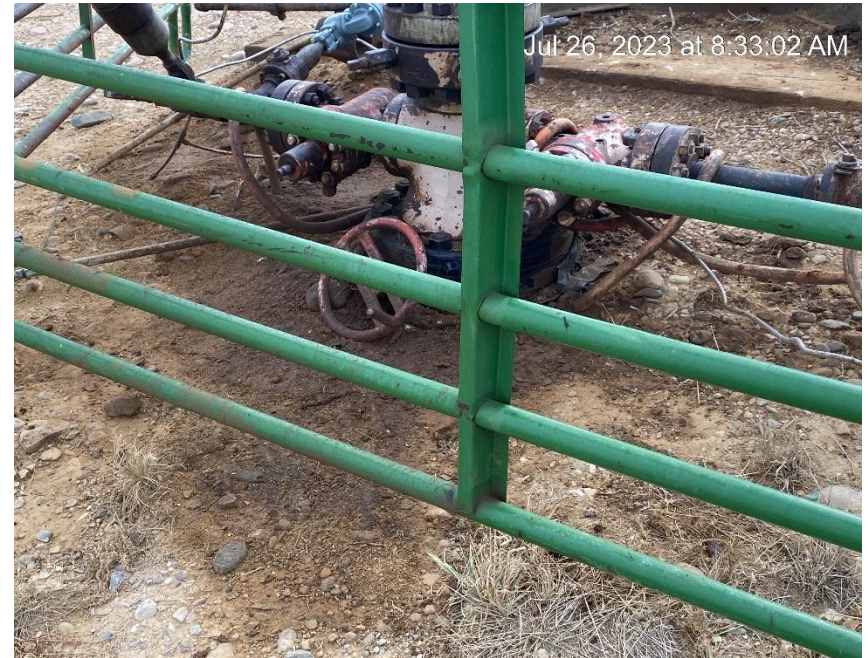
Bradenhead not visible or accessible

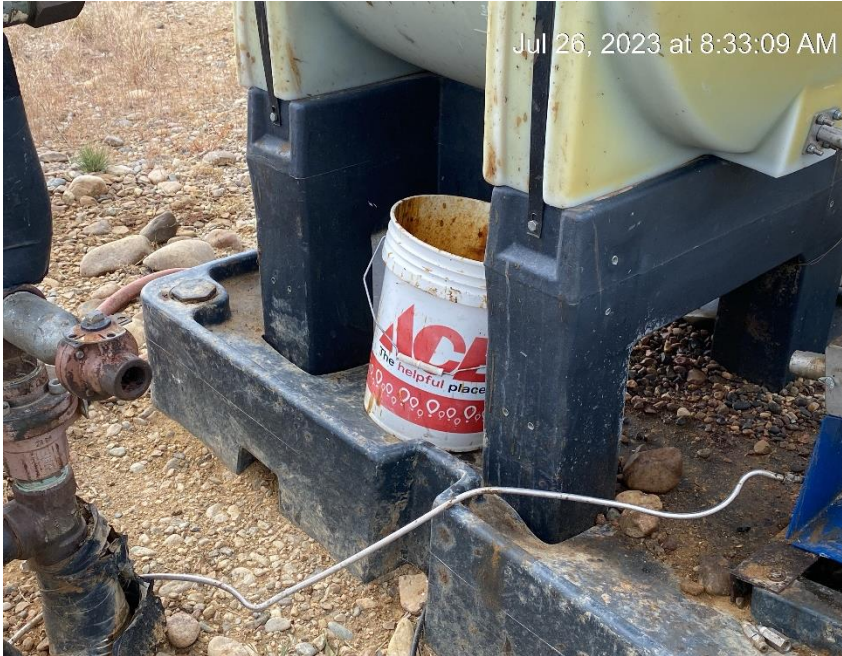
**Debris**

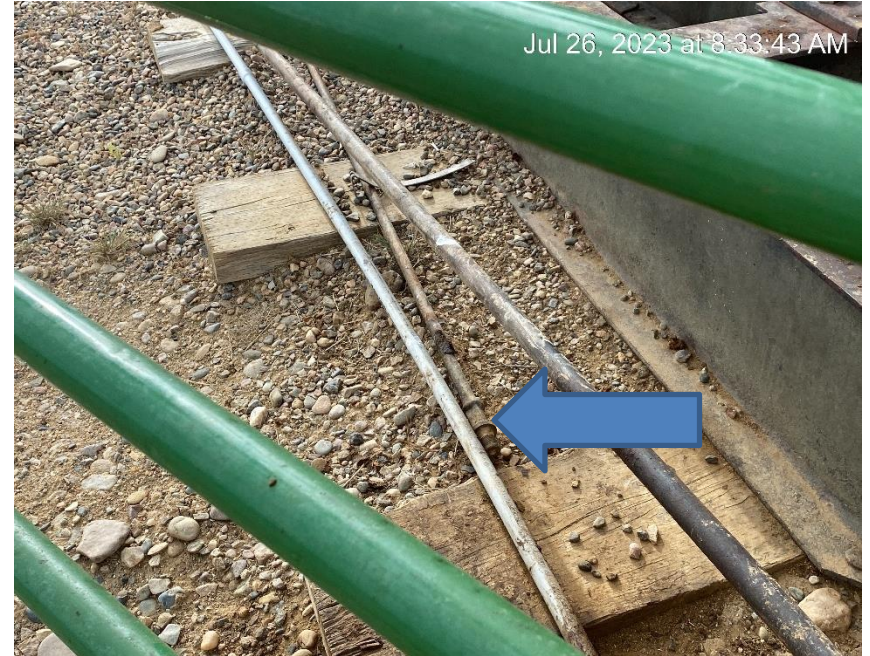
**Unused equipment**

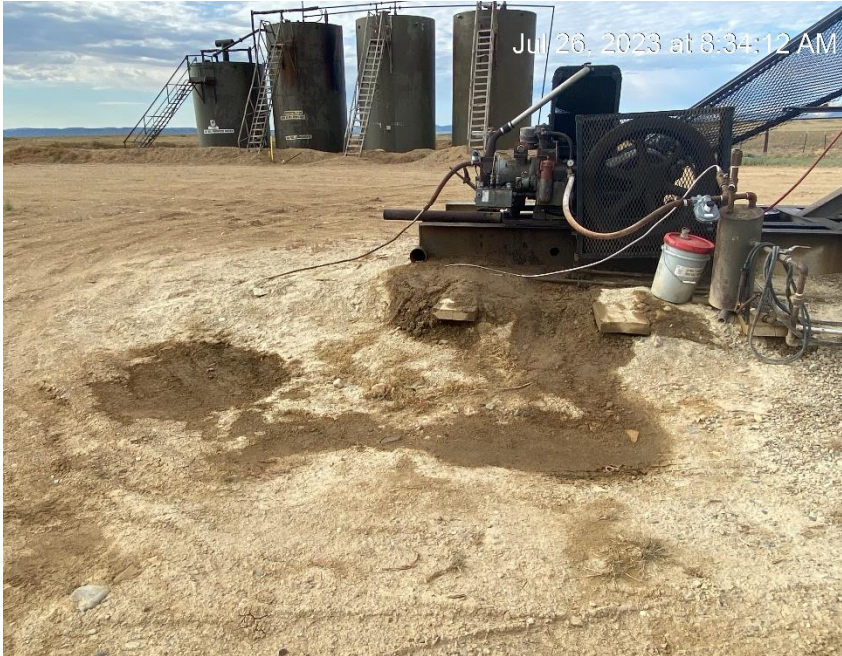
**Leaking equipment and stained soil**

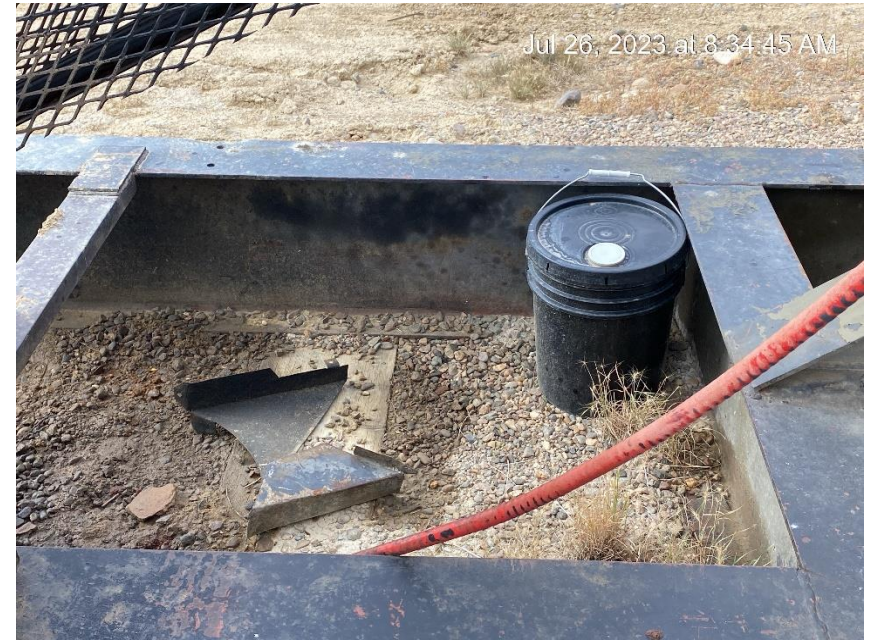
**Debris and stained soil**

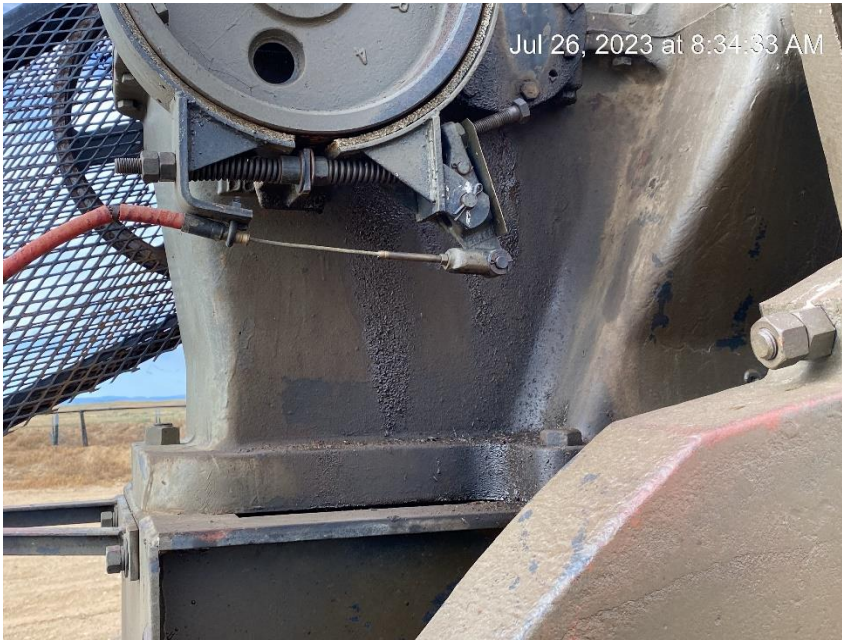
**Leaking equipment**

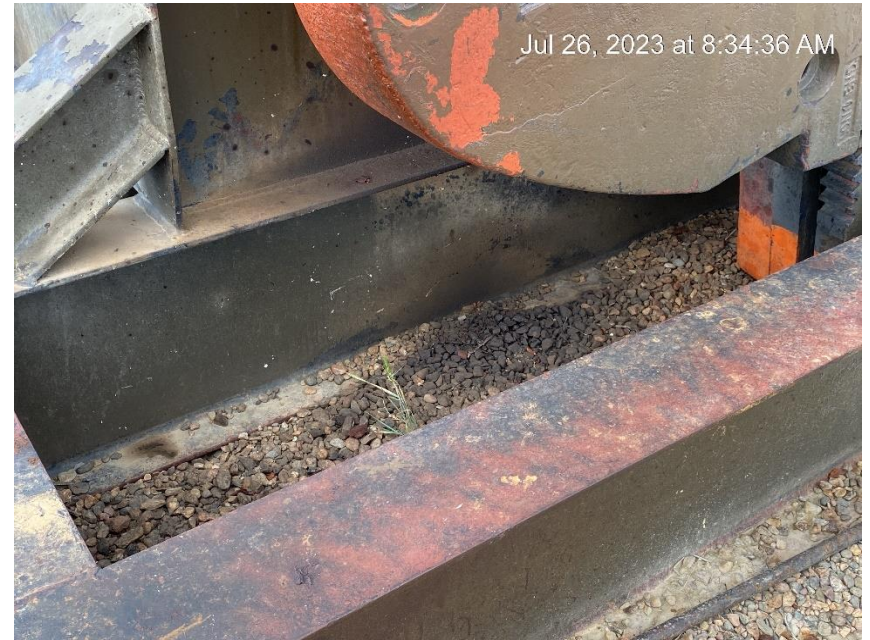
**Stained equipment and soil**

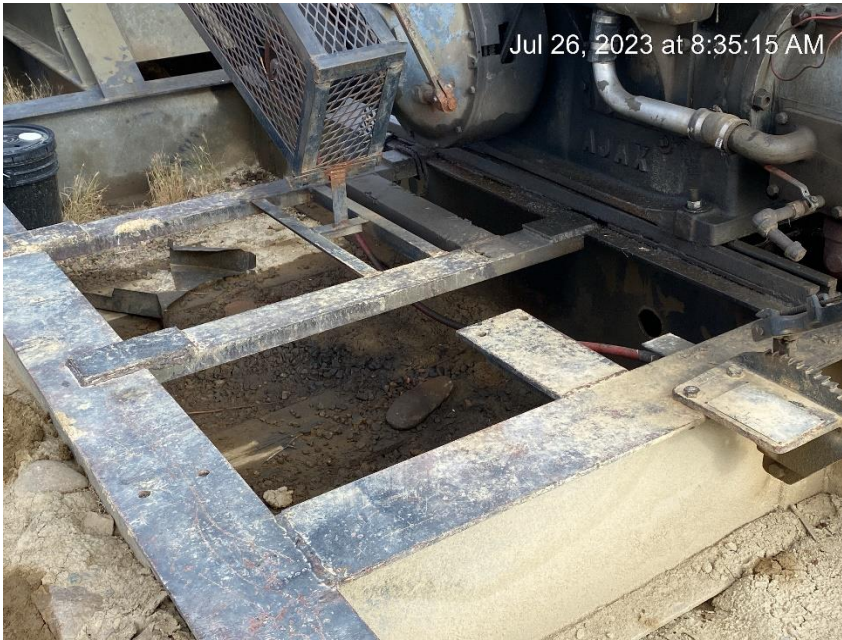
**Stained soil and debris**

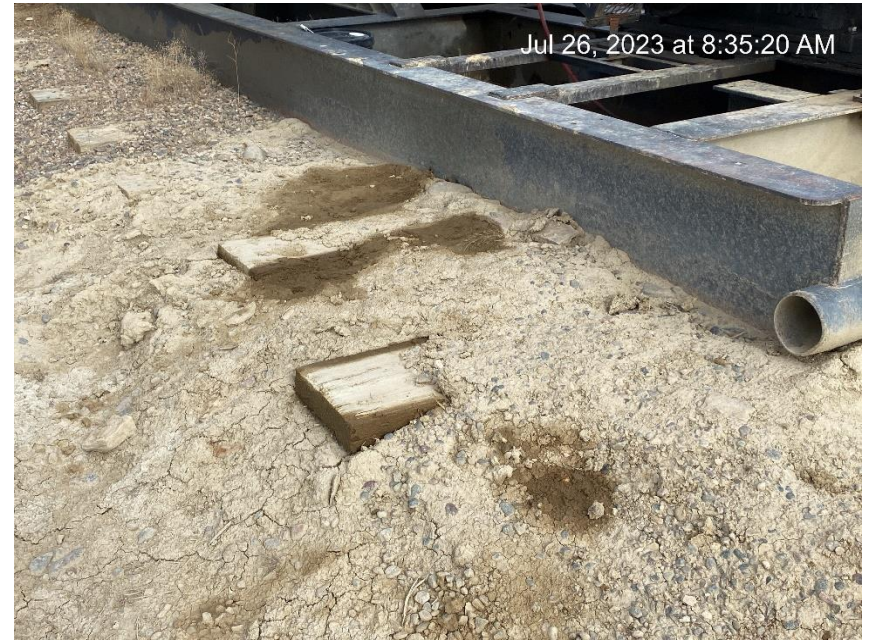
**Stained soil**

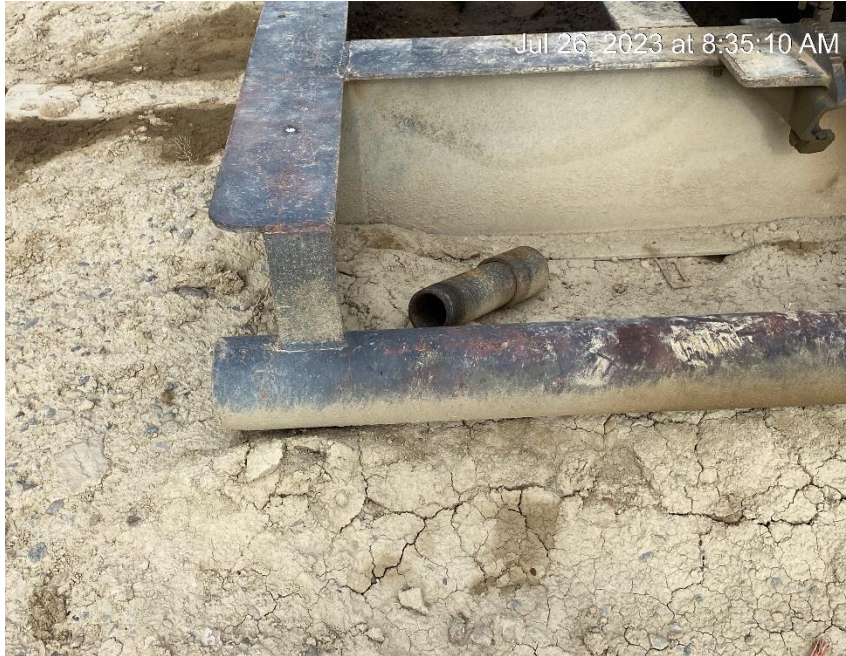
**Debris**

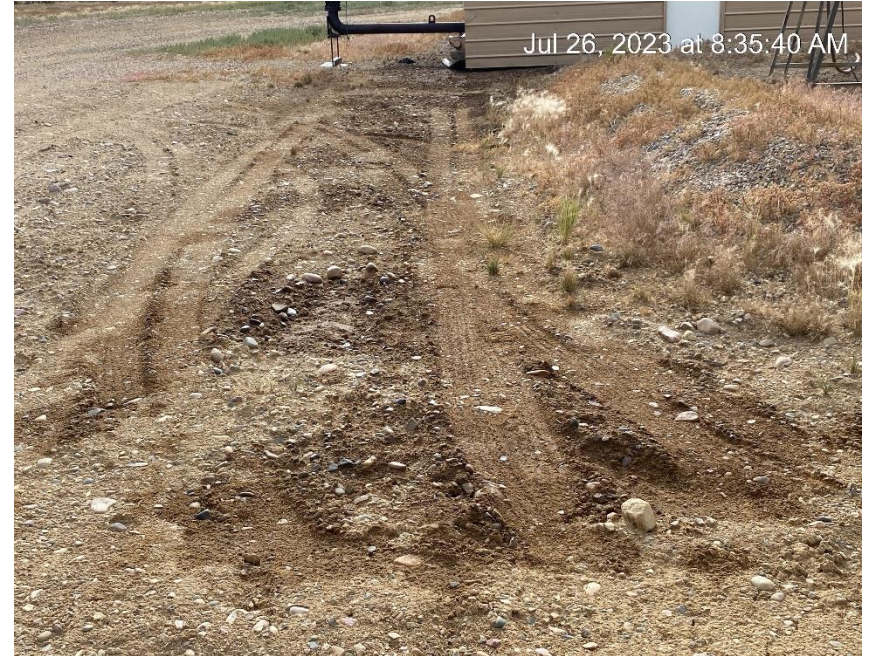
**Stained soils**

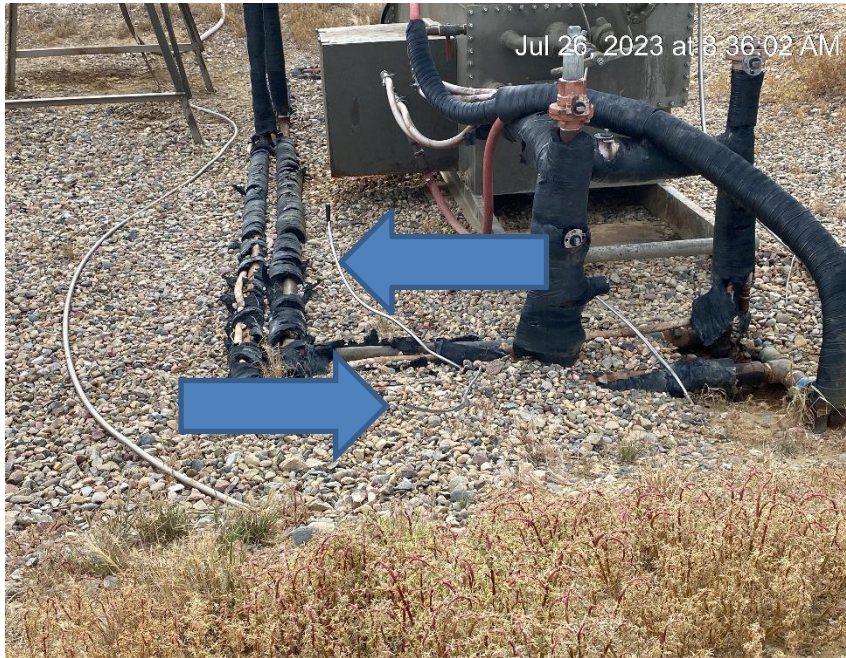
Debris

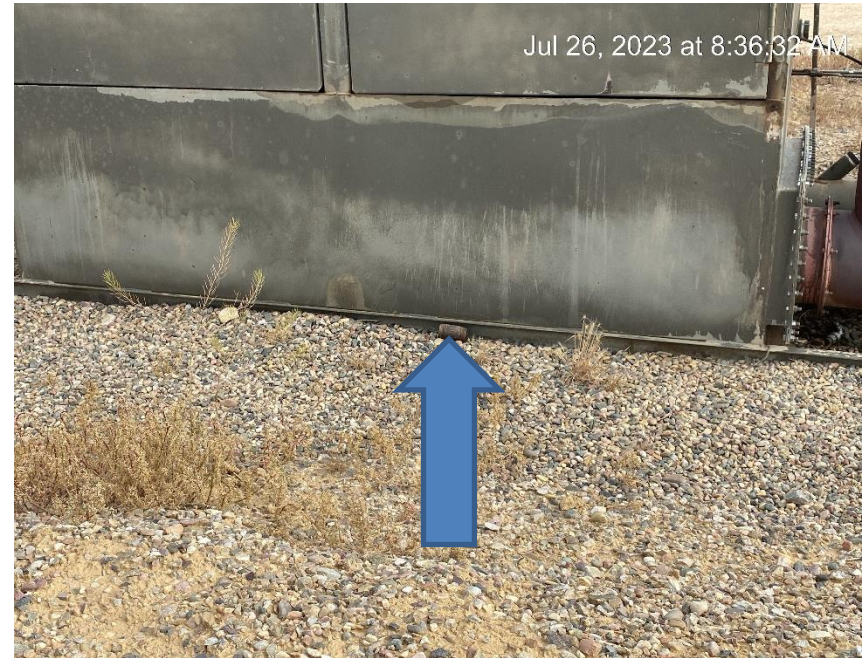
Debris

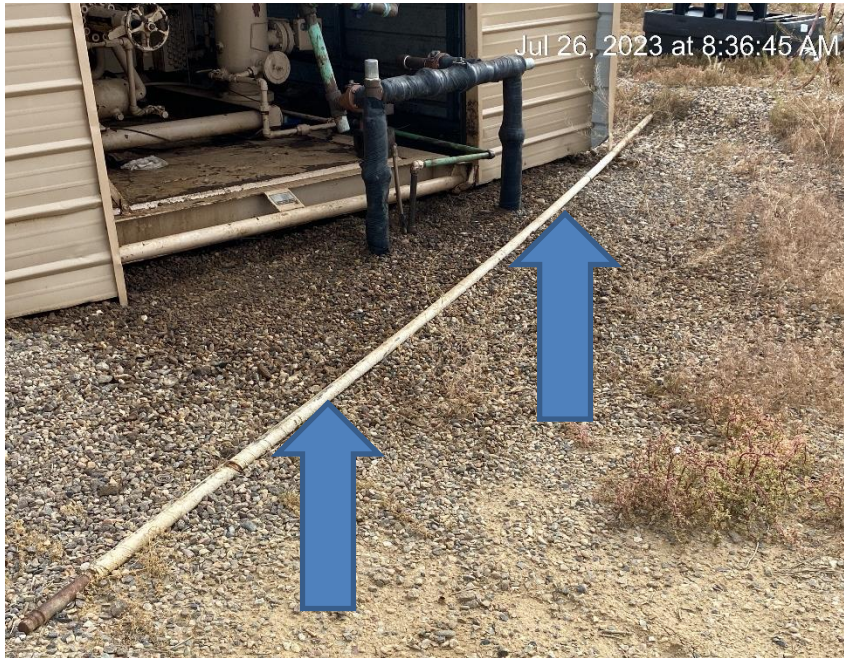
**Unused equipment**

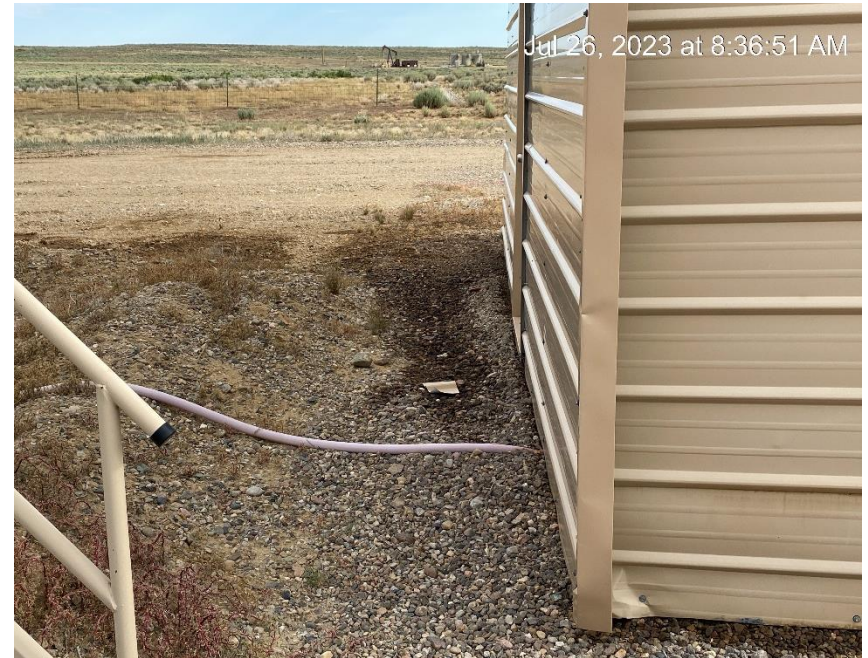
**Stained soil**

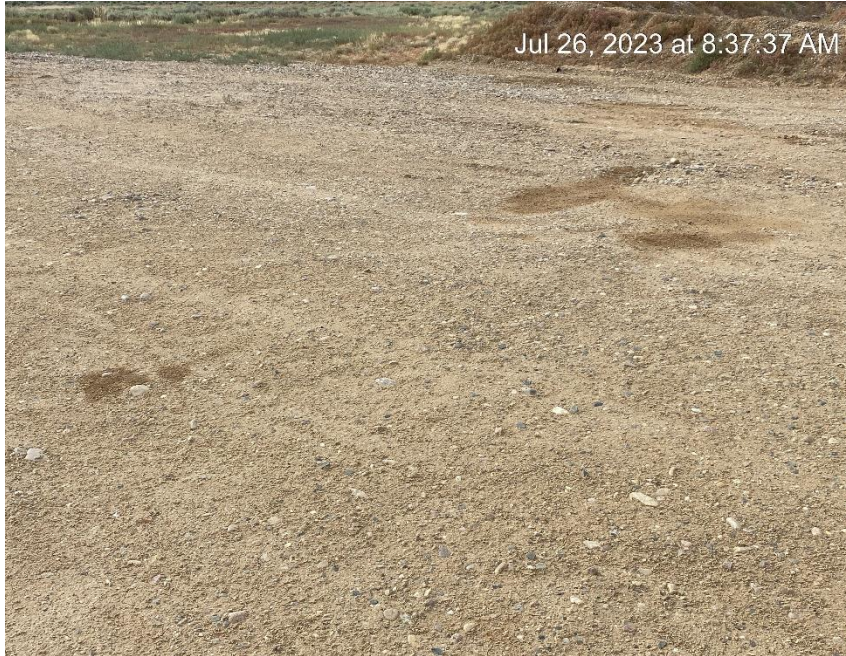
**Stained soils**
