**Gadeco LLC**  
**Hiawatha State 2-36**  
**Loc ID: 313297**

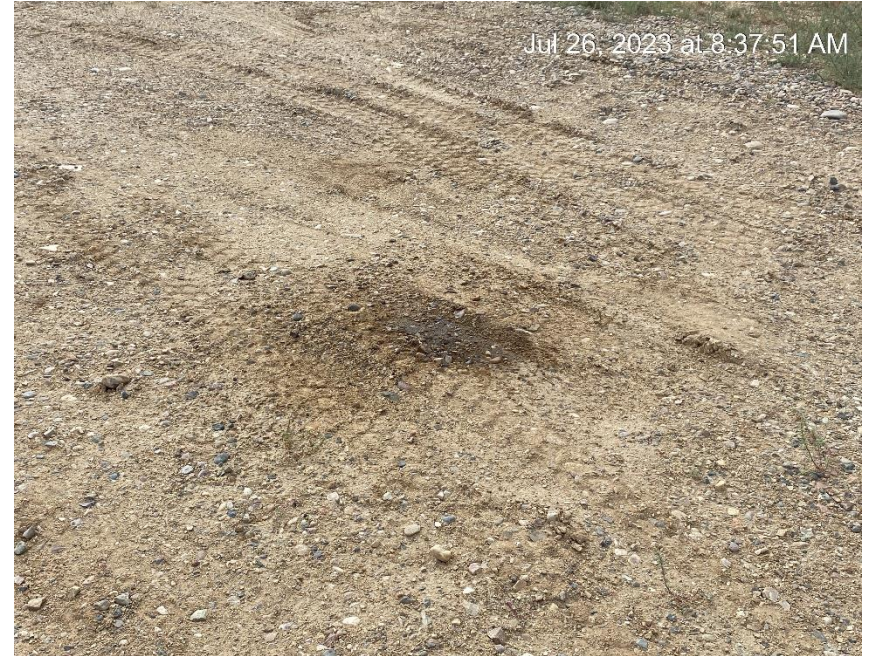
**Stained soil**

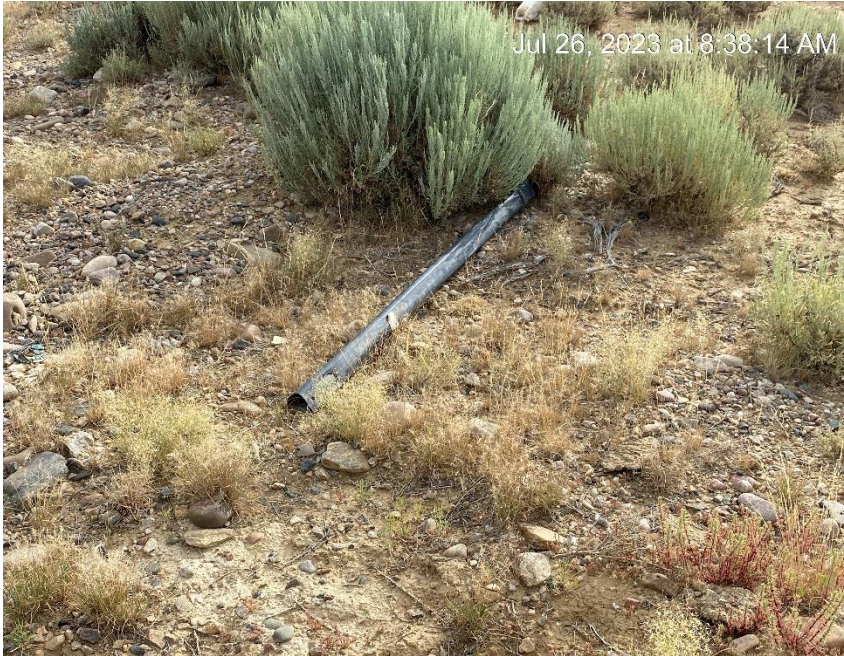
Debris

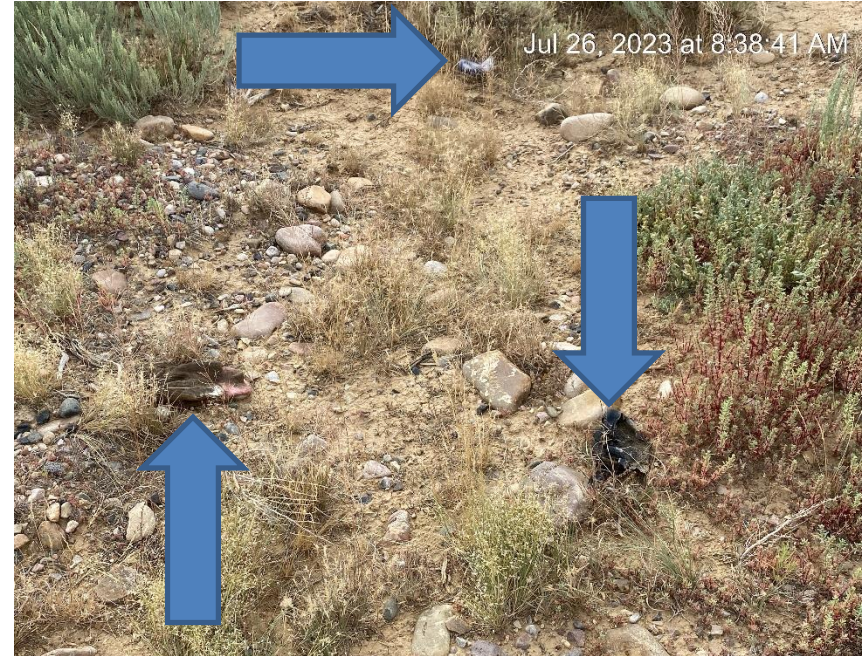
Debris

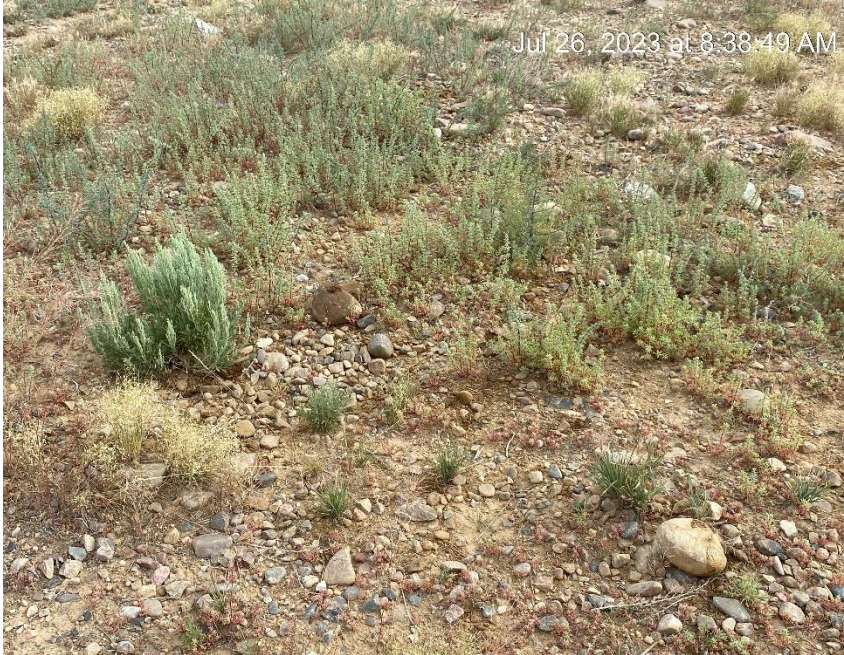
**Stained soil**

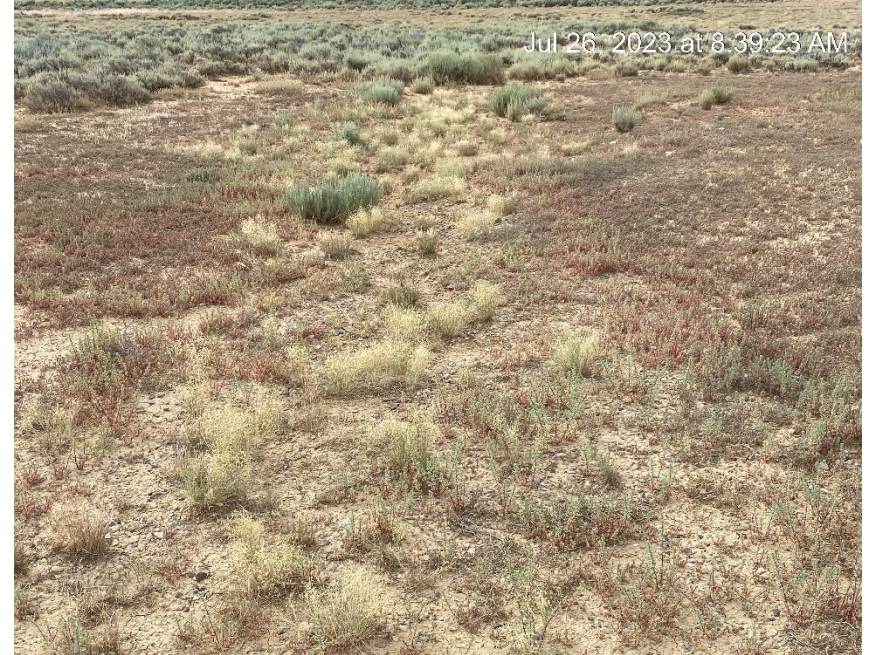
**Sediment migration from location**

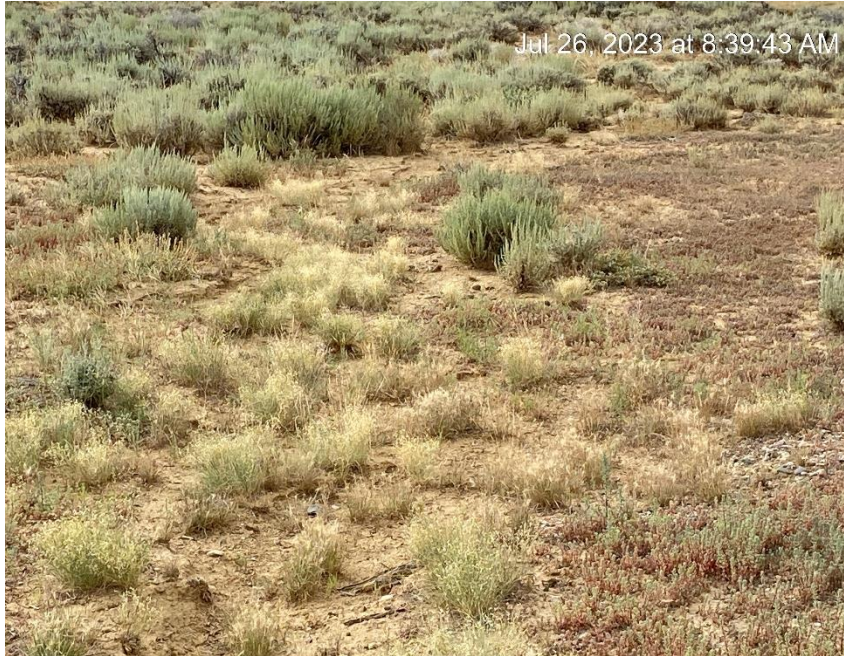
**Sediment migration leaving location**

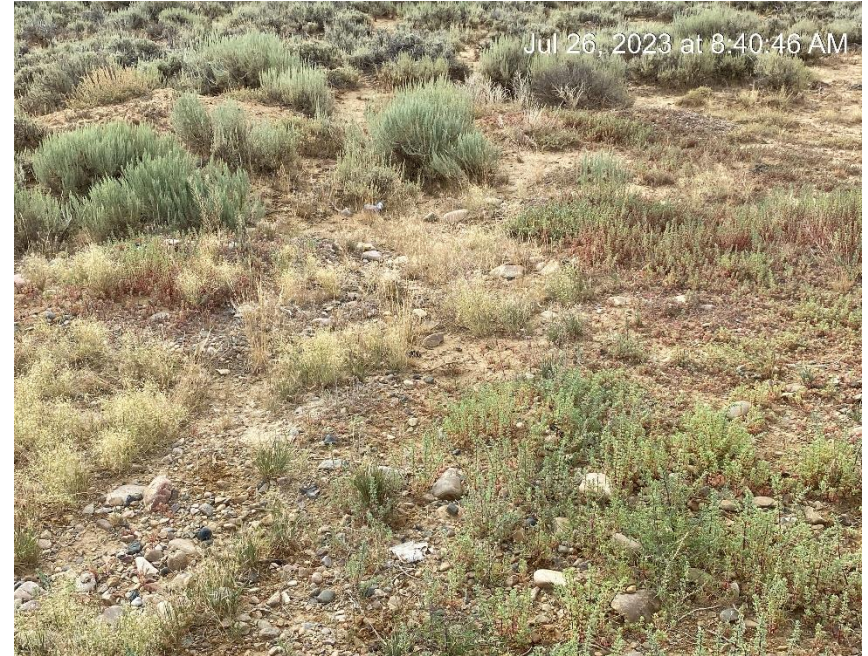
**Erosion off location**

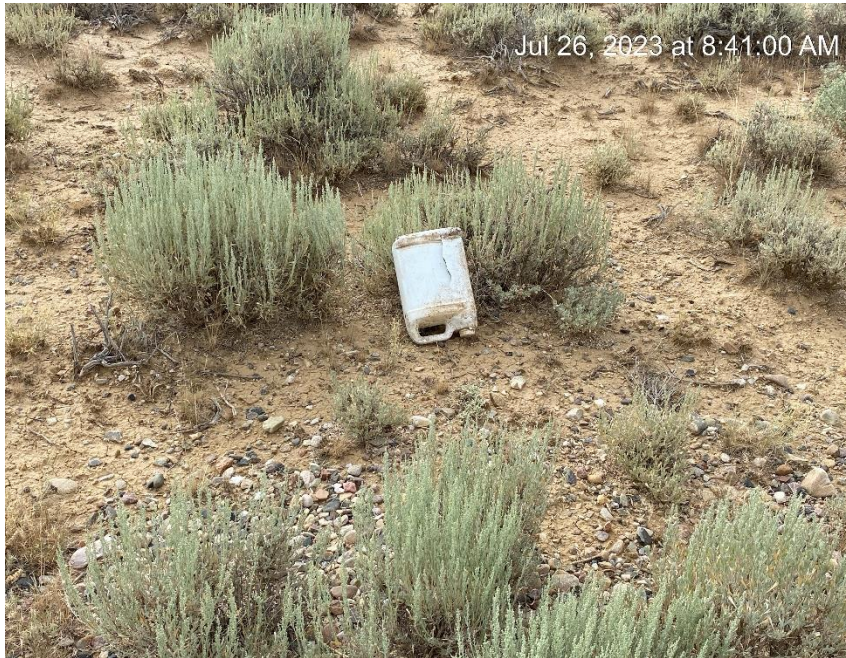
**Debris**

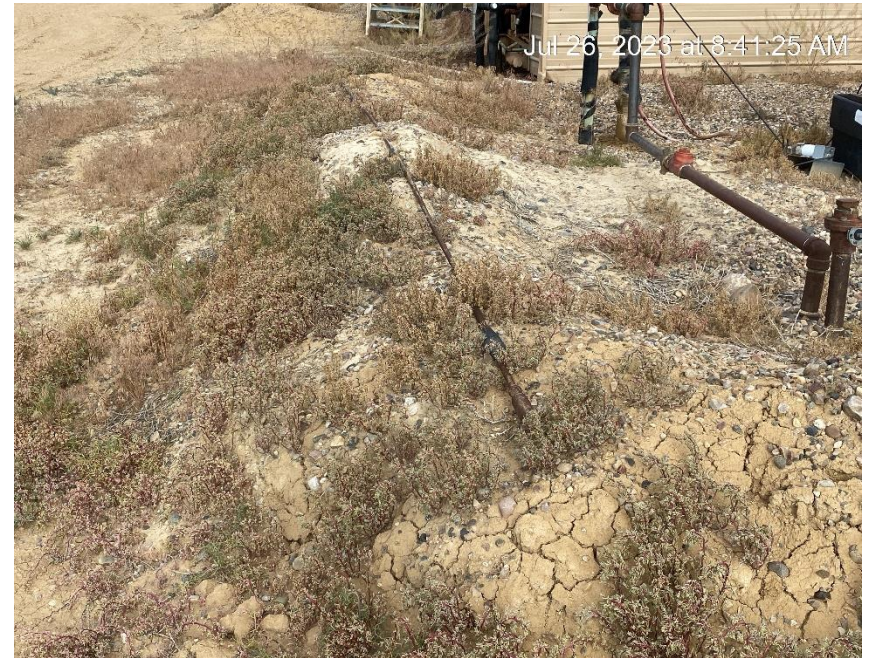
**Unused equipment**

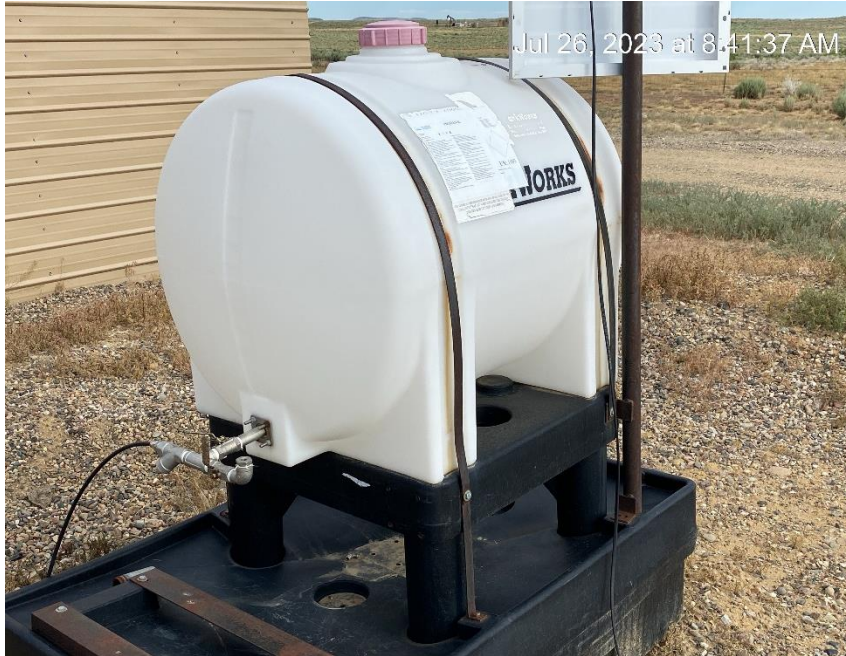
**Illegible chemical labels**

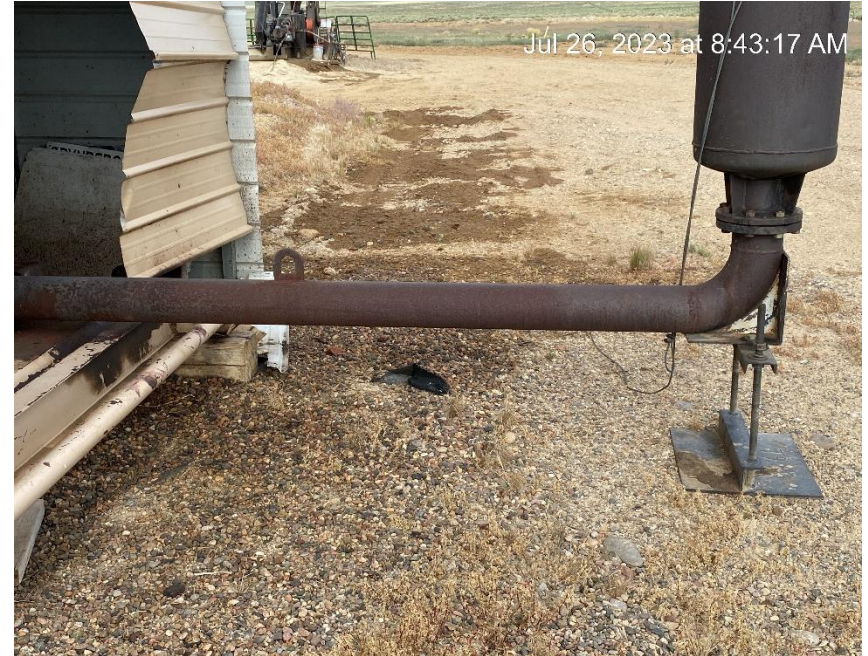
**Staining**

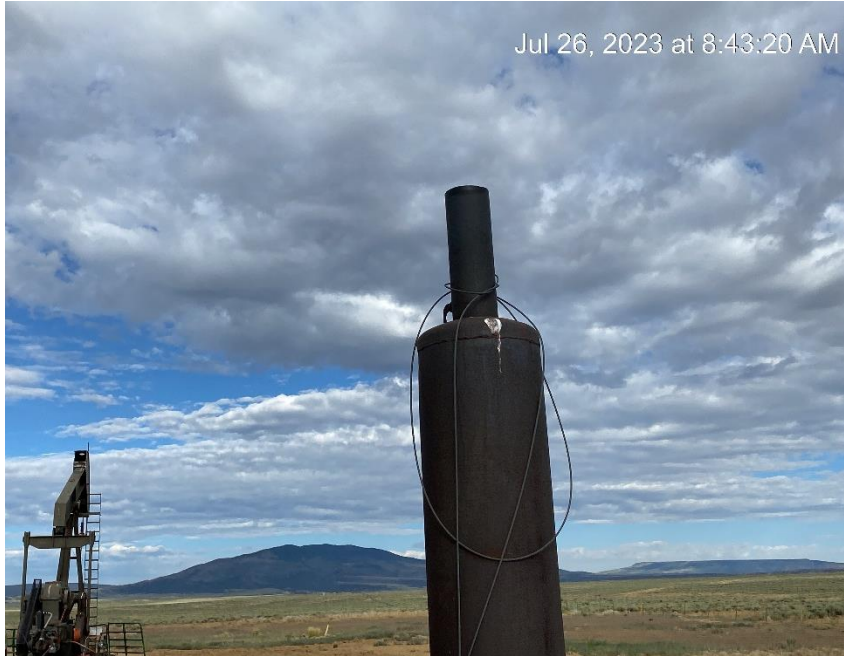
**No wildlife protection**

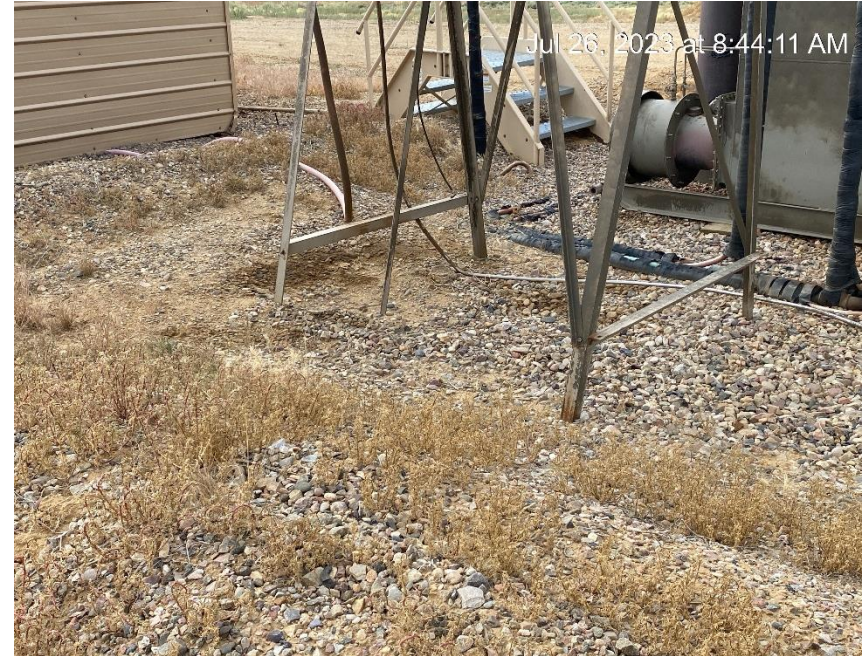
**Stained soil**

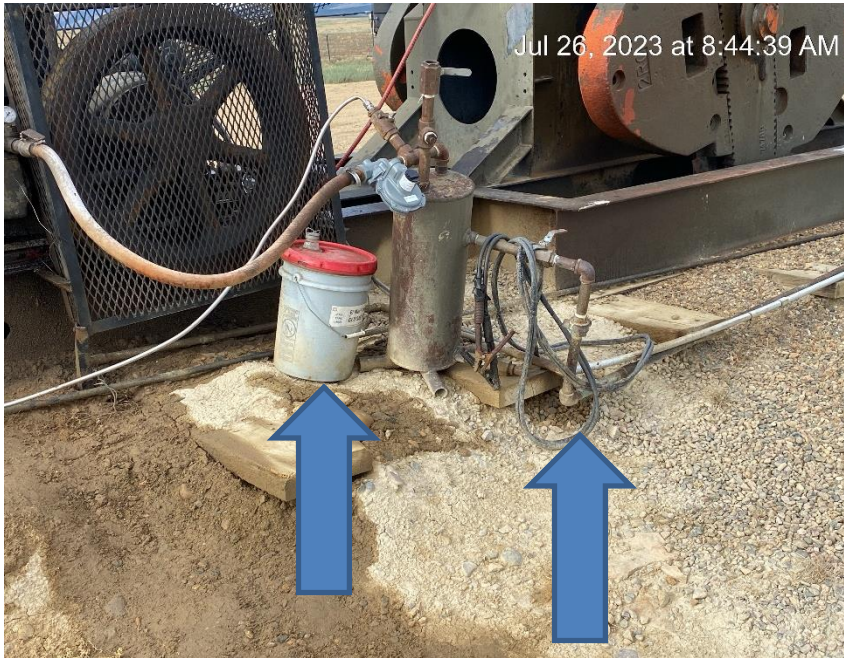
Debris

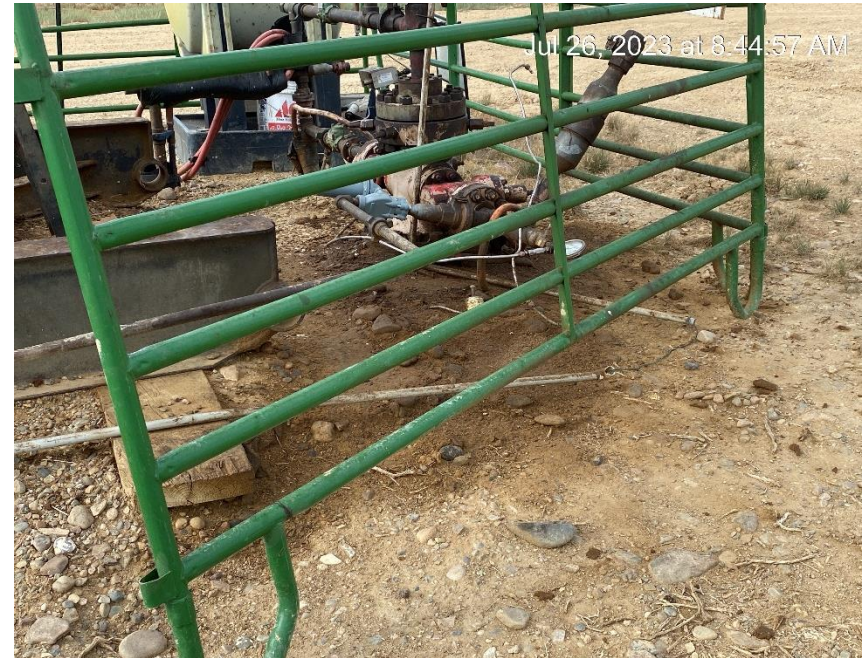
Stained soil around wellhead

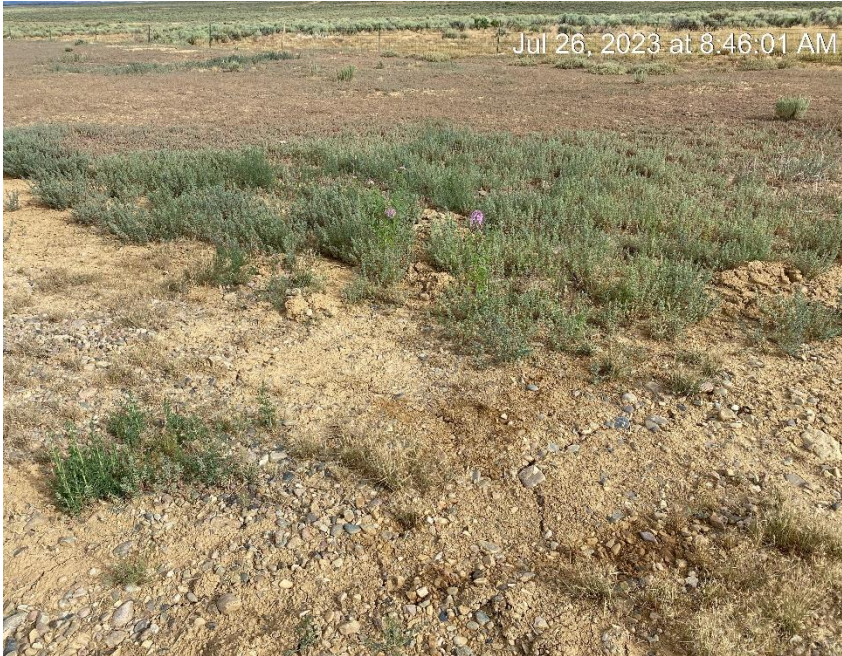
**Soil staining and weeds**

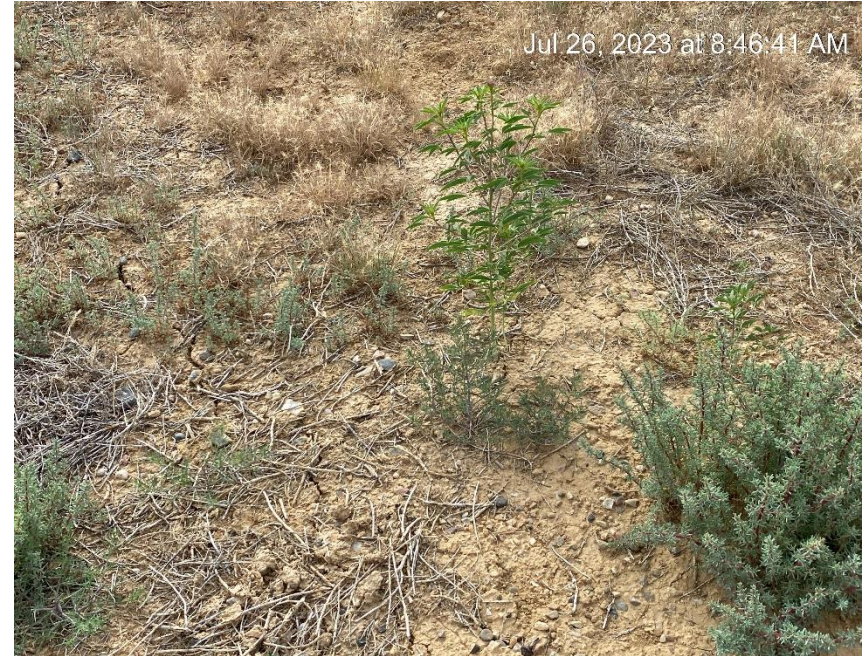
**Weeds**

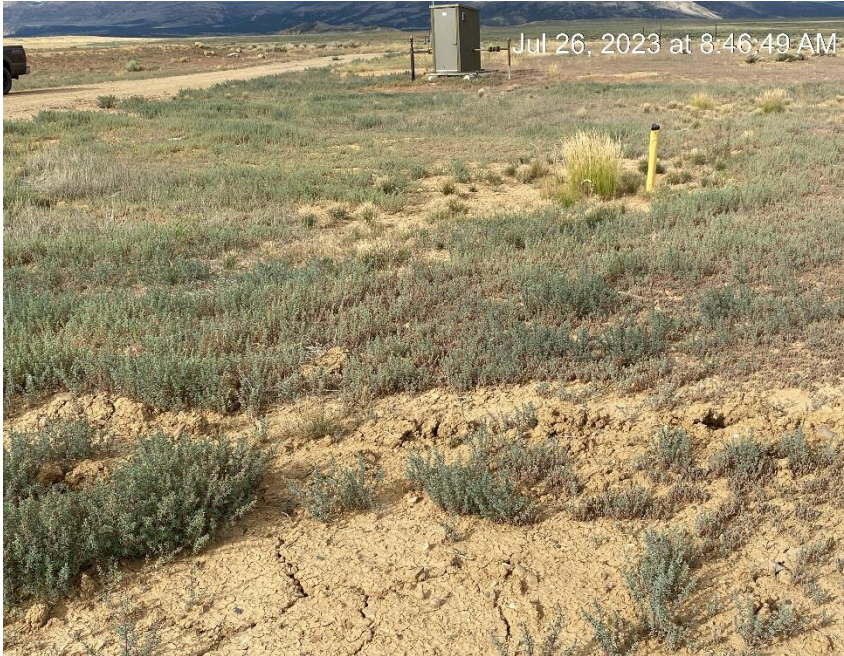
**Weed growth**

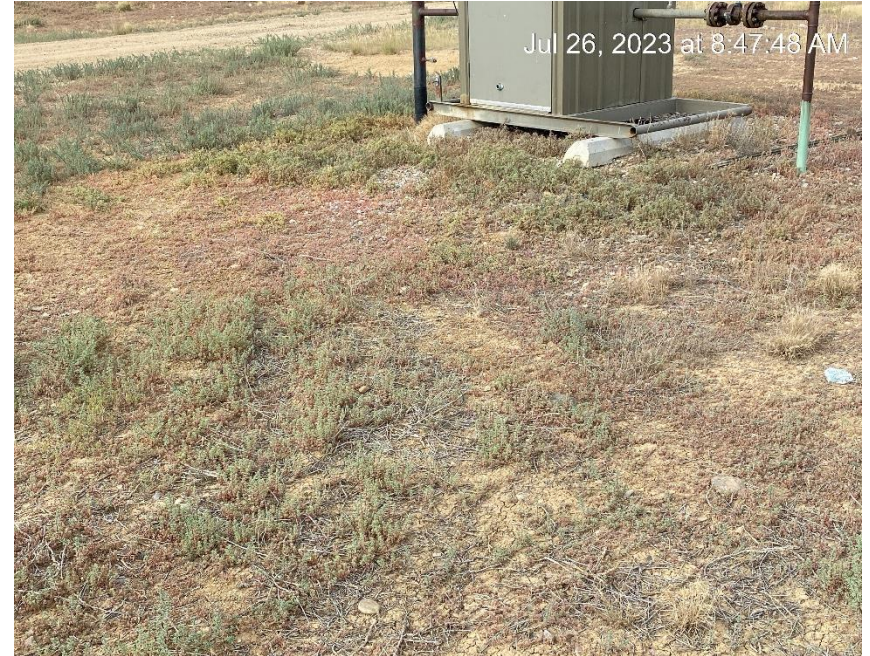
**Weeds partially sprayed**

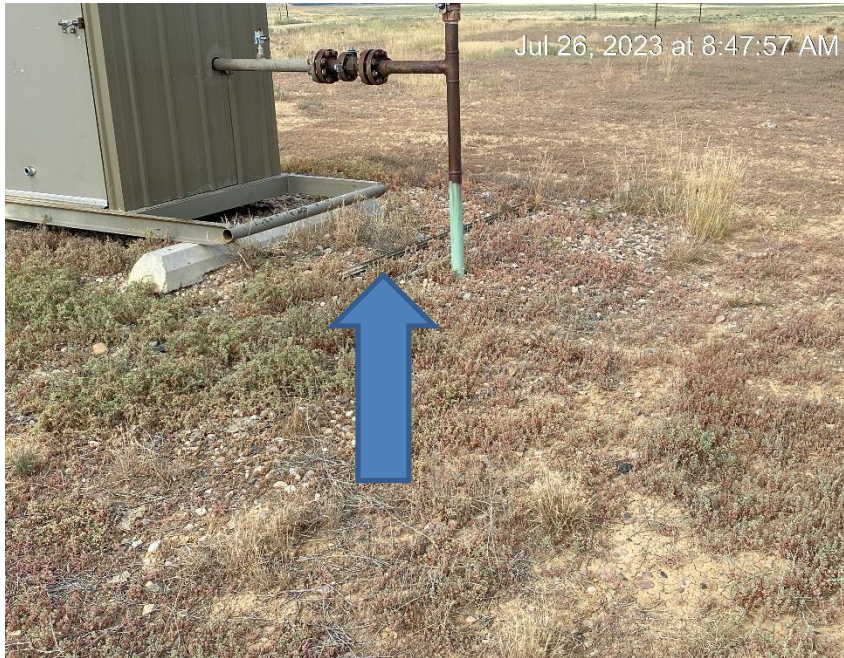
Debris

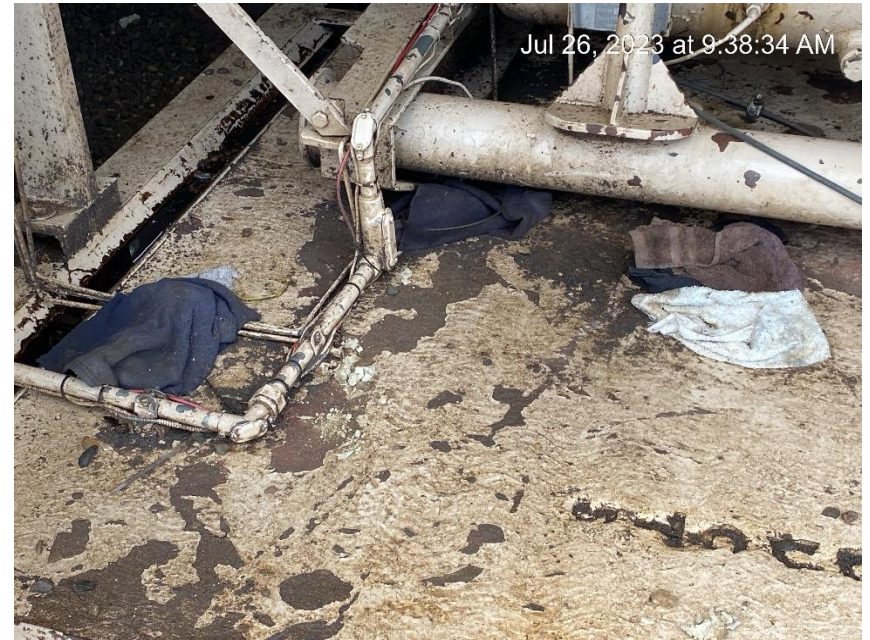
Debris and oil around compressor

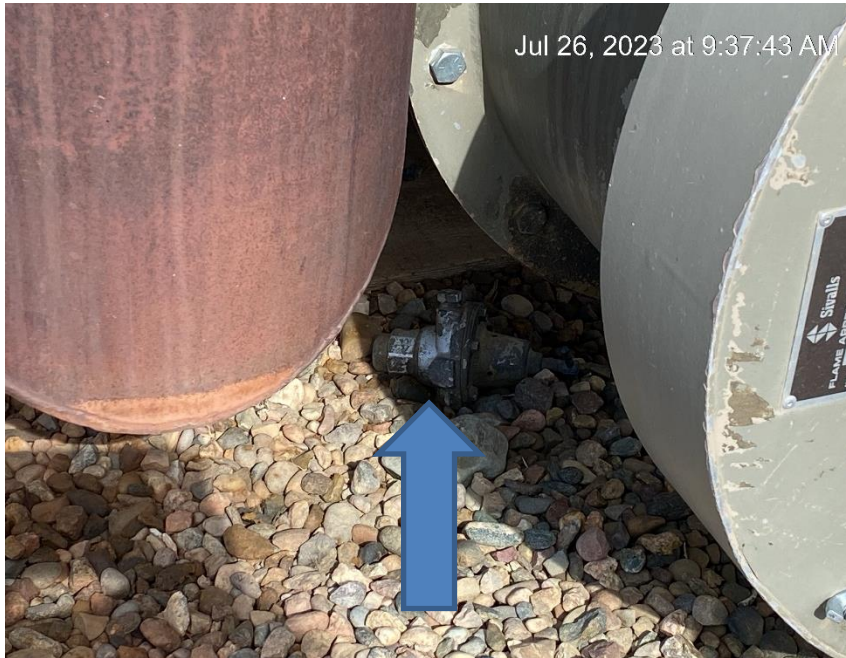
Debris

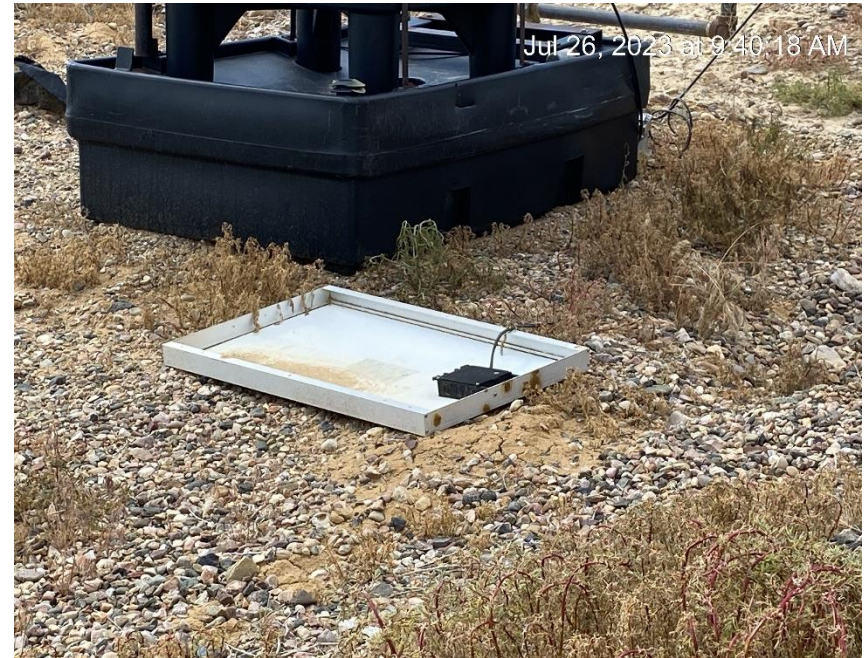
Debris

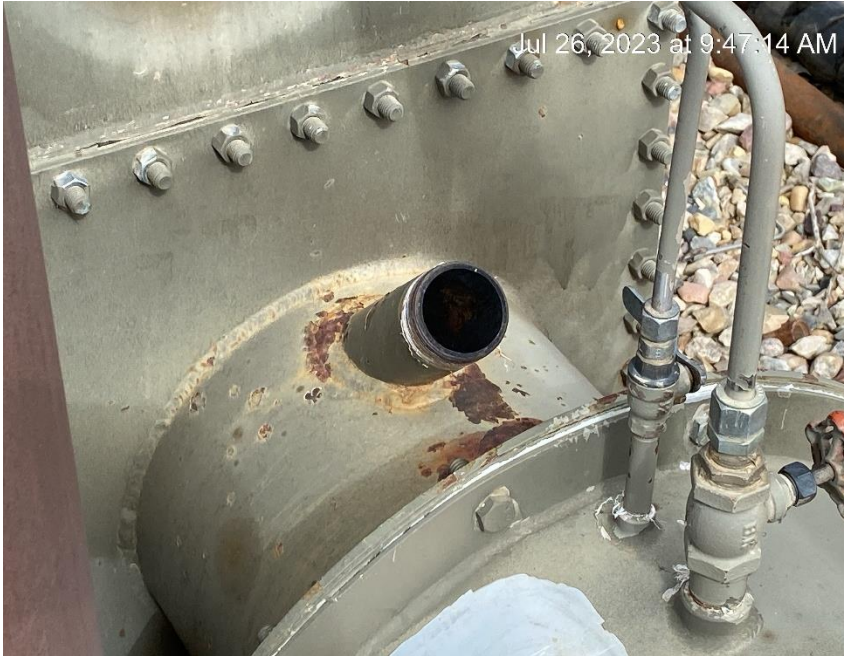
**Open to wildlife**

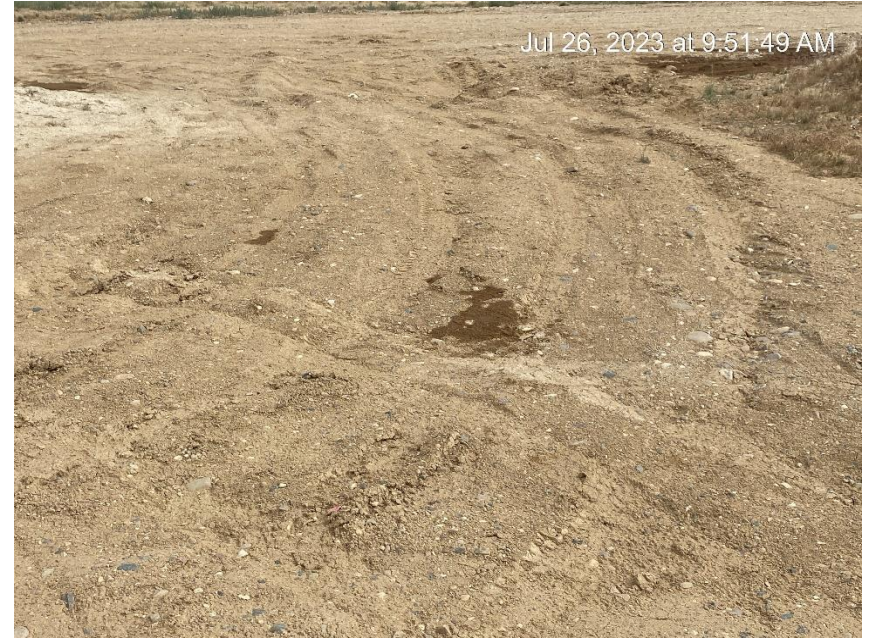
**Soil stain between pumping unit and separator**
