Inspection Photos

7/20/2023

Operator: CAERUS PICEANCE LLC #10456

Location Number: 479215

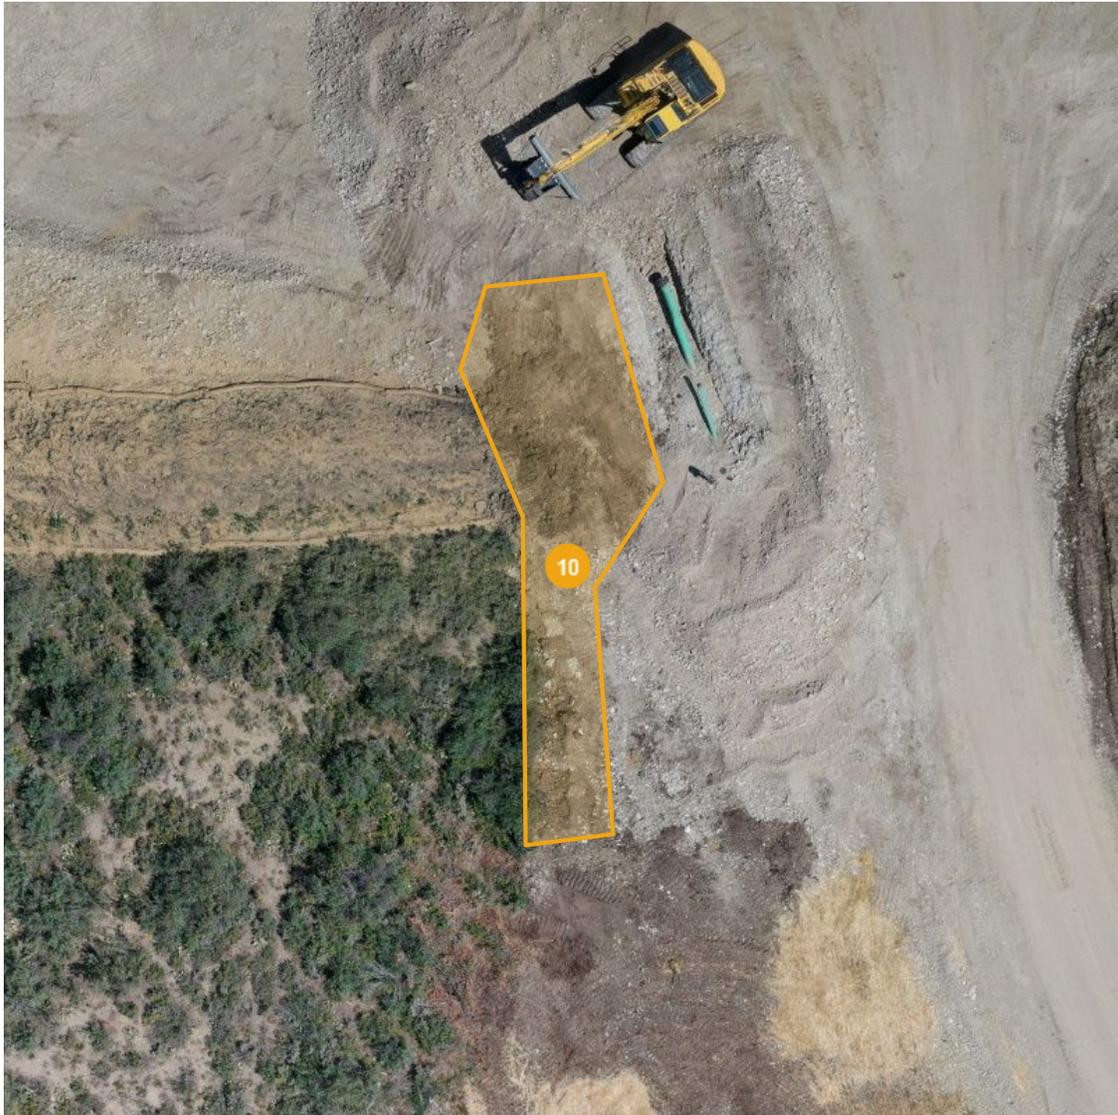
10 - Missing Part

Summary: **BMPs to protect topsoil, as well as to minimize erosion, degradation and sediment transport, as well as to ensure soils remain segregated remain missing or insufficient.**

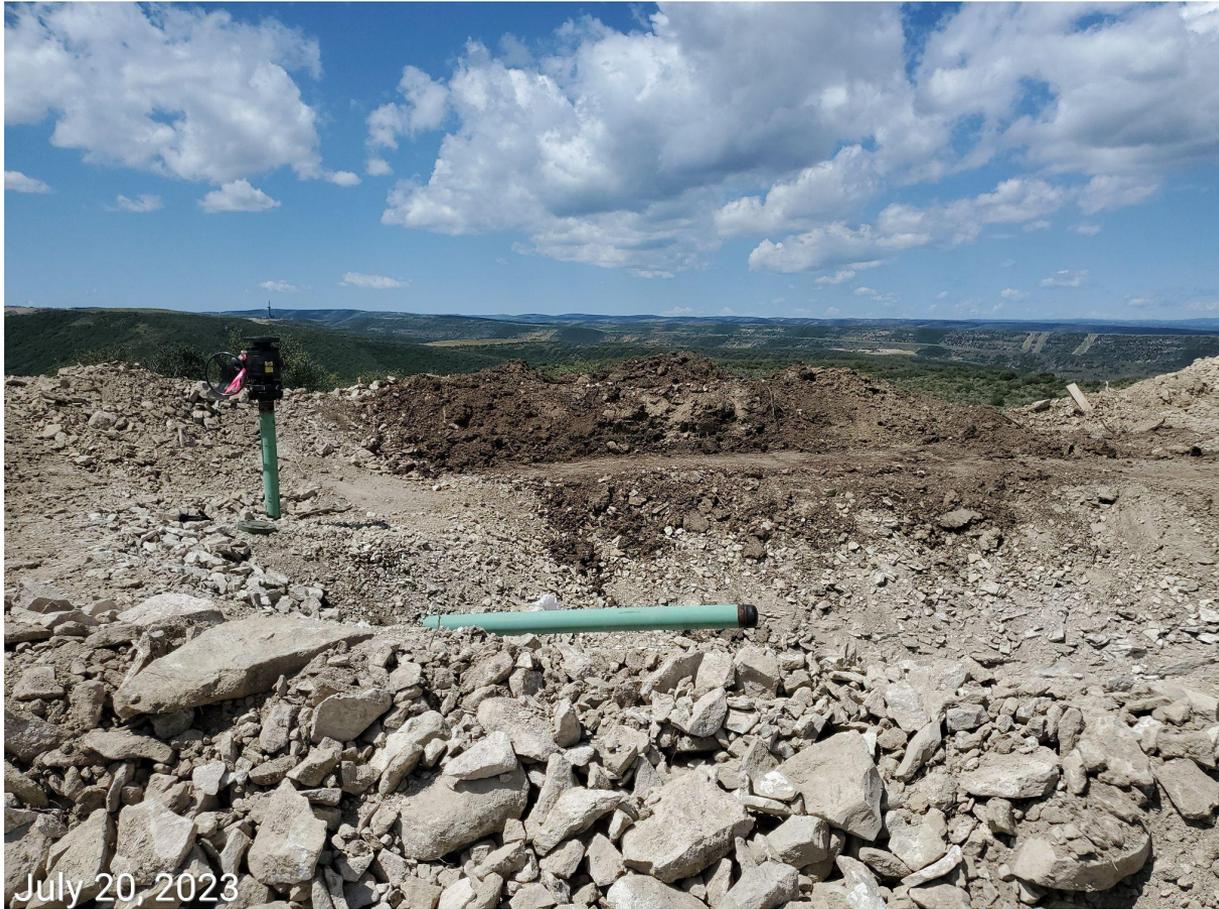
Photo taken from the pipeline excavation on the south end of the Location; BMPs to protect the topsoil, ensure soils remain segregated, as well as to minimize erosion and degradation remain missing or insufficient.

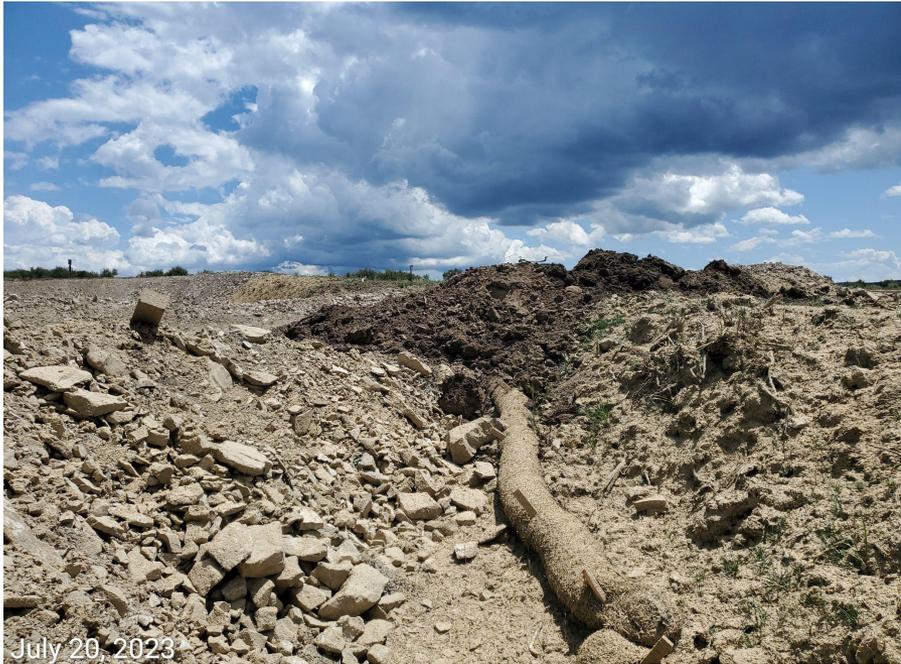
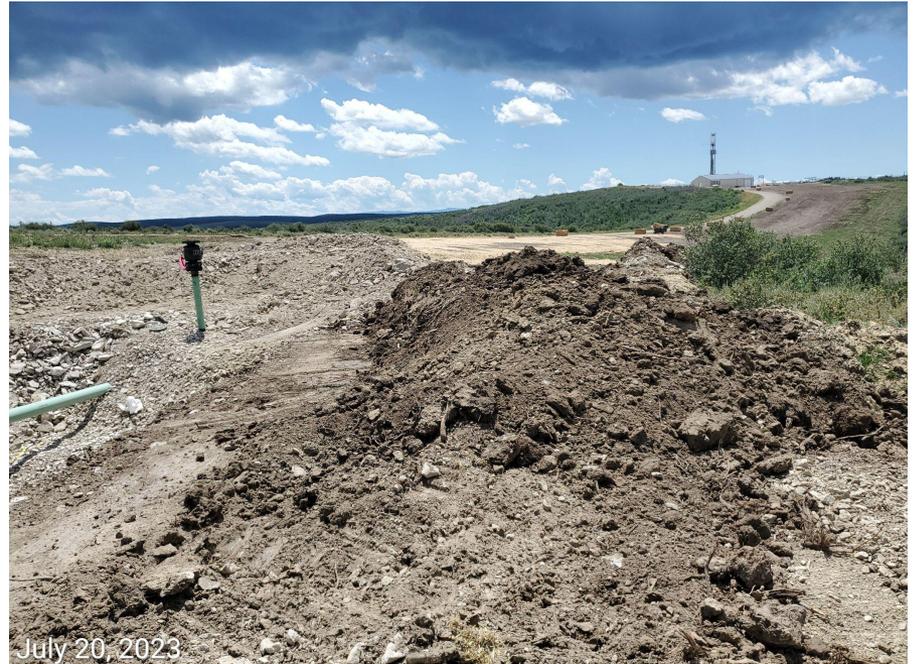
Photos examples showing topsoil stockpiles on the south end of the Location lack control measures to protect the topsoil, ensure soils remain segregated, controls to minimize erosion and degradation and offsite sediment transport.

Photo left also shows sediment trap and culvert at Location entrance has not been installed.

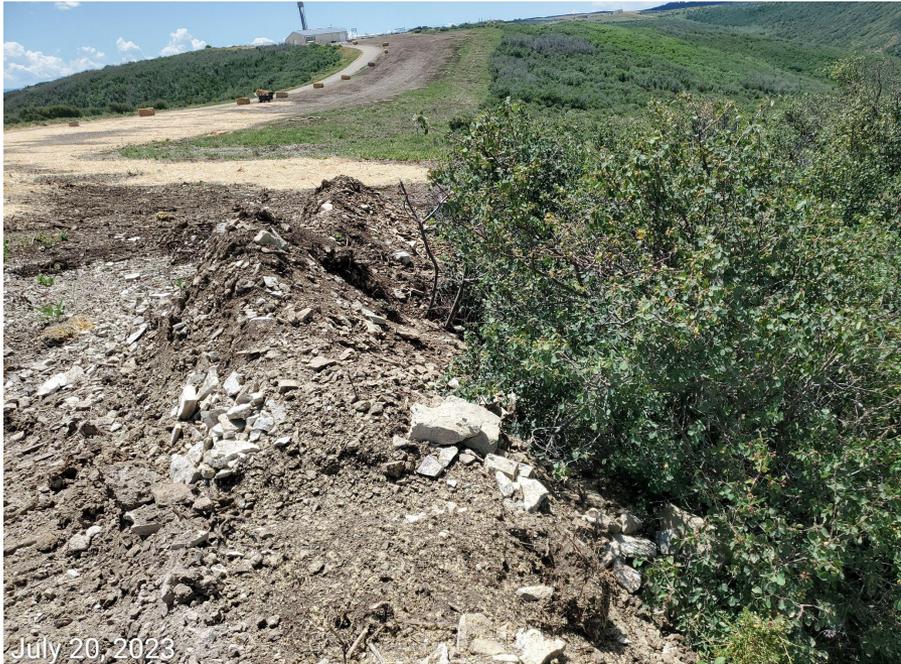
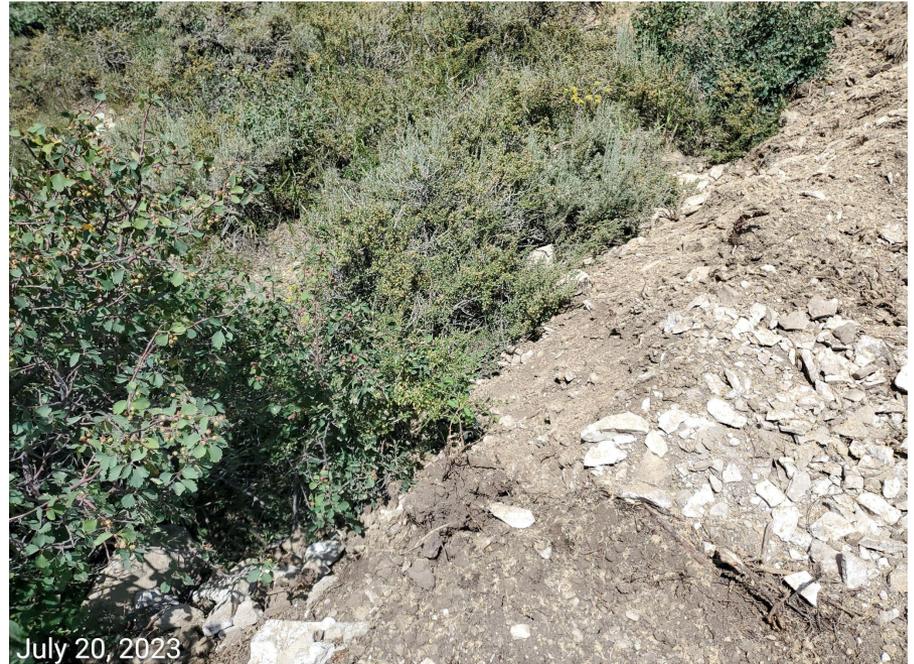
Photos examples showing topsoil stockpiles on the south end of the Location lack control measures to protect the topsoil, ensure soils remain segregated, controls to minimize erosion and degradation and offsite sediment transport.

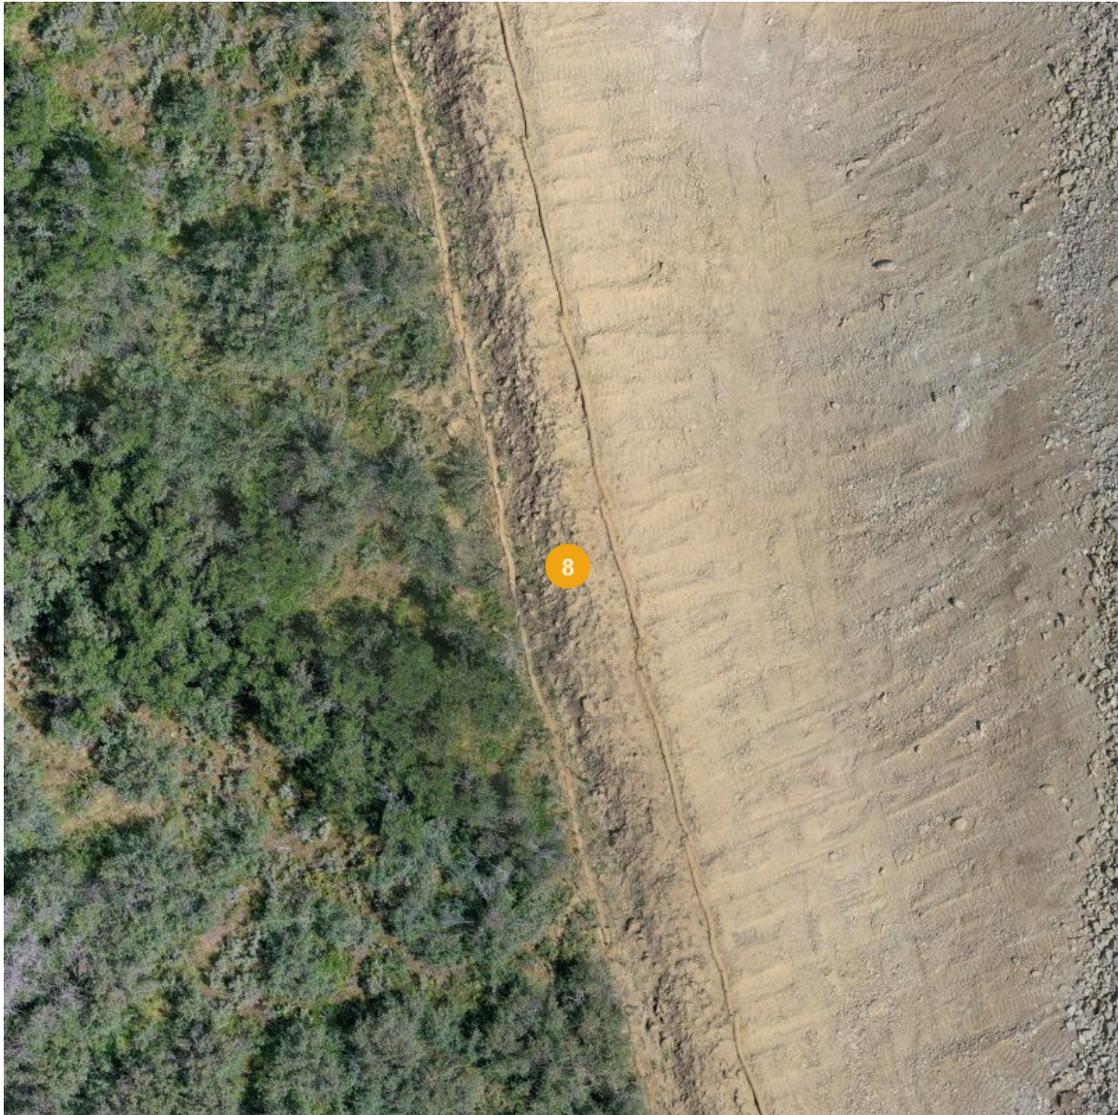
8 - Missing Part

Summary:	Spillway (outlet) with rip rap armoring per the Construction Layout Drawing not installed.
Created:	Jul 27, 2023, 8:16am by Aaron Trujillo
Cost of Repair:	—
Lat/Long:	39.7061874, -108.1174631
Northing:	1146688.0 US ft
Easting:	2263656.1 US ft
Elevation:	-19.77 US ft

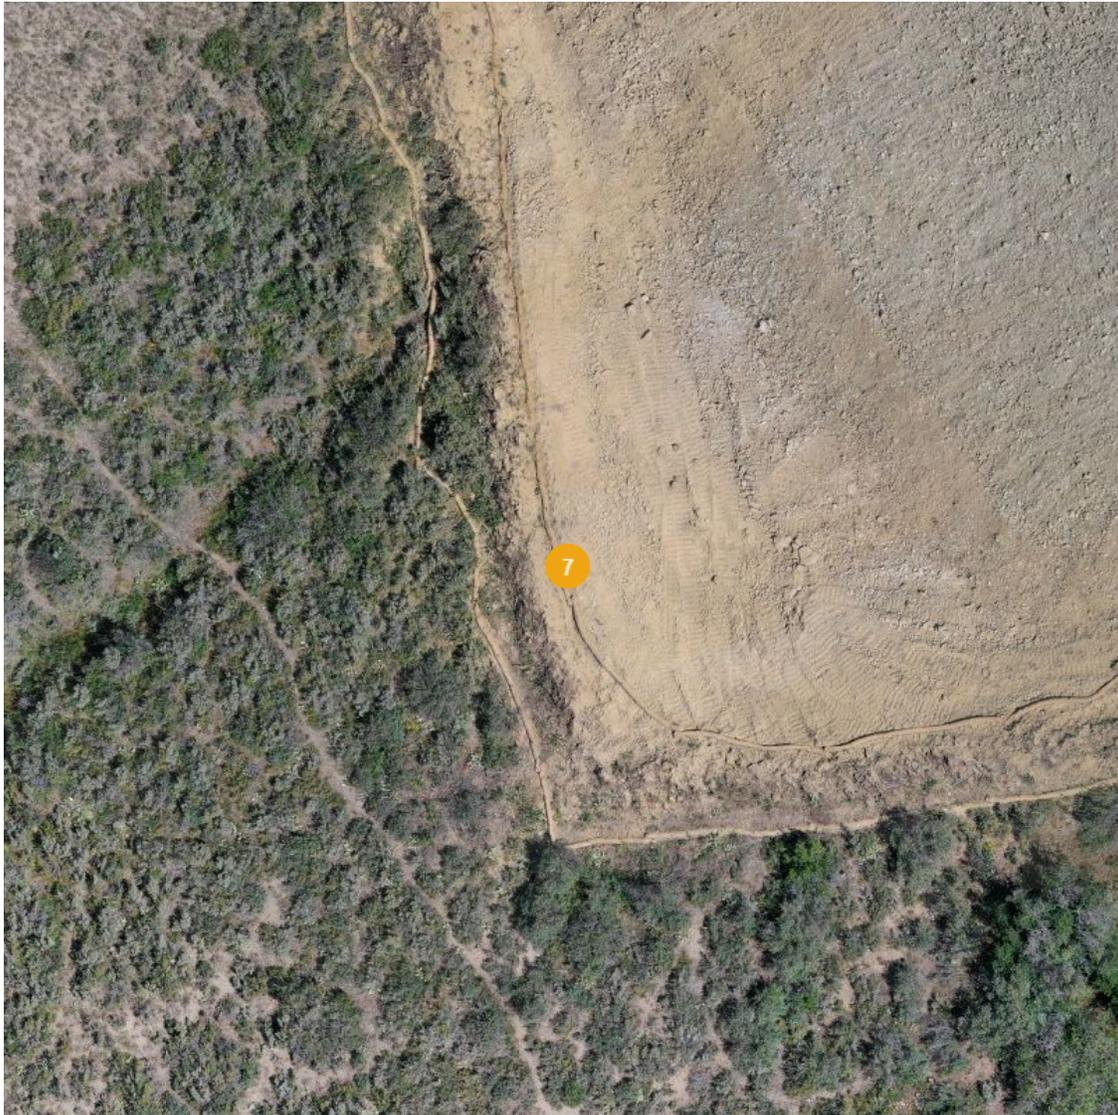
7 - Missing Part

Summary:	Spillway (outlet) with rip rap armoring per the Construction Layout Drawing not installed.
Created:	Jul 27, 2023, 8:15am by Aaron Trujillo
Cost of Repair:	—
Lat/Long:	39.7046151, -108.1169498
Northing:	1146111.2 US ft
Easting:	2263783.5 US ft
Elevation:	-39.10 US ft

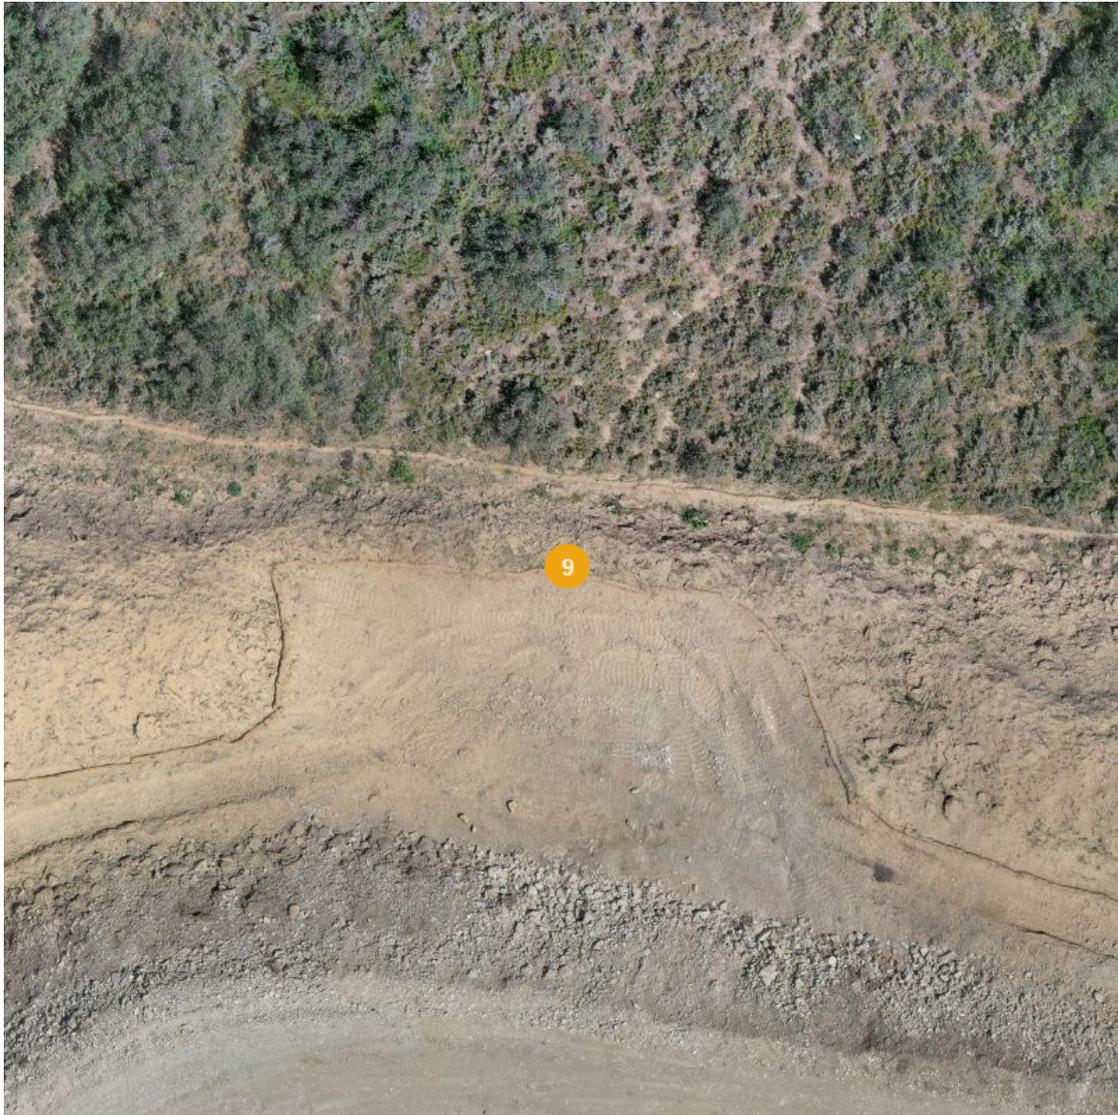
9 - Observation

Summary: **Additional sediment trap not listed on the Construction Layout Drawing. Control measure has not been constructed with an engineered outlet/spillway.**

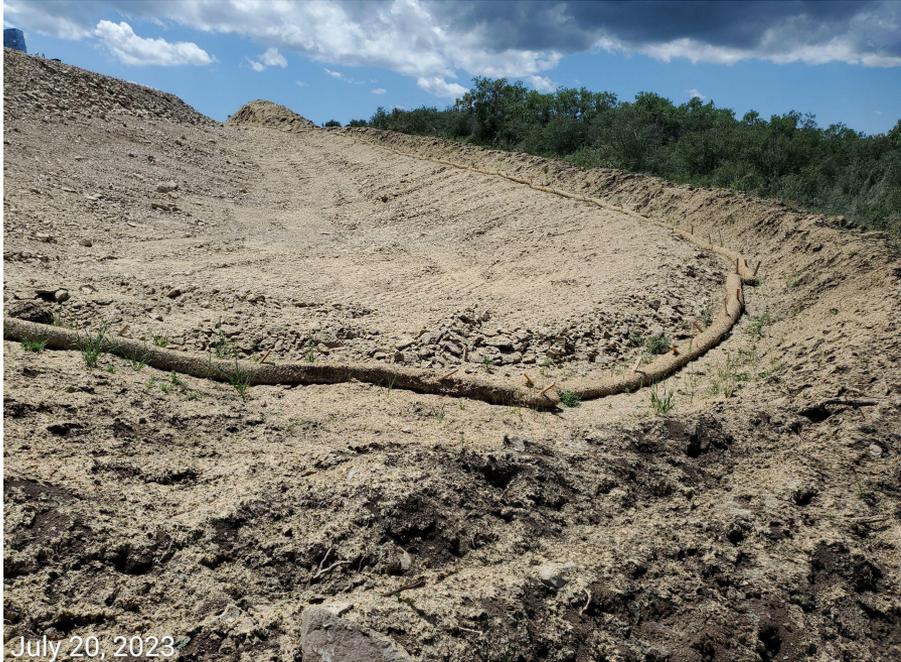
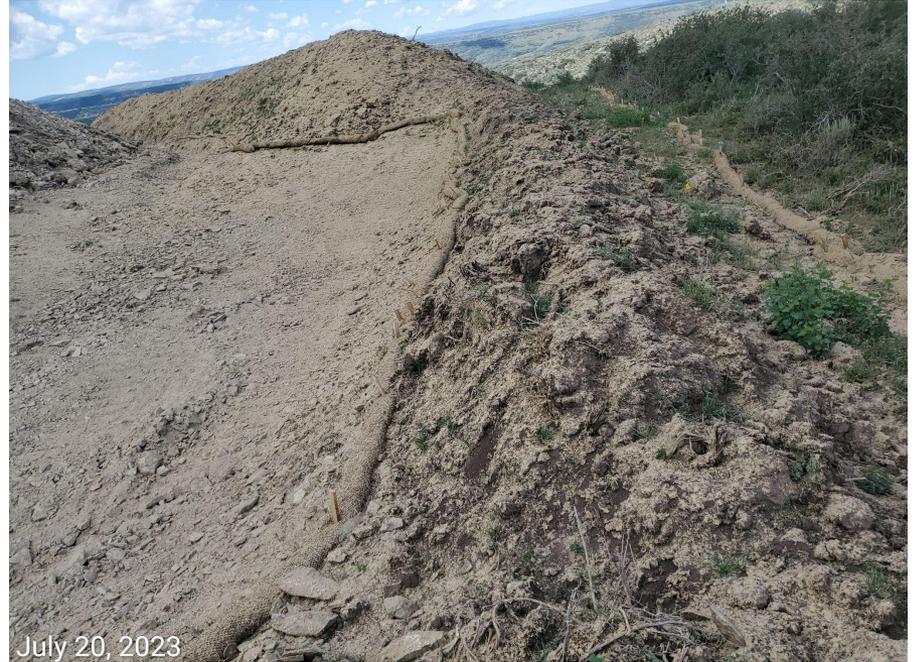
Northern/Northwestern “retention ponds”. “Spillways” (engineered outlet) w/ Riprap not installed.

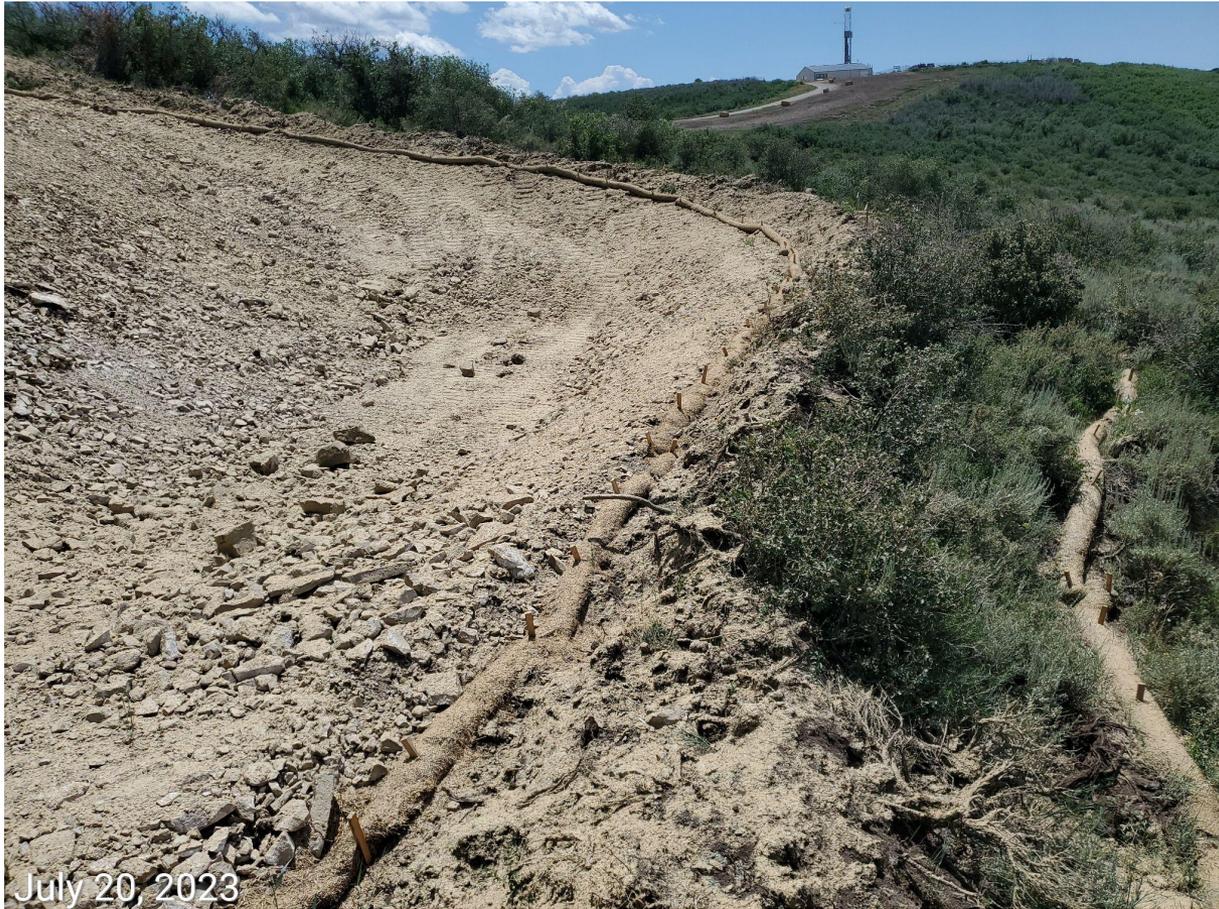
Southwestern “retention pond”. “Spillway” (engineered outlet) w/ Riprap not installed.

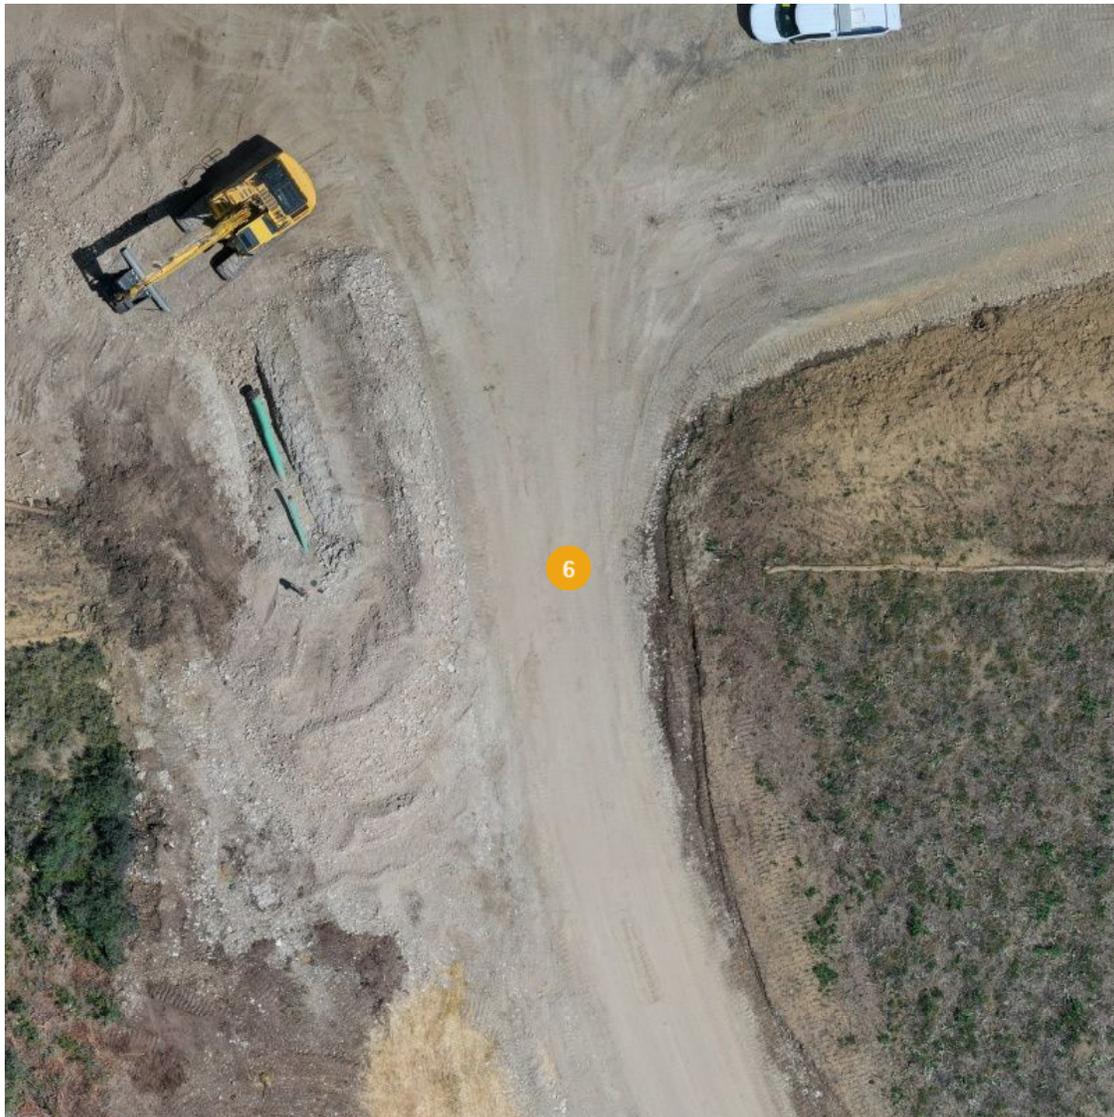
6 - Missing Part

40' 18-inch CMP not installed.

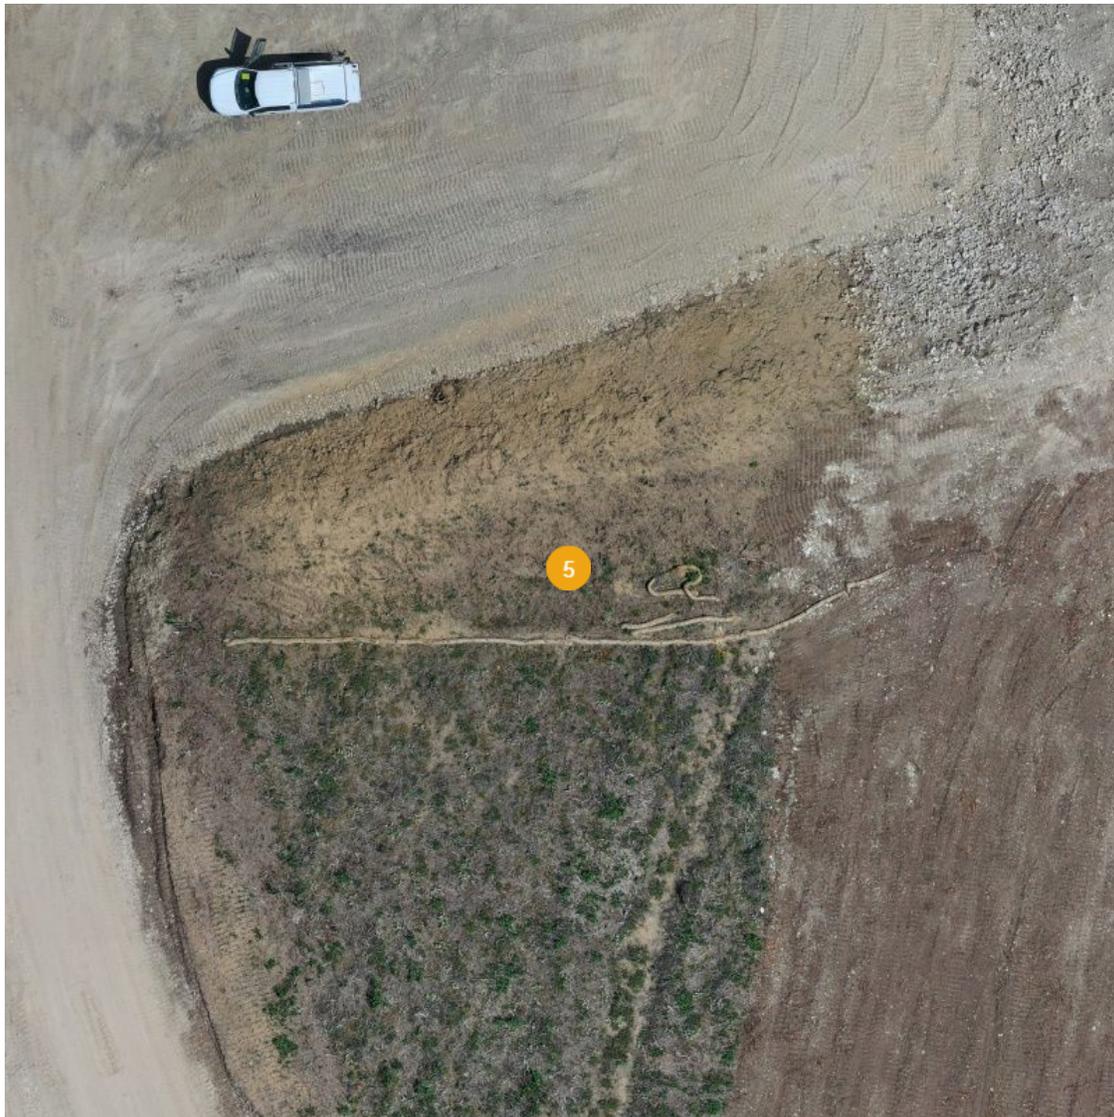
5 - Missing Part

Summary:	Diversion Ditch per the Construction Layout Drawing not installed.
Created:	Jul 27, 2023, 8:14am by Aaron Trujillo
Cost of Repair:	—
Lat/Long:	39.7046092, -108.1156928
Northing:	1146098.6 US ft
Easting:	2264137.0 US ft
Elevation:	5.03 US ft
NAD83(2011) / Colorado North (ftUS) (US survey foot)

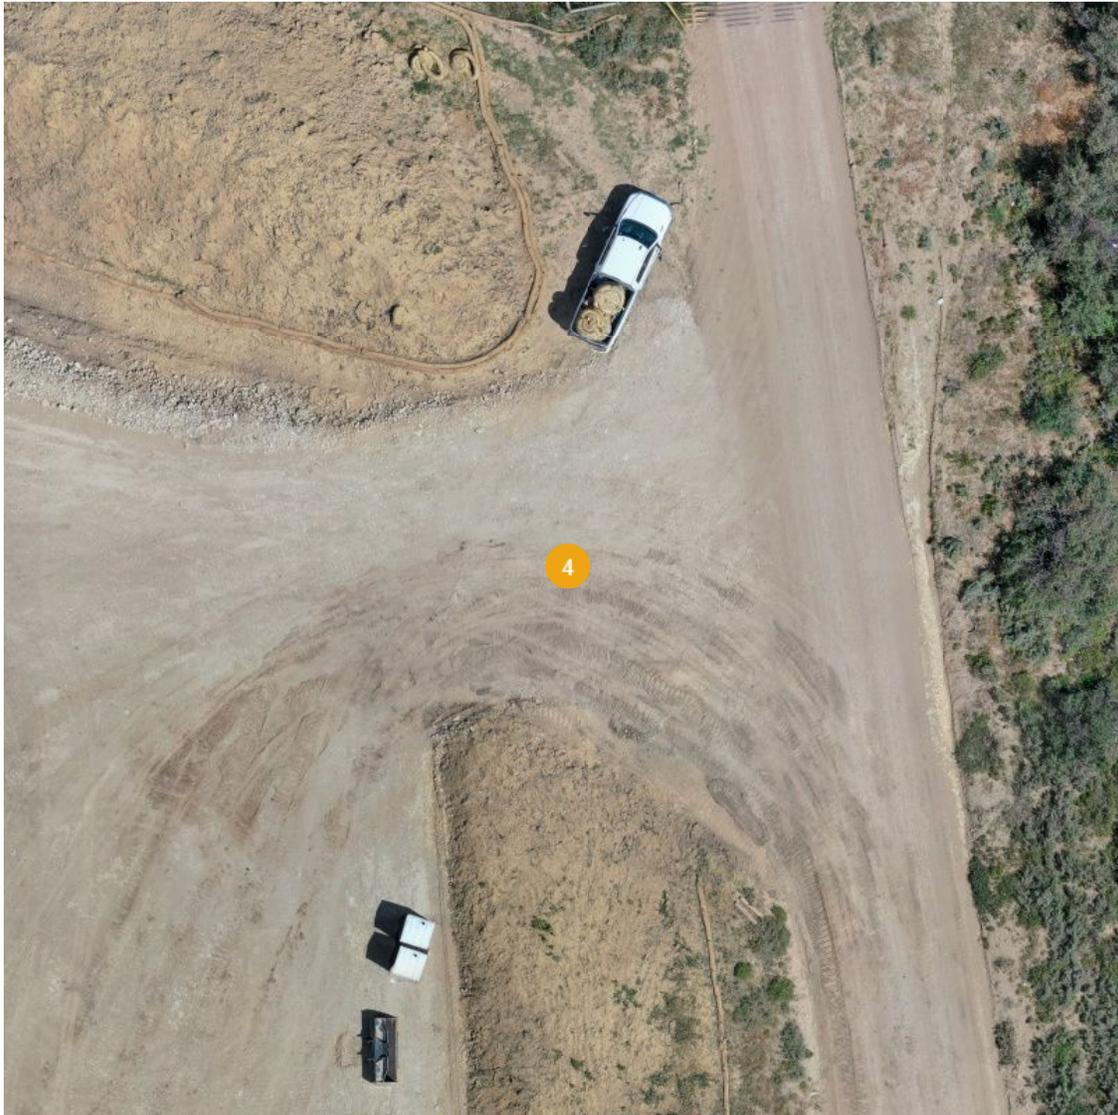
4 - Missing Part

40' 18-inch CMP not installed.

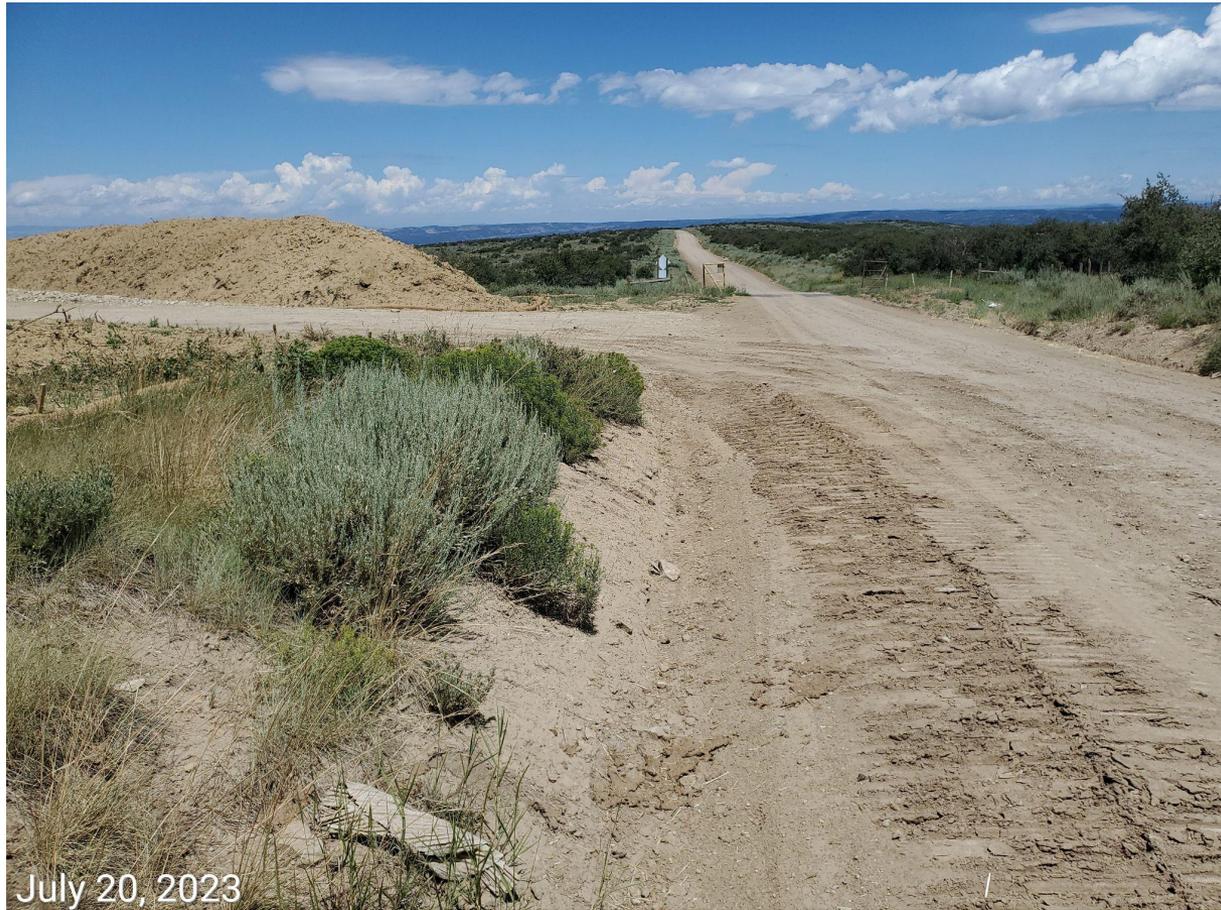
Northern Location entrance. Culvert not observed.

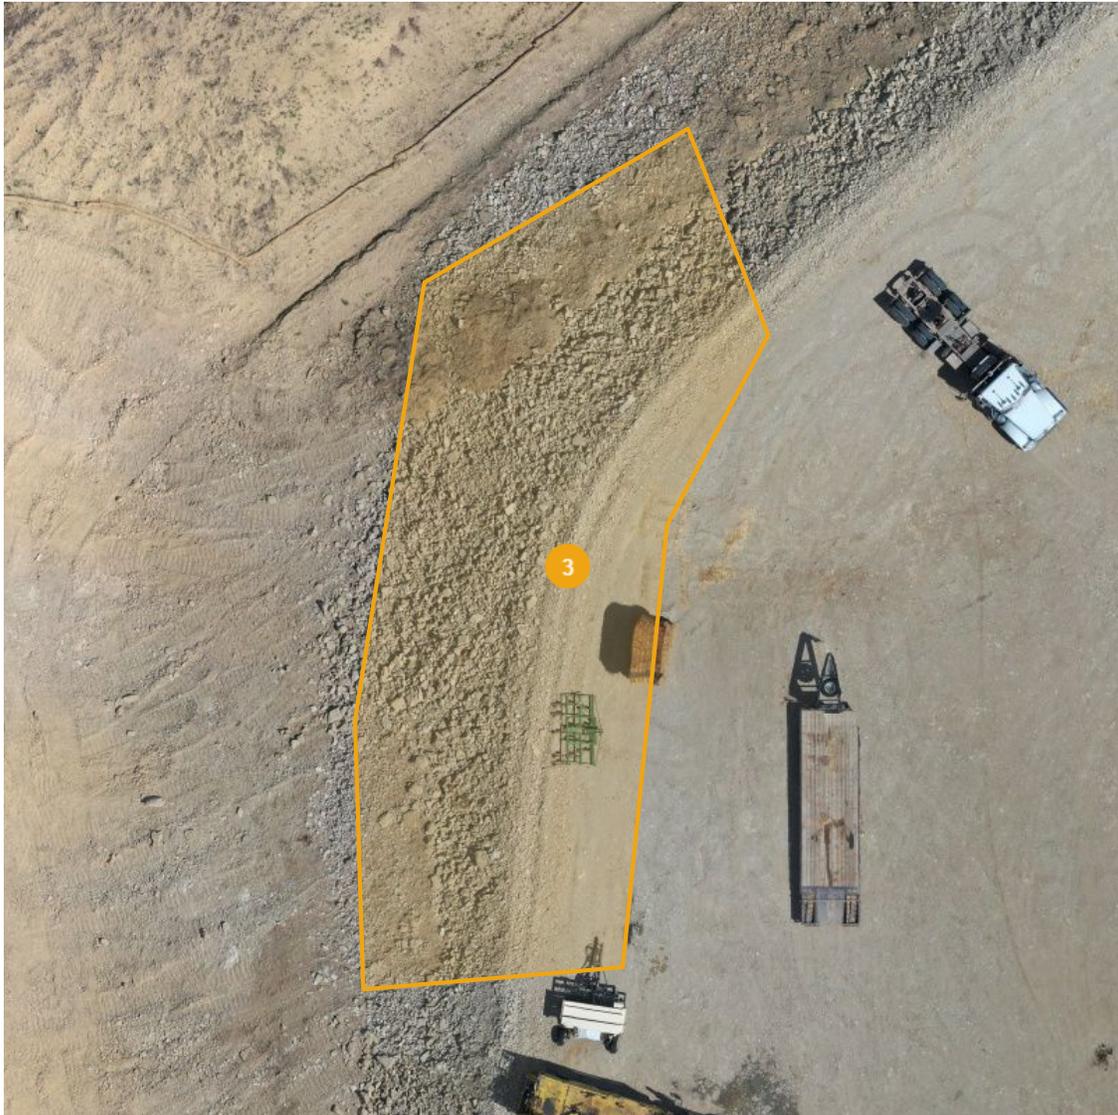
3 - Missing Part

Slope drain per the Construction Layout Drawing not installed.

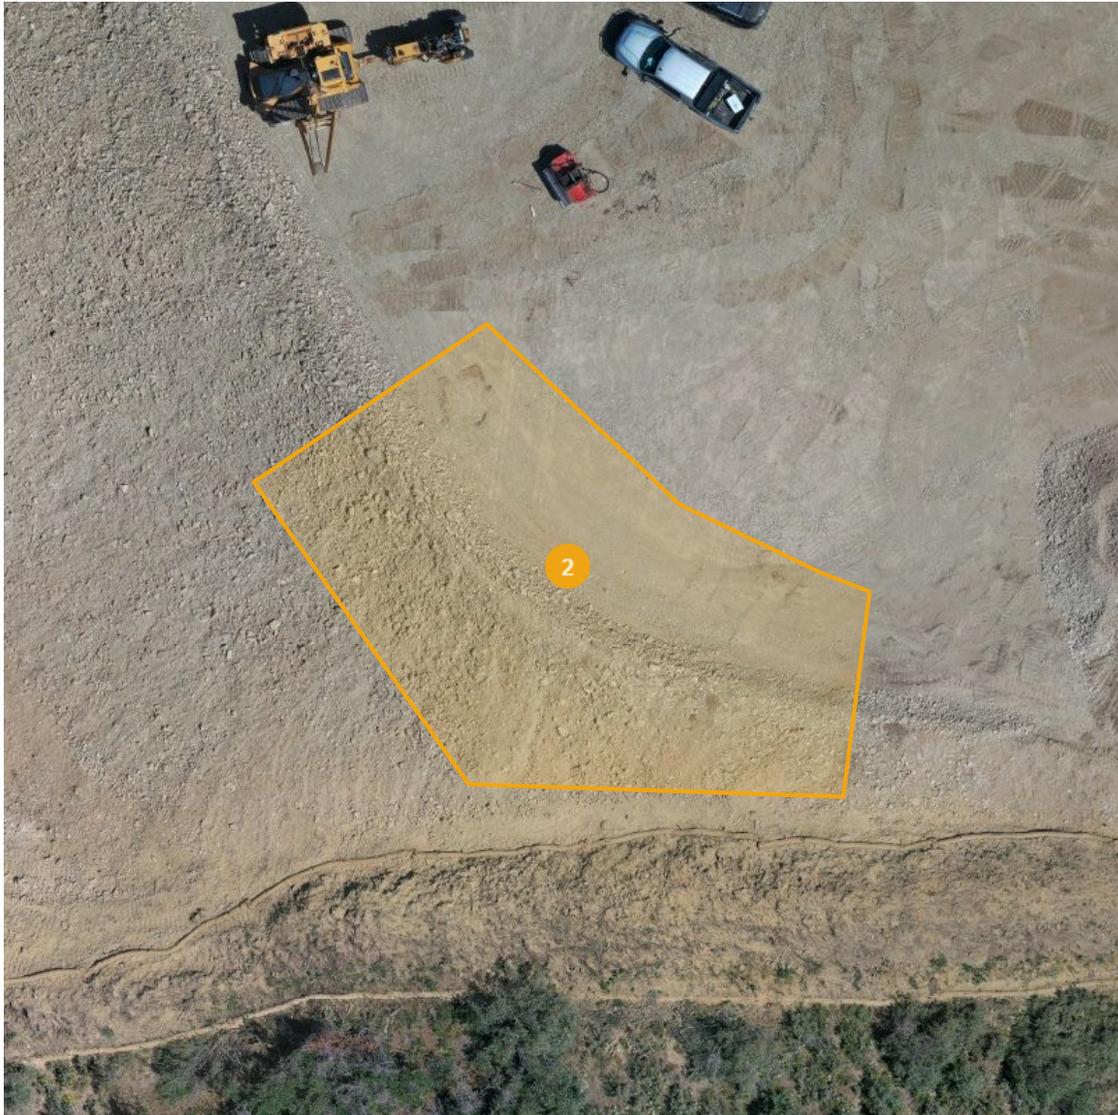
2 - Missing Part

Summary:	Slope drain per the Construction Layout Drawing not installed.
Created:	Jul 27, 2023, 8:11am by Aaron Trujillo
Cost of Repair:	—
Lat/Long:	39.70470, -108.11647
Area:	3168.39 ft ²
Surface Area:	3474.64 ft ²

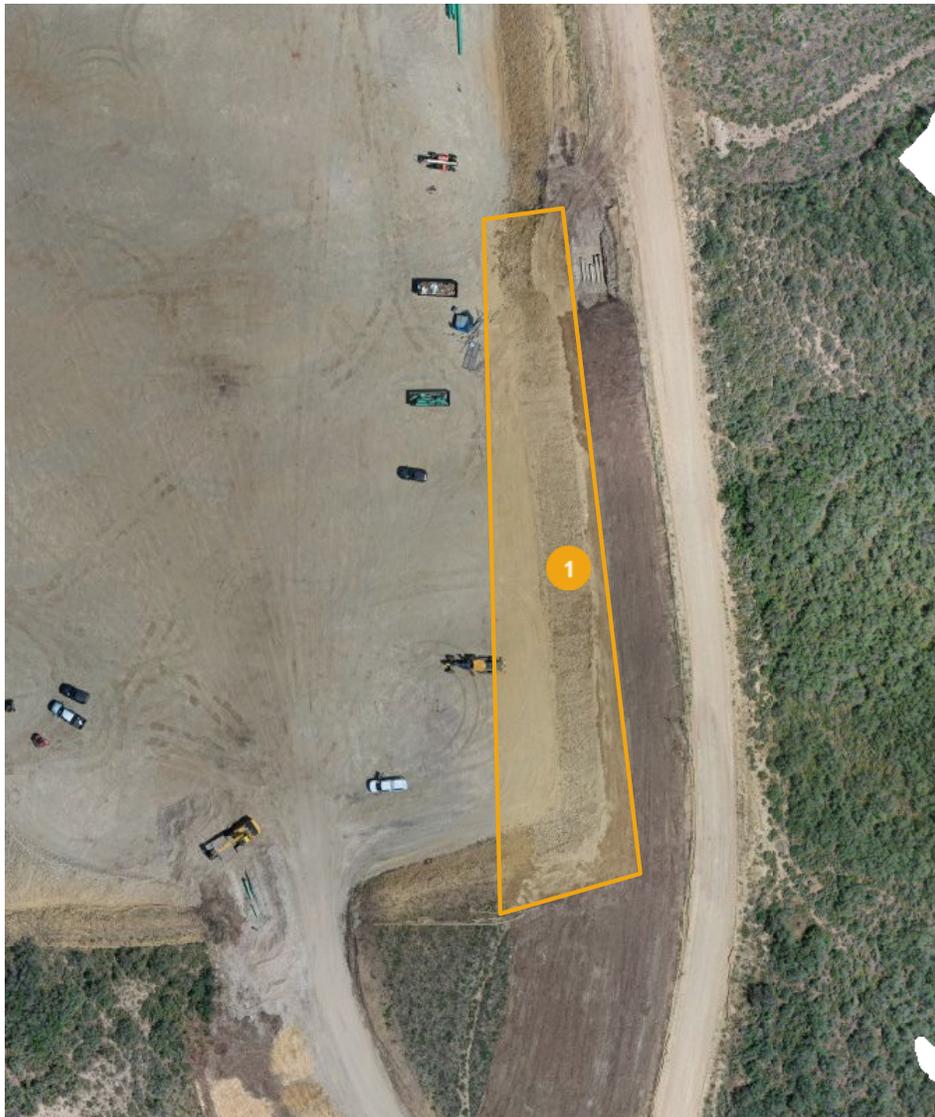
1 - Missing Part

Control Measures remain missing or insufficient at the cut slopes.

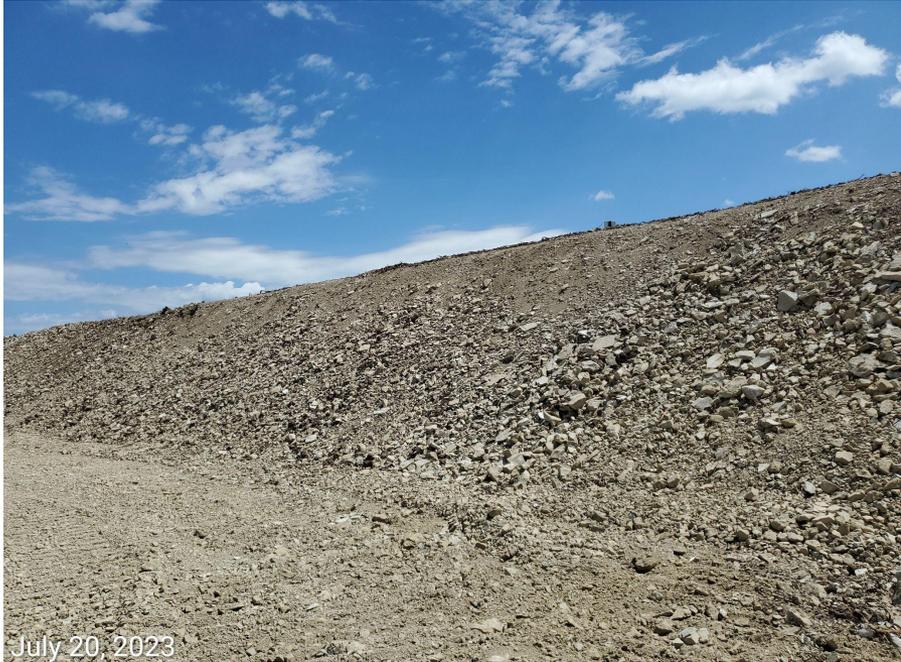
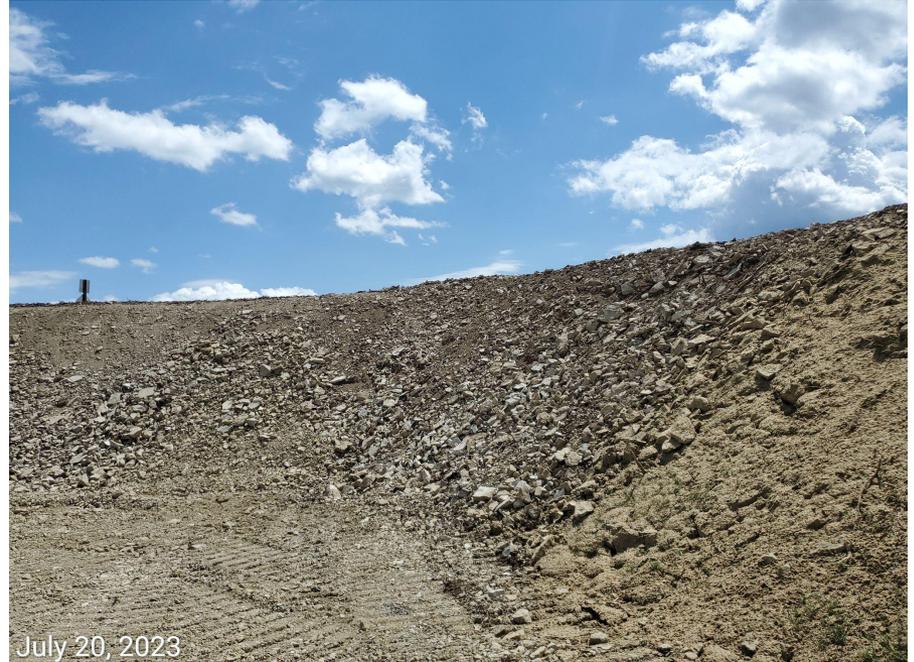
Controls remain missing or insufficient on large sections of the cut slope.

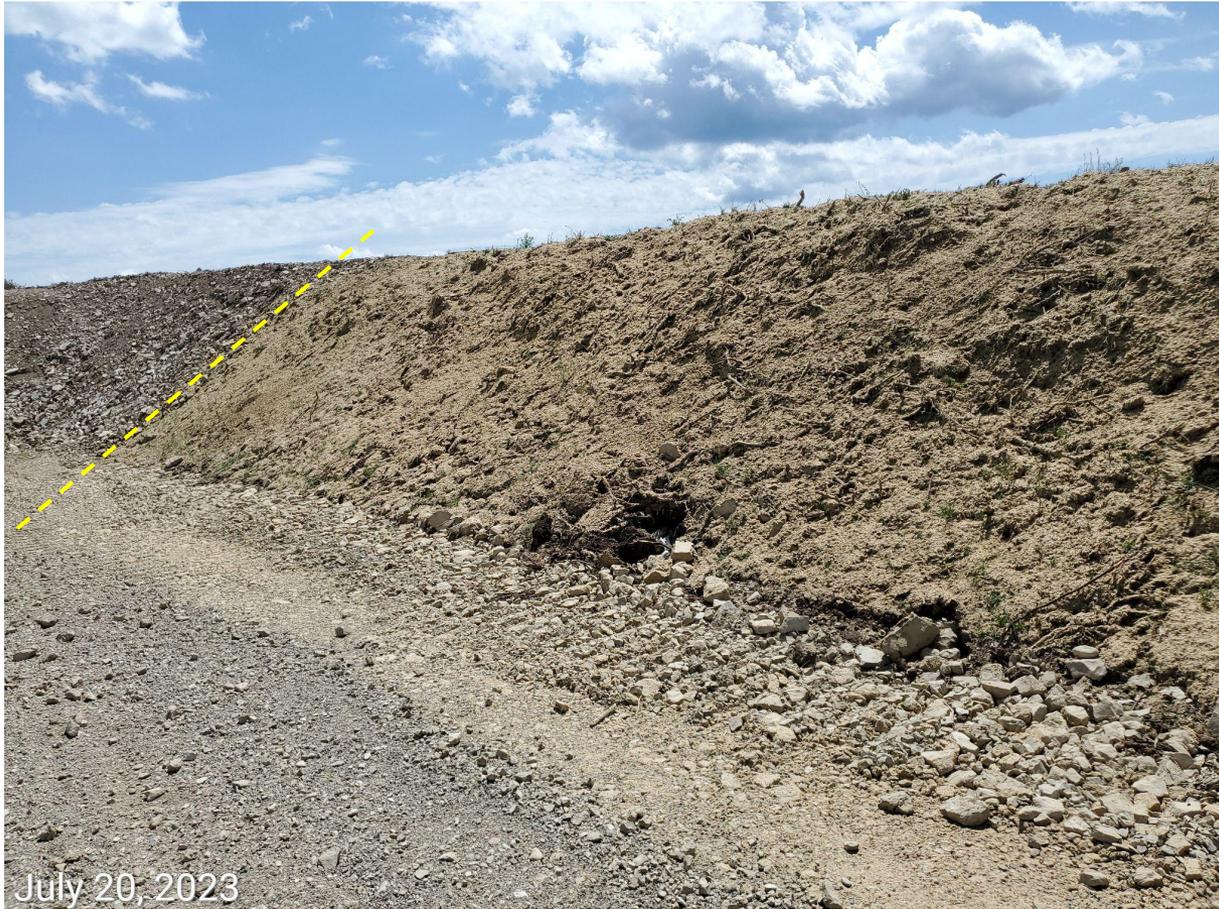
Controls to stabilize slopes, and to minimize erosion and degradation only applied to select sections of the cut slopes.
