Inspection Photos

7/20/2023

Operator: CAERUS PICEANCE LLC #10456

Location Number: 479215

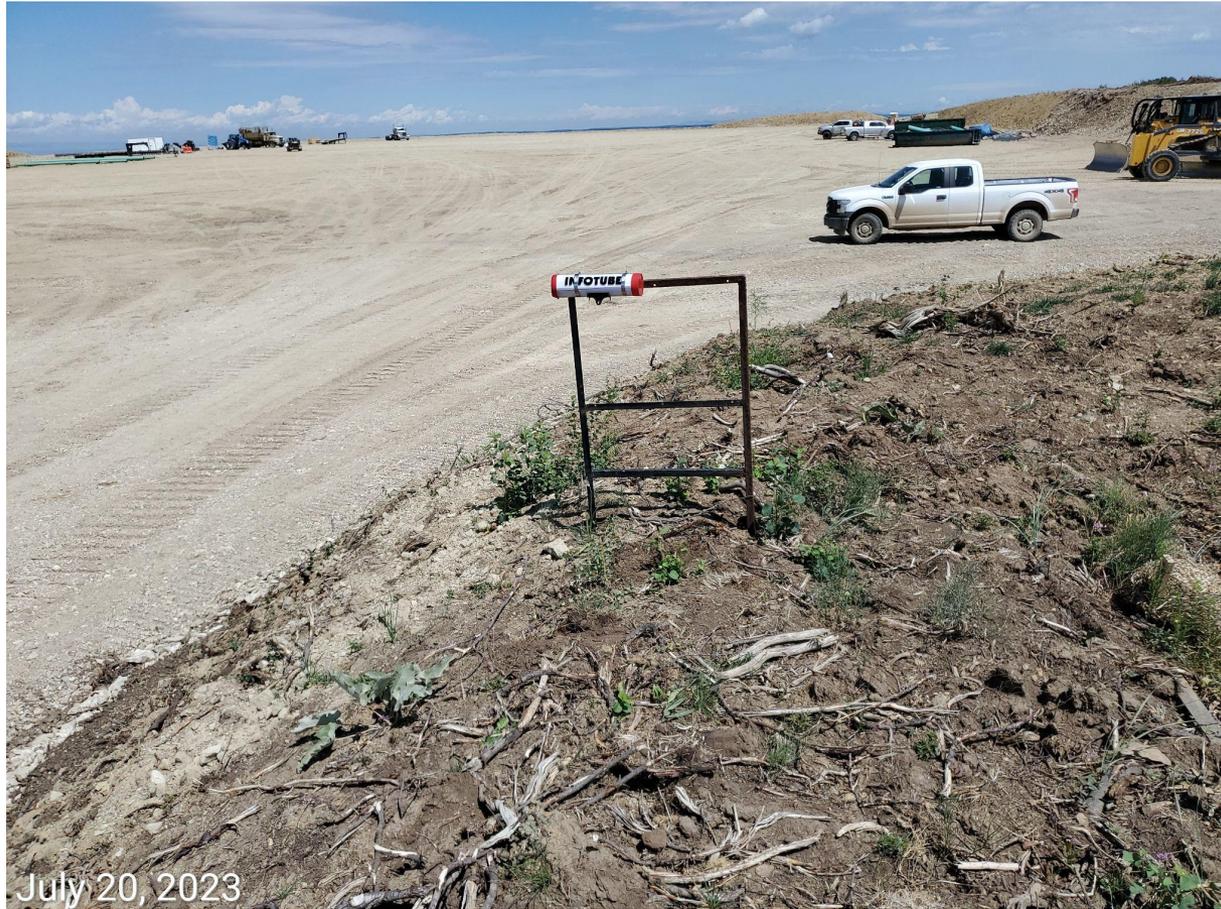
Signage remains missing at Location entrance; permit information posted within “infotube”

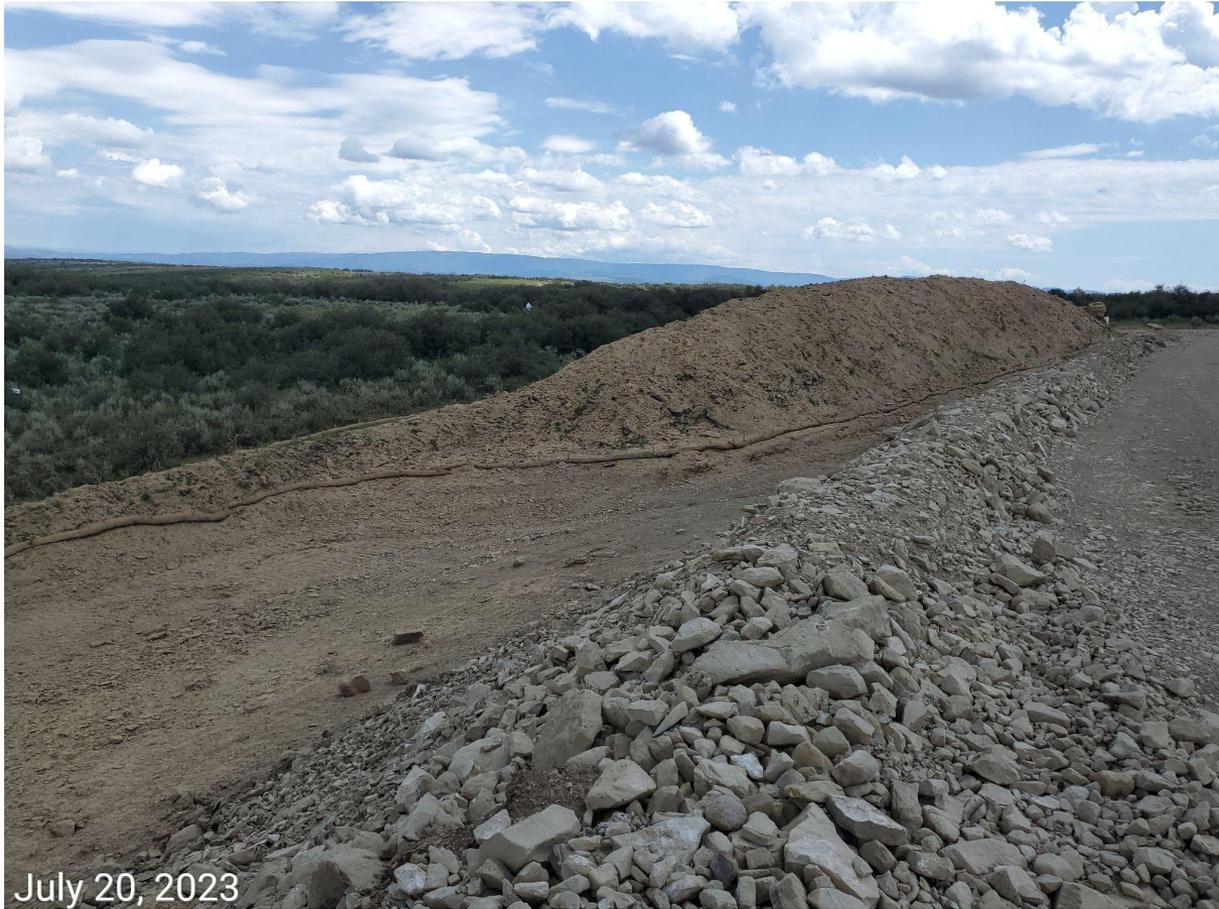
Photo example showing hydromulch has been applied to the majority of the topsoil stockpiles on the Location.

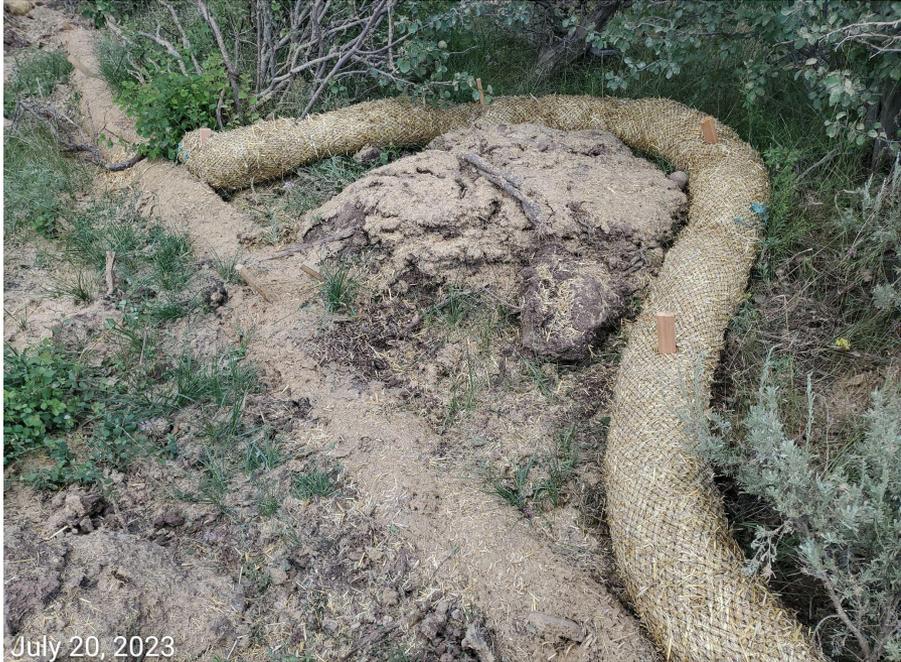
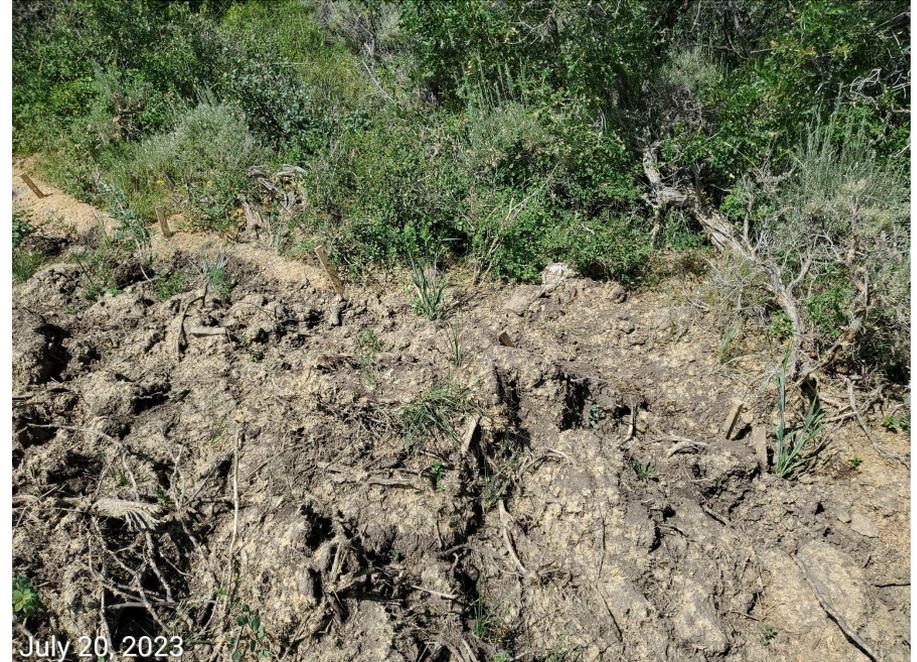
Photos examples of erosion logs observed on the Location that remain in disrepair, or have not been installed in accordance with good engineering practices.
