TEP
PA 541-34
Location ID:
335378

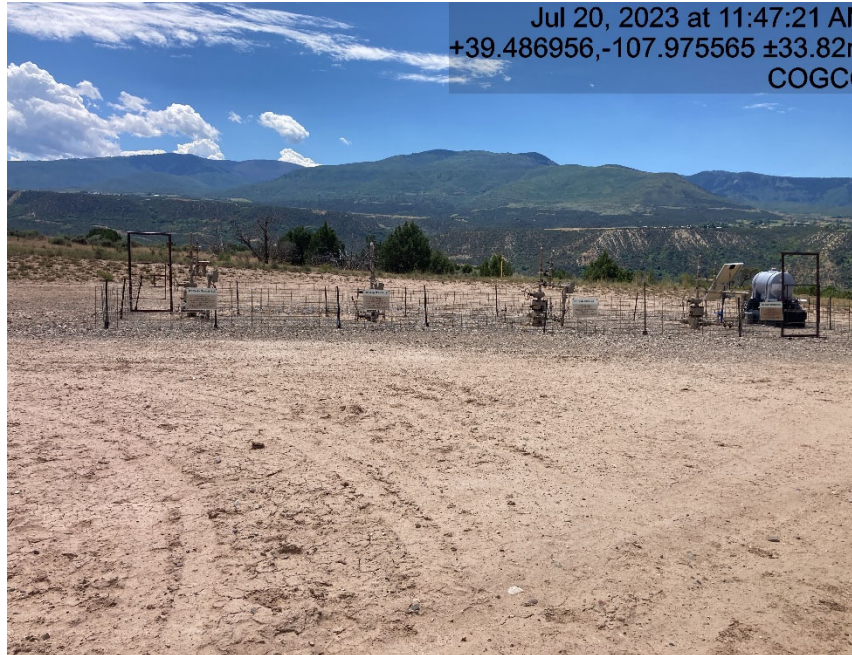
Well heads

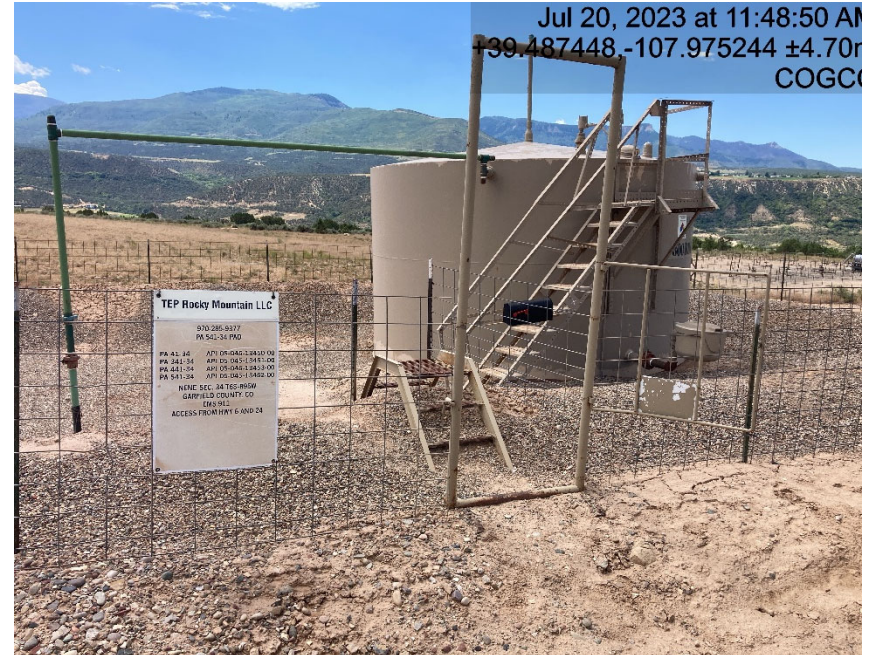
Tank battery

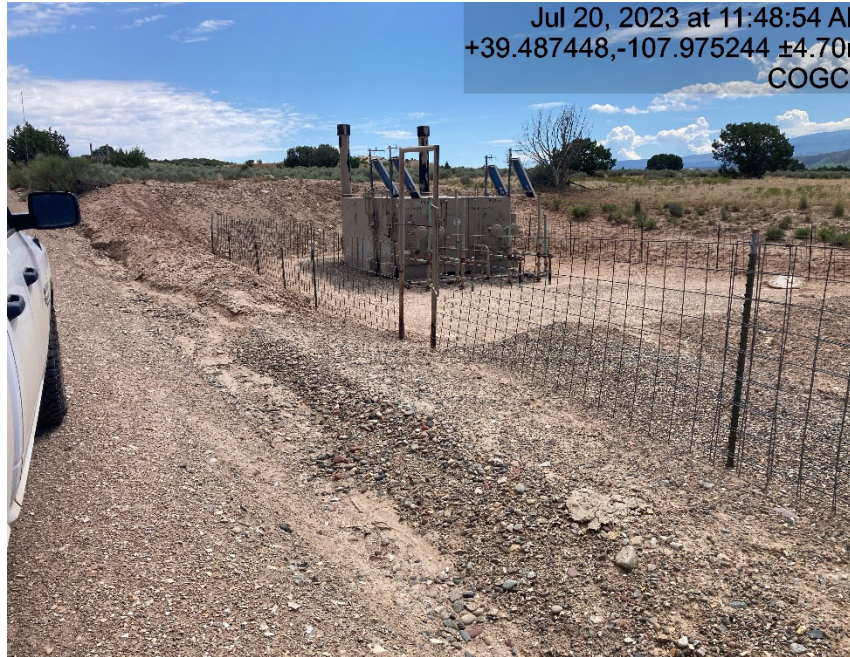
Separators and lack of calibration card access

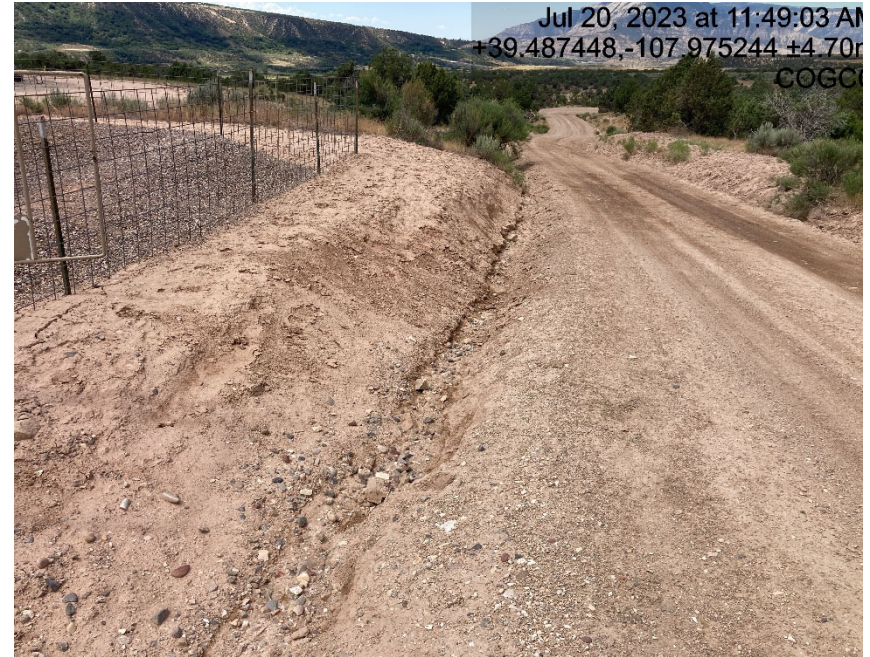
Ditch on side of location lacks erosion control

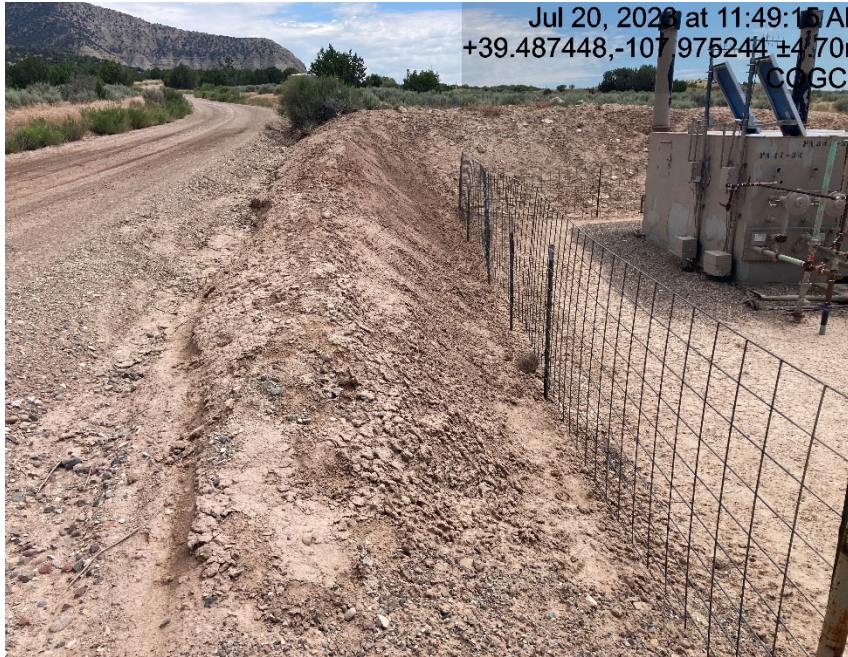
Cut slope lacks stabilization and migrating onto location encroaching on production equipment

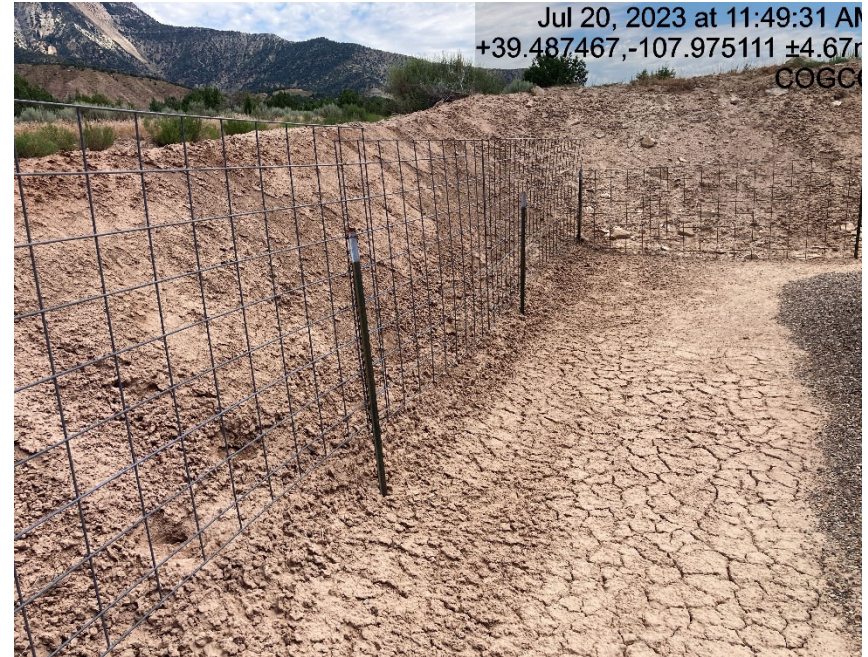
Cut slope lacks stabilization and migrating onto location encroaching on production equipment

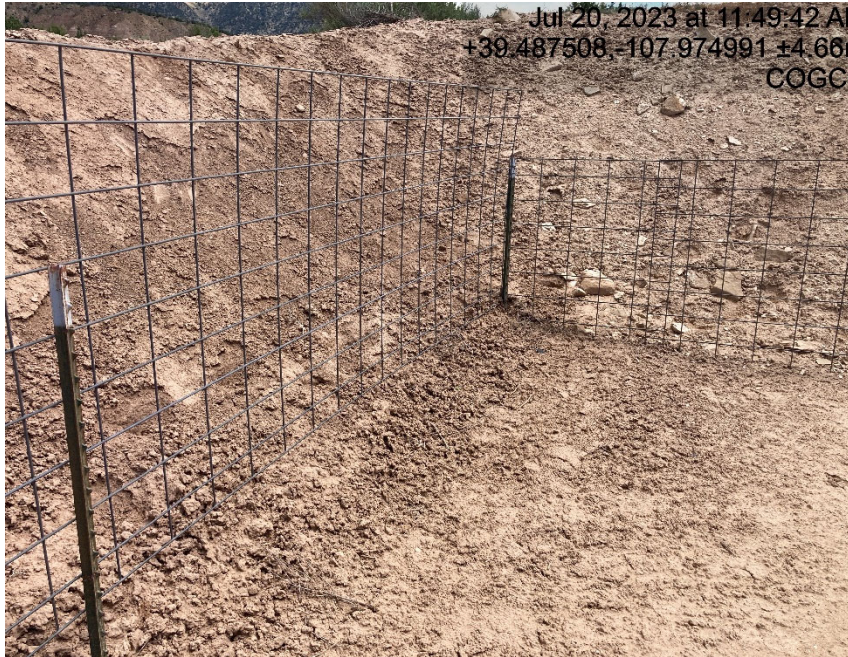
Cut slope lacks stabilization and migrating onto location encroaching on production equipment

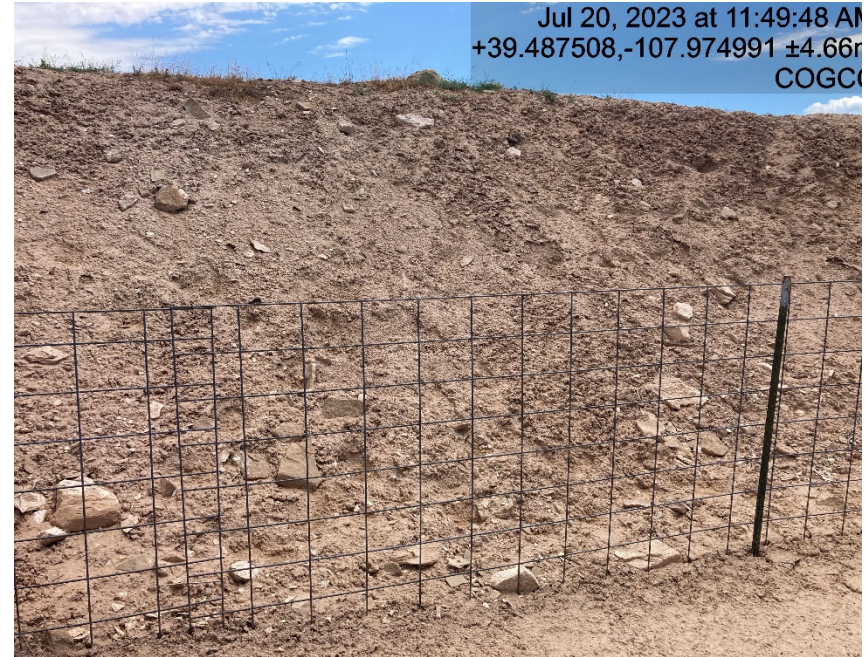
Cut slope lacks stabilization and migrating onto location encroaching on production equipment

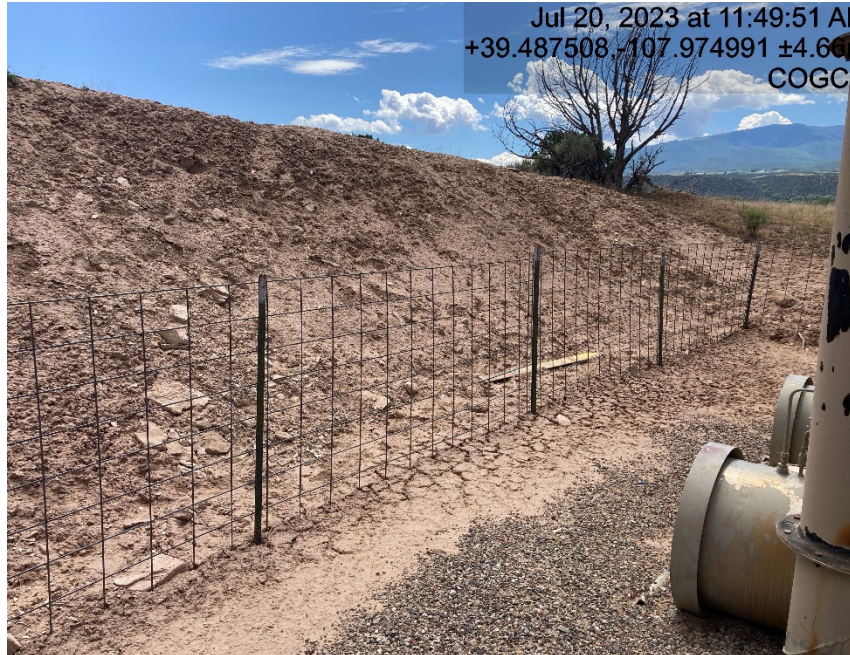
Cut slope lacks stabilization and migrating onto location encroaching on production equipment

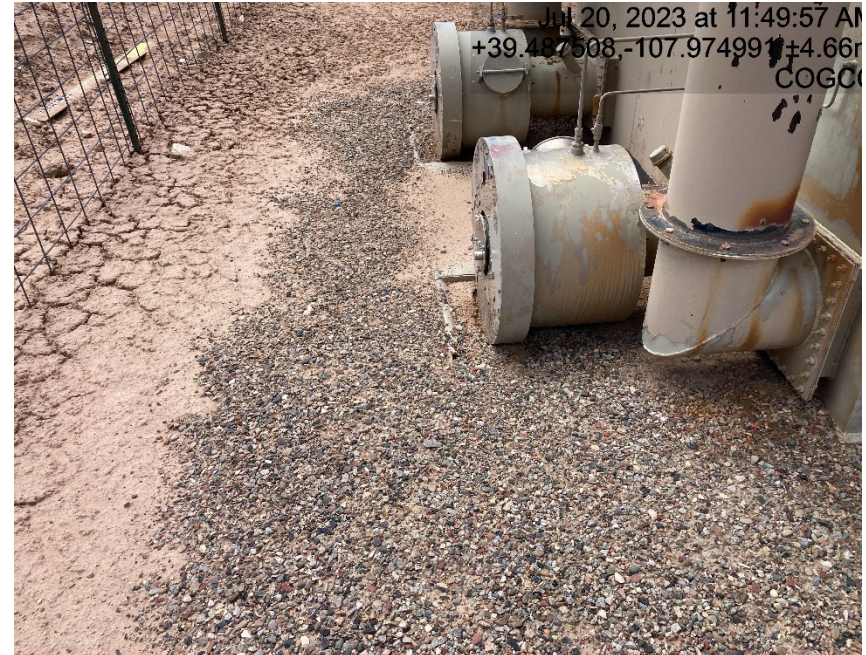
Sediment migrated over skid of production equipment

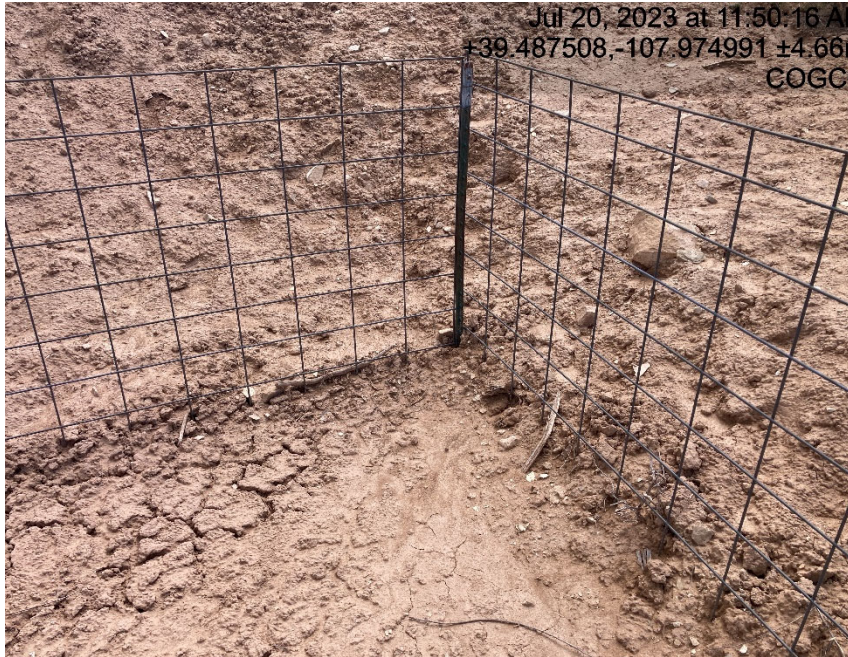
Cut slope lacks stabilization and migrating onto location encroaching on production equipment

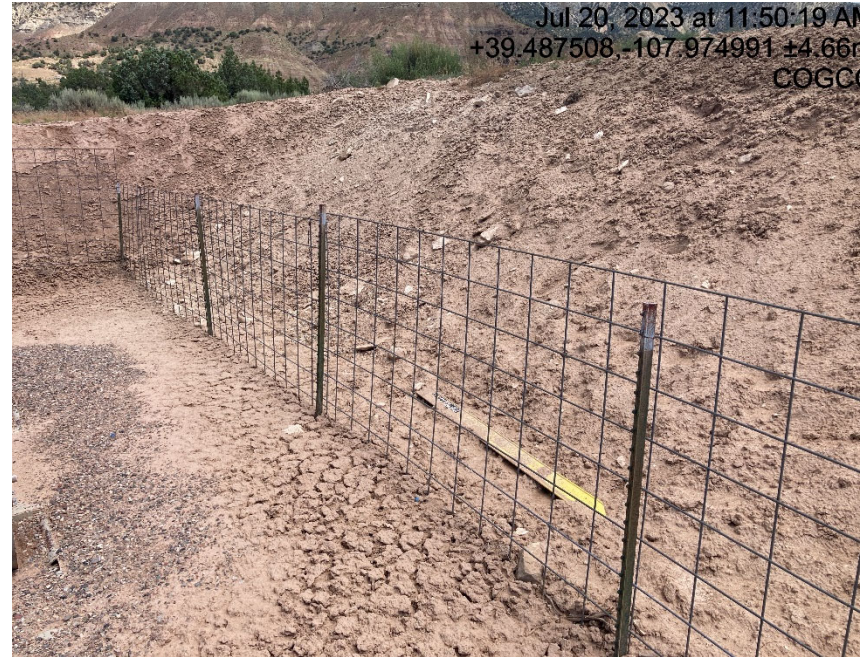
Cut slope lacks stabilization and migrating onto location encroaching on production equipment
