Inspection Photos  
Location Name: Windsor LV2 14-M Pad  
Location ID: 449441

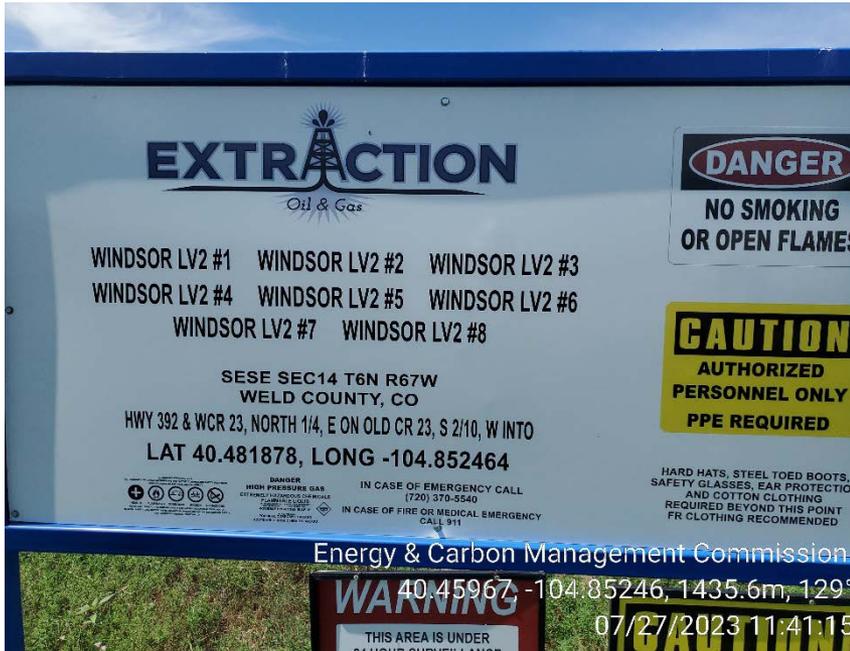
Lease road entrance sign

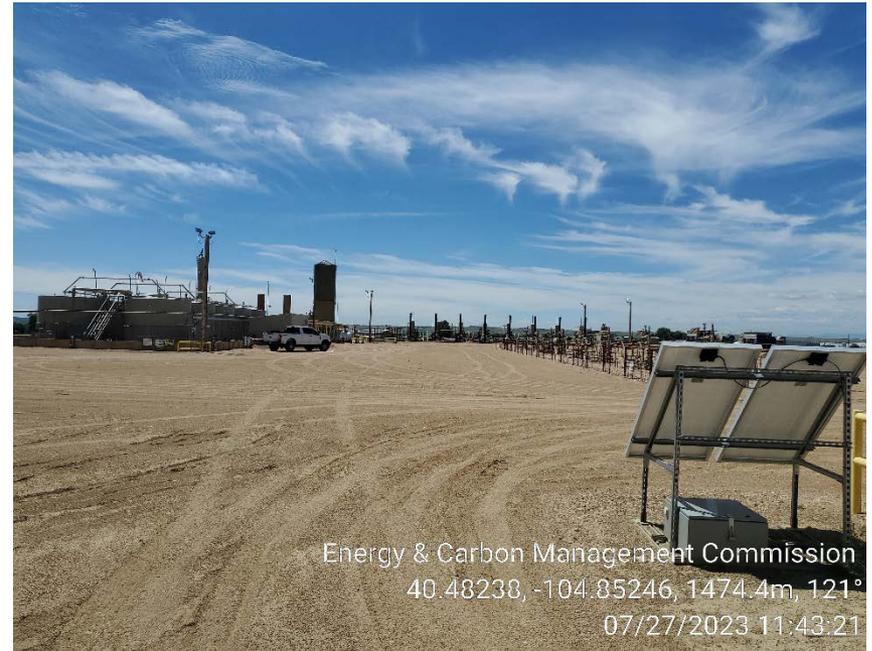
Production facility

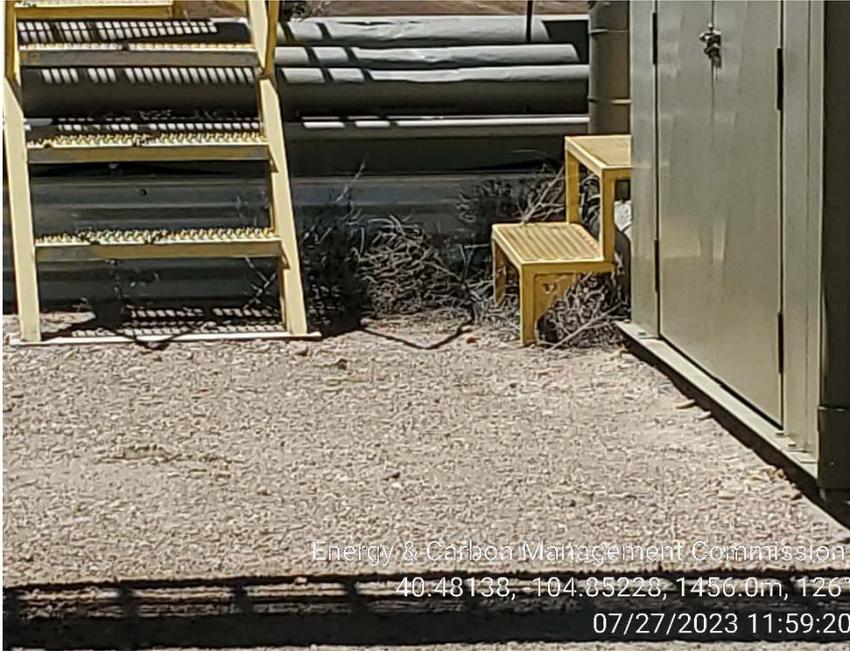
**Debris**

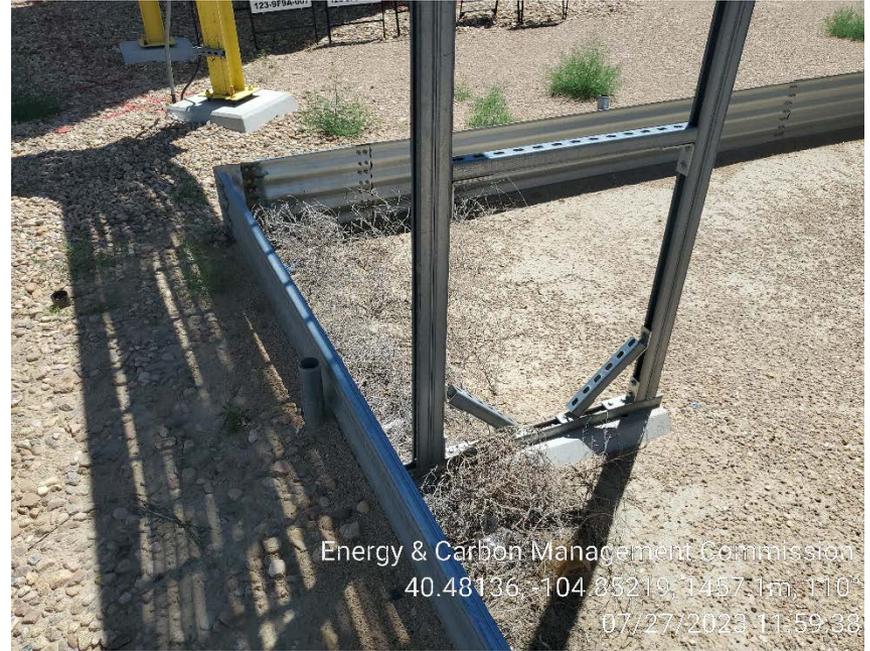
**Debris**

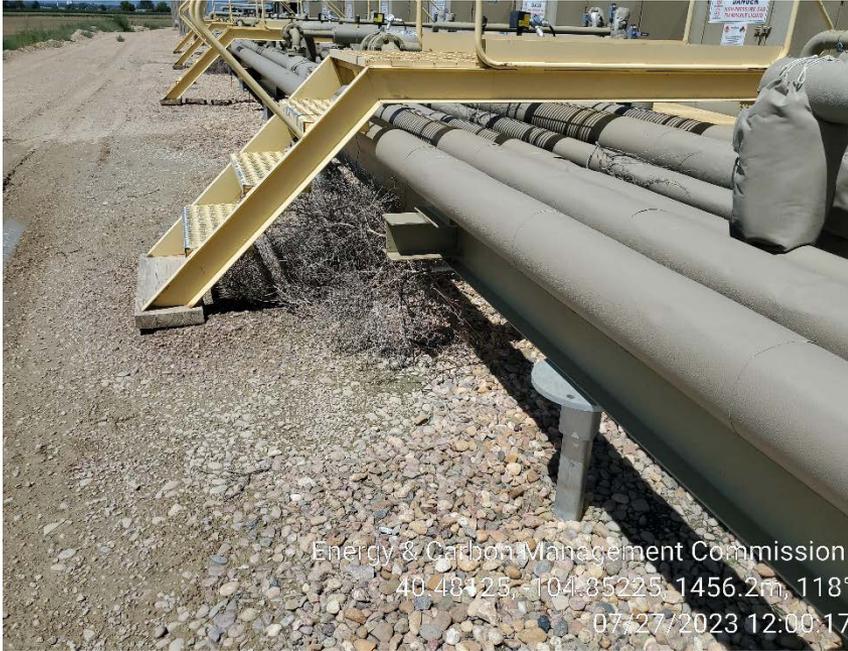
Debris

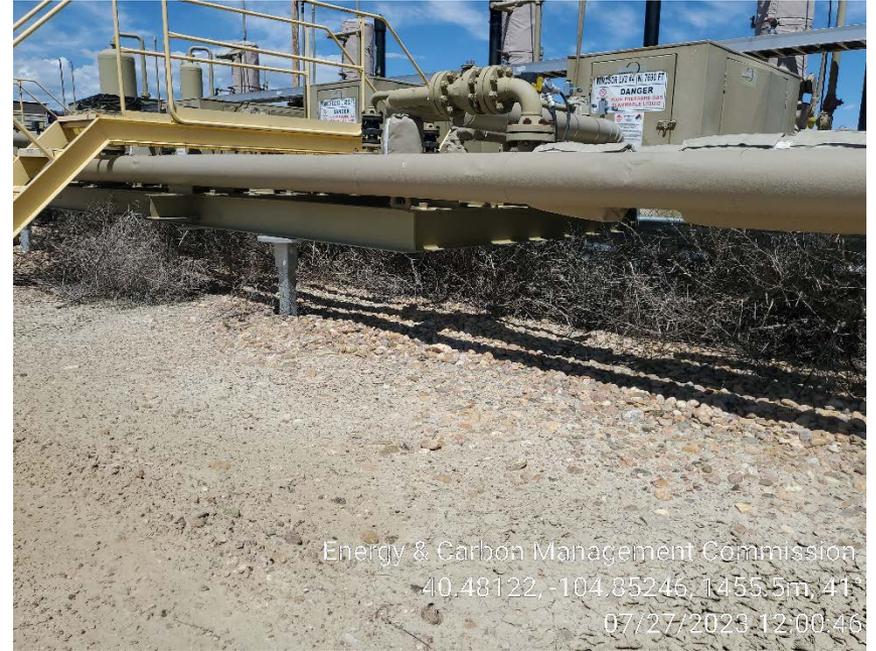
Debris

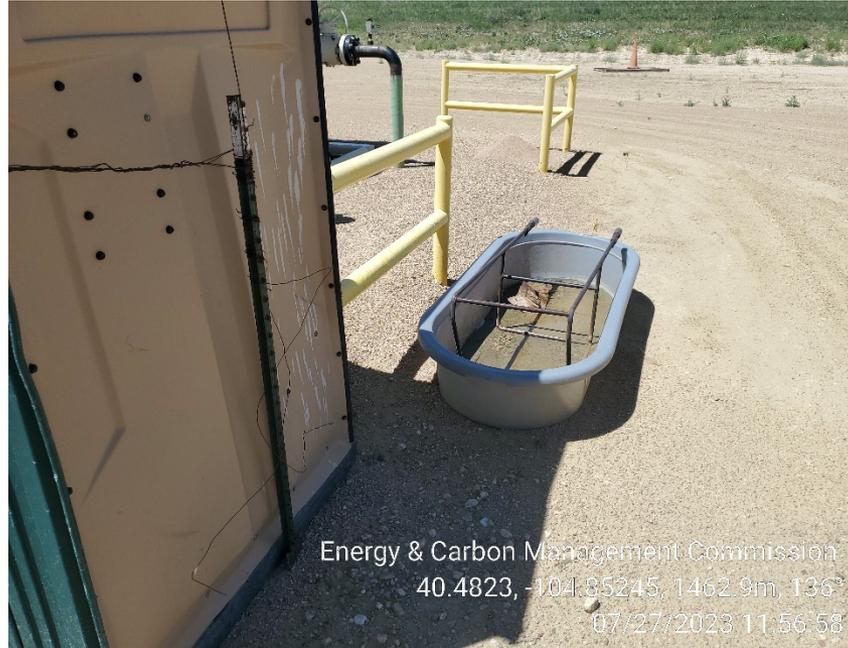
**Unused equipment**
