**Inspection Photos**  
**Location Name: Washburn GX15-62Hn**  
**Location ID: 428699**

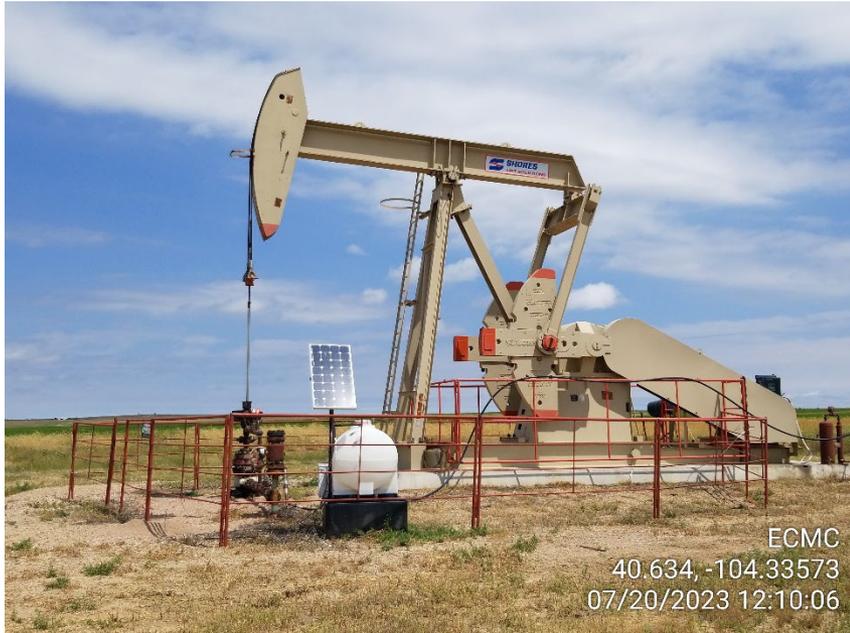
**Photo 1 – Pumping Unit**

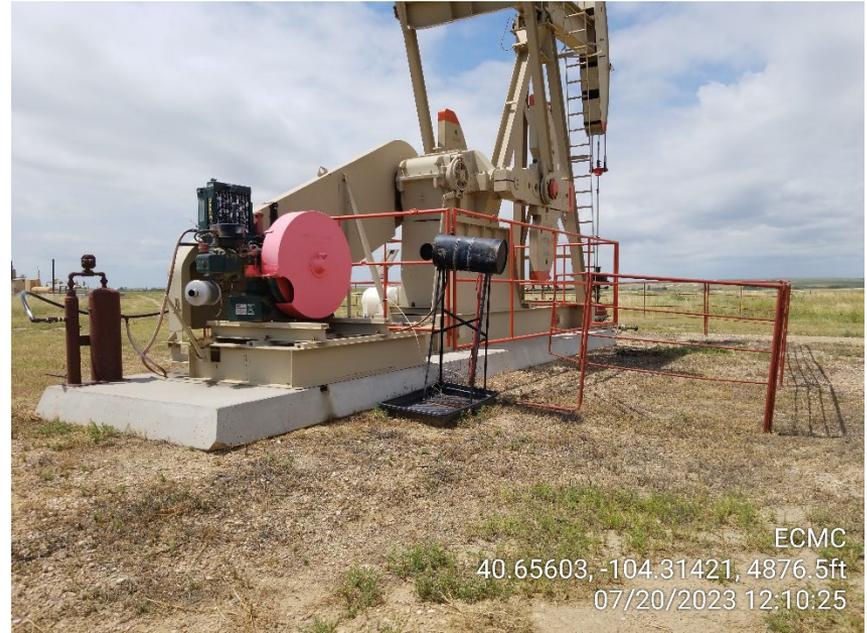
**Photo 2 – Gas Engine**

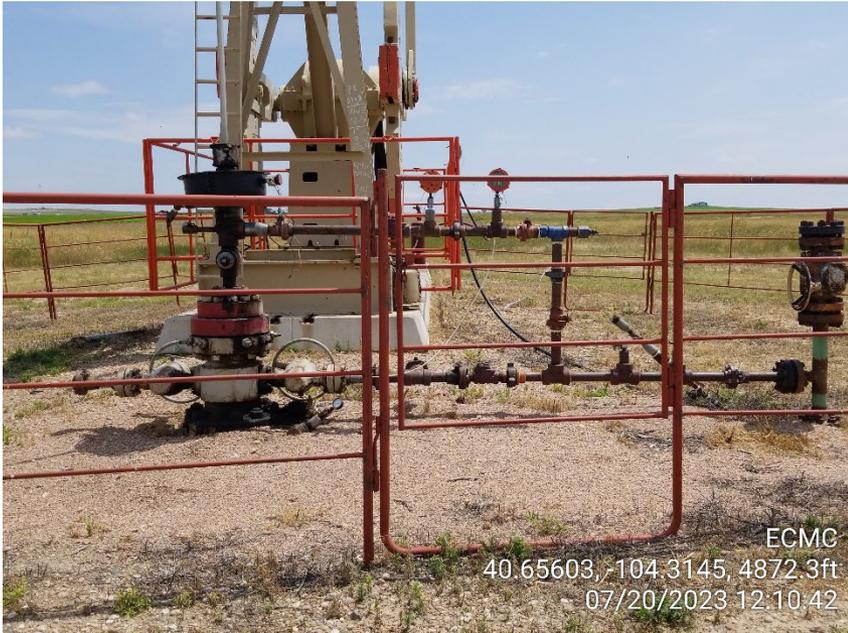
**Photo 3 – Wellhead**

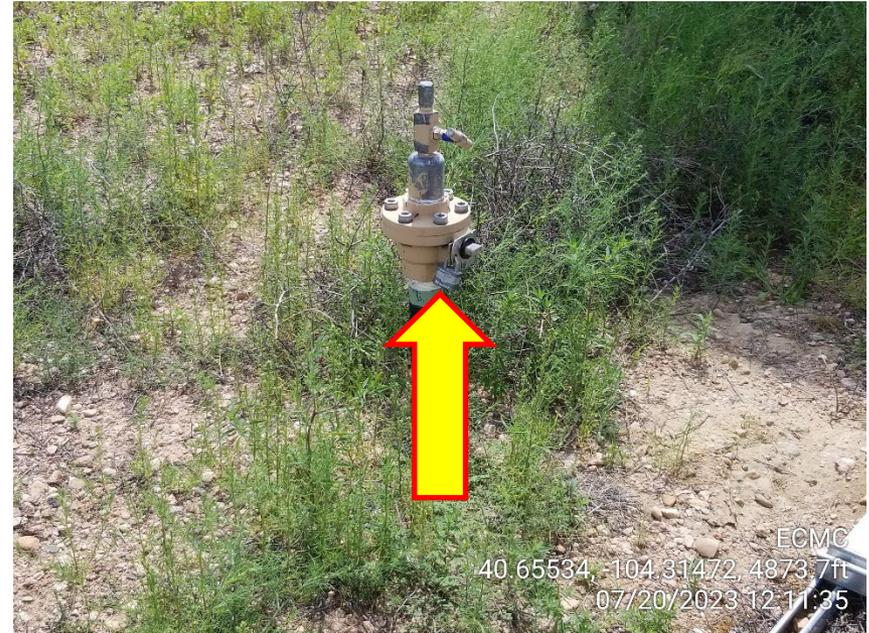
**Photo 4 – Riser has been Locked Out**

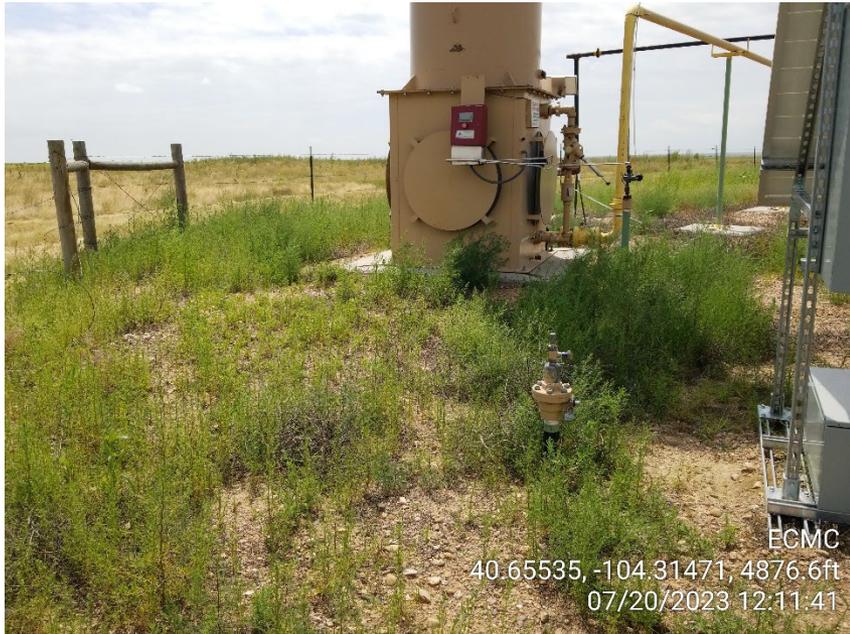
**Photo 5 – Weeds REMAIN at ECD**

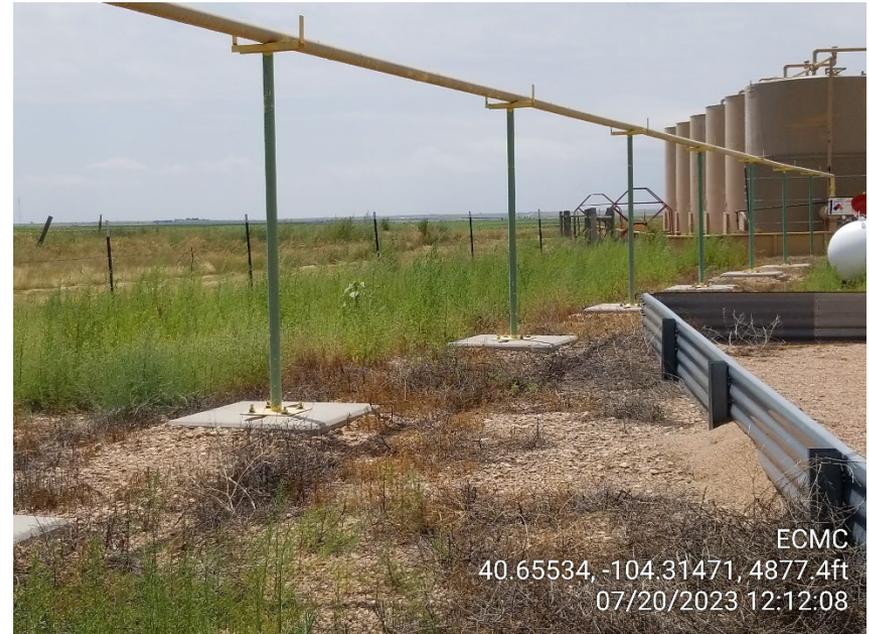
**Photo 6 – Weeds and Tumbleweed Debris East of Separators and ECD Overhead Line**

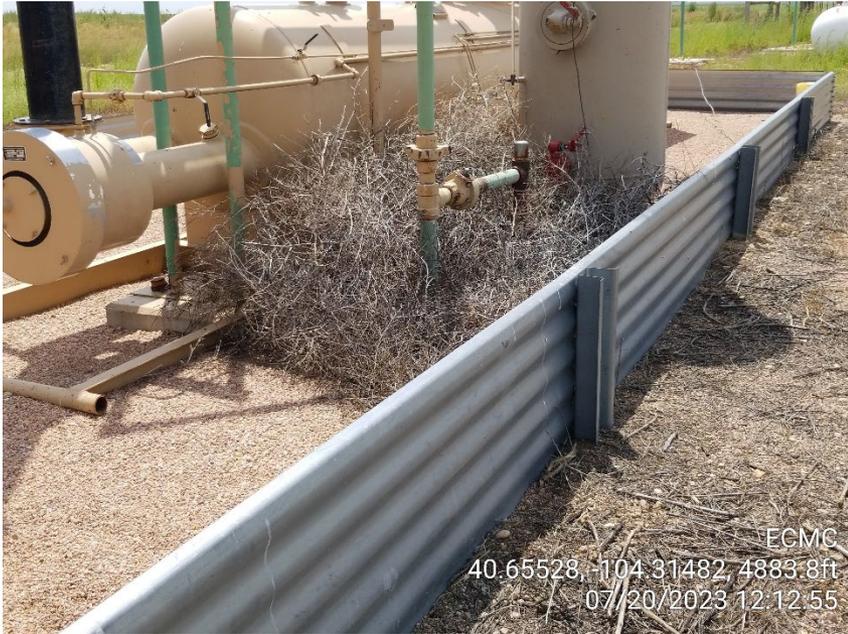
**Photo 7 – Tumbleweed Debris at South Separator**

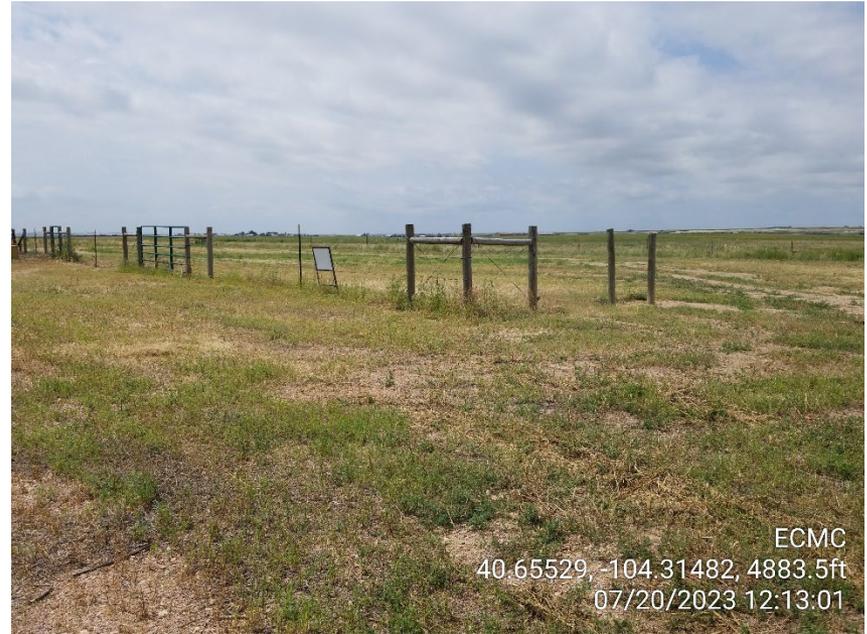
**Photo 8 – Weeds have been mowed**

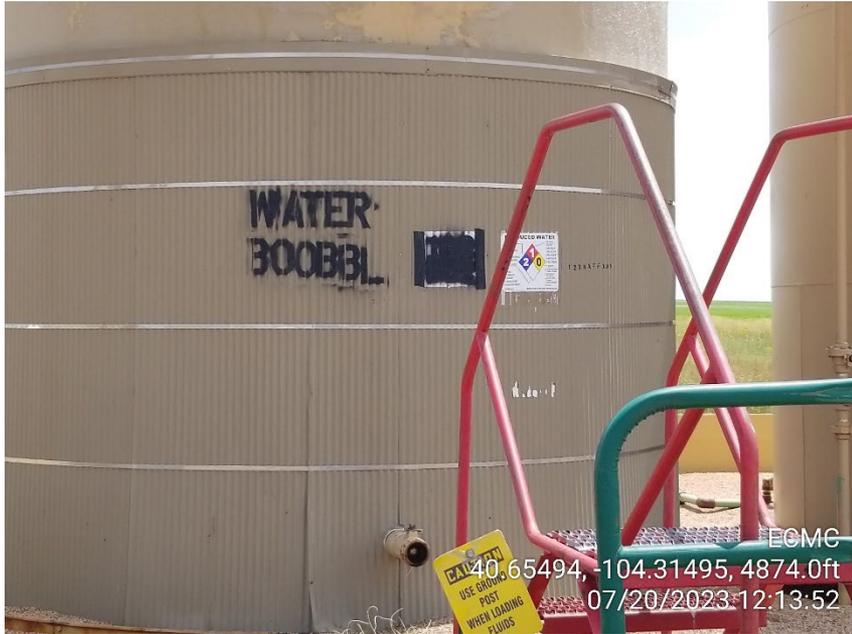
Photo 9 – Capacity Label now Adequate

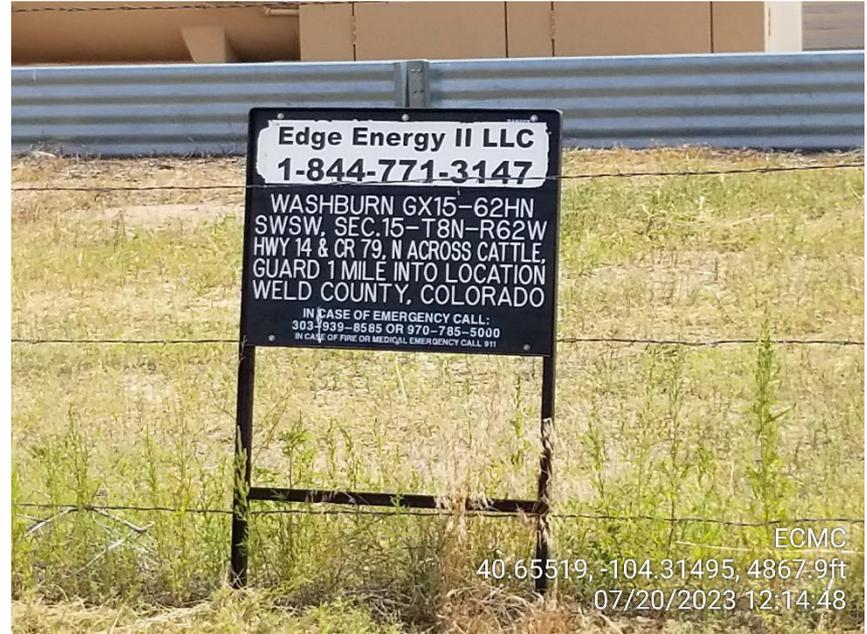
Photo 8 – Tank Battery Sign

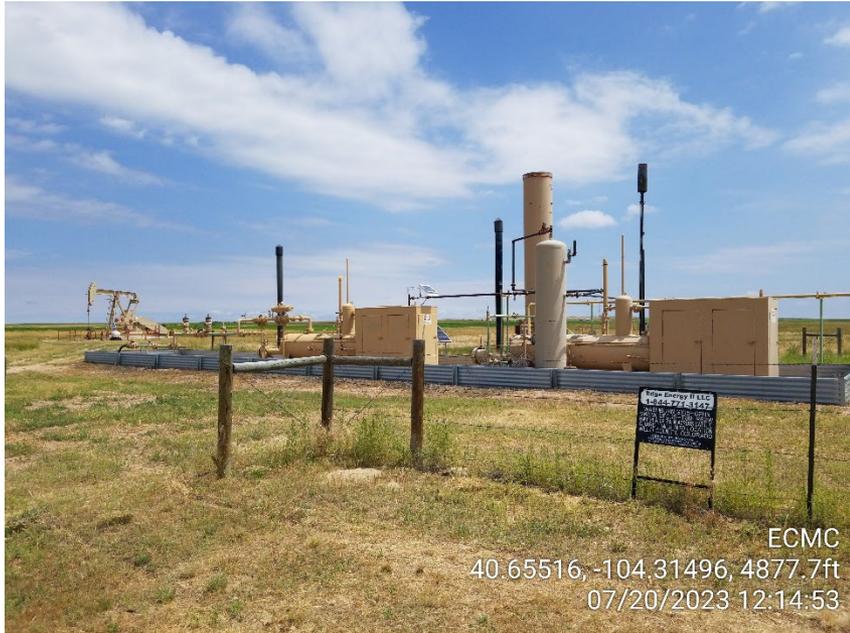
Photo 11 – Weeds mowed down

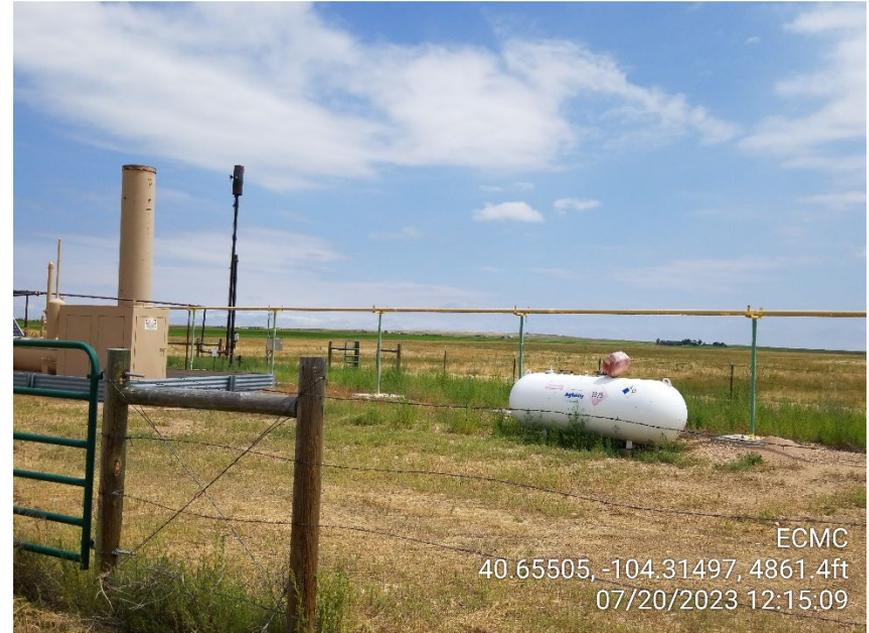
Photo 12 – Weeds mowed down – Some REMAIN East of Overhead Line

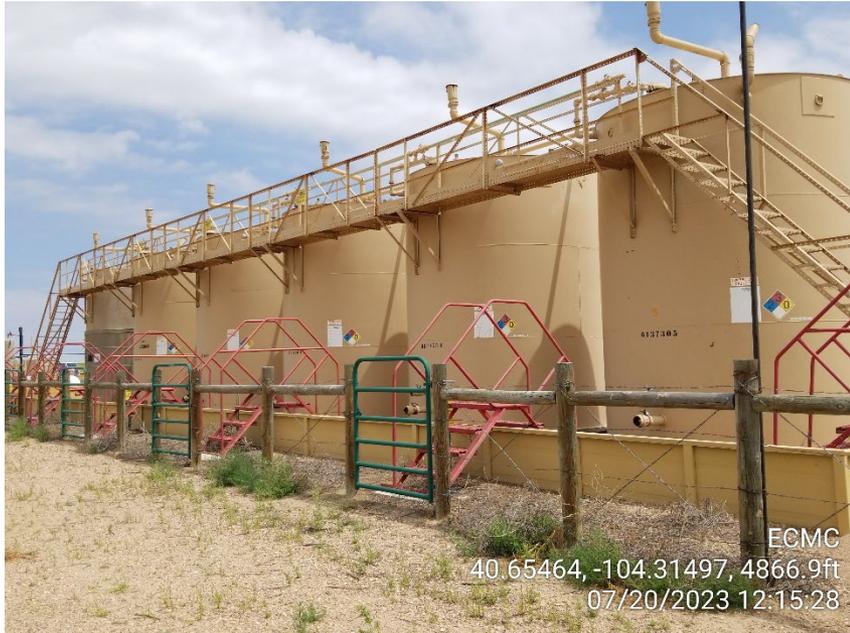
**Photo 13 – Tank Battery – Tumbleweed Debris has been removed**
