Storm Water Management and Erosion control
Location Name: CAERUS PICEANCE LLC F19 Pad
Location #: 311615

**Location Overview: Location is within High
Priority/Density/Black Bear Habitat areas.**
Section/Township/Range: 19 7S92W

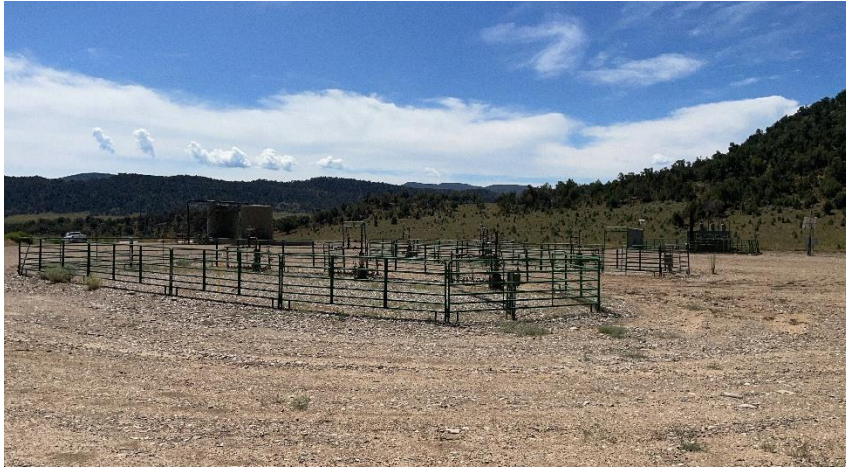
North West corner of location.

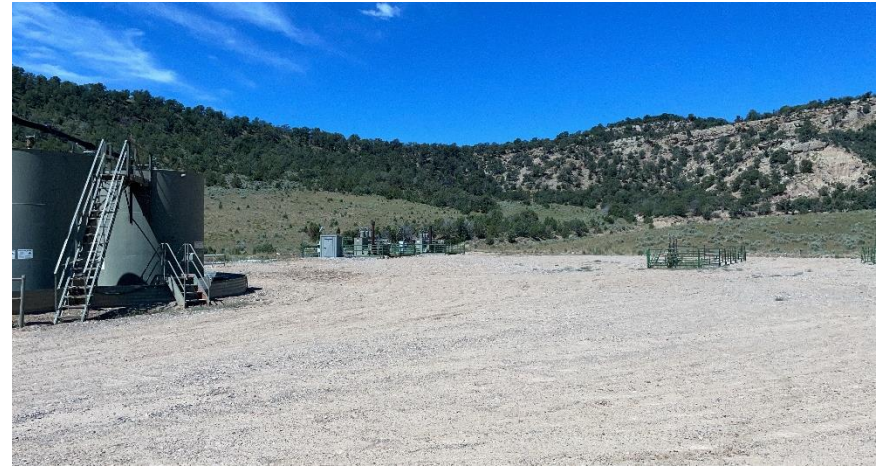
North East corner of location.

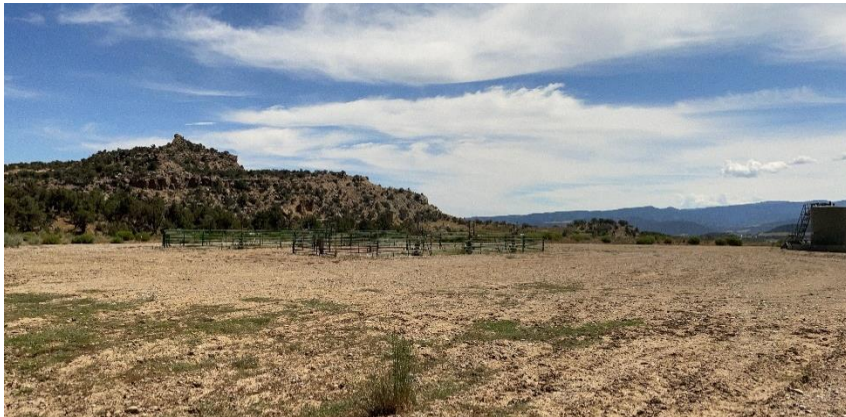
South West corner of location.

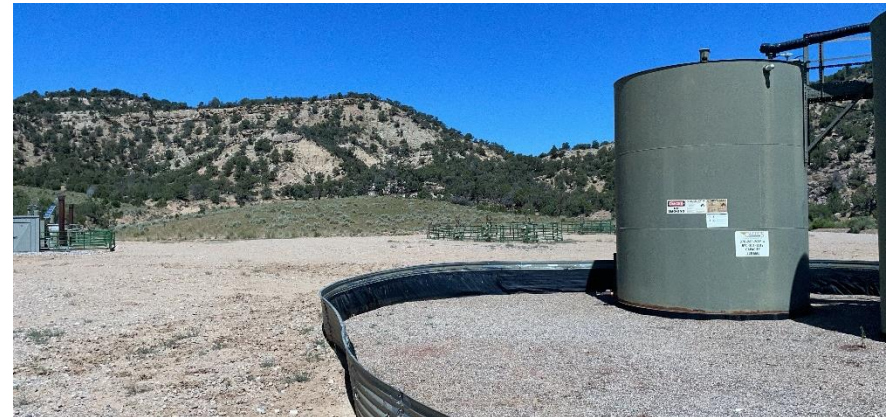
South East corner of location.

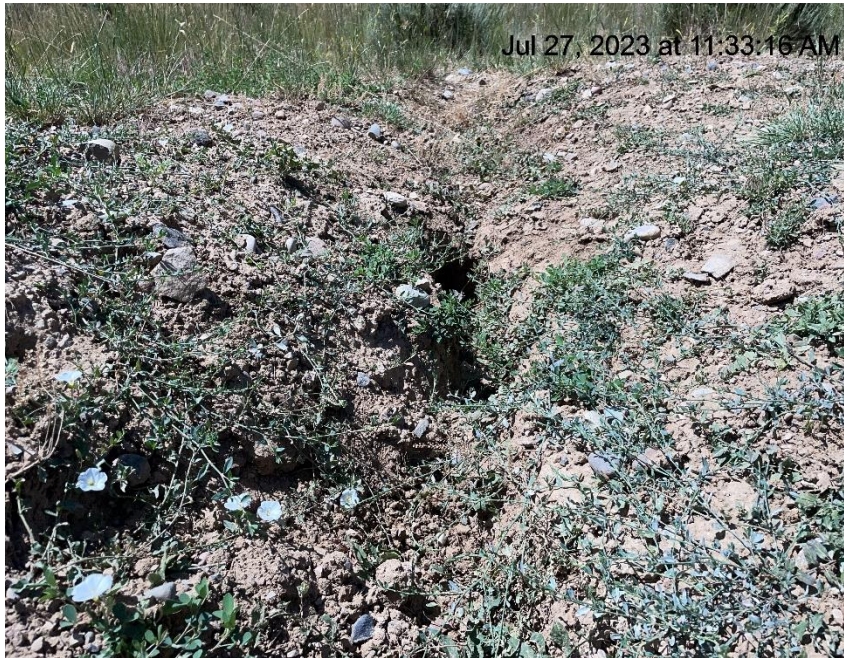
Photo # 4021 Erosion & transport of sediment off location/insufficient BMP's (S/SW edge of location near Summit meter house)

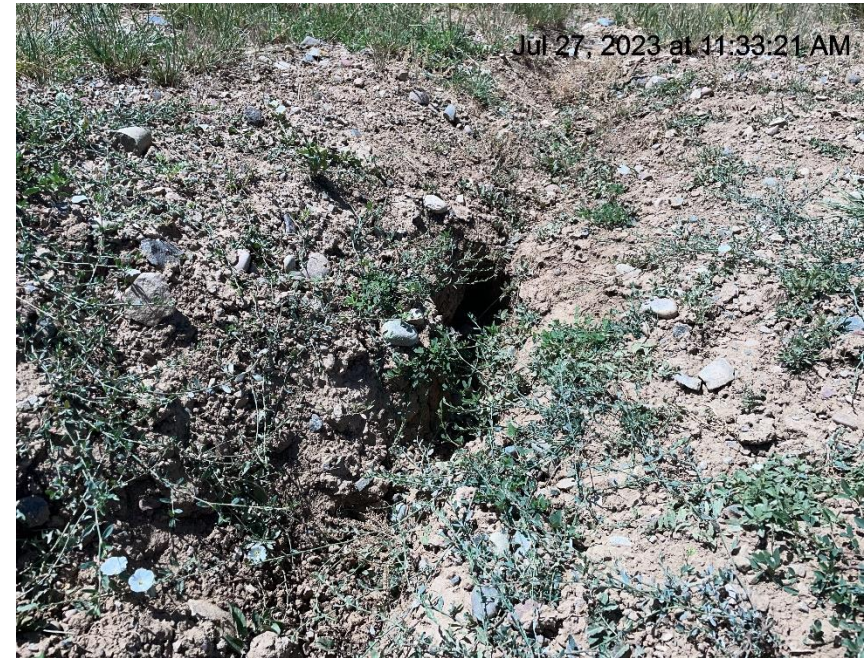
Photo # 4022 Erosion & transport of sediment off location/insufficient BMP's (S/SW edge of location near Summit meter house)

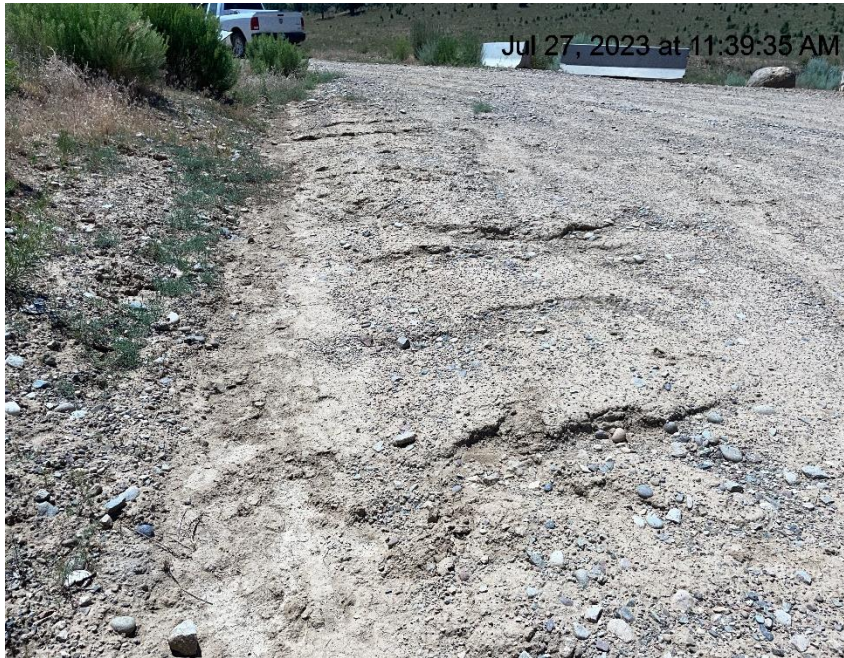
Photo # 4038 Rill erosion & transport of sediment (N/NE area of pad)

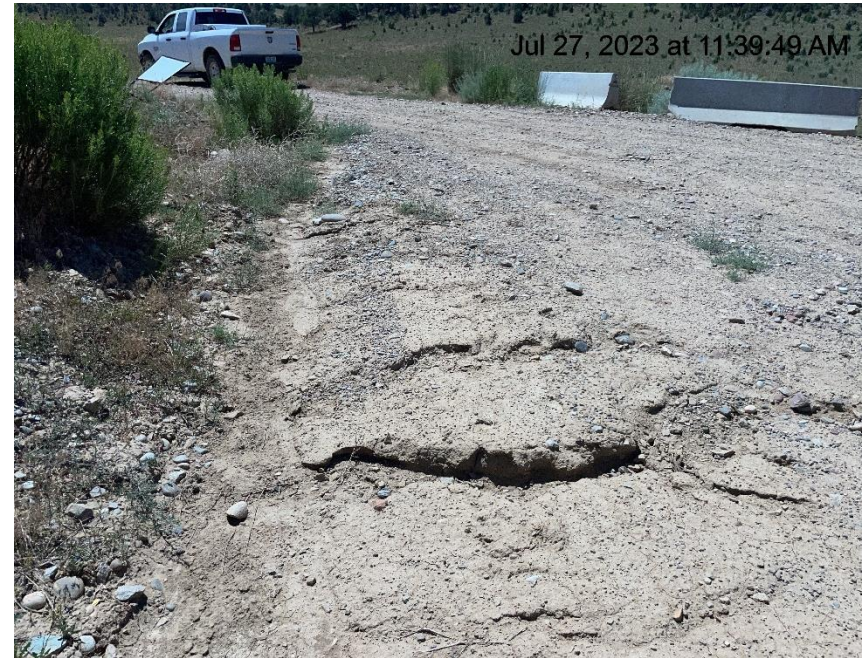
Photo # 4040 Rill erosion & transport of sediment (N/NE area of pad)

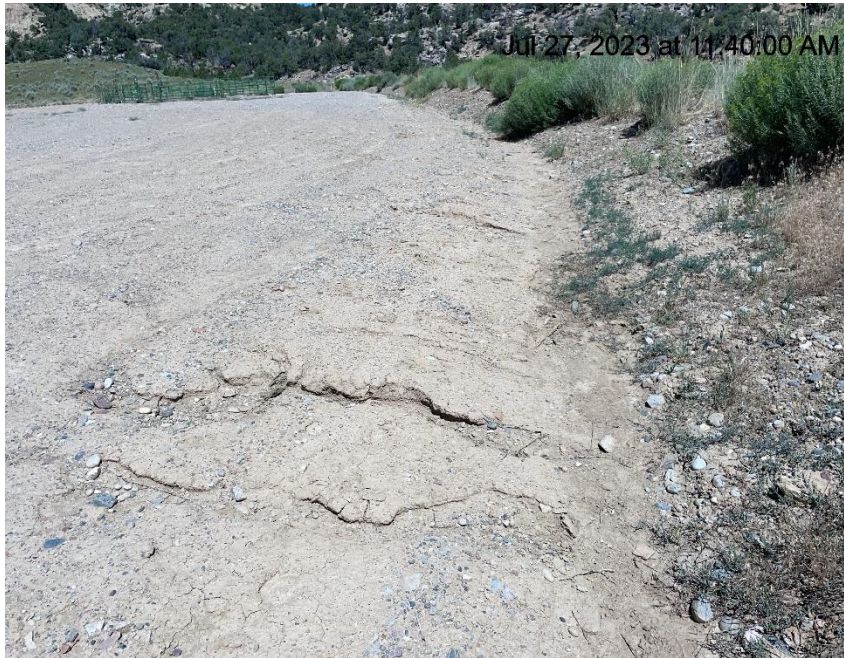
Photo # 4041 Rill erosion & transport of sediment (N/NE area of pad)

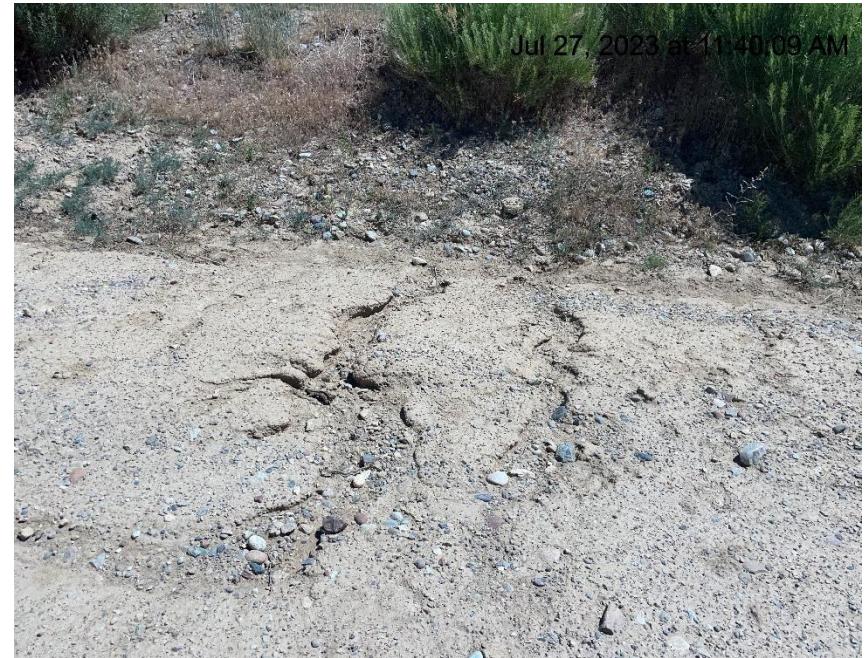
Photo # 4042 Rill erosion & transport of sediment (N/NE area of pad)

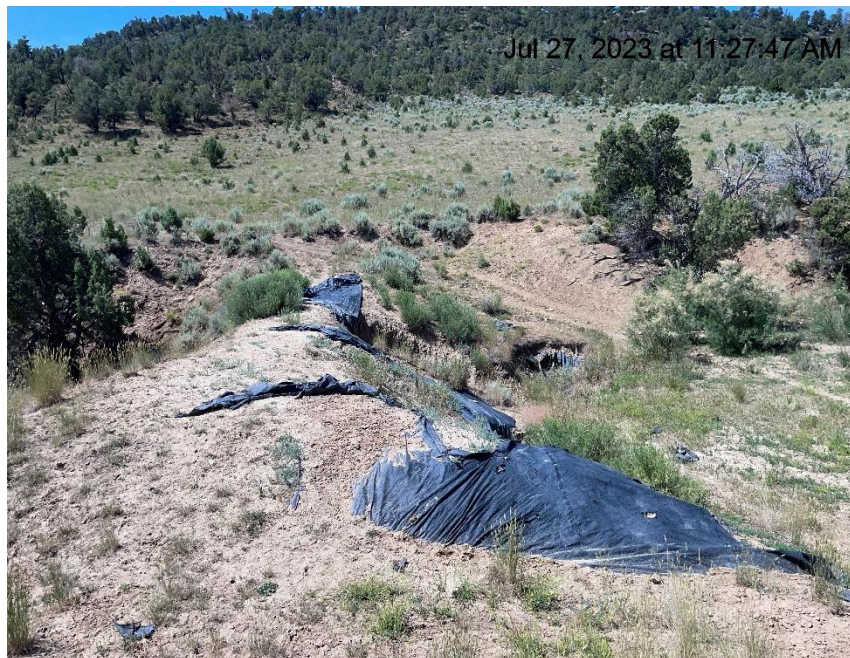
**Photo # 4010 Geotextile/liner & erosion observed
approximately 25-35 yards S/SW of location**

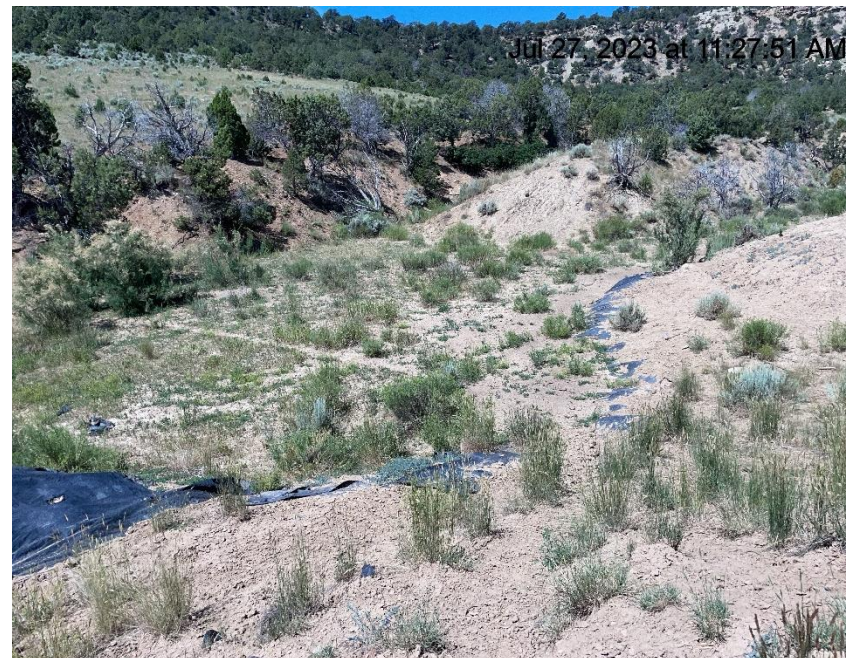
**Photo # 4011 Geotextile/liner & erosion observed
approximately 25-35 yards S/SW of location**

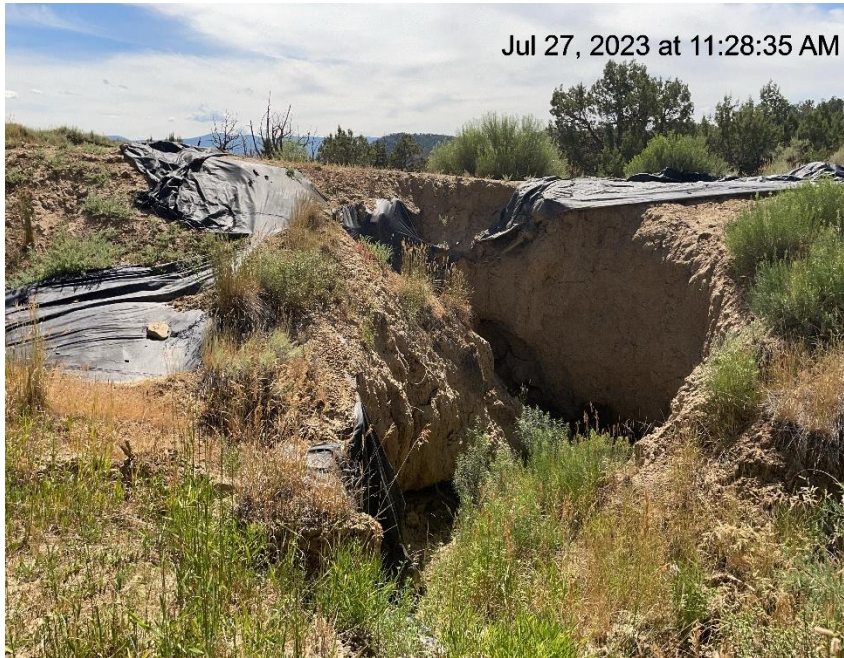
Photo # 4012 Geotextile/liner & erosion observed approximately 25-35 yards S/SW of location

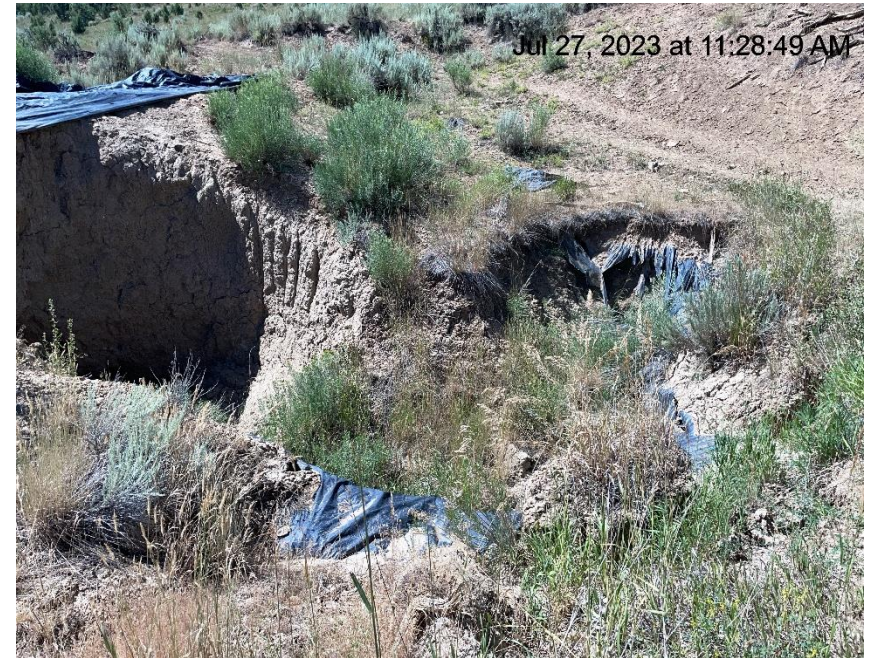
Photo # 4013 Geotextile/liner & erosion observed approximately 25-35 yards S/SW of location

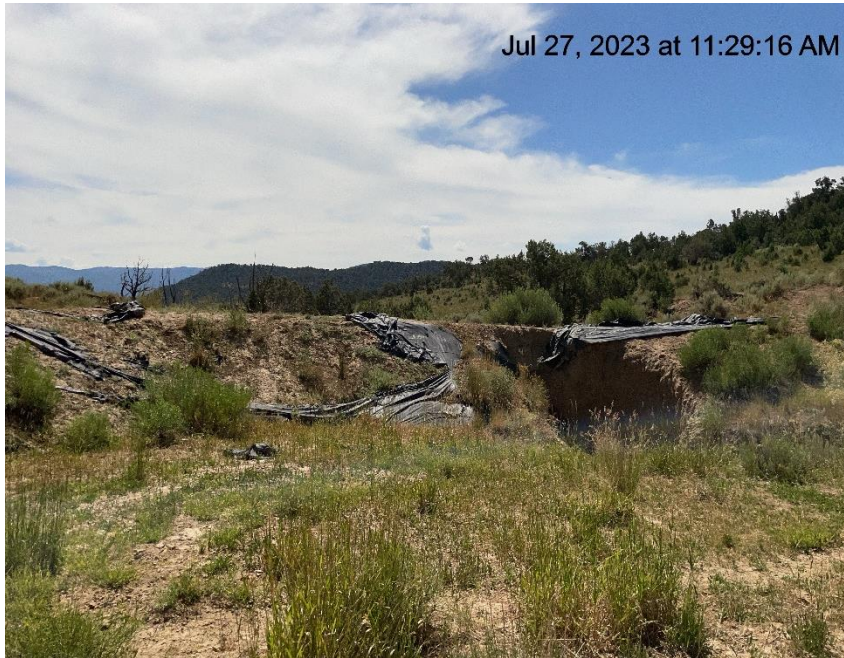
**Photo # 4014 Geotextile/liner & erosion observed
approximately 25-35 yards S/SW of location**
