Inspection Photos
Location Name: CAERUS PICEANCE LLC O19EB Pad
Location #: 431050

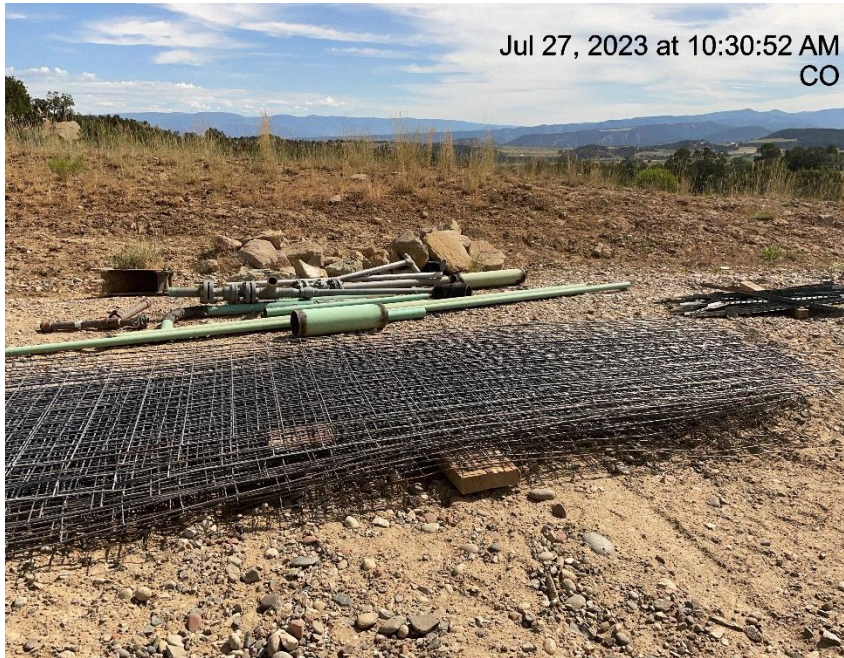
Photo # 3933 Unused supplies

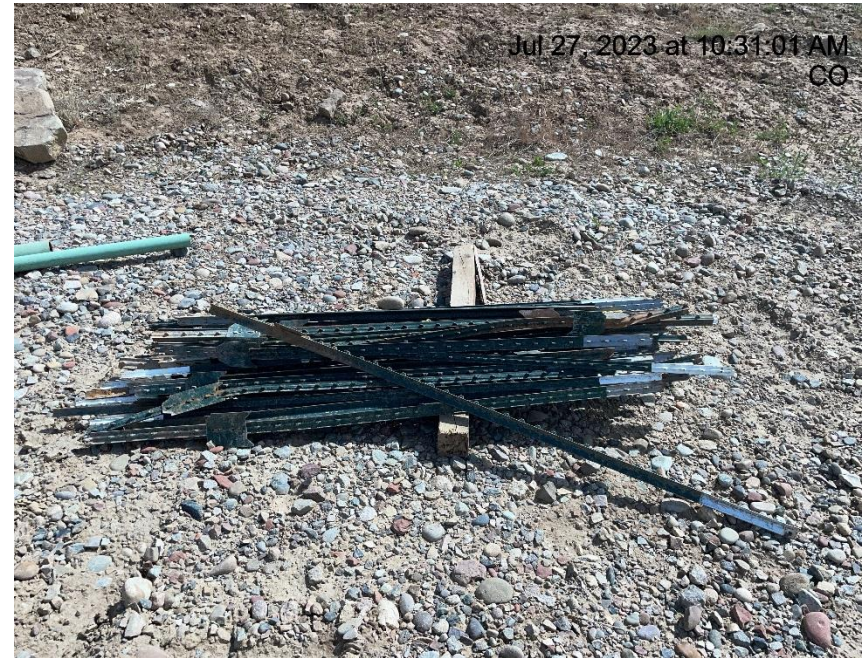
Photo # 3934 Unused supplies

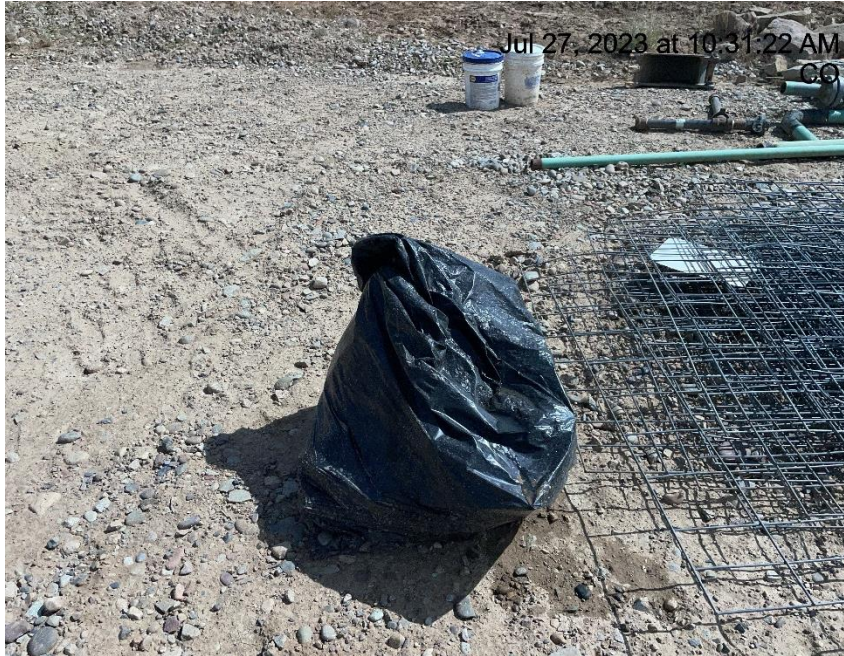
Photo # 3935 Trash

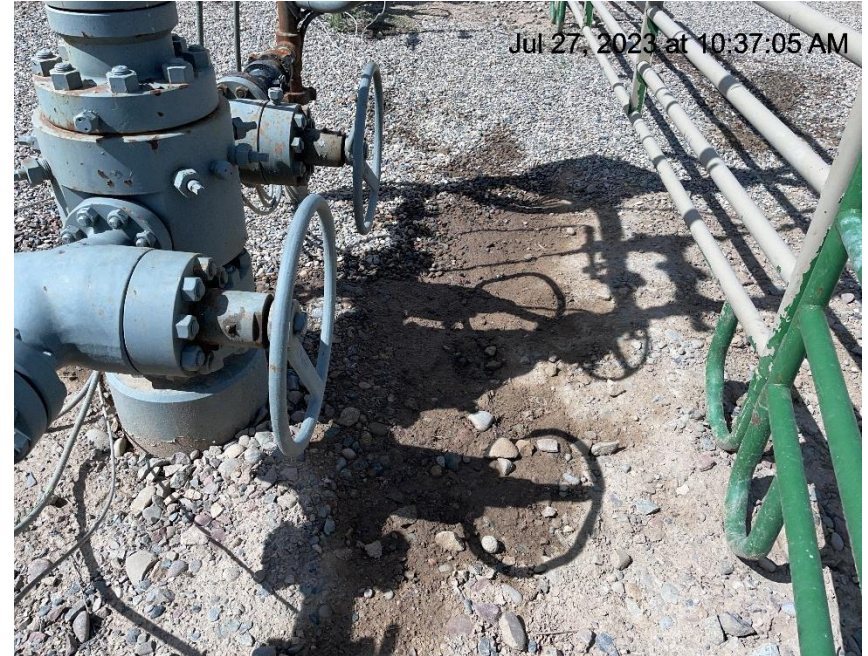
Photo # 3937 Stained soils & gravel near FED 19-13D wellhead

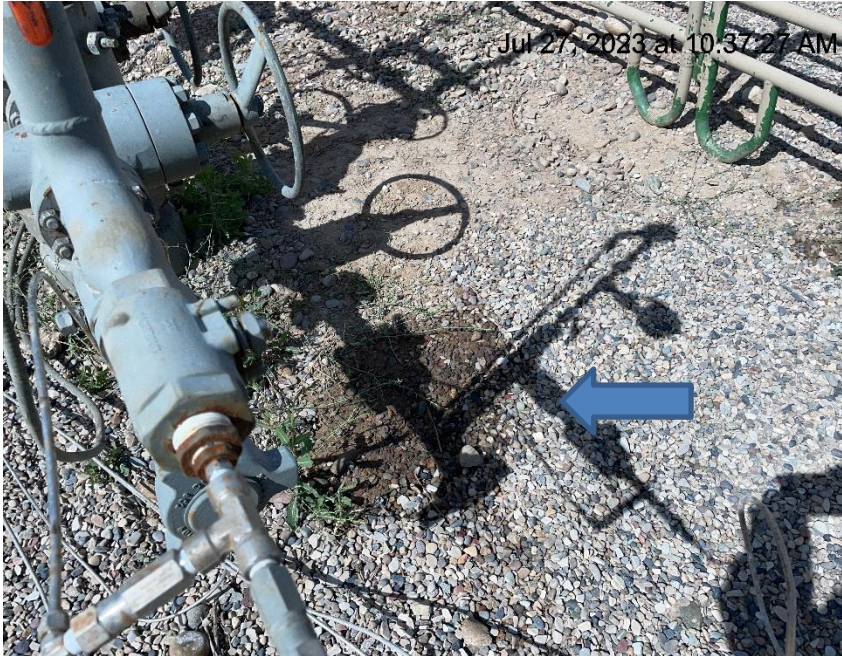
Photo # 3940 Stained soils & gravel near 30-4A wellhead

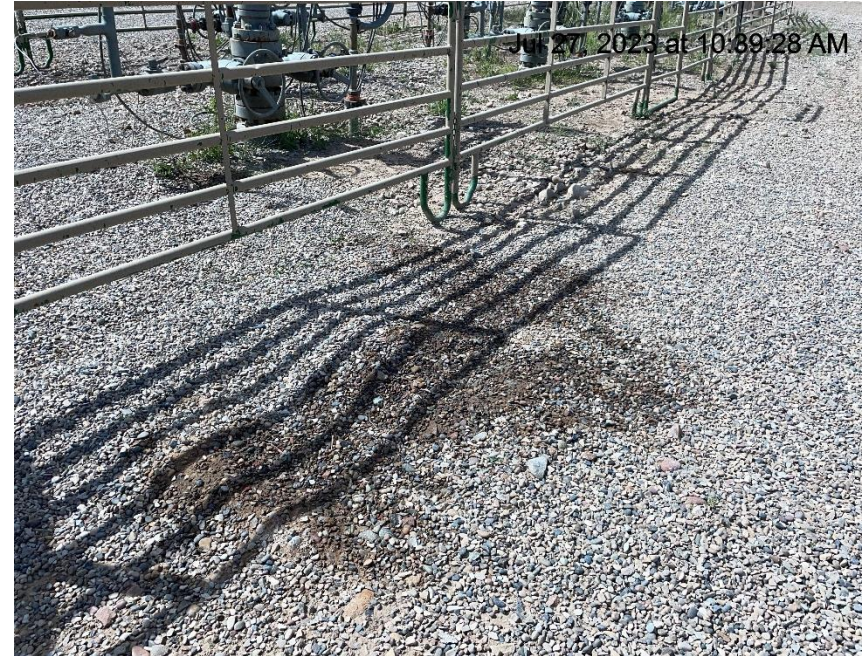
Photo # 3942 Stained soils & gravel near wellheads

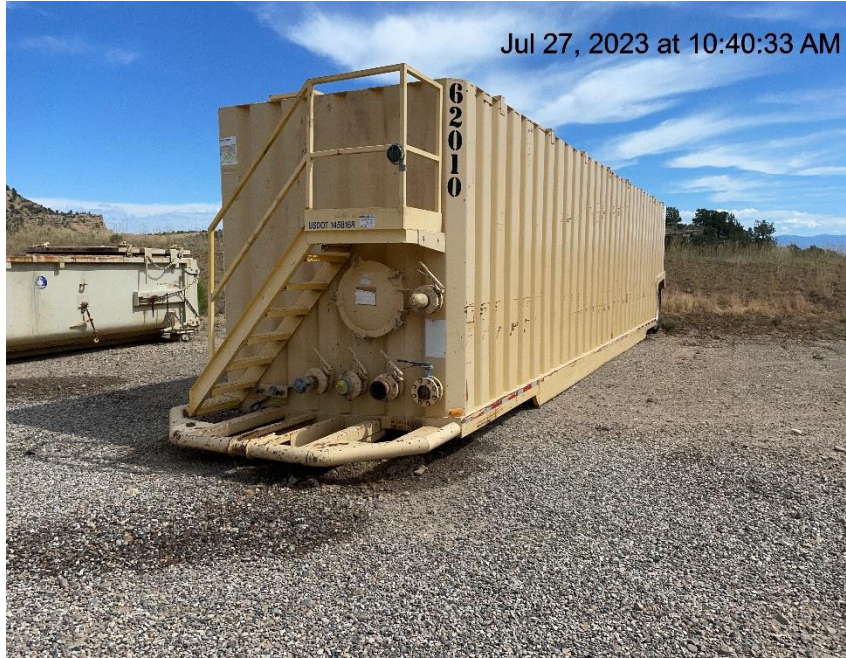
Photo # 3946 Stained soils & gravel

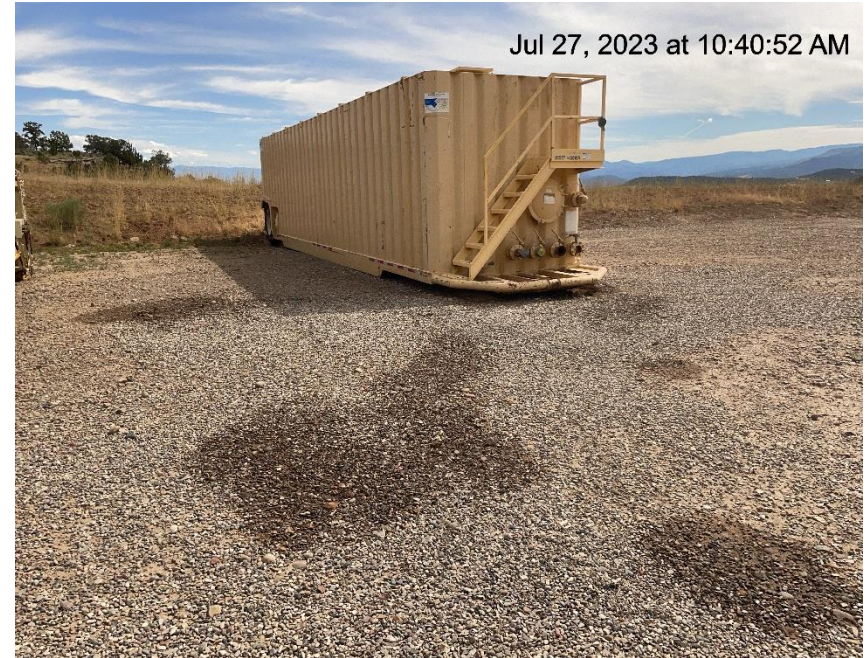
Photo # 3947 Stained soils & gravel

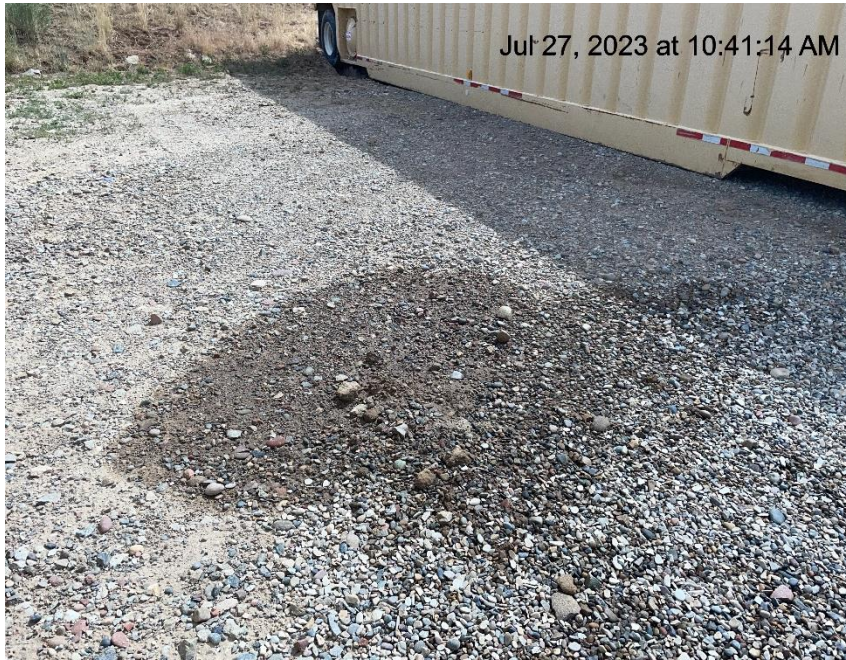
Photo # 3949 Stained soils & gravel

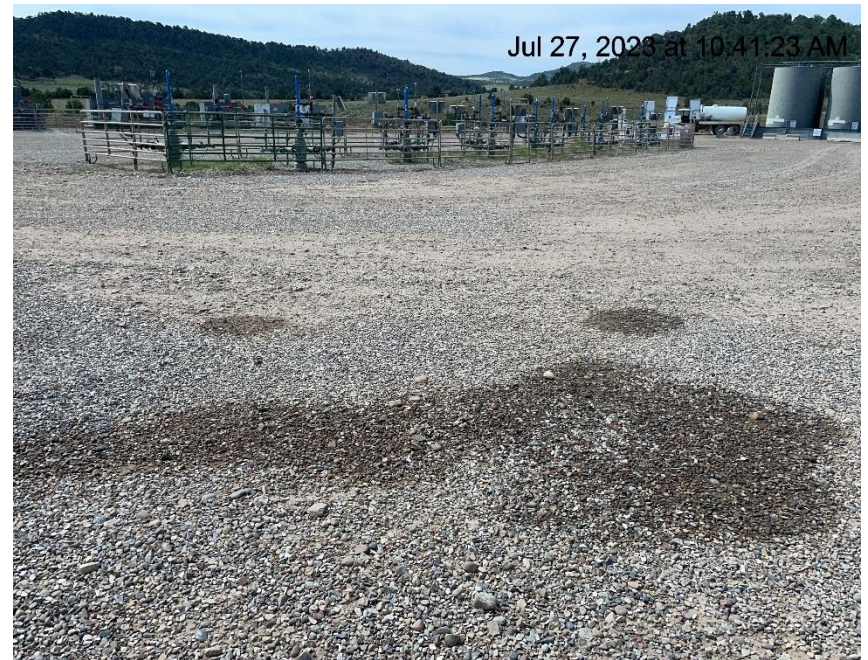
Photo # 3950 Stained soils & gravel

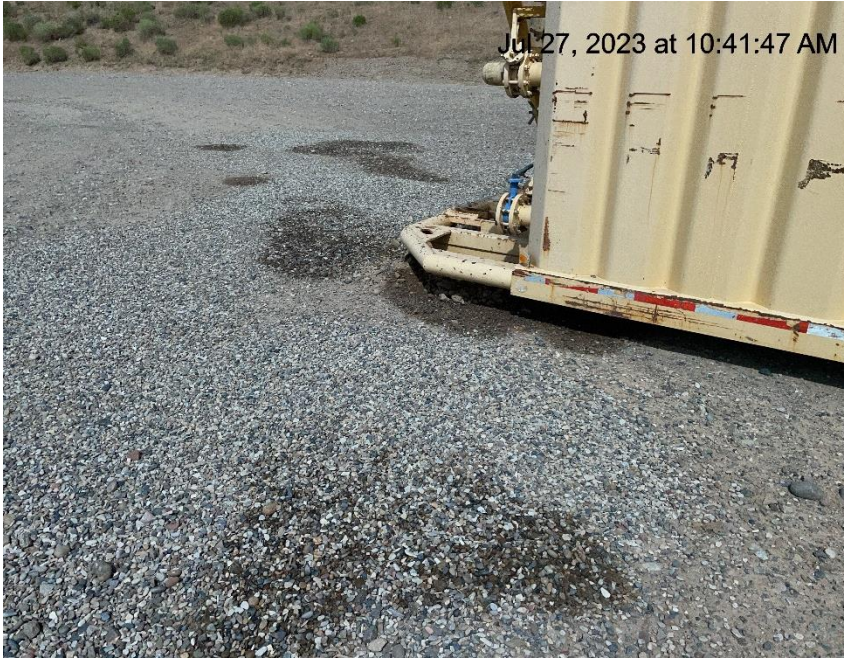
Photo # 3952 Stained soils & gravel

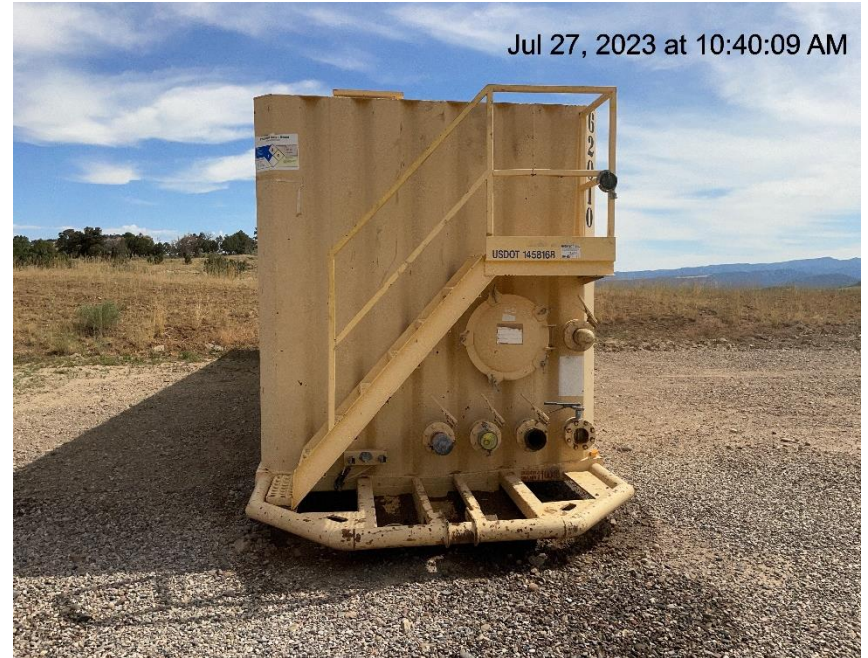
Photo # 3944 Unused equipment & stained soils & gravel

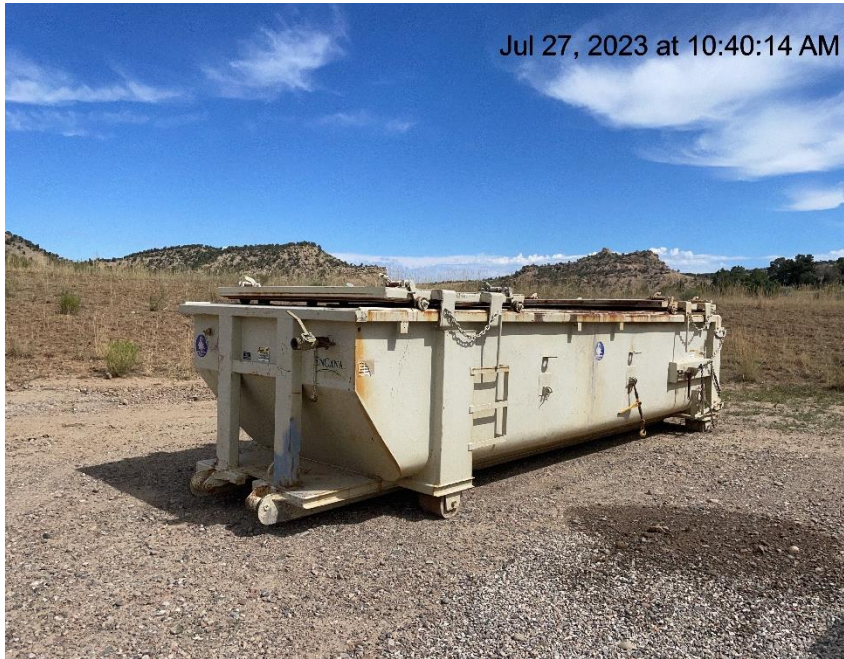
Photo # 3971 Unused equipment & stained soils & gravel

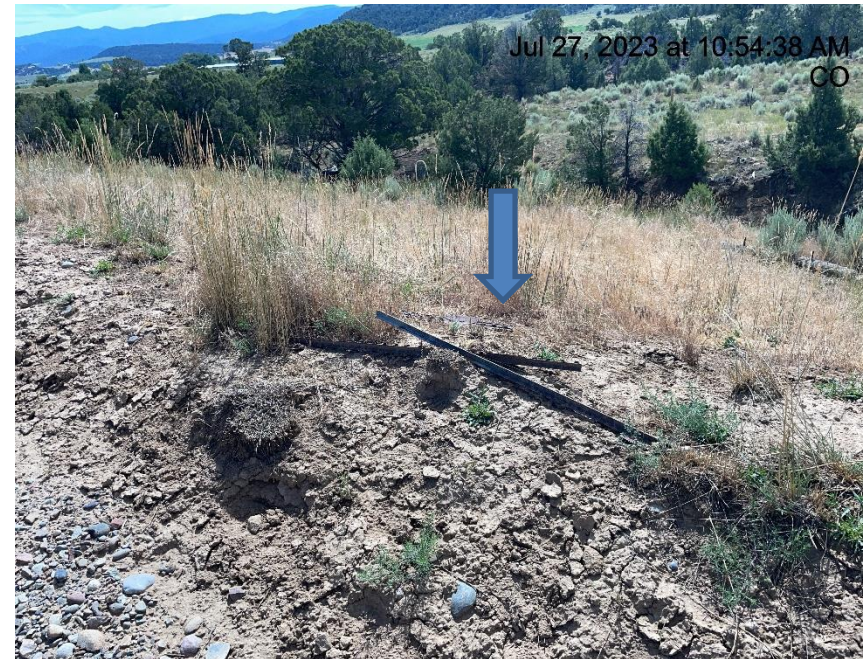
Photo # 3963 Debris
