TEP
PA 13-34
Location ID:
335436

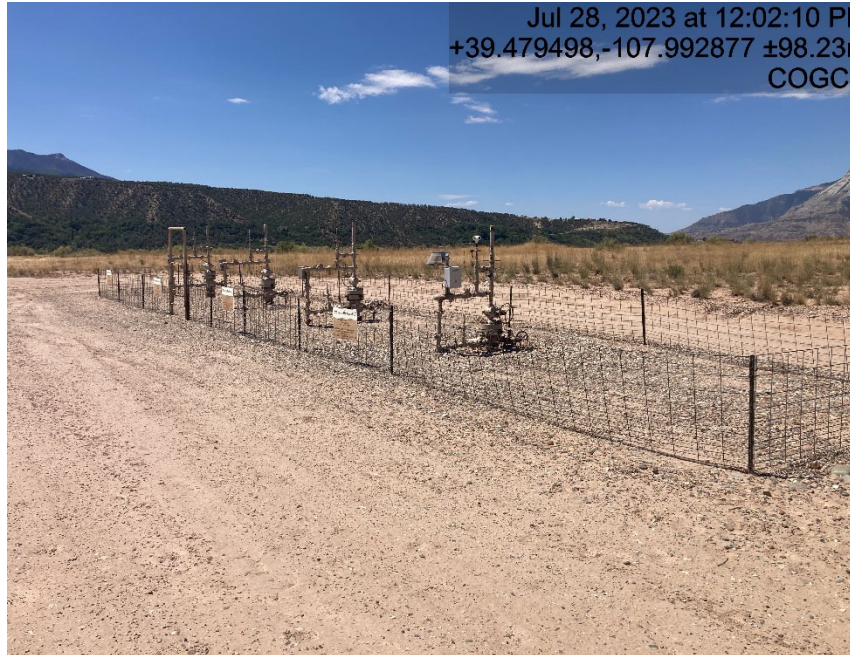
Well heads

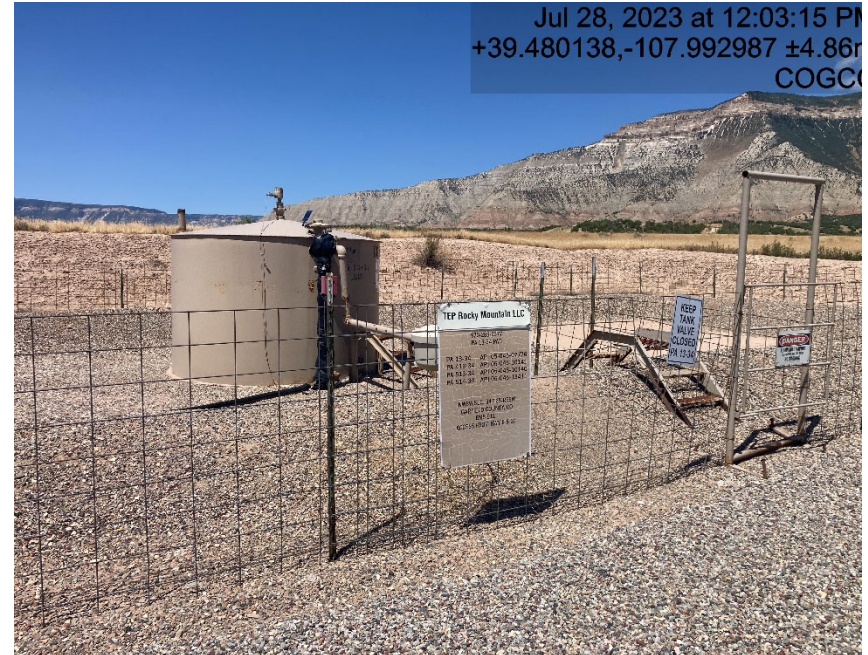
Tank battery

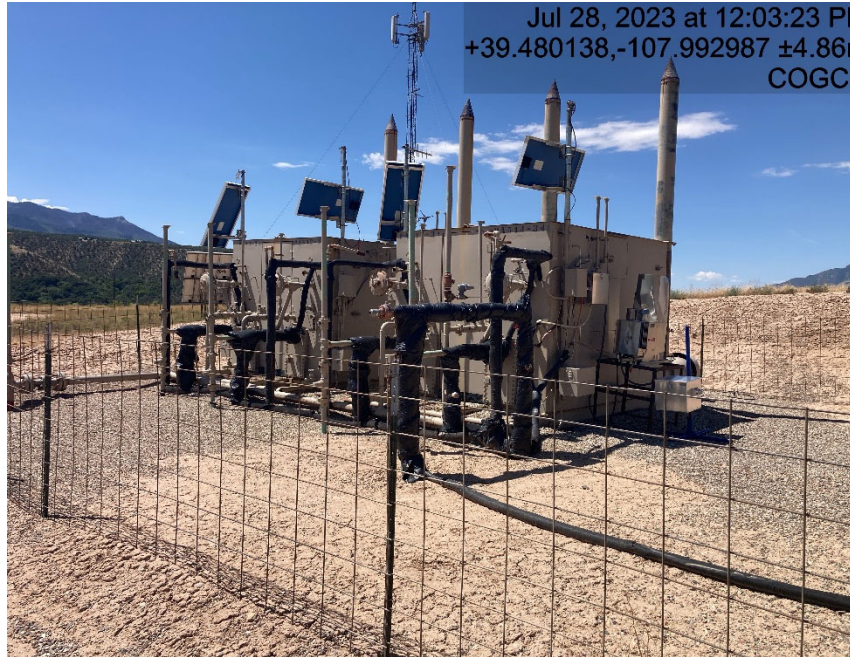
Separators and lack of access to calibration cards

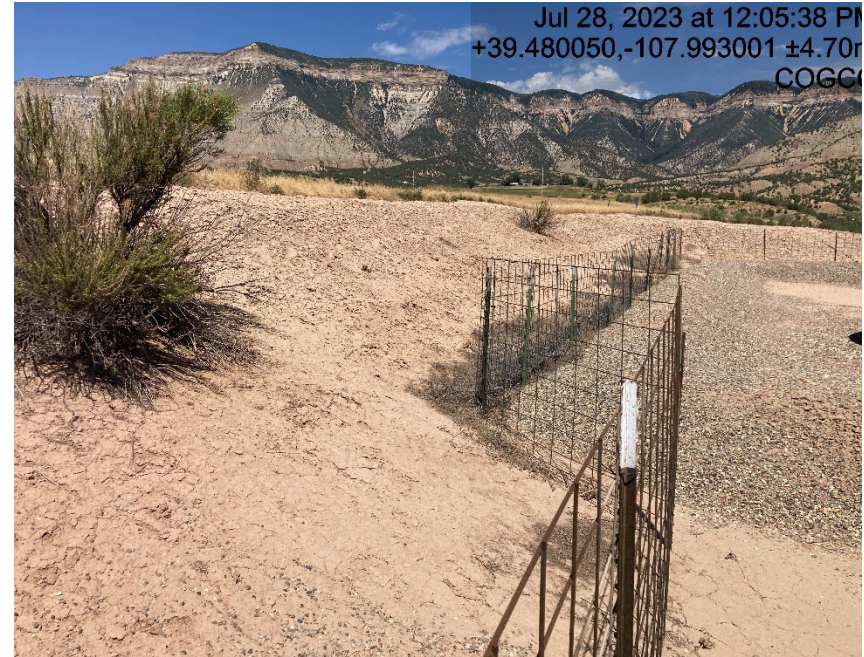
Cut slope lacks stabilization and Weeds have turned in to debris

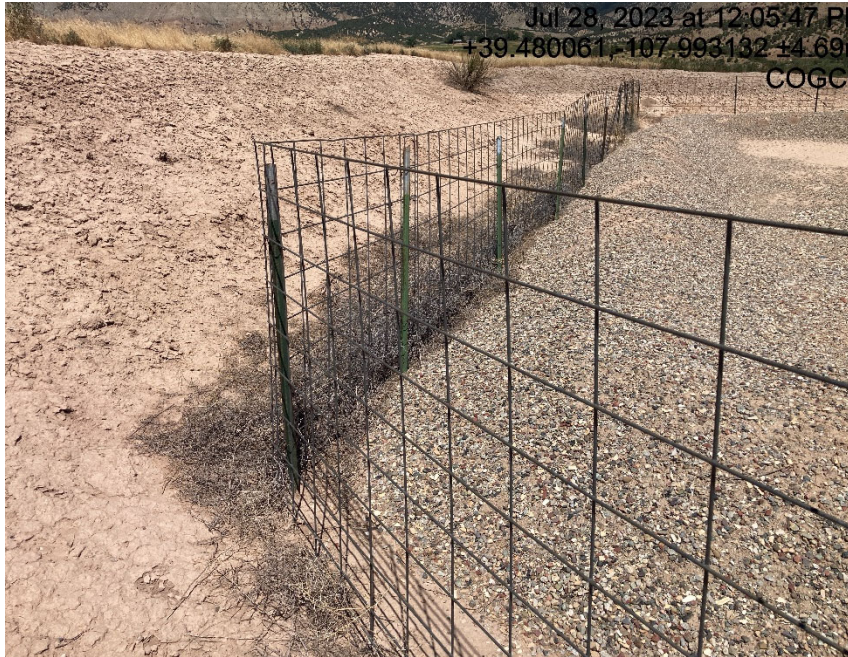
Weeds have turned in to debris

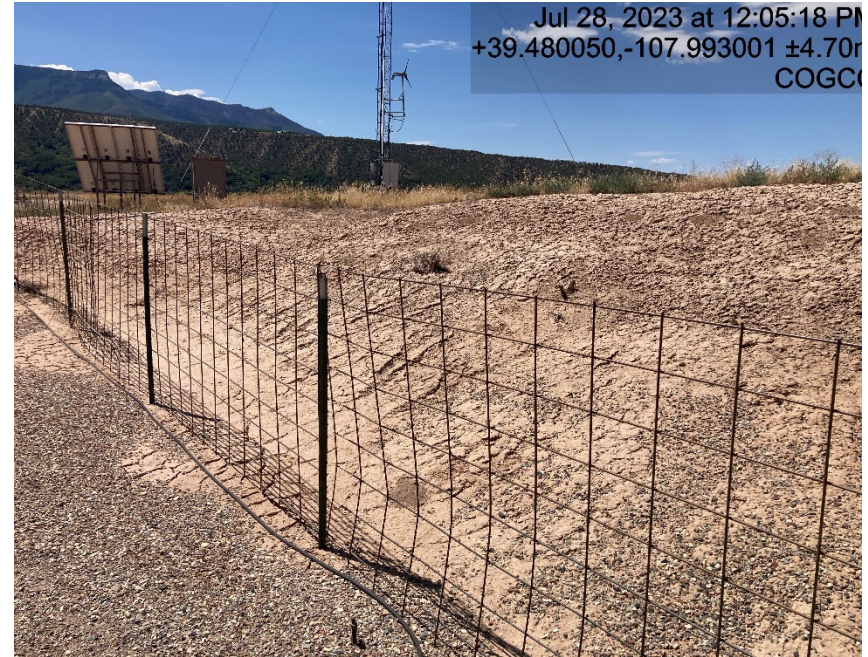
Lack of stabilization, erosion and sediment migration encroaching on production equipment

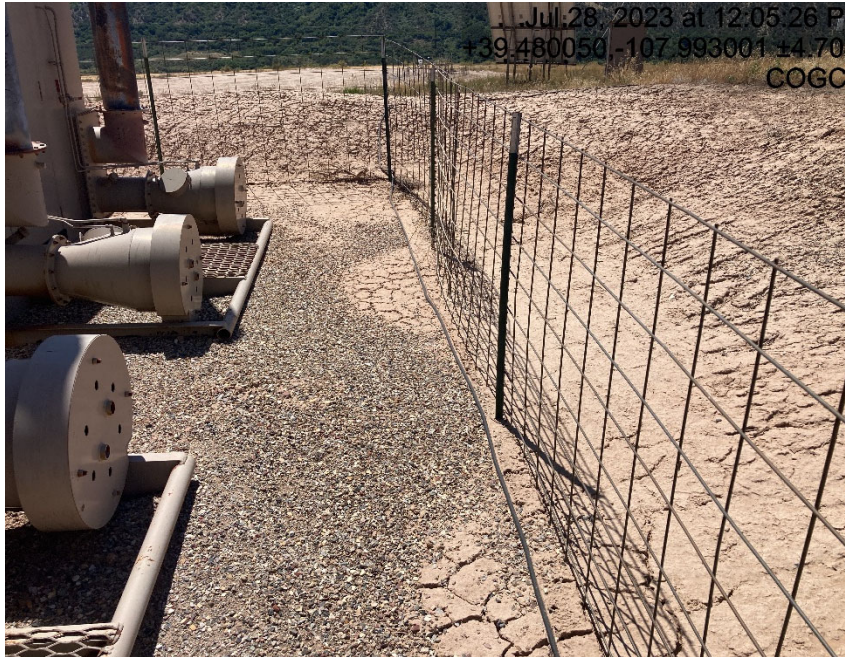
Lack of stabilization, erosion and sediment migration encroaching on production equipment

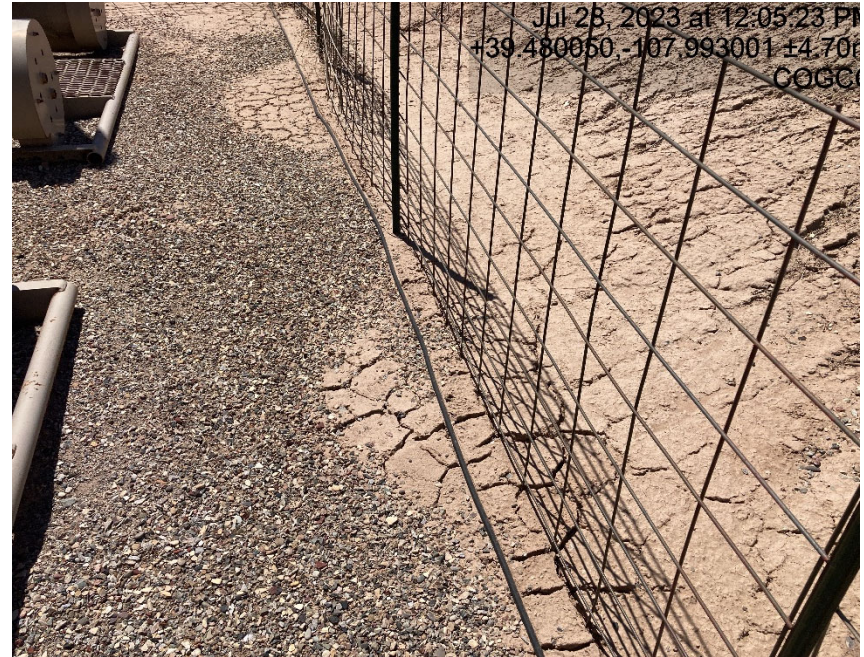
Lack of stabilization, erosion and sediment migration encroaching on production equipment

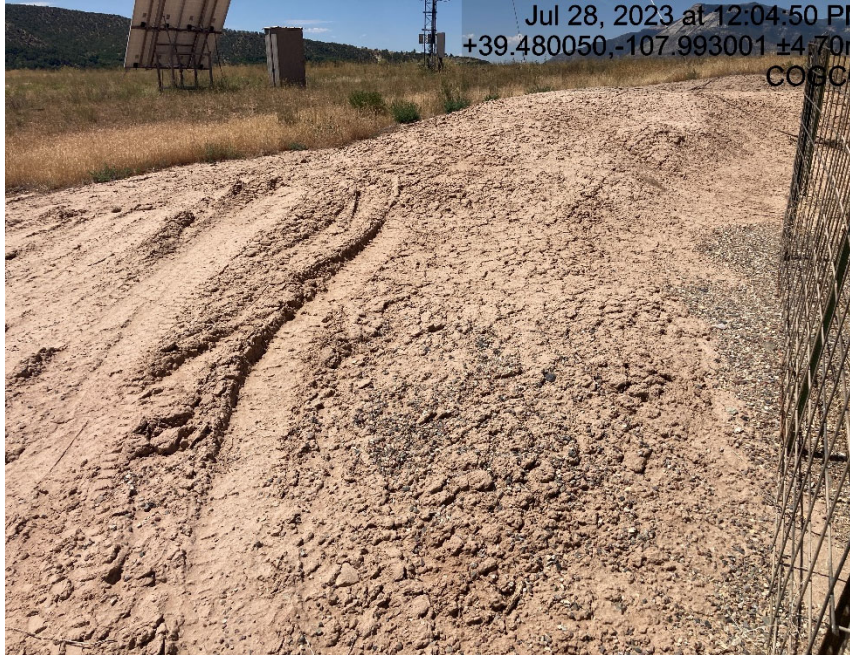
Lack of stabilization and erosion

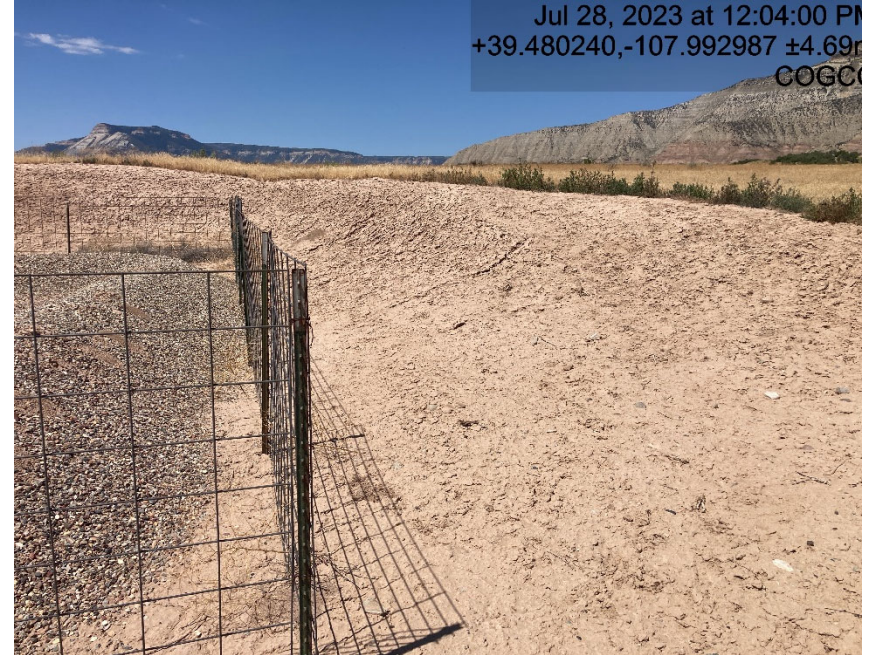
Lack of stabilization and erosion
