Construction & Stormwater Inspection

Operator: GMT Exploration Co, #10243

Location ID: 478822

Location Name: Vulcan 6-64 10-8

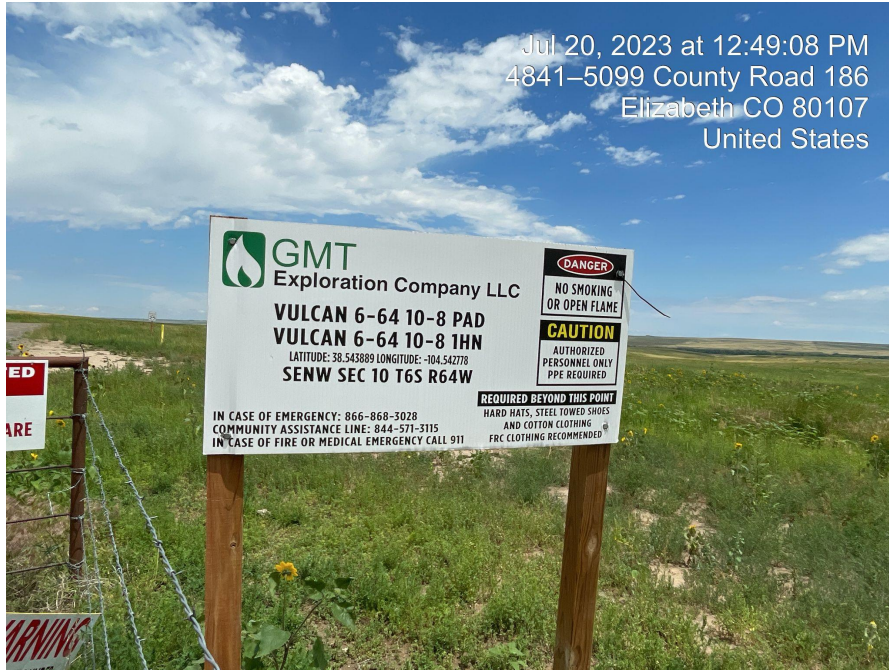
Photo 1. Photo of location sign.

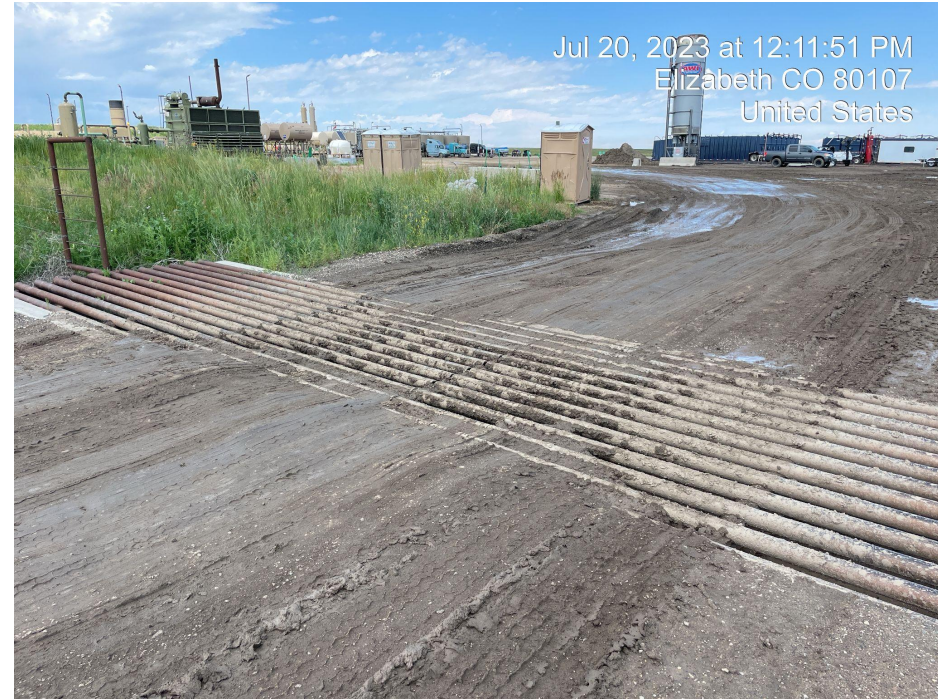
Photo 2. Photo of site entrance. .

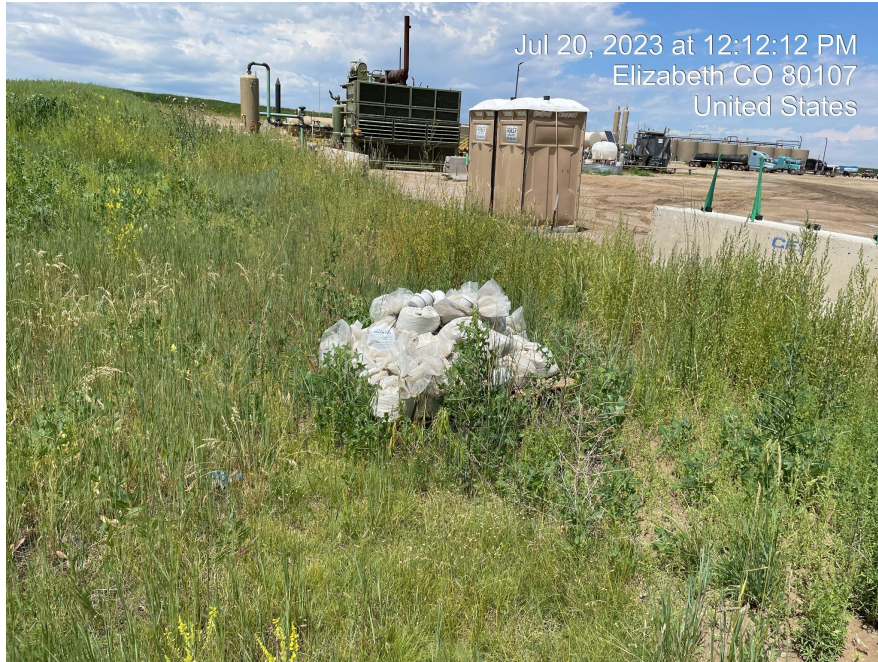
Photo 3. Photo of Trash at entrance of pad.

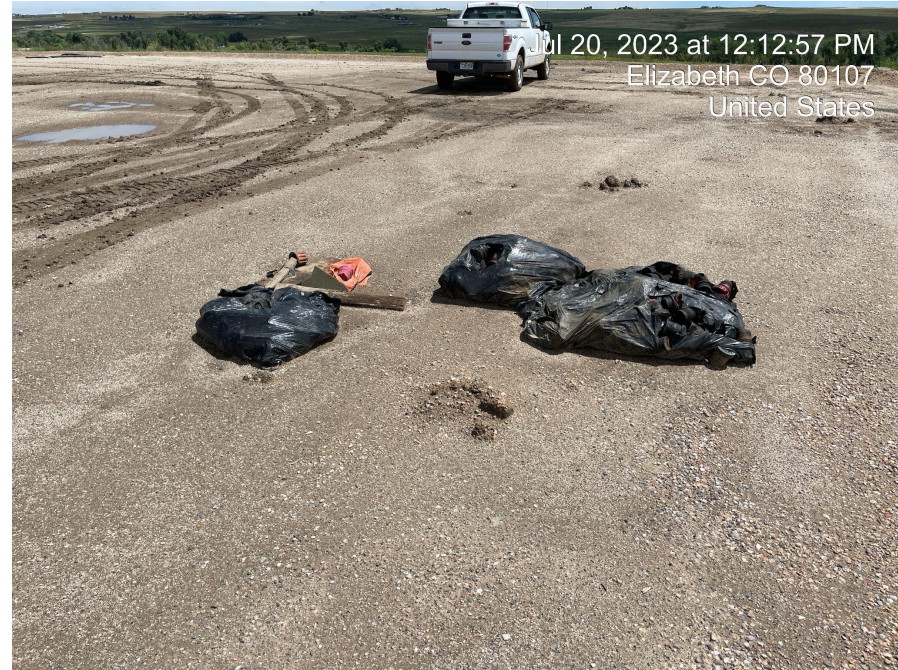
Photo 4. Trash on site.

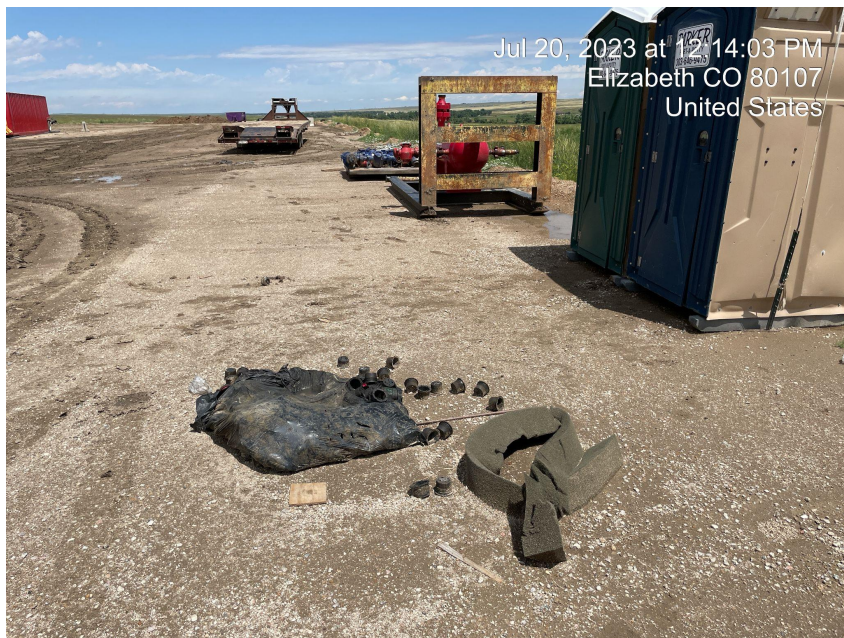
Photo 5. Photo of trash spilling out of bag onsite.

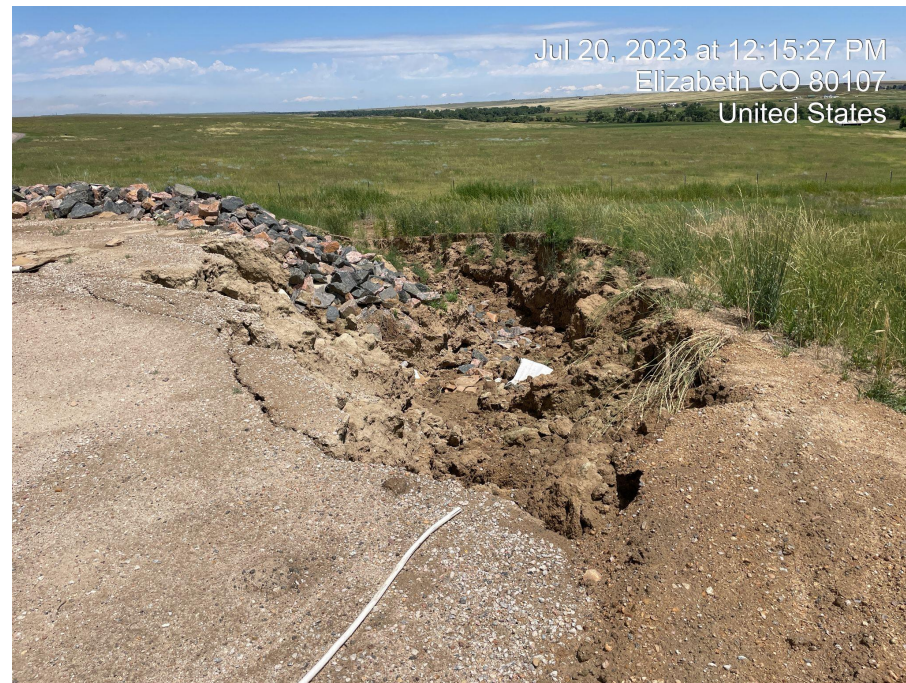
Photo 6. Photo of Northeast corner slough off.

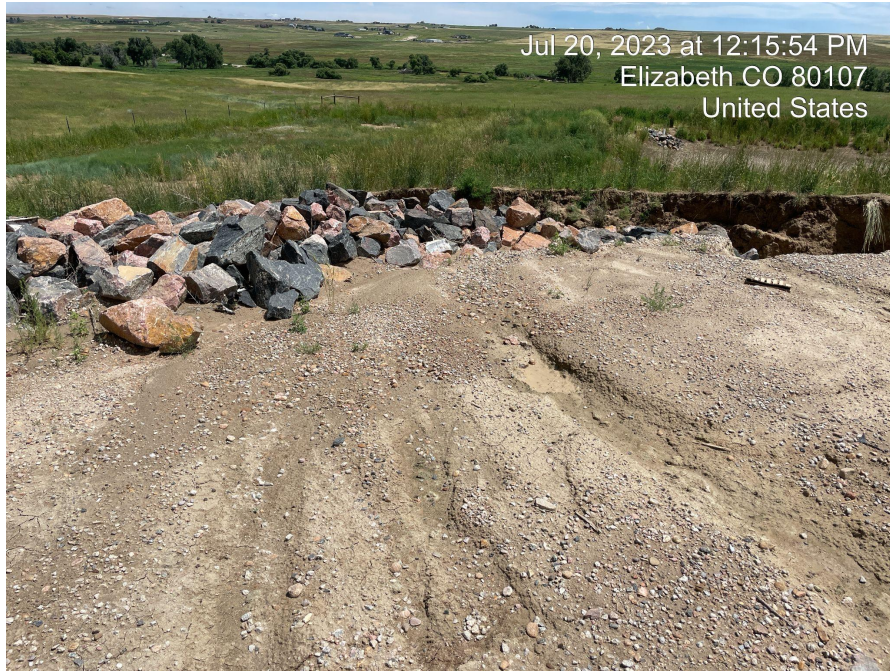
Photo 7. Photo of erosion from stormwater

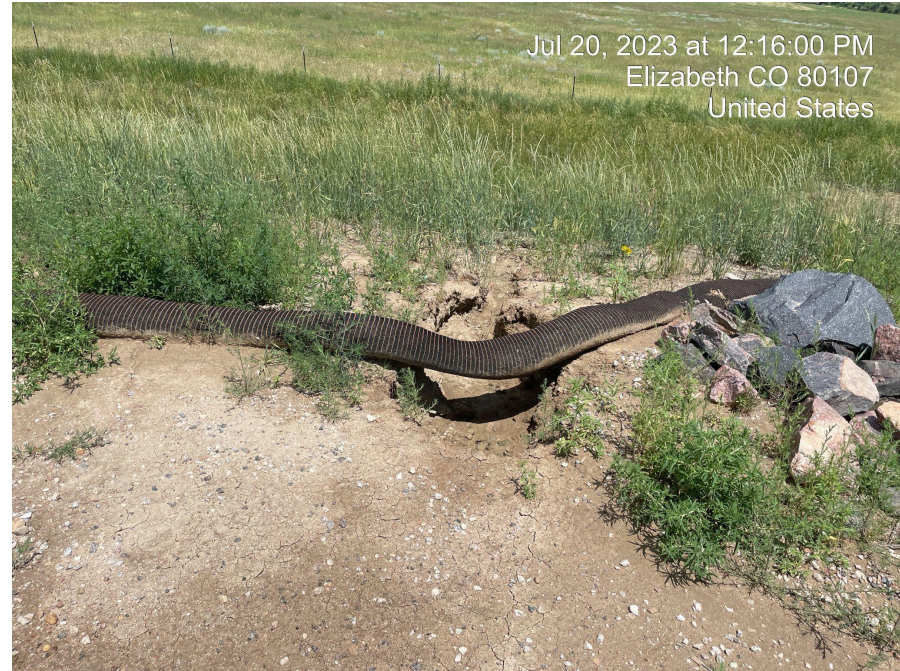
Photo 8. Photo of wattle undermined by stormwater.

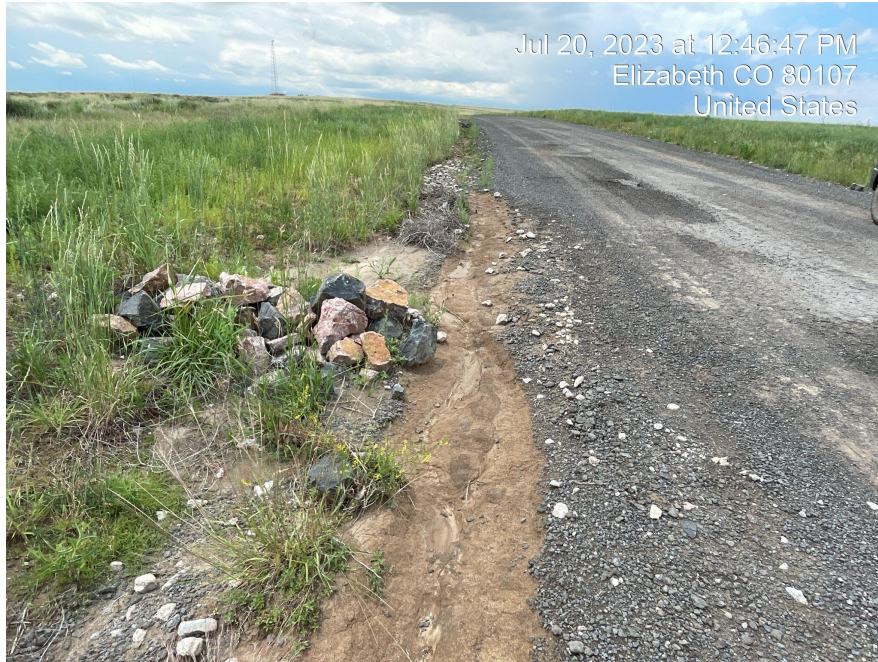
Photo 9. Photo of stormwater by passing rock check dam in access road.

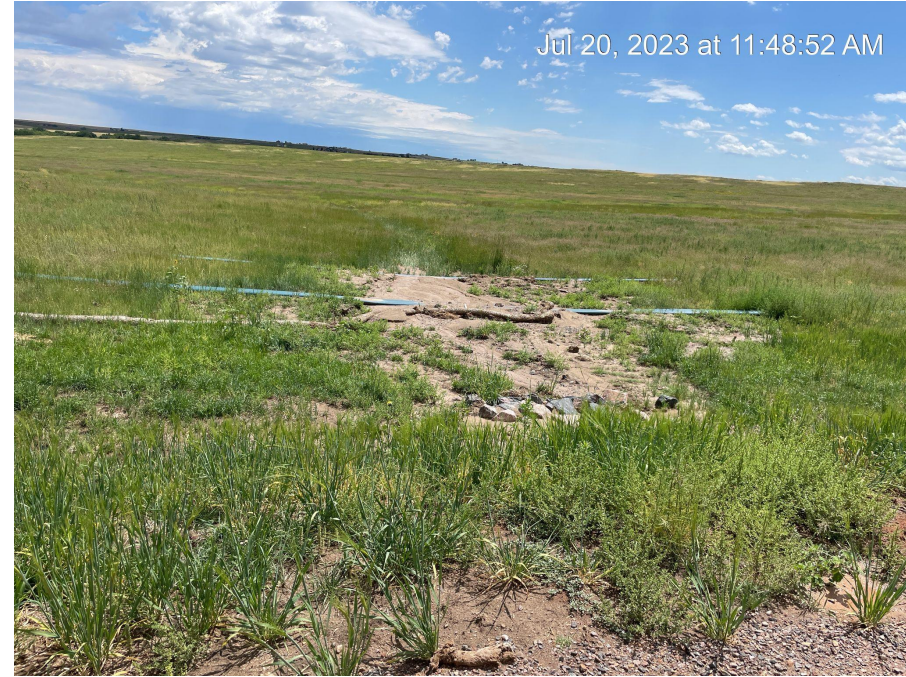
Photo 10. Photo of pipe parallel to access road capturing sediment carried off site by stormwater.

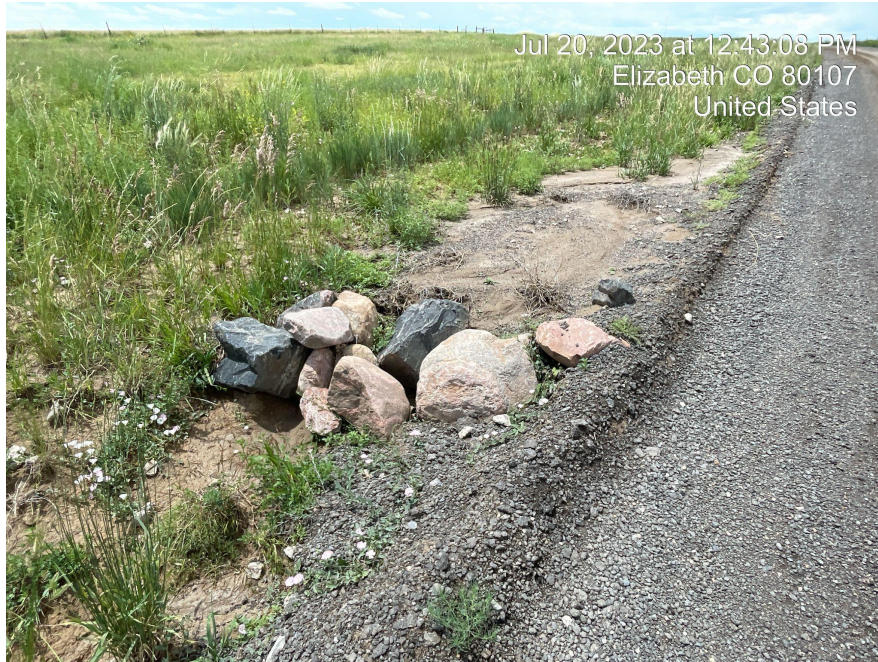
Photo 11. Photo of rock check dam in access road that has been tunnelled under by stormwater.

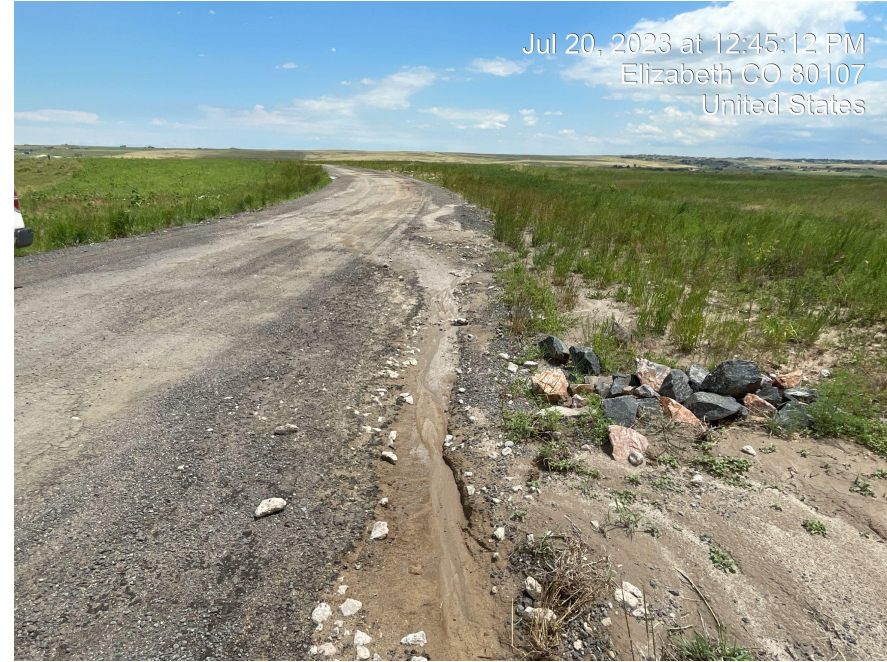
Photo 12. Rock check dam in access road filled with sediment, stormwater has bypassed the BMP.
