Inspection Photos

Location Name: TEP ROCKY MOUNTAIN LLC RIVER RANCH B Pad

Location #: 336038

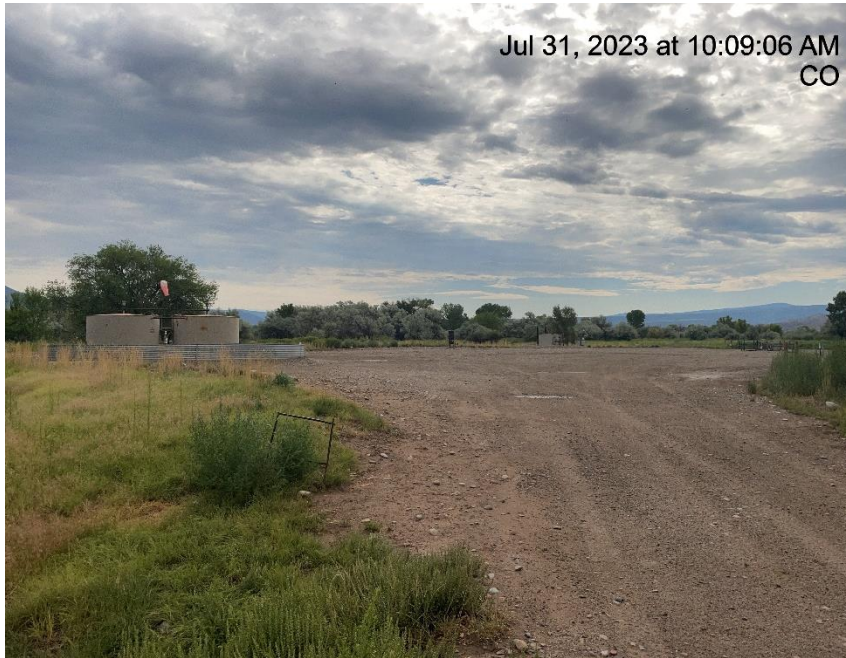
Photo # 4212 From entrance to location

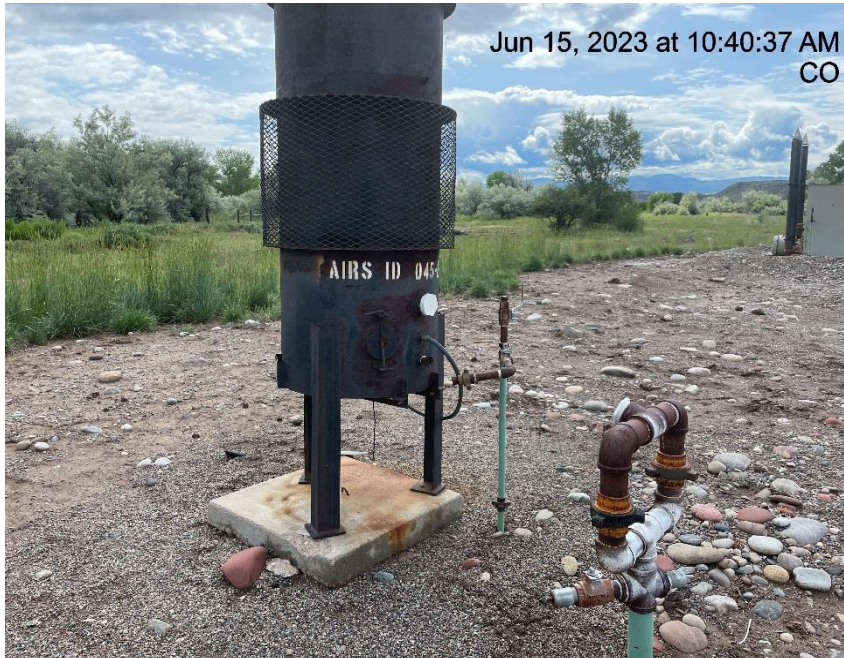
Photo # 594 From inspection 708900778 conducted on 06/15/2023 Unused equipment/ECD is disconnected

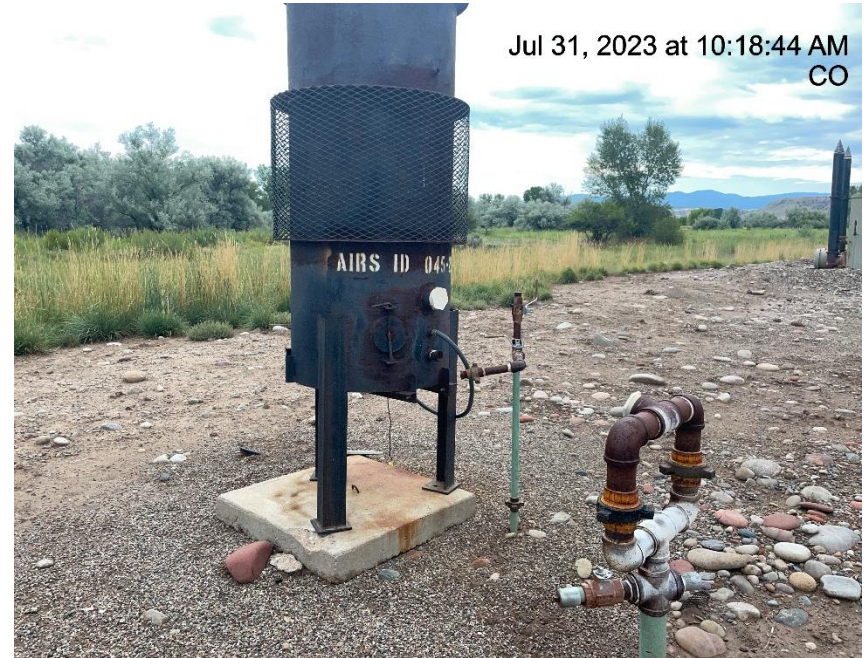
Photo # 4223 Unused equipment/ECD is disconnected

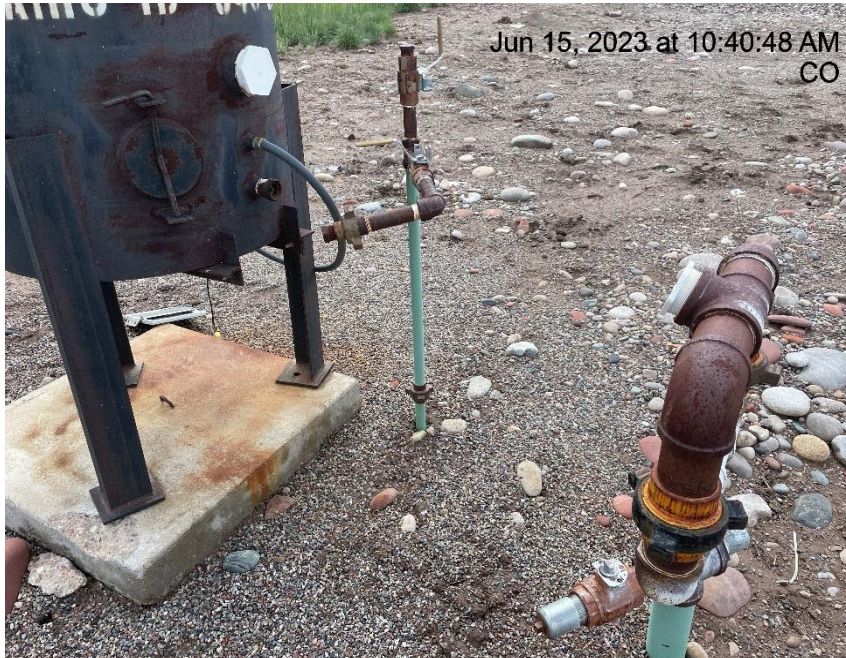
Photo # 595 From inspection 708900778 conducted on 06/15/2023 Unused equipment/ECD is disconnected

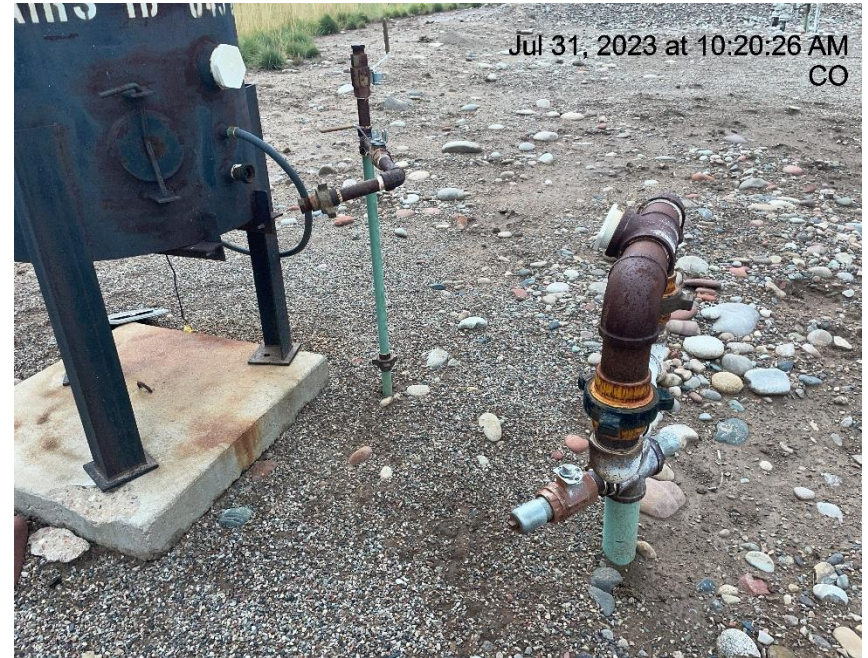
Photo # 4228 Unused equipment/ECD is disconnected

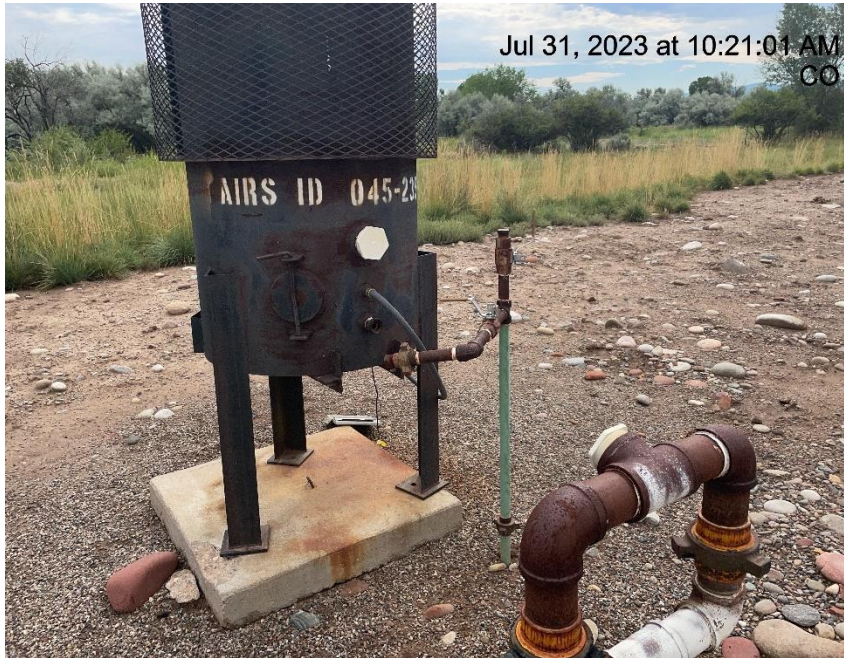
Photo # 4235 Unused equipment/ECD is disconnected

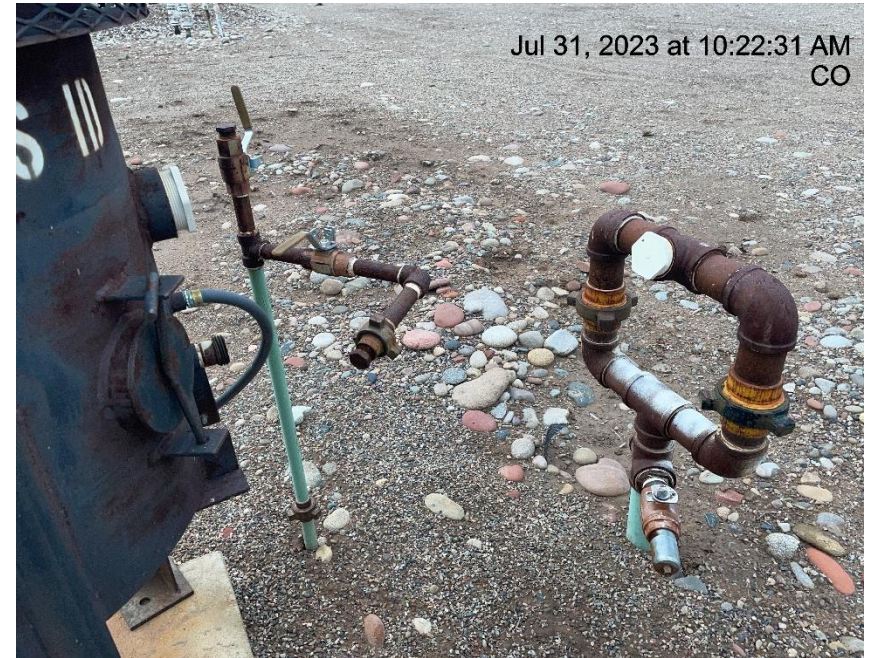
Photo # 4245 Unused equipment/ECD is disconnected

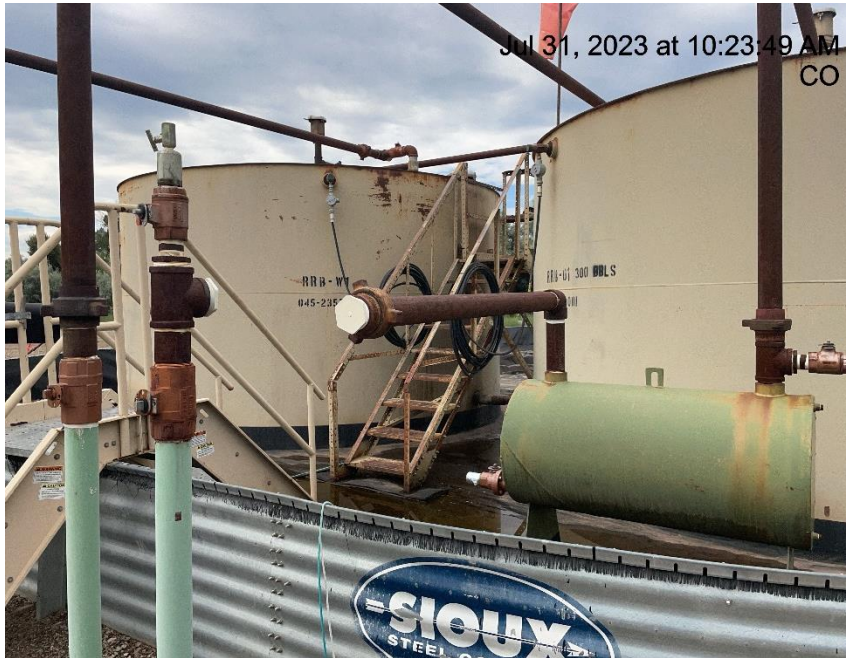
Photo # 4246 ECD line disconnected at tank battery

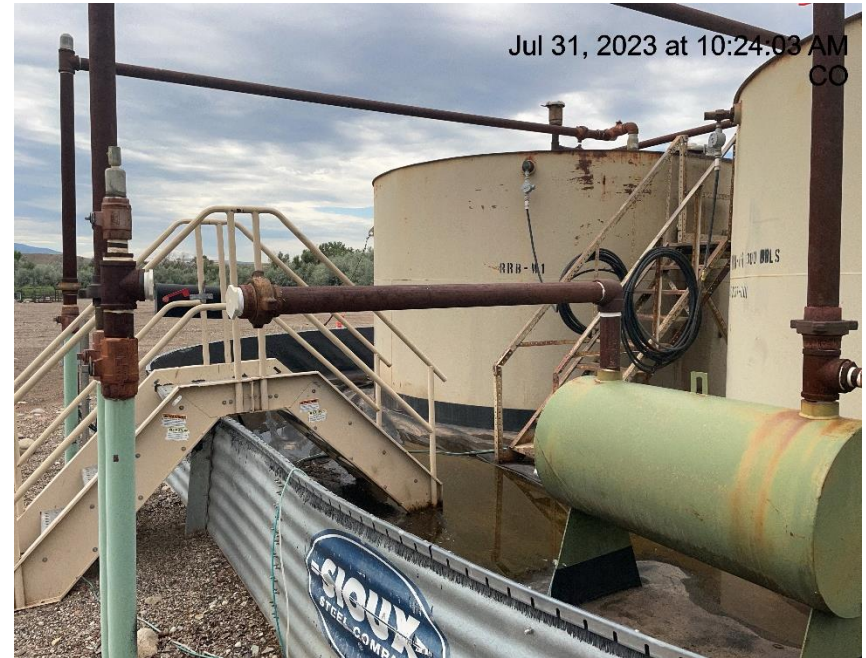
Photo # 4248 ECD line disconnected at tank battery
