**Storm Water Management and Erosion control**  
**Location Name: TEP ROCKY MOUNTAIN LLC ROBINSON A Pad**  
**Location #: 336015**

**Location Overview: Location is within a 411a Surface Water External Buffer, approximately 642 yards from the Colorado River & is in close proximity to National Wetlands Inventory area. Location is within High Priority/Density/Black Bear Habitat areas.**

**Section/Township/Range: 8 6S92W**

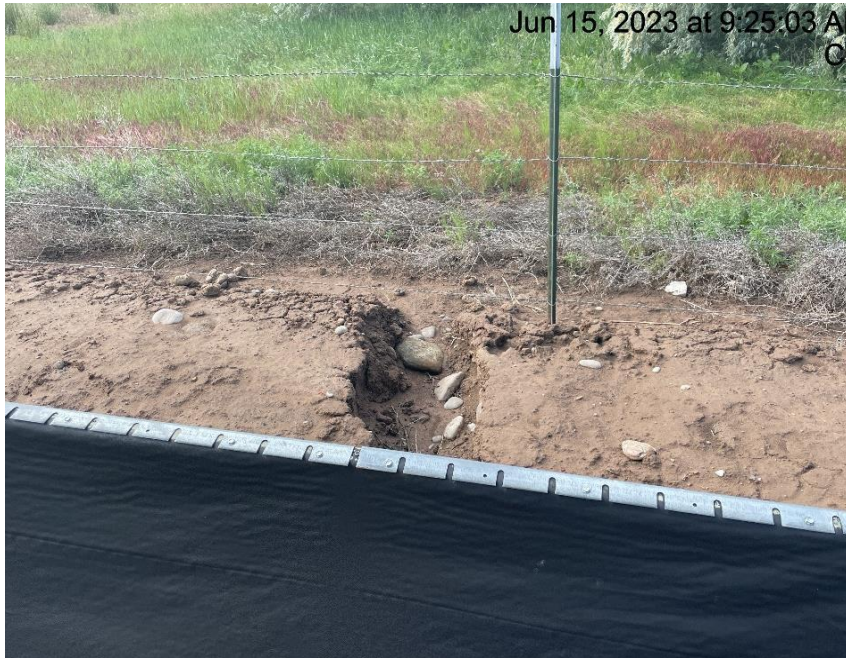
**Photo # 502 From inspection 708900775 conducted on 06/15/2023 Berm needs maintenance – erosion through berm & transport of sediment off location**

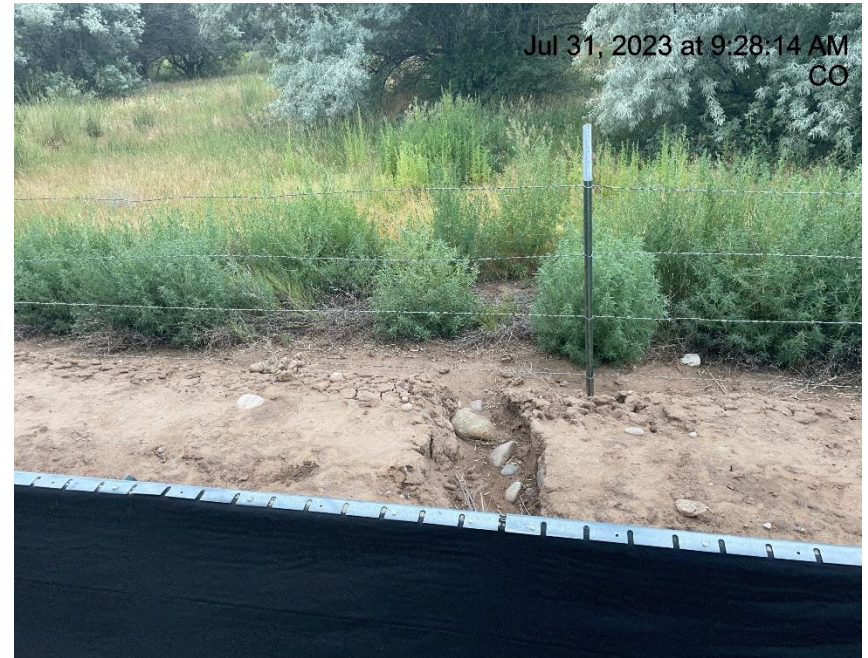
**Photo # 4161 Berm needs maintenance - erosion through berm & transport of sediment off location**

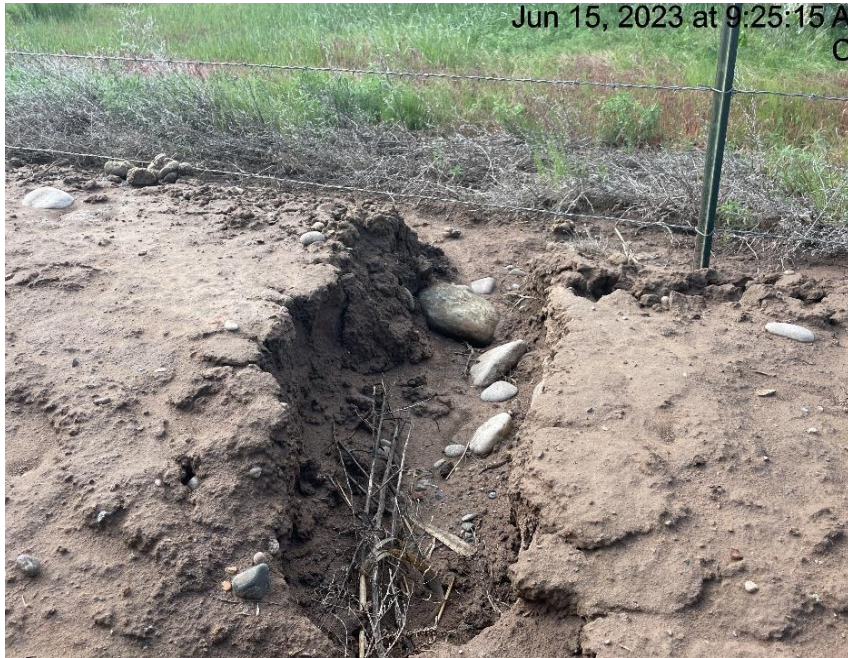
**Photo # 503 From inspection 708900775 conducted on 06/15/2023 Berm needs maintenance – erosion through berm & transport of sediment off location**

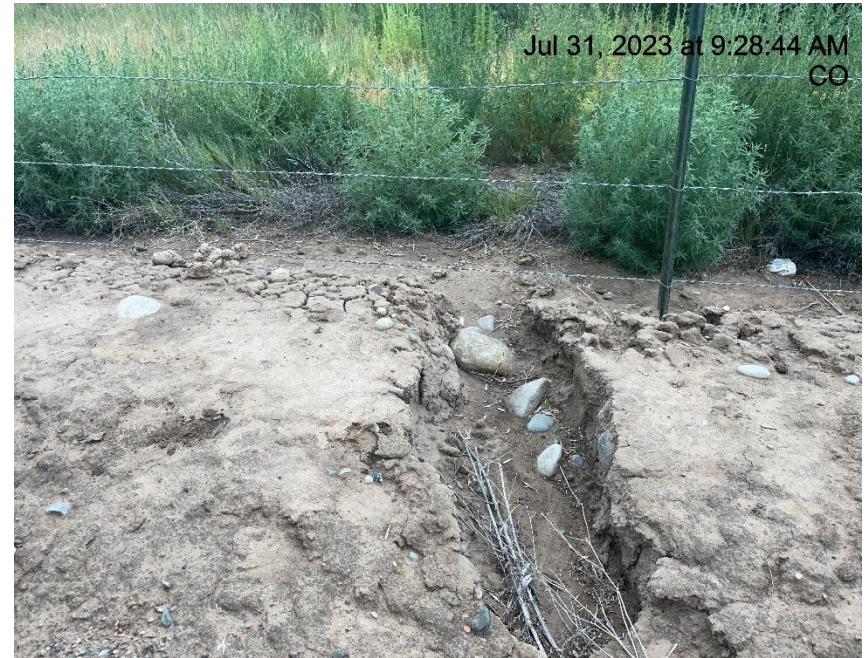
**Photo # 4162 Berm needs maintenance - erosion through berm & transport of sediment off location**

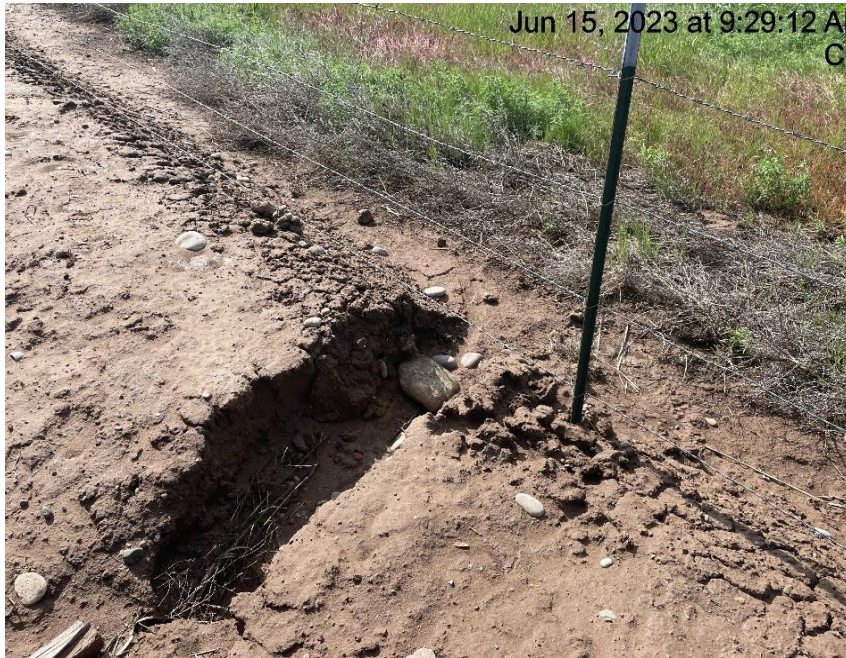
**Photo # 510 From inspection 708900775 conducted on 06/15/2023 Berm needs maintenance – erosion through berm & transport of sediment off location**

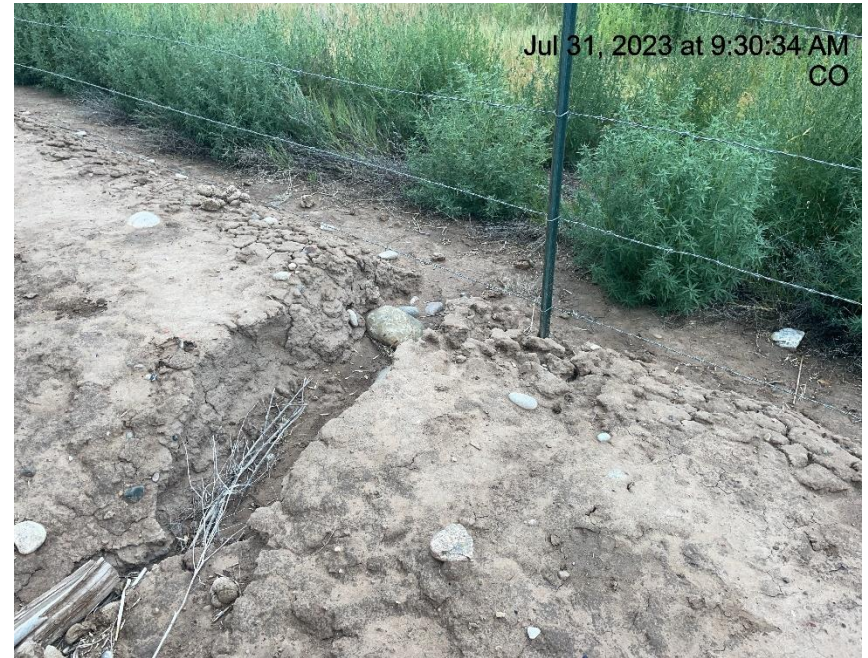
**Photo # 4164 Berm needs maintenance - erosion through berm & transport of sediment off location**

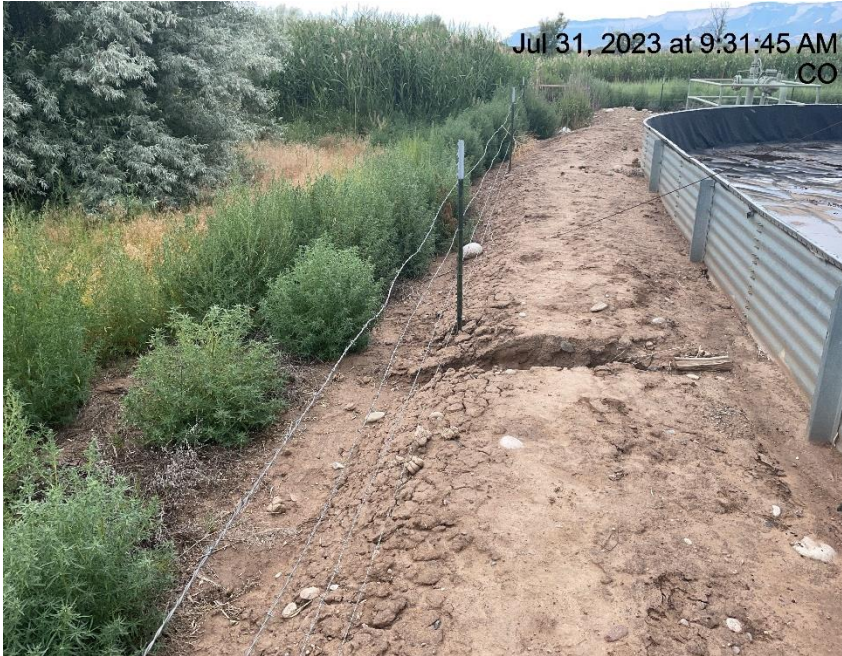
**Photo # 4169 Berm needs maintenance – erosion through berm & transport of sediment off location/Failure to minimize erosion & transport of sediment off location**
