Colorado Oil and Gas Conservation Commission

# HMU-67S92W/19SWNE, #311615

## Annotation Report

Operator: CAERUS PICEANCE LLC #10456

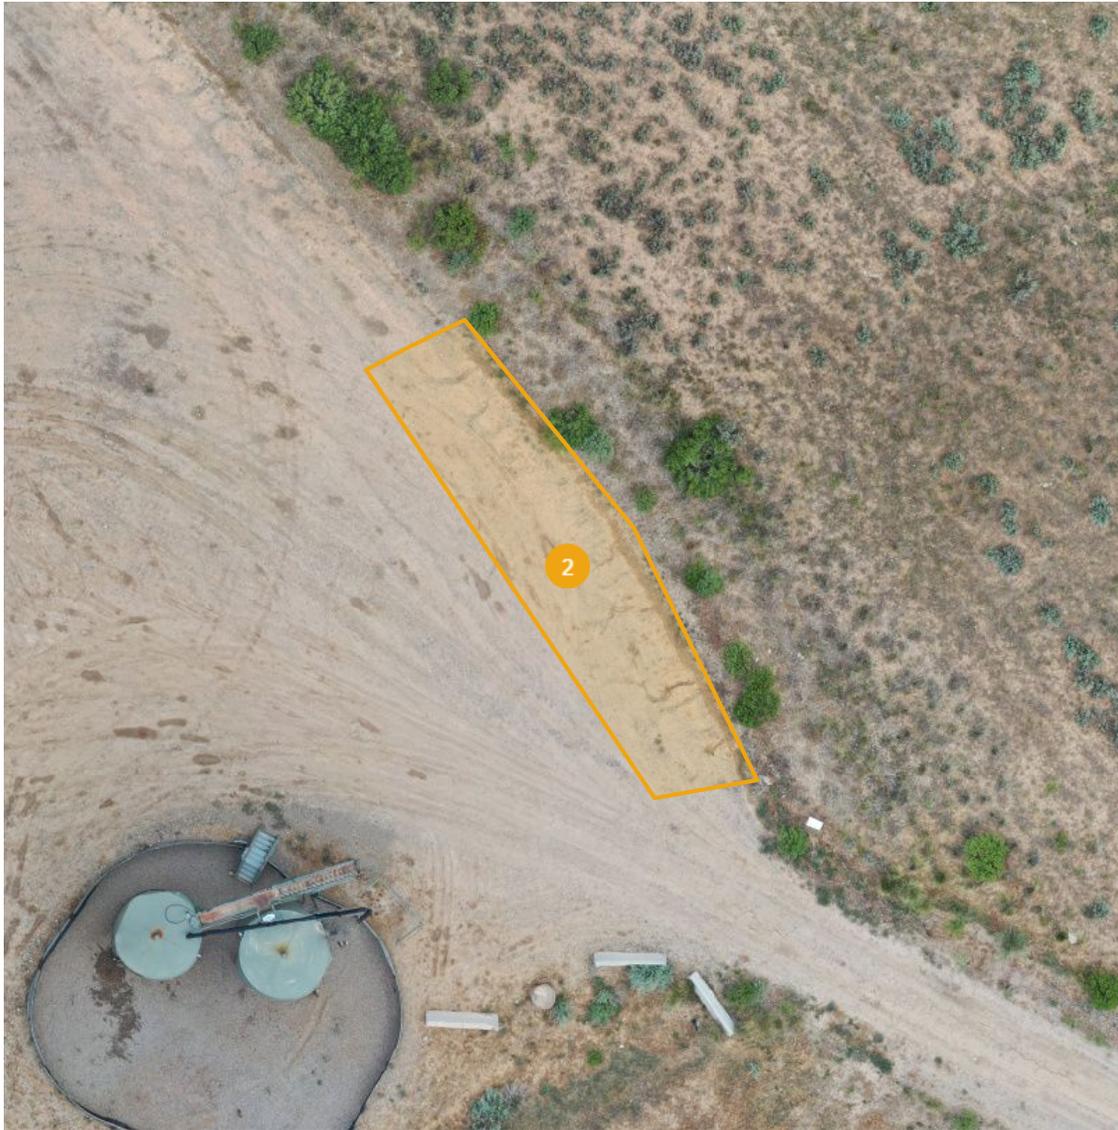
## 2 - Erosion

Summary:	N/A
Created:	Aug 1, 2023, 8:13am by Aaron Trujillo
Cost of Repair:	—
Lat/Long:	39.43218, -107.70815
Area:	1174.74 ft <sup>2</sup>
Surface Area:	1244.91 ft <sup>2</sup>

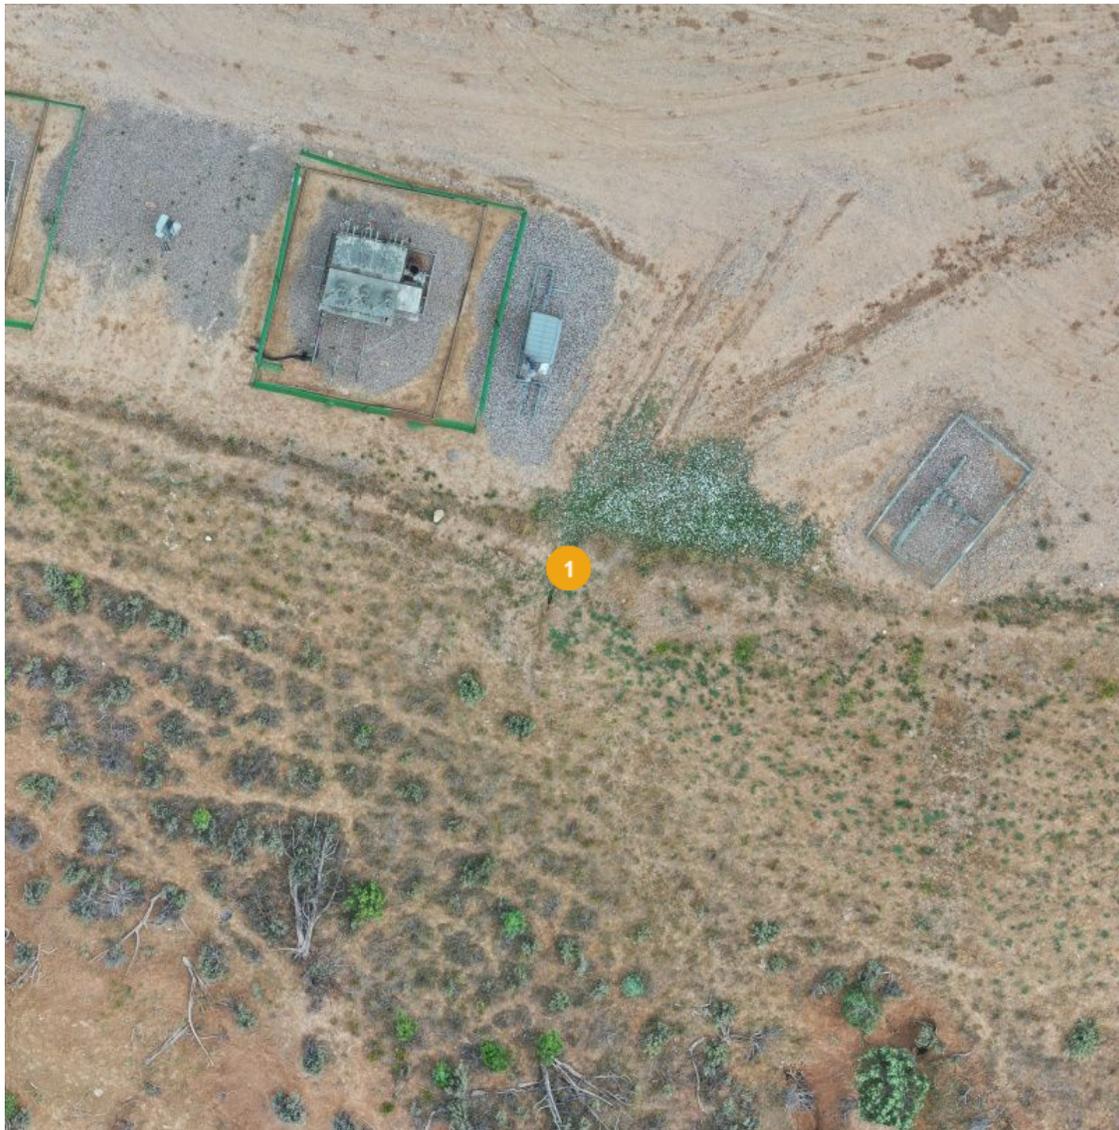
### 1 - Erosion

Summary: **Improperly engineered/installed outlet for stormwater discharge; outlet lacks armoring; erosion degradation evident.**

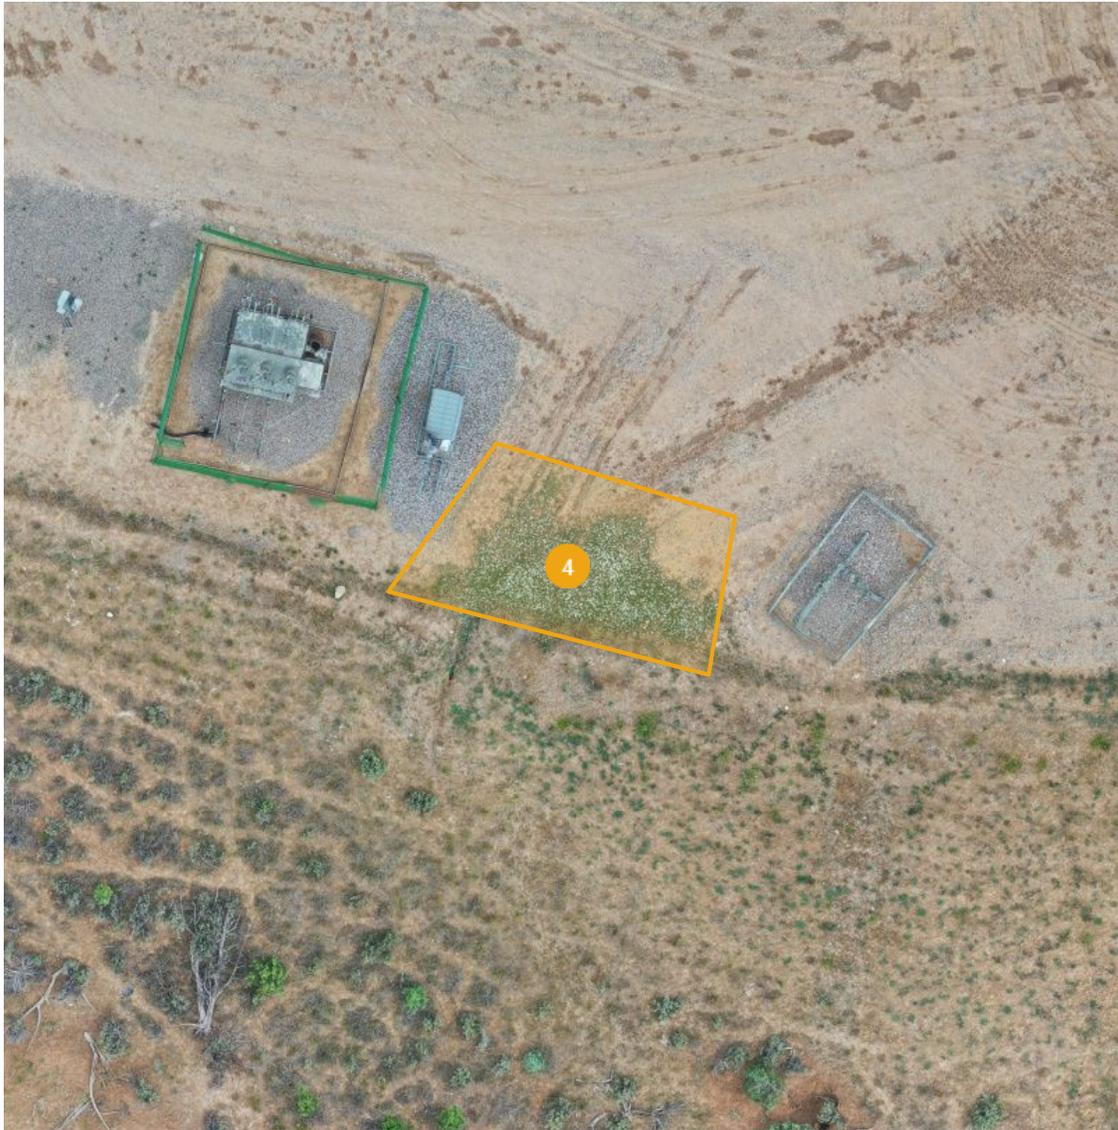
### 4 - Observation

Field Bindweed

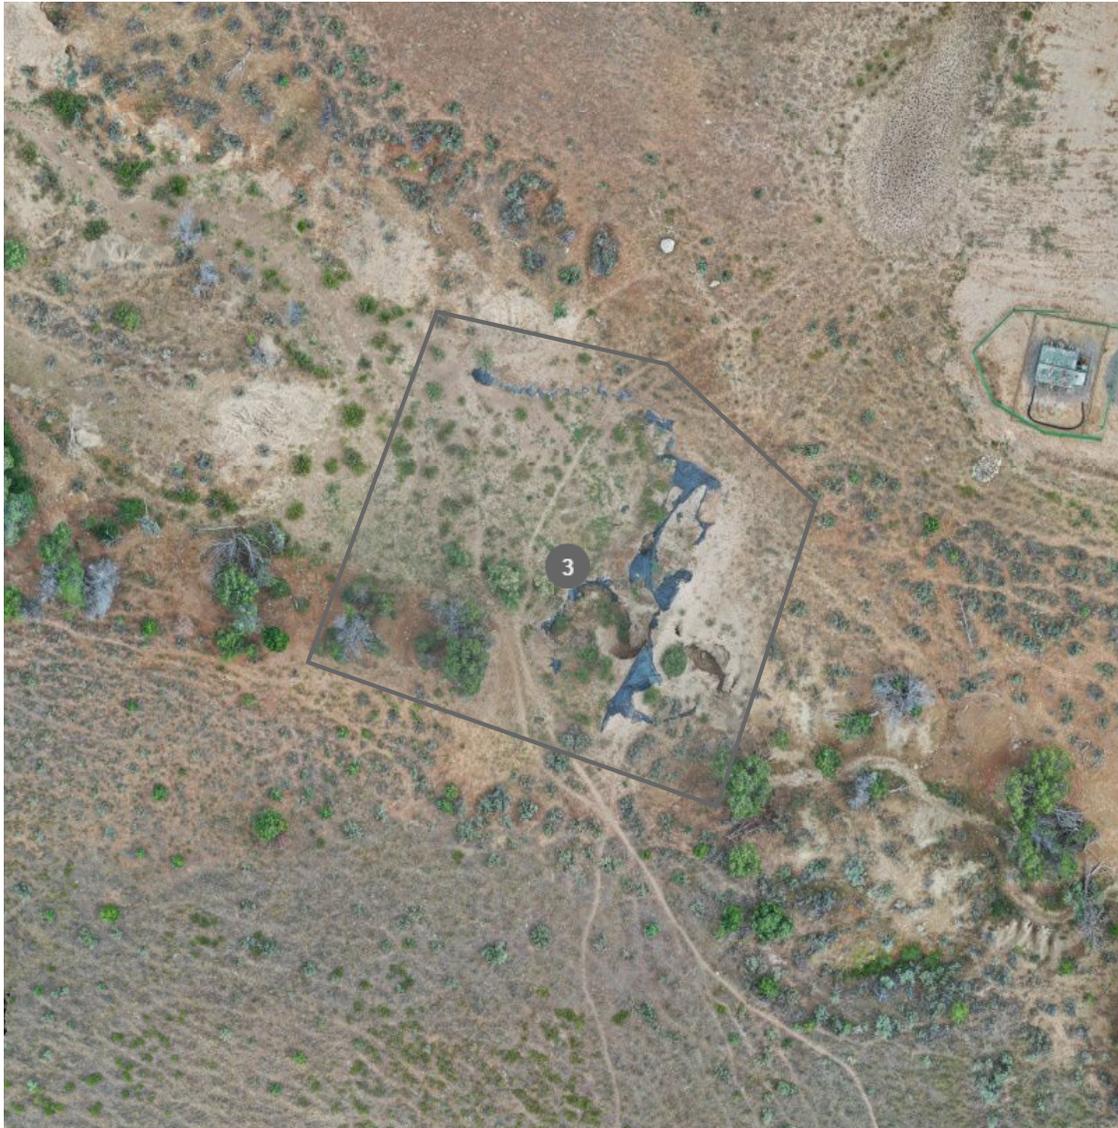
### 3 - Observation

Summary:	Failed livestock pond unrelated to this O&G Location's disturbance.
Created:	Aug 1, 2023, 8:14am by Aaron Trujillo
Cost of Repair:	—
Lat/Long:	39.43190, -107.70958
Area:	0.27 acres
Surface Area:	0.39 acres

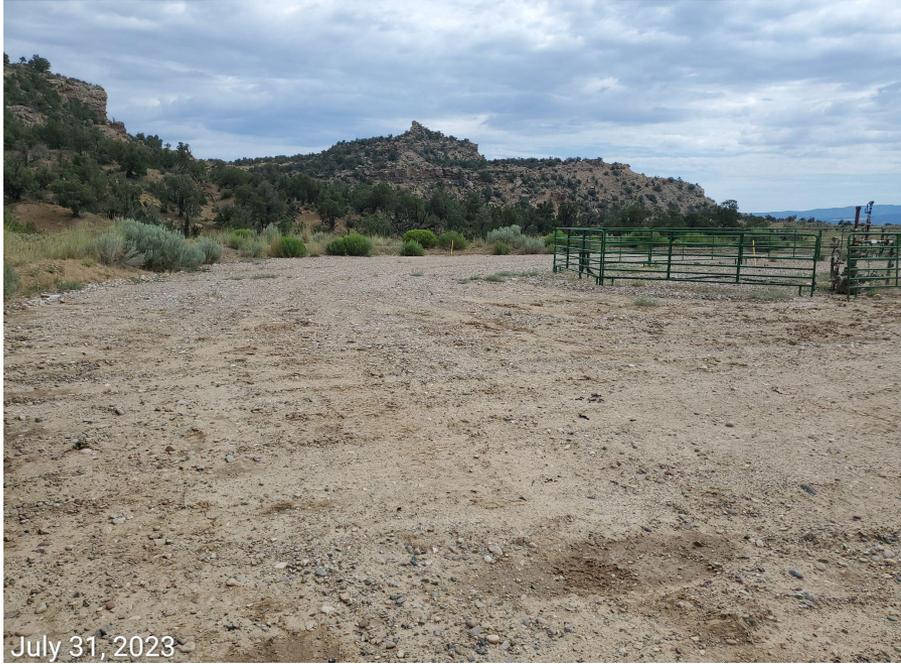
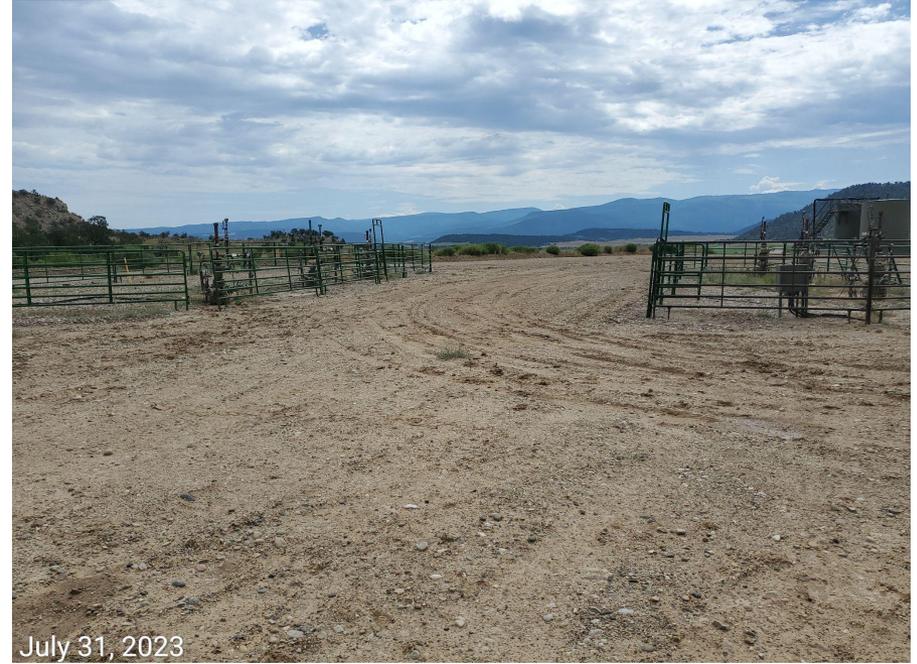
**Photo 1:** Photos 1-2 taken from the west end of the working pad areas of the Location. Photos provide an overview of the location from north, northeast, southeast to south.

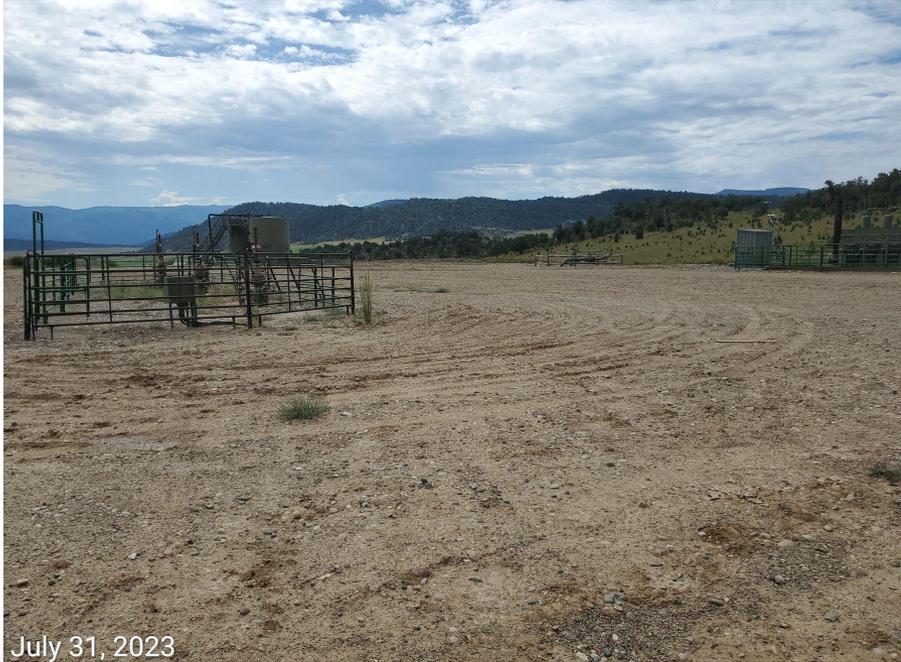
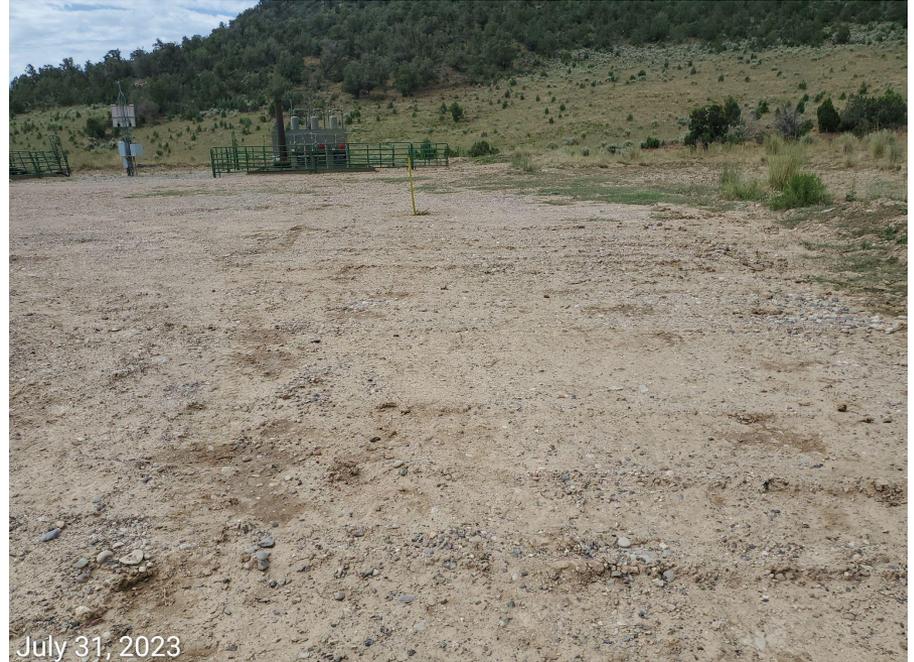
**Photo 2:** See comments under photo 1.

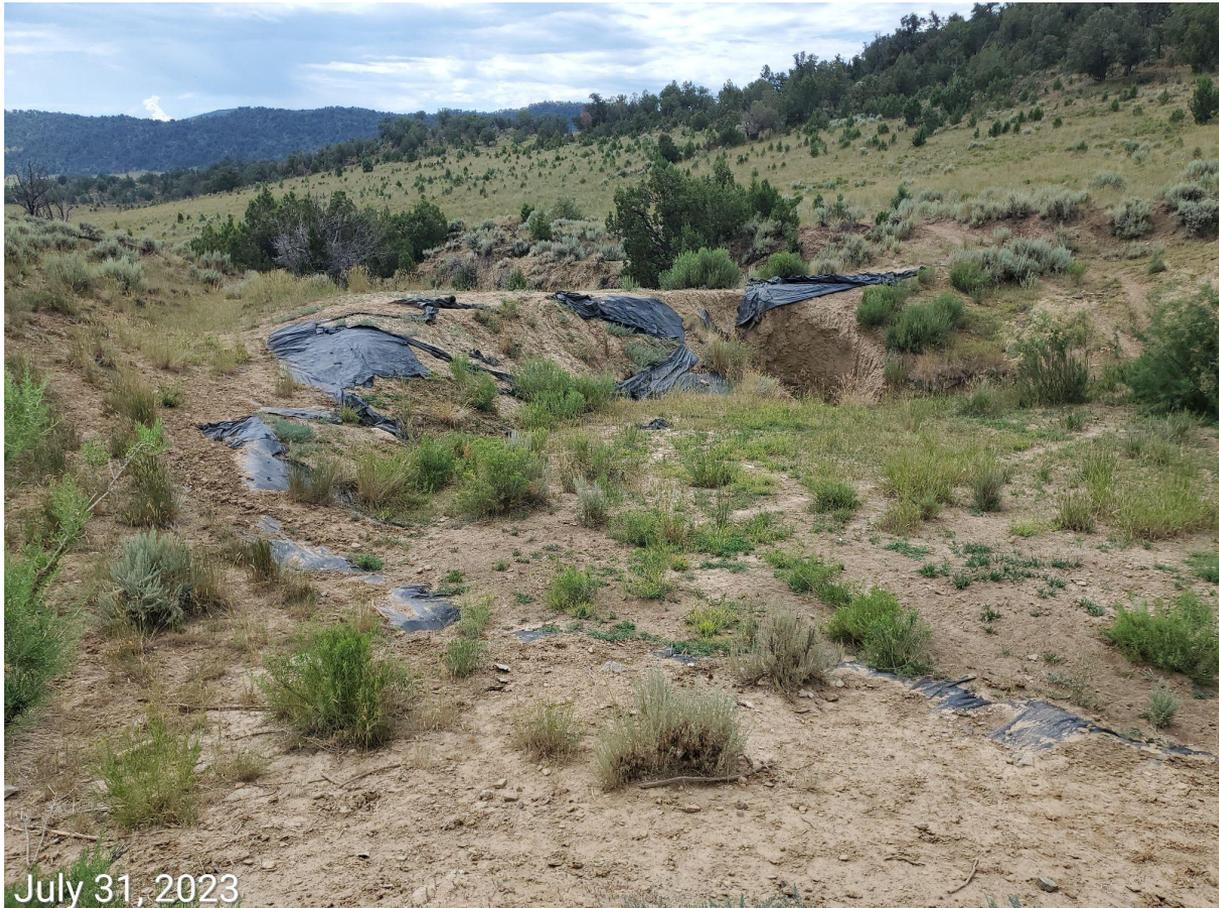
**Photo 3:** Photo taken from the adjacent drainage southwest of the pad. Areas appear to be a failed livestock pond installed by the surface owner, and is unrelated to the O&G Location's disturbance.

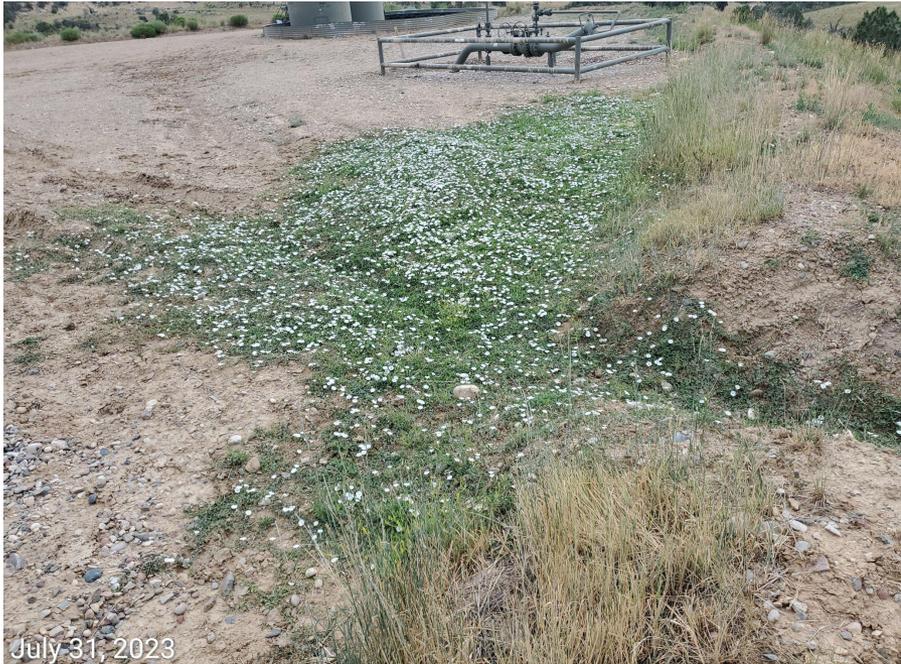
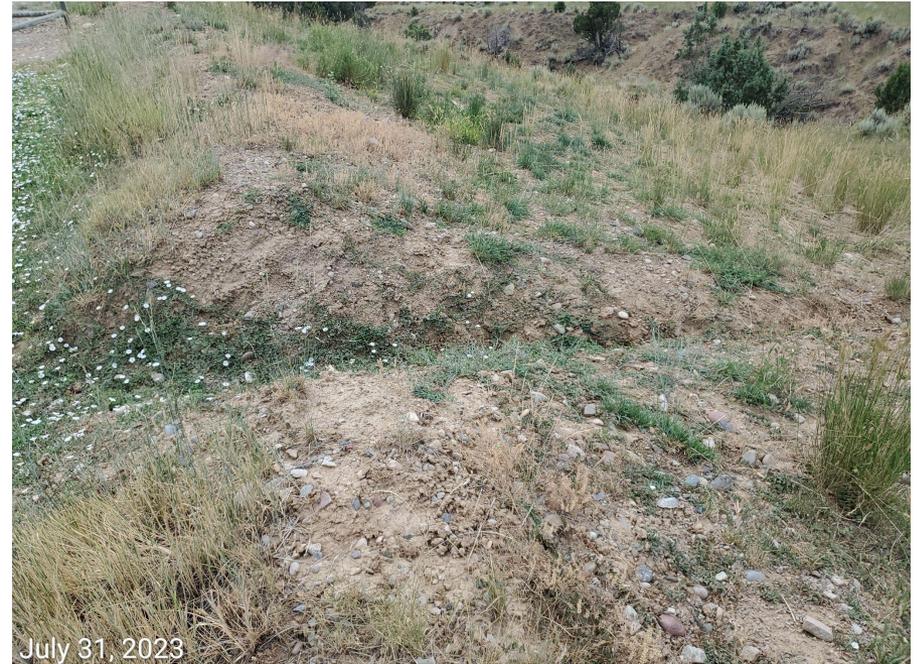
**Photo 4:** Photos taken from the southeast end of the working pad. Photo shows outlet to allow for stormwater discharge from the Location has not been installed in accordance with good engineering practices, resulting in erosion degradation. Photos also show Undesirable and Noxious Plant establishment; Field bindweed established on pad and interim areas.

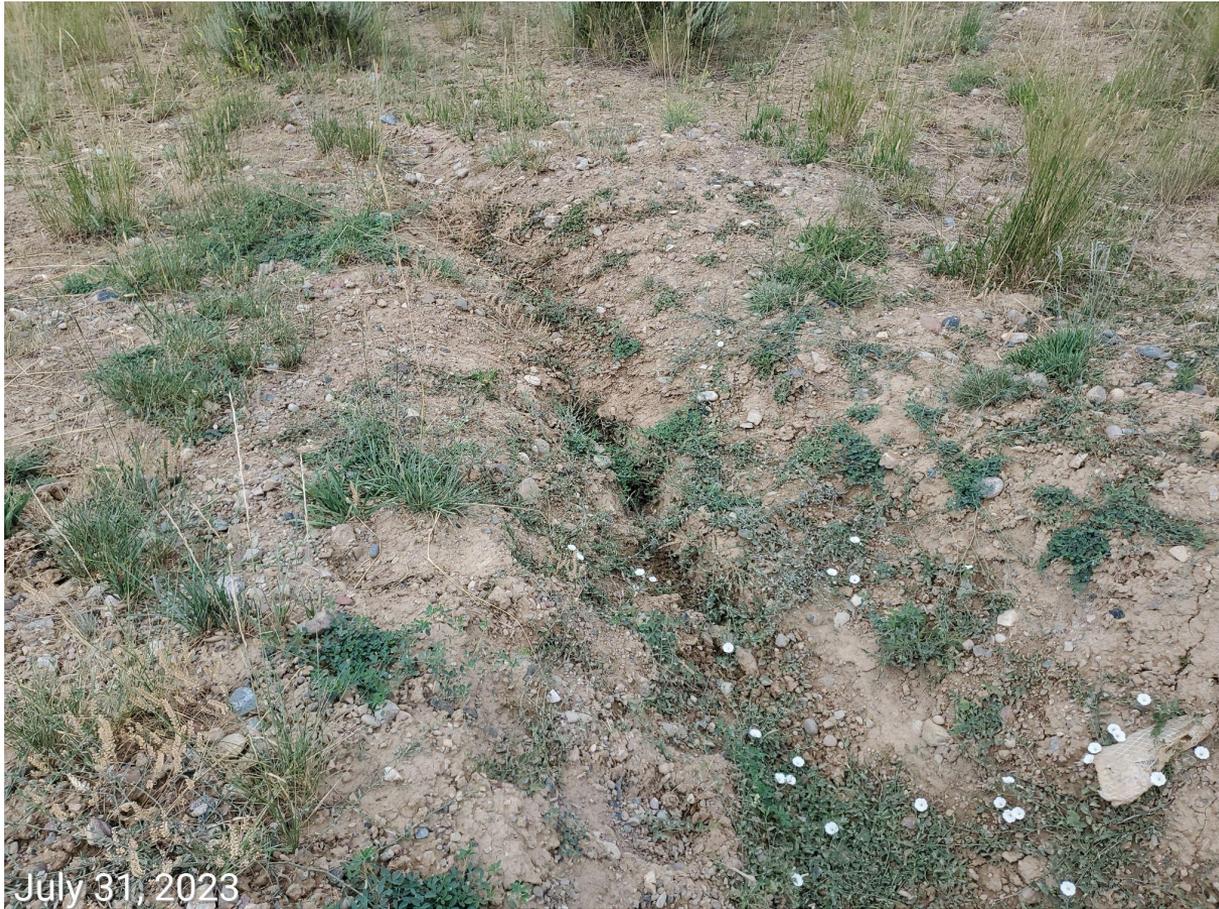
**Photo 5:** Erosion degradation due to improper stormwater discharge from the southeastern working pad area.

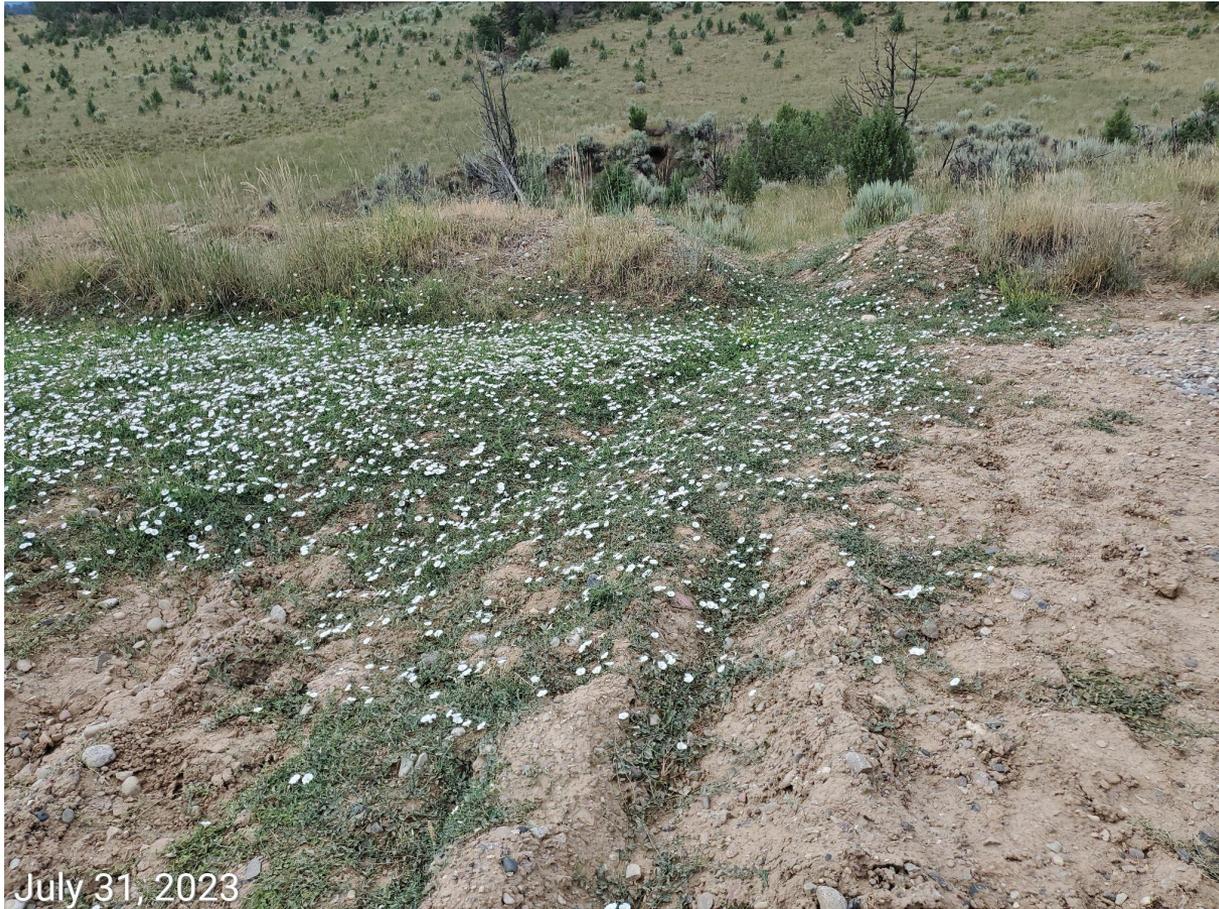
**Photo 6:** Photo taken from the southeastern areas of the working pad. Photo shows Undesirable and Noxious Plant establishment; Field bindweed established on pad and interim areas.

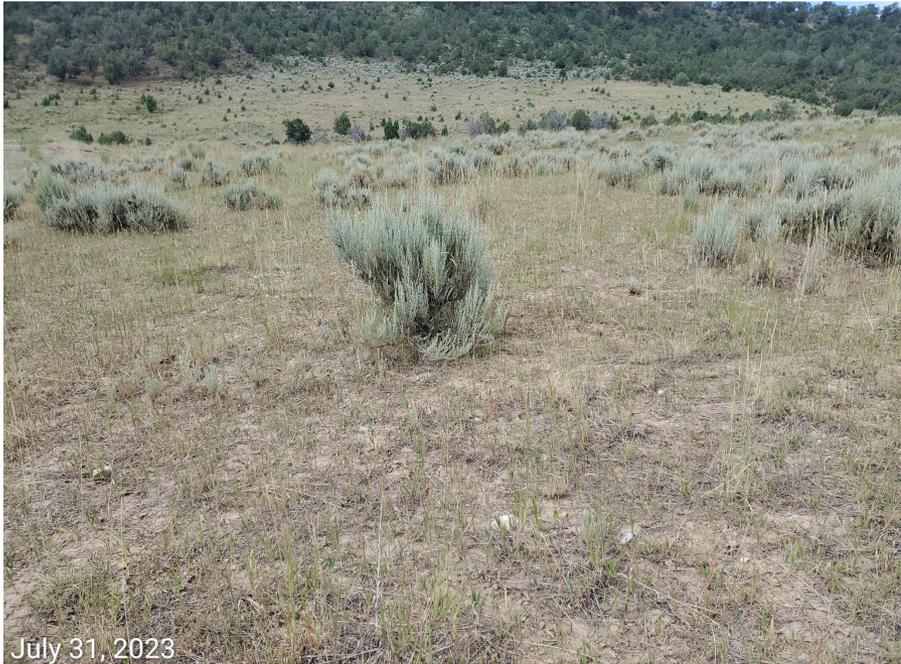
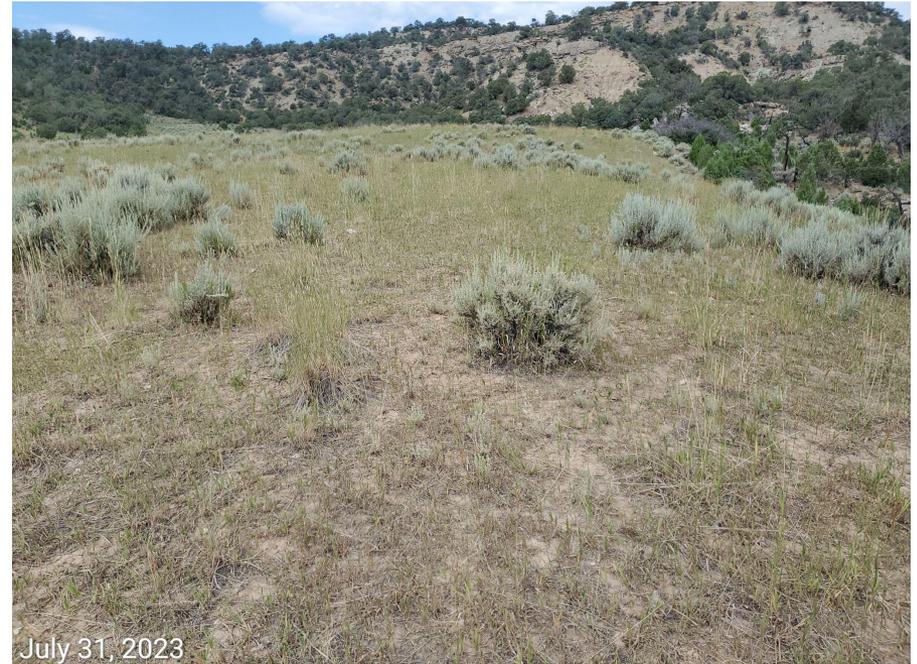
**Photo 7:** Photos taken from the interim areas on the west end of the Location. Photos examples showing vegetative establishment over the interim areas. Vegetation observed predominantly introduced species such as crested wheat and smooth brome.
