Work Completion Report

Location Completed	SAKATA_RED_W-62N66W_6SENE
Alt Loc Name	SAKATA_RED_W-62N66W_6SENE
Visited On	07/28/2023
Performed By	Peerless
One-Call Number	
Red Zone Date	
Red Zone APC Rep

Assoc Work Task	Facility Weed Control
Assoc Job	SAKATA FEDERAL 8-6A
Work Summary	Mowed weeds surrounding battery and addressed pot holes on the pad.
SqFtAffected	
AcresAffected	0.20000
Seed Mix	None used
LandUse	Crop
CropType	Corn
SoilType	Clay Loam
CompletionDate	7/28/2023 12:00:00 AM
StabilizationDate	7/28/2023 12:00:00 AM
SeedingDate	
Mulch	None
Straw Bales	
SoilAmendType	None
SoilAmendUnits	
SoilAmendAmount	
SoilAmendRate	NA
Top Soil	NA
Topsoil Source	
General Notes

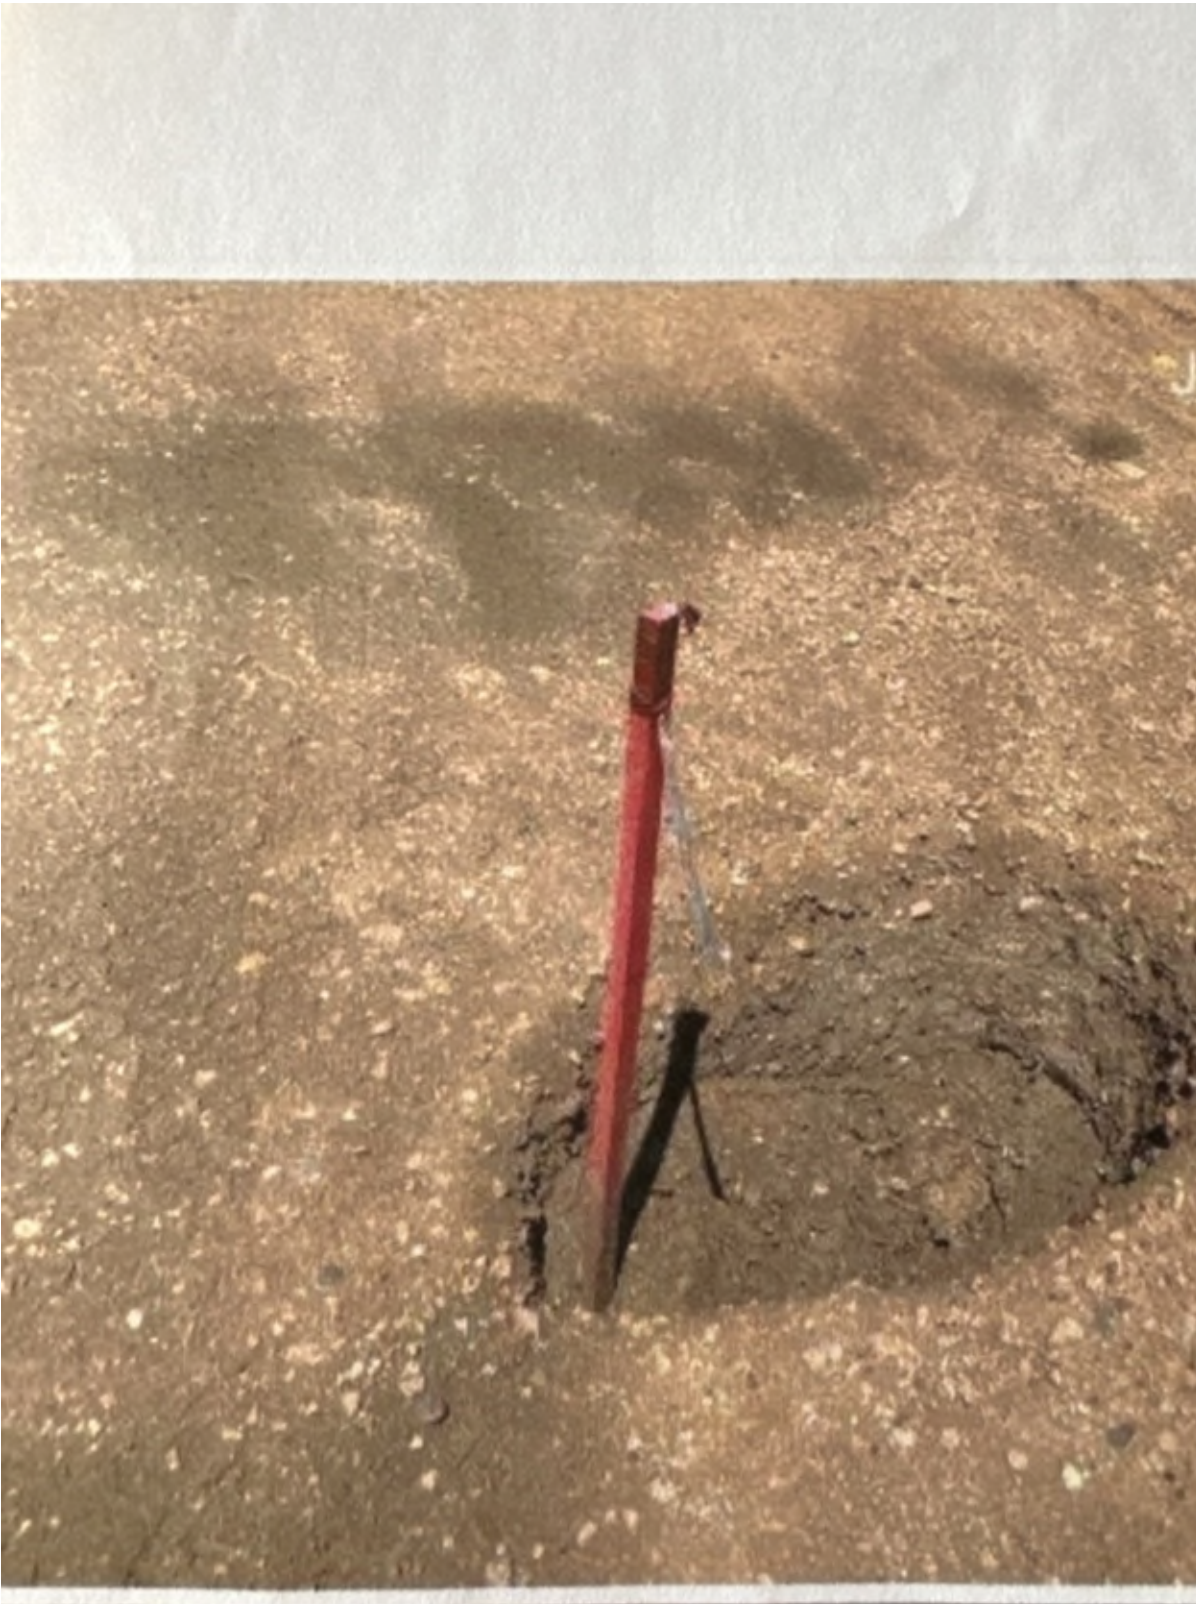
Photo Type	Pre-Completion
Photo Name	Pre-Completion
Photo Notes	
PhotoBlobID

Work Task	Facility Weed Control
Job	SAKATA FEDERAL 8-6A
Requested On	7/12/2023 12:00:00 AM
Requested By	Tyler Scherden
Did COGCC issue a CA for Work?	No
Start By Date	
Due By Date	
Recur Frequency	
Status	Completed
Notes	Mow weeds surrounding battery, address pothole on pad if present.
