Inspection Photos

API: 071-09018

Operator: EVERGREEN NATURAL RESOURCES

Inspection Date: 7/24/2023

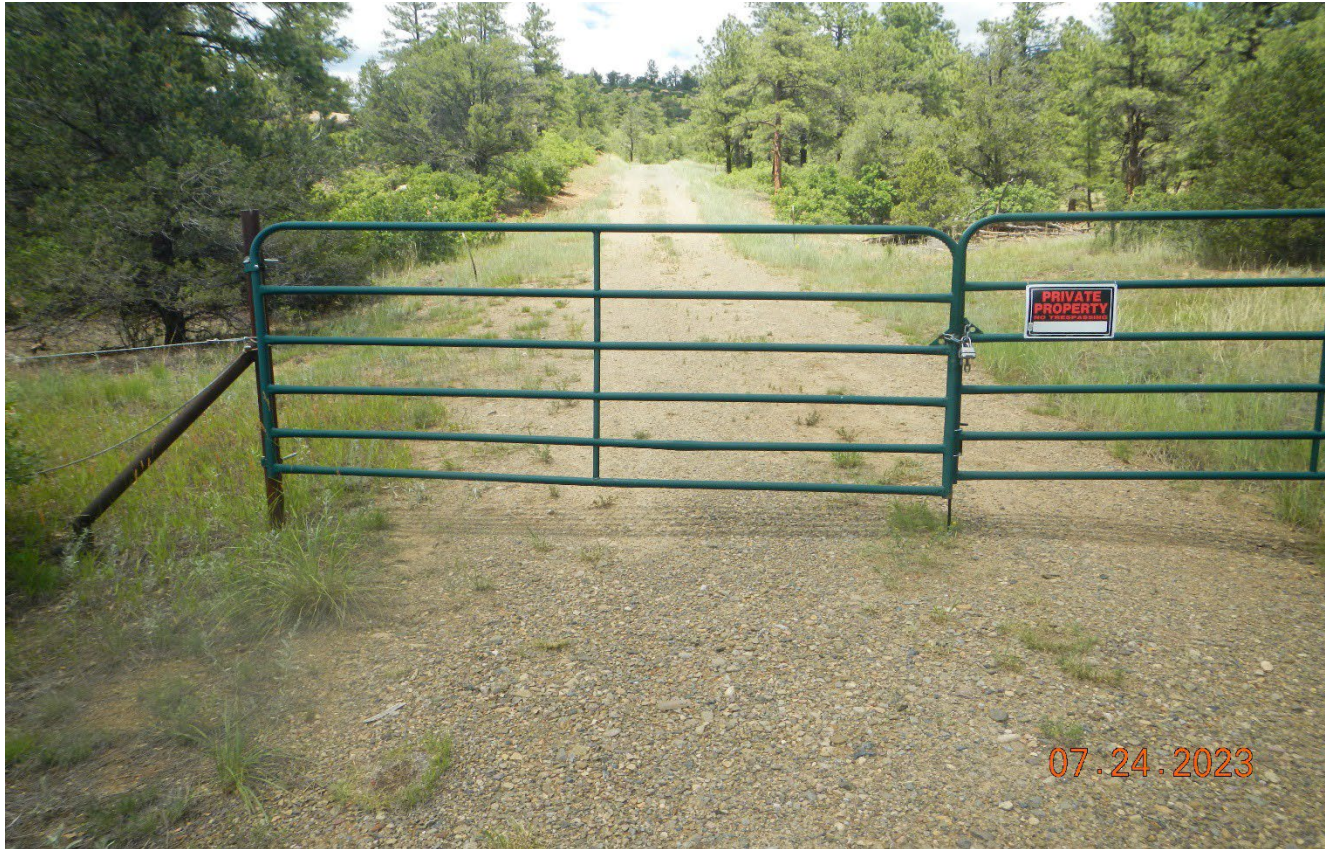
Photo 1. Facing north at the beginning of the access road.

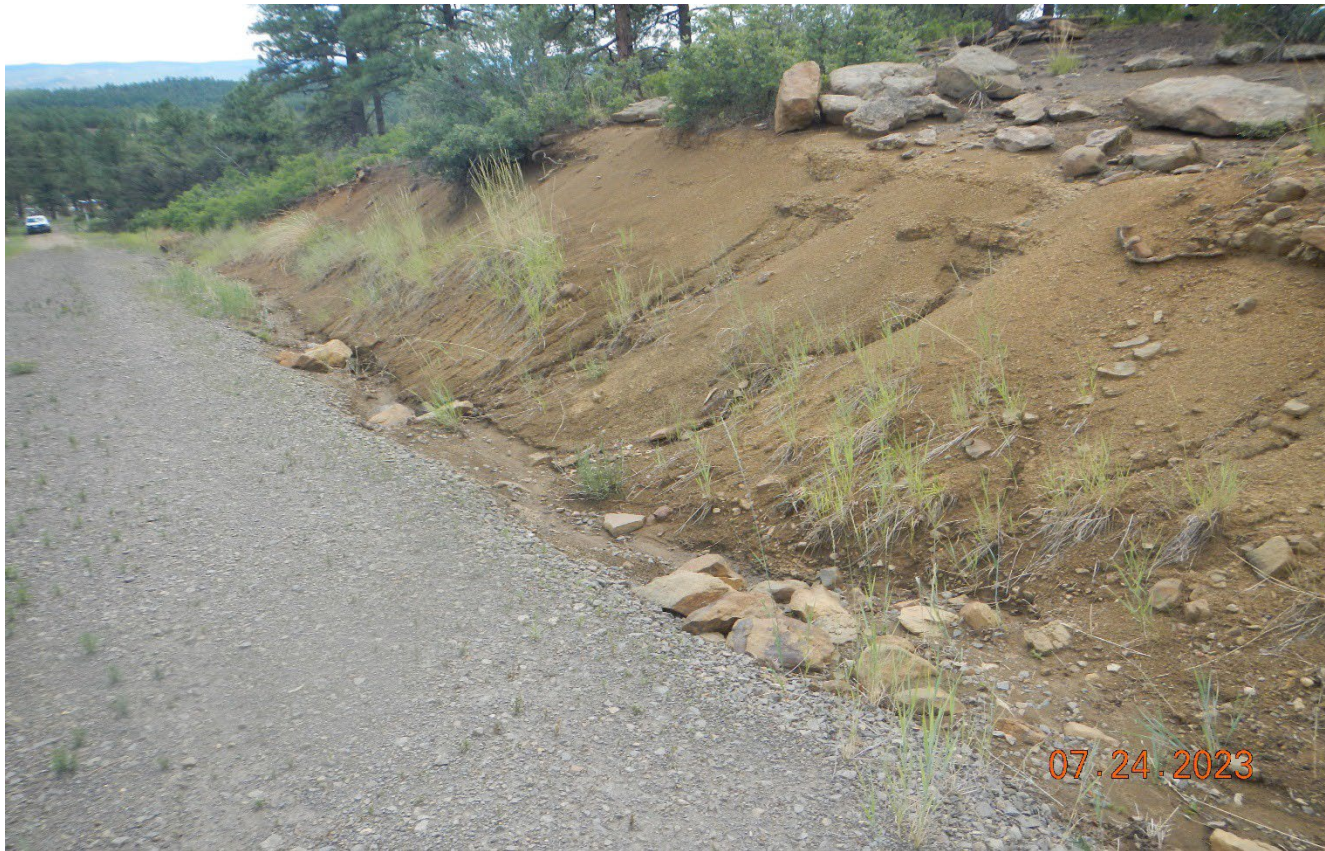
Photo 2. Facing southwest along the roadside. The rock check dams are not functioning or maintained and the roadside is not stabilized. Bare soil and rill erosion evident.

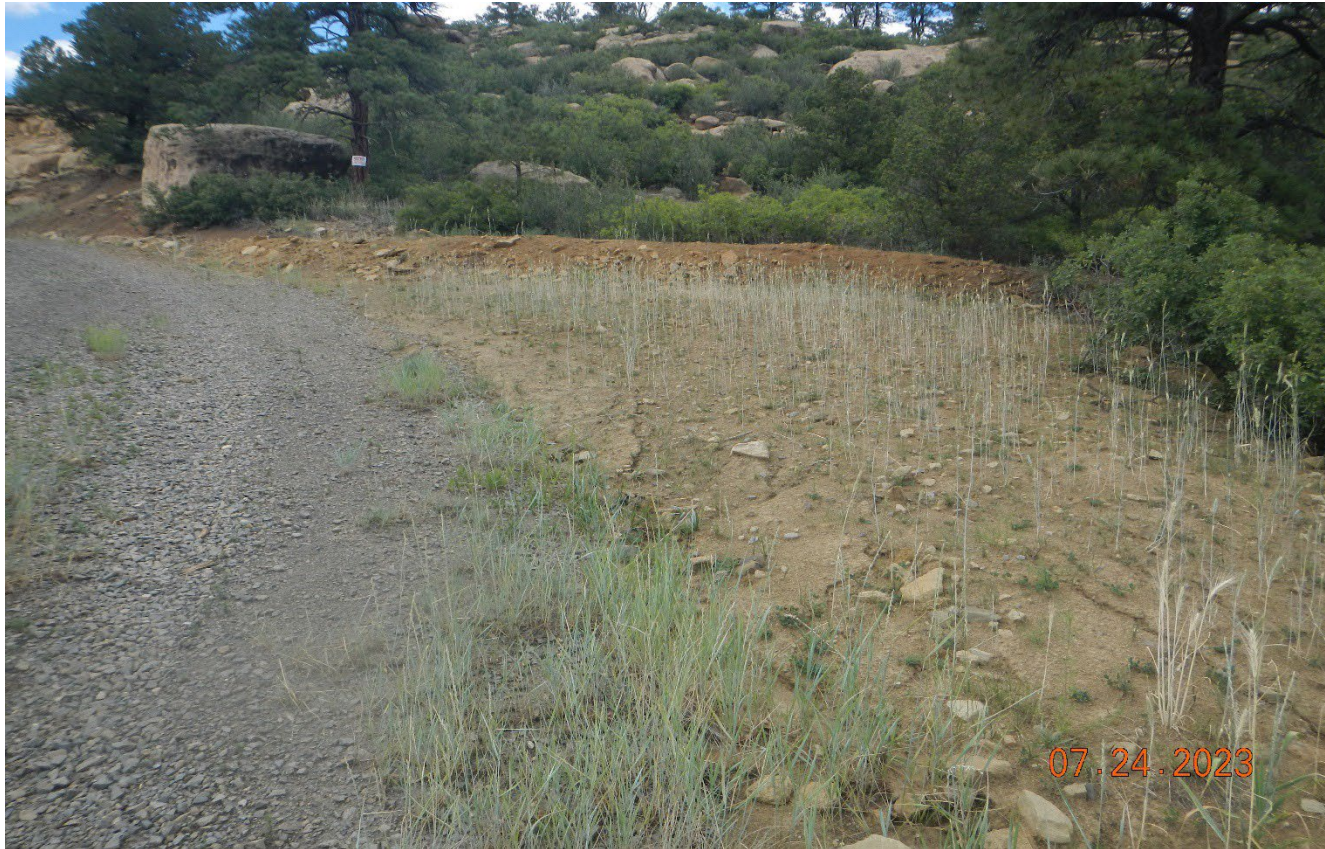
Photo 3. Facing northwest near the location. A diversion berm was placed to divert stormwater off the road. This area was reseeded but has not yet established sufficient vegetation cover for stabilization.

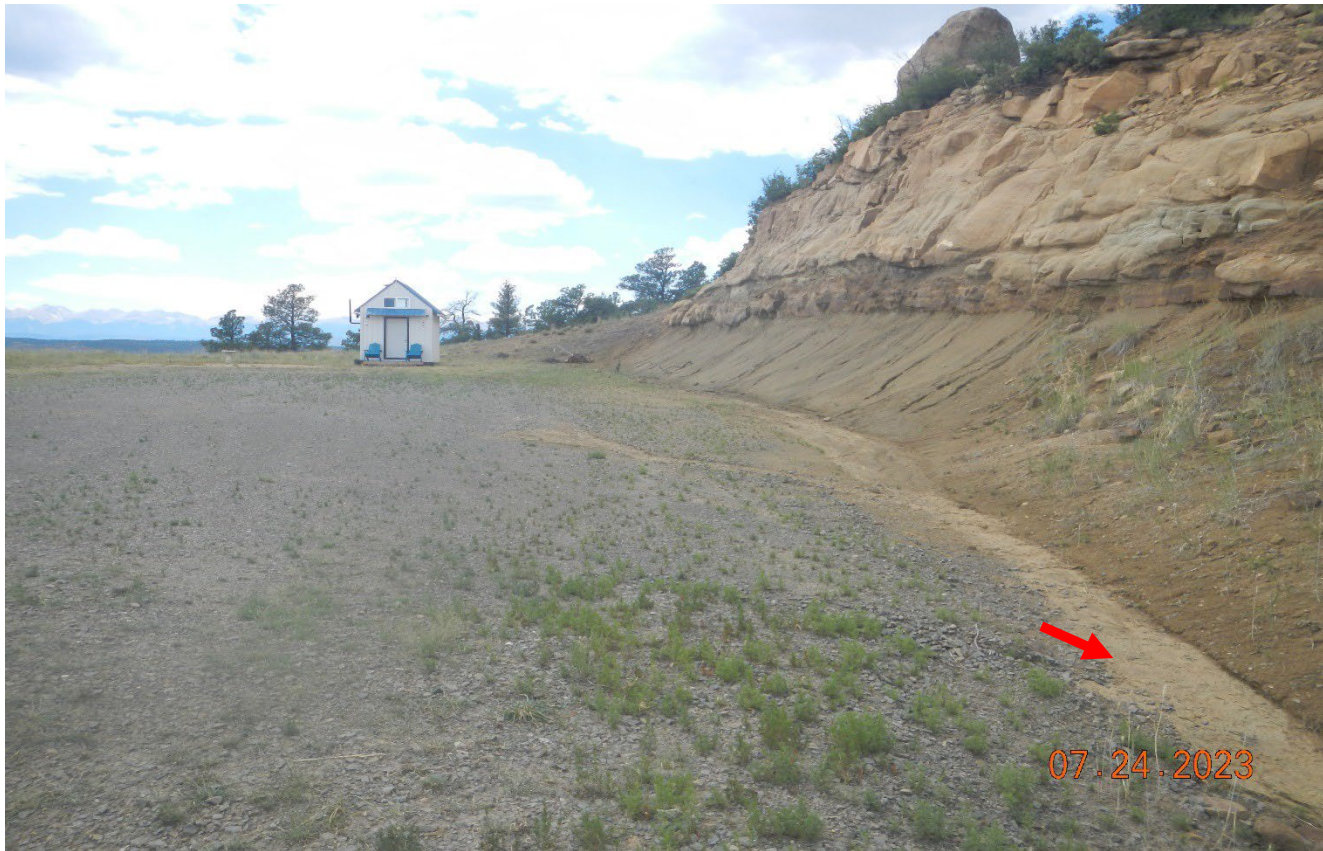
Photo 4. Facing west toward the location. There is sediment deposition shown at red arrow. BMP's will need to be installed to prevent sediment migration offsite. The landowner has placed a shed on the location.

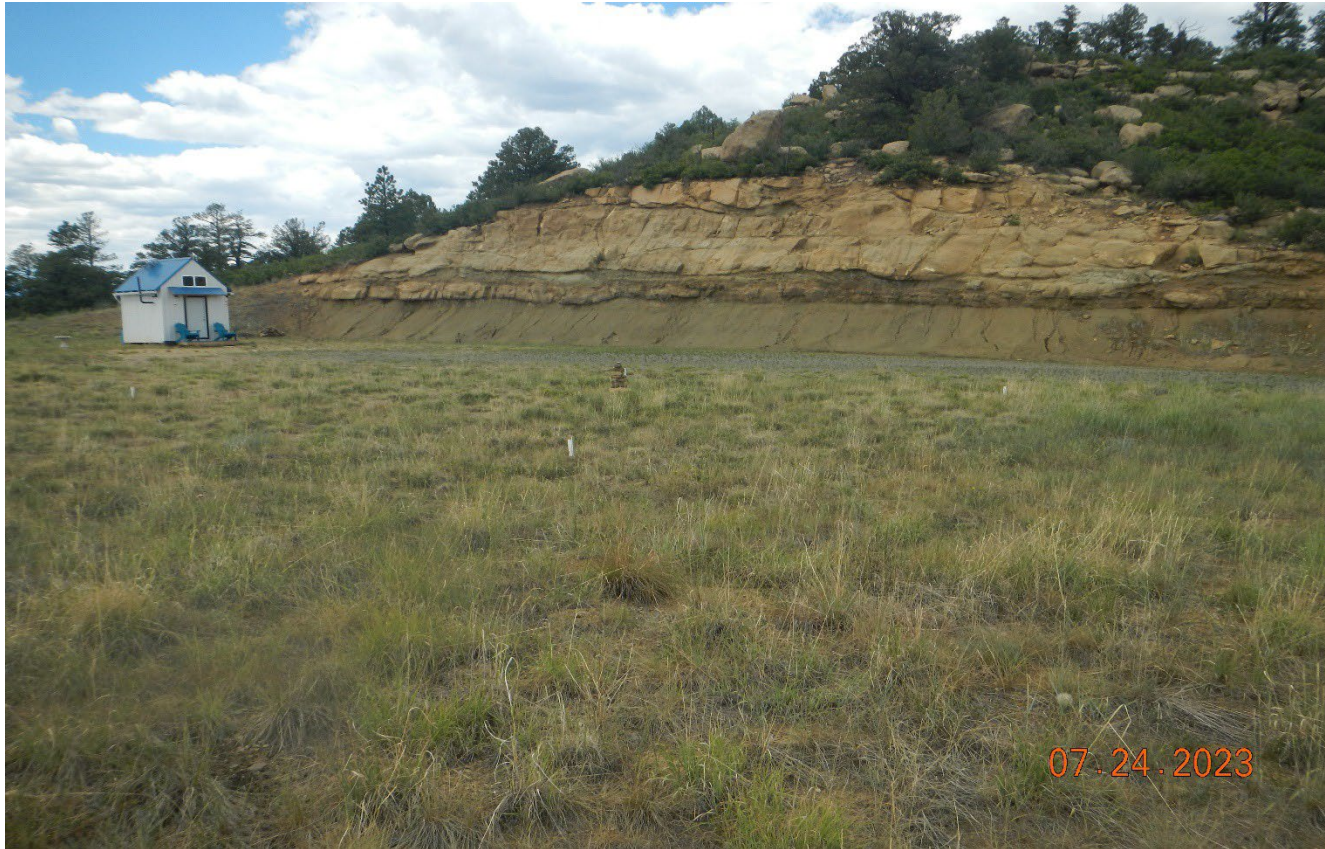
Photo 5. Facing northwest at the location. The well has been cut and capped below grade and there is no above ground well marker. All oil and gas equipment has been removed. The landowner has placed a shed on the location.

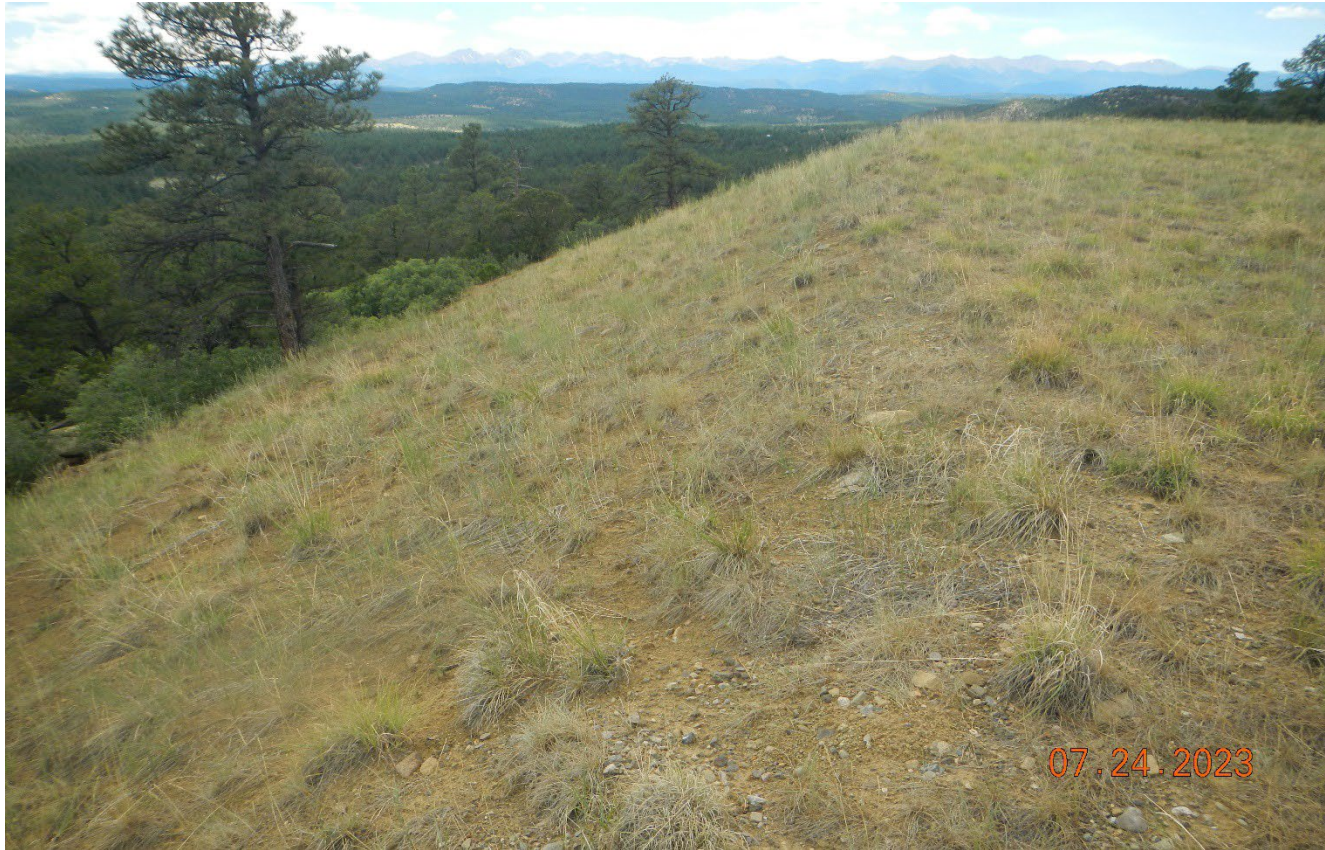
Photo 6. Facing toward the fill slope.

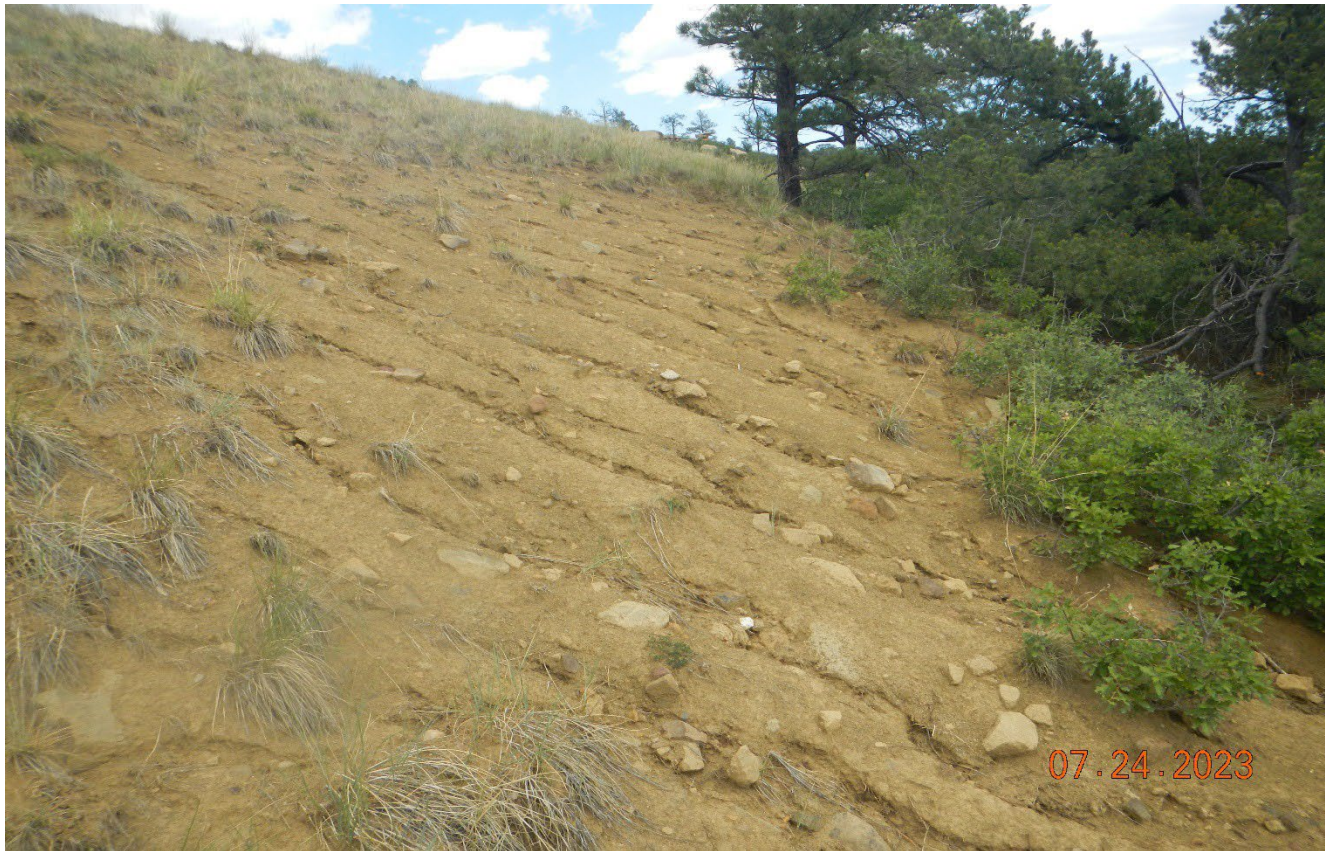
Photo 7. Facing northeast at the bottom of the fill slope. There are areas at the base of the fill slope that are not stabilized and have rill erosion occurring.

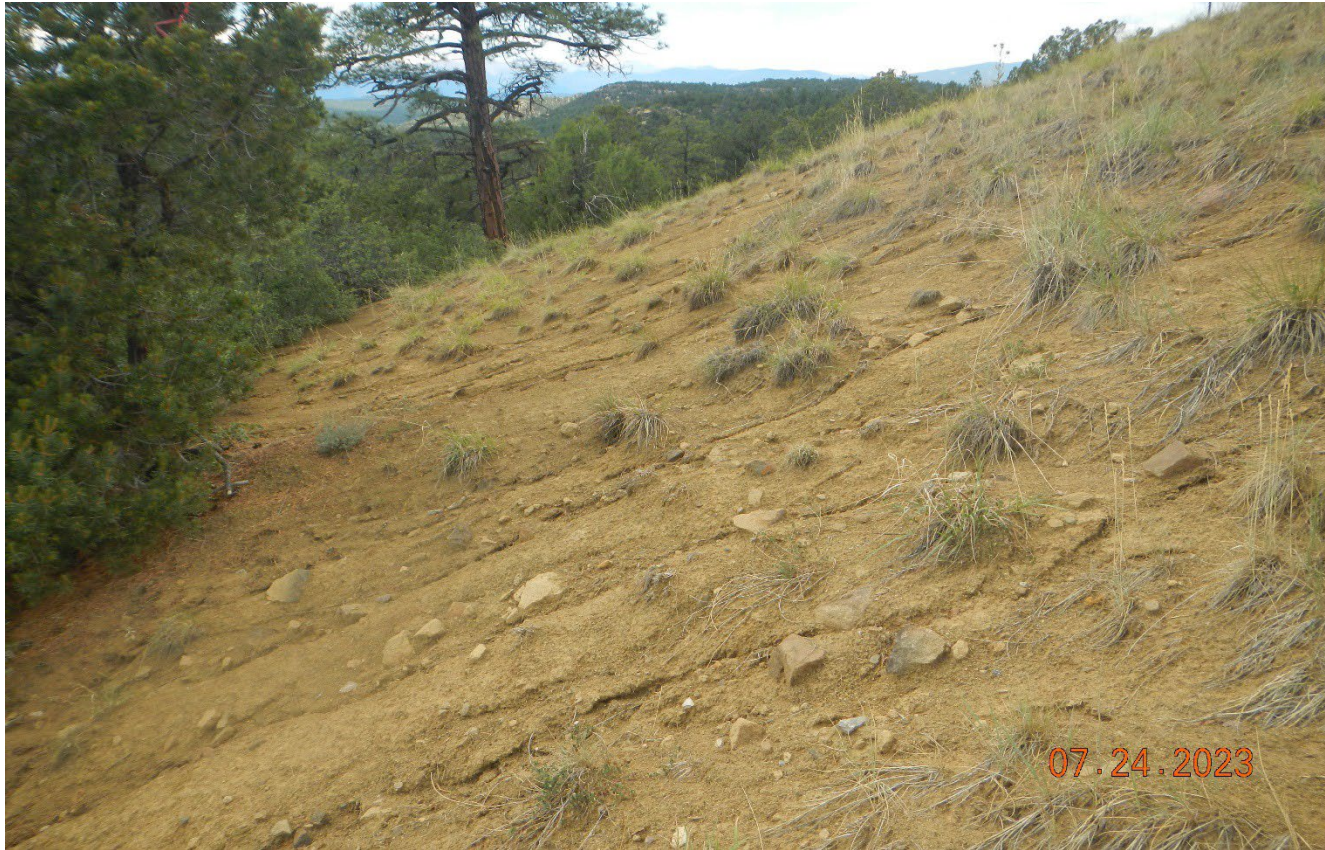
Photo 8. Facing northwest at the bottom of the fill slope. There are areas at the base of the fill slope that are not stabilized and have rill erosion occurring.

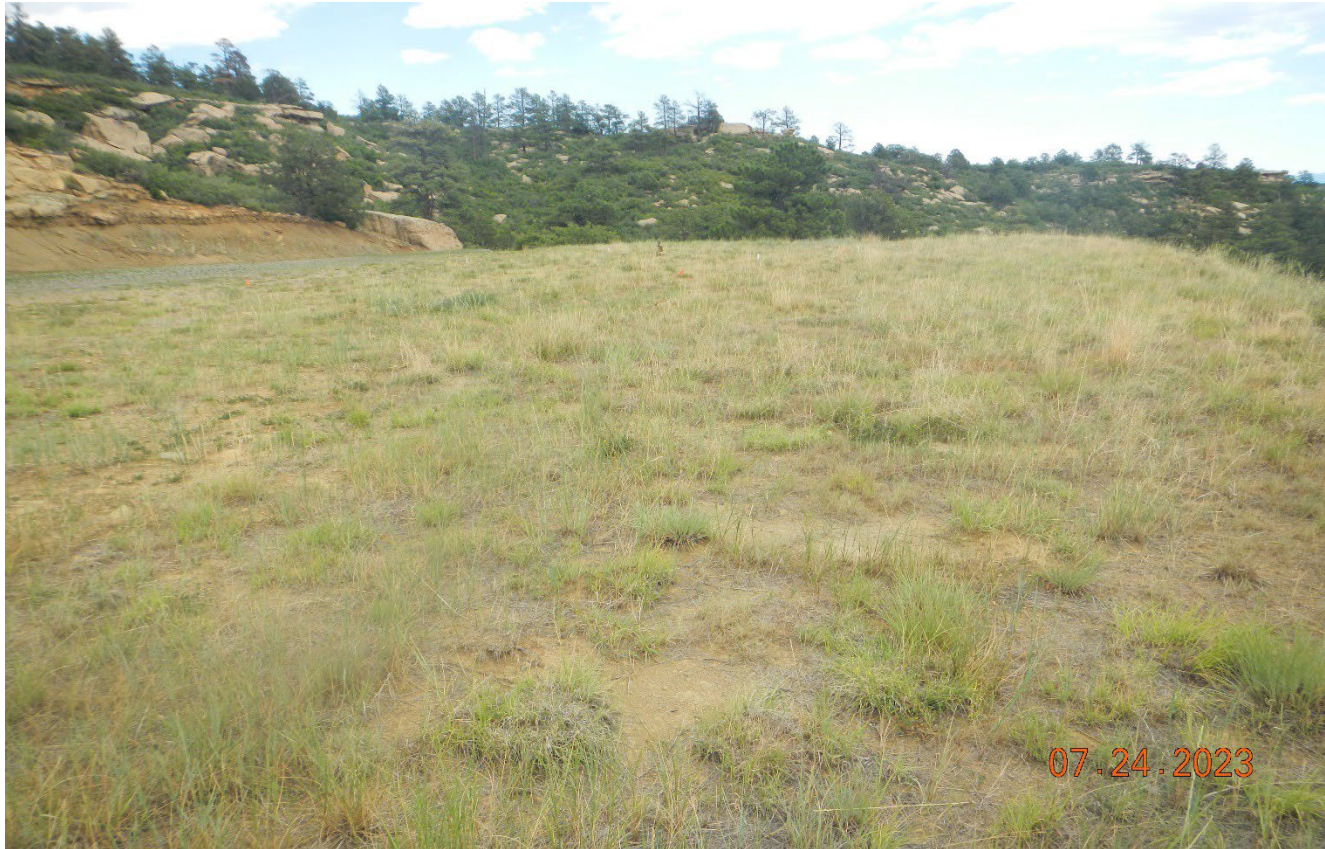
Photo 9. Facing northeast at the location. The well has been cut and capped below grade. All oil and gas equipment has been removed.

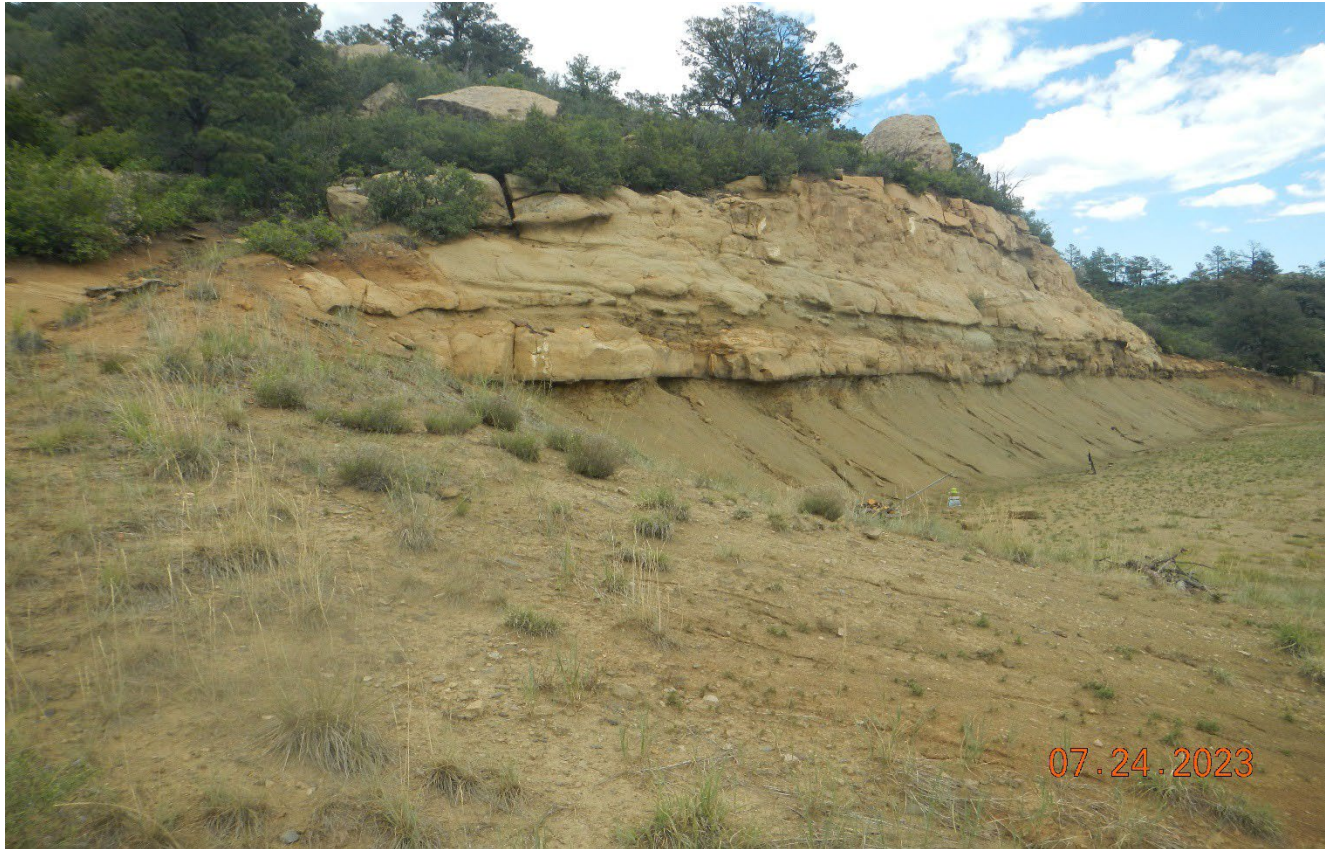
Photo 10. Facing northeast toward the cut slope. There are areas of bare soil and rill erosion.

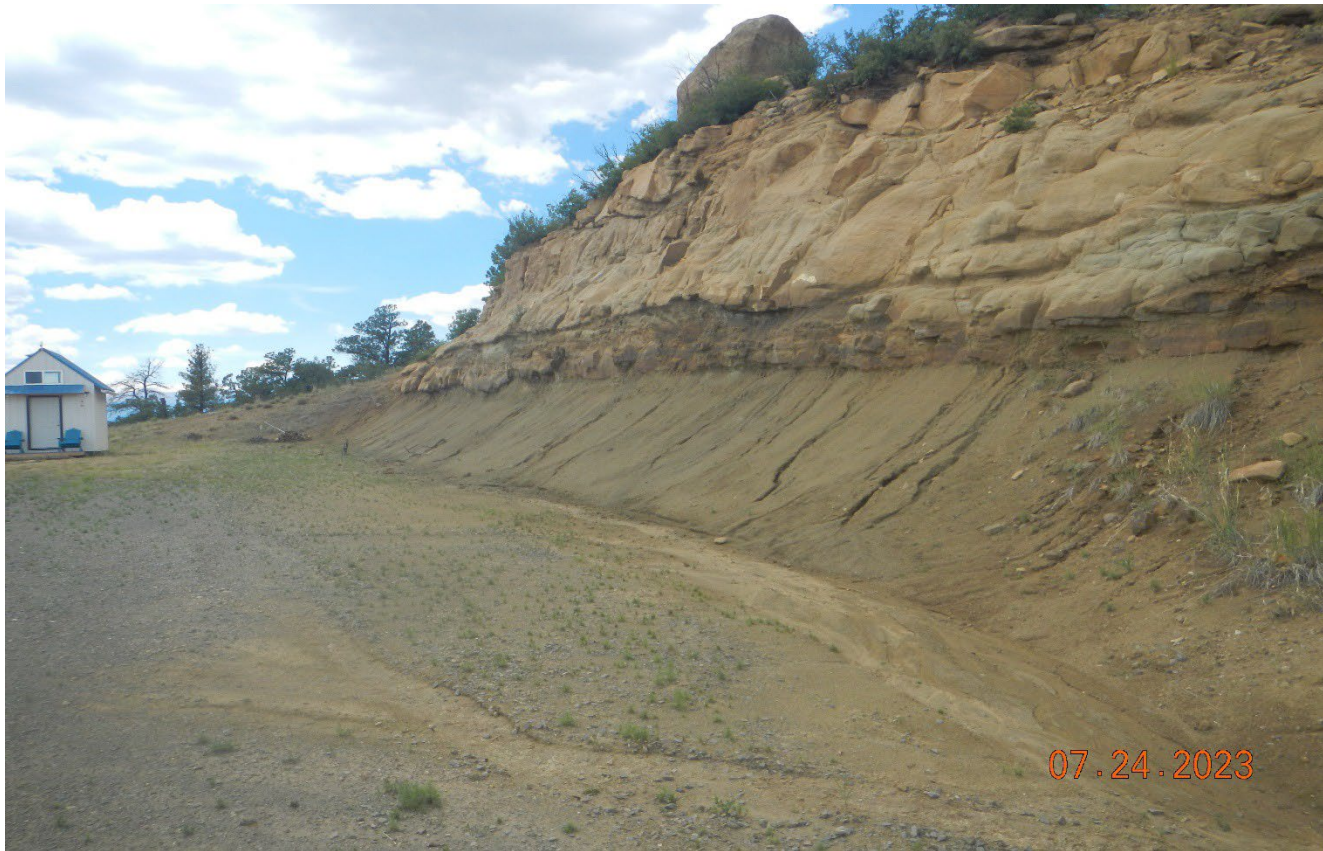
Photo 11. Facing northwest toward the cut slope. There appears to be some unstable rock along the cutslope which may fall onto the wellpad. BMP's will need to be installed for stabilization of the cut slope and rock/sediment movement.
