TEP
MV 43-31
Location ID:
334912

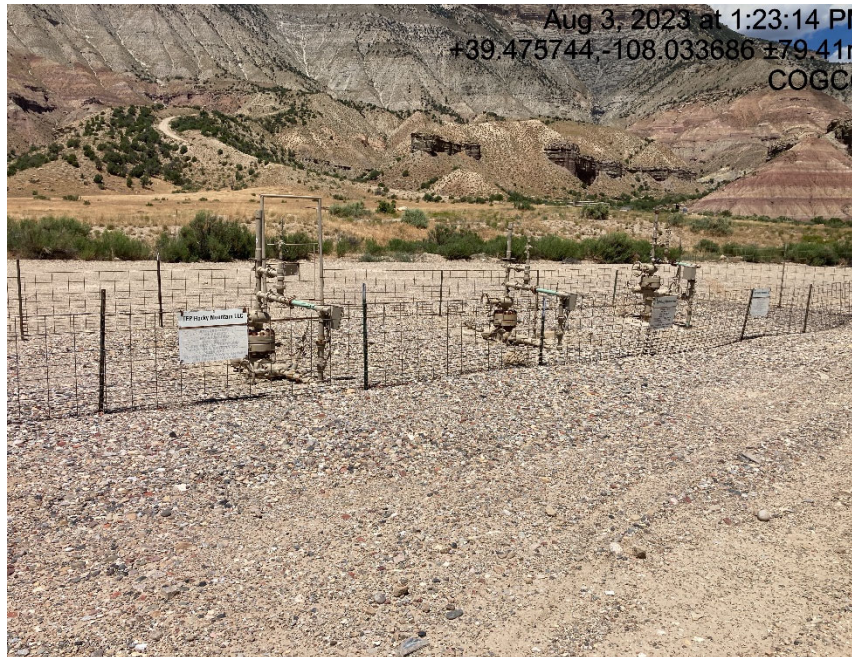
Well heads

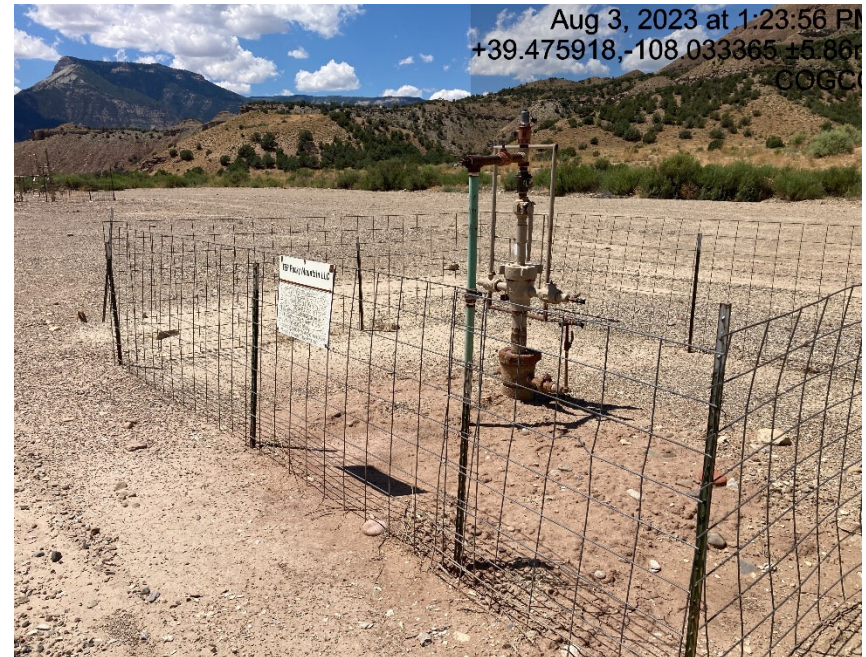
Well heads

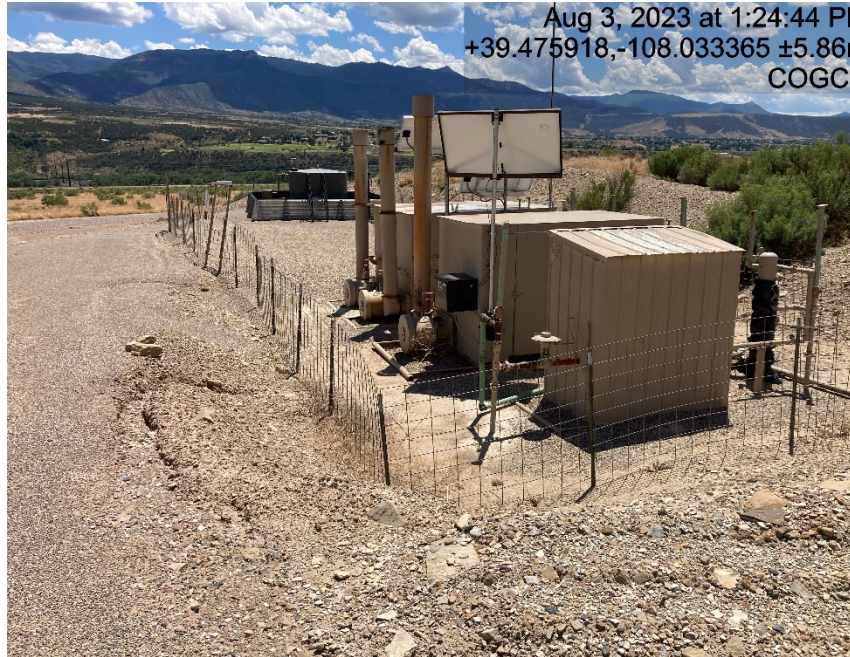
Separators

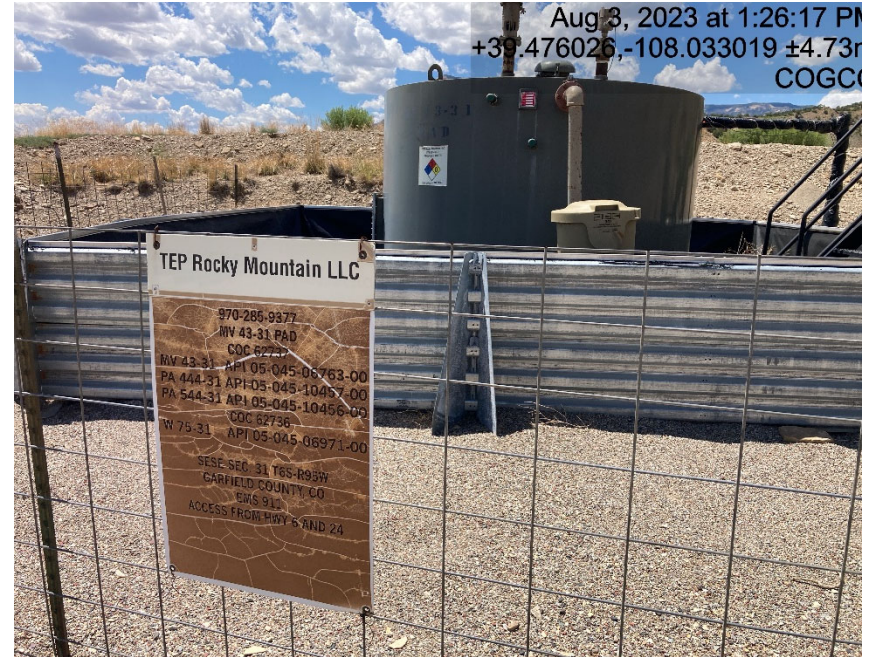
Tank battery and signage is fading

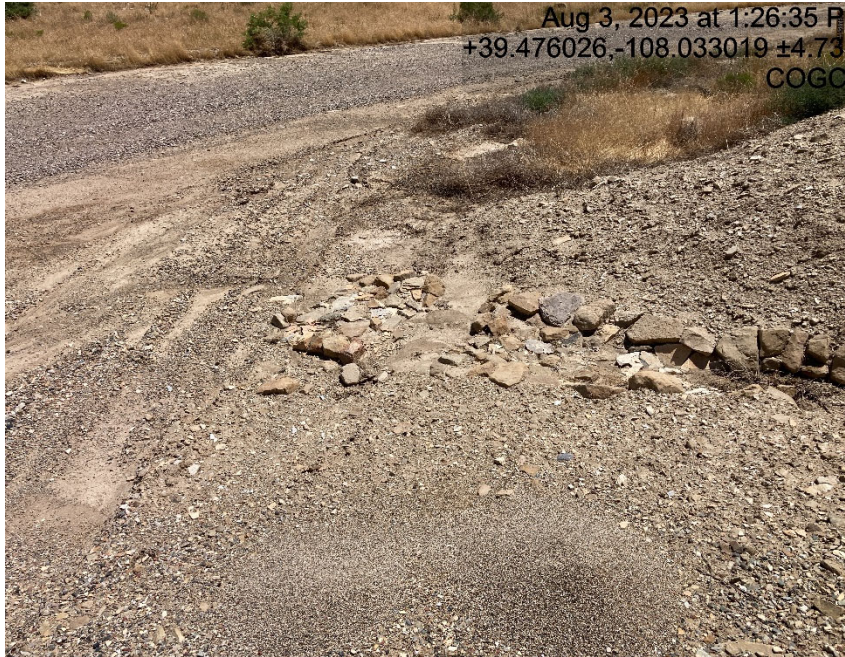
BMP's on location

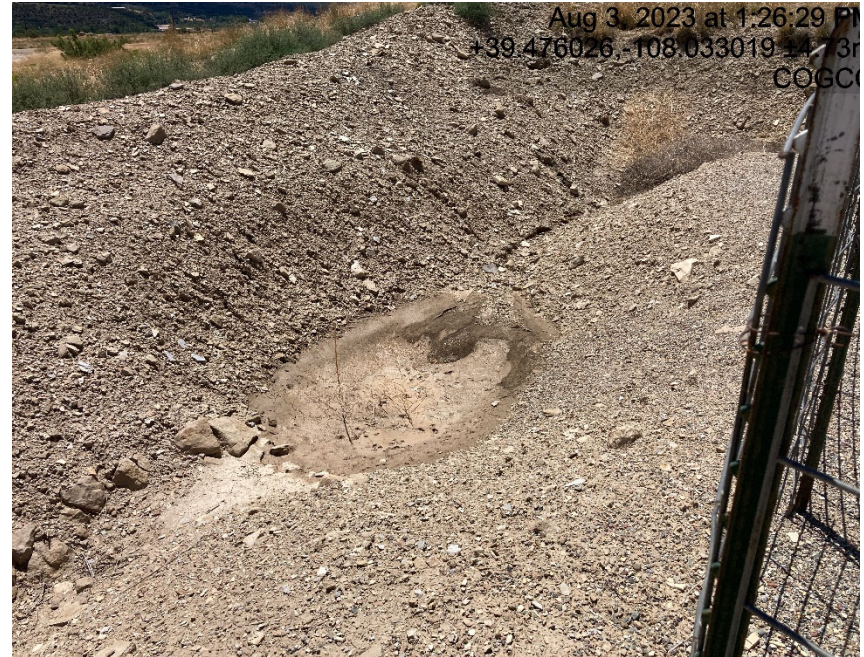
Cut slope lacks stabilization

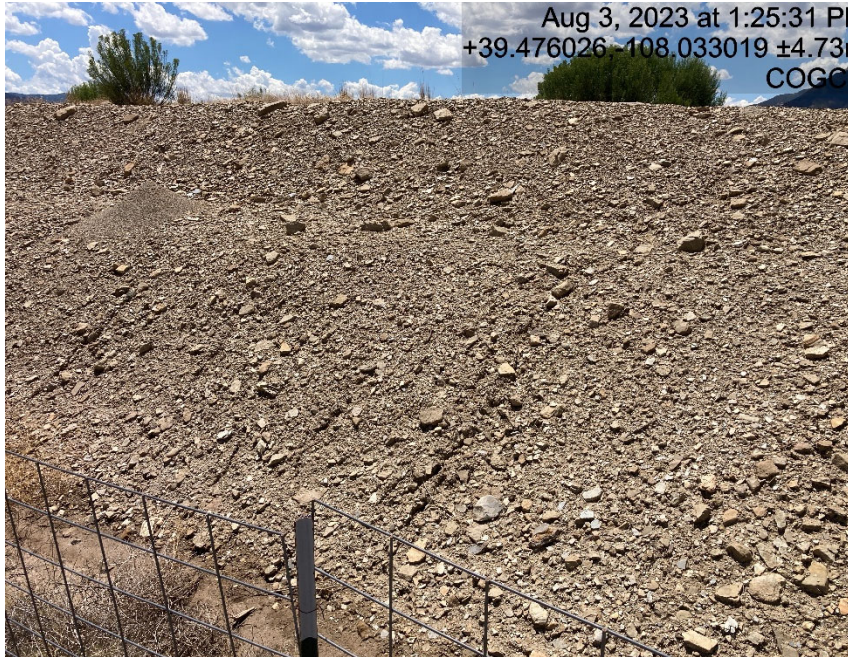
Cut slope lacks stabilization

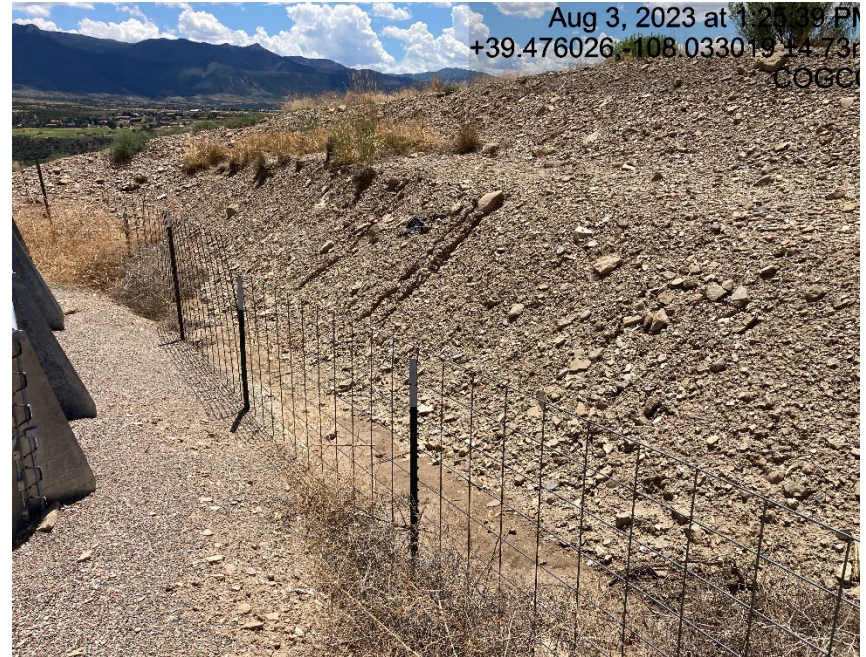
Cut slope lacks stabilization

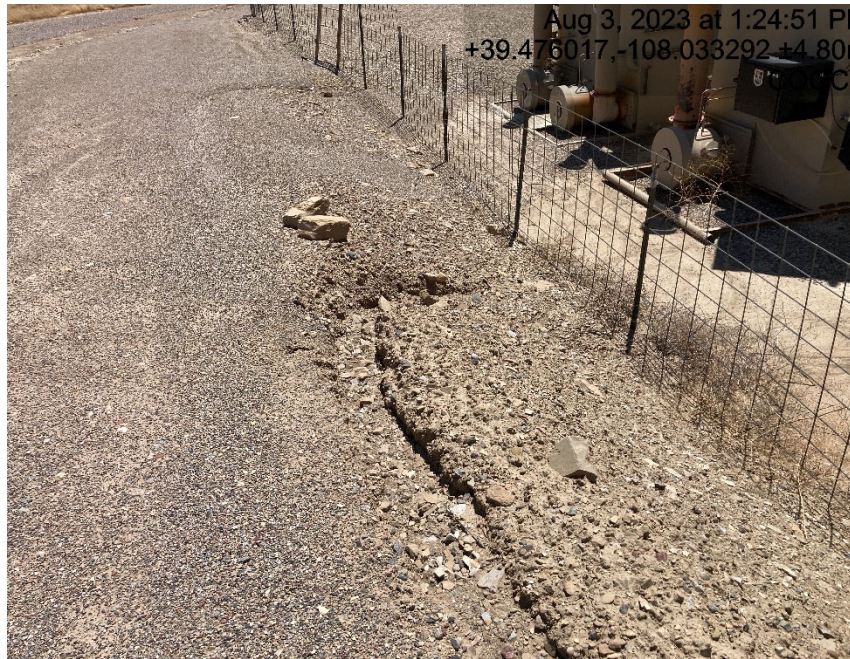
Erosion on cut slope causing run on

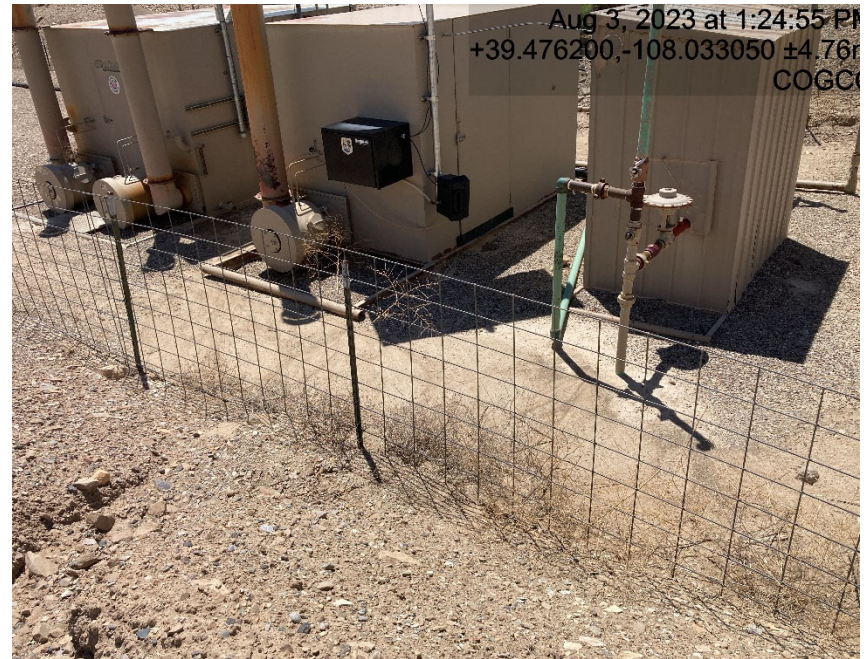
Erosion on cut slope causing run on

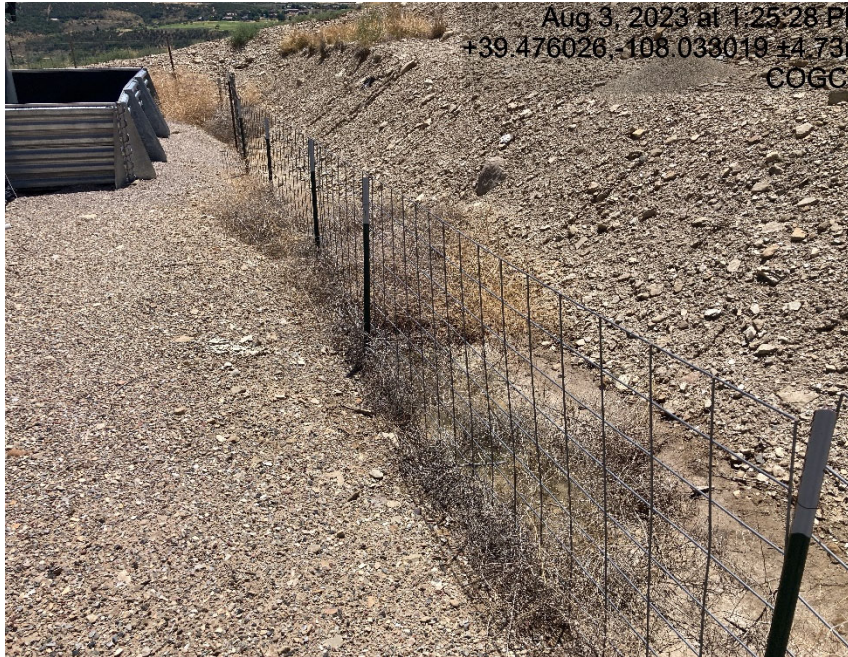
Weeds turned into debris

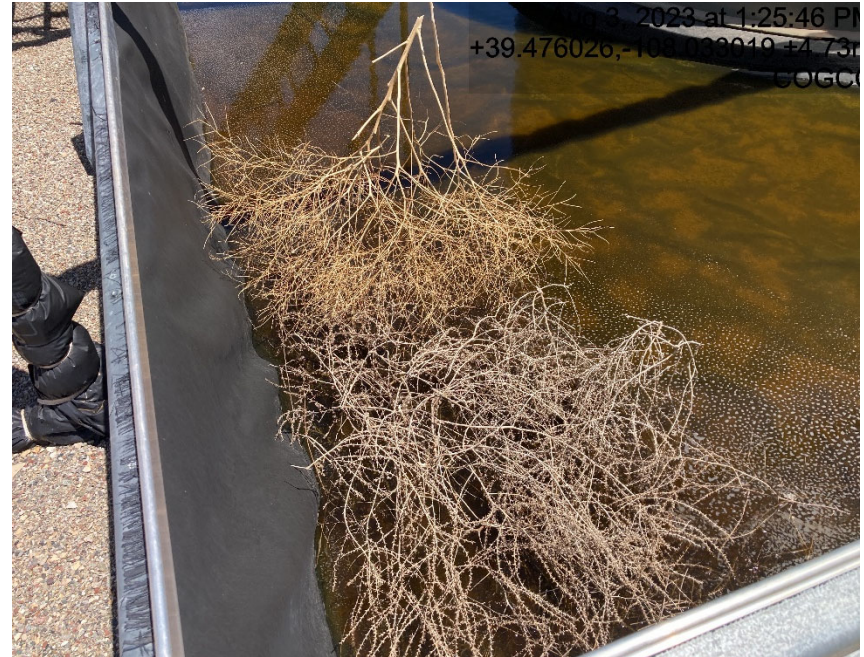
Weeds turned into debris

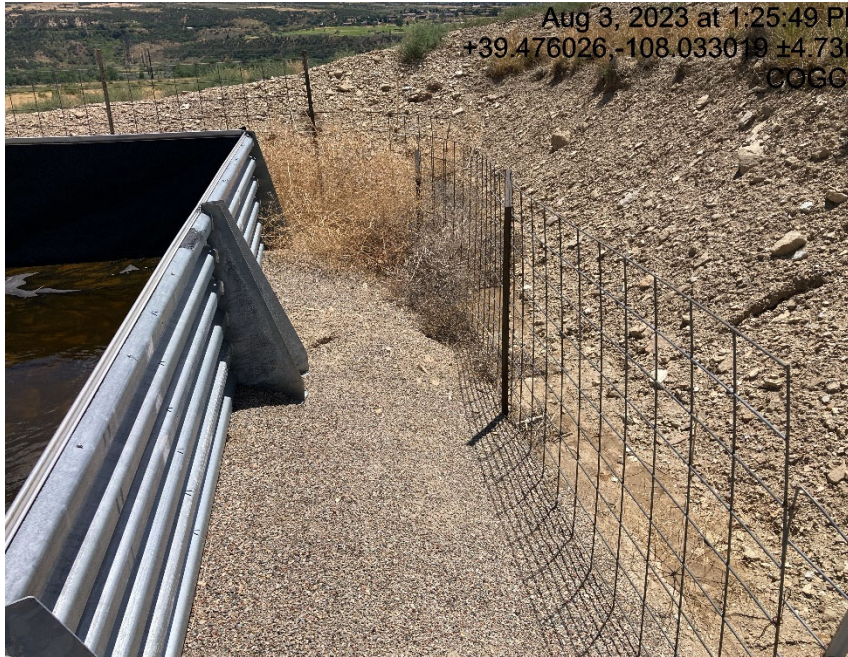
Weeds turned into debris

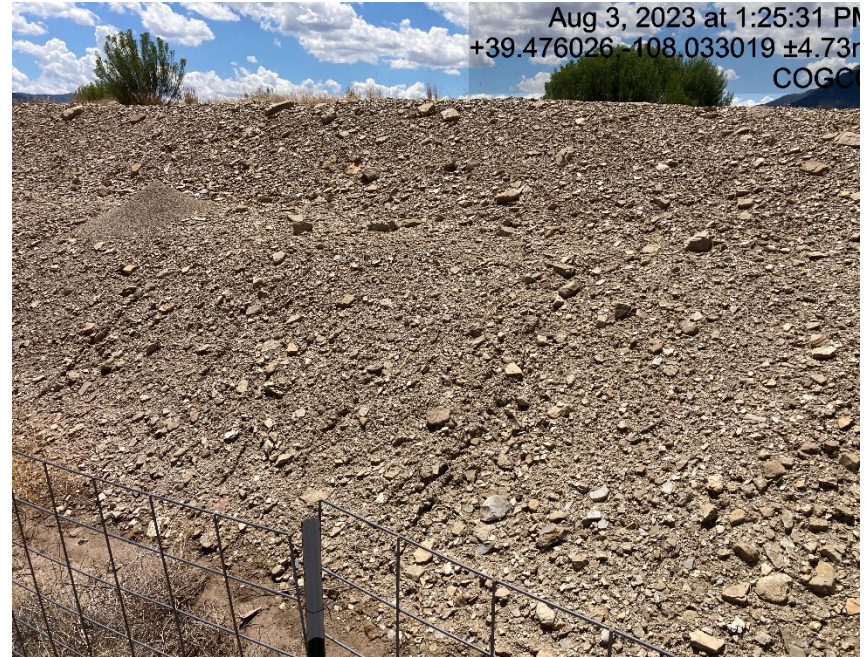
Cut slope lacks stabilization
