TEP
PA 31-6
Location ID:
334920

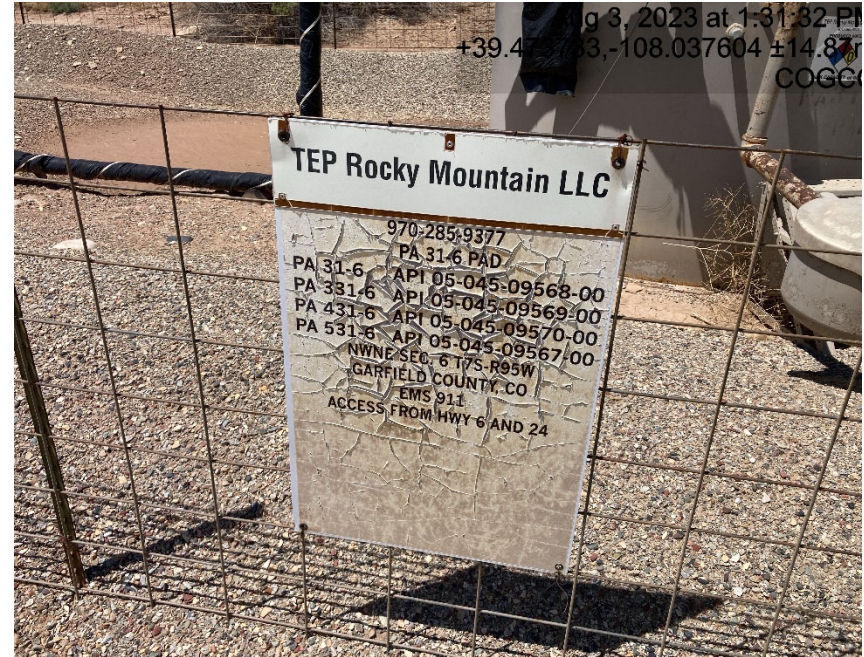
Battery signage is becoming weathered

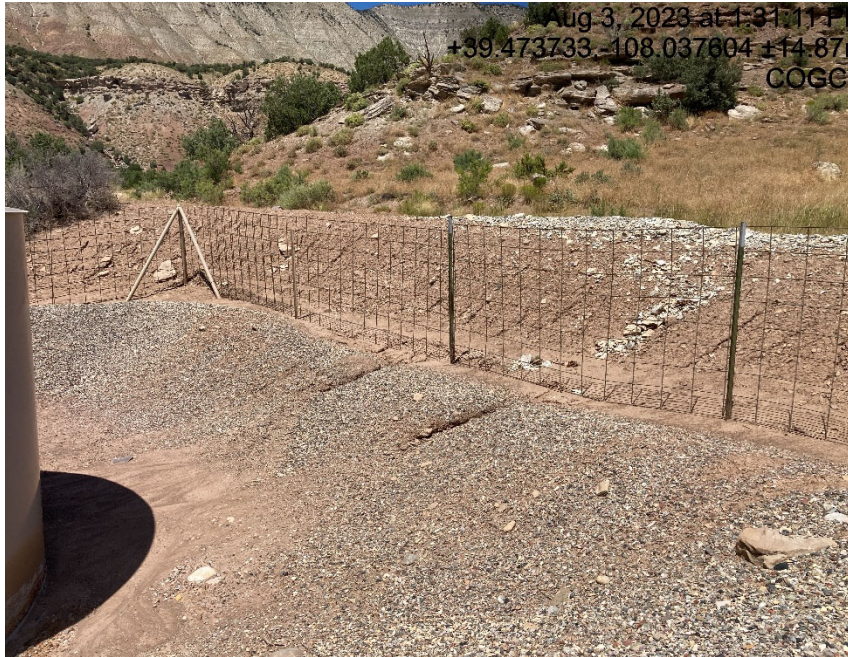
Lack of stabilization and erosion

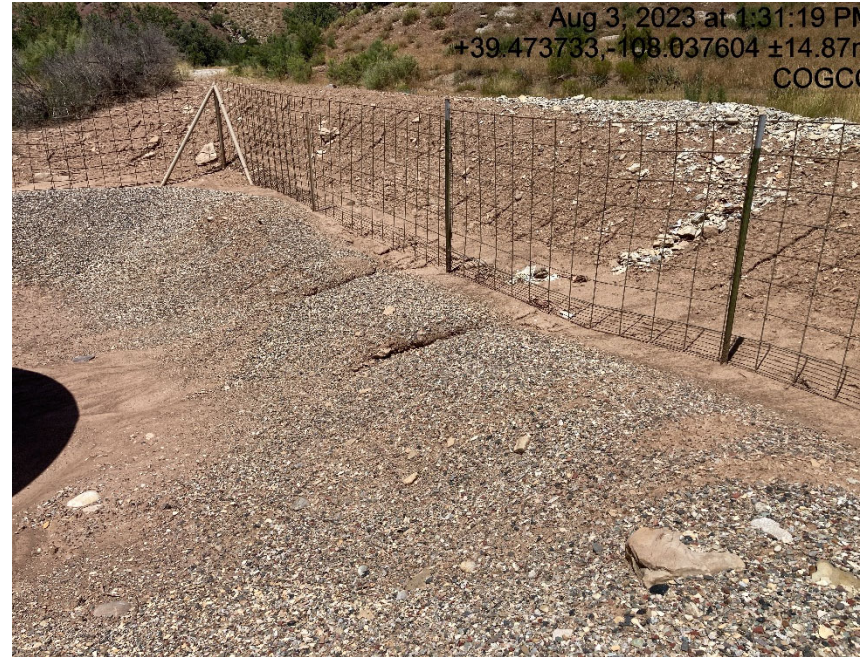
Lack of stabilization and erosion

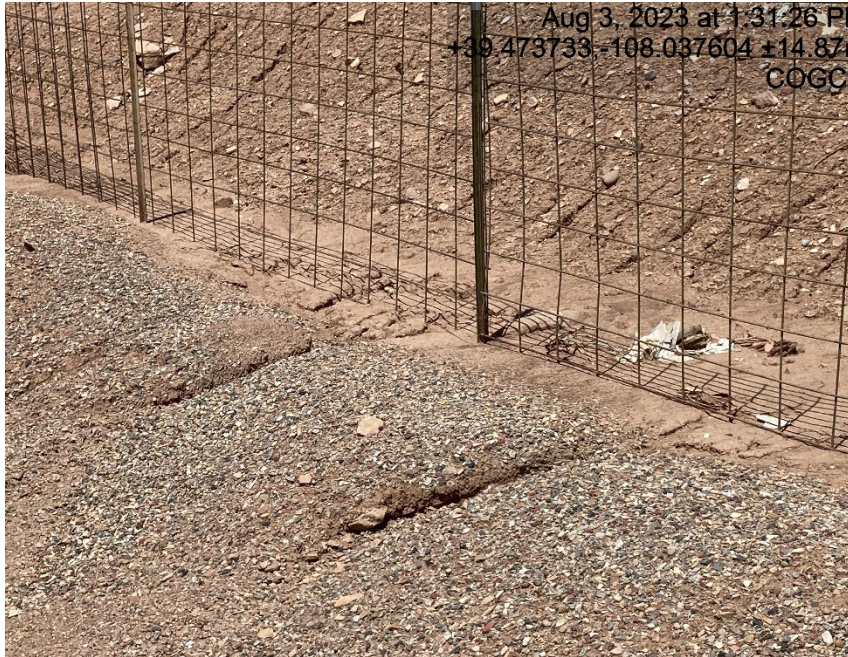
Erosion

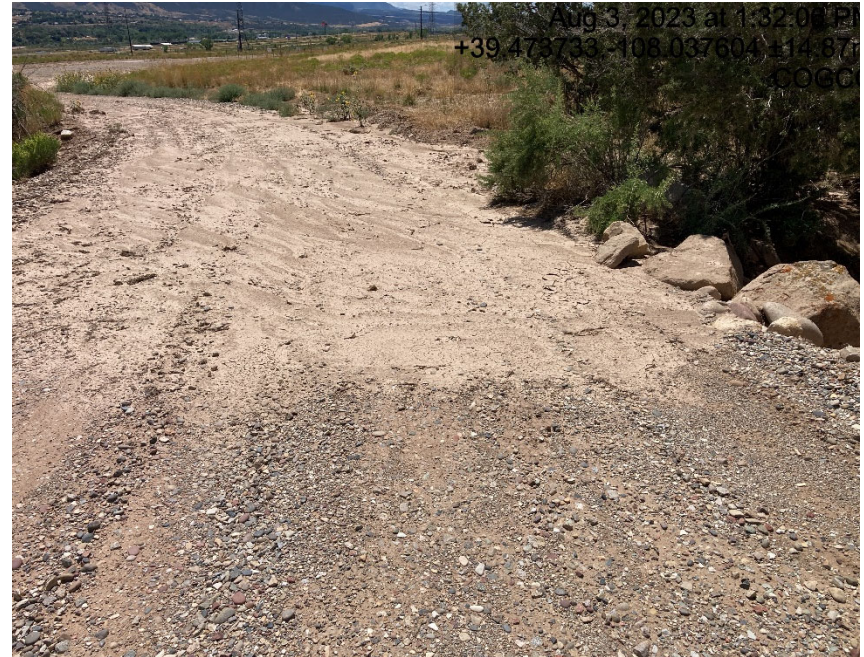
Sediment on access road

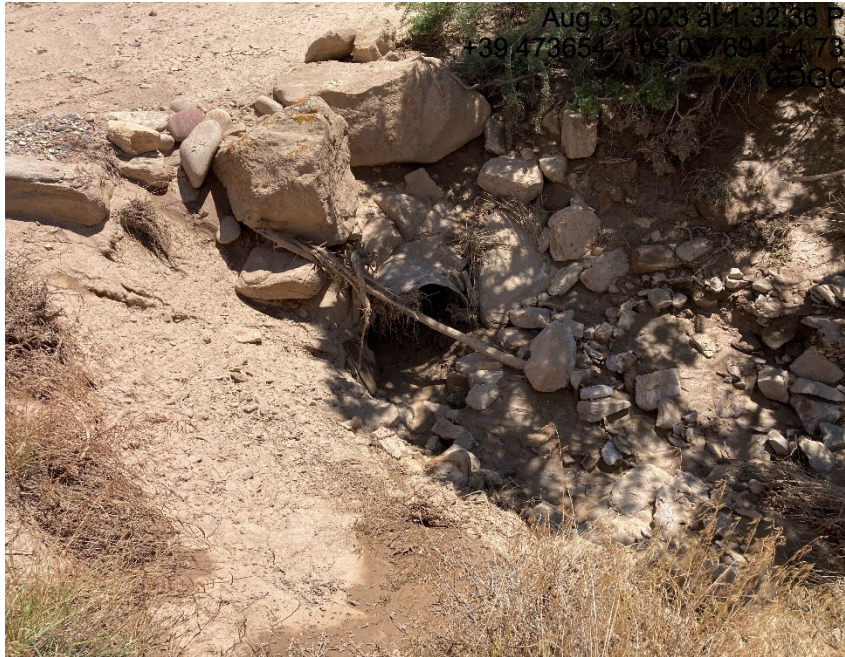
Culvert needs maintained

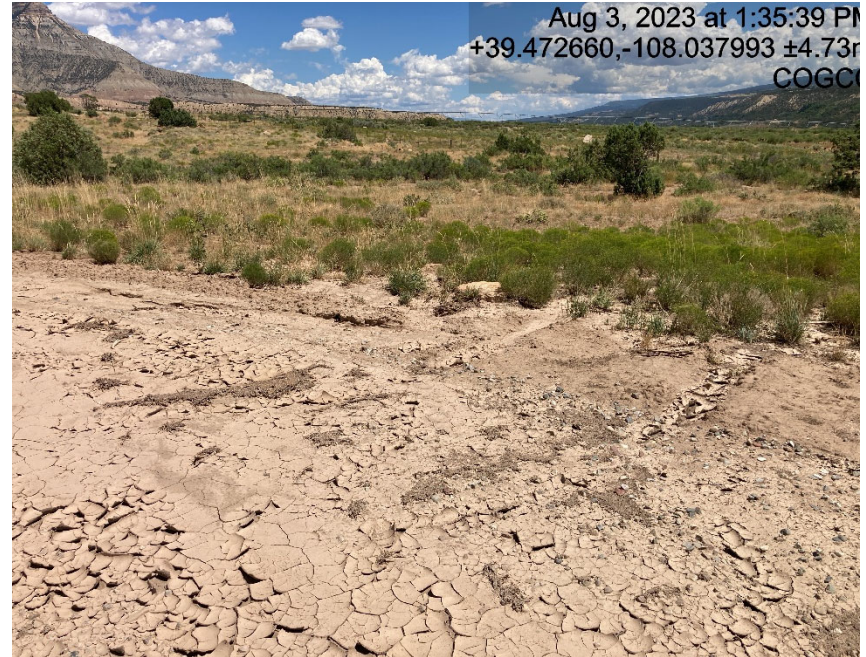
Sediment migrating from location

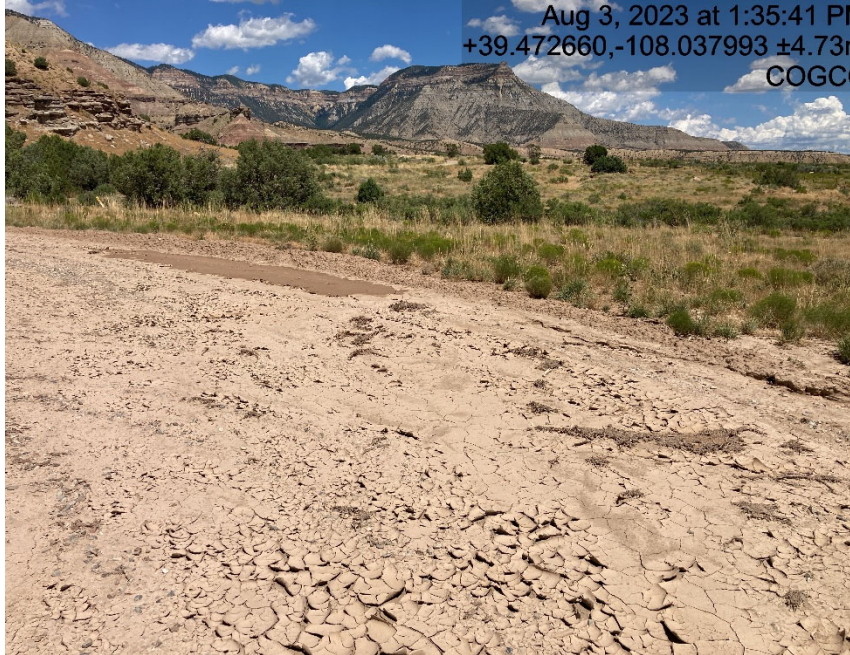
Sediment migrating from location
