Inspection Photos

API: 071-06101

Operator: MANZANO LLC

Inspection Date: 8/2/2023

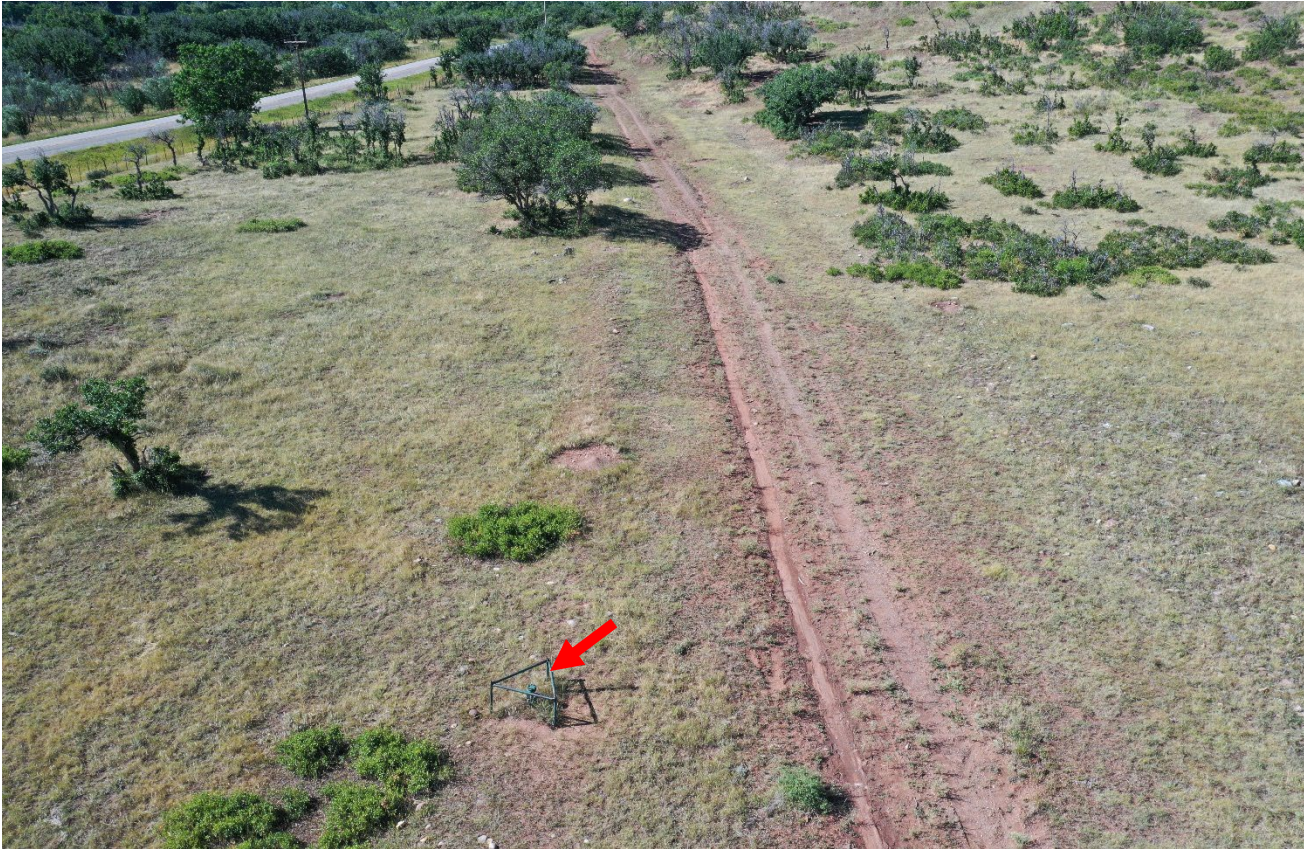
Photo 1. Drone aerial photo facing southwest toward the access road which is not reclaimed. There is a pipeline riser that has not been removed shown at red arrow.

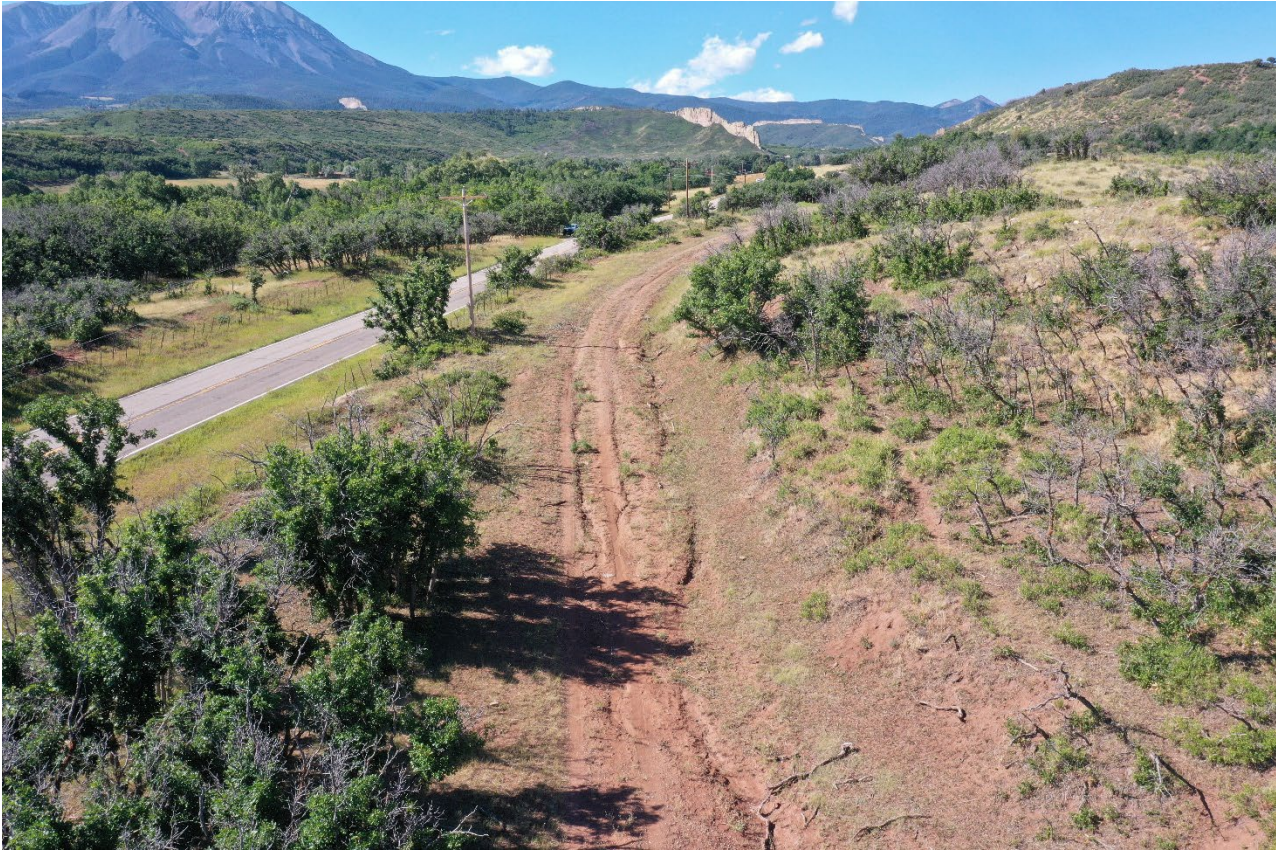
Photo 2. Facing southwest along the access road. There is signs or erosion along the road.

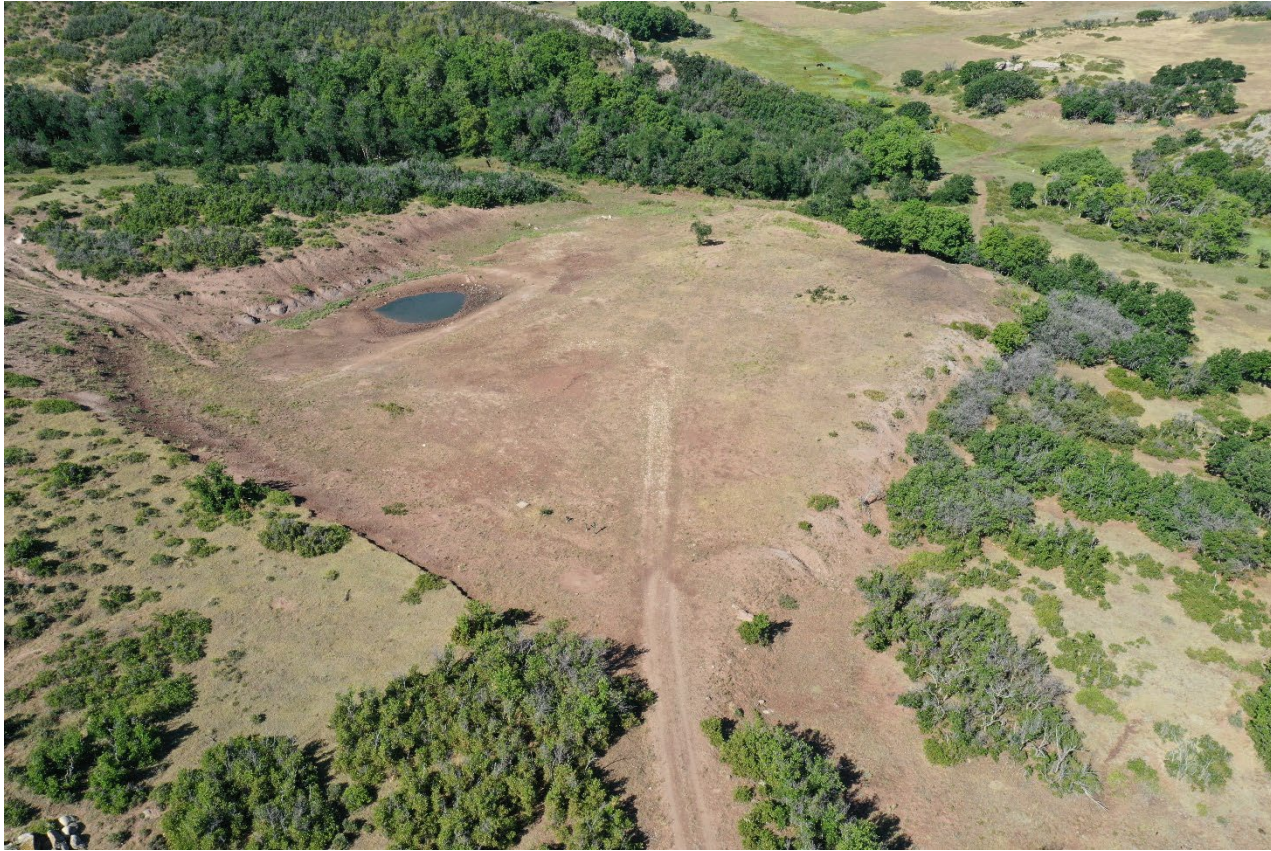
Photo 3. Facing northwest toward the location which has not been recontoured or reclaimed.

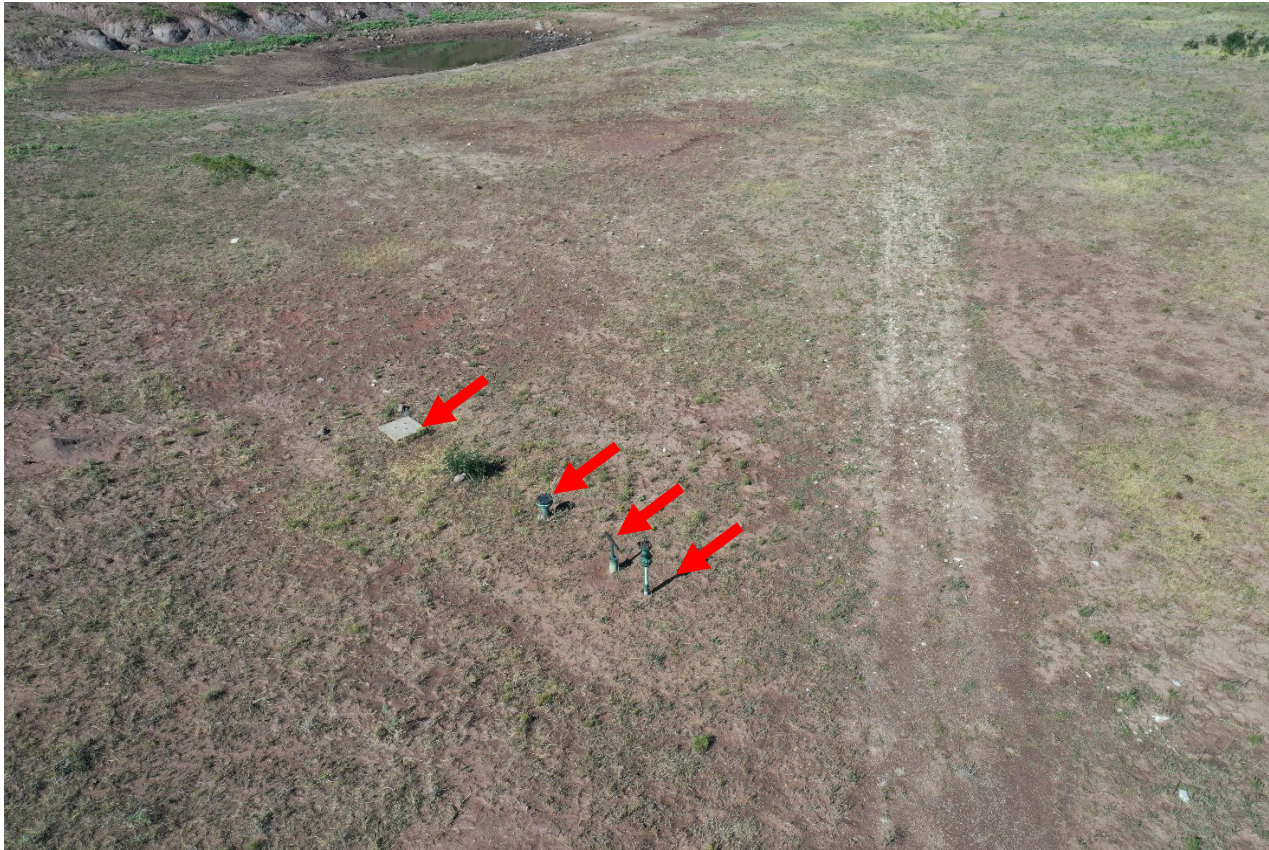
Photo 4. There are 3 pipeline risers and a cement block that have not been removed.

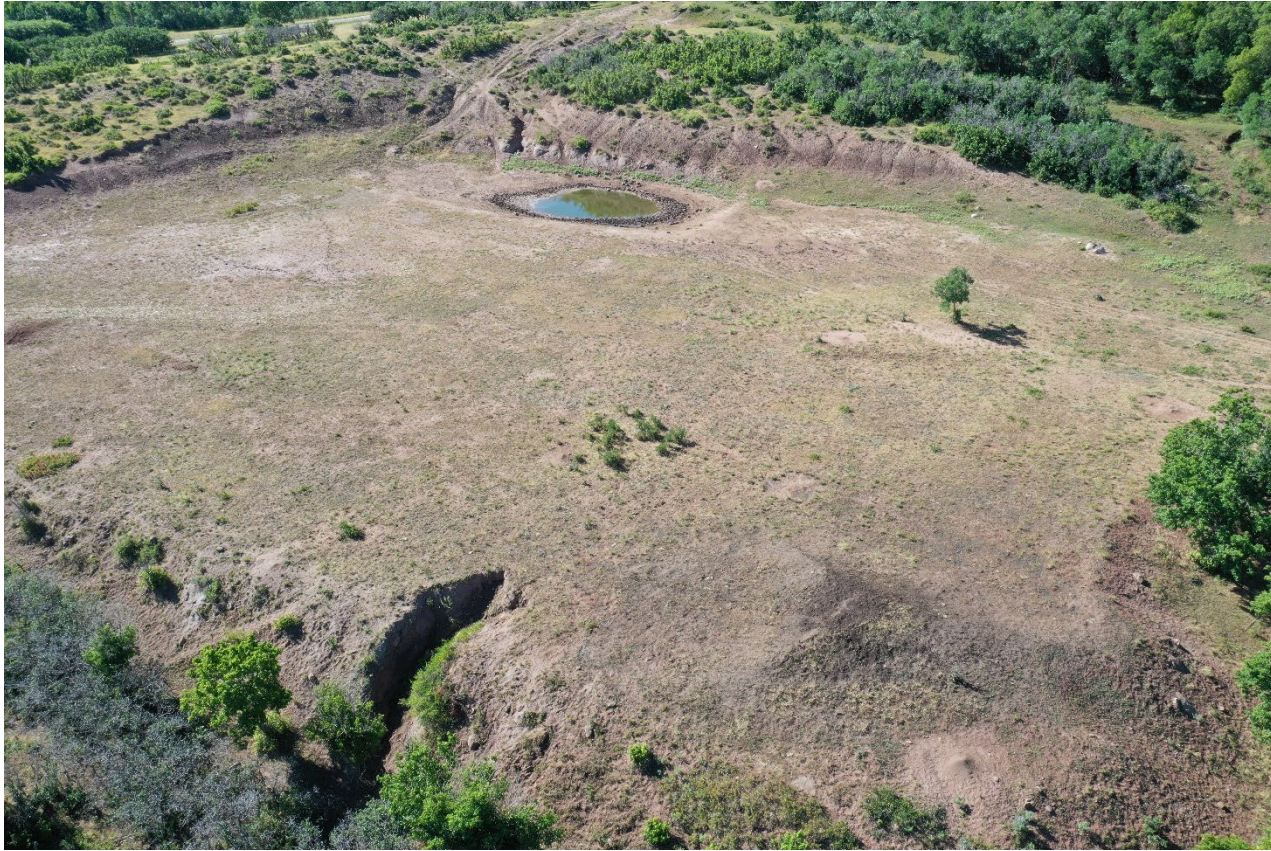
Photo 5. Facing south at the location. There is a large erosion gully along the fill slope shown at red arrow..

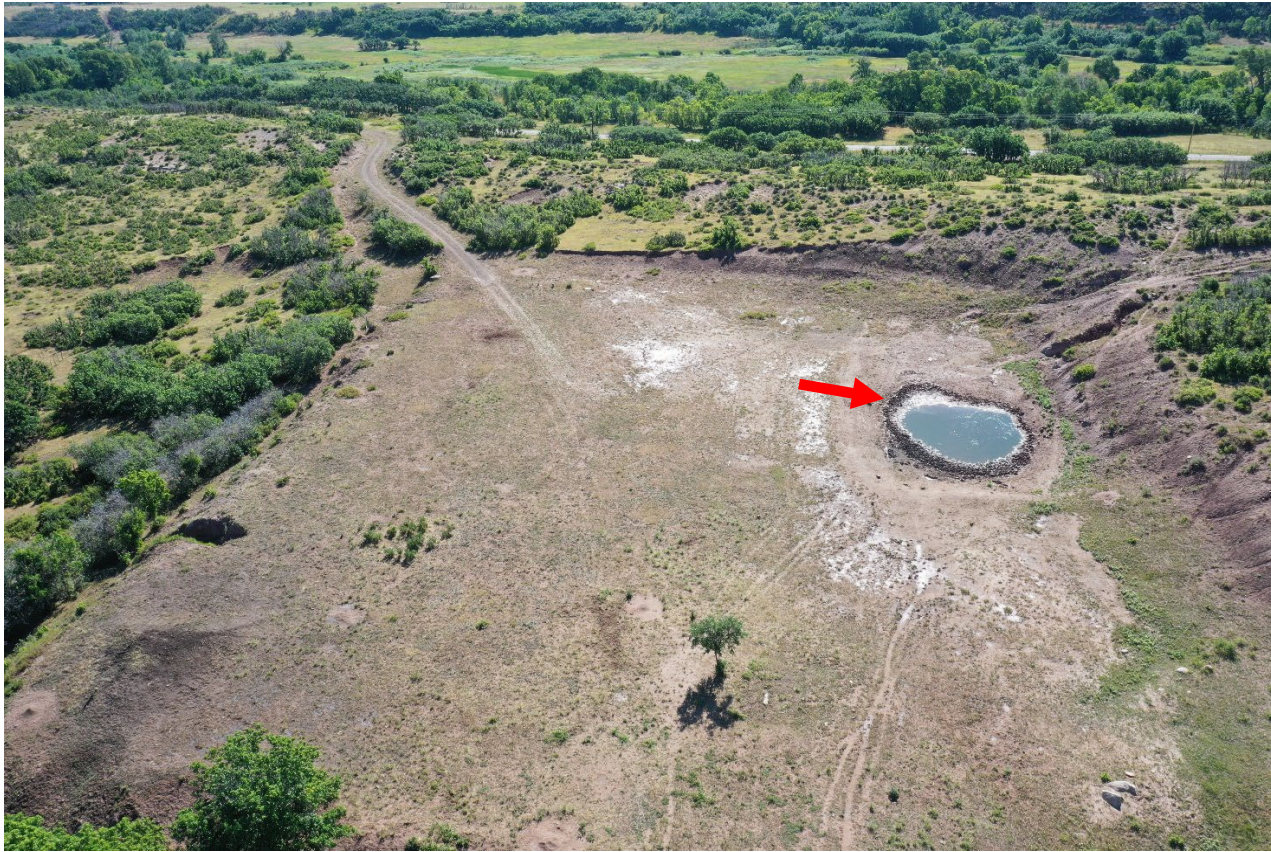
Photo 6. Facing southeast toward the location. A shallow pit remains shown at red arrow.

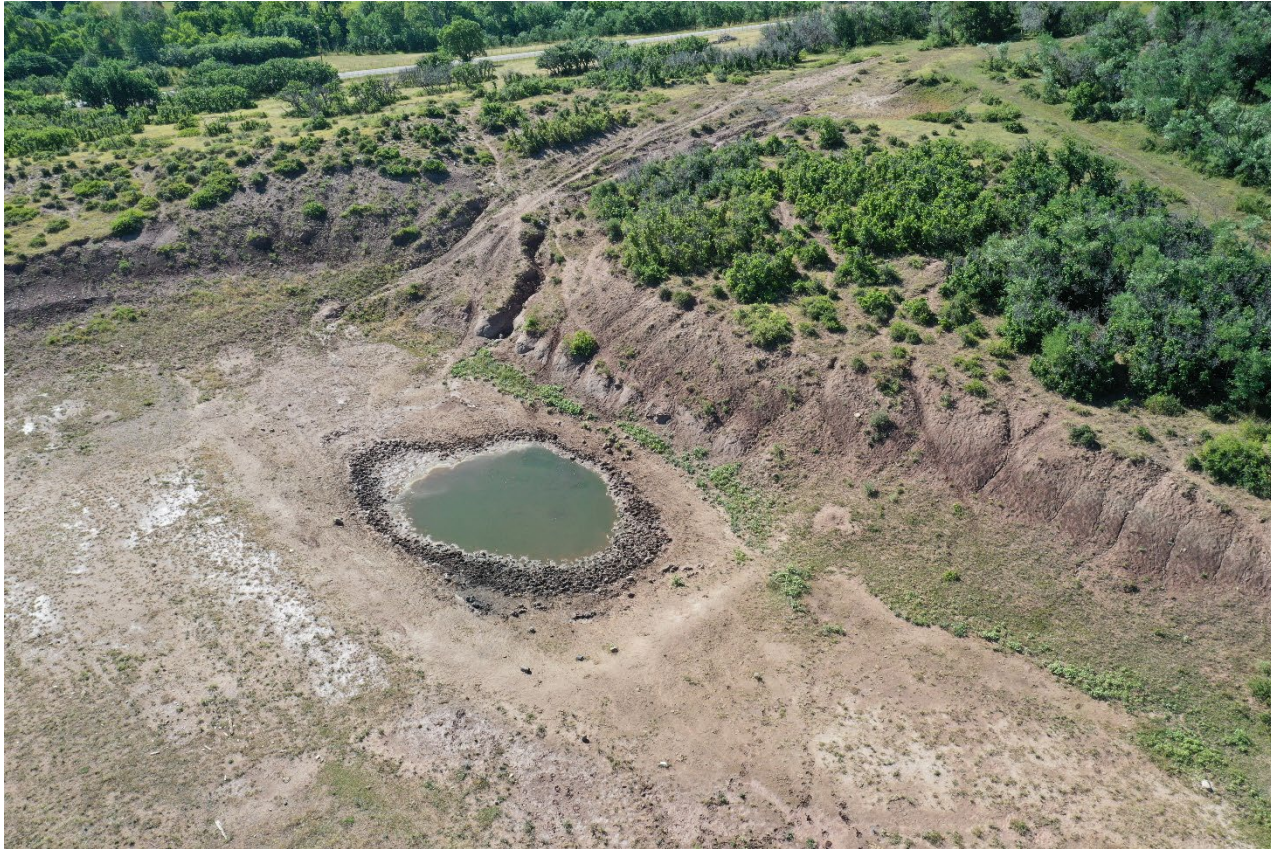
Photo 7. Facing southeast toward the cut slope which has signs of erosion gully's and rills.
