GRMR Oil & Gas LLC  
Myers 19-11HA  
Loc ID: 441283

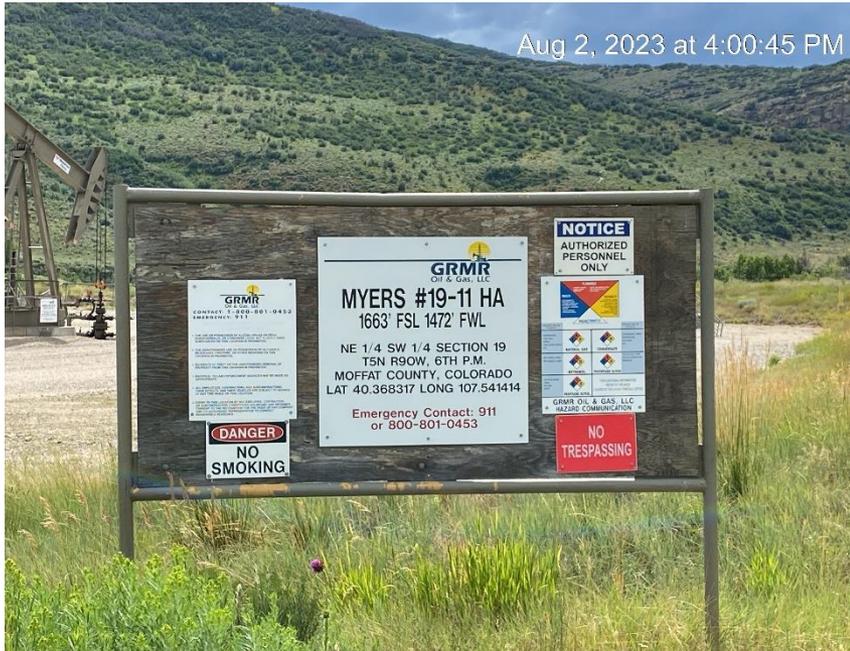
Location sign missing required information.

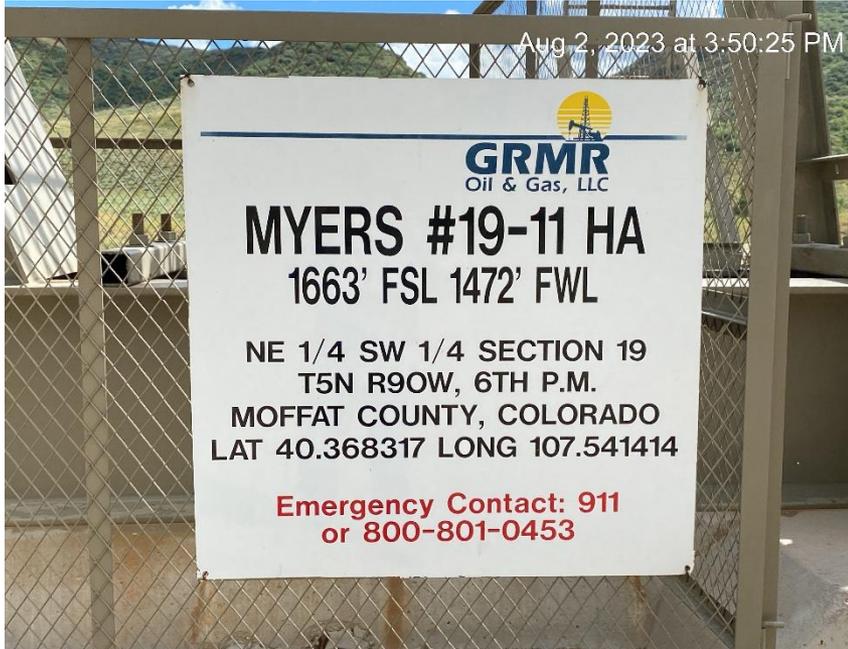
Wellhead sign lacking required information.

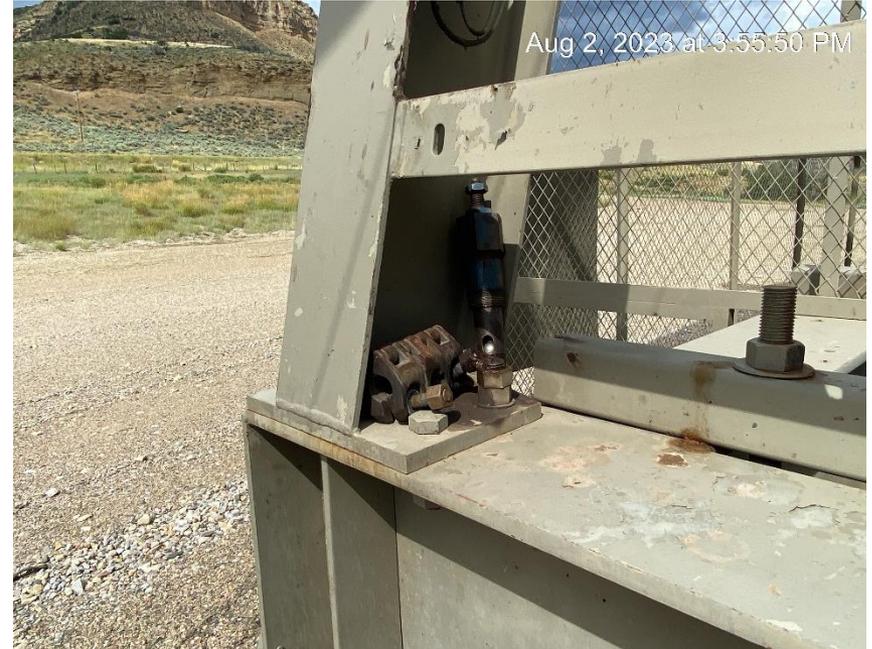
Debris

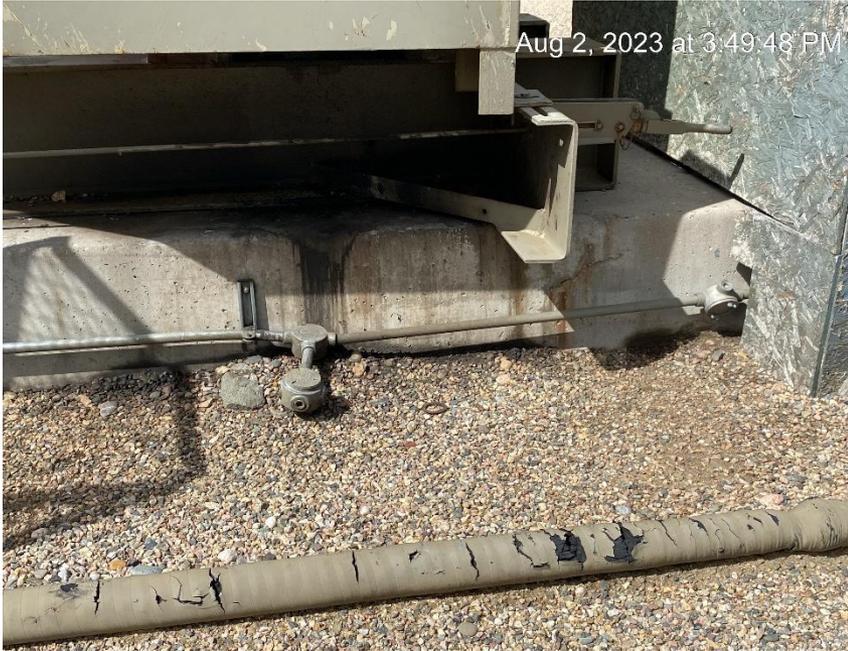
**Engine leakage. Stained soil.**

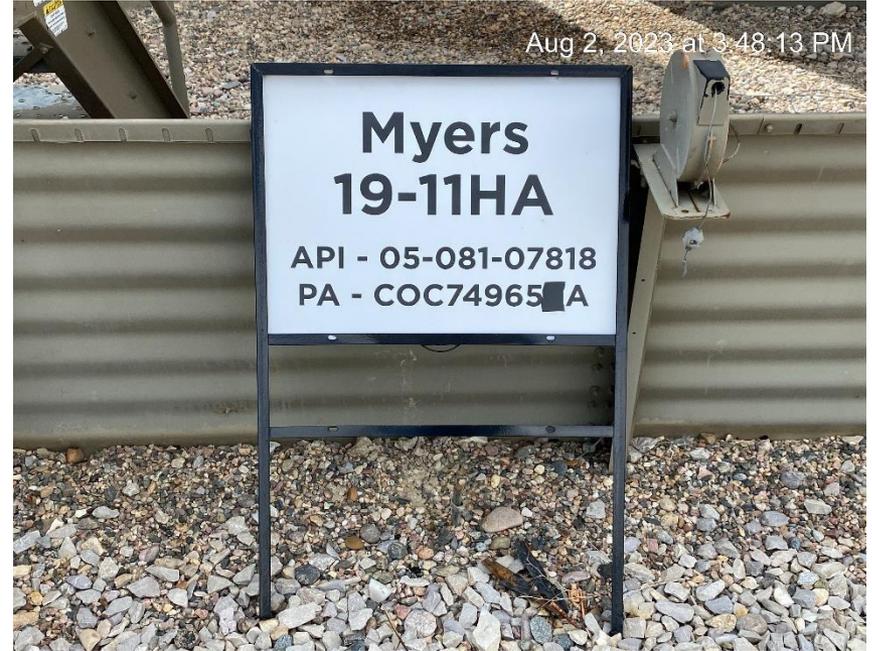
**Tank battery sign missing required information**

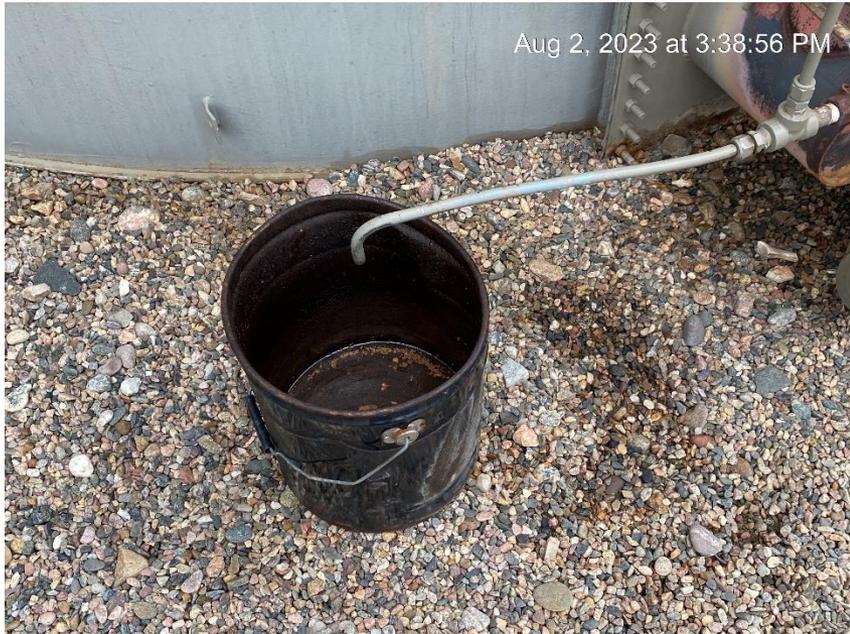
**Debris. Stained soil and gravel.**

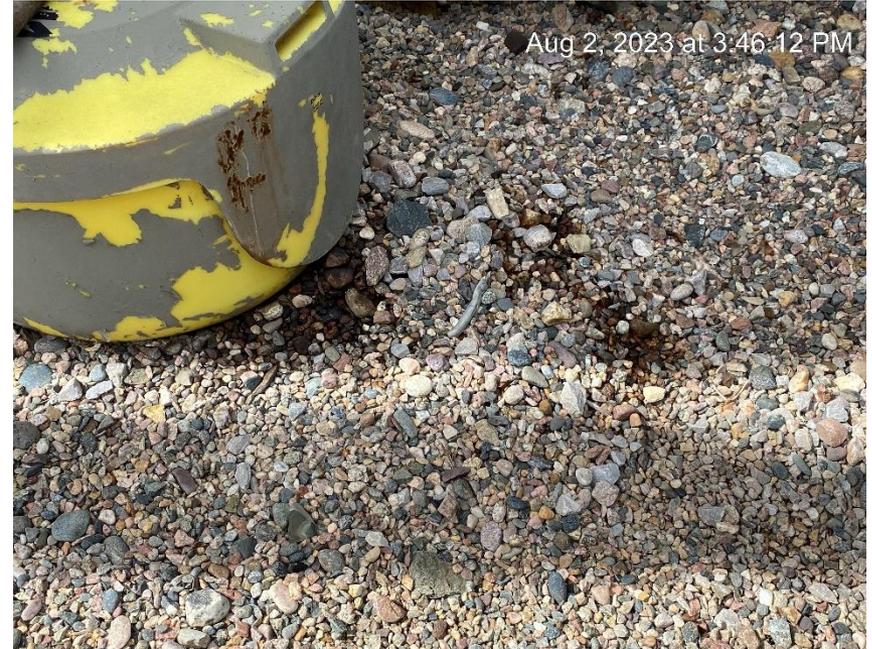
**Stained soil. Gravel cover-up.**

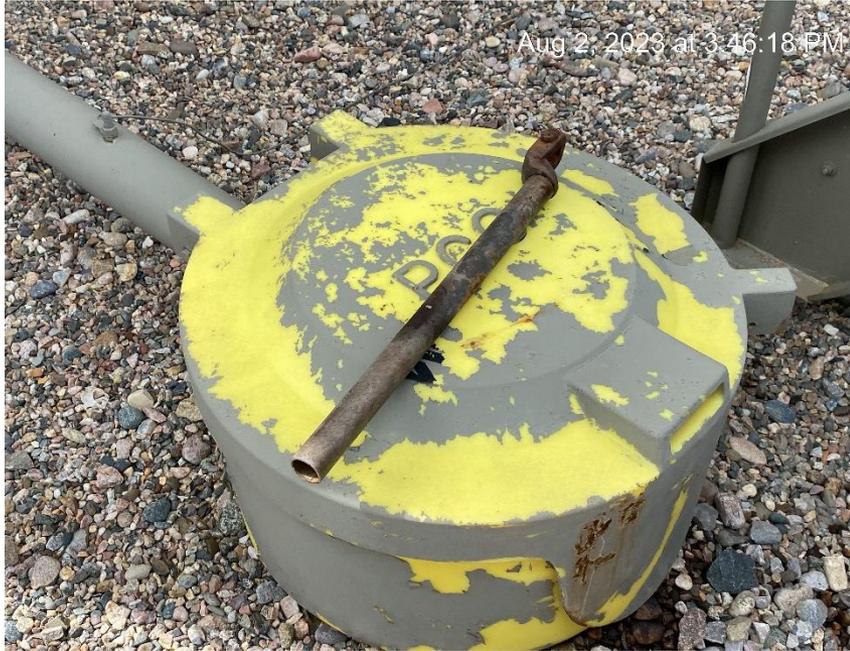
Debris

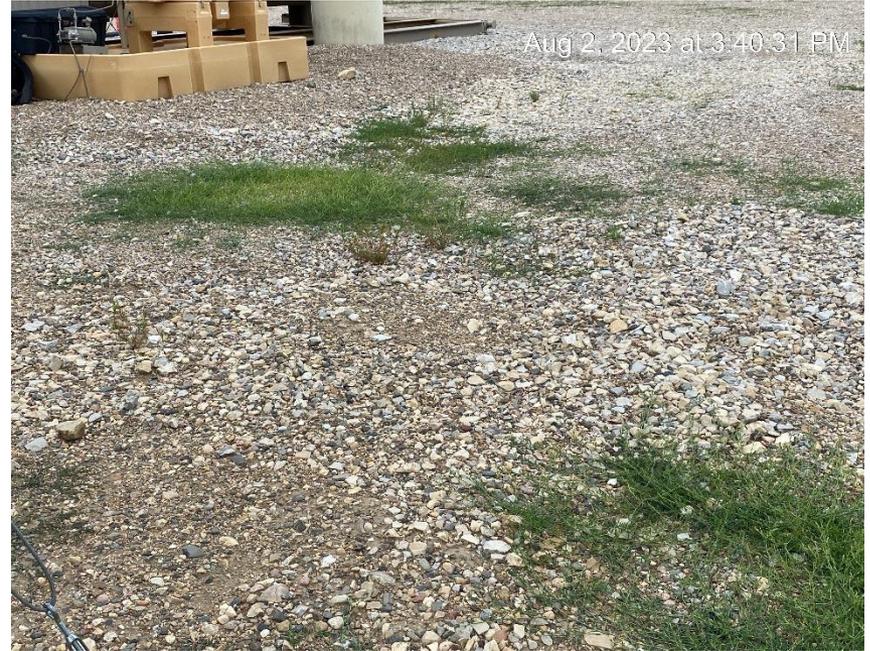
Weed growth

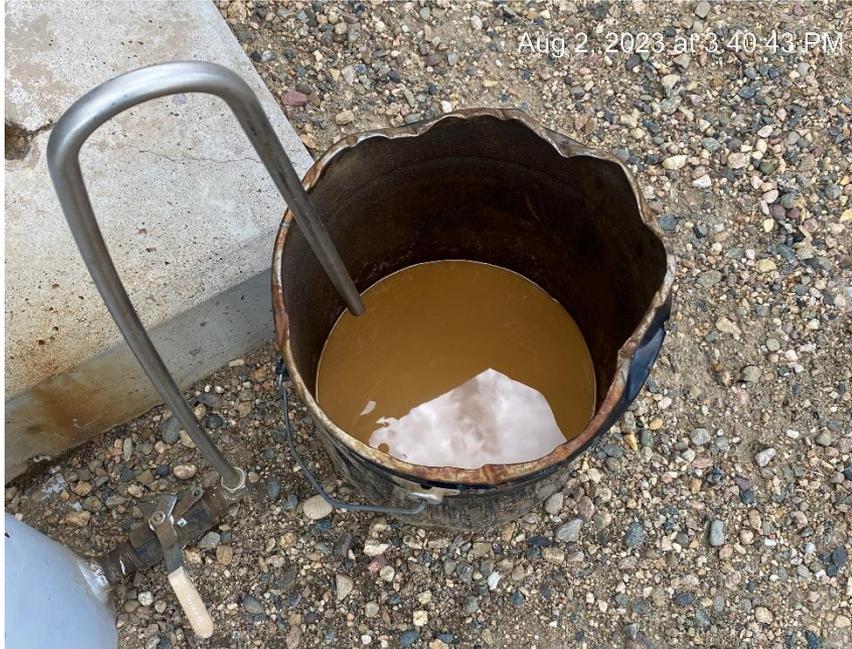
**Debris. Open to wildlife.**

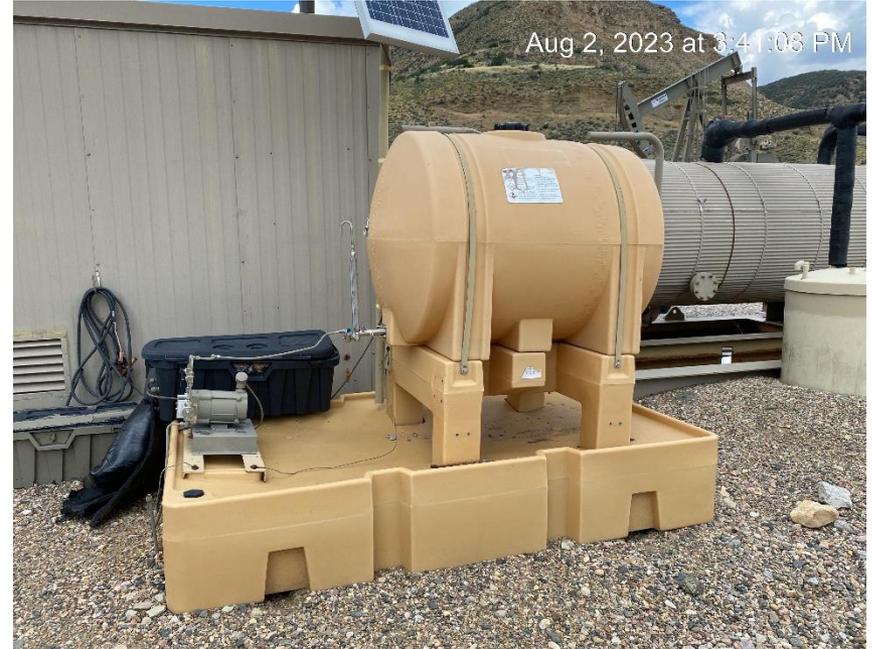
**Labels missing and illegible**

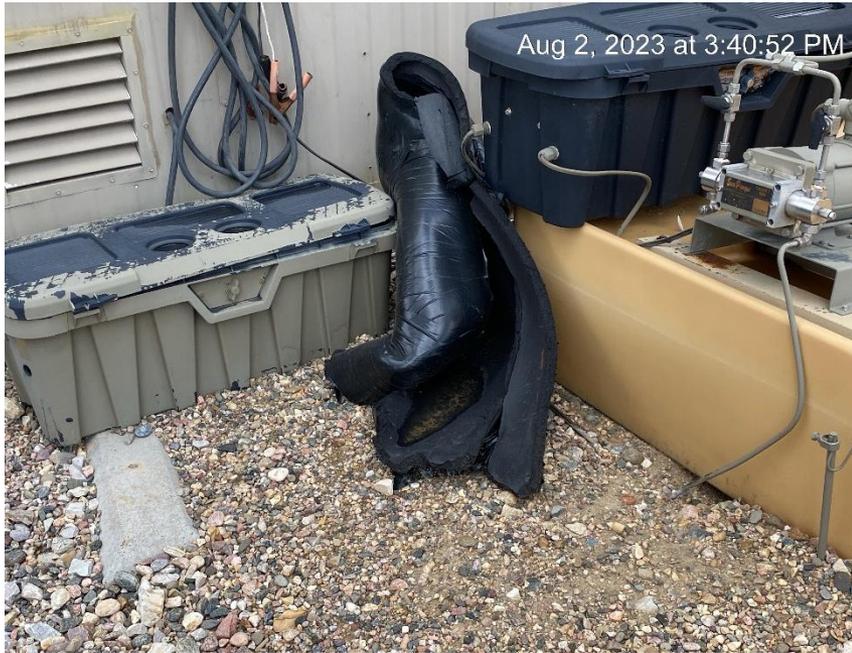
Debris

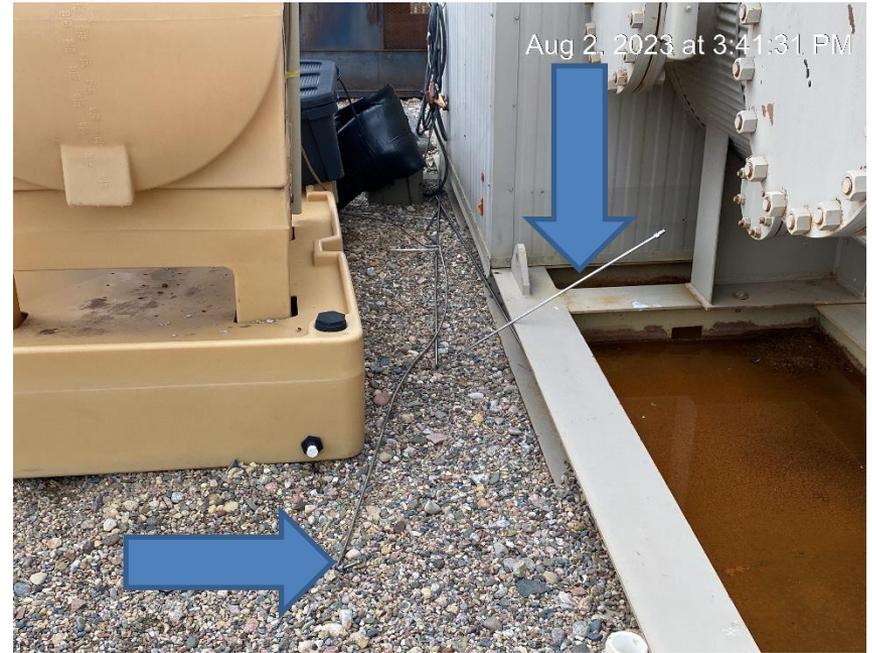
Debris

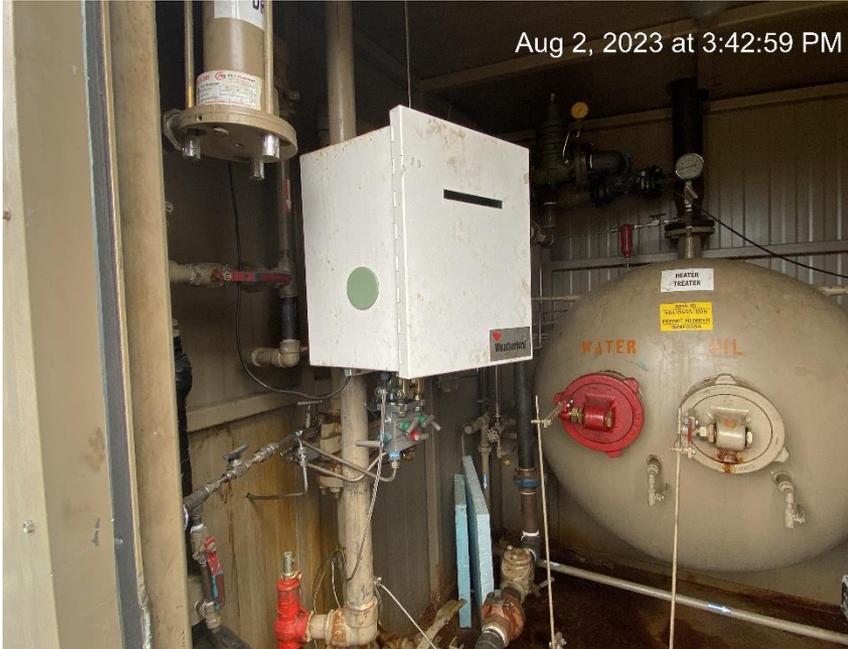
**No visible display of gas calibration**

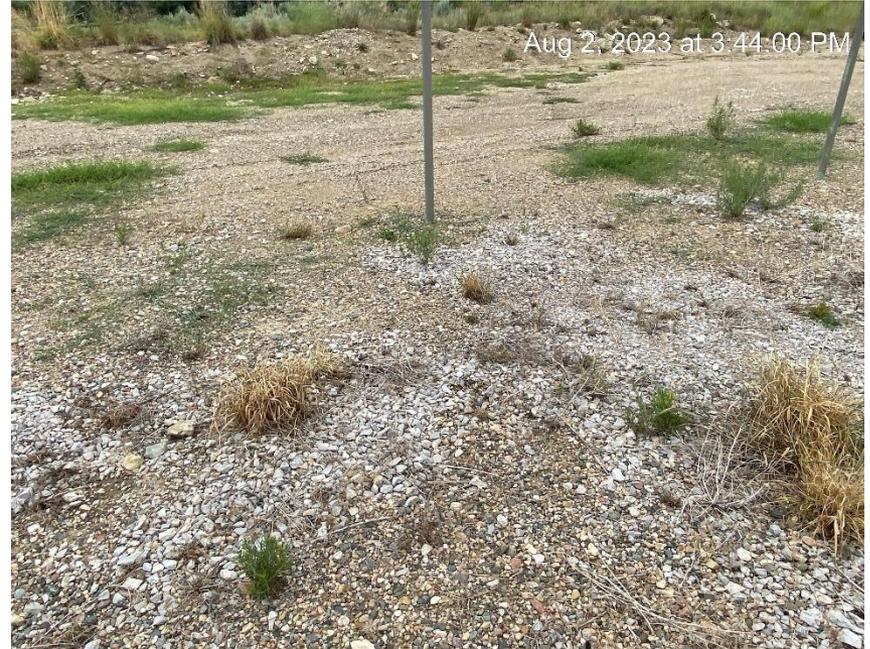
**Weed growth**

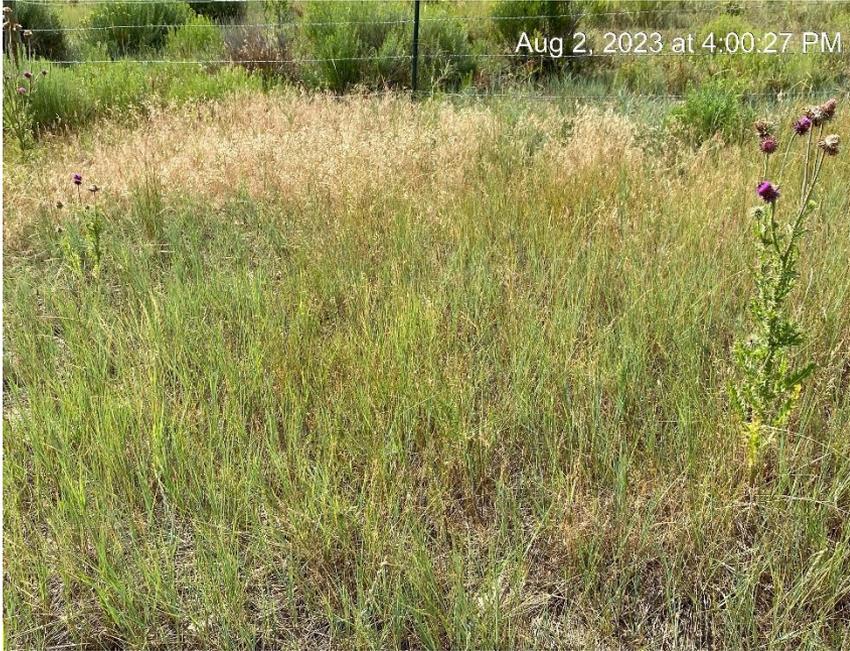
**Thistle**

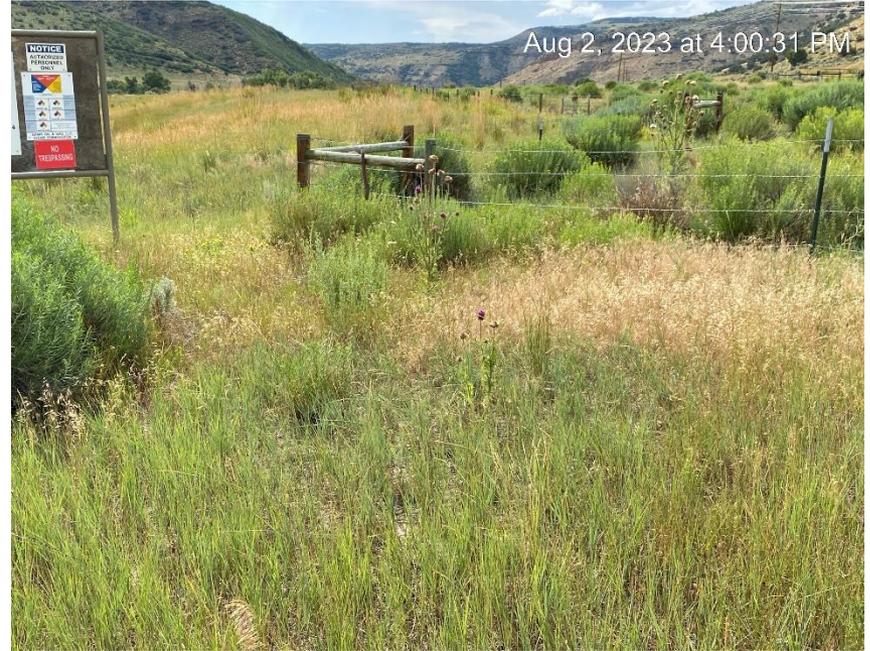
**Thistle**

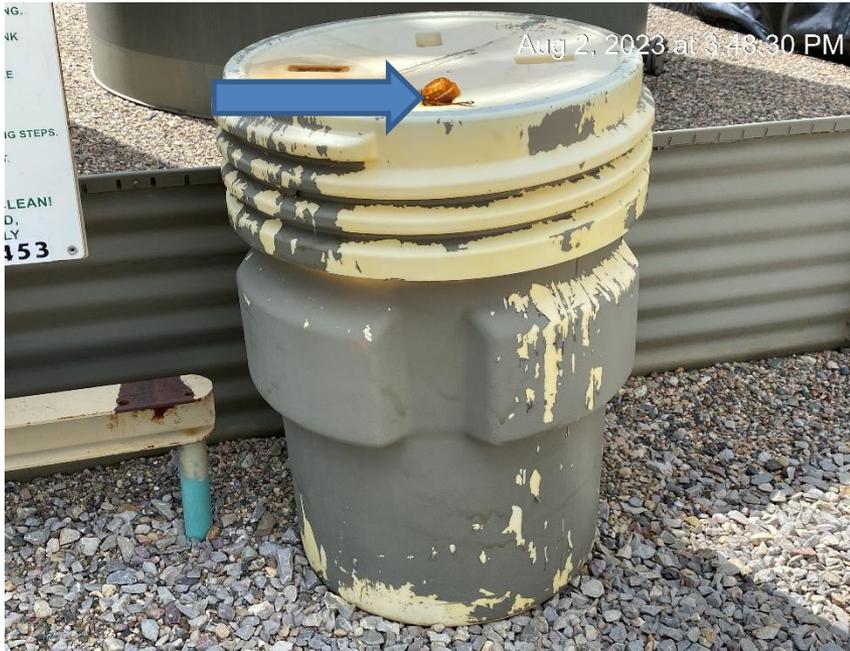
Debris. Unidentified spill materials?
