Inspection Photos

Location Name: TEP ROCKY MOUNTAIN LLC, FEDERAL-67S96W/3NESE

Location ID: 334831

Date: 8/7/2023

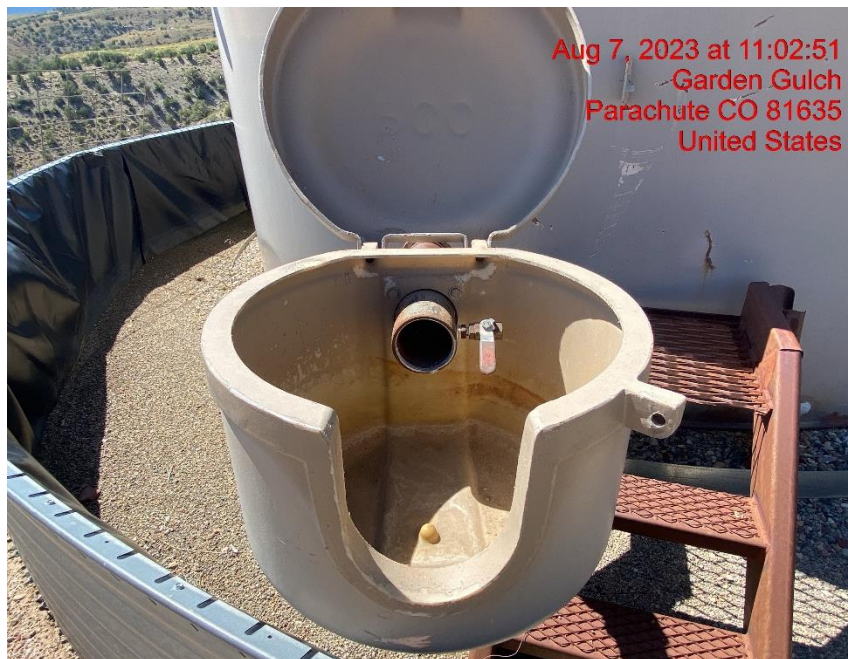
Open-Ended Load Line – Photo #05534

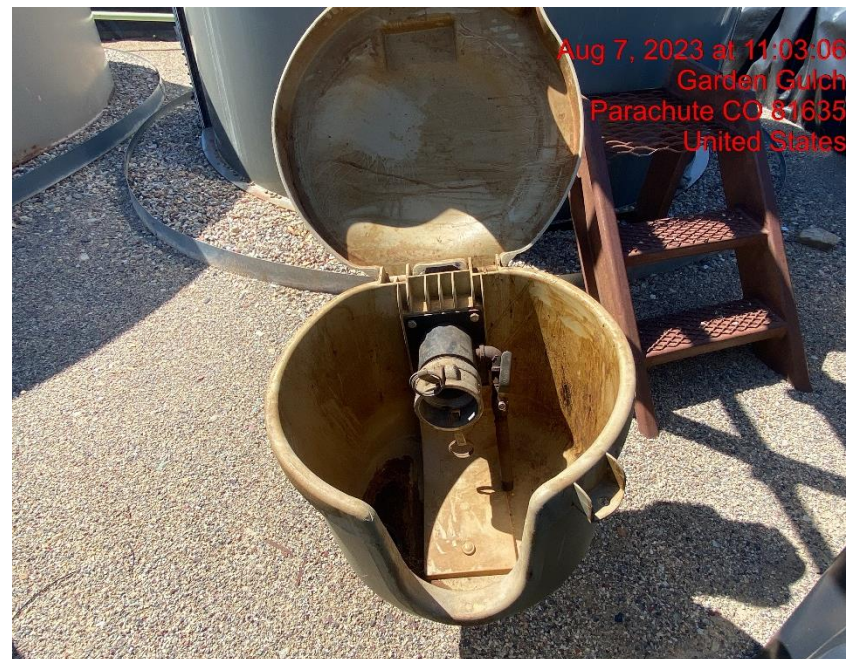
Open-Ended Load Line – Photo #05535

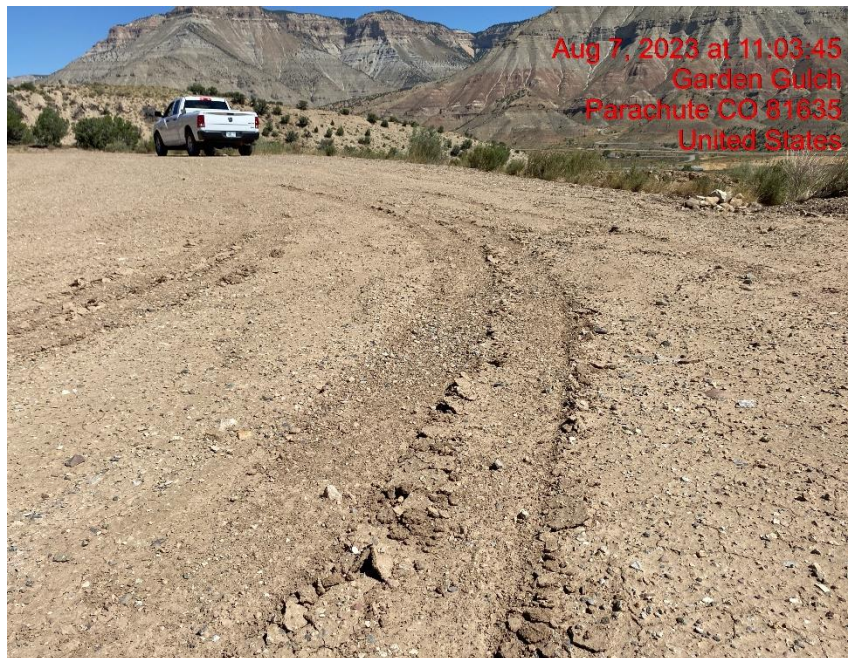
Location Lacks Stabilization – Photo #05537

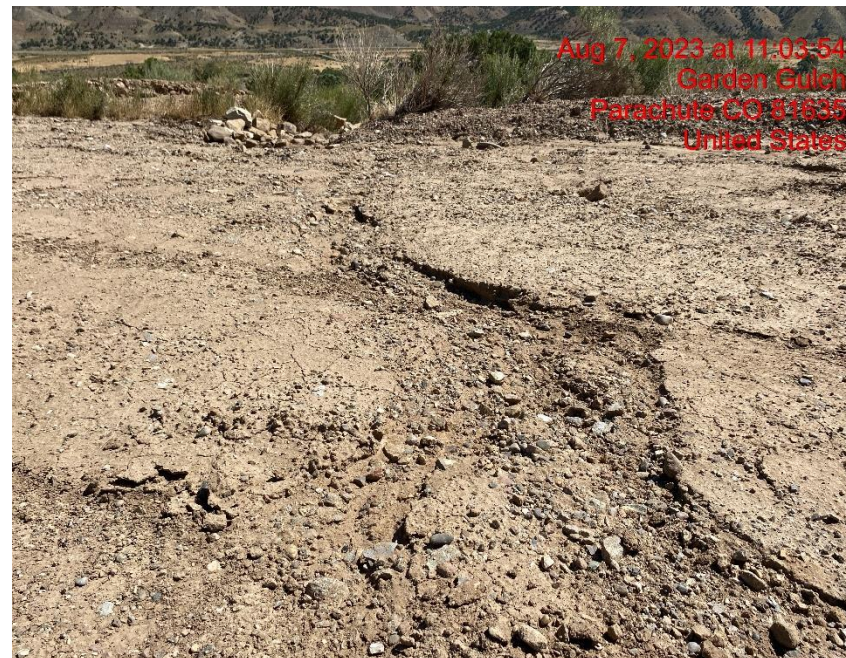
Location Lacks Stabilization – Photo #05538

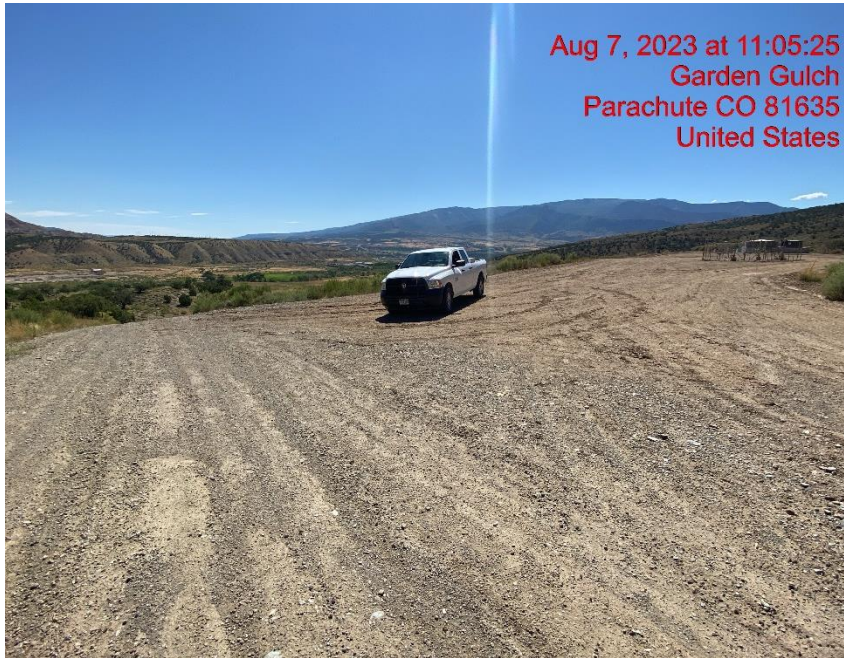
**Insufficient Vehicle Tracking BMPs at Location Entrance/Exit
– Photo #05540**

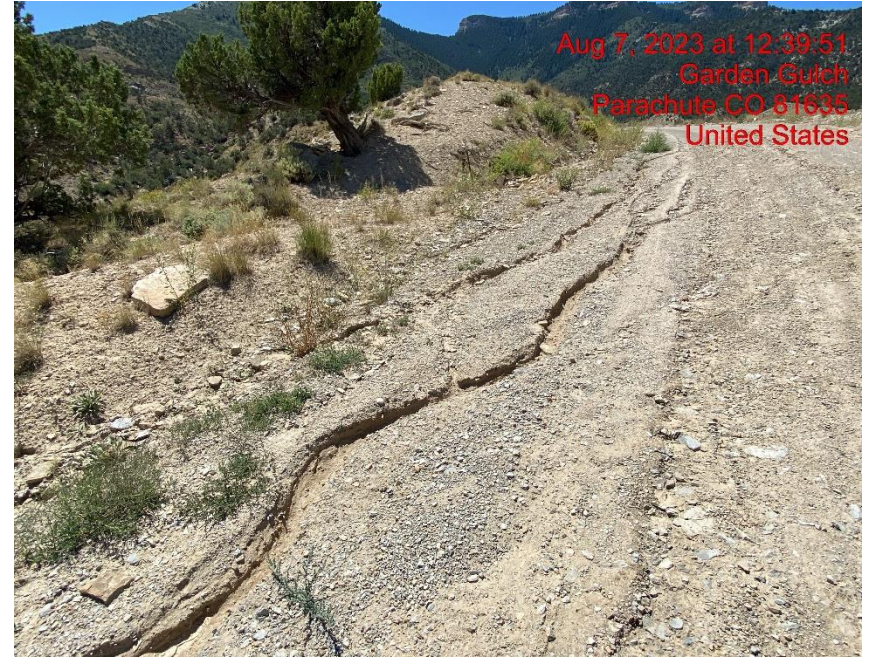
Rill Erosion Cutting Through Lease Road – Photo #05610

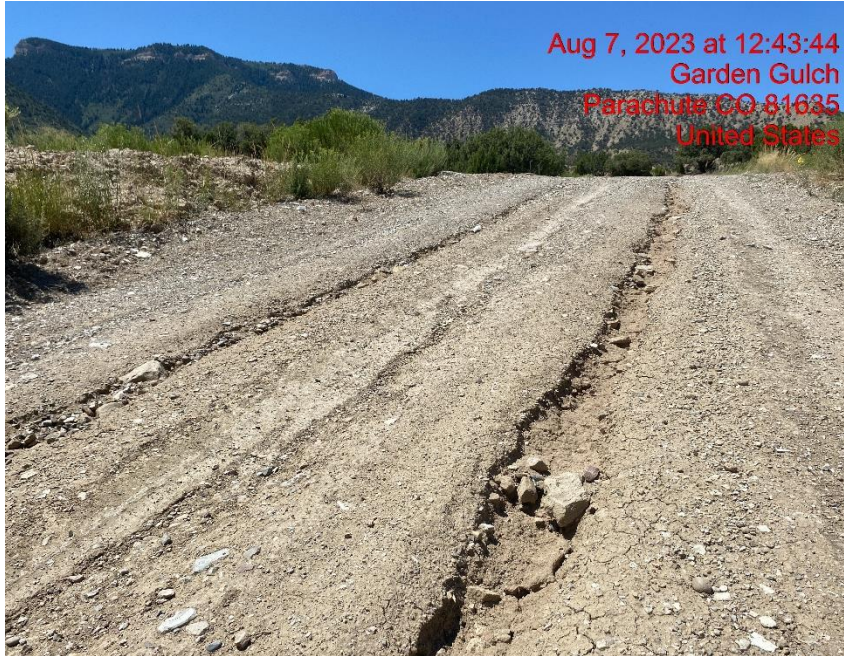
Rill Erosion Cutting Through Lease Road – Photo #05613

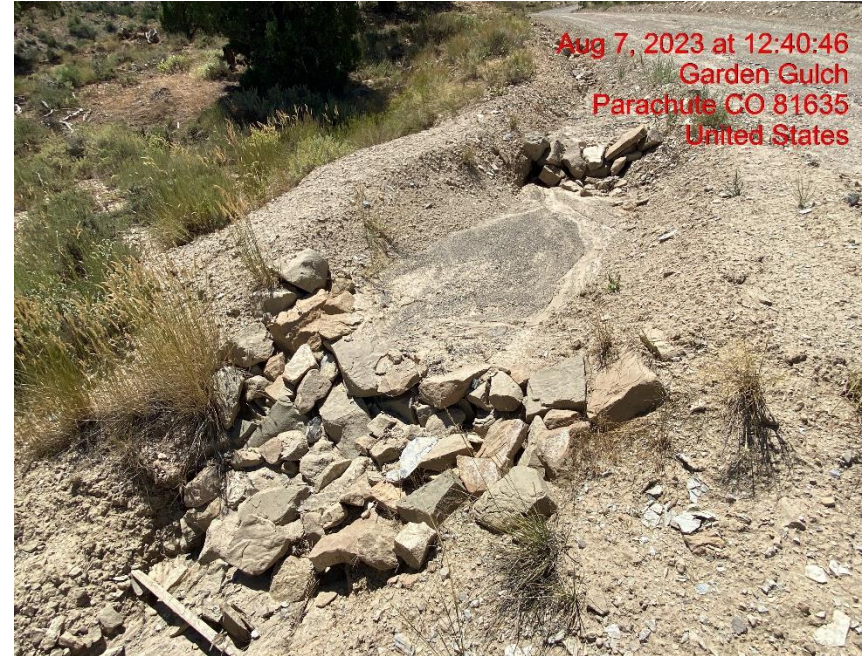
Check Dam Needs Maintenance – Photo #05611
