## Inspection Photos

Location Name: TEP ROCKY MOUNTAIN LLC, FEDERAL-67S96W/3SESE

Location ID: 334876

Date: 8/7/2023

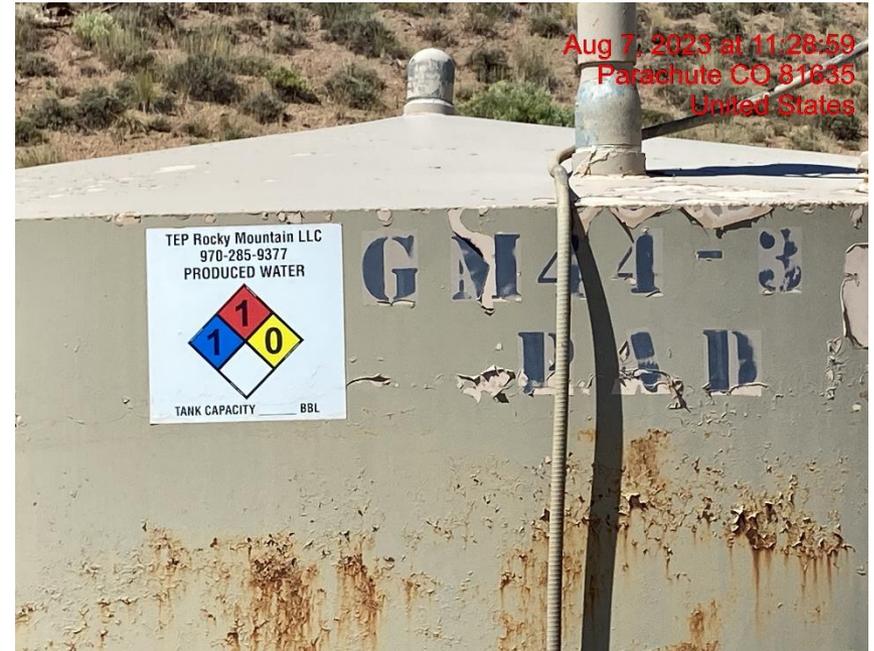
Tank Label Missing Tank Capacity – Photo #05550

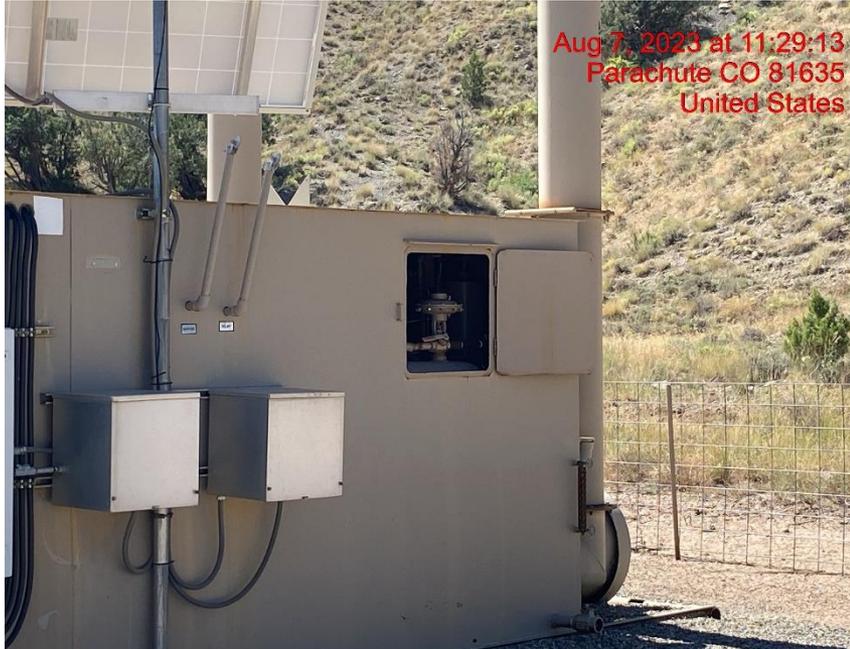
**Separator Hatch Unsecured – Photo #05551**

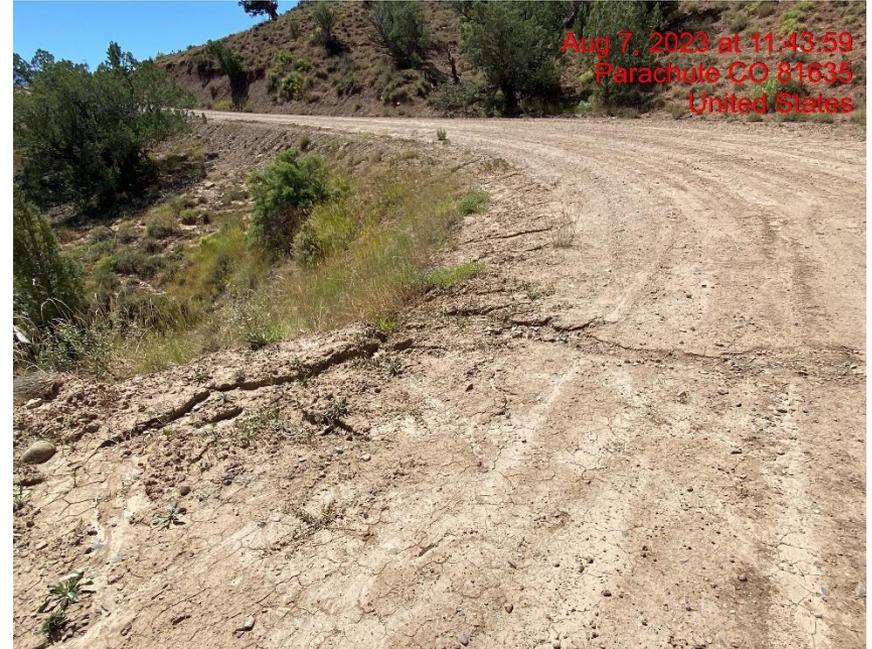
**Rill Erosion Transporting Sediment to Nearby Watershed – Photo #05555**

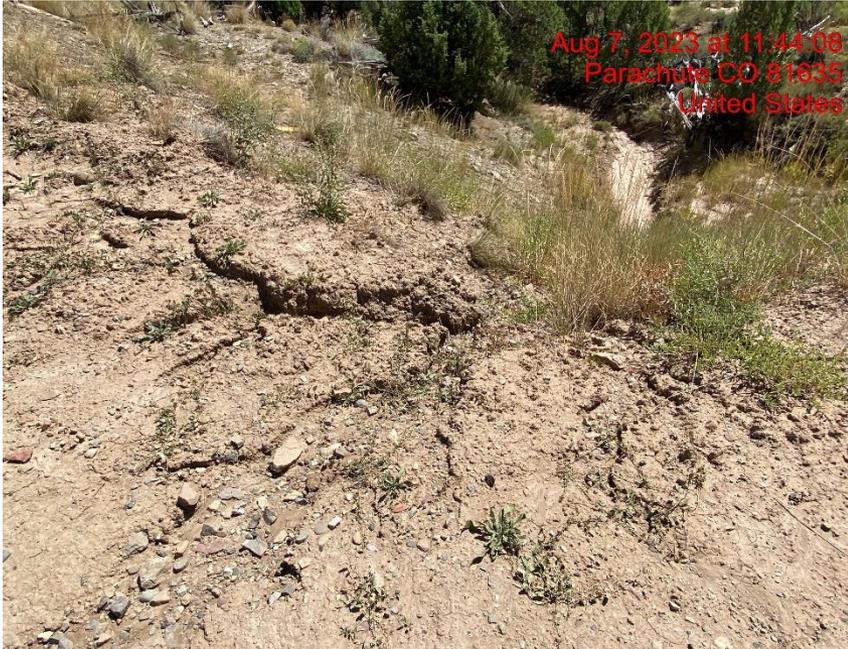
**Rill Erosion Transporting Sediment to Nearby Watershed –  
Photo #05556**

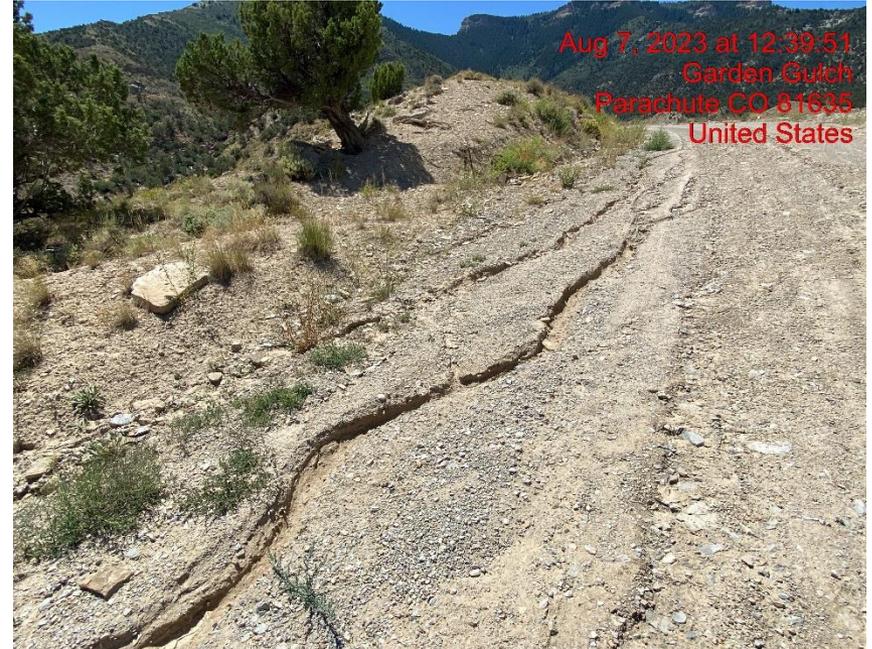
**Rill Erosion Cutting Through Lease Road – Photo #05610**

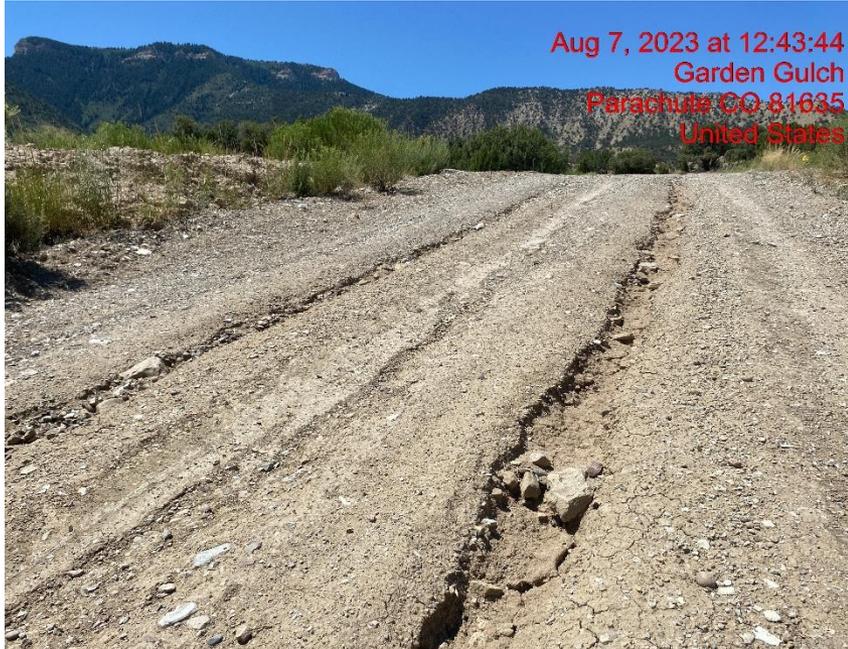
**Rill Erosion Cutting Through Lease Road – Photo #05613**

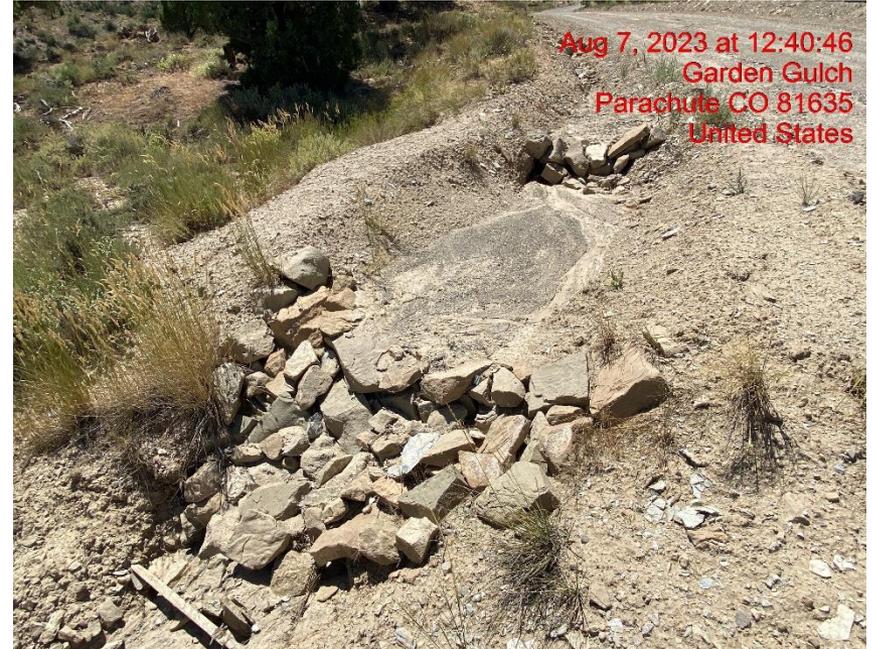
**Check Dam Needs Maintenance – Photo #05611**
