## Van Buren Federal A2

COGCC Inspection # 712700438

Date completed 8/8/2023

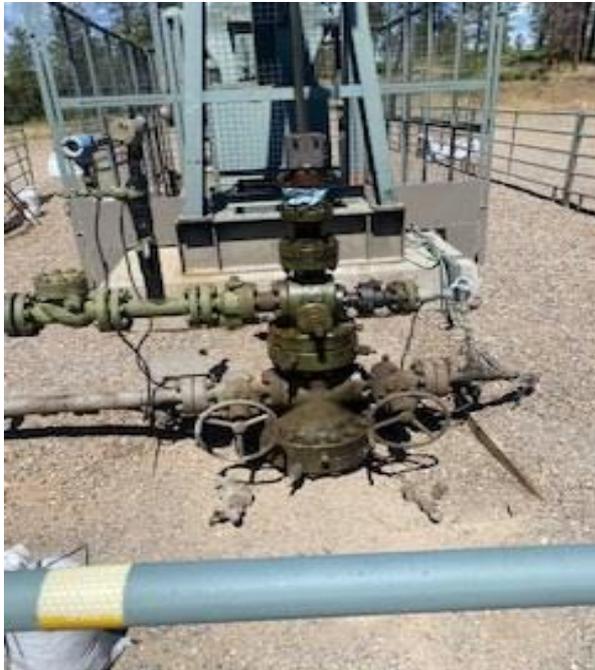
Removed stained soil from around the wellhead

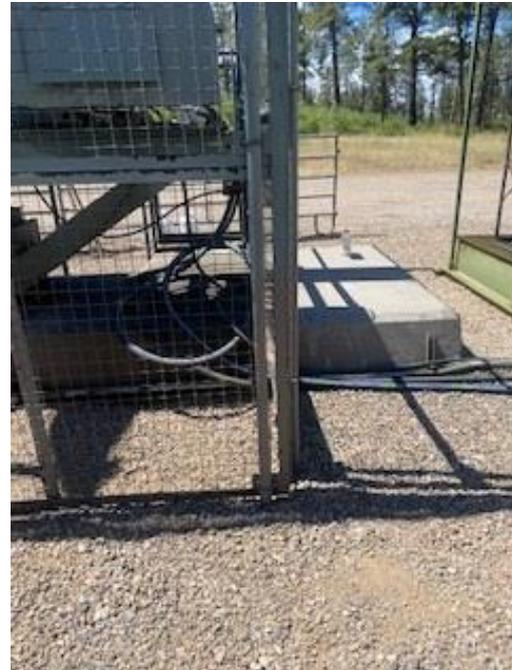
Removed stained soil from inside pump jack cage

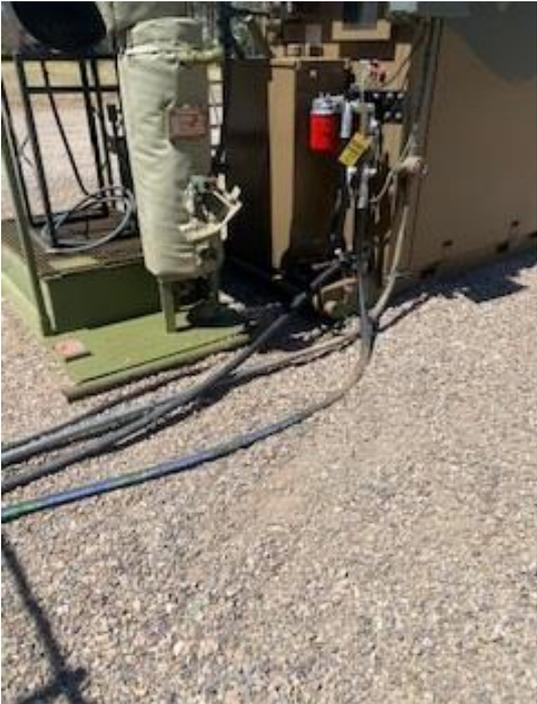
Removed stained soil from around oil lift
