Inspection Photos
Location Name: CAERUS PICEANCE LLC D13W Pad
Location ID: 334676

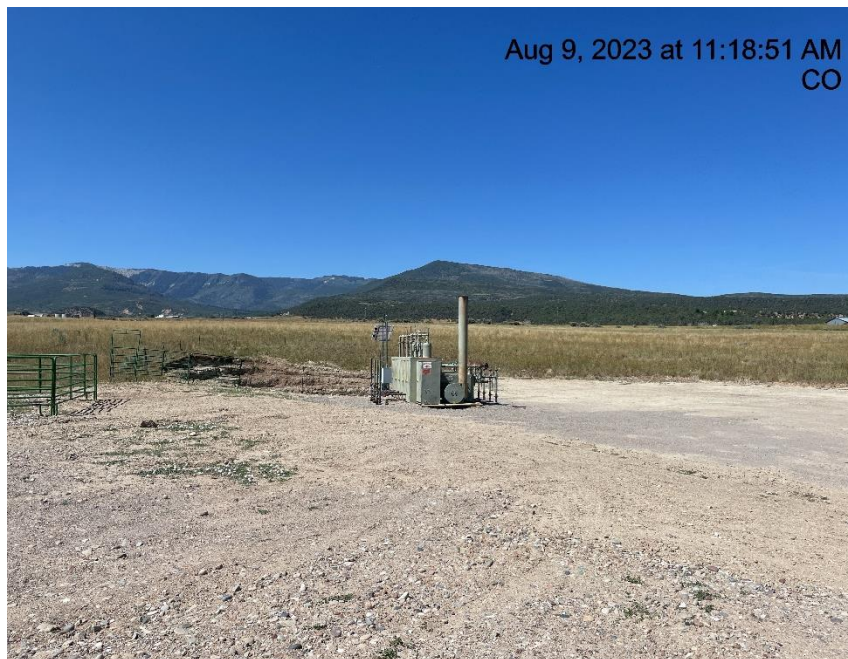
Photo # 5526 From entrance to location

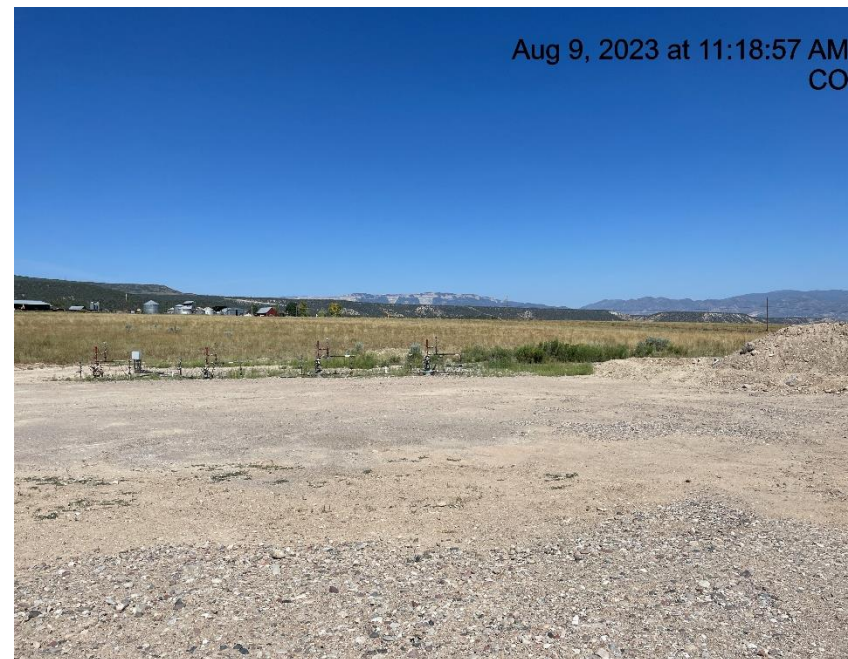
Photo # 5527 From entrance to location

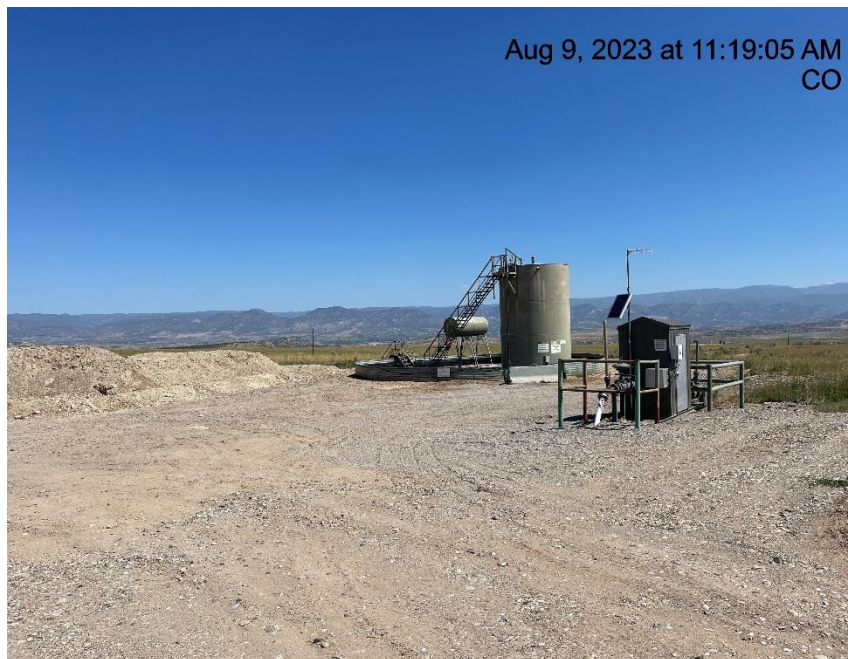
Photo # 5528 From entrance to location

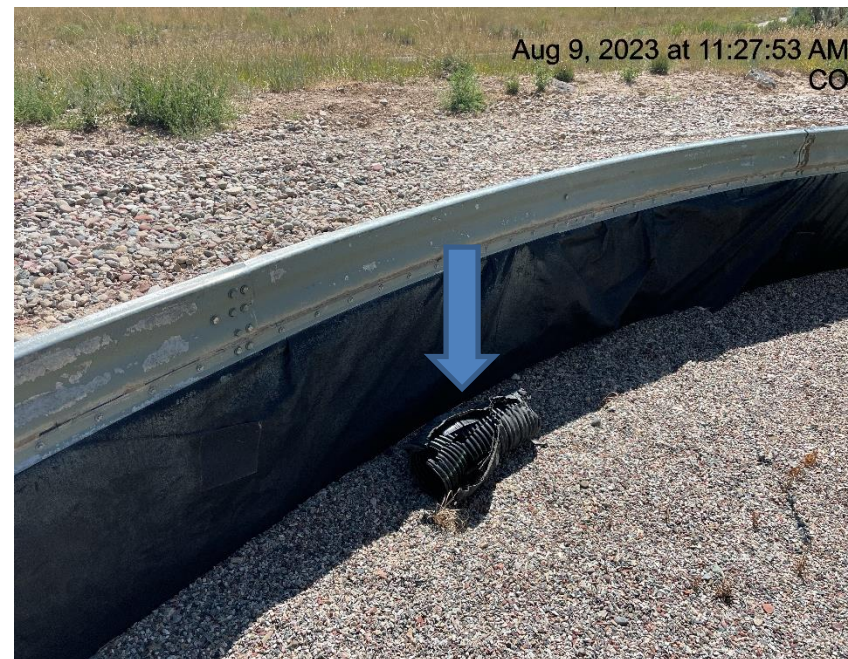
Photo # 5537 Debris

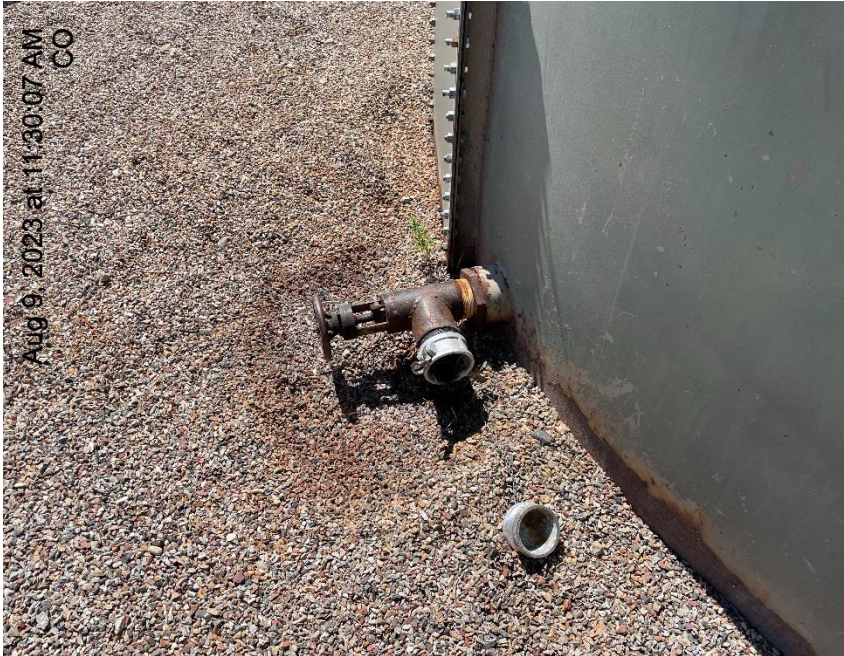
Photo # 5607 Open ended load line & tank valve leaking fluid

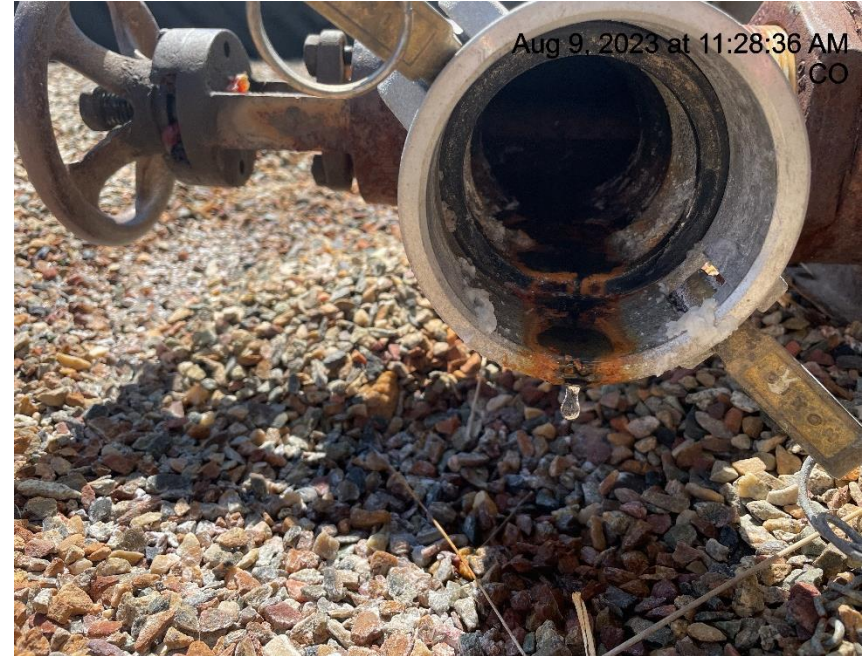
Photo # 5552 Tank valve leaking fluid

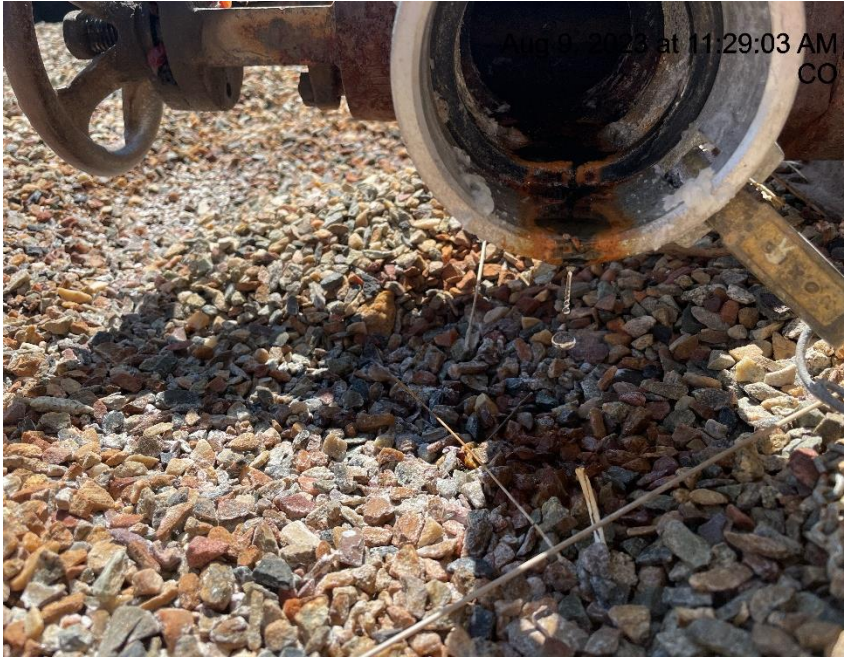
Photo # 5571 Tank valve leaking fluid

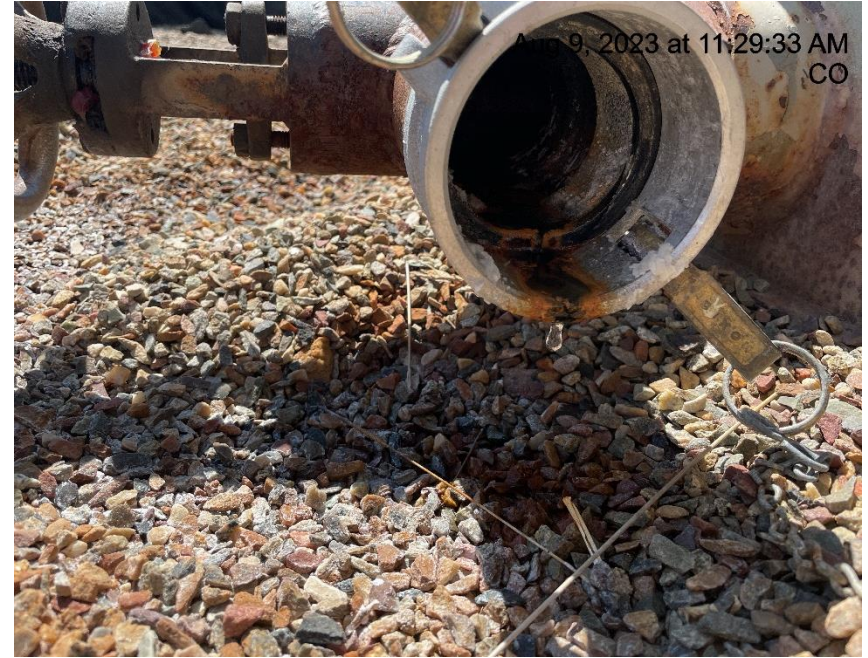
Photo # 5590 Tank valve leaking fluid
