Inspection Photos

Location Name: Bowman 13-22-5-44

API Number: 125-09496

COLORADO
Energy & Carbon Management
Commission
Department of Natural Resources

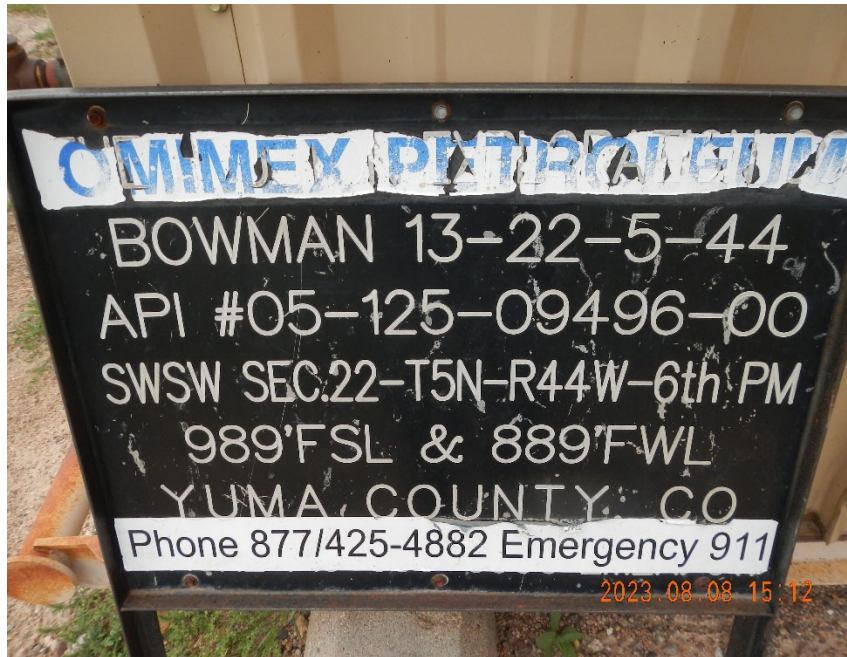
1. Well sign at well location.

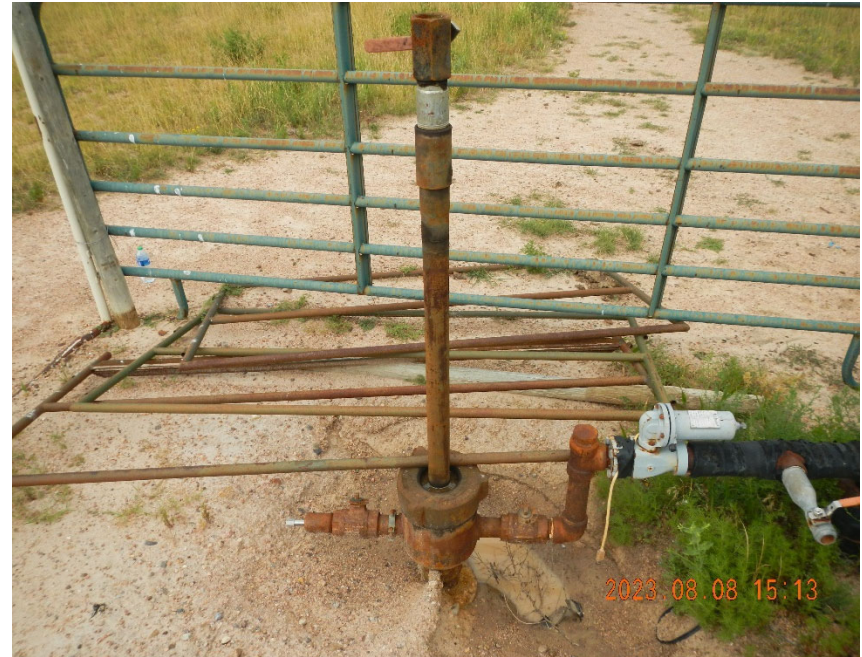
2. View of Wellhead. Note Pump Jack barrier rails on Wellhead.

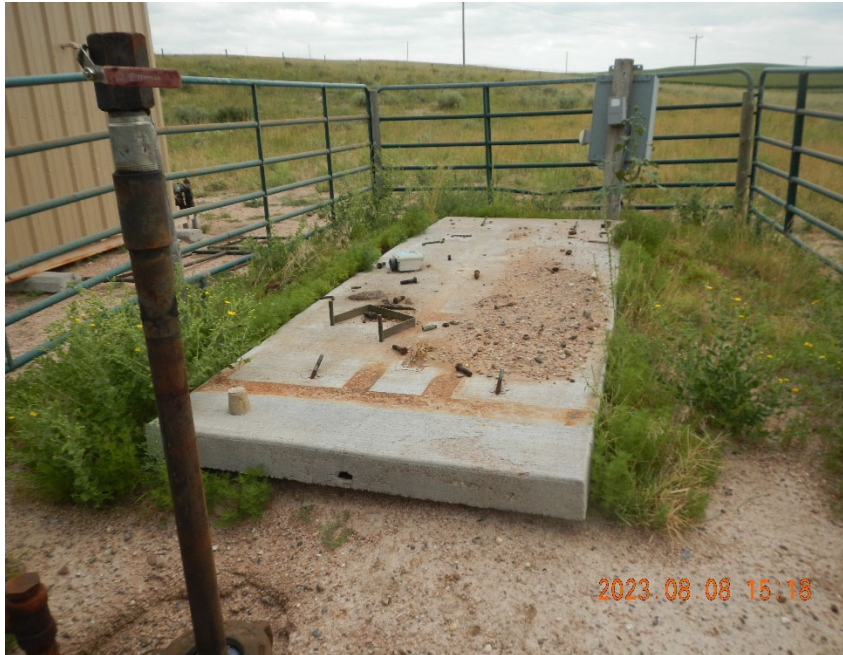
3. Concrete pad and production related debris left at location. Note vegetation.

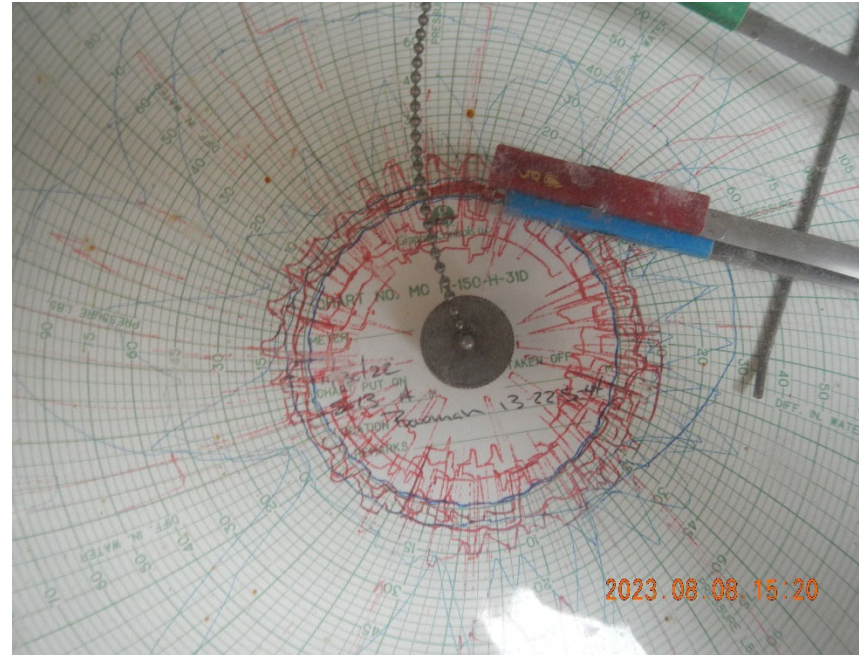
4. View of Chart in Meter Box at time of inspection.

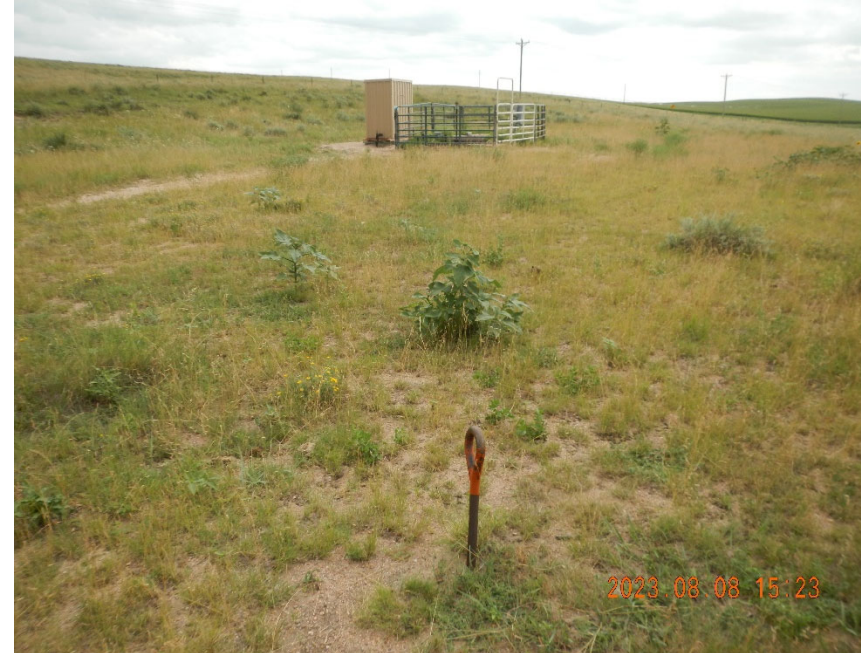
6. Location overview and unmarked marker.

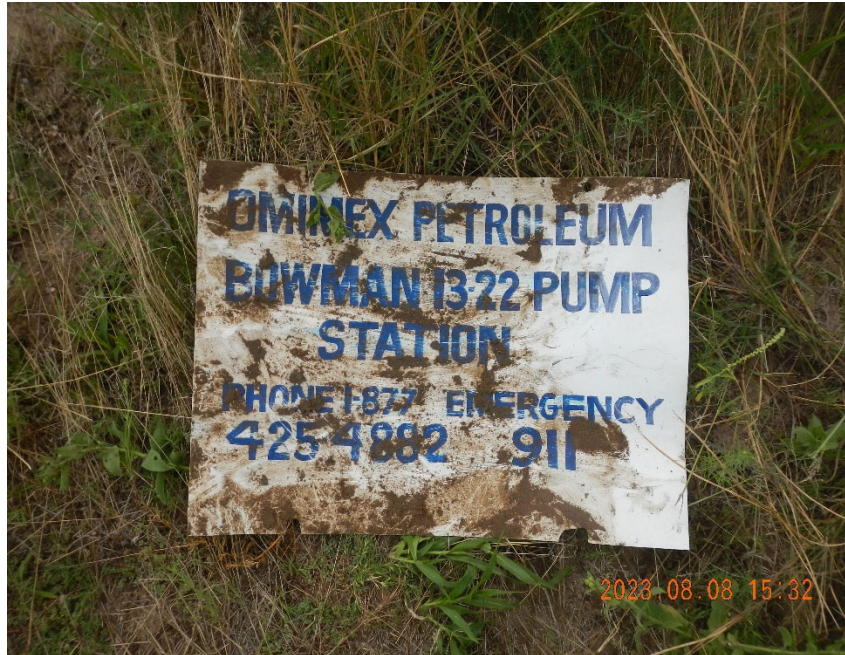
7. Tank Battery sign out of bracket and face down on ground.

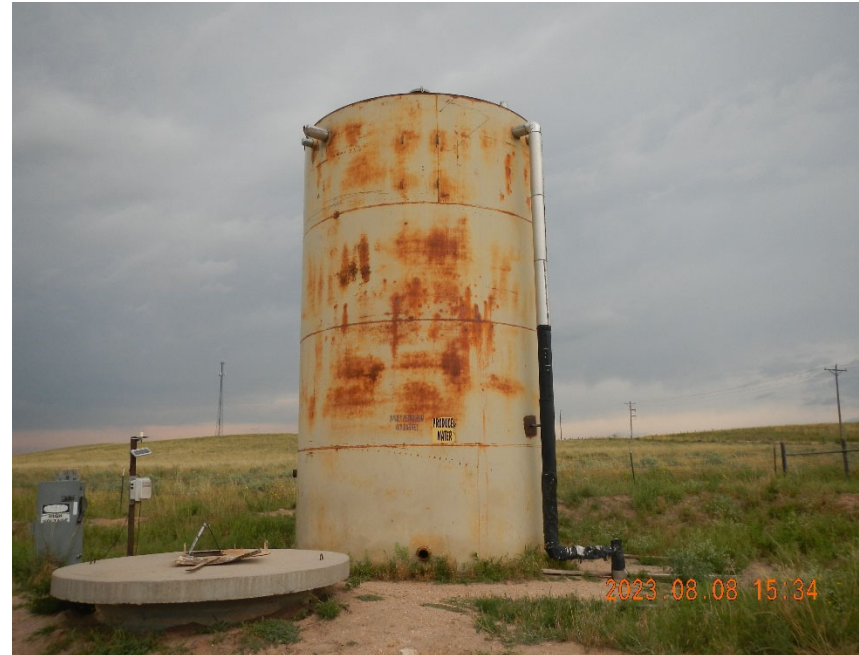
8. View of Steel Tank and Concrete Vault. Note Vegetation.

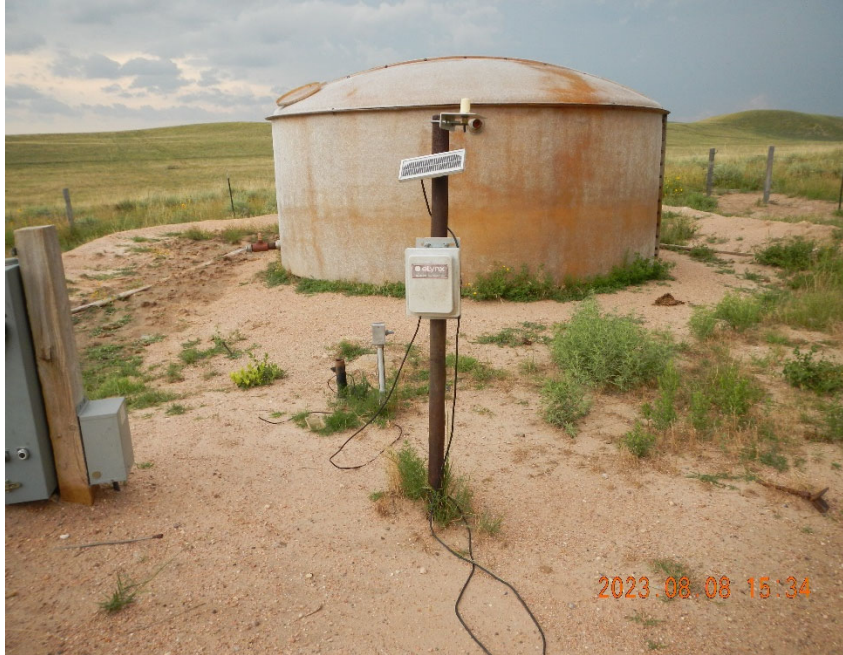
9. View of Fiberglass Tank. No Placards or Signage. Note vegetation.

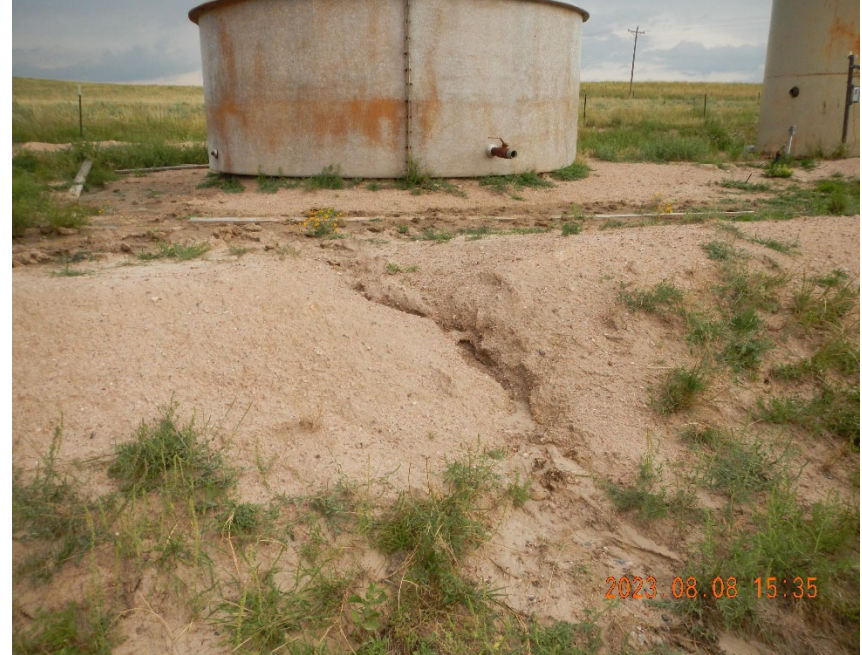
10. Washed out containment berm in SW corner.

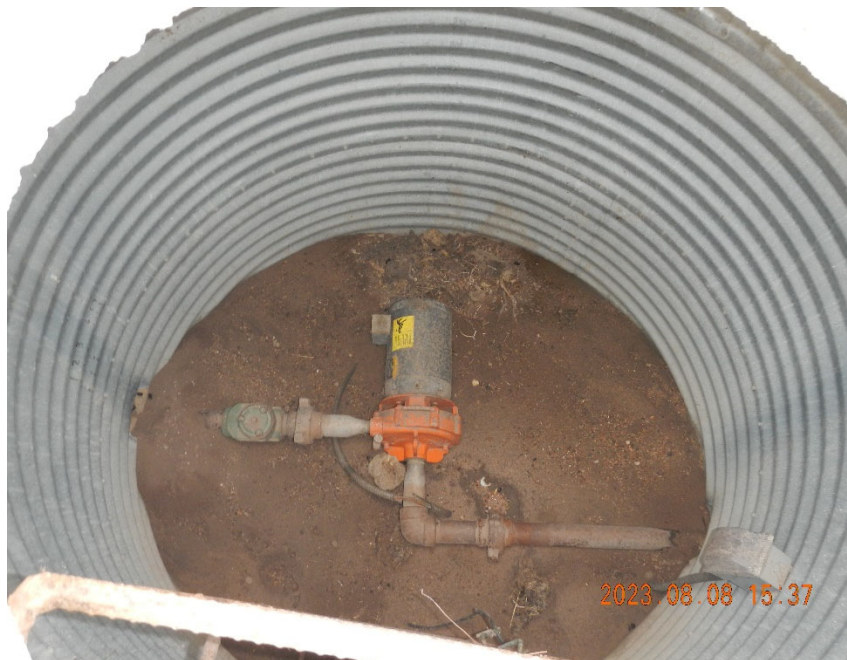
11. Electric pump in bottom of vault.

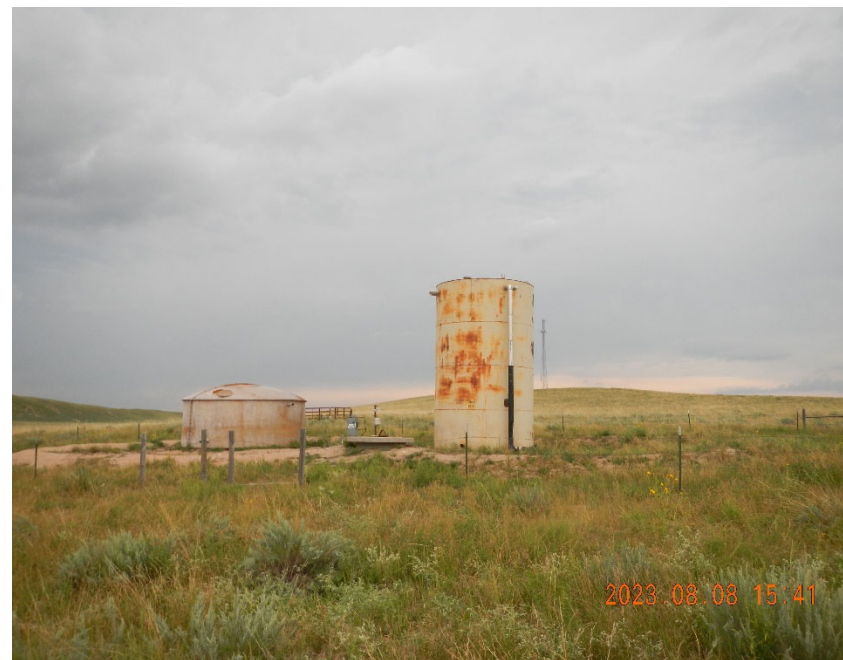
12. Tank Battery overview.
