NAME: BOMBARDIER 31-36, API #: 071-07081, INSP. # 695108545

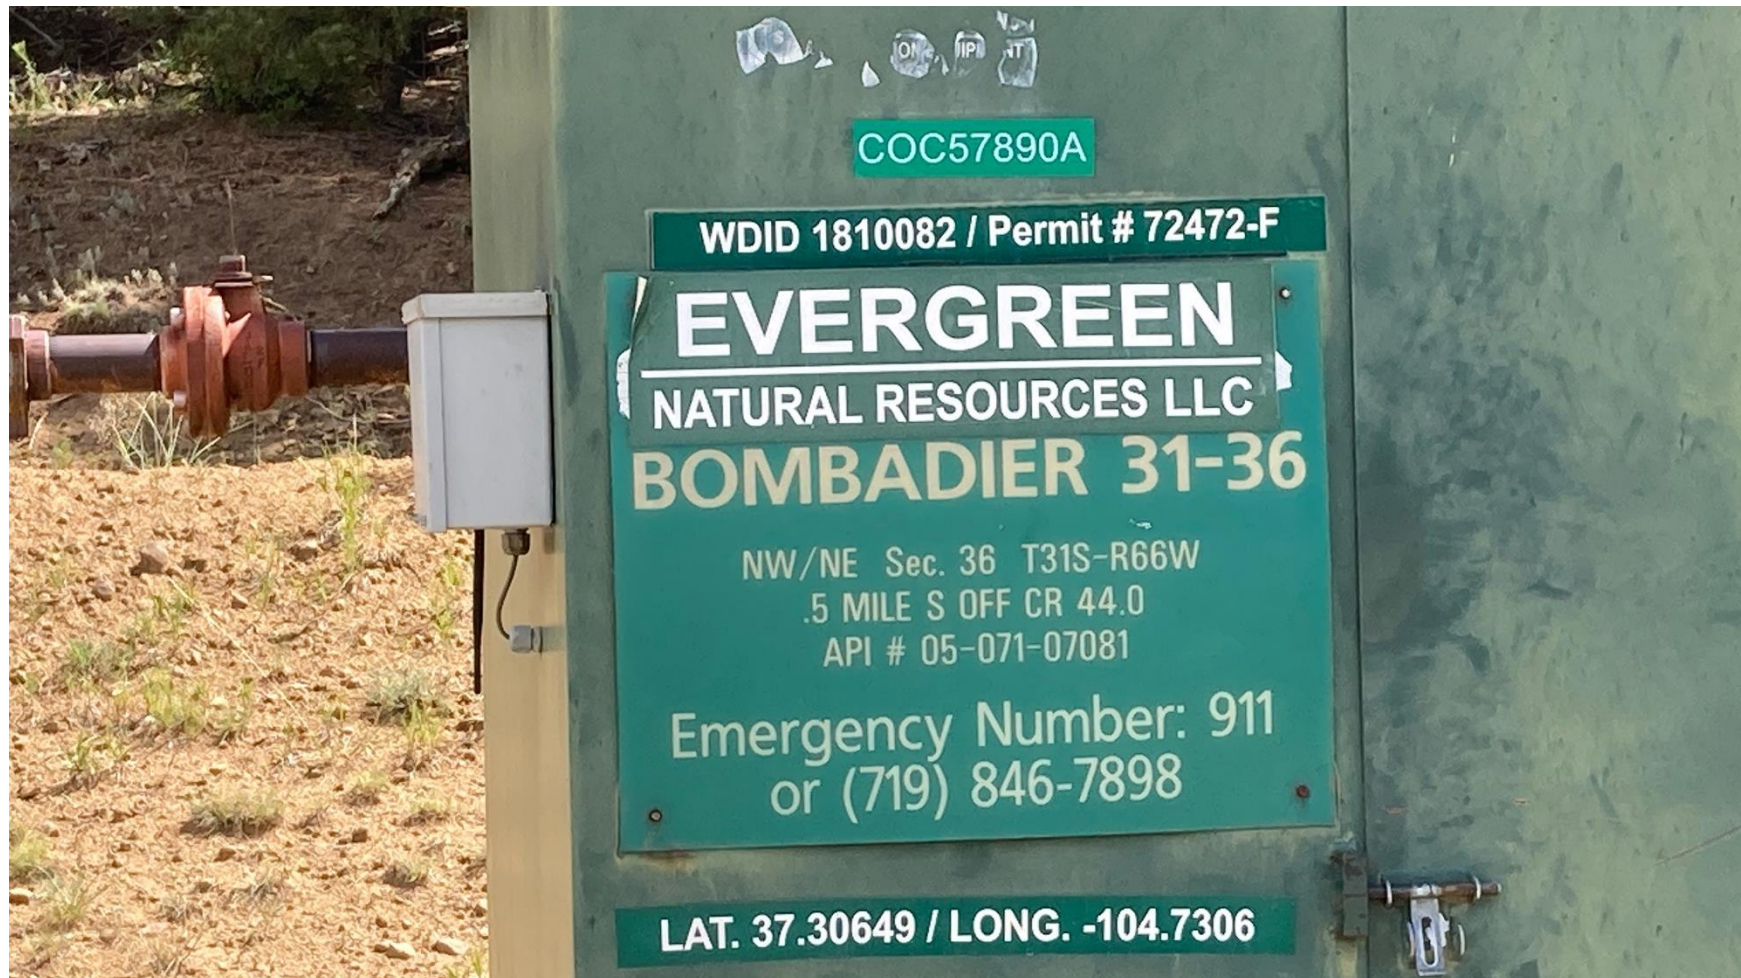
PHOTO 1: WELL SIGN

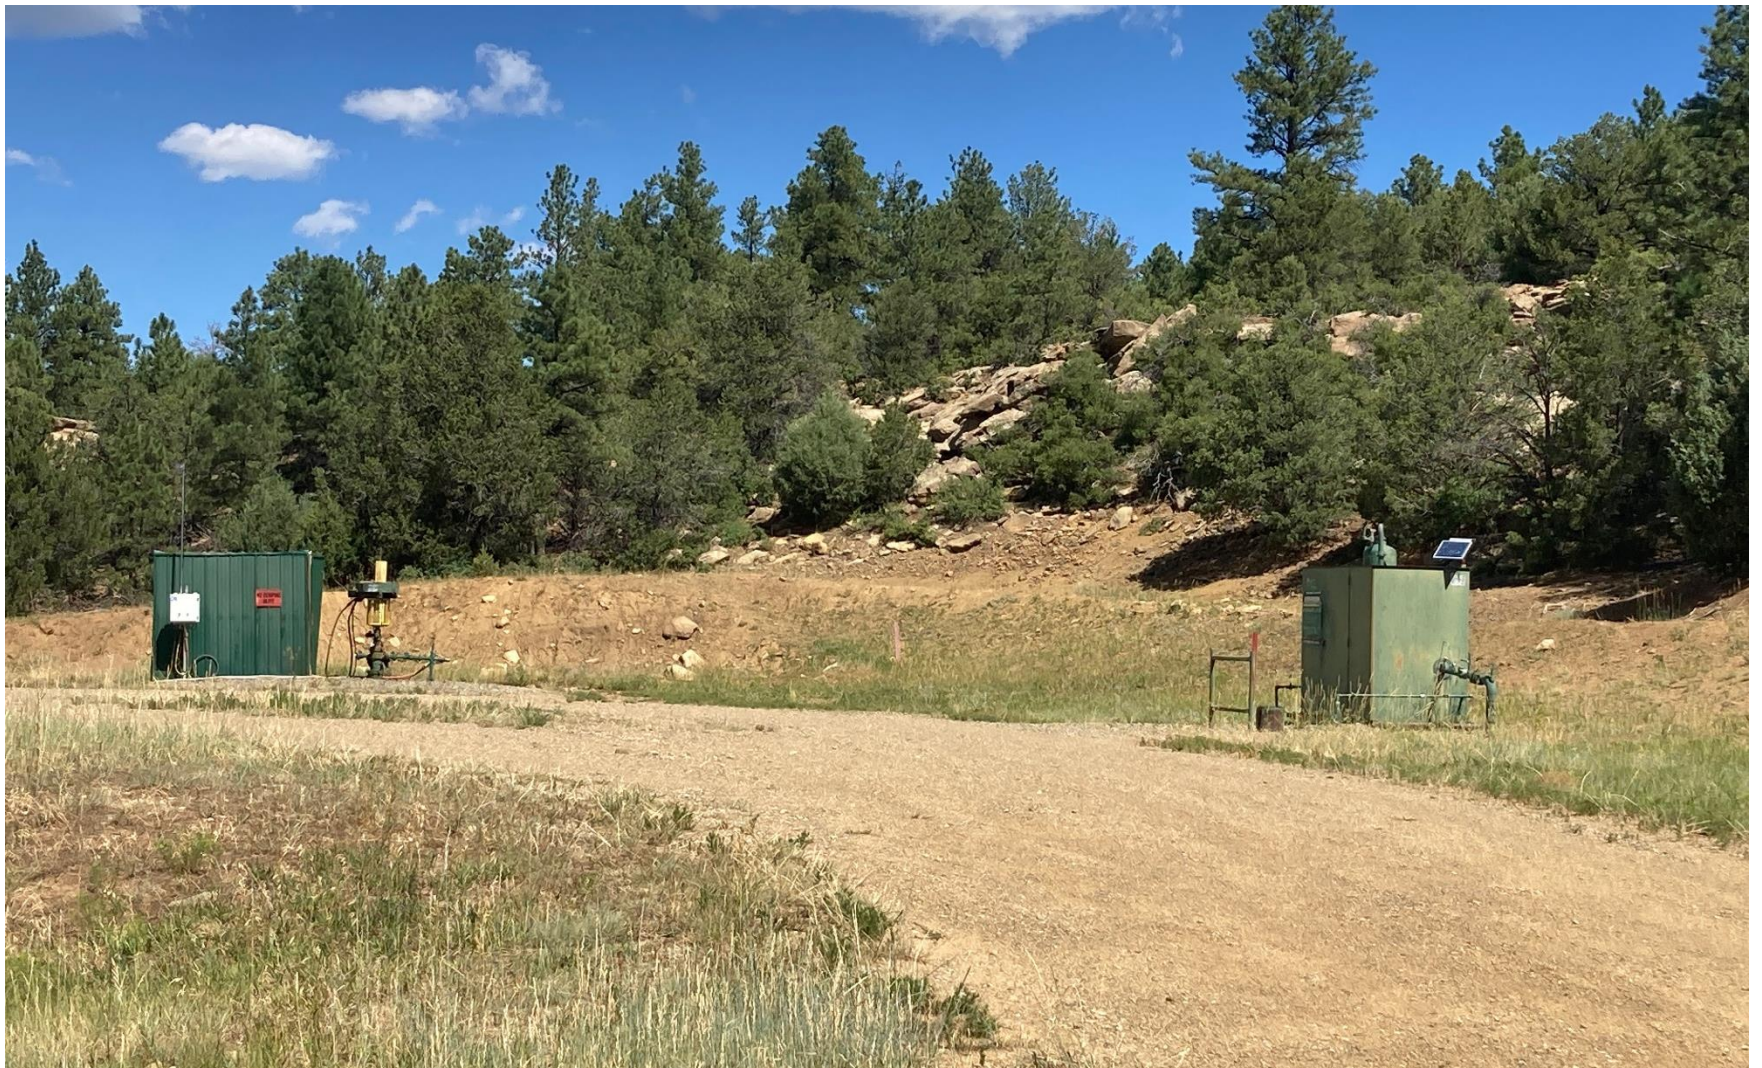
PHOTO 2: LOCATION

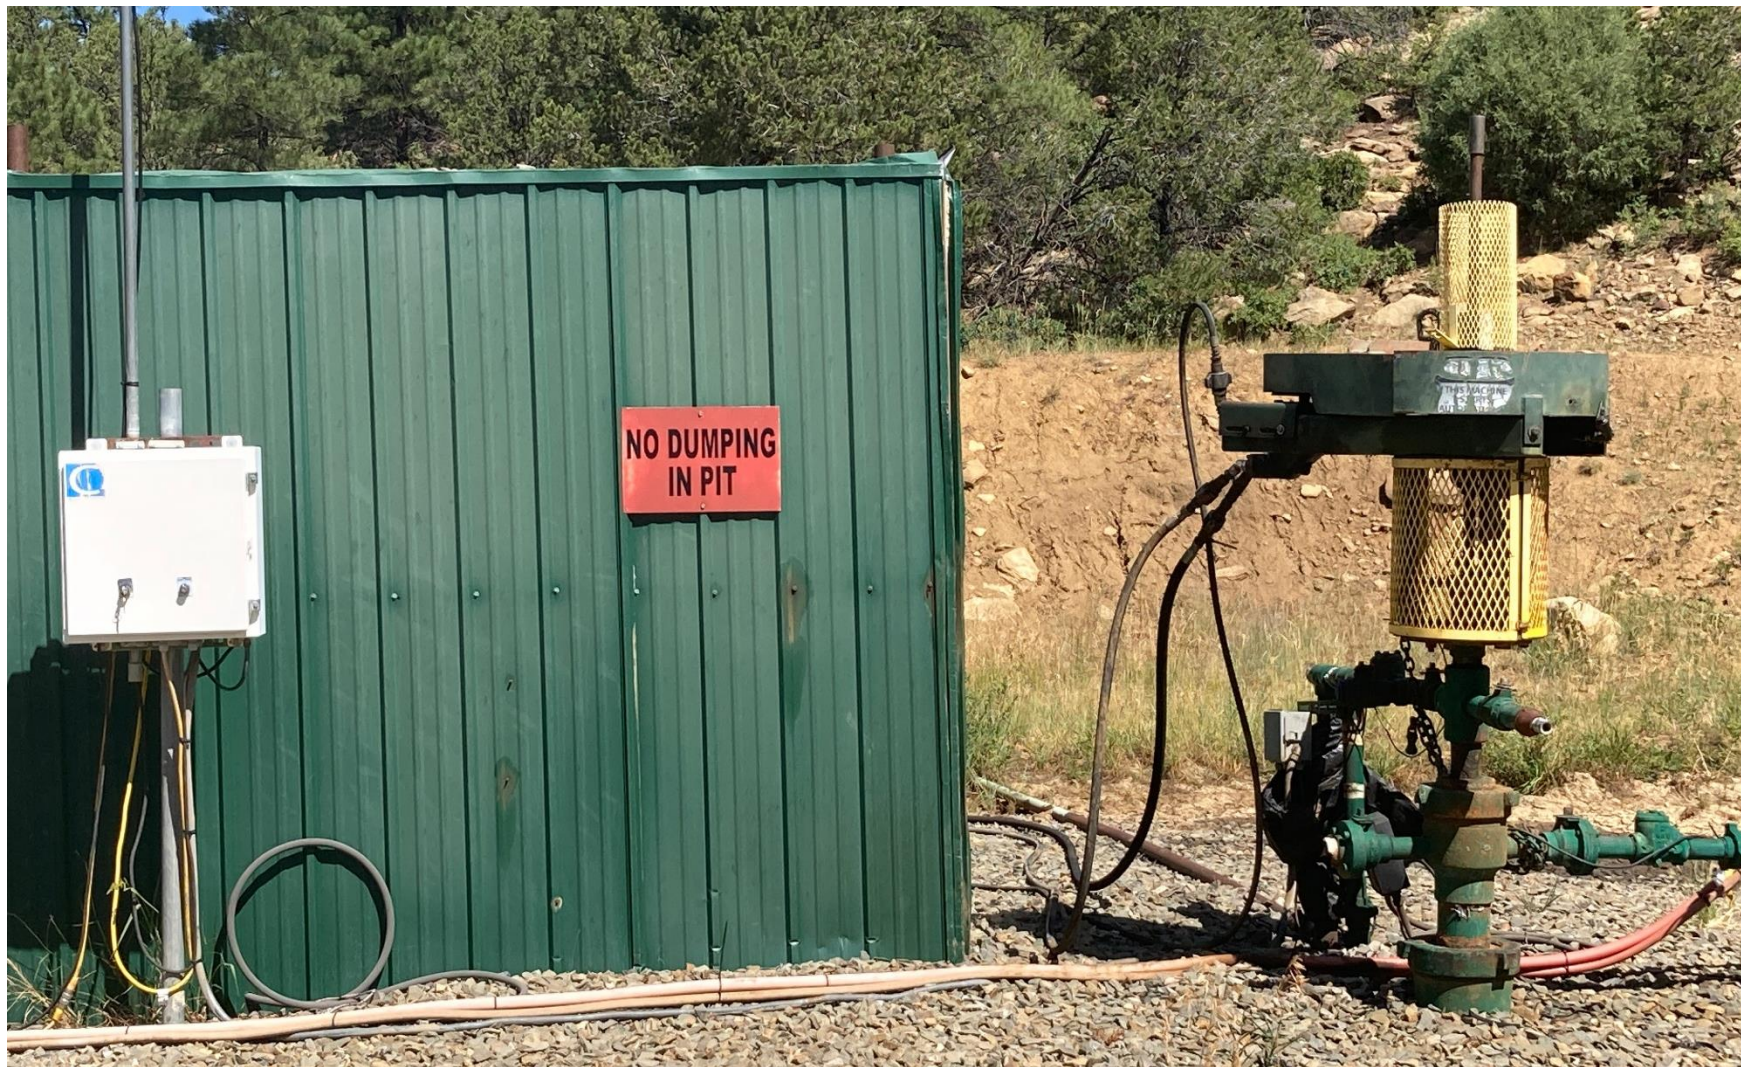
PHOTO 3: WELLHEAD AND EQUIPMENT

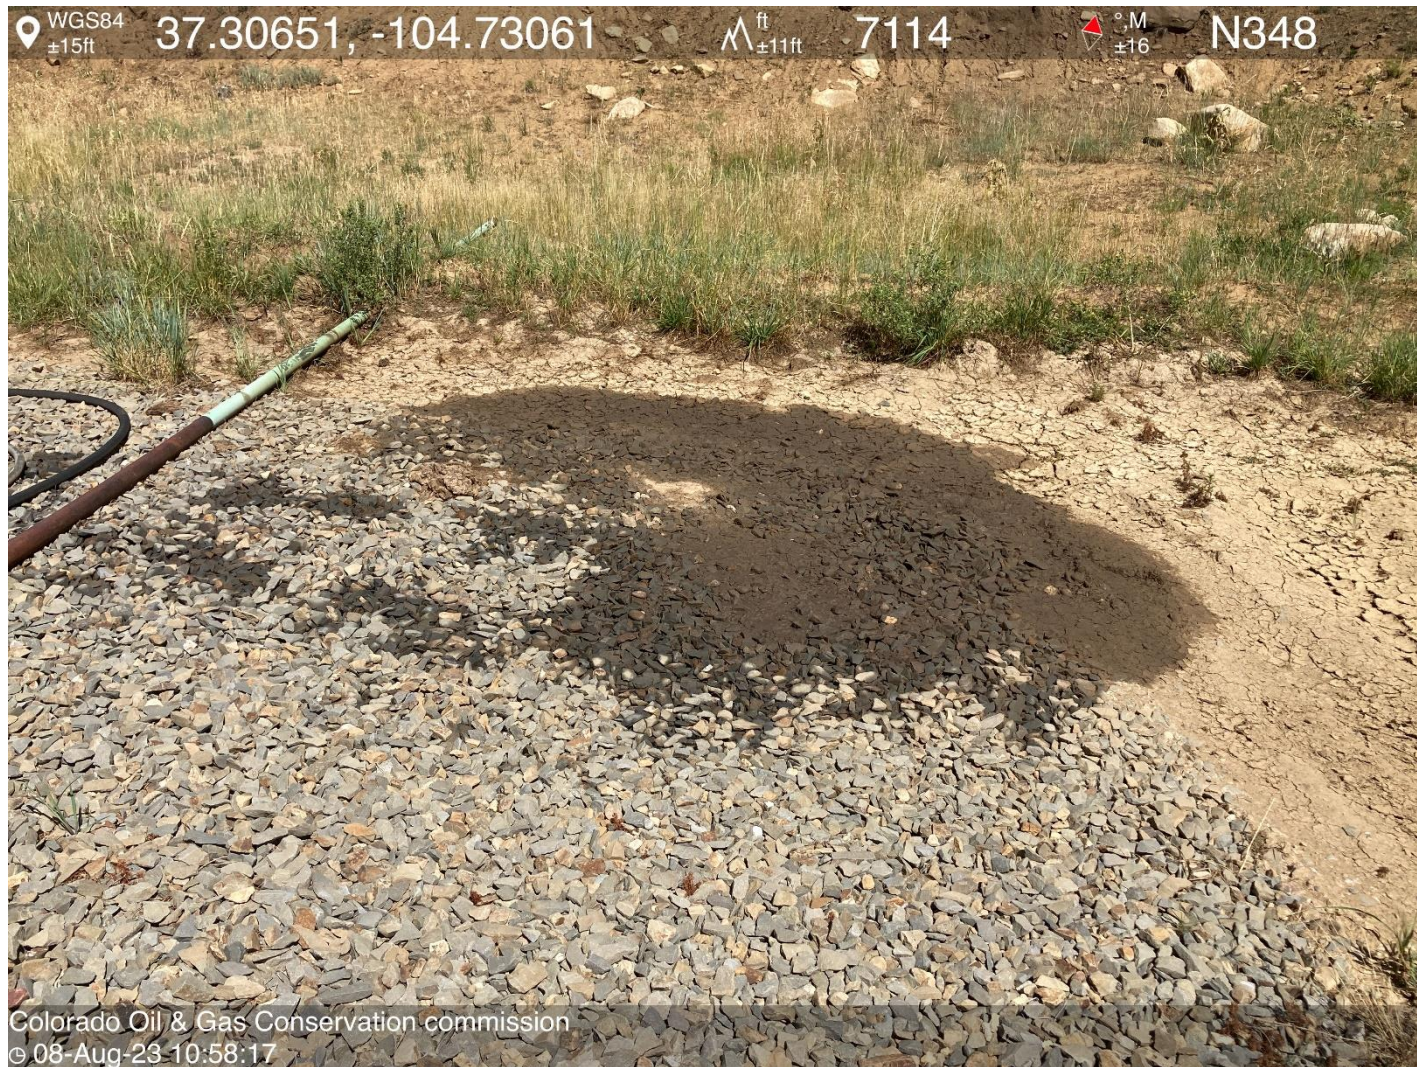
PHOTO 4: AREA OF IMPACTED SOIL BETWEEN WELLHEAD AND PIT. Conduct maintenance on equipment, cleanup stained material and review self inspection processes. COMPLY WITH RULE 1002,.(2).D. CA DATE 9-9-2023.

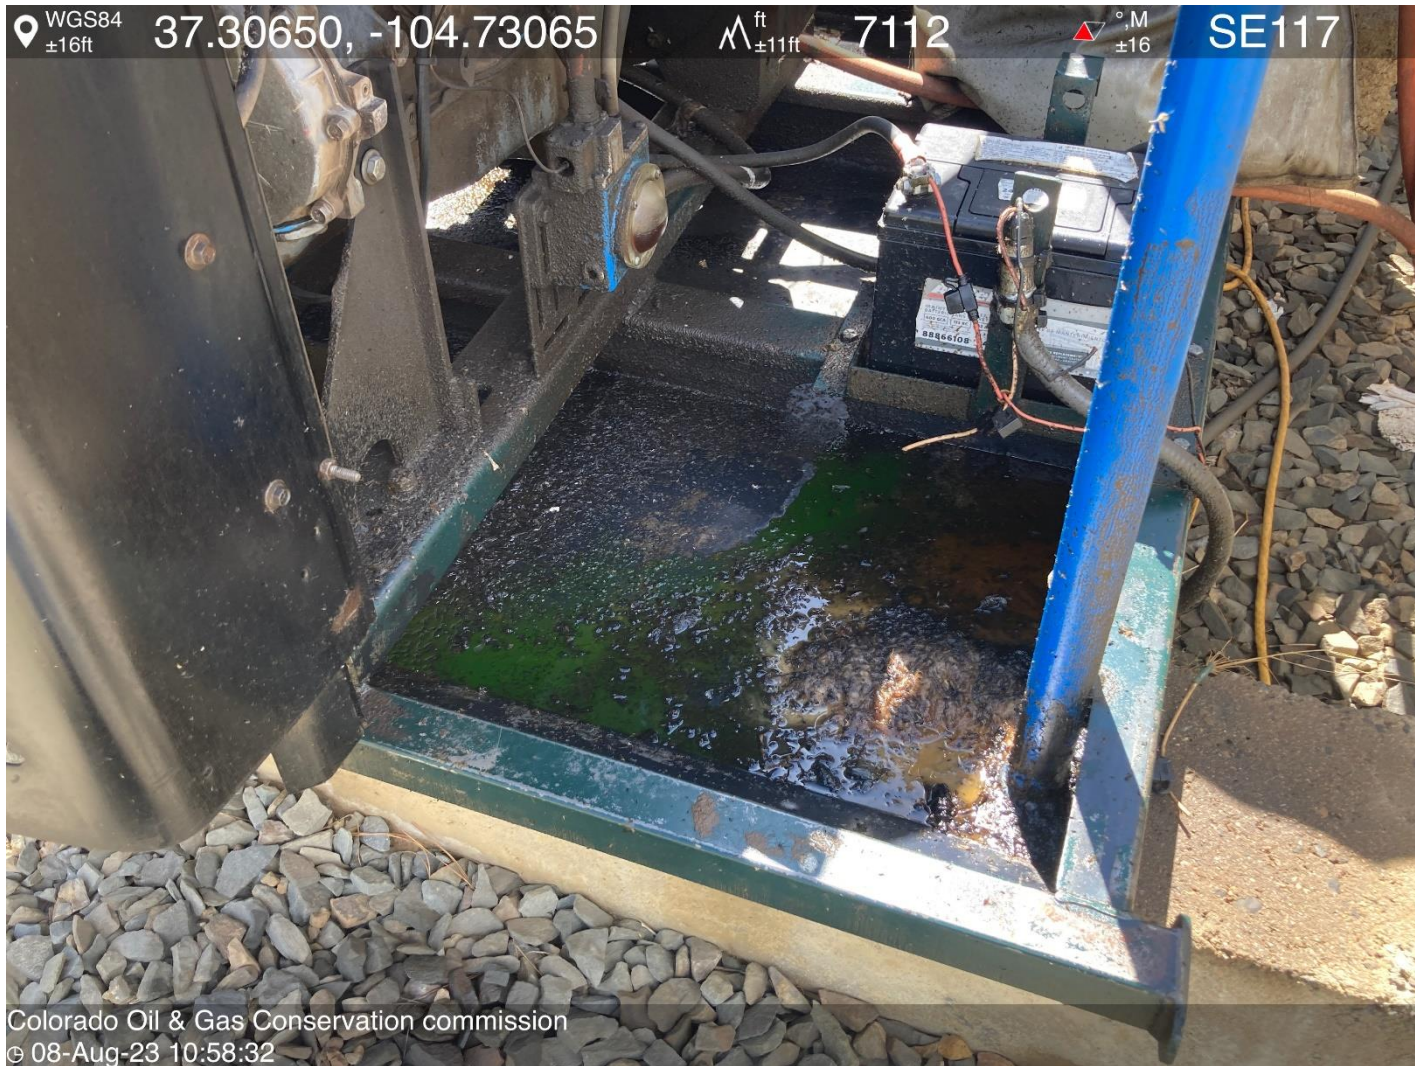
PHOTO 5: ANTIFREEZE AND OILY WASTE IN PRIME MOVER SKID. COMPLY WITH RULE 1002.f.(2)B, Comply with general provisions of the oil and gas act for wildlife protection AND SB-181. CA DATE 8-10-2023.

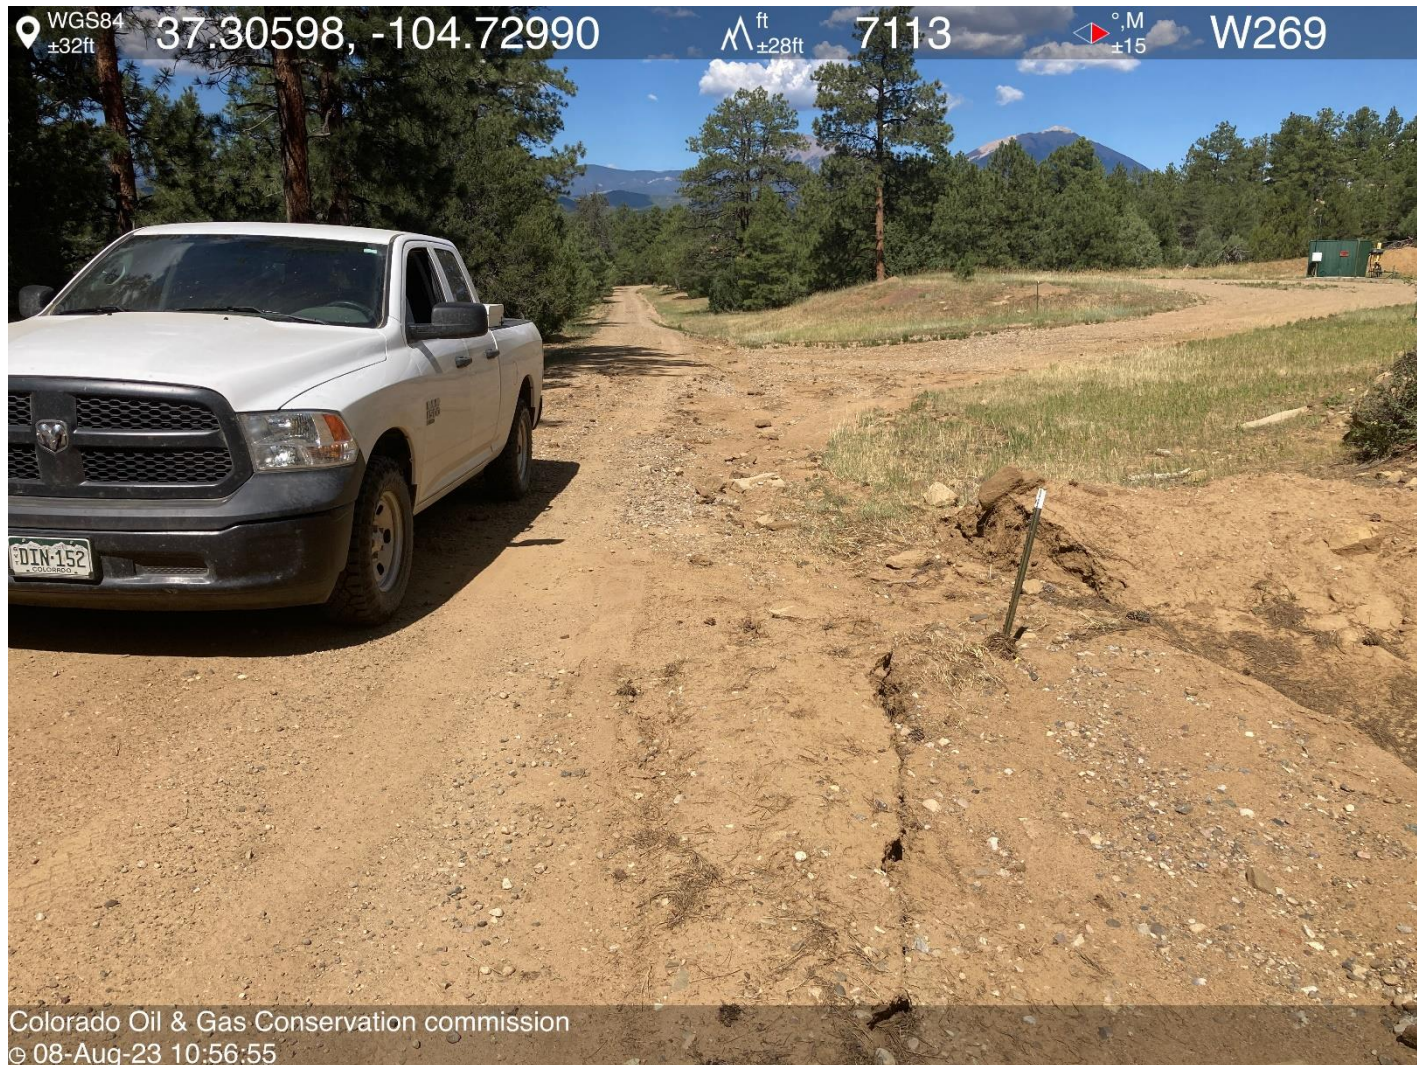
PHOTO 6: CULVERT JUST EAST OF LOCATION ENTRANCE IS FILLED WITH SEDIMENT. Install or repair required BMPs per Rule 1002.f.(2)C. CA DATE 9-9-2023.

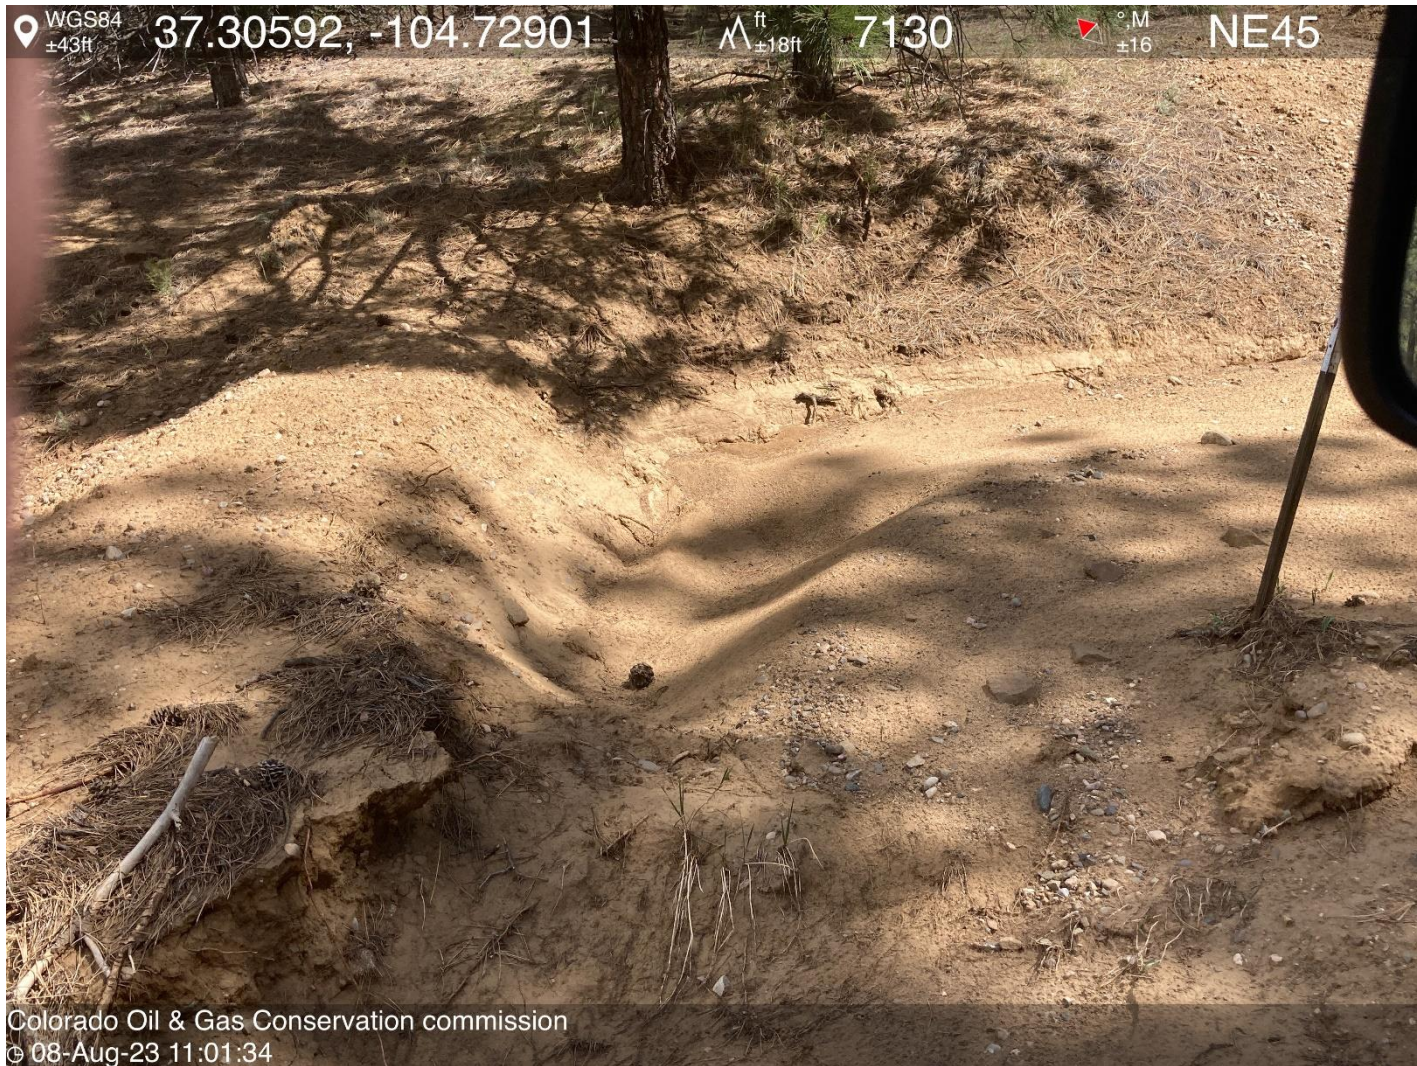
PHOTO 7: CULVERT ABOUT 100 YARDS EAST OF LOCATION ENTRANCE IS FILLED WITH SEDIMENT. Install or repair required BMPs per Rule 1002.f.(2)C. CA DATE 9-9-2023.
