Inspection Photos

Location Name: TEP ROCKY MOUNTAIN LLC, FEDERAL-67S96W/3SWSE

Location ID: 334846

Date: 8/7/2023

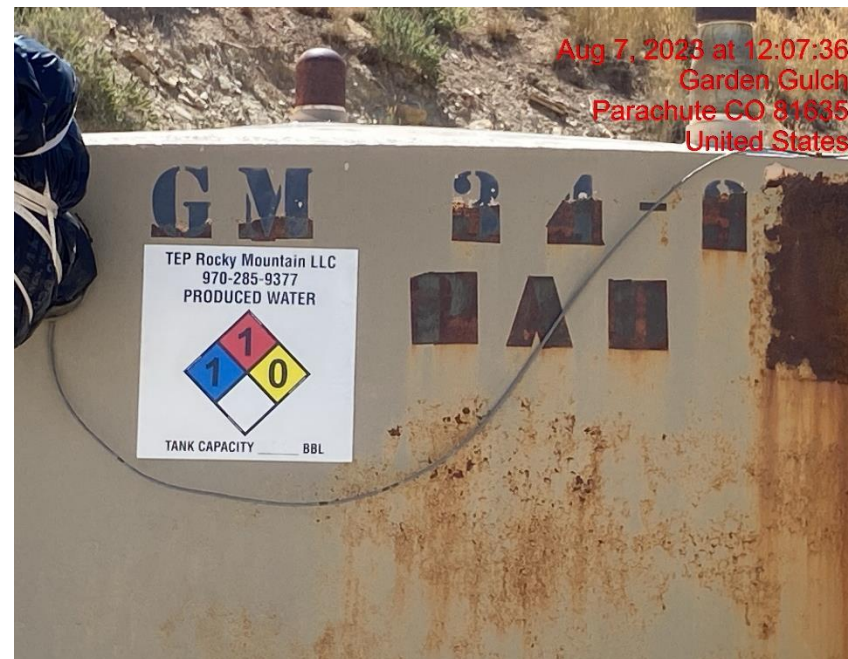
Tank Label Does Not State Capacity – Photo #05581

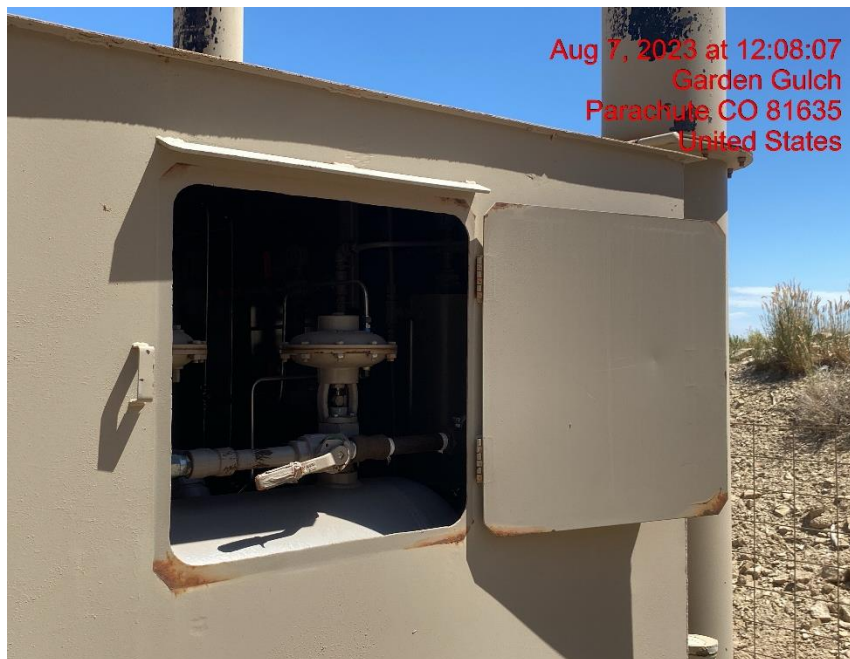
Separator Hatch Unsecured – Photo #05583

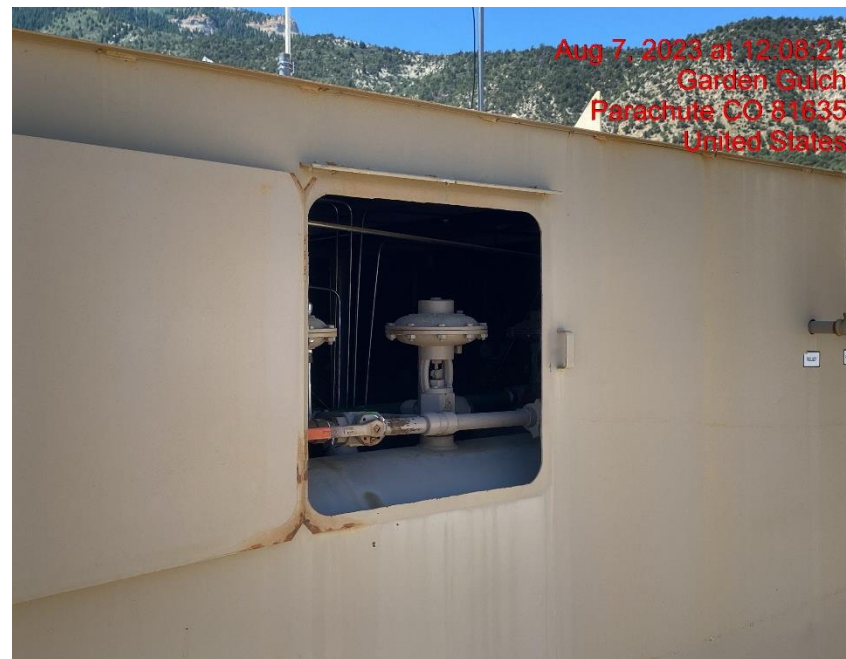
Separator Hatch Unsecured – Photo #05584

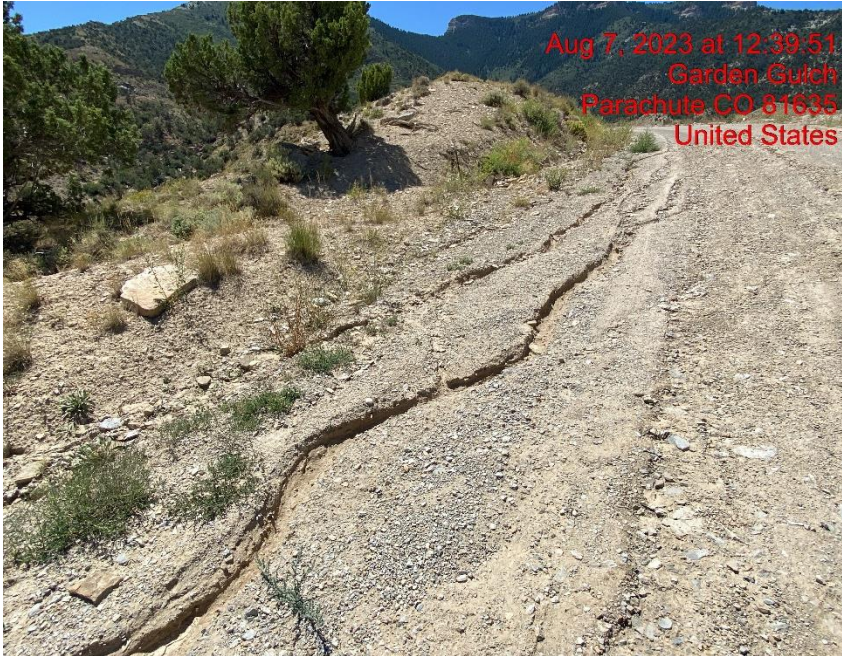
Rill Erosion Cutting Through Lease Road – Photo #05610

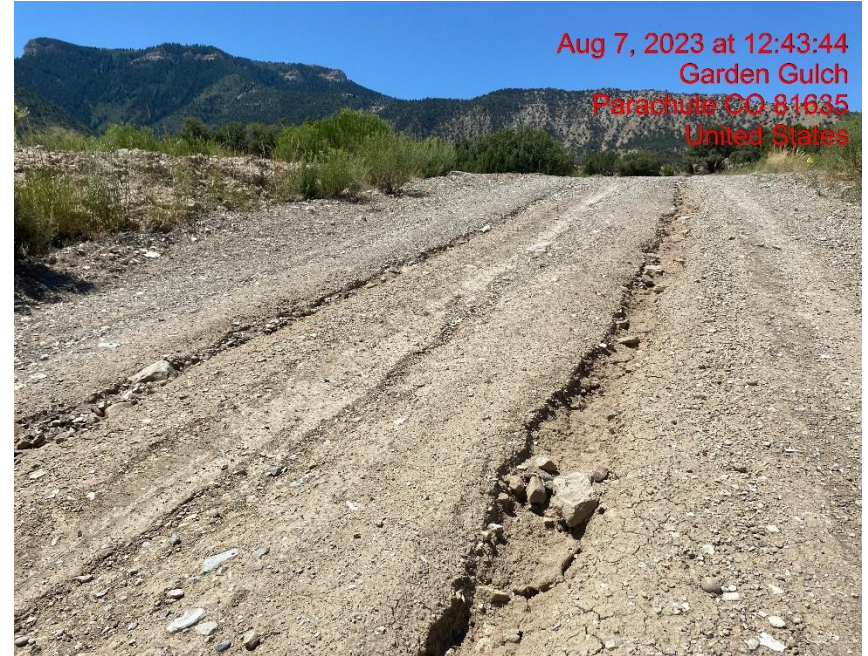
Rill Erosion Cutting Through Lease Road – Photo #05613

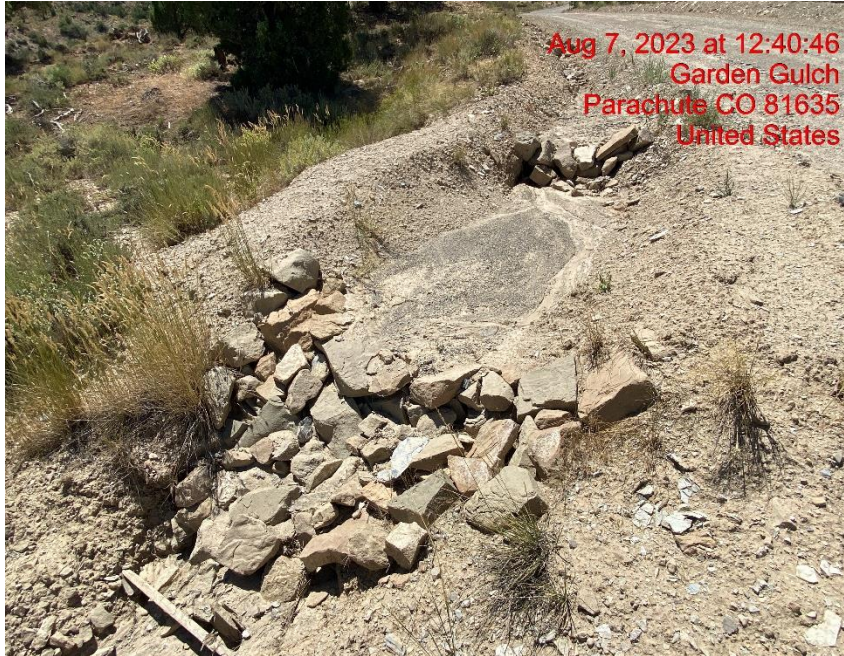
Check Dam Needs Maintenance – Photo #05611
