## Inspection Photos

Location Name: TEP ROCKY MOUNTAIN LLC, OXY USA INC-67S96W/10NWNE

Location ID: 323862

Date: 8/7/2023

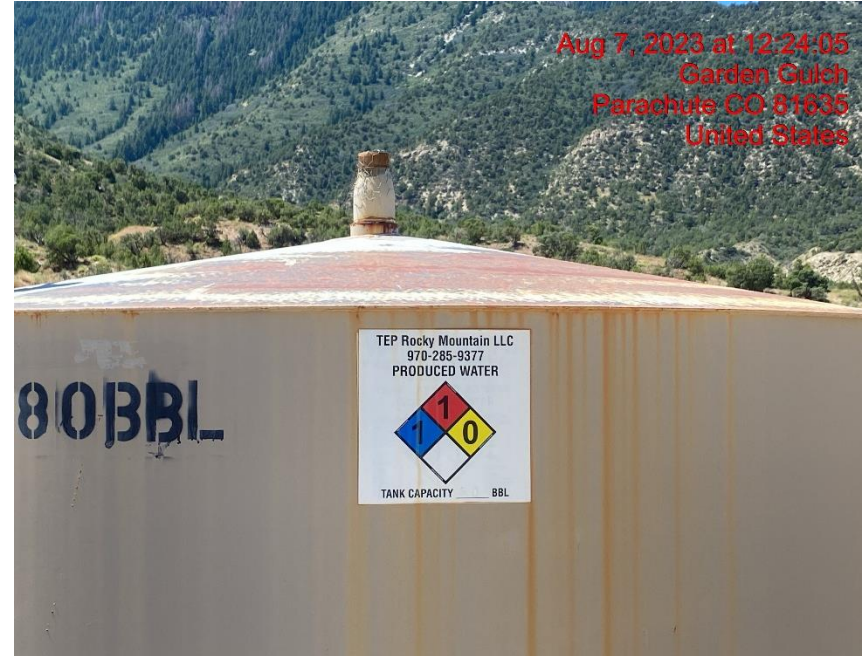
Tank Label Does Not State Capacity – Photo #05594

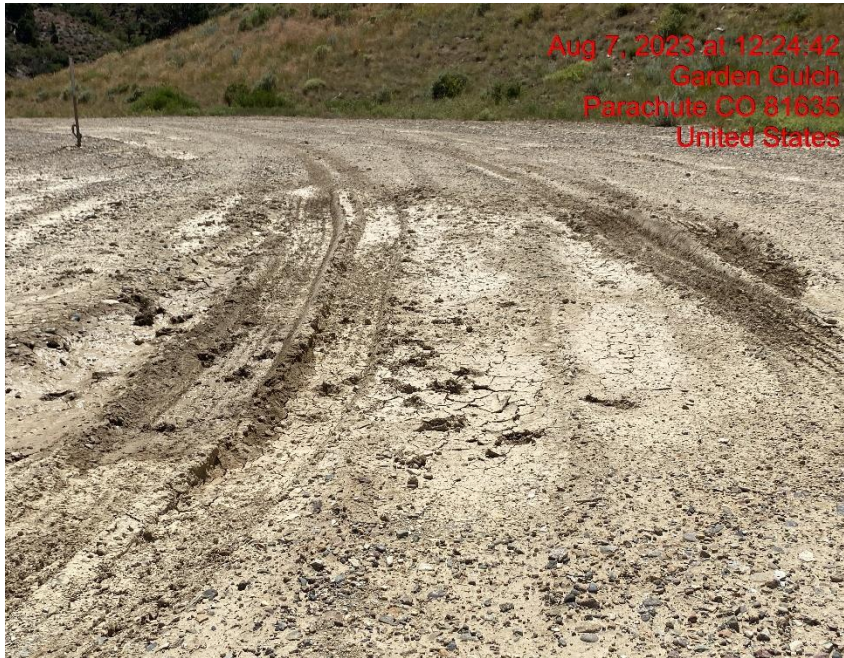
**Location Lacks Stabilization – Photo #05596**

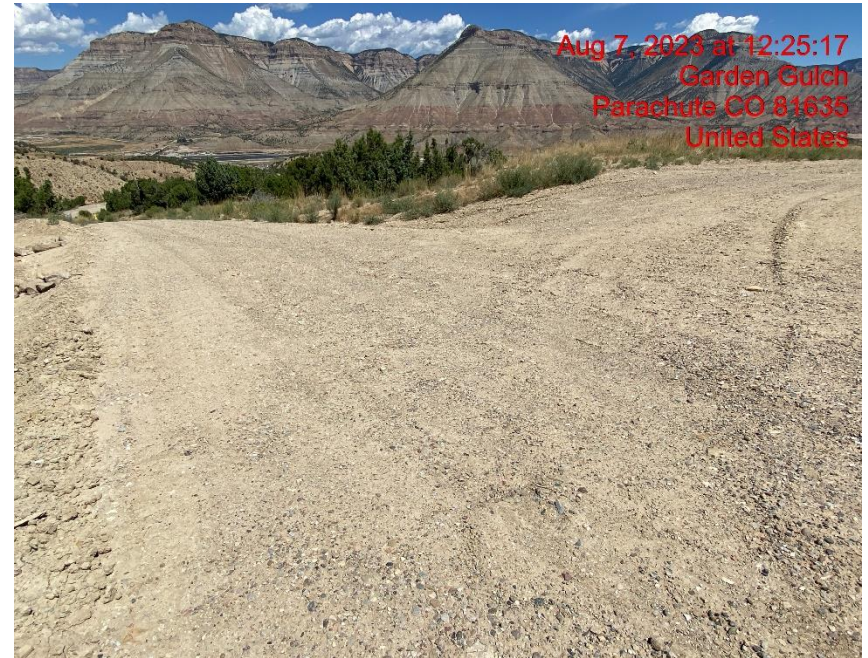
**Insufficient Vehicle Tracking BMPs at Location Entrance/Exit  
– Photo #05598**

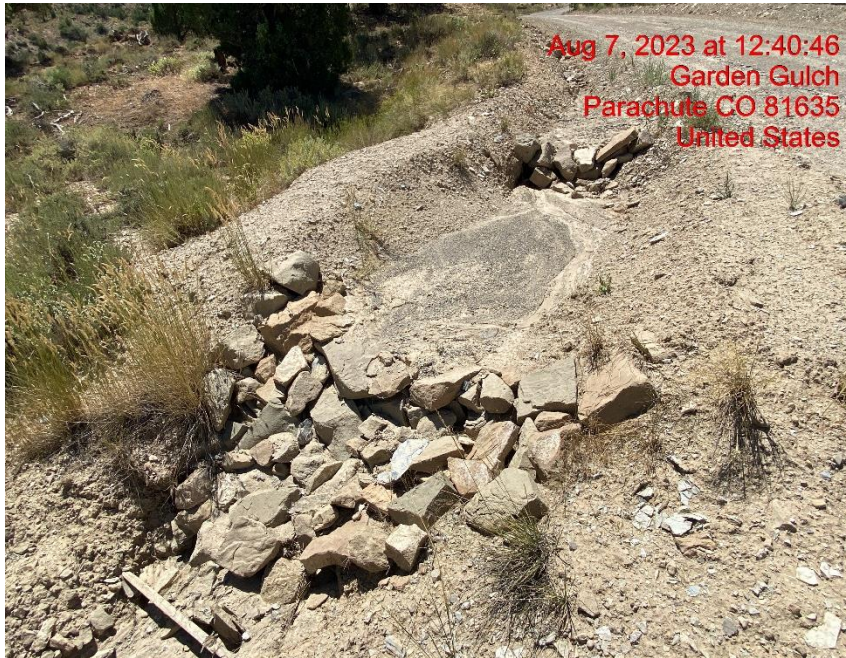
**Check Dam Needs Maintenance – Photo #05611**
