Inspection Photos

API: 071-07391

Operator: EVERGREEN NATURAL RESOURCES

Inspection Date: 8/8/2023

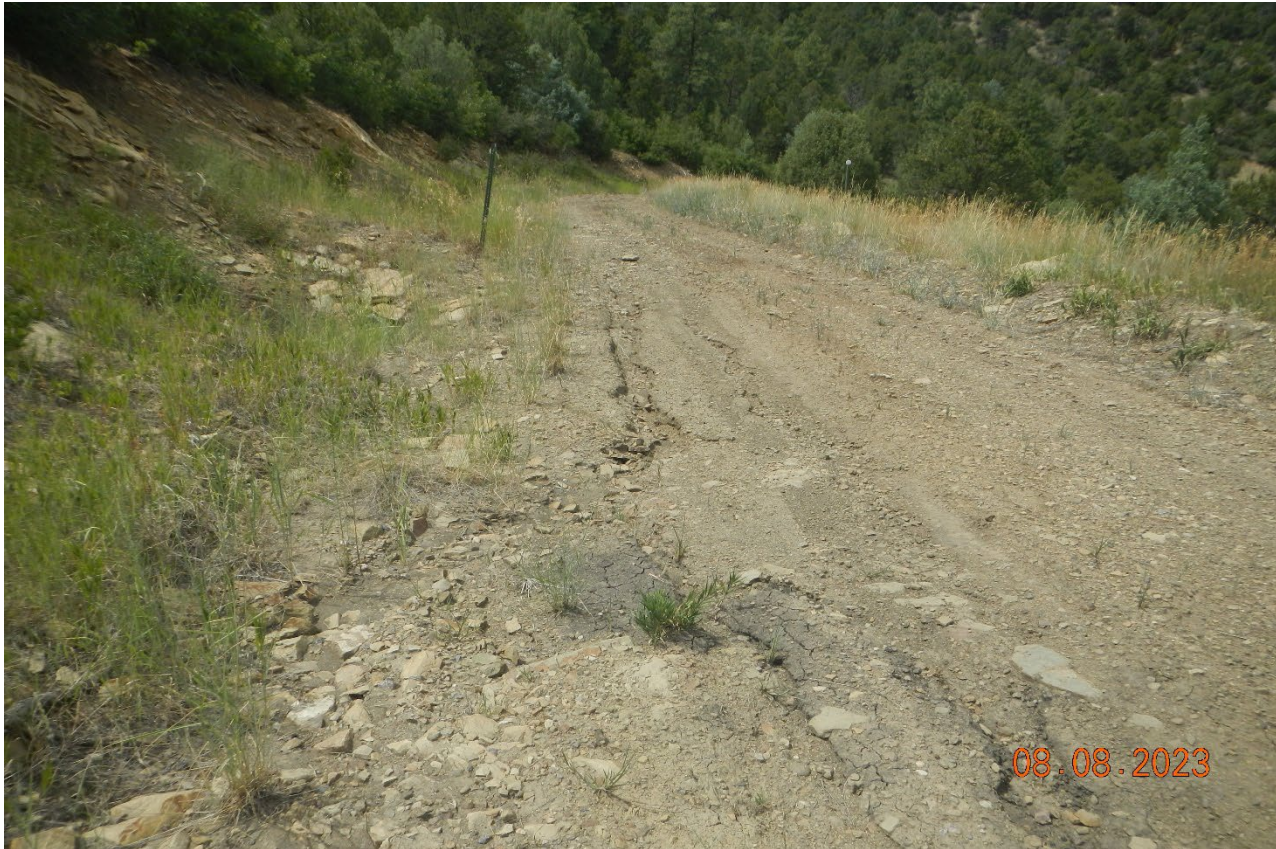
Photo 1. Facing northwest east along the access road traveling from the SECO CANYON 11-22 location. Stormwater is bypassing the culvert causing erosion. The road is not stabilized and gravel has washed away.

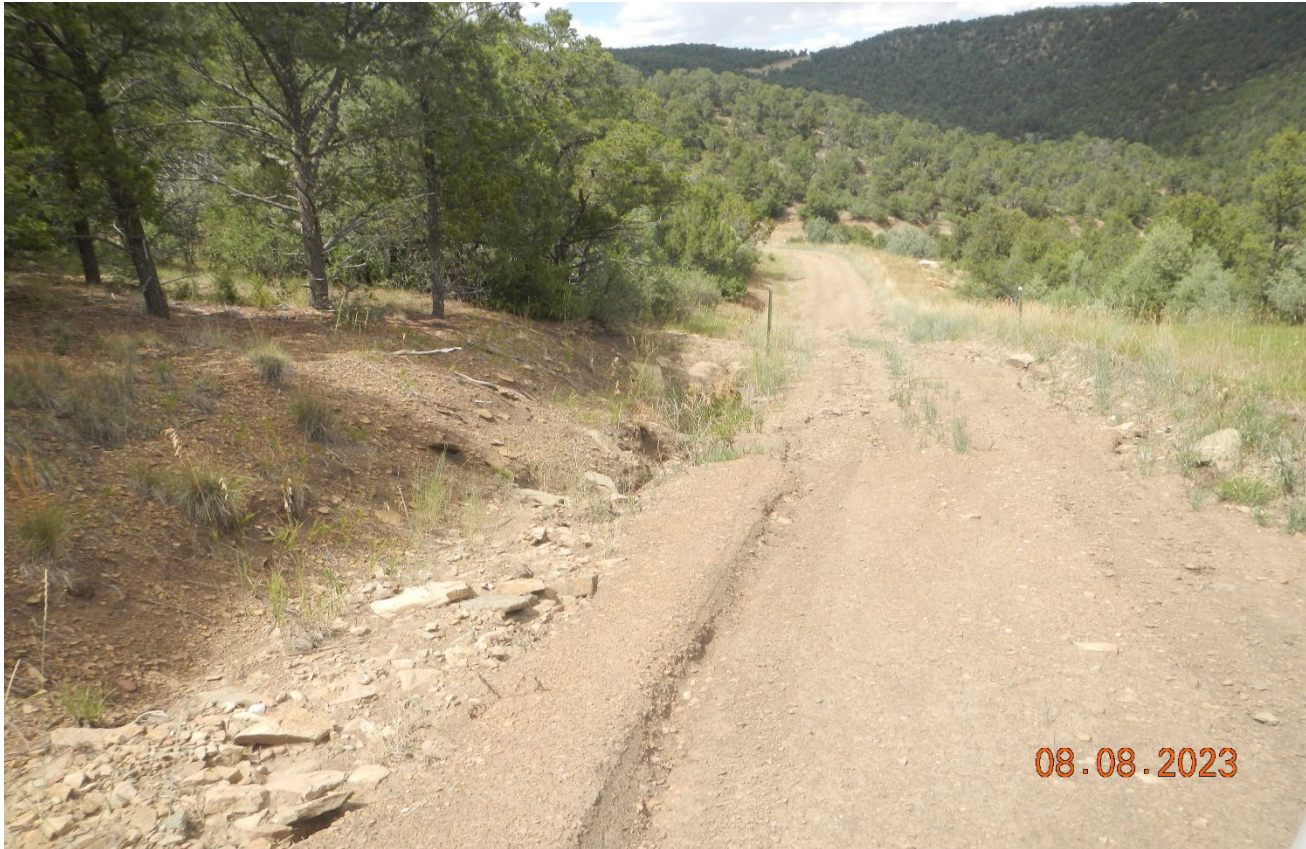
Photo 2. Facing northwest east along the access road traveling from the SECO CANYON 11-22 location. Stormwater is bypassing the culvert causing erosion. There is an erosion gully forming at this culvert.

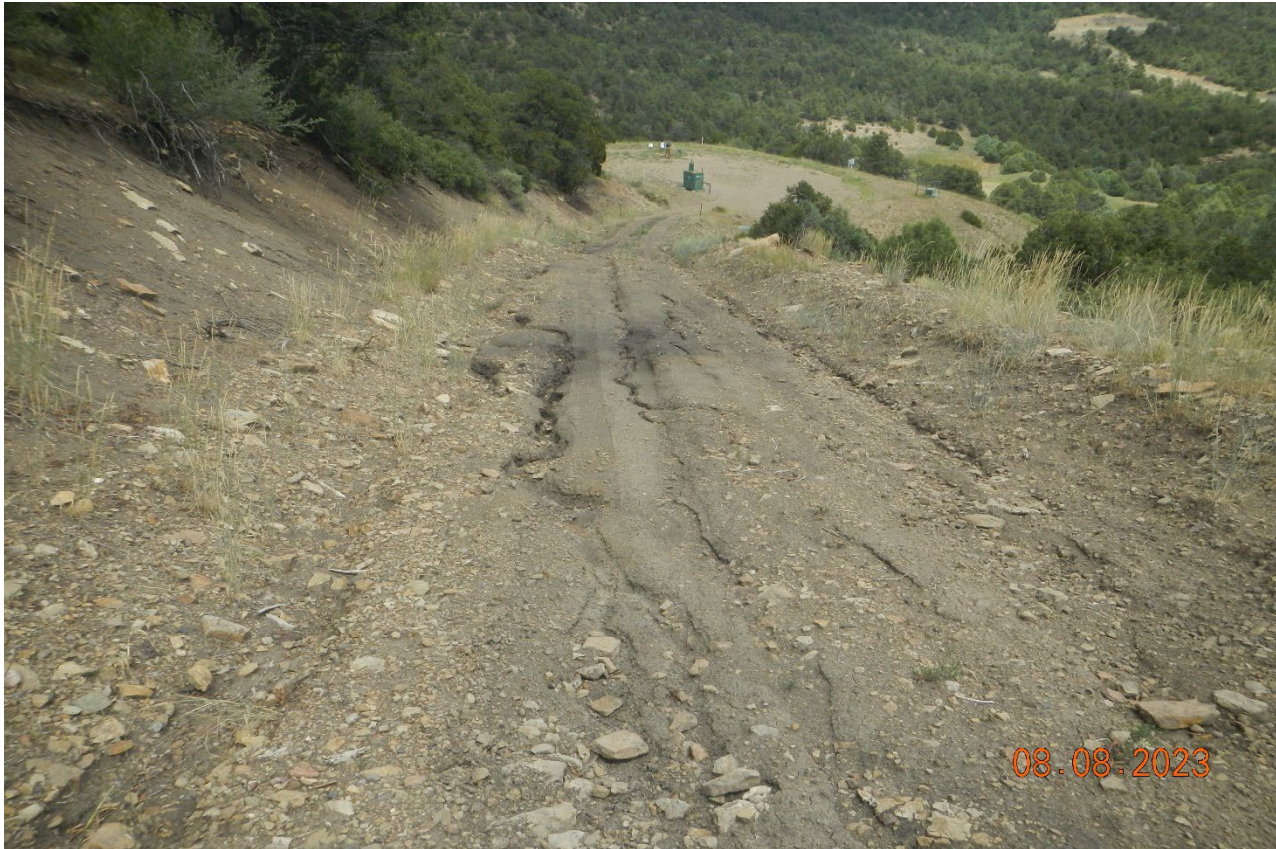
Photo 3. Facing northeast east along the access road toward the location. The road is not stabilized and gravel has washed away.

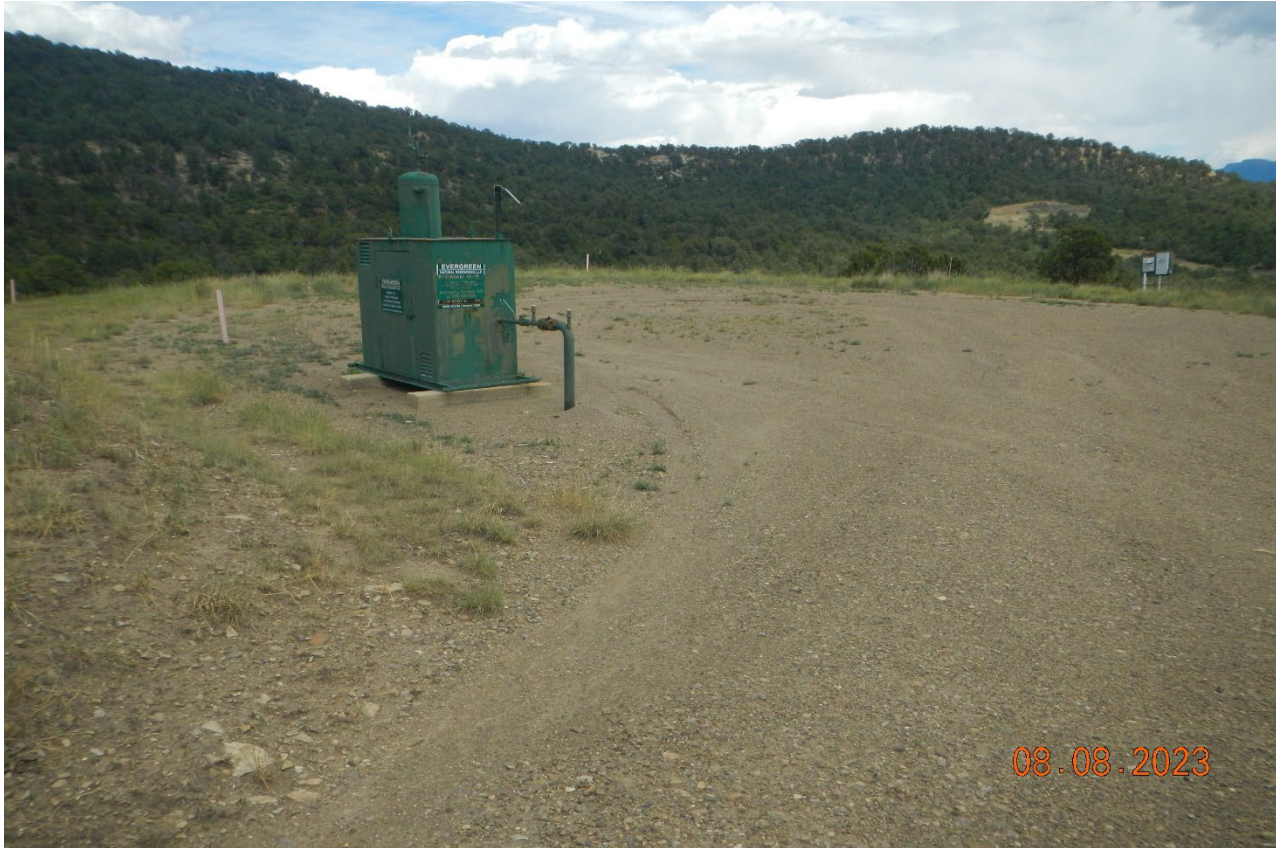
Photo 4. Facing toward the wellsite.

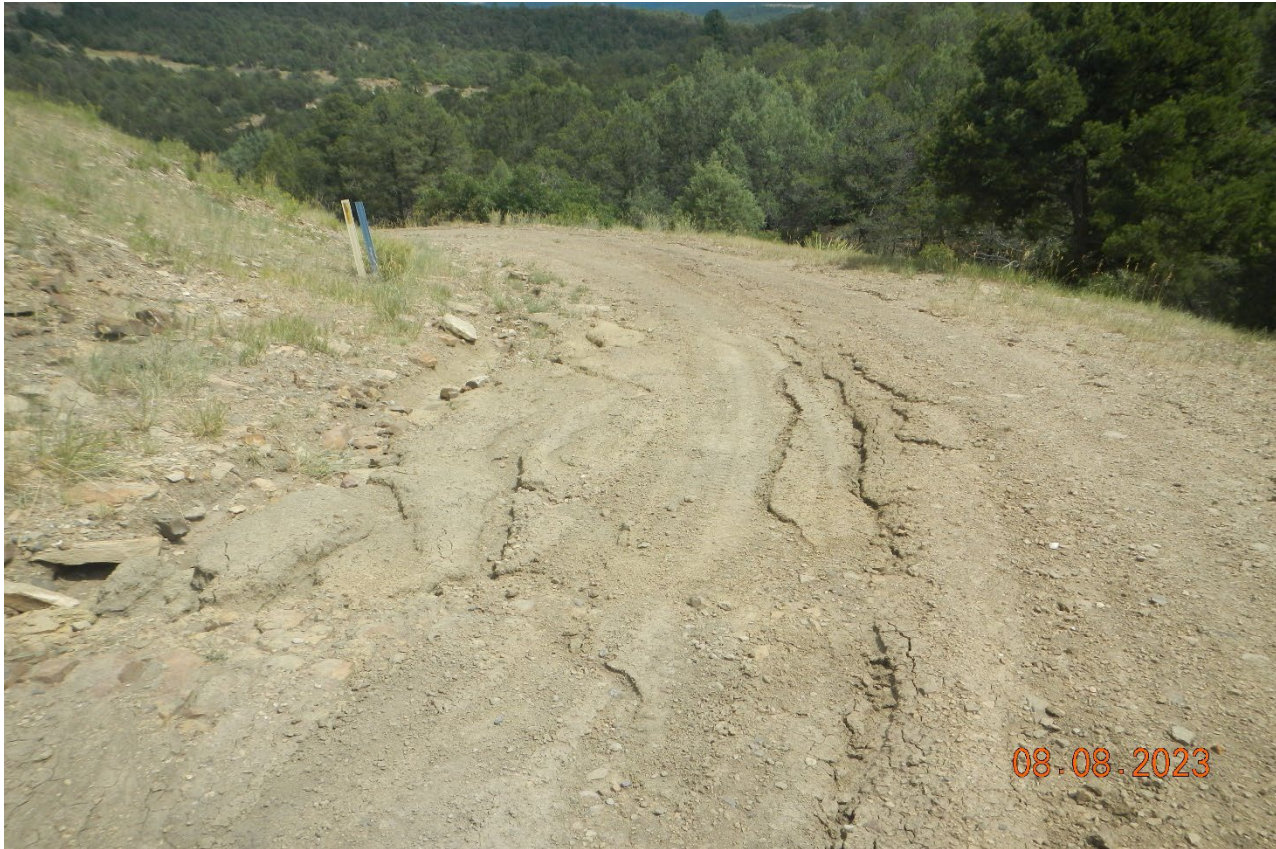
Photo 5. Facing northeast east along the access road near the location. The road is not stabilized and gravel has washed away.

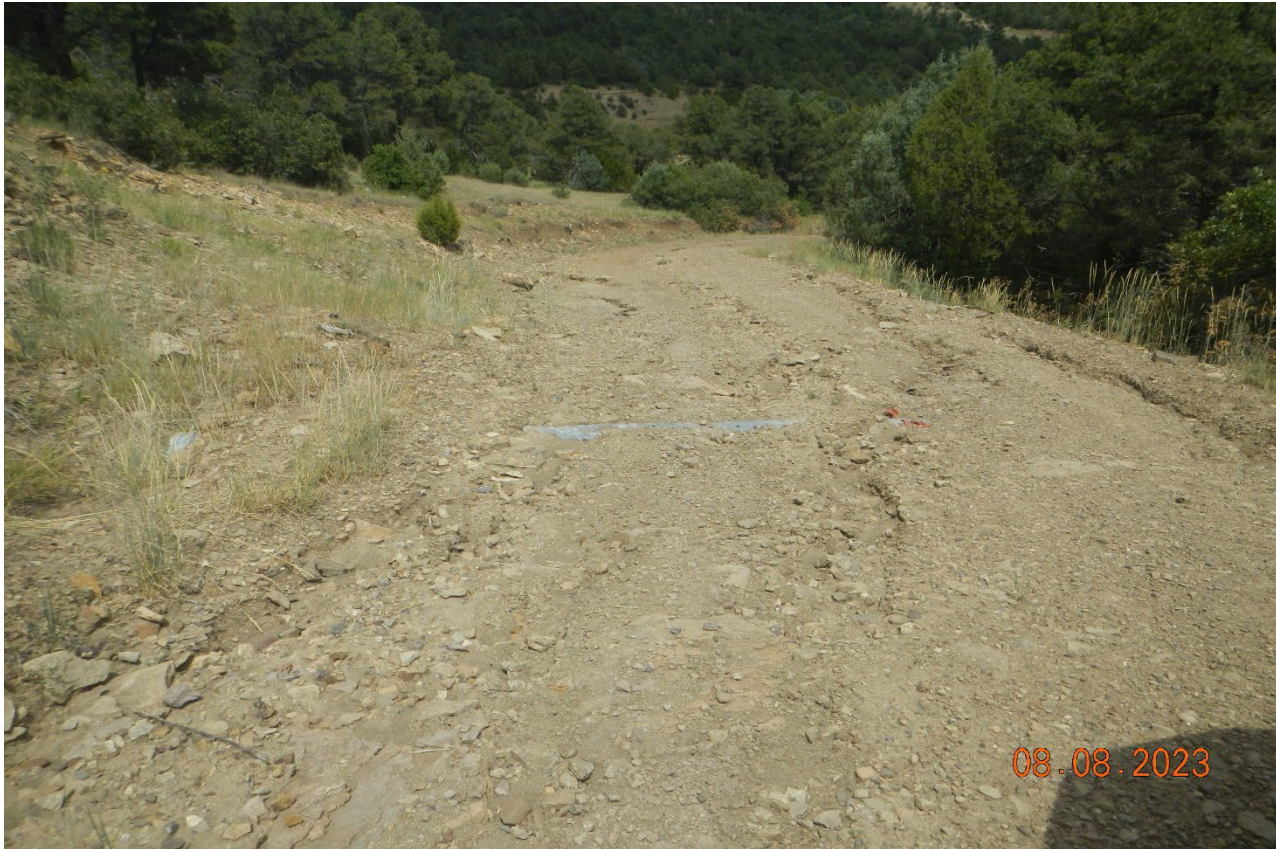
Photo 6. This culvert near the location is partially full of sediment and stormwater is bypassing the culvert causing erosion of the road.
