Inspection Photos

API: 071-07829

Operator: EVERGREEN NATURAL RESOURCES

Inspection Date: 8/8/2023

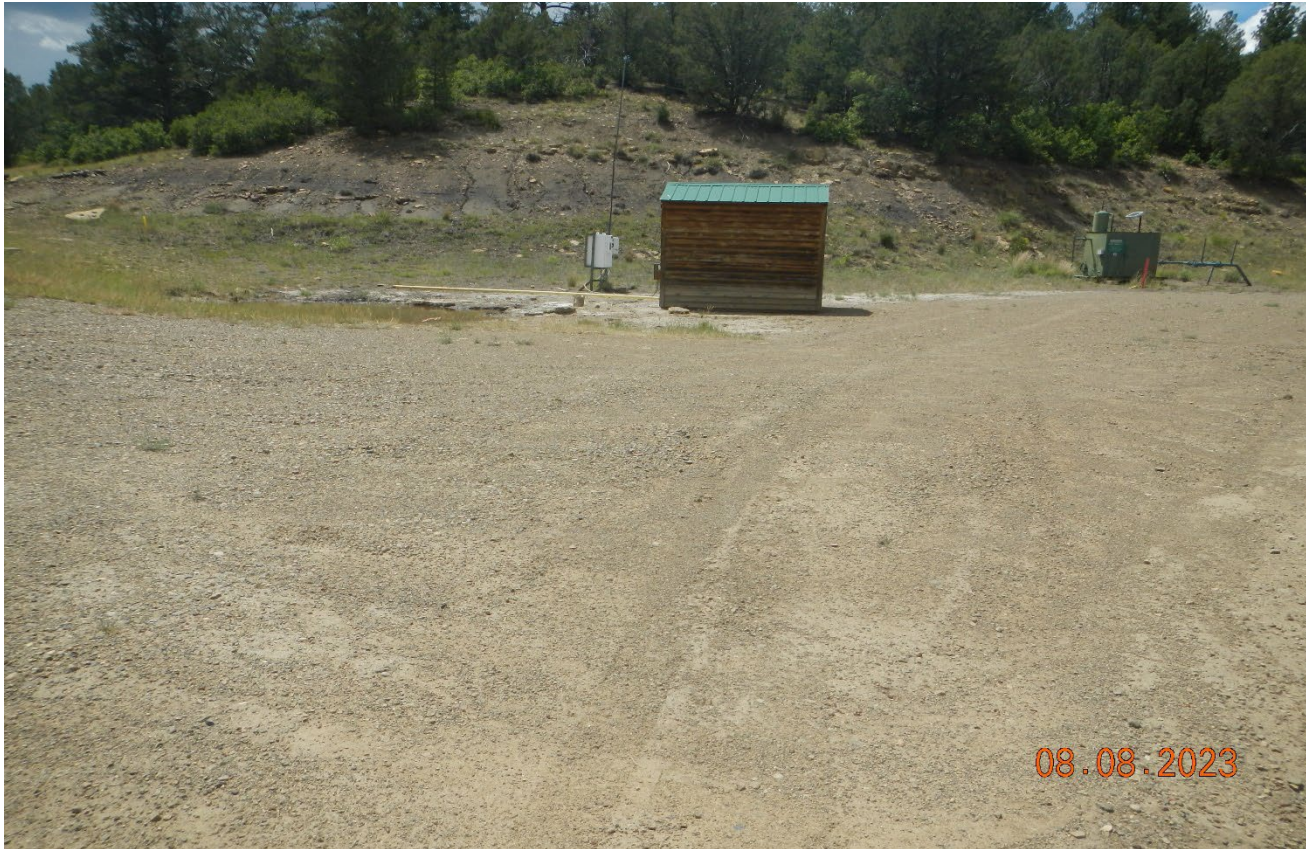
Photo 1. Facing southwest toward the wellsite.

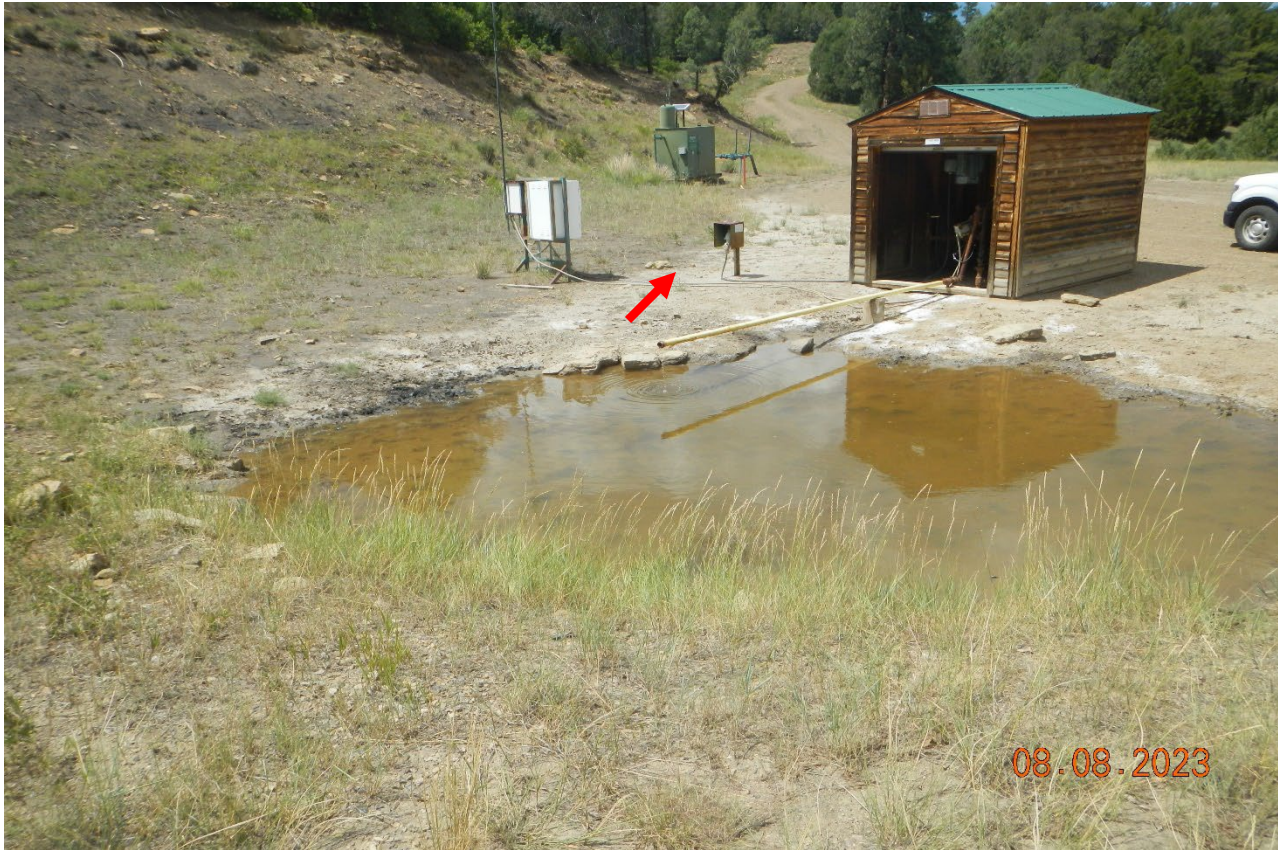
Photo 2. Facing toward the pit which is above freeboard level and is not constructed to allow adequate freeboard. There appears to be whitened soils where water may have over flowed toward the red arrow direction.

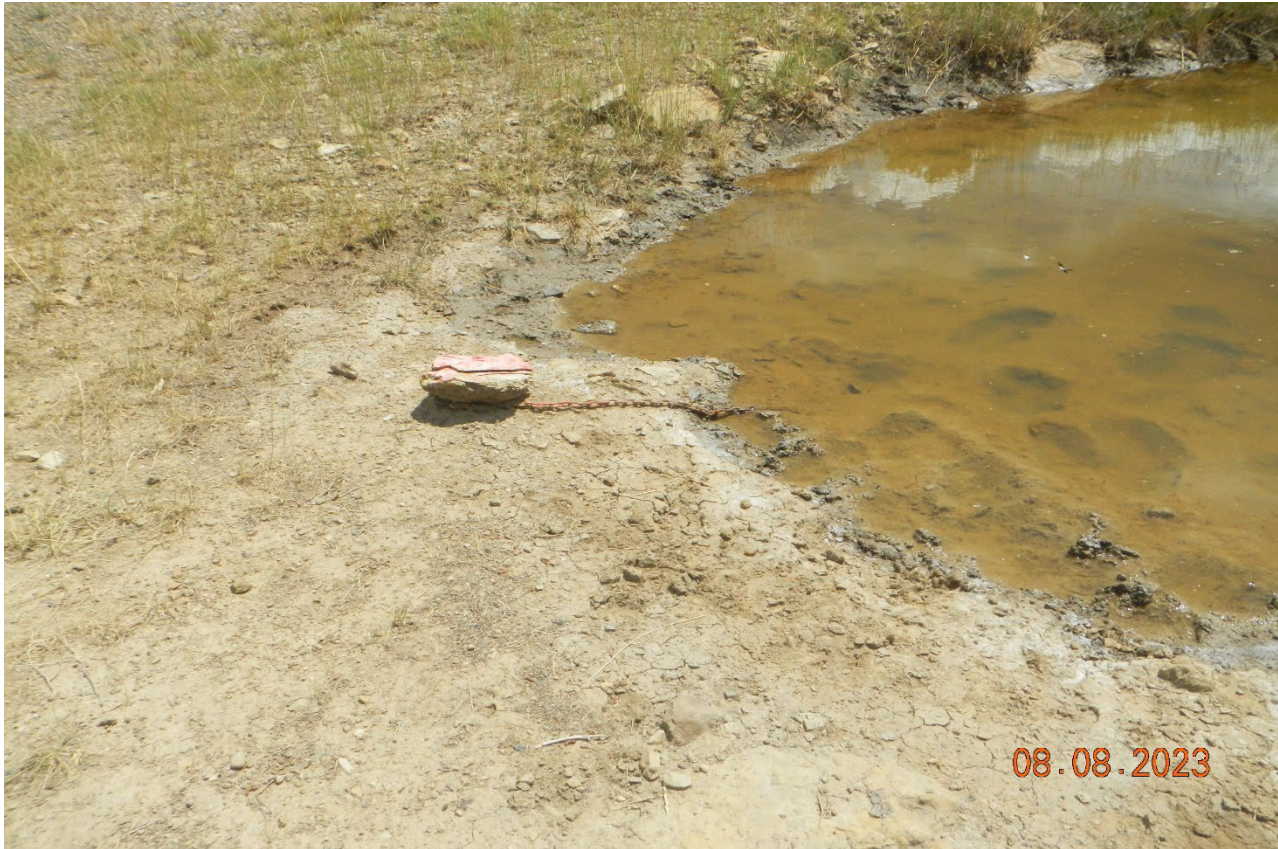
Photo 3. The water level is above freeboard and lays flat n the ground which does not show proper freeboard.

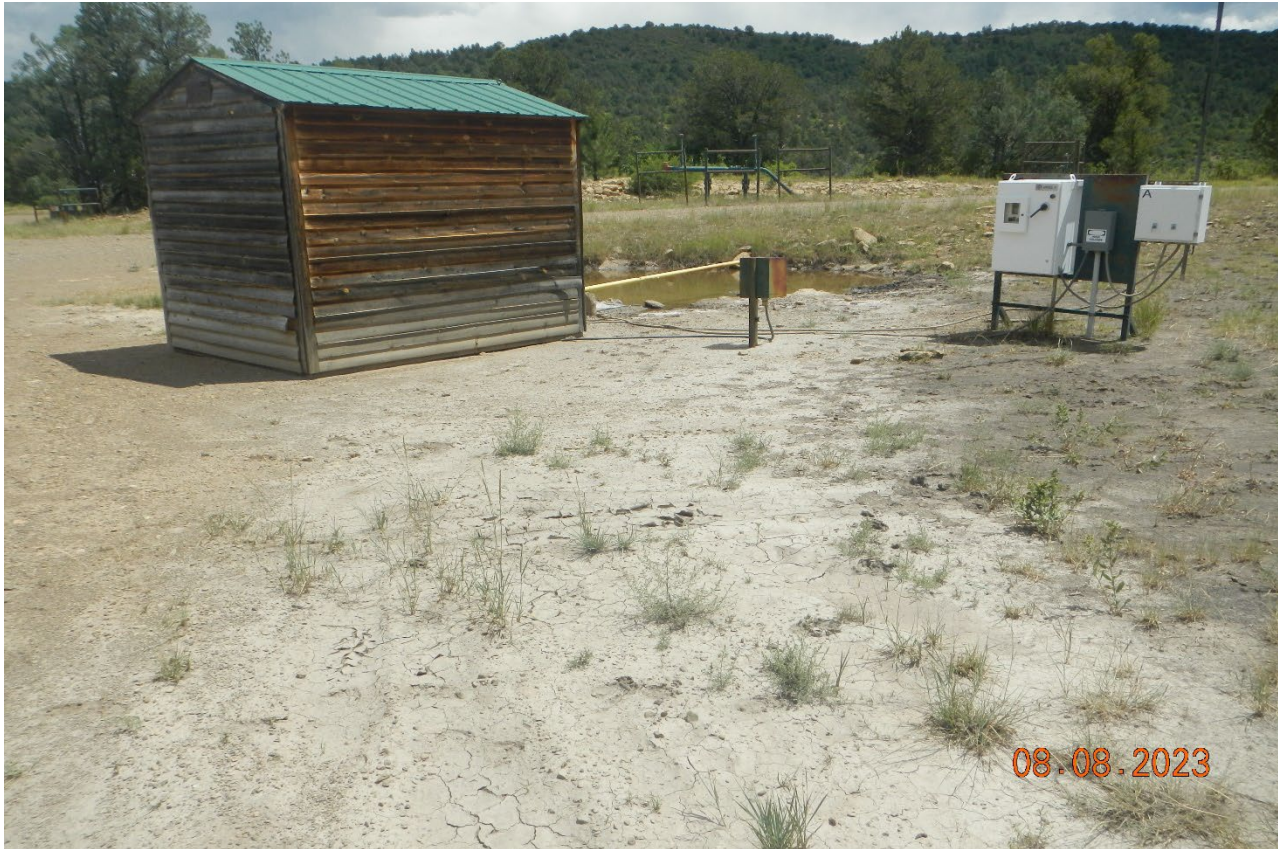
Photo 4. Facing southeast toward the wellsite. There appears to be whitened soils where water may have over flowed toward the red arrow direction.
