**Inspection Photos**  
**Location Name: Perrin-Mahoney #2**  
**Location ID: 336295**

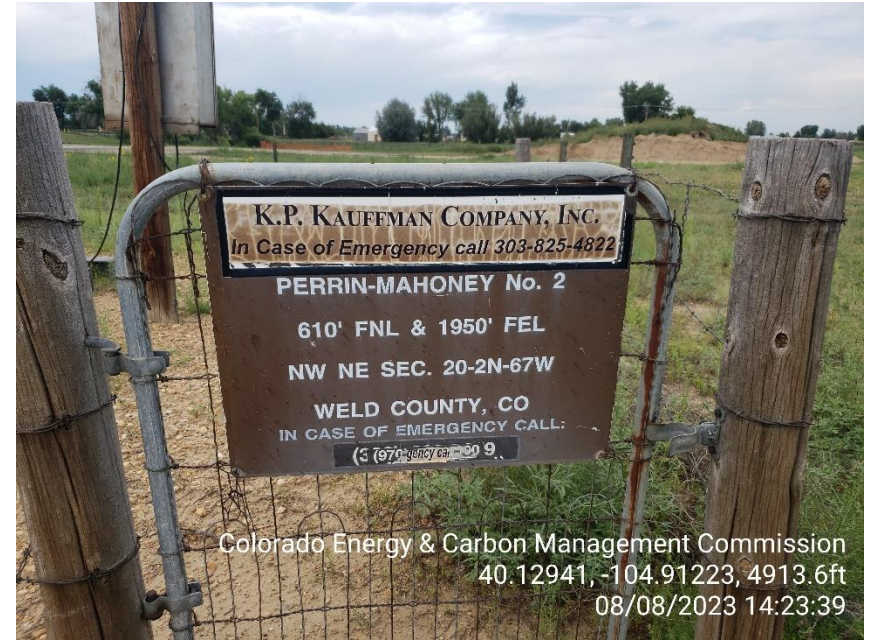
**Photo 2 WH sign.**

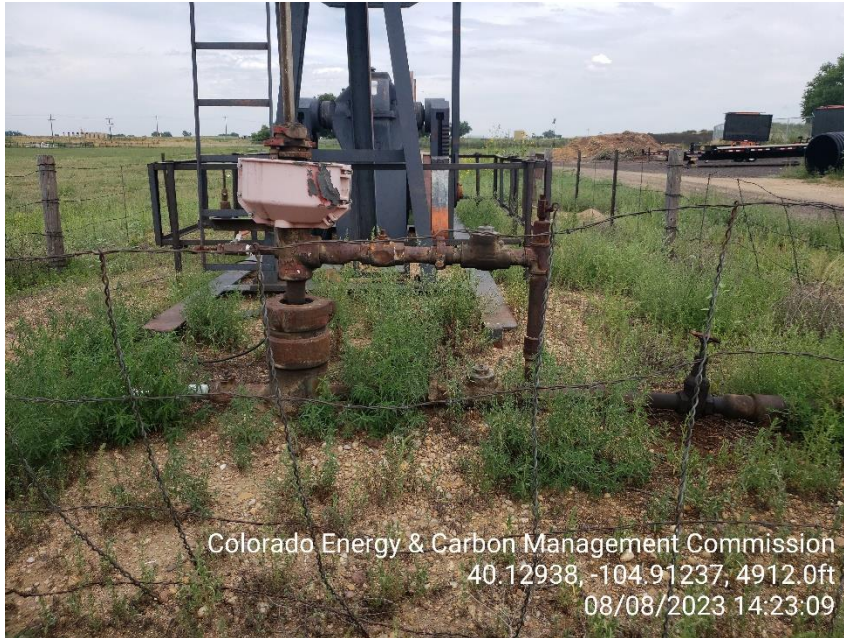
**Photo 3 Undesirable vegetation around the WH.**

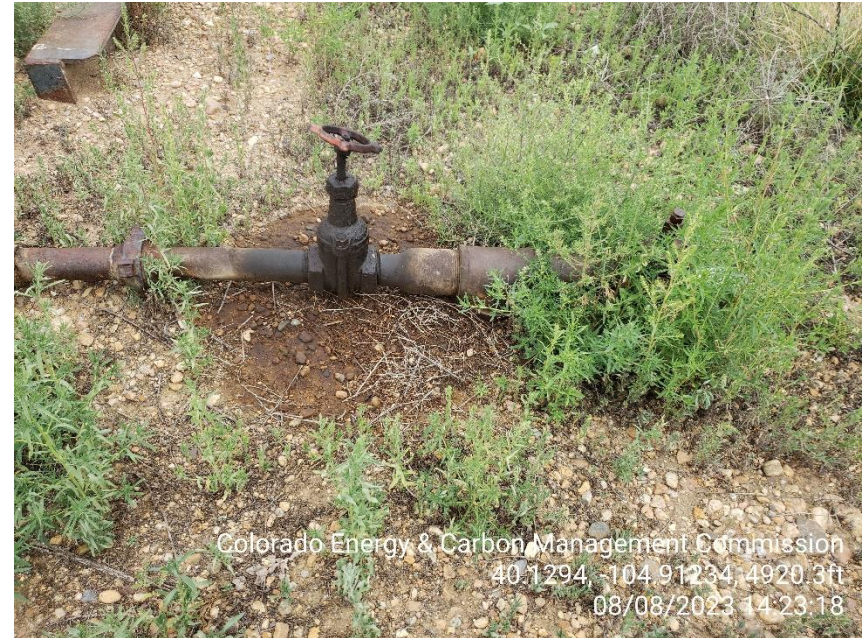
**Photo 4 Stained soil at the WH flow line valve, Undesirable vegetation.**

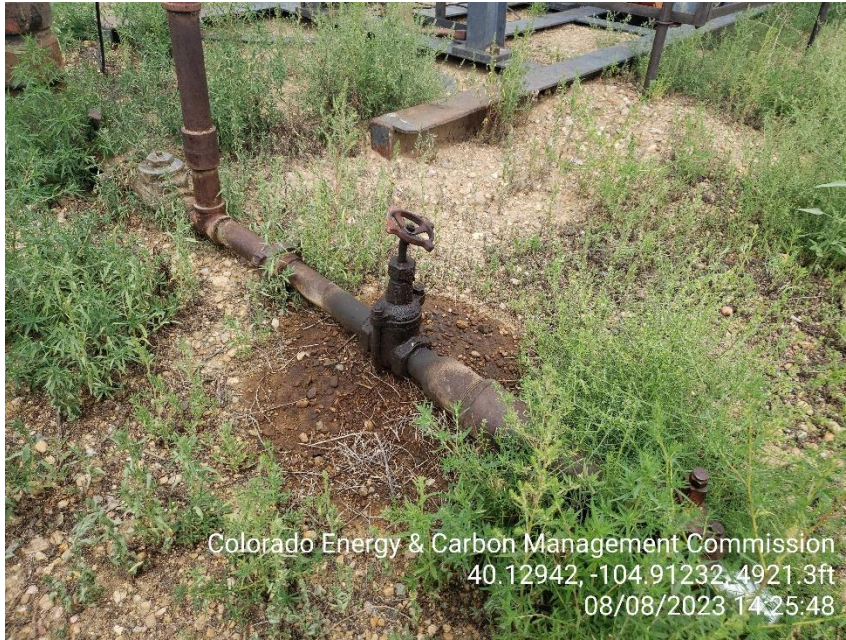
**Photo 5 Stained soil at the WH flow line valve, Undesirable vegetation .**

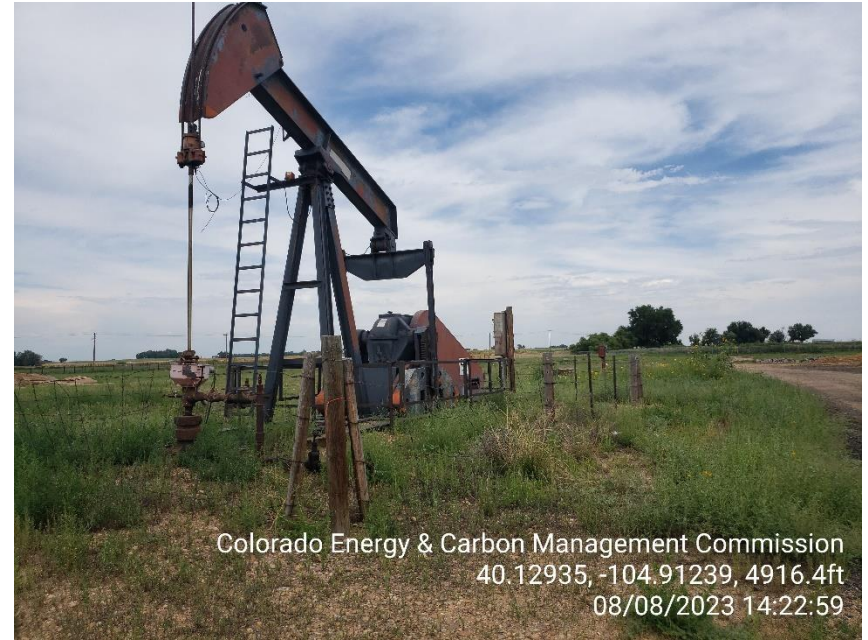
**Photo 6 Undesirable vegetation around location.**

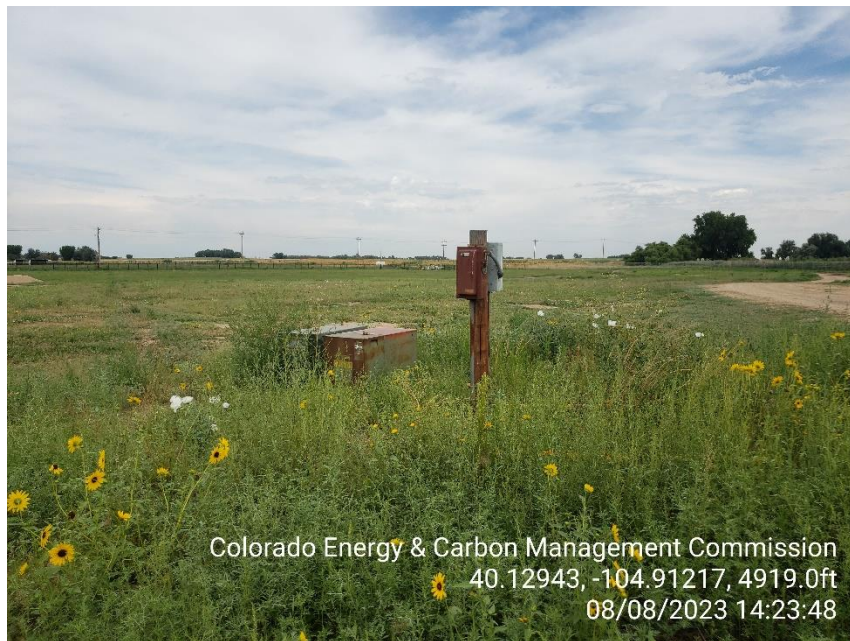
**Photo 7 Undesirable vegetation around ancillary equip.**

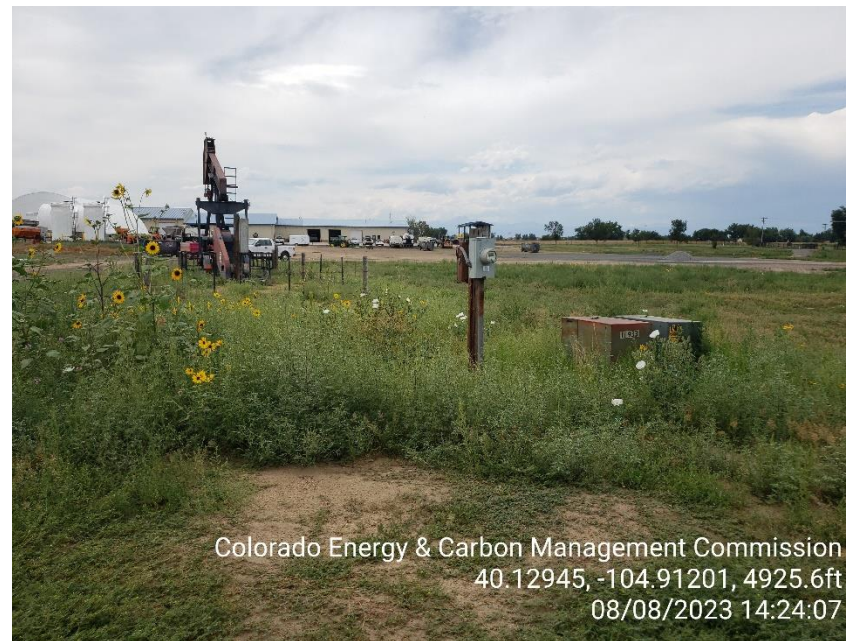
**Photo 8 Undesirable vegetation around location.**

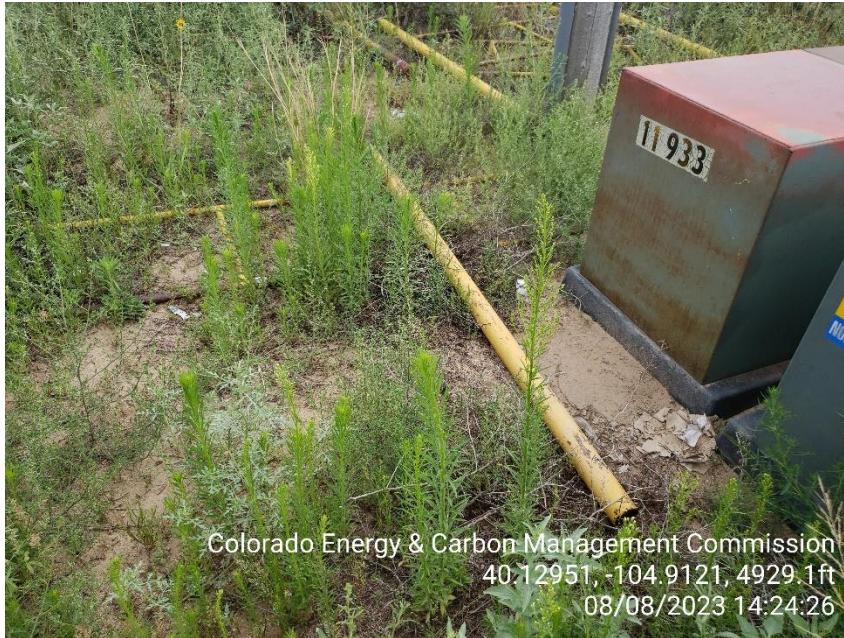
**Photo 9 Undesirable vegetation and trash around ancillary equip.**

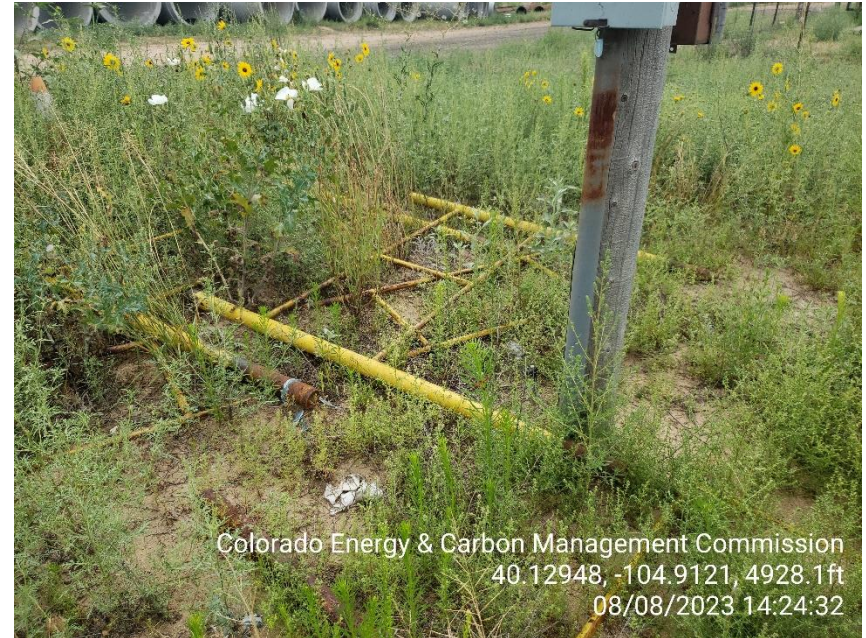
**Photo 10 Undesirable vegetation and trash around location.**
