Caerus Piceance LLC  
Piceance Creek Unit-62S97W 11SESE  
Loc ID: 335771

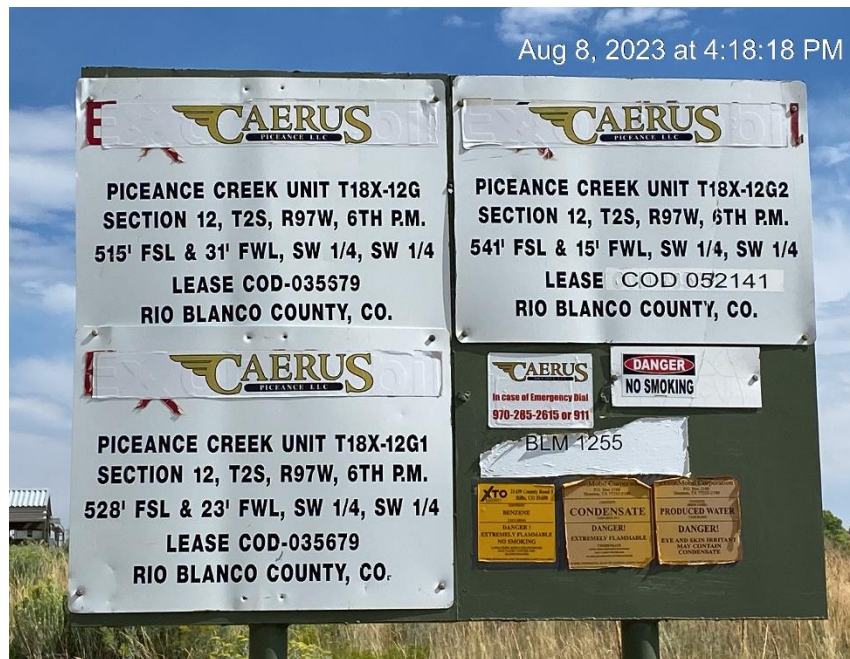
Location entrance sign. Additional information required as signs are replaced.

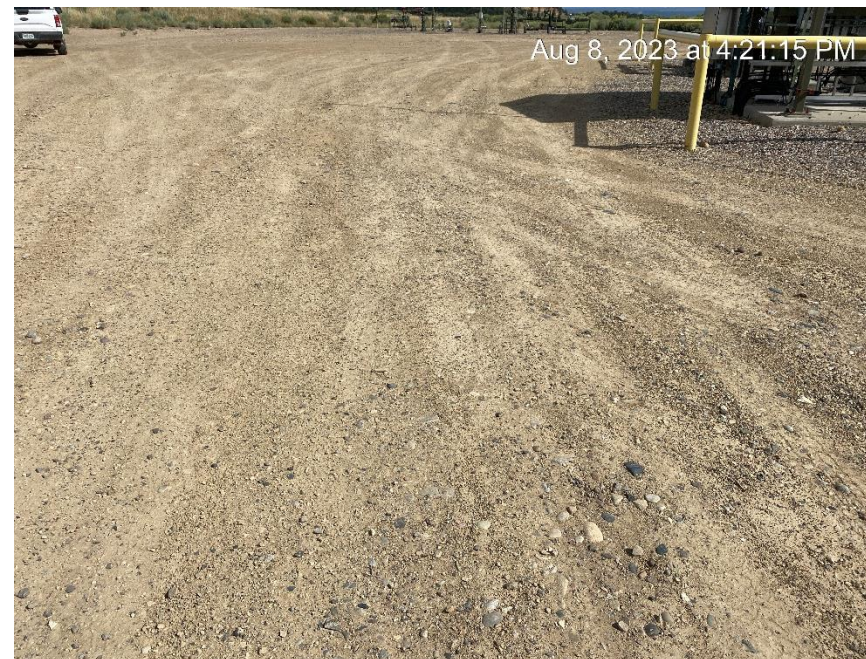
Entrance to location

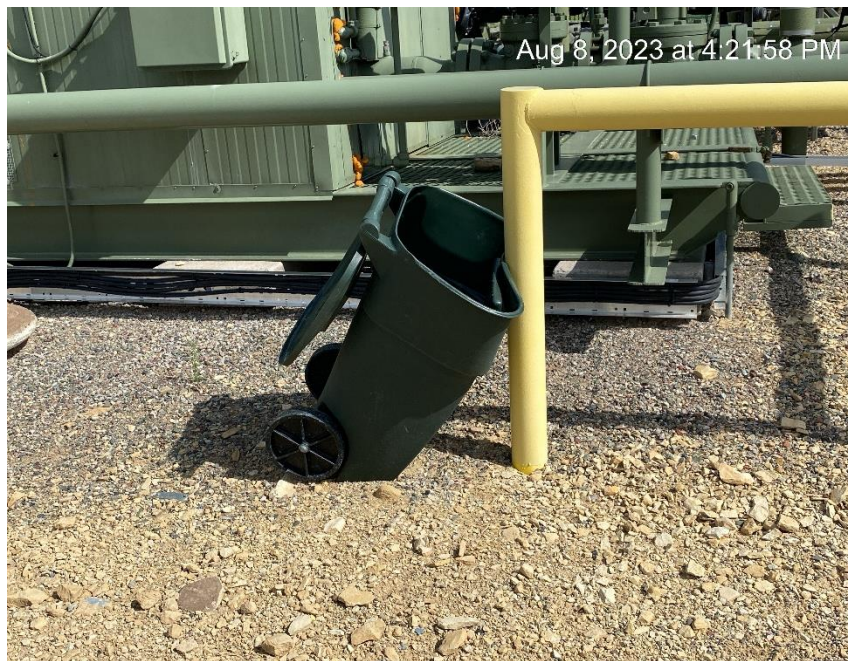
Debris

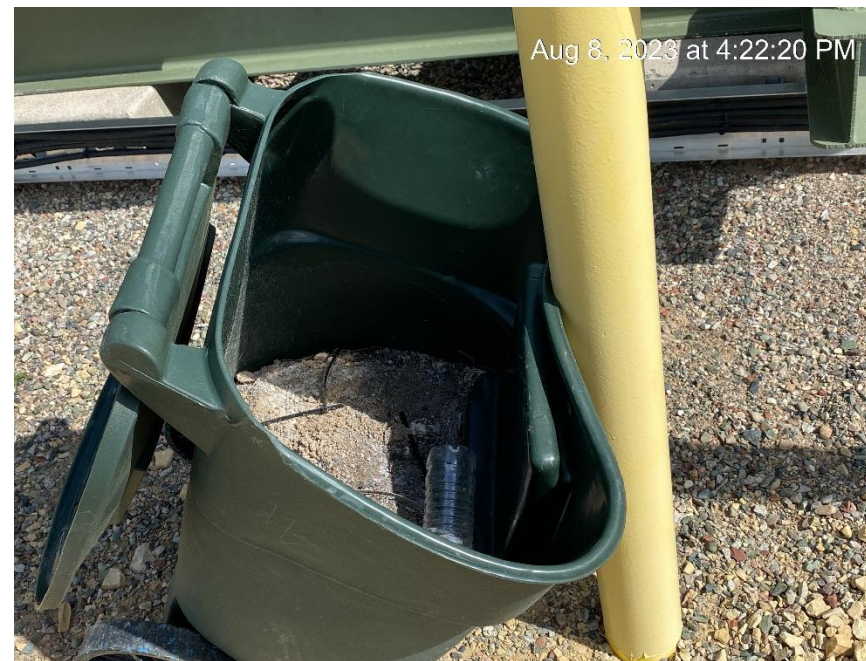
Debris

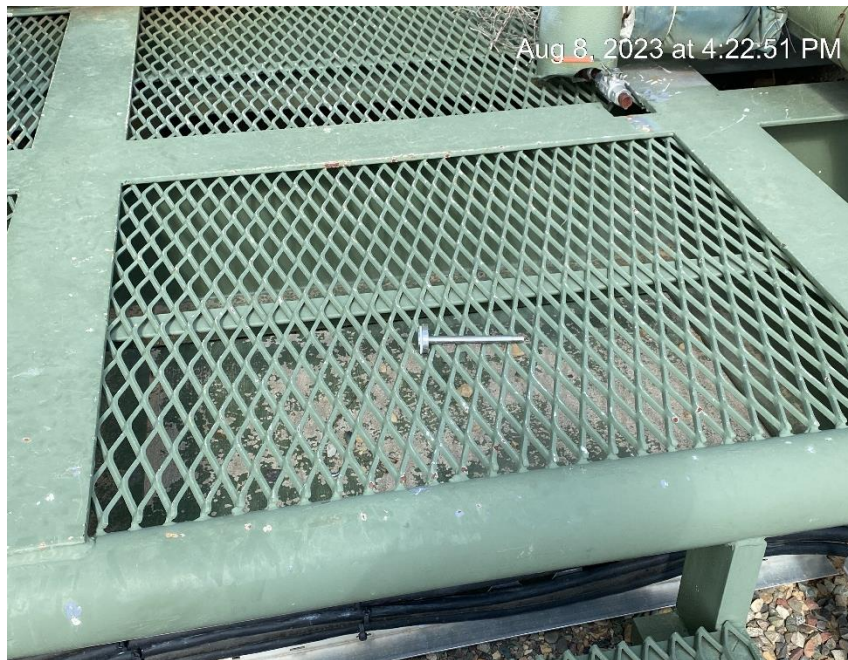
Debris

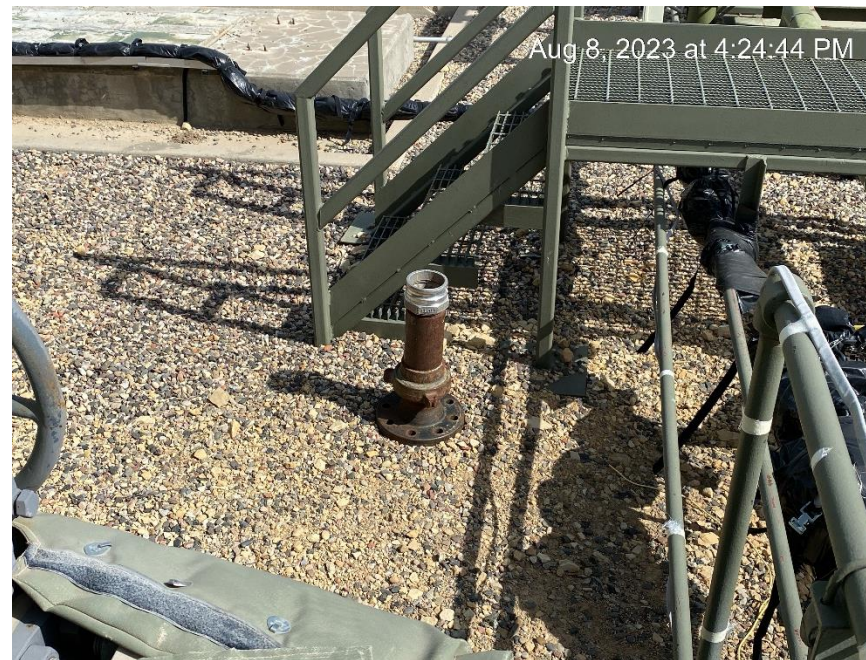
Debris

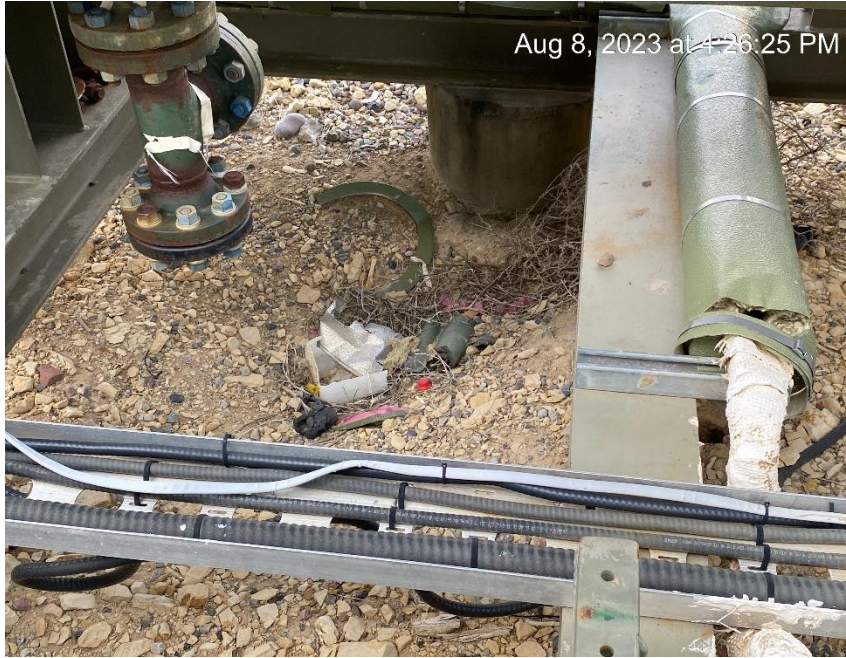
**Debris**

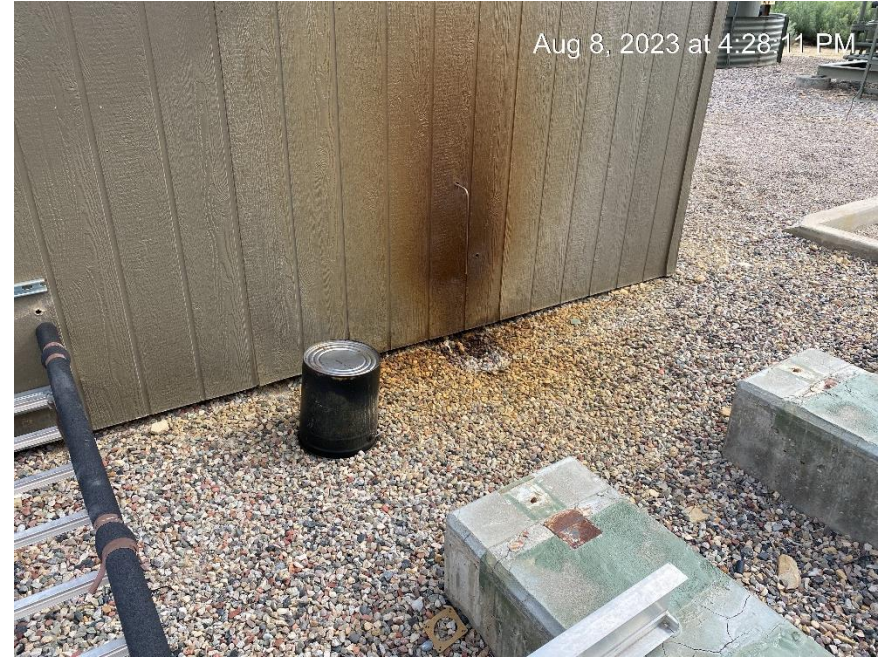
**Debris. Soil staining.**

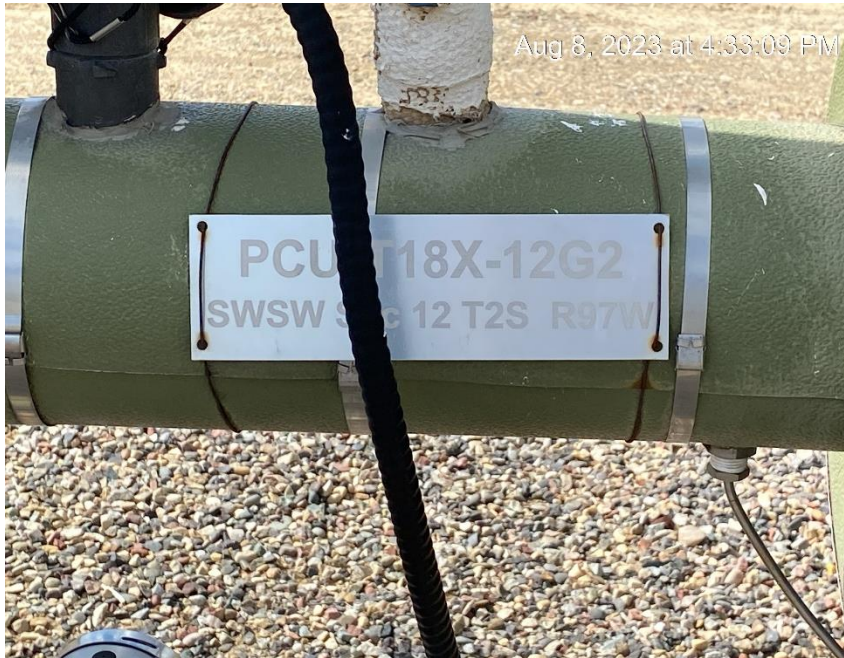
Well sign missing required information

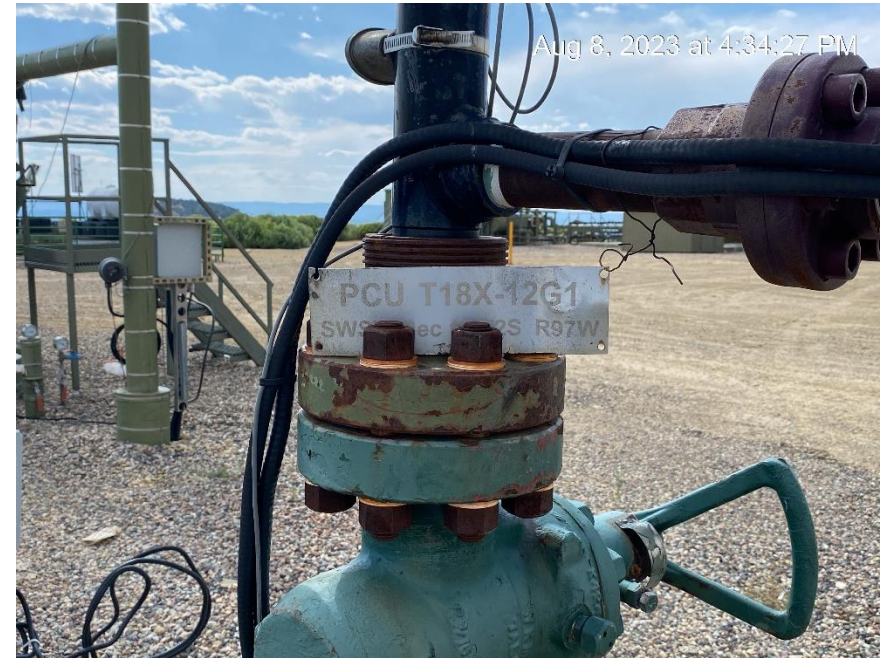
Well sign missing required information

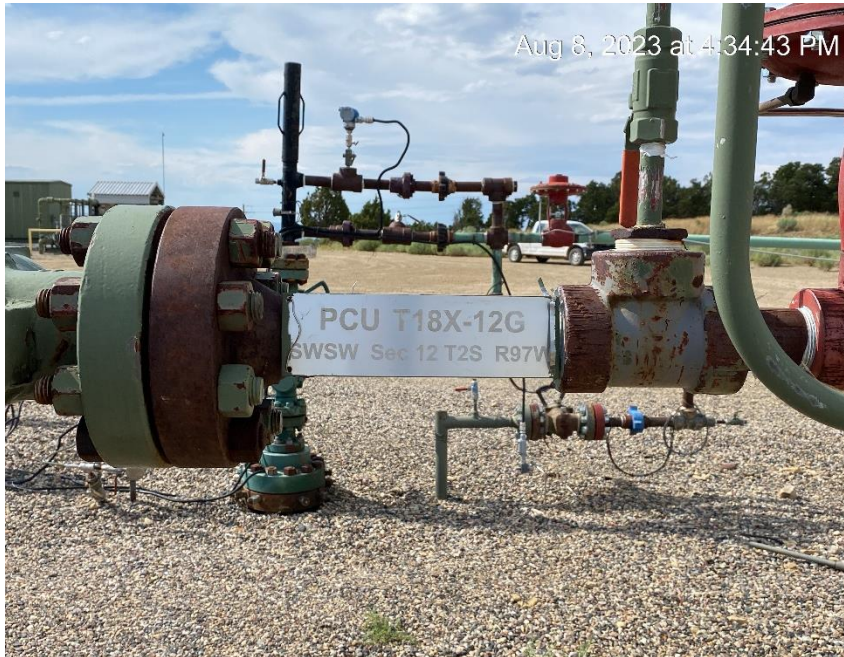
**Well sign missing required information**

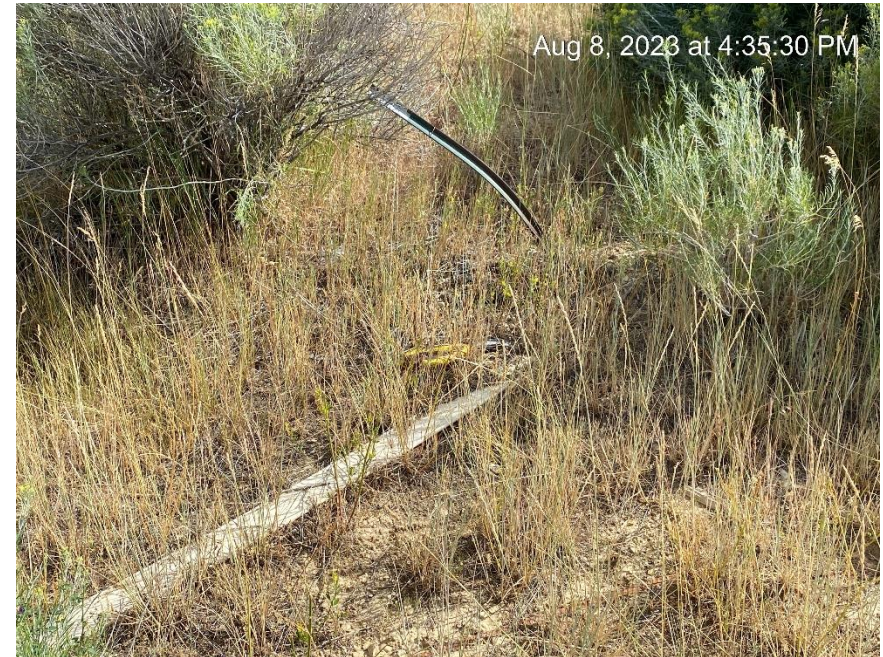
**Unmarked anchor**
