Inspection Photos
Location Name: CAERUS PICEANCE LLC J23NW Pad
Location #: 335405

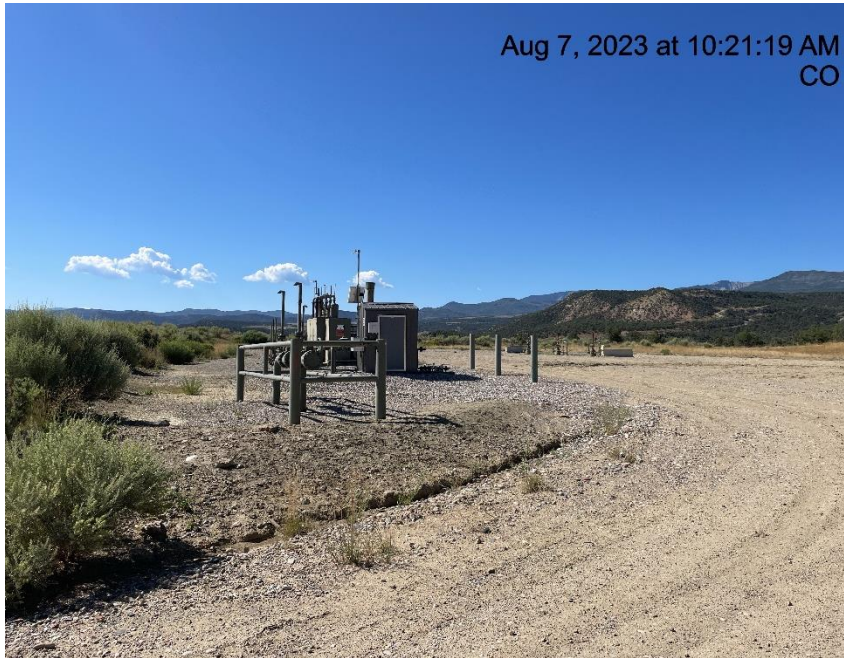
Photo # 4906 From entrance to location

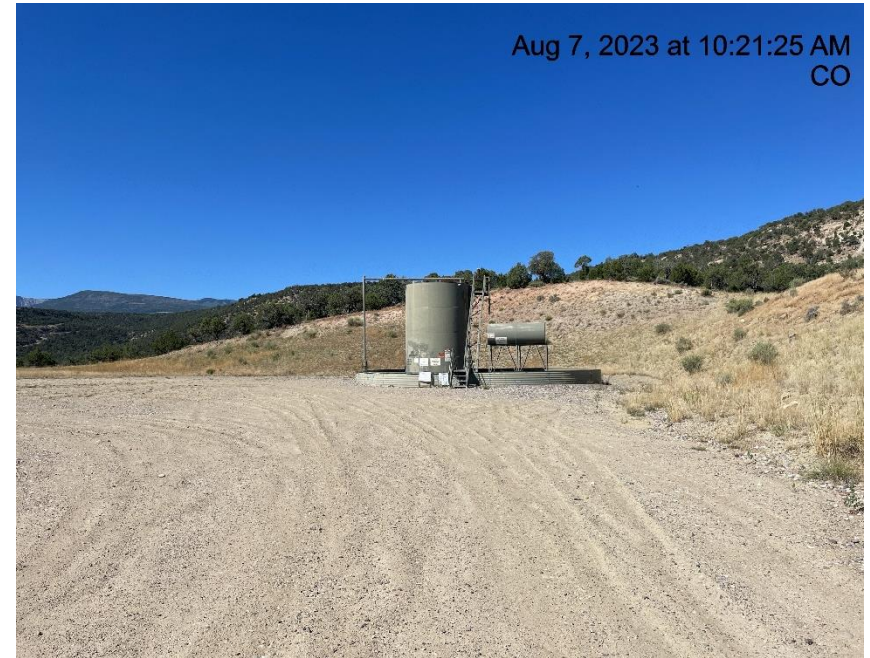
Photo # 4907 From entrance to location

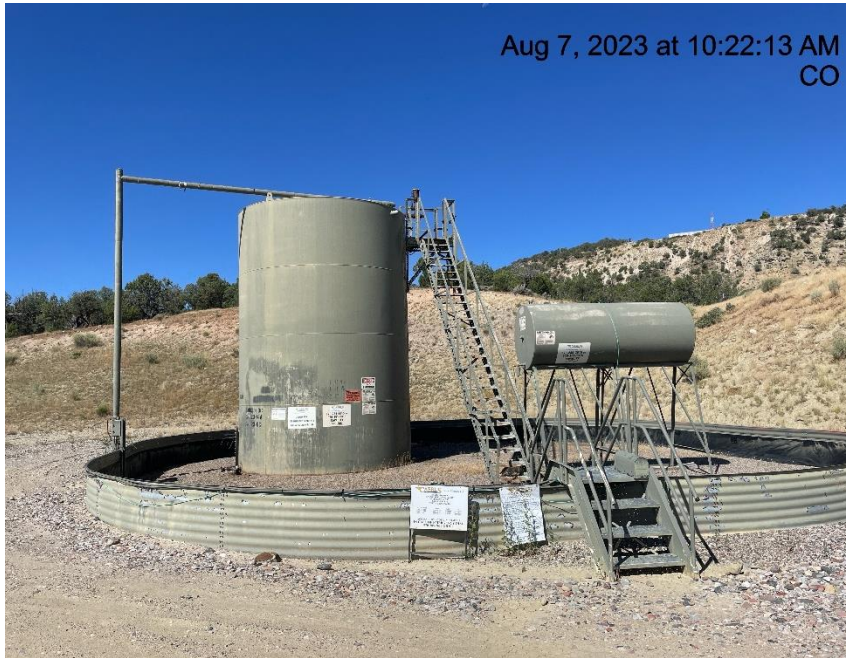
Photo # 4908 Location

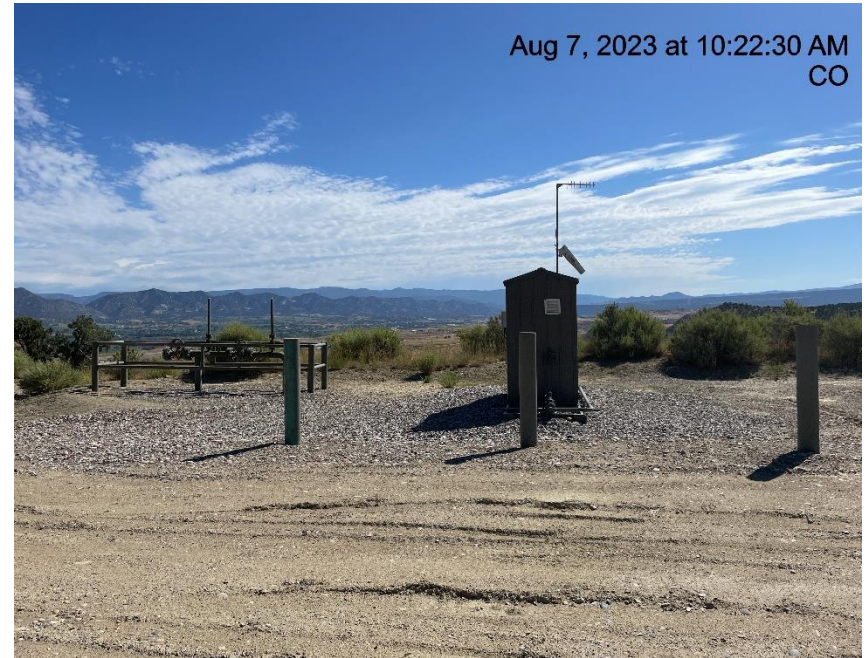
Photo # 4909 Location

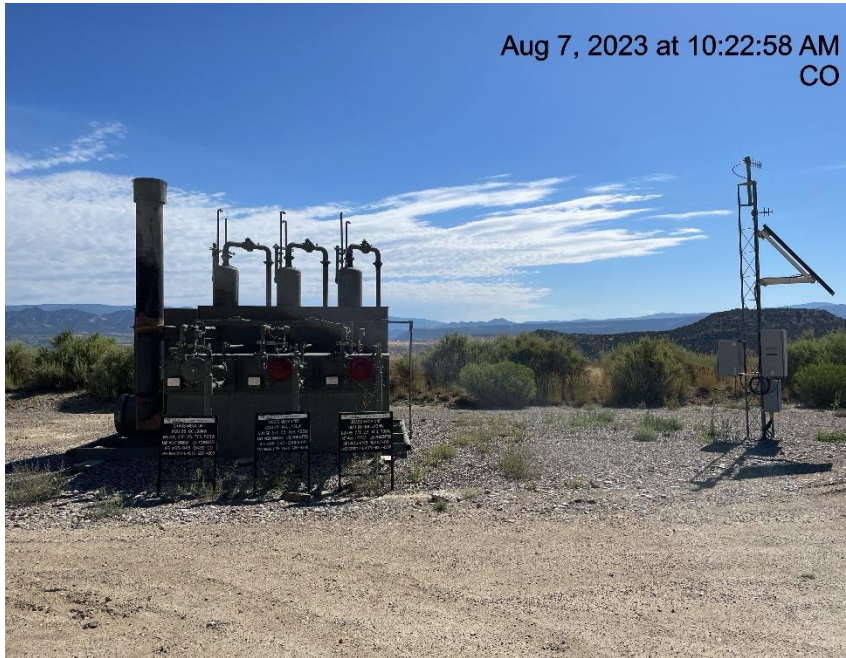
Photo # 4910 Location

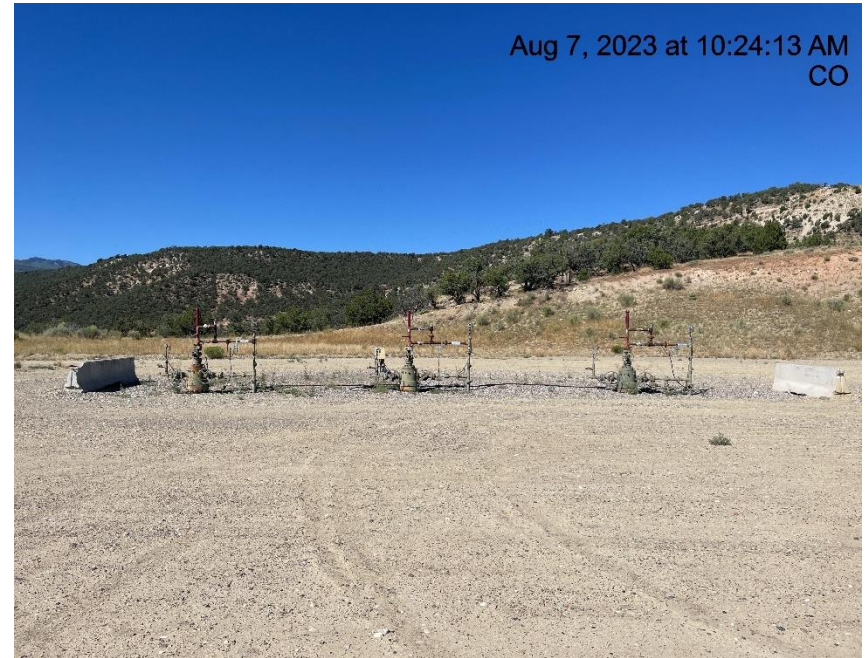
Photo # 4911 Location

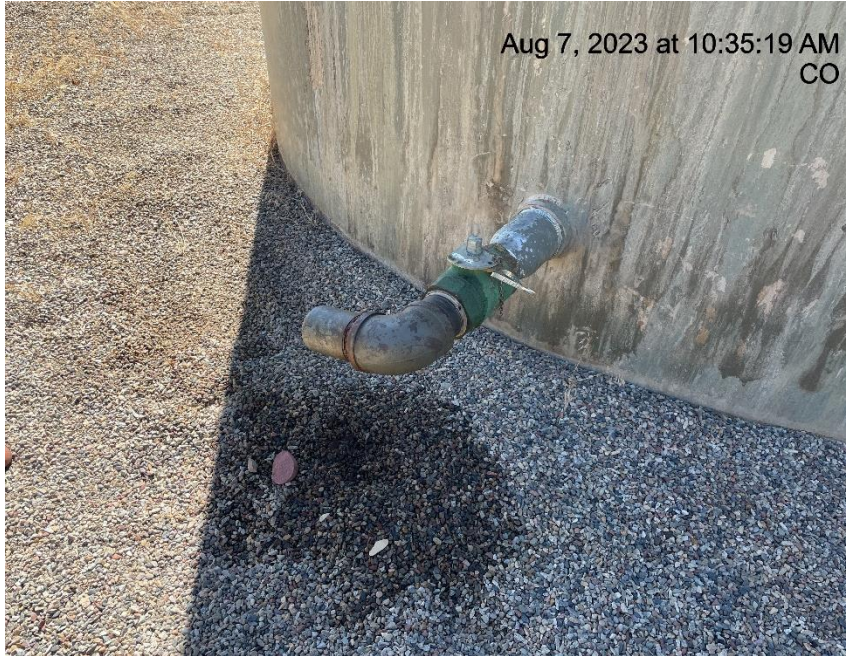
Photo # 4954 Stained gravel

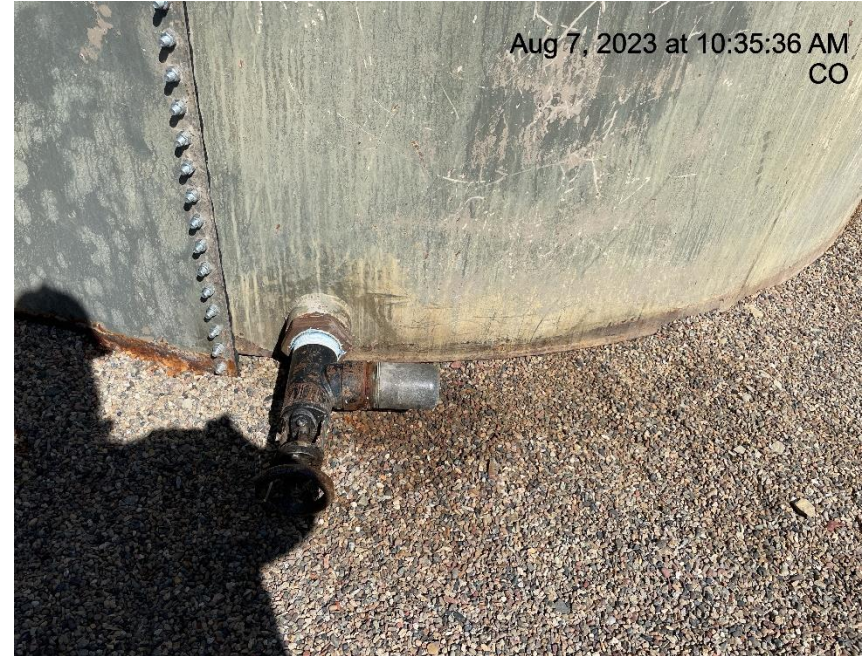
Photo # 4955 Stained gravel

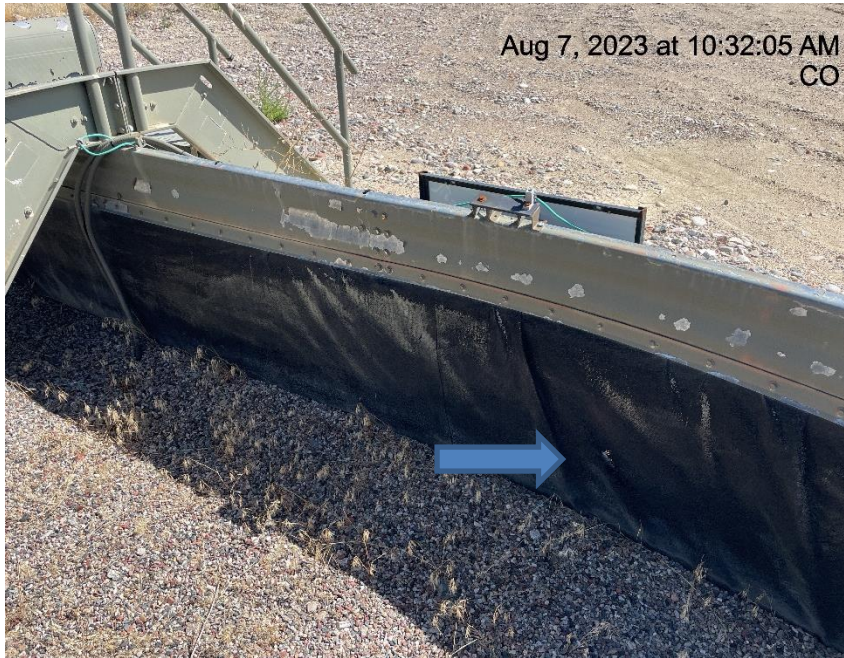
Photo # 4930 Secondary containment liner needs maintenance

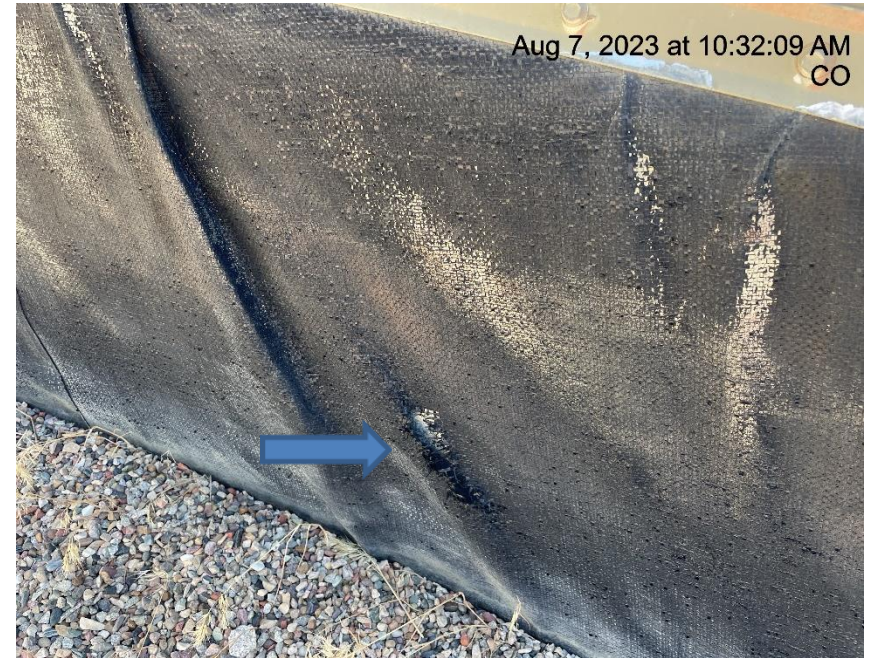
Photo # 4931 Secondary containment liner needs maintenance

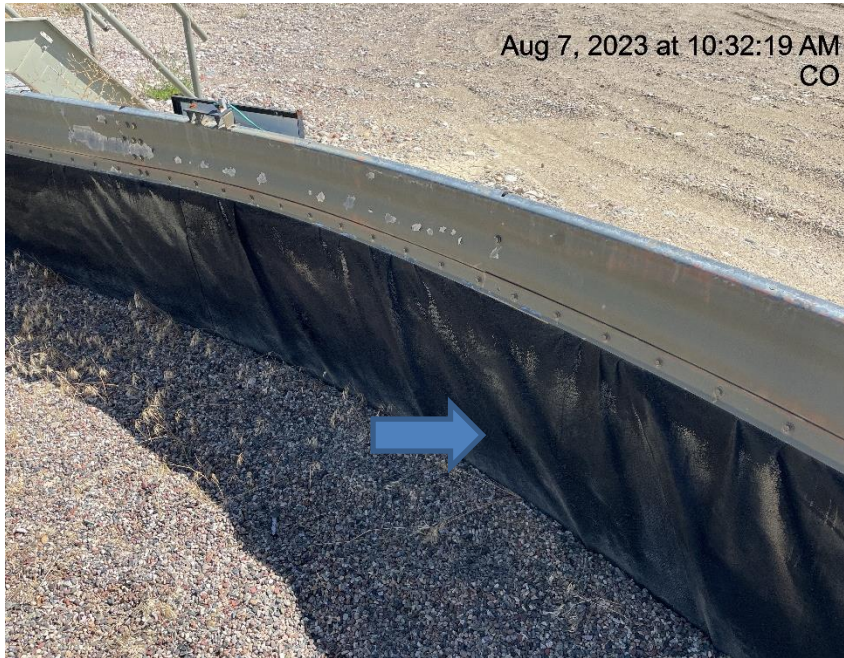
Photo # 4932 Secondary containment liner needs maintenance

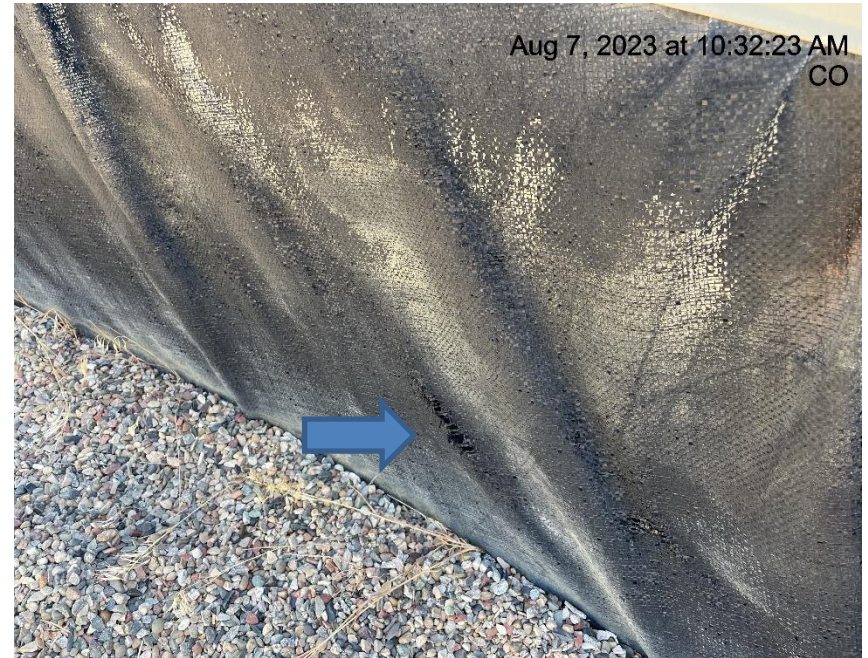
Photo # 4933 Secondary containment liner needs maintenance

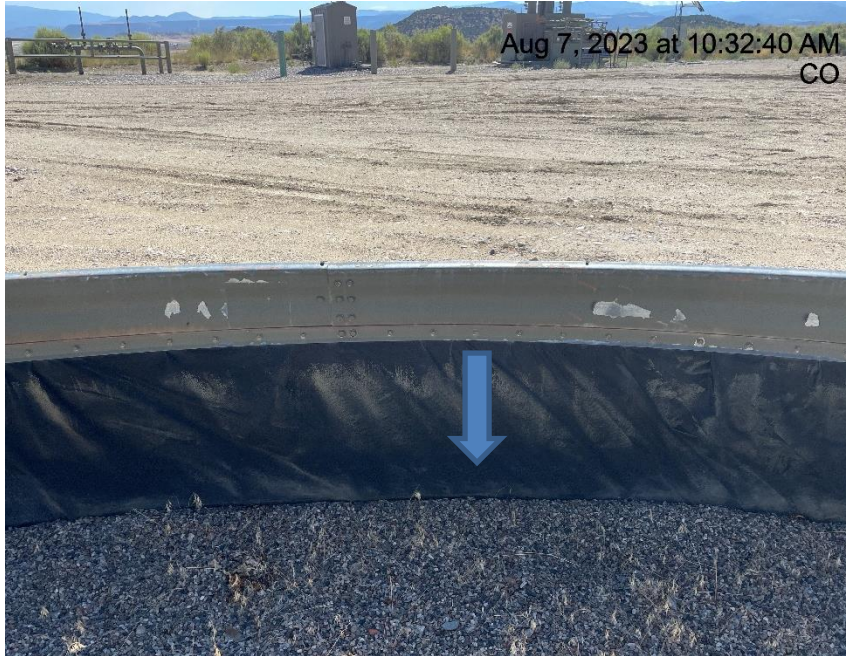
Photo # 4934 Secondary containment liner needs maintenance

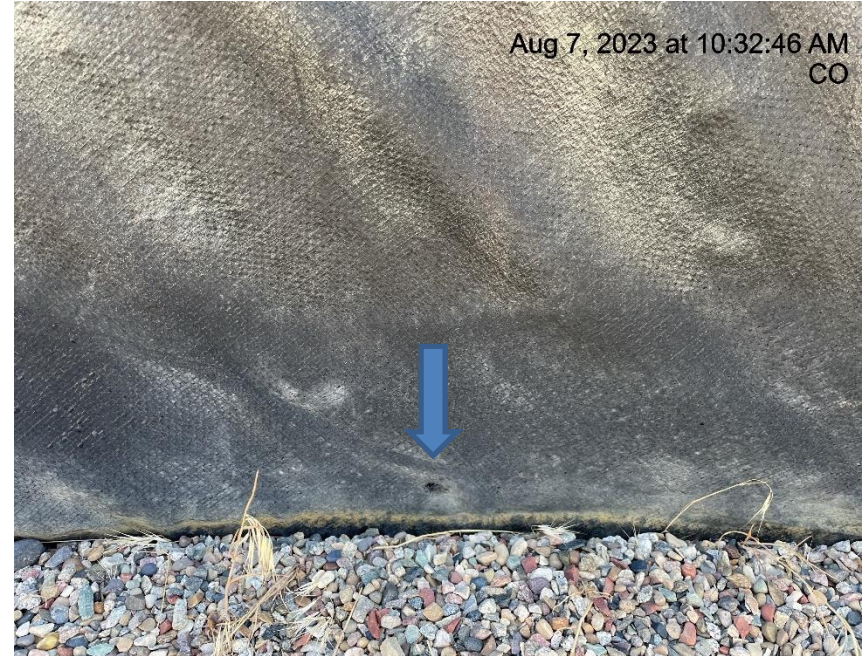
Photo # 4988 Secondary containment liner needs maintenance

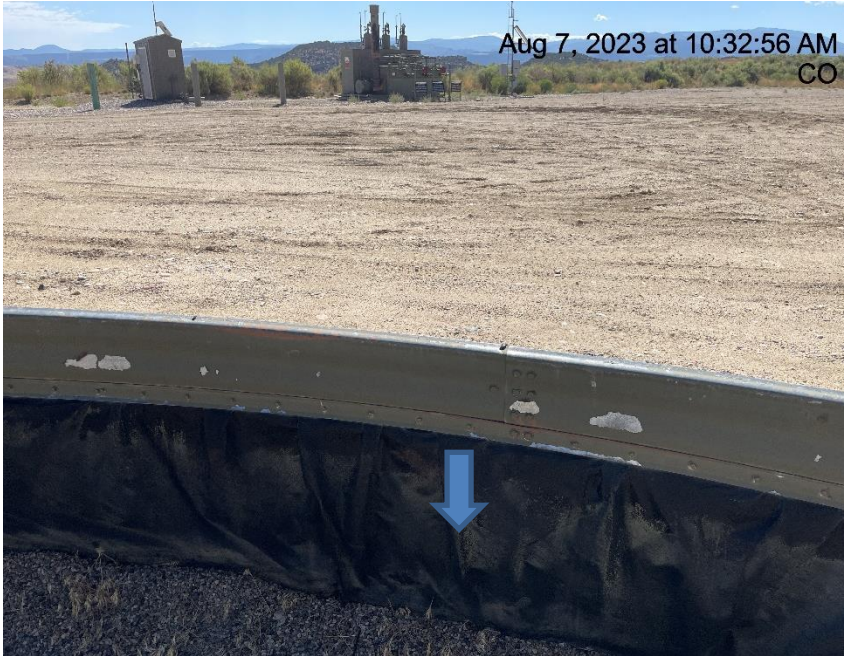
Photo # 4937 Secondary containment liner needs maintenance

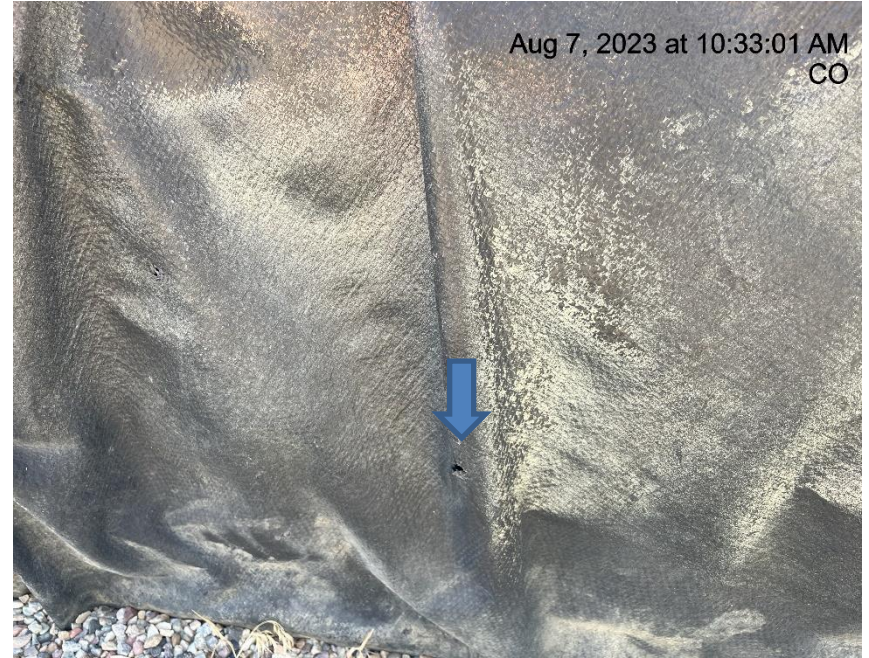
Photo # 5000 Secondary containment liner needs maintenance

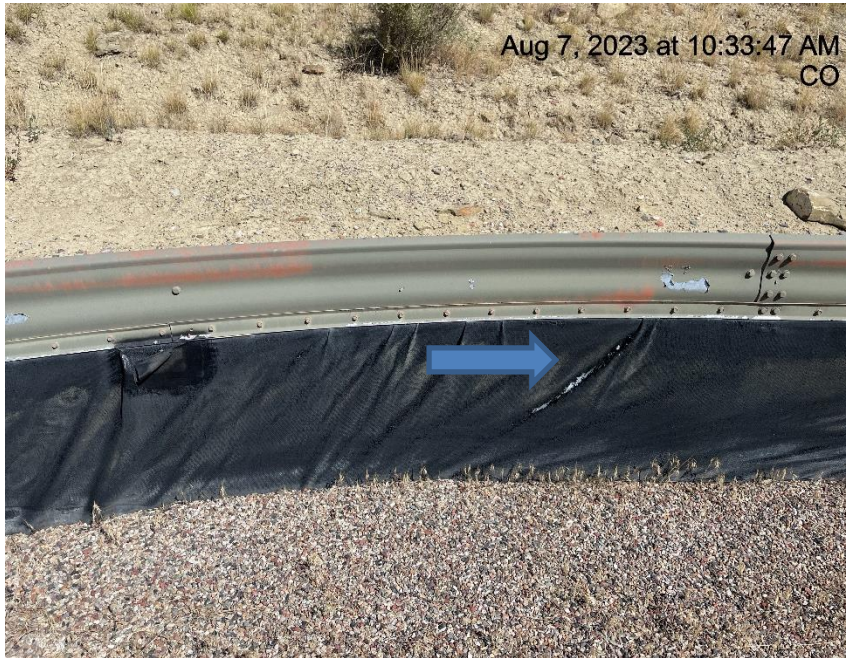
Photo # 4941 Secondary containment liner needs maintenance

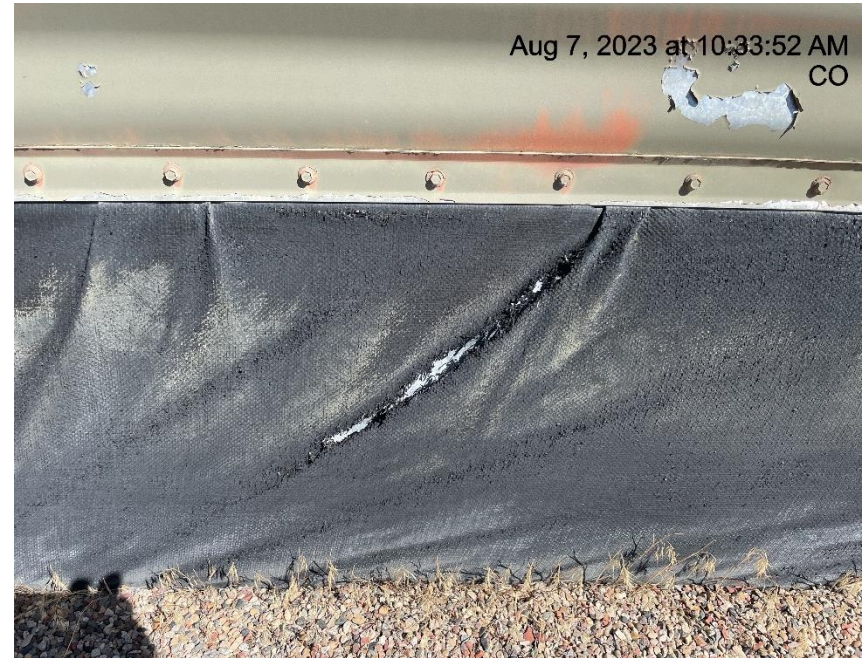
Photo # 4942 Secondary containment liner needs maintenance

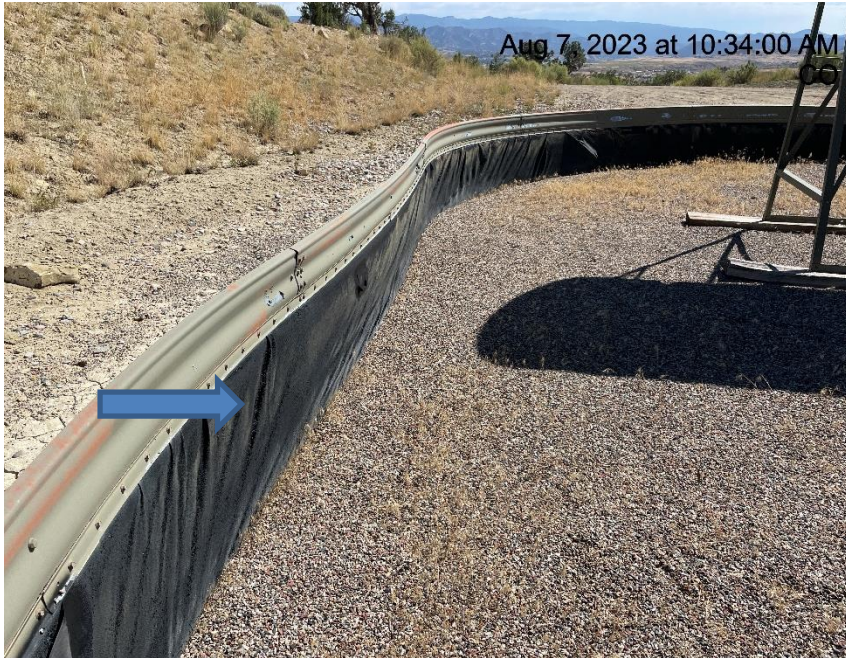
Photo # 4943 Secondary containment liner needs maintenance

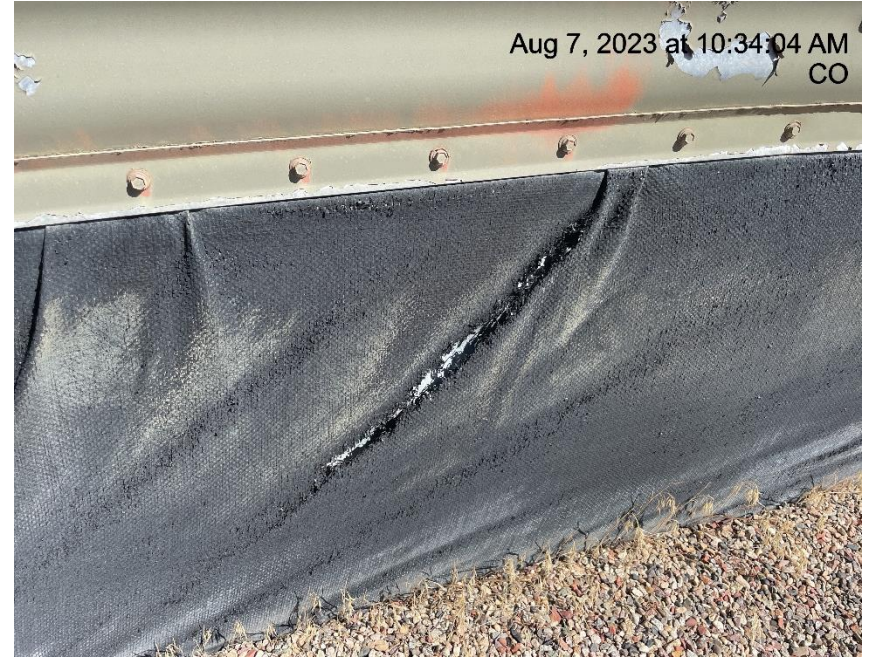
Photo # 4944 Secondary containment liner needs maintenance

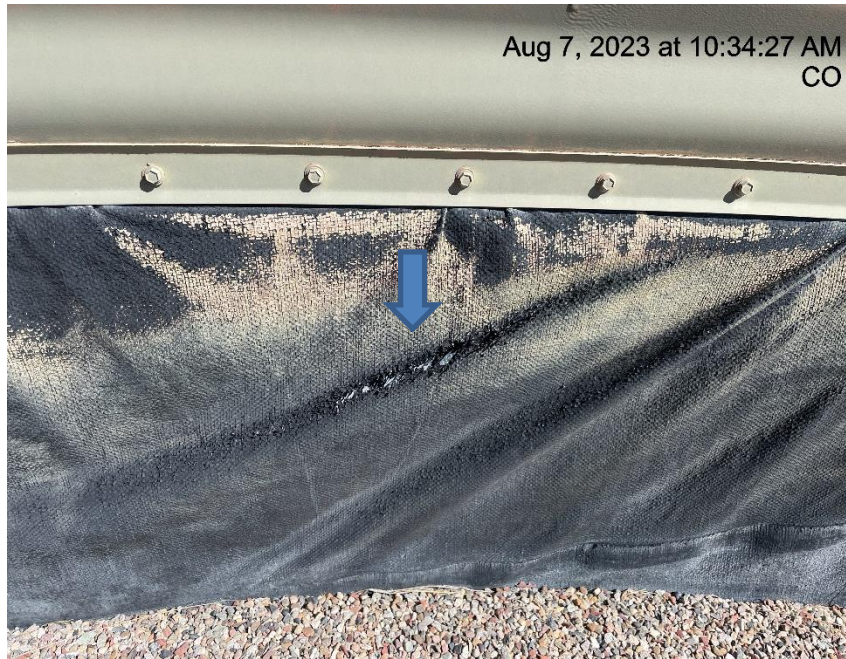
Photo # 4947 Secondary containment liner needs maintenance

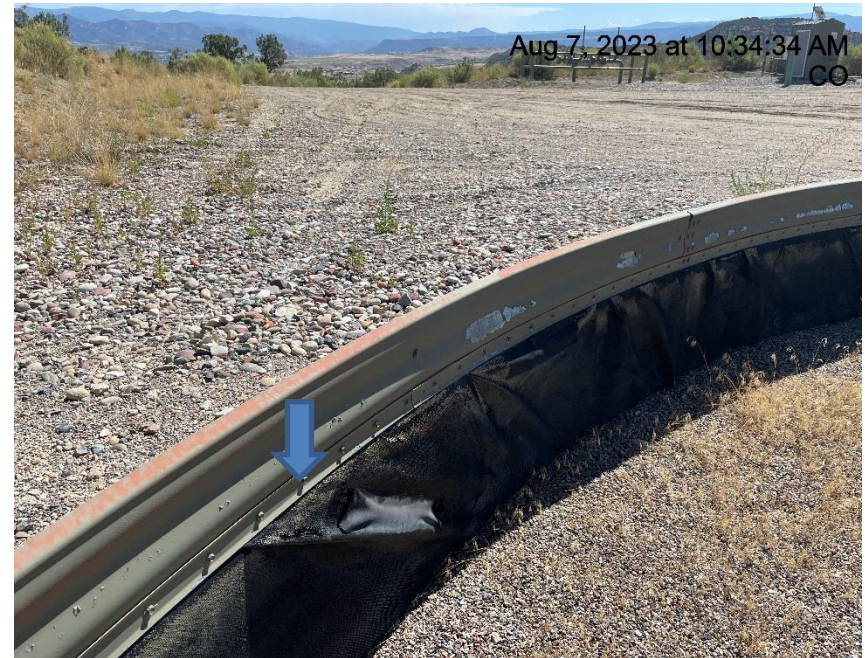
Photo # 4948 Secondary containment liner needs maintenance

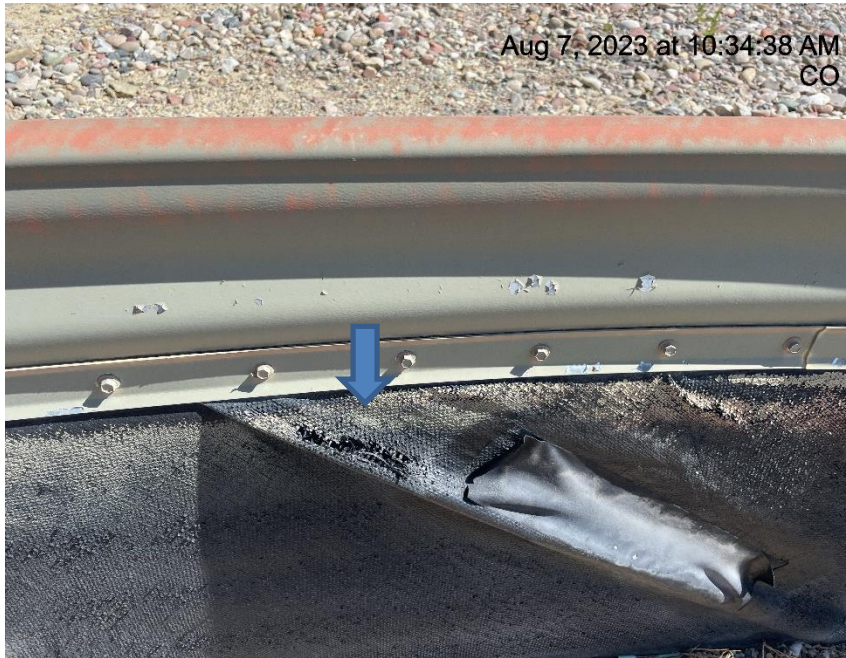
Photo # 4949 Secondary containment liner needs maintenance

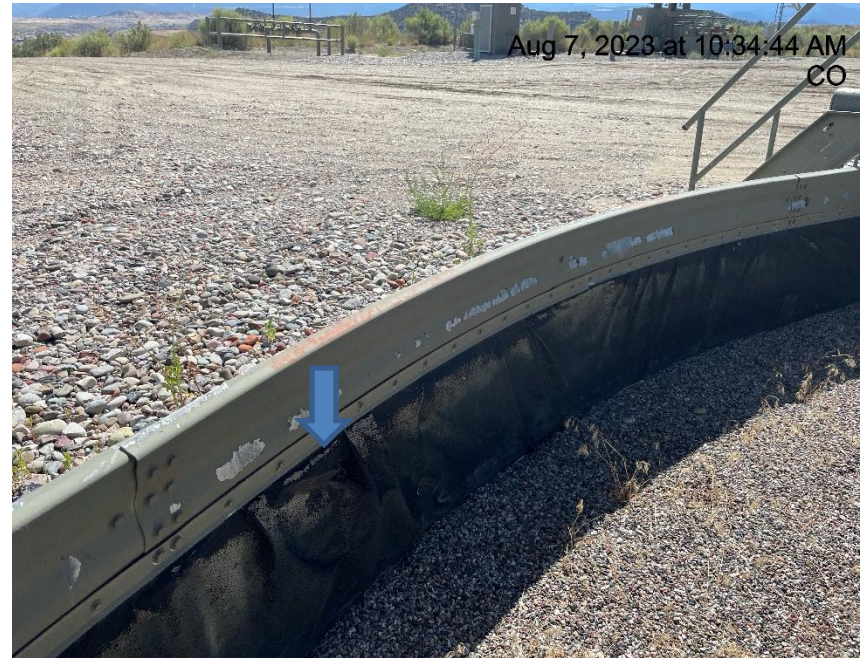
Photo # 5950 Secondary containment liner needs maintenance

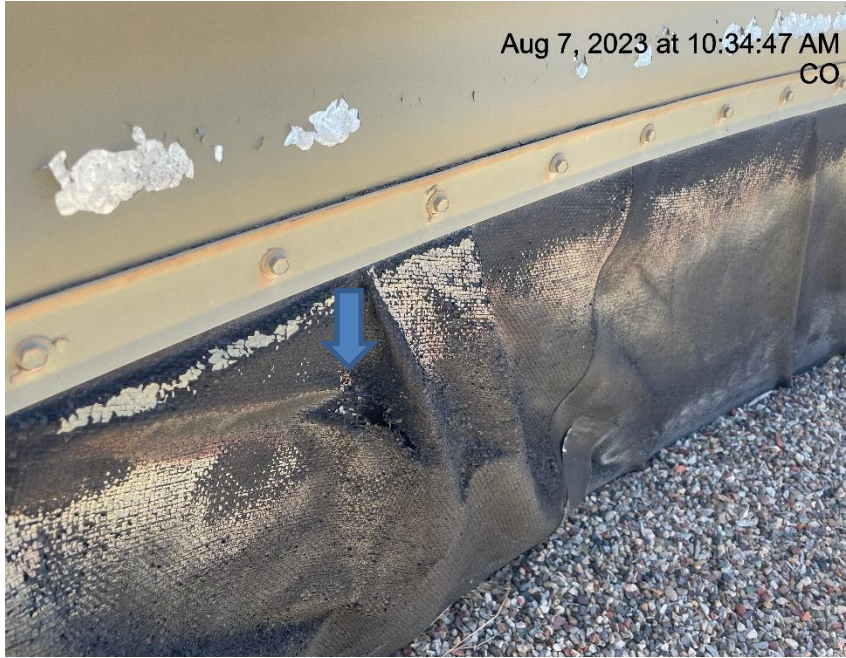
Photo # 4951 Secondary containment liner needs maintenance

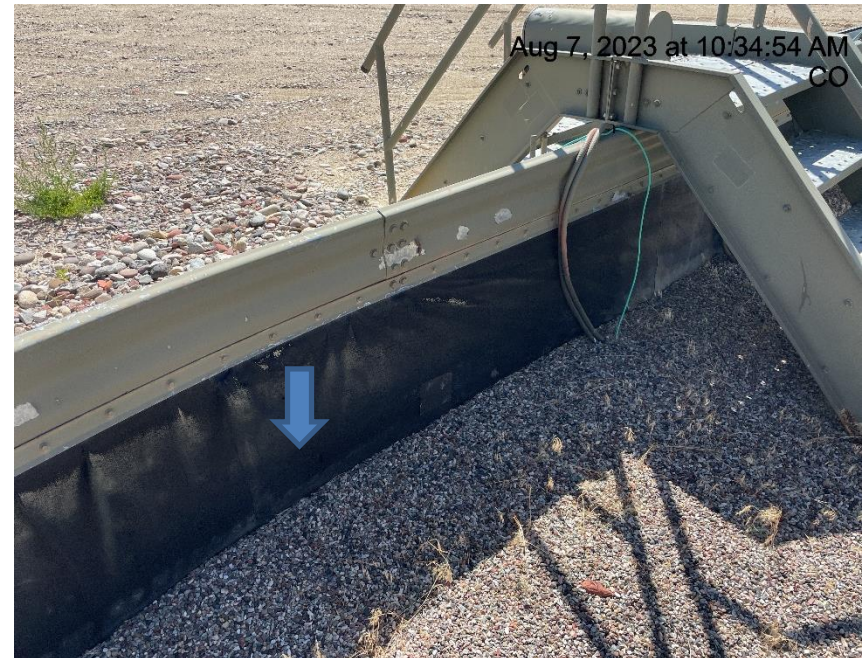
Photo # 4952 Secondary containment liner needs maintenance

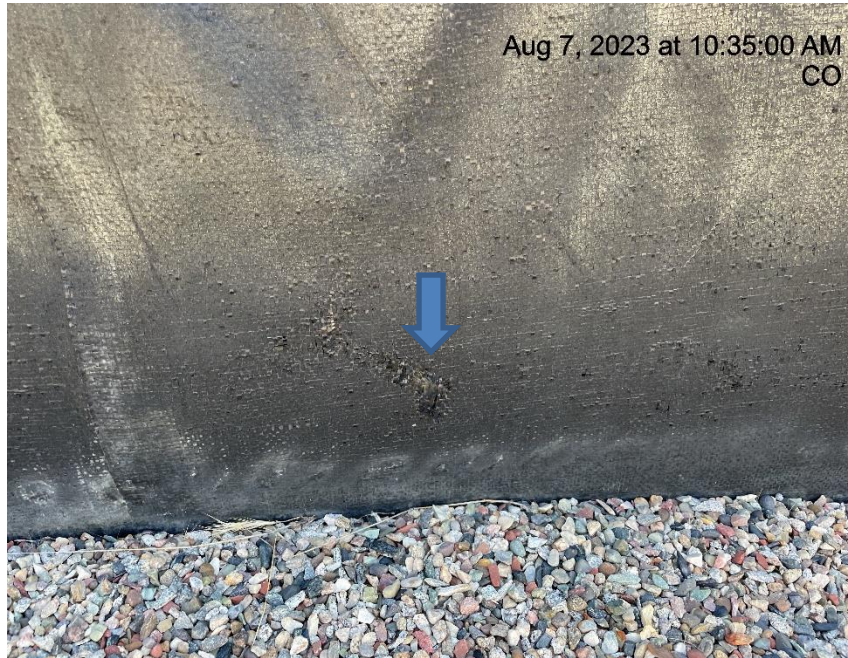
Photo # 4953 Secondary containment liner needs maintenance
