Inspection Photos
Location Name: CAERUS PICEANCE LLC J18 Pad
Location #: 334865

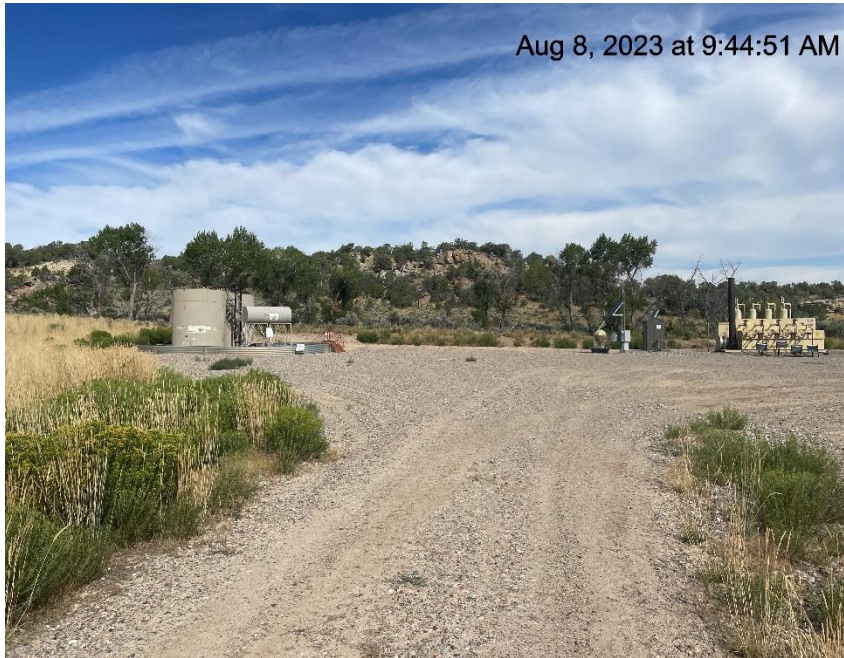
Photo # 5169 From entrance to location

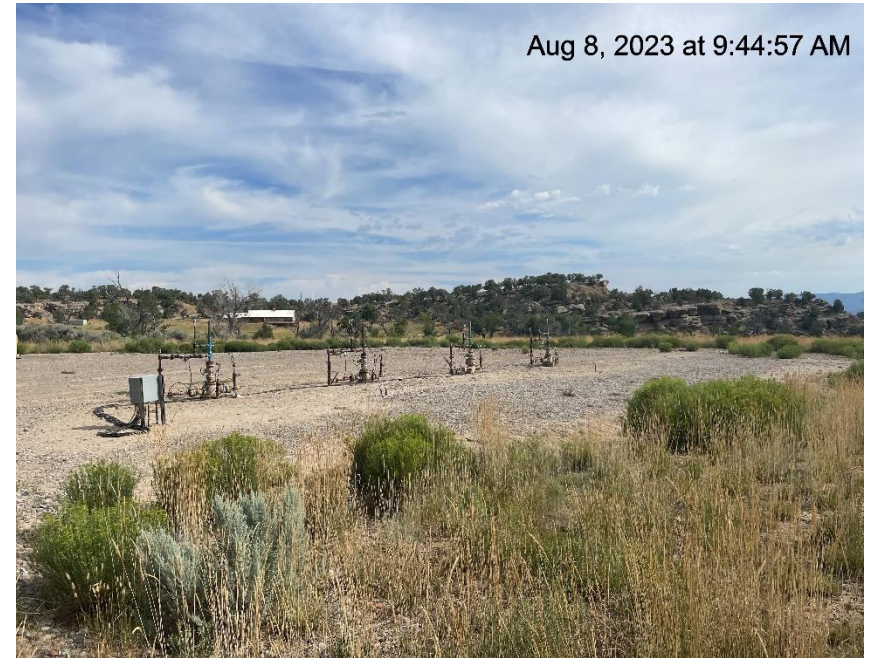
Photo # 5170 From entrance to location

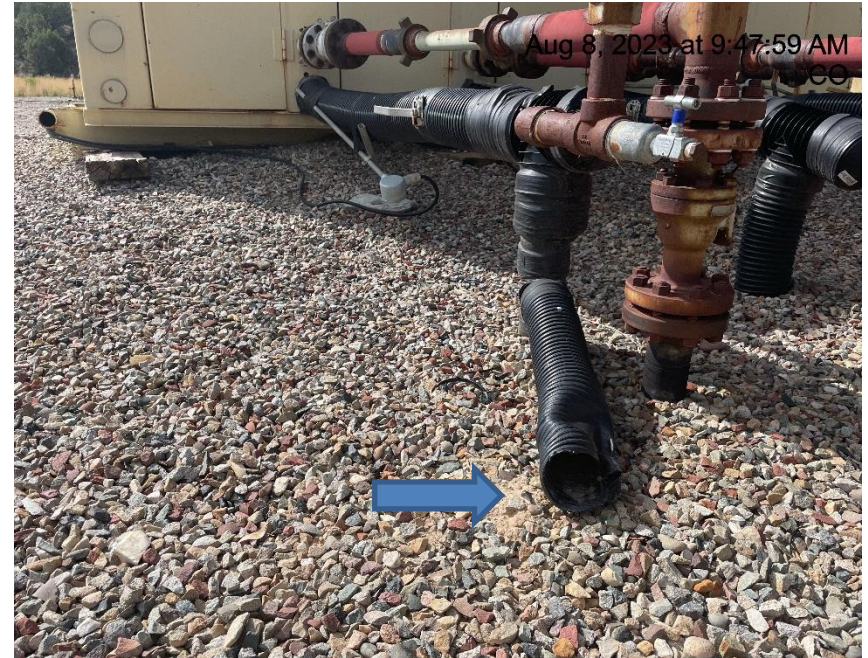
Photo # 5179 Flowline heating insulation open ended

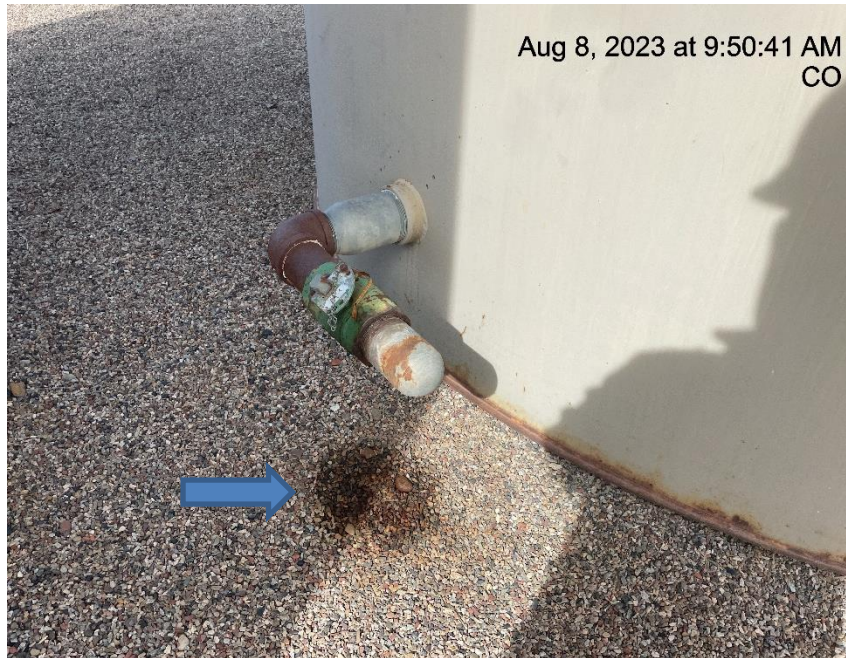
Photo # 5181 Stained gravel
